Corrosion induced failures of post-tensioned bridges

Technical Report · May 2022

Trondheim – May – 2022

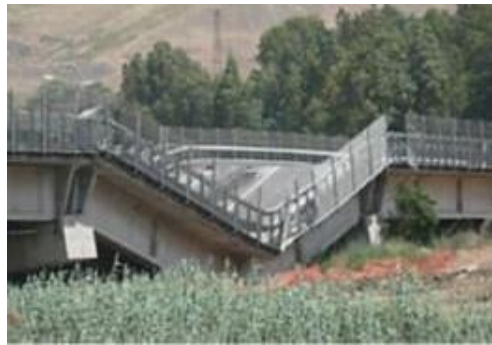
In the Petrulla Viaduct (ID-4) the collapse was determined by the breakage of the tendons, with subsequent expulsion of the anchorages (Figure 3.1.7) due to the release of stored elastic energy in the tendons. The breakage was followed by loss of prestress, hence loss of shear capacity, and consequent inward rotation of the lower flanges of the I-section beams. This mechanism ended by forming a plastic hinge (Figure 3.1.8) at mid span of one of the beams (Anania et al, 2018).

Figure 3.1.8. Collapse mechanism of Petrulla Viaduct (ID-4) (Anania et al, 2018).

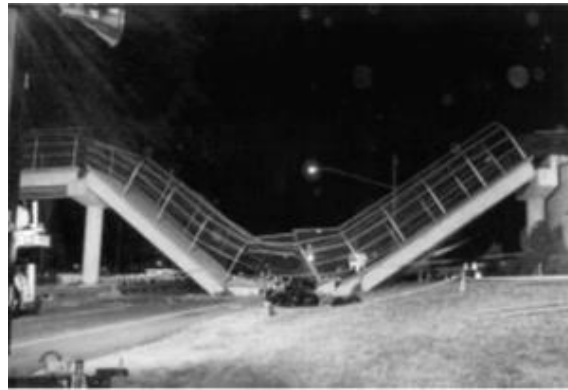
The collapse in Lowe’s Motor Speedway (ID-9) occurred while 107 people were passing over it (Poston and West, 2005), with the complete failure of one span (Figure 3.1.11). The collapse of Annone Viaduct (ID-21) was due to overloading, after the bridge suffered from numerous collisions and subsequent repairs over time (Di Prisco et al, 2018).

Figure 3.1.11. Collapsed span of Lowe’s Motor Speedway (ID-9) (Poston and West, 2005).

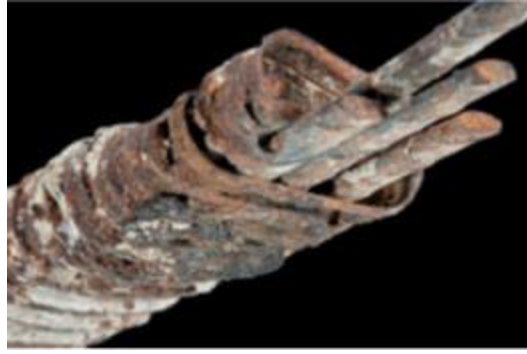
In Berlin Congress Hall (ID-19, described in Section 3.1) the roof failed next to the final groove of the ring beam (Helmerich and Zunkel, 2014). In that location, most of the tendons and the metallic ducts in which the tendons were encased appeared heavily corroded (Figure 3.3.11).

Figure 3.3.11. Remaining bituminized roofing on a completely failed, non-grouted and heavily corroded tendon in Berlin Congress Hall (ID-19) (Helmerich and Zunkel, 2014).

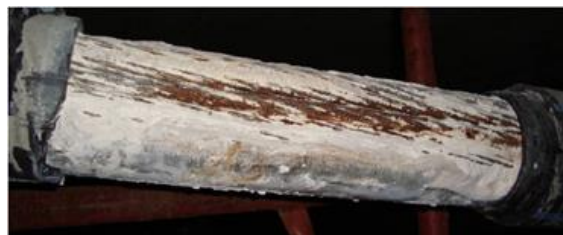
Corrosion, mostly in the form of pitting, took place in segments of the tendon that exhibited visible segregation of the grout or had partial or full depth voids (Ahern et al, 2018). In these locations the grout remained unhardened with a white, soft, and chalky appearance (Figures 4.2.2.1 and 4.2.2.2). The whitish grout had high pH, and contained only trace levels of chlorides, but high sulphate levels, even if the corrosion process occurred without infiltration of external chlorides or sulphates into the ducts. It is important to highlight that no corrosion attacks were found in the areas where the tendons were embedded in a regular hardened cement grout (Carsana and Bertolini, 2015).

Figure 4.2.2.2. Example of whitish segregated grout embedding corroding strands in an Italian bridge (ID-18) (Bertolini and Carsana, 2011).

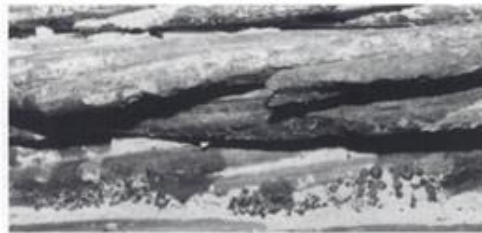
In Florida, concerns about grouting practices rose again in 2000, with the failure of external tendons (Figure 4.2.2.3) at the Mid-Bay Bridge (ID-7).

Figure 4.2.2.3. Broken wire in one of the strands of Mid-Bay Bridge (ID-7) (Venugopalan and Powers, 2003).

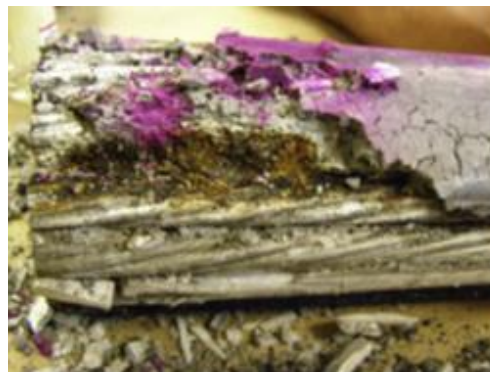
The post-tensioning industry in the United States responded with the adoption of more rigorous grout specifications (low permeability and little to no bleed) and execution programmes to ensure high-quality grouting operations. Thanks to the measures adopted, the number of tendon failures due to corrosion dropped. However from 2011 other bridges, constructed with the new measures adopted in 2000 (e.g., ID-15, Figure 4.2.2.4), reported tendon failures due to grout segregation.

Figure 4.2.2.4. Corrosion of a strand embedded in deficient grout in Ringling Causeway Bridge (ID-15). Pink colour shows the pH indicator (phenolphthalein) sprayed on the grout surface (Lau and Lasa, 2016).

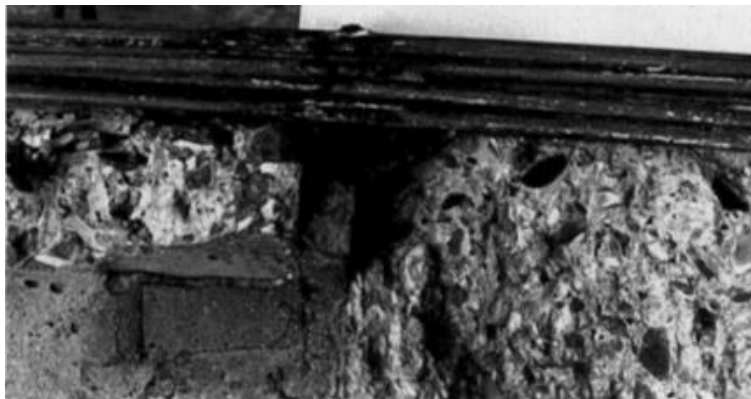
ID-1.5. Longitudinal tendon crossing a transverse joint: corrosion at localized joint (Woodward and Williams, 1988).

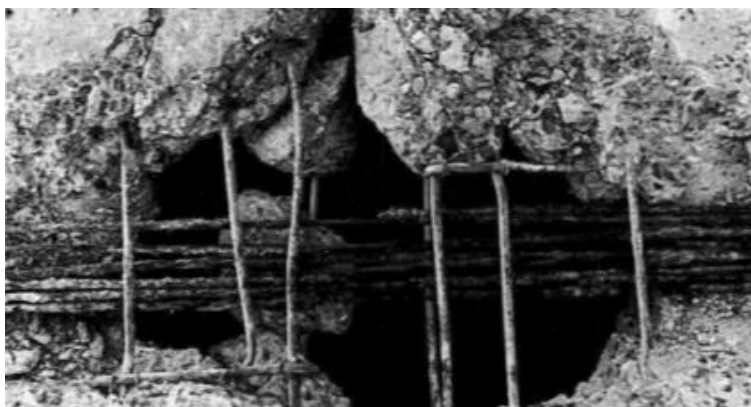
ID-1.6. Transverse tendon crossing a longitudinal joint: duct poorly grouted and corrosion on wires within segments (Woodward and Williams, 1988).

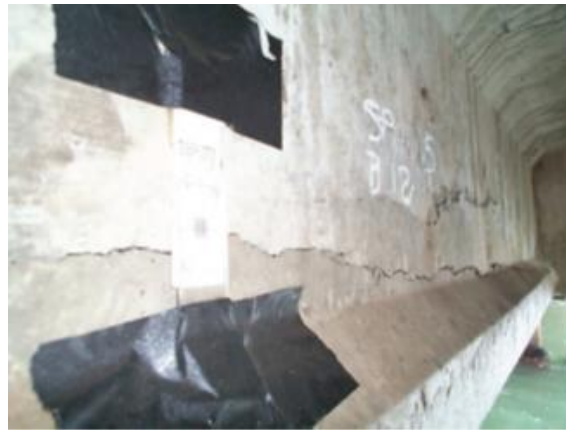
ID-3.2. Typical longitudinal web cracking along a beam (Papè and Melchers, 2011).

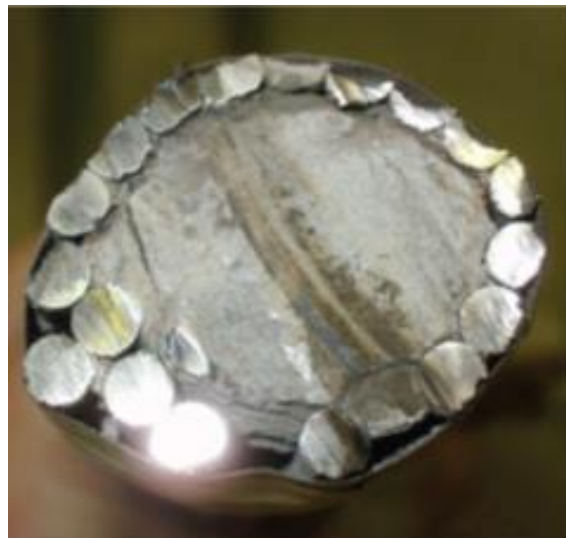
ID-3.3. Cross-sectional view of one of the most severely corroded tendons. Note the concave corrosion profiles at top and right. The central part is grout. The tape just visible around the outside as applied during recovery to keep the tendon together at the cross-sectional cut. There is no tendon duct (Papè and Melchers, 2011).

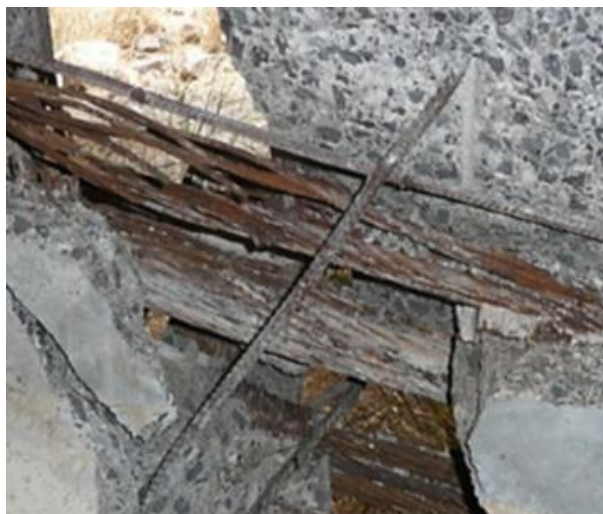
ID-4.3. Tendons in the bridge after collapse (Anania et al, 2018).

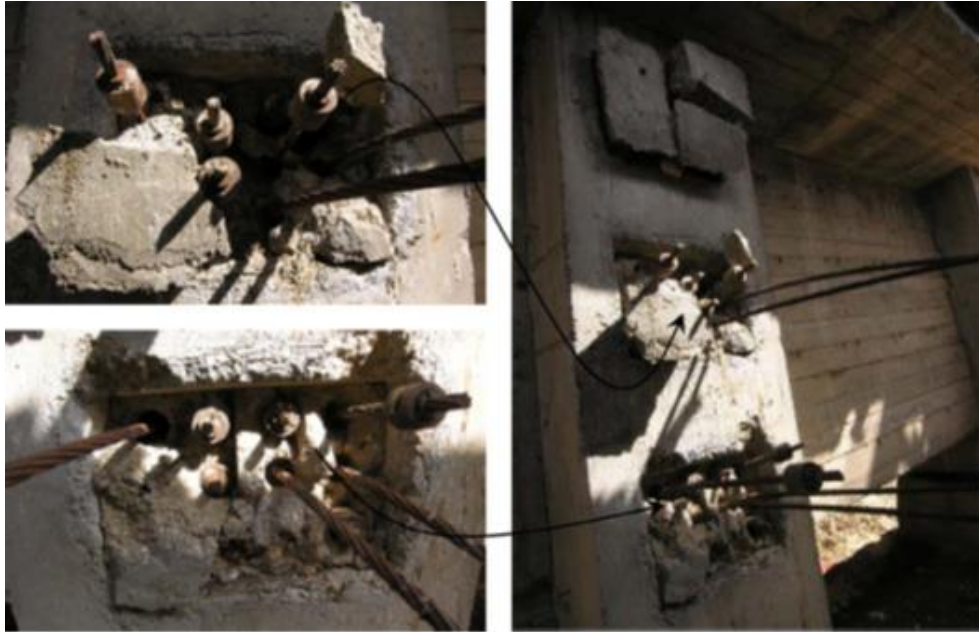
ID-4.4. Expulsion of the ducts head anchorages. Global view of the expulsion at the head of the girder beam (Anania et al, 2018).

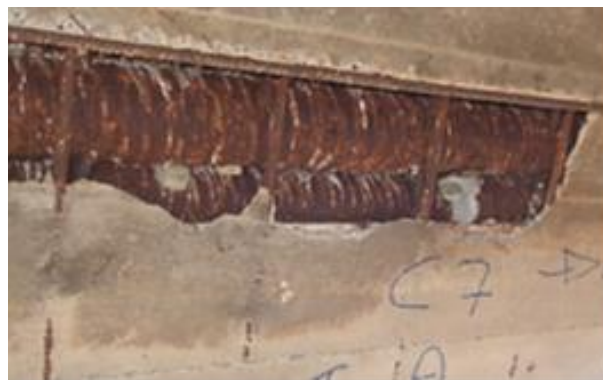
ID-4.5. No gap among the tendons (Anania et al, 2018).

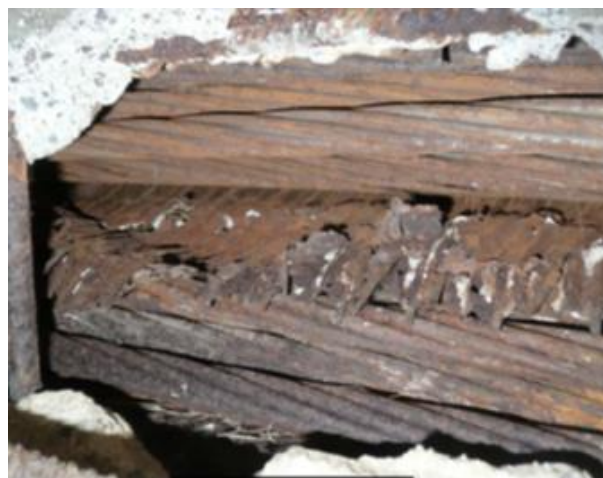
ID-4.6. Congestion of strands in the mid span of the bridge beams (Anania et al, 2018).

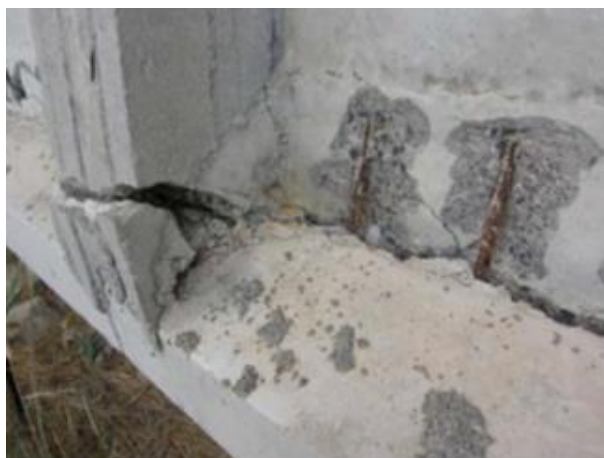
ID-4.9. Detailed view of vertical mild reinforcement expelled by the rotation of the lower flange (Anania et al, 2018).

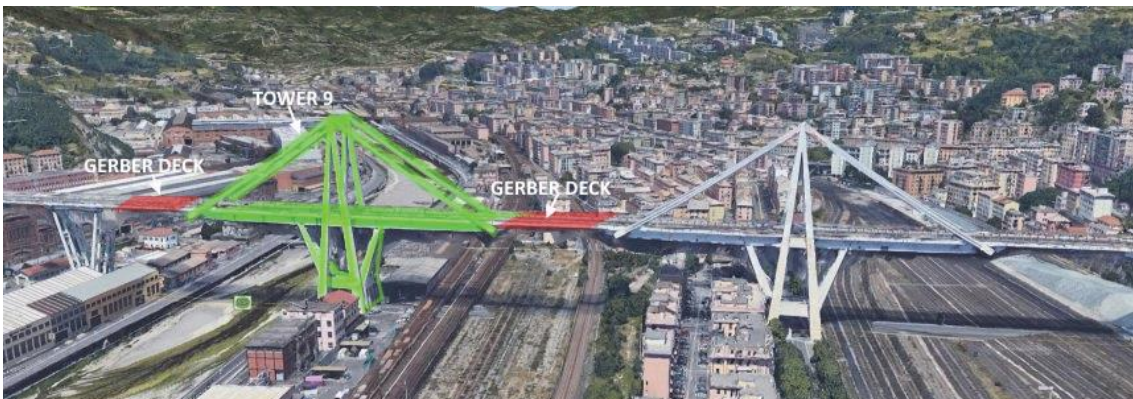
Figure 6.3. Involved structure in the collapse: tower and Gerber decks (Bazzucchi et al, 2018).

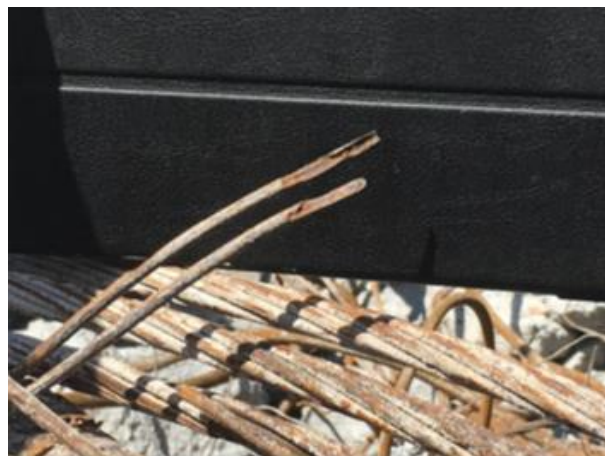
ID-6.8. Pit corrosion in the debris after failure (Nuti et al, 2020).

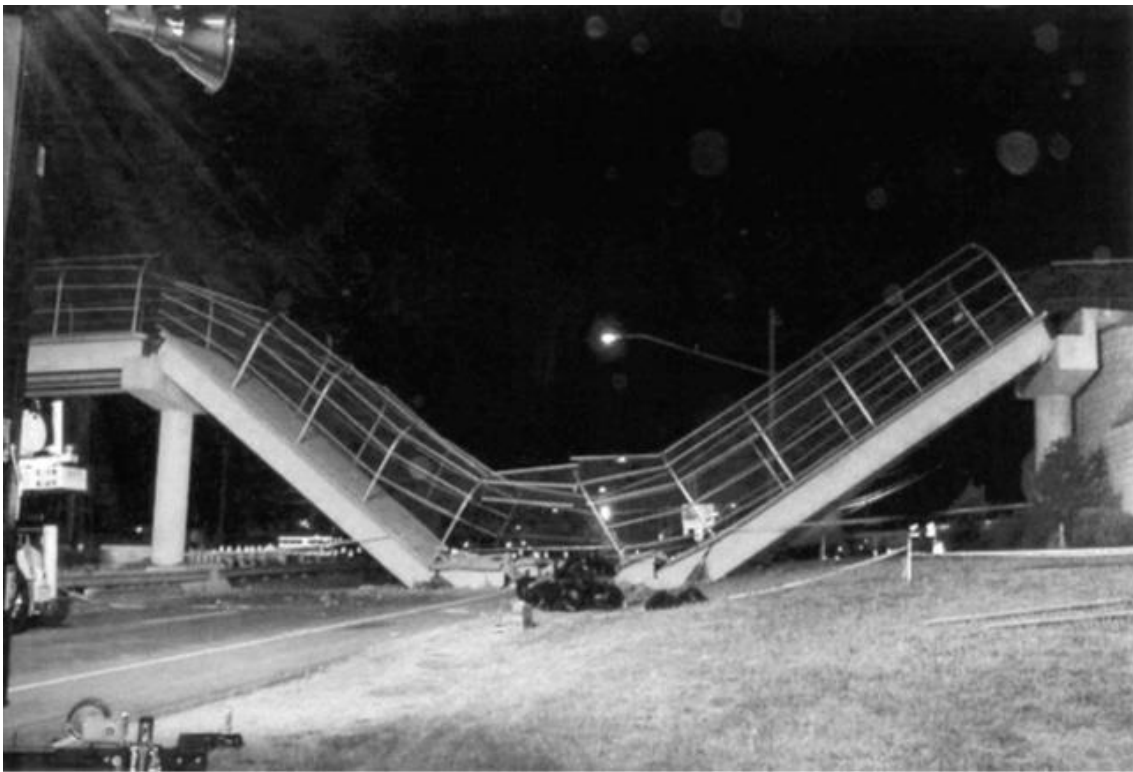
ID-9.1. Collapsed span of pedestrian bridge (Poston and West, 2005).

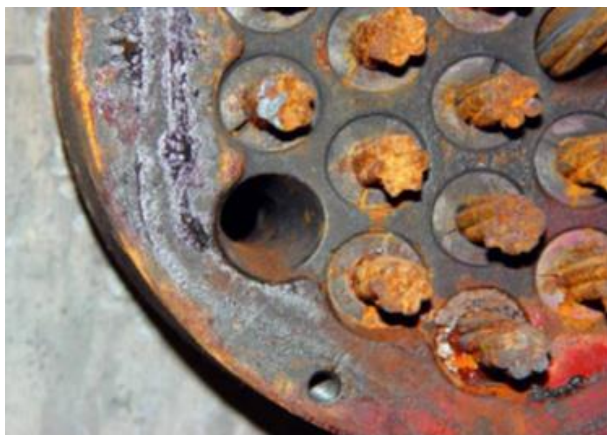
ID-14.1. Close-up view of an anchorage head at tendon location E3E-CO4S (continuity tendon) showing signs of corrosion from water collecting at the anchorage (Reis, 2007).

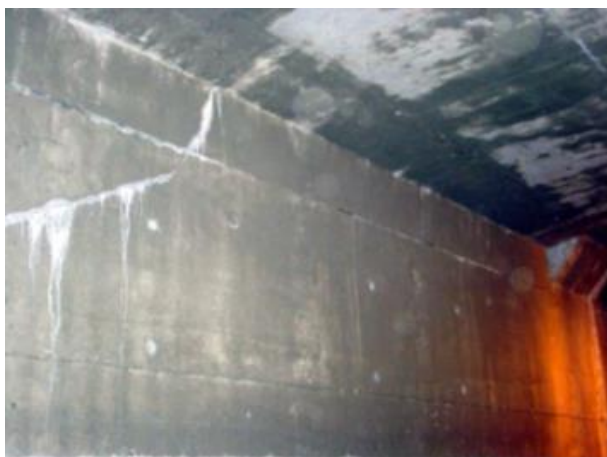
ID-14.2. View of interior web wall showing a crack and effervescence (Reis, 2007).

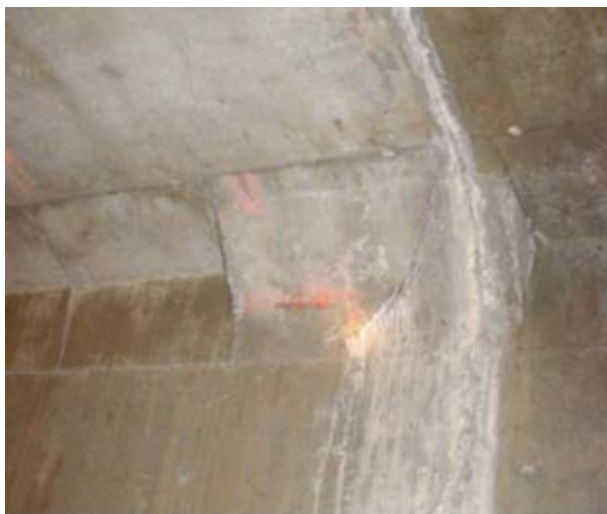
ID-14.3. View of a crack showing effervescence (Reis, 2007).

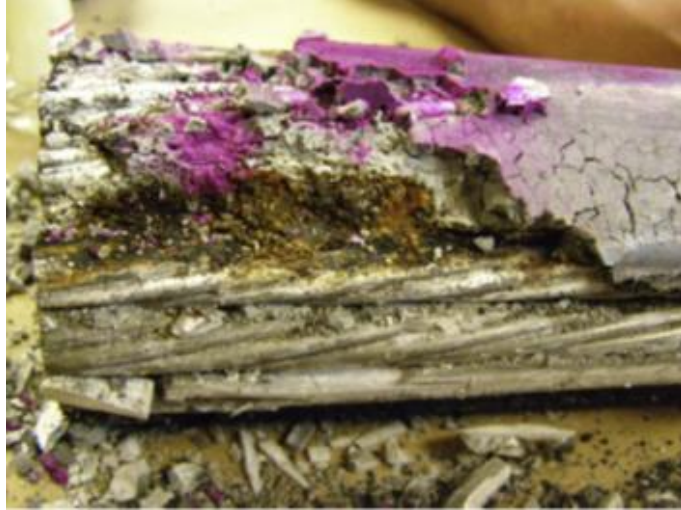
ID-15.6. Corrosion of a strand embedded in deficient grout. Pink colour shows the Ph indicator (phenolphthalein) sprayed on the grout surface (Lau and Lasa, 2016).

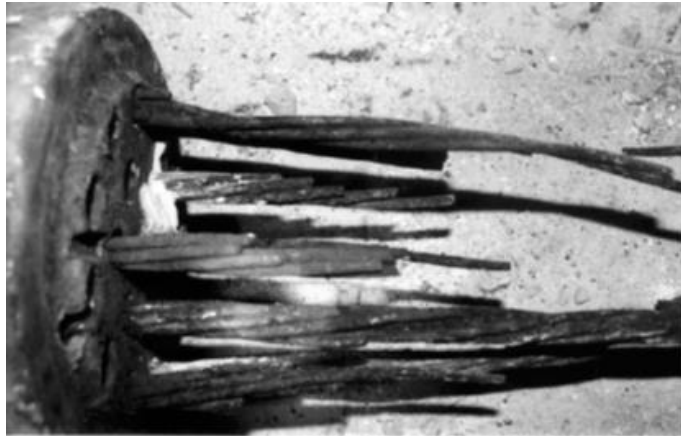
ID-17.1. Failed tendon of Niles Channel Bridge. June 1999 (Powers et al, 2002).

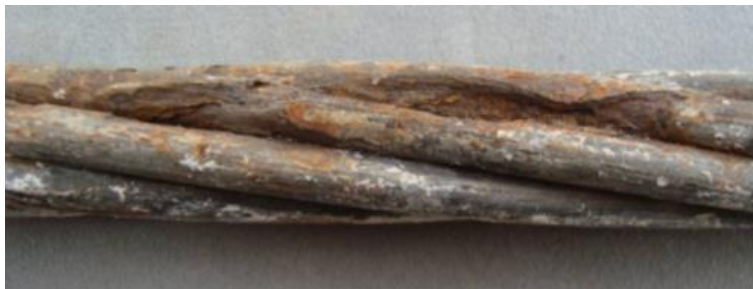
ID-18.3. Example of corrosion attacks on a prestressing strand in contact with the whitish segregated grout (Bertolini and Carsana, 2011).

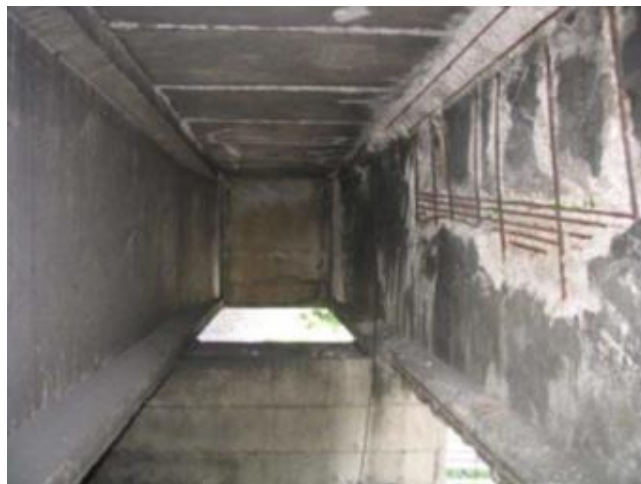
ID-21.6. Damage observed on internal surfaces of the prefabricated beams in 2006 (Di Prisco et al, 2018).

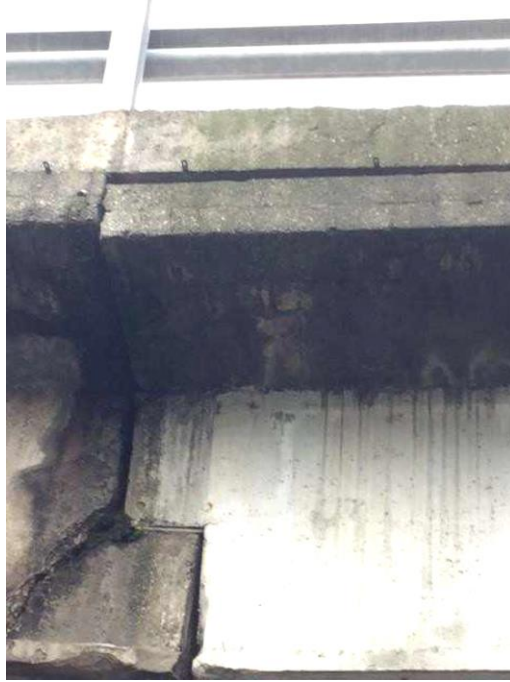
ID-21.7. Critical dapped-end joint view before the collapse: side view (Di Prisco et al, 2018).

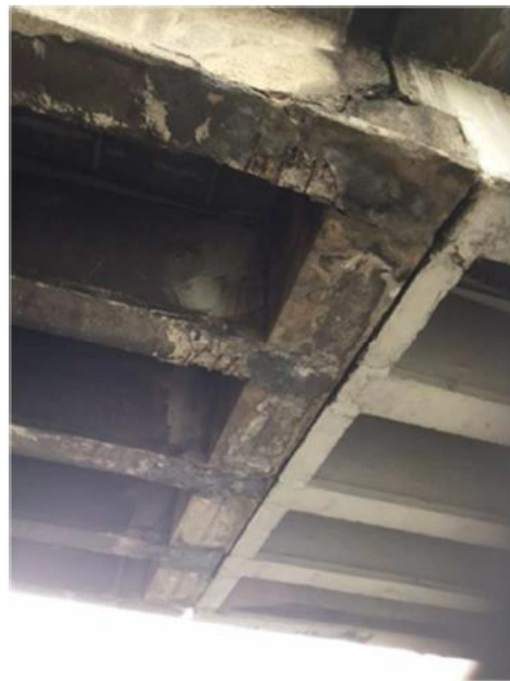
ID-21.8. Critical dapped-end joint view before the collapse: bottom view (Di Prisco et al, 2018).

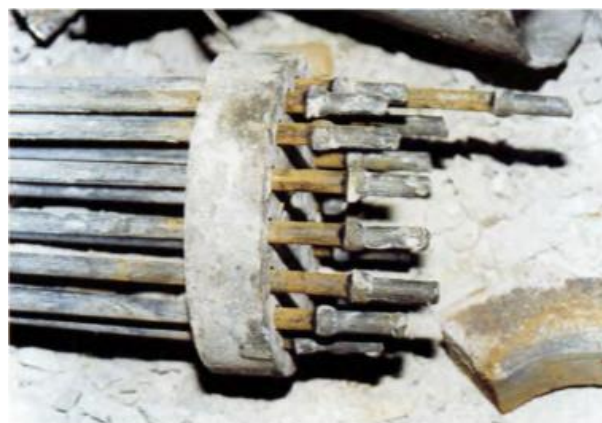
ID-30.3. Corrosion of wires at anchorage plate is greater than that exhibited inside ducts. (Dickson et al, 1993).
