Corrosion induced failures of post-tensioned bridges

Technical Report · May 2022

NTNU
Norwegian University of
Science and Technology
Faculty of Engineering
Department of Structural Engineering

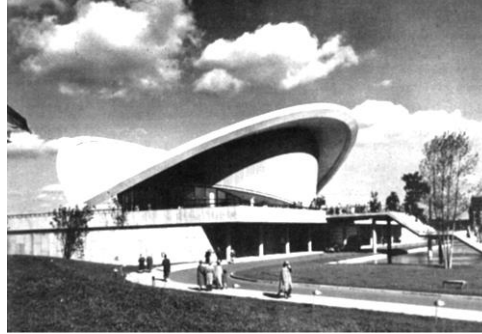
ID-19 was a structure covered by a double curved roof (Figure 3.1.4) erected on only two bearings (Figure 3.1.5). The roof consisted of two prestressed parts (inner- and outer-roof, respectively) resting on a concrete ring beam. It suddenly collapsed (Figure 3.1.6) due to corrosion-induced fractures in the tendons. The collapse occurred without early indications (Helmerich and Zunkel, 2014).

Figure 3.1.4. Original structure of Berlin Congress Hall (ID-19) before sudden collapse (Helmerich and Zunkel, 2014).

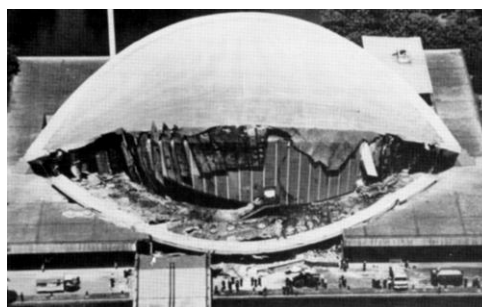
Figure 3.1.6. Berlin Congress Hall (ID-19). View from the South on the collapsed roof overhang in 1980 (Helmerich and Zunkel, 2014).

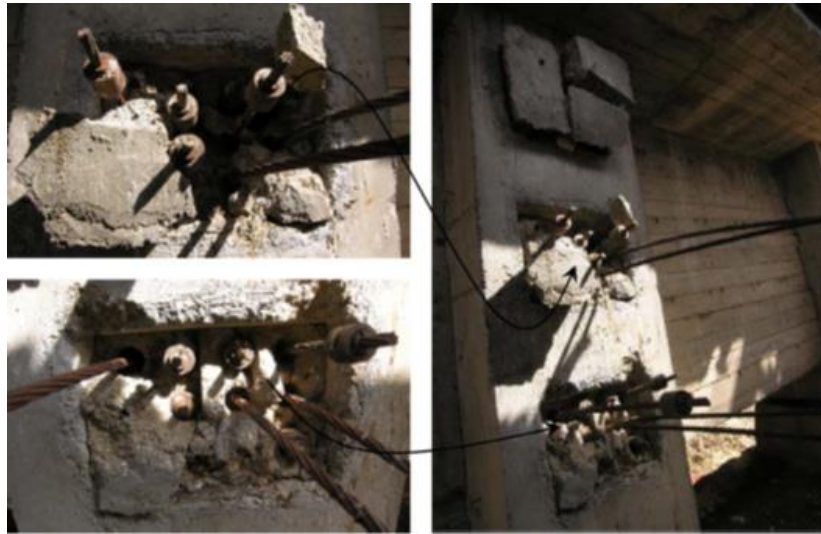
In the Petrulla Viaduct (ID-4) the collapse was determined by the breakage of the tendons, with subsequent expulsion of the anchorages (Figure 3.1.7) due to the release of stored elastic energy in the tendons. The breakage was followed by loss of prestress, hence loss of shear capacity, and consequent inward rotation of the lower flanges of the I-section beams. This mechanism ended by forming a plastic hinge (Figure 3.1.8) at mid span of one of the beams (Anania et al, 2018).

Figure 3.1.7. Petrulla Viaduct (ID-4). Expulsion of the anchorages. Global view of the expulsion at the end of the beam (Anania et al, 2018).

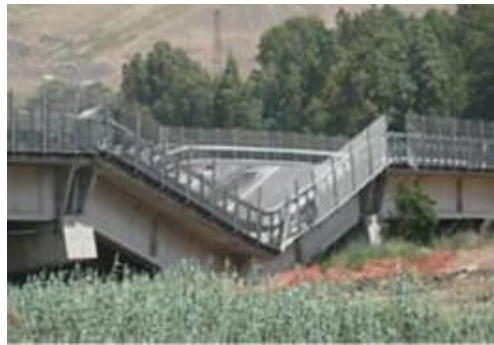
Figure 3.1.8. Collapse mechanism of Petrulla Viaduct (ID-4) (Anania et al, 2018).

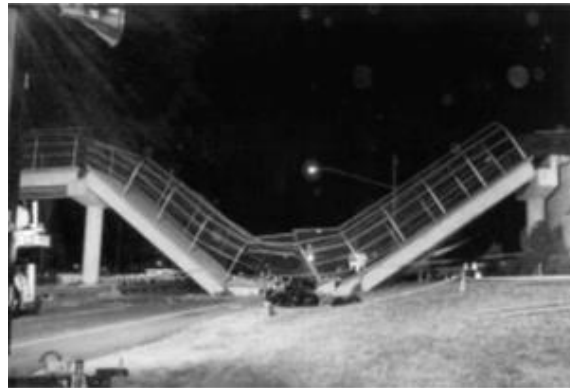
The collapse in Lowe’s Motor Speedway (ID-9) occurred while 107 people were passing over it (Poston and West, 2005), with the complete failure of one span (Figure 3.1.11). The collapse of Annone Viaduct (ID-21) was due to overloading, after the bridge suffered from numerous collisions and subsequent repairs over time (Di Prisco et al, 2018).

Figure 3.1.11. Collapsed span of Lowe’s Motor Speedway (ID-9) (Poston and West, 2005).

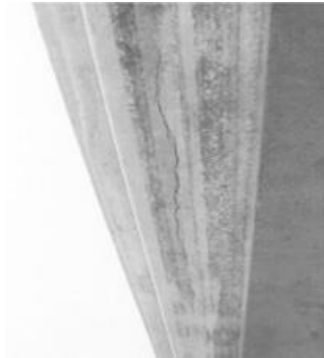
- longitudinal cracks (Figure 3.1.17) along the stem soffit at mid span directly under the grout plug location;
- corrosion staining around the grout plugs in several beams.

It was evident that the grout plugs, used in the process to give the strands their profile in the beams, clearly represented a weakness for the bridge.

Figure 3.1.17. Lowe's Motor Speedway (ID-9): longitudinal crack in double-T stem directly under the grout plug location (Poston and West, 2005).

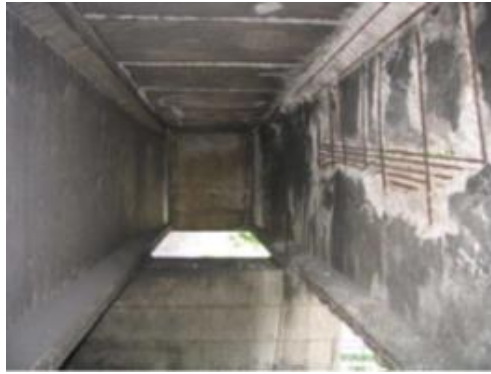
In Annone Overpass (ID-21) high levels of corrosion as well as concrete spalling were observed along the beams (Figure 3.1.19). However, the presence of a shear crack at the Gerber joint (Figure 3.1.20) was well known from more than 10 years before the collapse (Di Prisco et al, 2018).

Figure 3.1.19. Annone Overpass (ID-21). Damage observed on internal surfaces of the prefabricated beams in 2006 (Di Prisco et al, 2018).

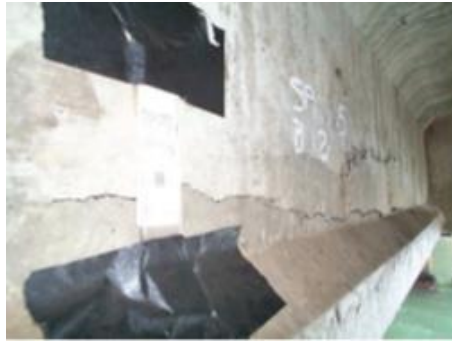
Sorell Bridge (ID-3) was demolished because of the appearance of cracking (Figure 3.1.21) along the web of 51 beams. The cracks followed the path of the post-tensioning tendons, leaving the tendons without concrete protection in some cases (Papè and Melchers, 2011).

The cracks raised concern especially because the tendons were encased directly in the concrete, without ducts. Hence, the tendons would have been directly exposed to the external environment (rich in chlorides since the bridge crossed a lagoon). Moreover, the damage was extended to several beams.

Figure 3.1.21. Typical longitudinal web cracking along a beam in Sorell Bridge (ID-3) (Papè and Melchers, 2011).

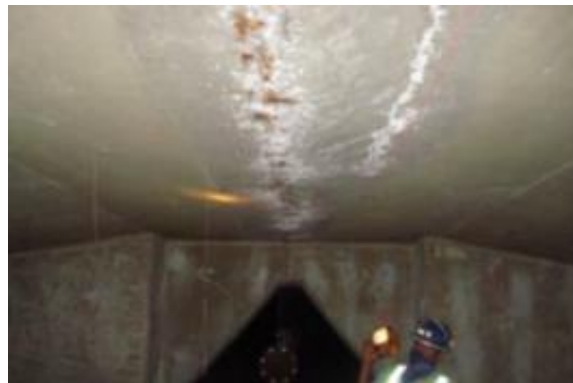
Figure 3.1.23. Bridge in the Midwest, USA (ID-13). Presence of efflorescence, delamination, and spalling observed on post-tensioned box girders (Venugopalan, 2008).

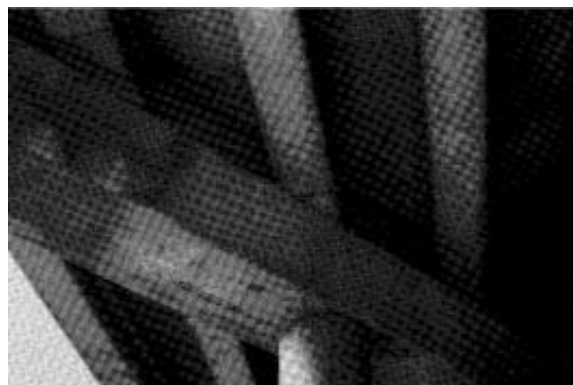
Figure 3.1.24. Harlem Avenue overpass, USA (ID-32). Corrosion of the bottom of the girder. (Gustaferro et al, 1983).

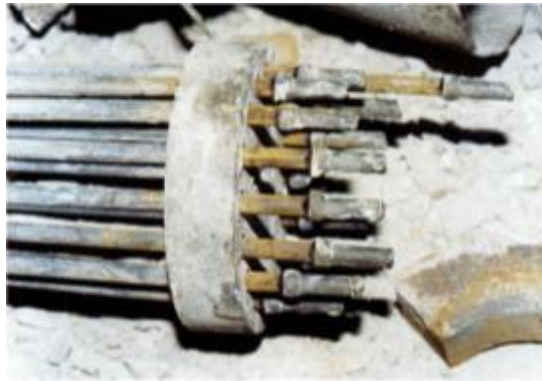
Figure 3.3.3. Corrosion of wires at anchorage plate in I-94 Bridge over US 81 (ID-30) (Dickson et al, 1993).

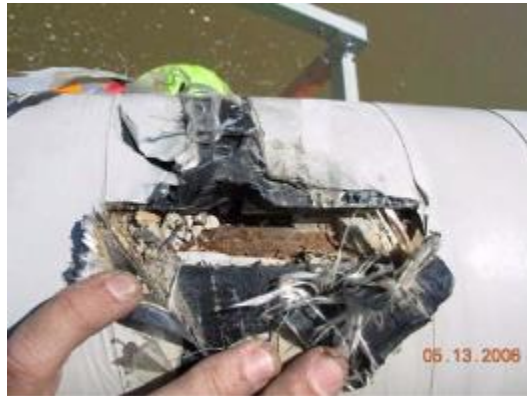
Failed tendons (either cables or prestressing tendons, externally or internally post-tensioned) usually appeared corroded, with longitudinal and transverse splits in the PE duct (Figure 3.3.6). There were also cases with completely ruptured tendons, lying on the bottom of the span (Figure 3.3.7) or tendon slippage from the ducts in the failed section of the structure (Figure 3.3.4).

Figure 3.3.6. Luling Bridge (ID-10). Corrosion of wires at PE split (Mehrabi, 2009).

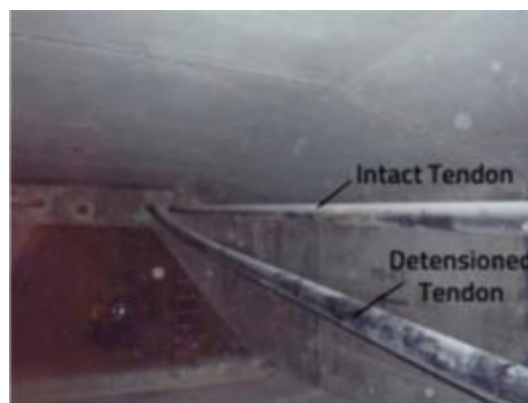
Figure 3.3.7. Ringling Causeway Bridge (ID-15). Detensioned tendon discovered in July 2011 (Ahern et al, 2018).

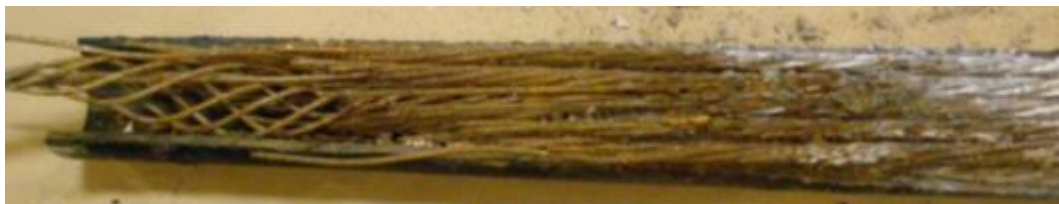
Figure 3.3.8. Corroded tendon in a Florida Bridge (ID-20) (Lau and Lasa, 2016).

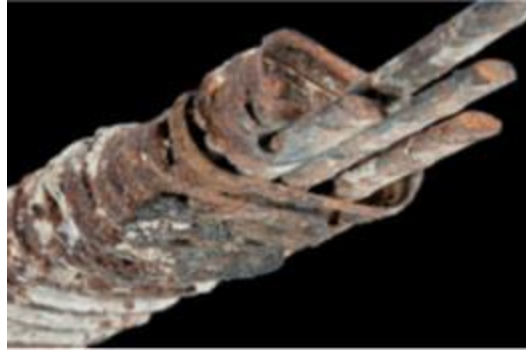
In Berlin Congress Hall (ID-19, described in Section 3.1) the roof failed next to the final groove of the ring beam (Helmerich and Zunkel, 2014). In that location, most of the tendons and the metallic ducts in which the tendons were encased appeared heavily corroded (Figure 3.3.11).

Figure 3.3.11. Remaining bituminized roofing on a completely failed, non-grouted and heavily corroded tendon in Berlin Congress Hall (ID-19) (Helmerich and Zunkel, 2014).

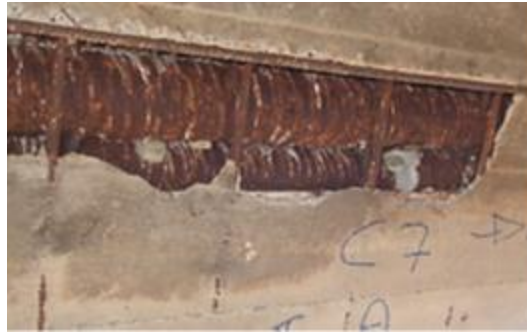
Figure 4.2.1.1. No gap among the tendons in Petrulla Viaduct (ID-4) (Anania et al, 2018).

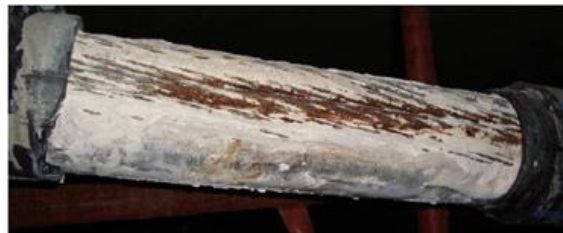
Figure 4.2.2.2. Example of whitish segregated grout embedding corroding strands in an Italian bridge (ID-18) (Bertolini and Carsana, 2011).

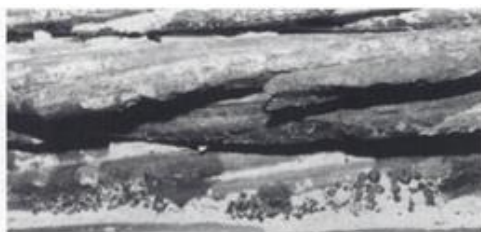
In Florida, concerns about grouting practices rose again in 2000, with the failure of external tendons (Figure 4.2.2.3) at the Mid-Bay Bridge (ID-7).

Figure 4.2.2.3. Broken wire in one of the strands of Mid-Bay Bridge (ID-7) (Venugopalan and Powers, 2003).

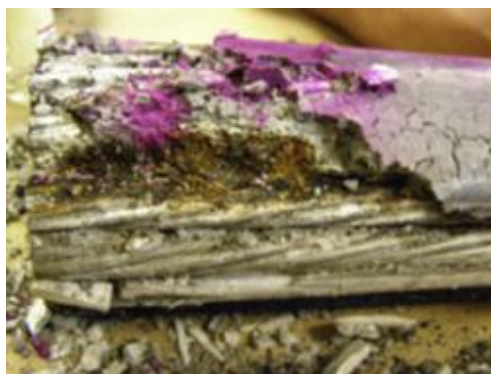
Figure 4.2.2.4. Corrosion of a strand embedded in deficient grout in Ringling Causeway Bridge (ID-15). Pink colour shows the pH indicator (phenolphthalein) sprayed on the grout surface (Lau and Lasa, 2016).

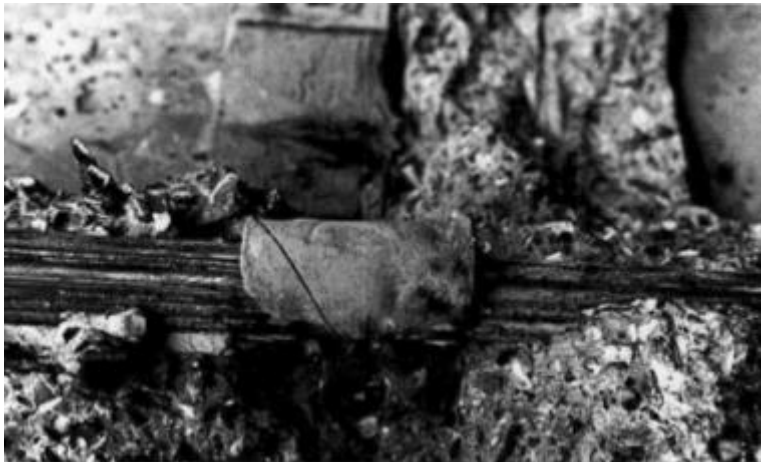
ID-1.3. Cardboard tube across transverse joint (Woodward and Williams, 1988).

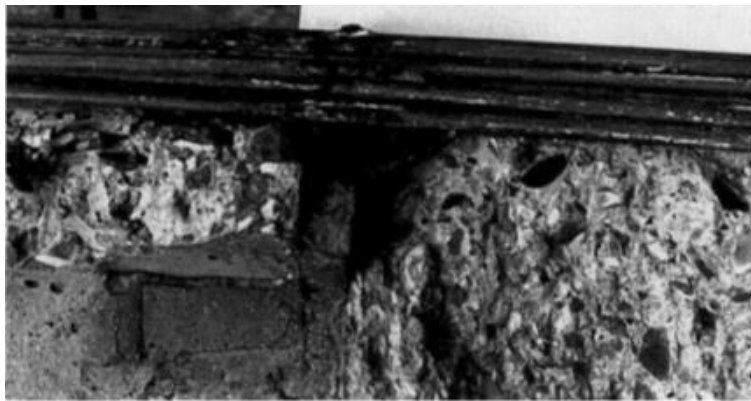
ID-1.5. Longitudinal tendon crossing a transverse joint: corrosion at localized joint (Woodward and Williams, 1988).

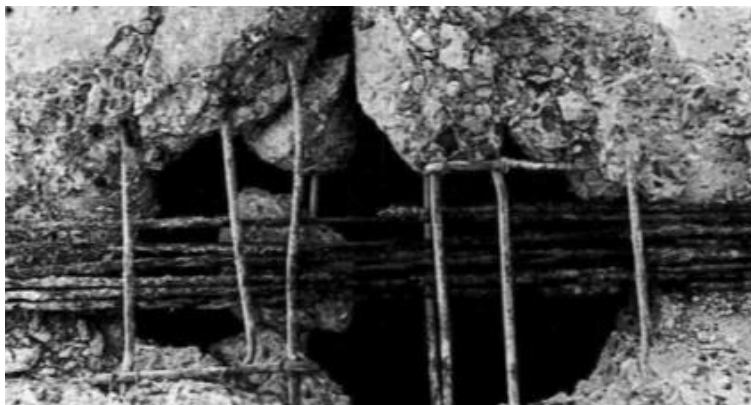
ID-1.6. Transverse tendon crossing a longitudinal joint: duct poorly grouted and corrosion on wires within segments (Woodward and Williams, 1988).

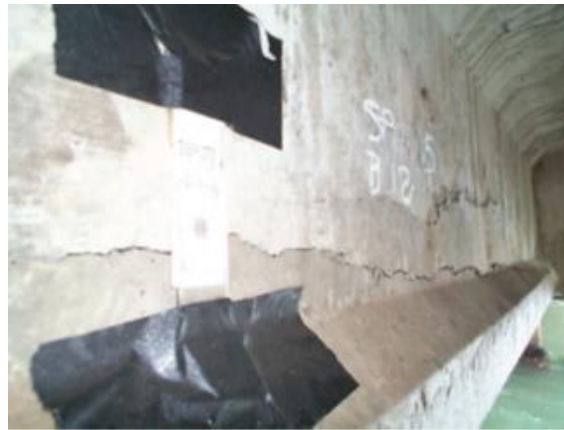
ID-3.2. Typical longitudinal web cracking along a beam (Papè and Melchers, 2011).

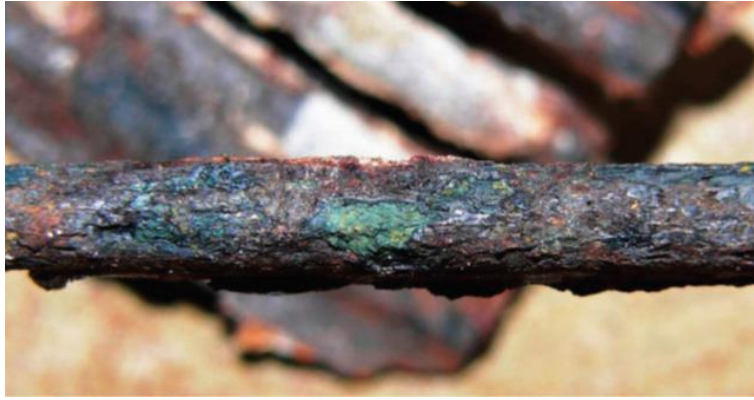
ID-3.4. Prestressing strand with corrosion products including dark-green-coloured rust (Papè and Melchers, 2011).

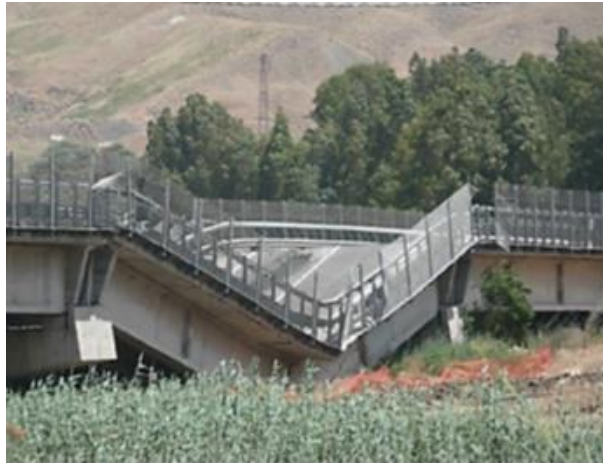
ID-4.1. Collapse mechanism of the bridge (Anania et al, 2018).

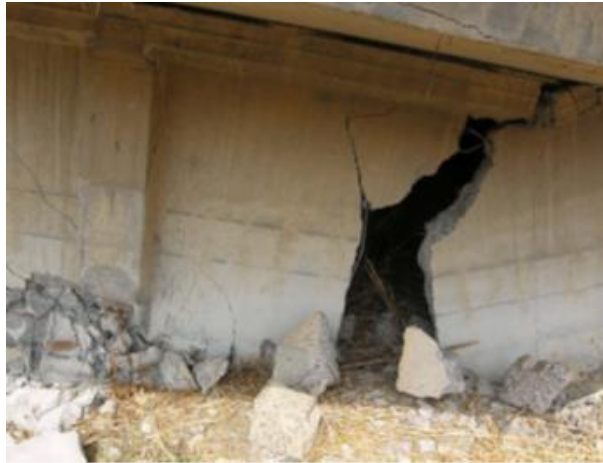
ID-4.2 Bridge beam: mid span fracture (Anania et al, 2018).

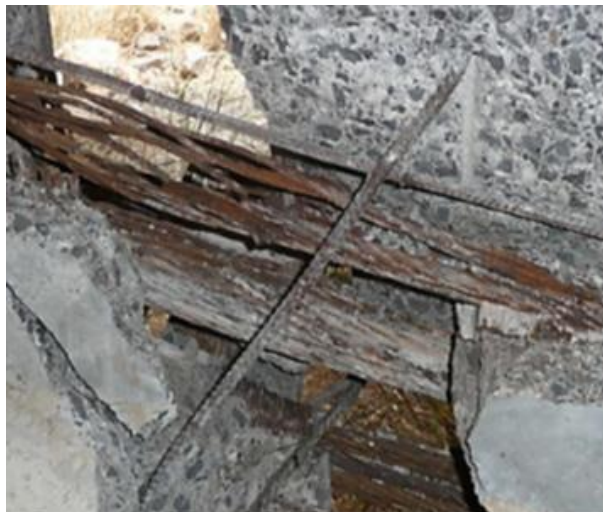
ID-4.3. Tendons in the bridge after collapse (Anania et al, 2018).

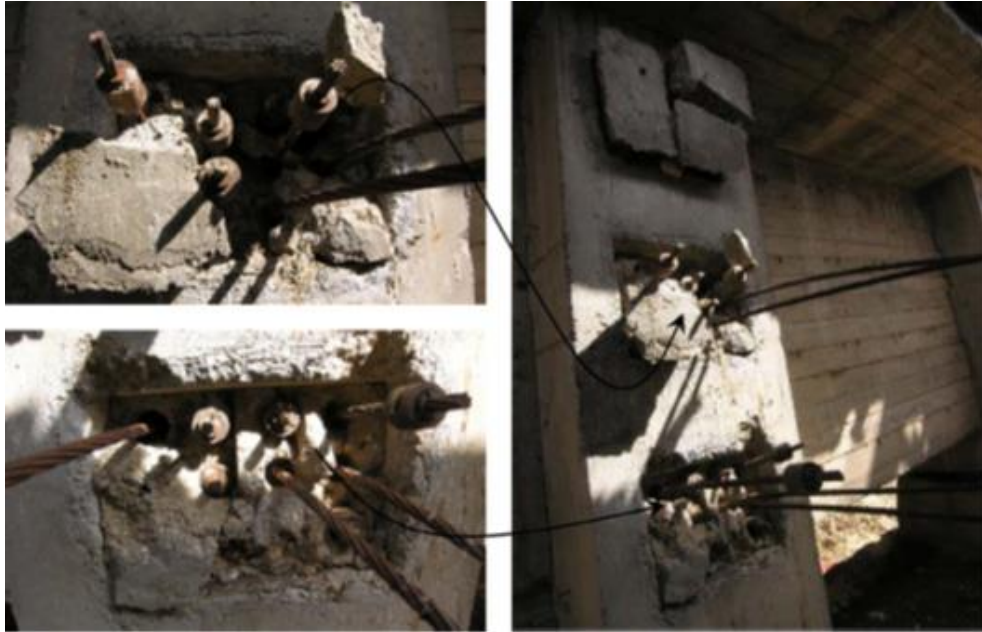
ID-4.4. Expulsion of the ducts head anchorages. Global view of the expulsion at the head of the girder beam (Anania et al, 2018).

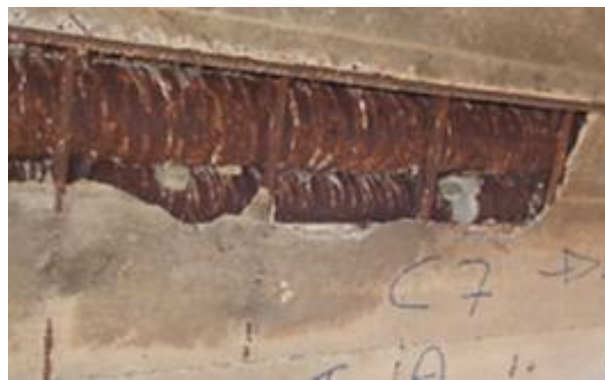
ID-4.5. No gap among the tendons (Anania et al, 2018).

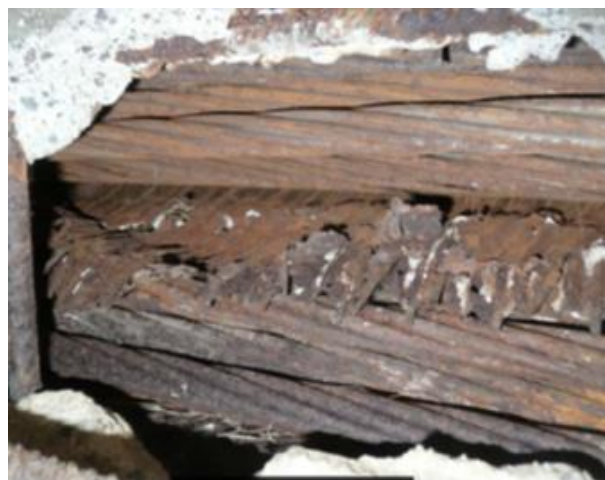
ID-4.6. Congestion of strands in the mid span of the bridge beams (Anania et al, 2018).

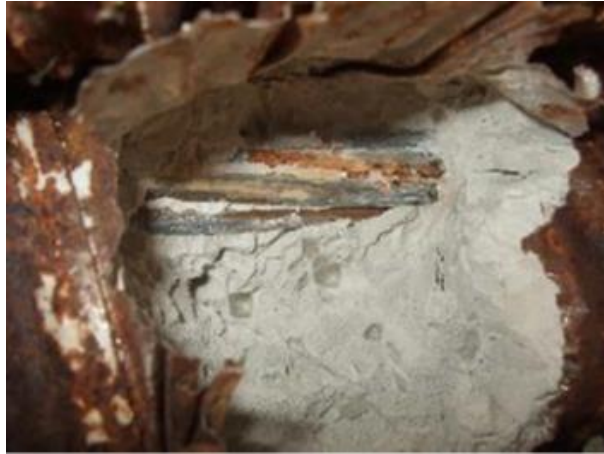
ID-4.7. View of the non-Portland cement grout for the bonding of tendons and advanced corrosion of both duct and strands (Anania et al, 2018).

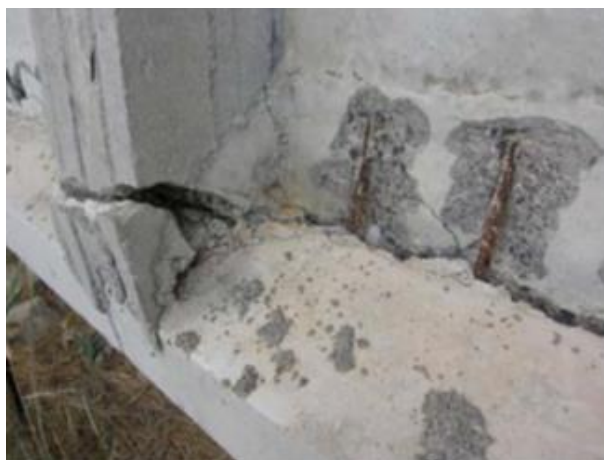
ID-4.9. Detailed view of vertical mild reinforcement expelled by the rotation of the lower flange (Anania et al, 2018).

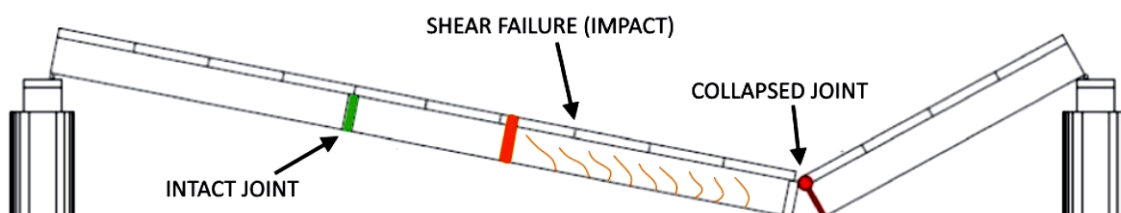
ID-5.3. Collapse mechanism (Bazzucchi et al, 2018).

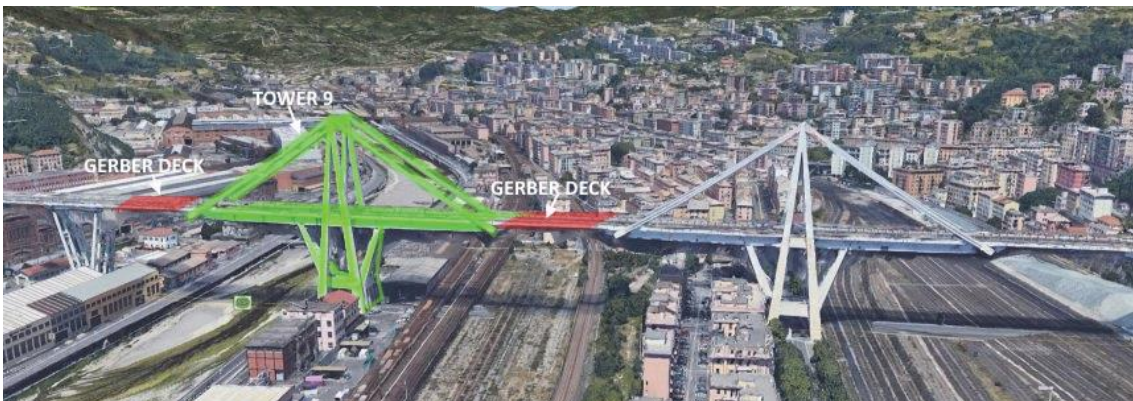
Figure 6.3. Involved structure in the collapse: tower and Gerber decks (Bazzucchi et al, 2018).

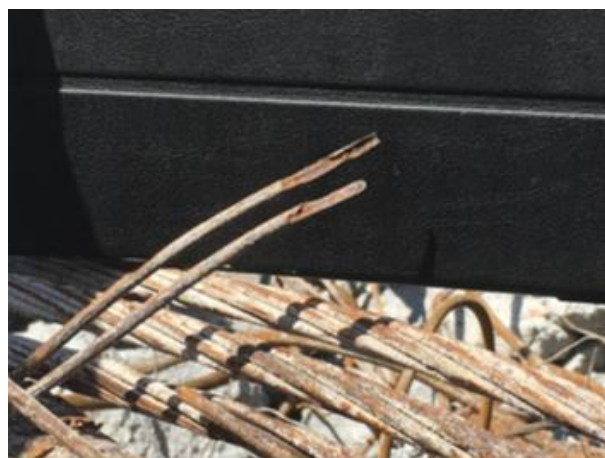
ID-6.8. Pit corrosion in the debris after failure (Nuti et al, 2020).

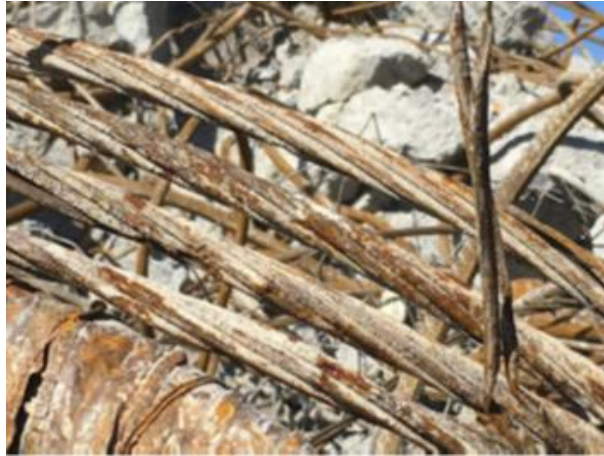
ID-6.9. Pitting corrosion of prestressing tendons (Morgese et al, 2020).

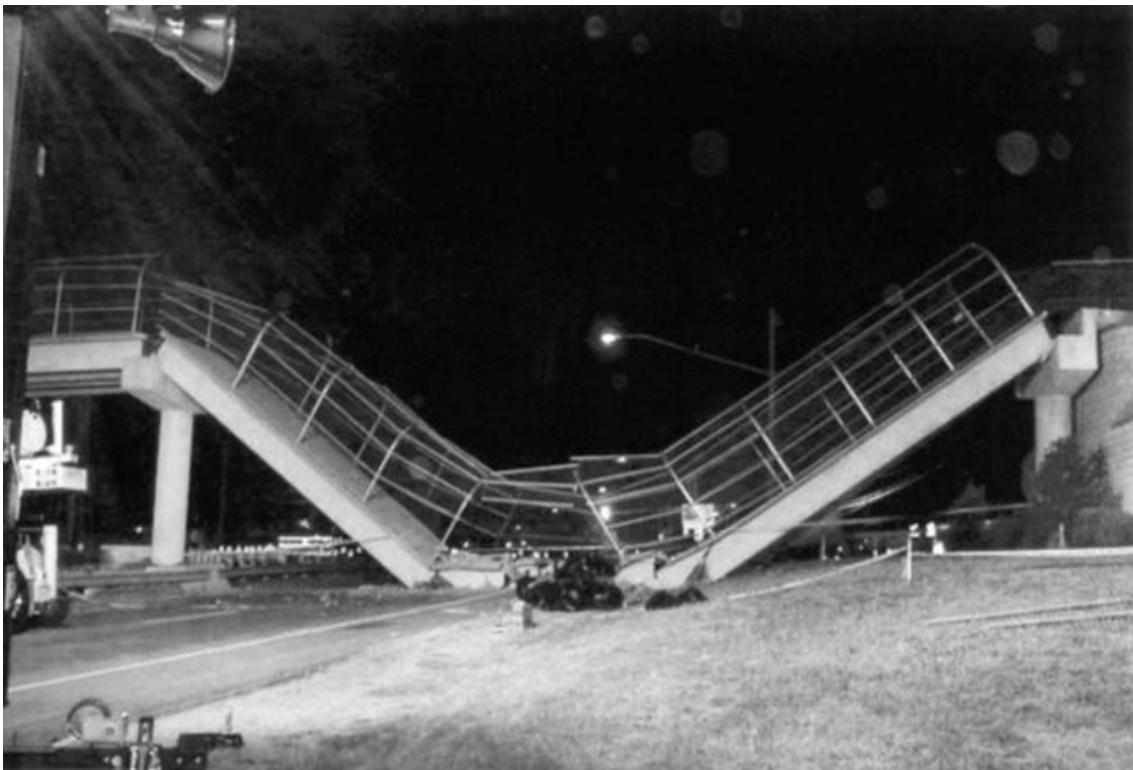
ID-9.1. Collapsed span of pedestrian bridge (Poston and West, 2005).

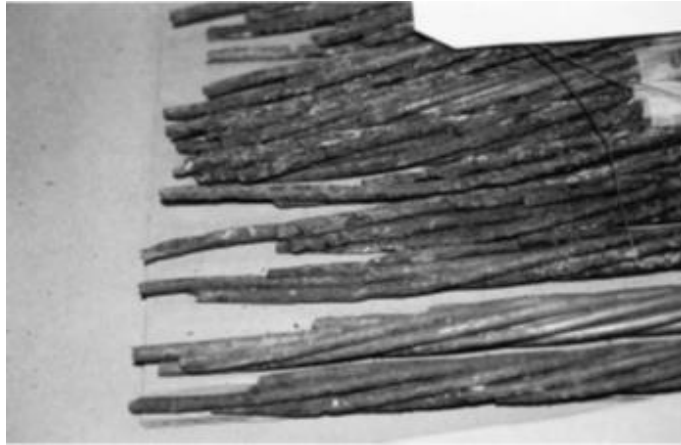
ID-9.3. Strand from one of the collapsed double-T's beams (Poston and West, 2005).

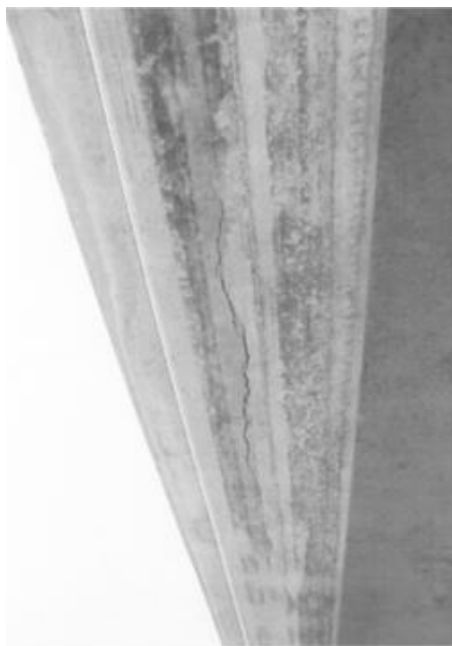
ID-9.5. Longitudinal crack in double-T beams stem directly under the grout plug location (Poston and West, 2005).

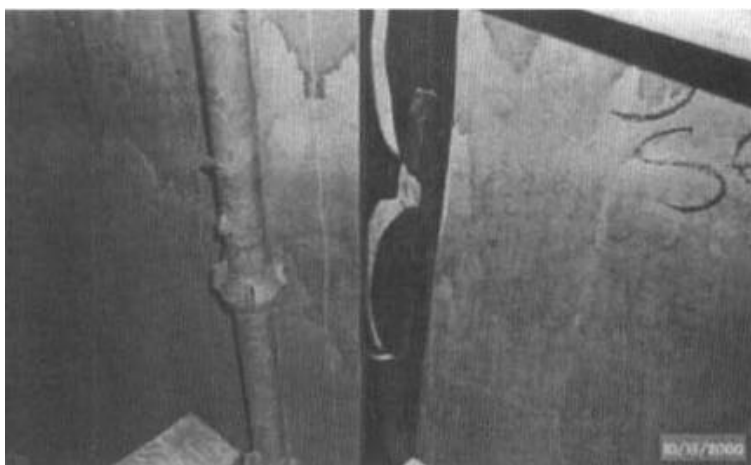
ID-11.7. Cracked PE duct (Theryo et al, 2011).

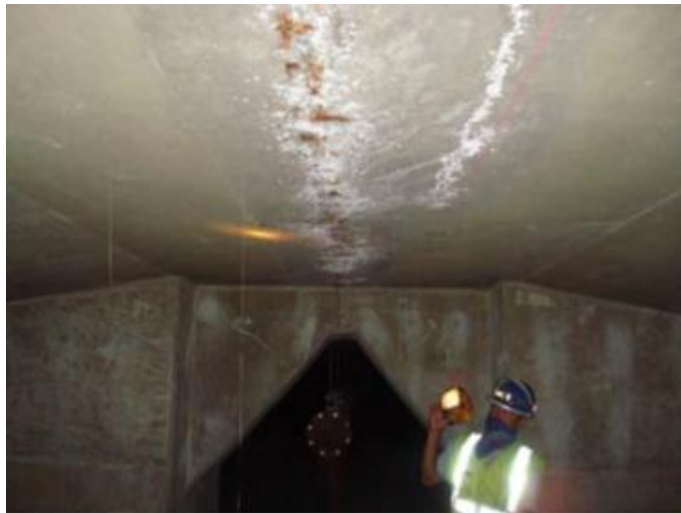
ID-13.2. Presence of efflorescence, delamination, and spall observed on post-tensioned box girders (Venugopalan, 2008).

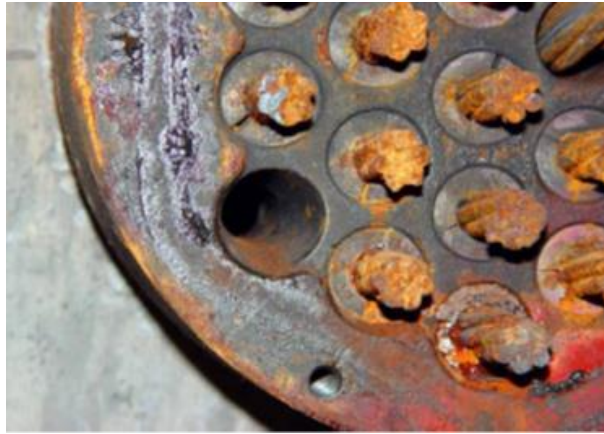
ID-14.1. Close-up view of an anchorage head at tendon location E3E-CO4S (continuity tendon) showing signs of corrosion from water collecting at the anchorage (Reis, 2007).

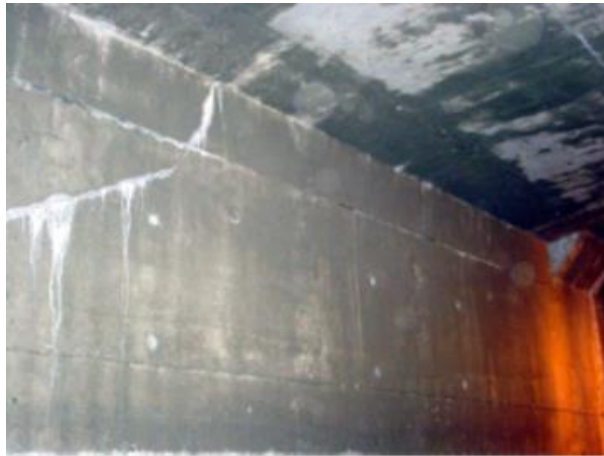
ID-14.2. View of interior web wall showing a crack and effervescence (Reis, 2007).

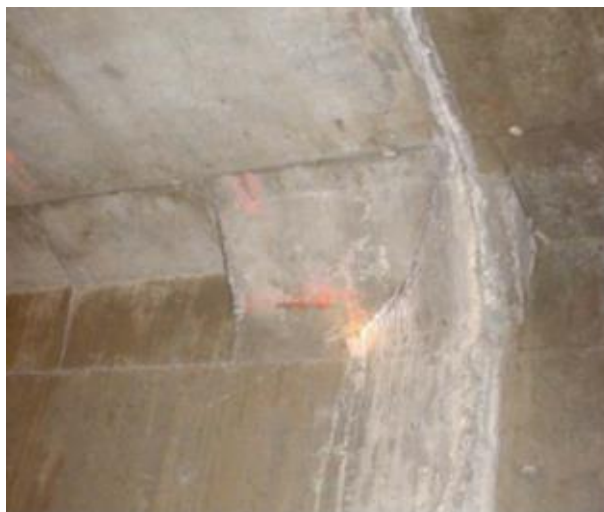
ID-14.3. View of a crack showing effervescence (Reis, 2007).

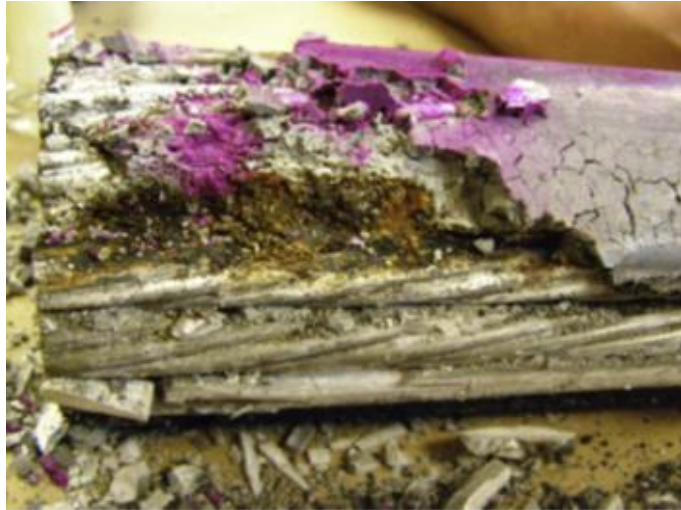
ID-15.6. Corrosion of a strand embedded in deficient grout. Pink colour shows the Ph indicator (phenolphthalein) sprayed on the grout surface (Lau and Lasa, 2016).

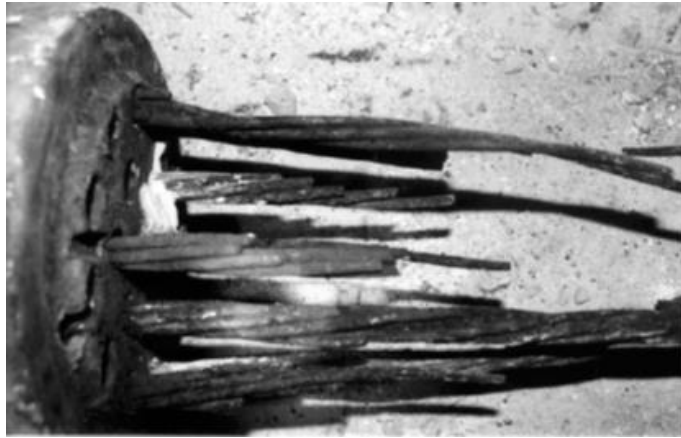
ID-17.1. Failed tendon of Niles Channel Bridge. June 1999 (Powers et al, 2002).

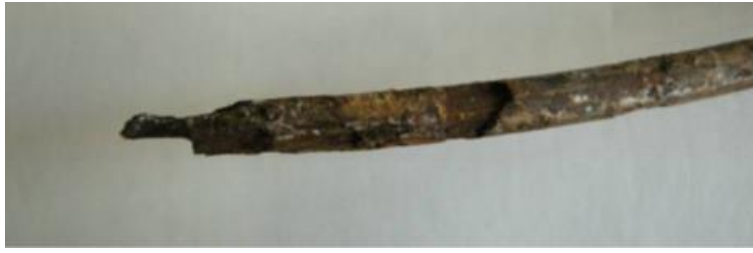
ID-18.1. Example of penetrating corrosion attacks observed on a wire of the failed cable (Bertolini and Carsana, 2011).

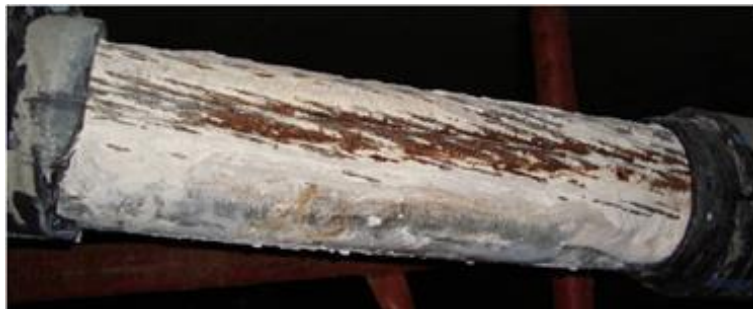
ID-18.2. Example of whitish segregated grout embedding corroding strands (Bertolini and Carsana, 2011).

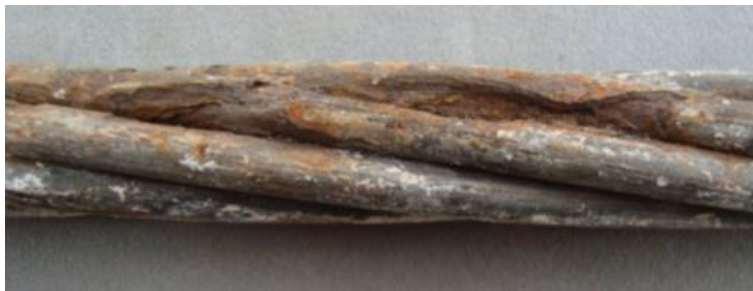
ID-18.3. Example of corrosion attacks on a prestressing strand in contact with the whitish segregated grout (Bertolini and Carsana, 2011).

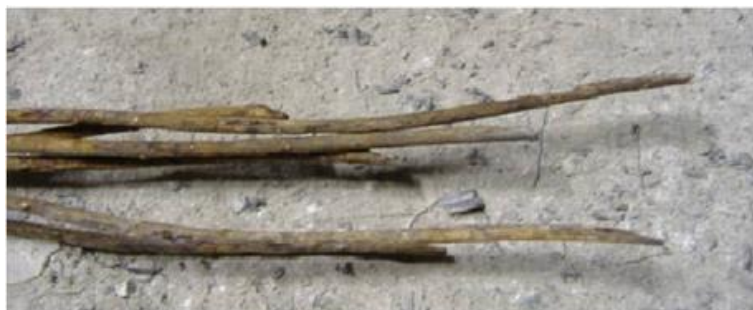
ID-18.4. Example of failed wires in a prestressing strand in contact with the whitish segregated grout (Bertolini and Carsana, 2011).

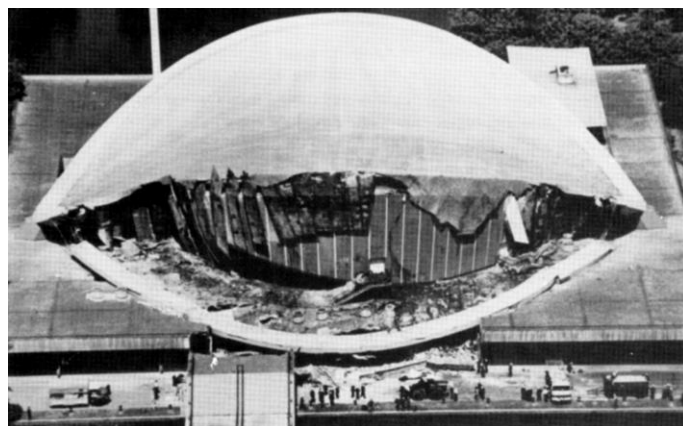
ID-19.5. View from the South on the collapsed roof overhang in 1980 (Helmerich and Zunkel, 2014).

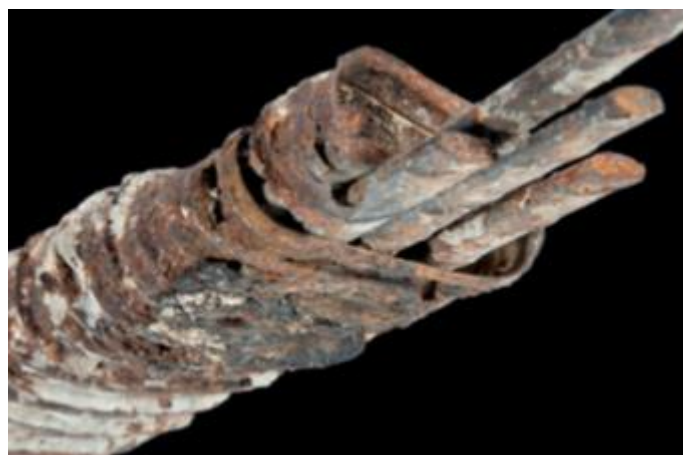
ID-19.6. Remaining bituminized roofing on a completely failed, non-grouted and heavily corroded tendon (Helmerich and Zunkel, 2014).

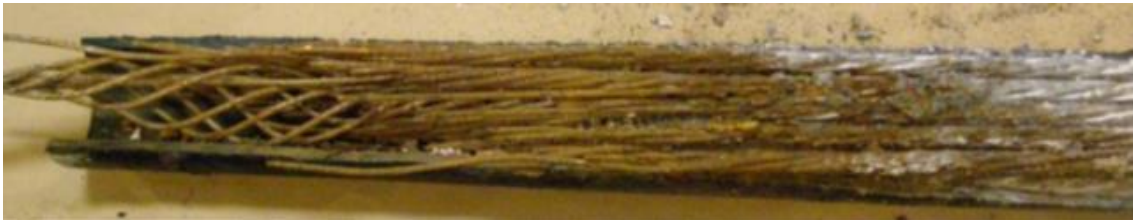
ID-20.2. Corroded tendon (Lau and Lasa, 2016).

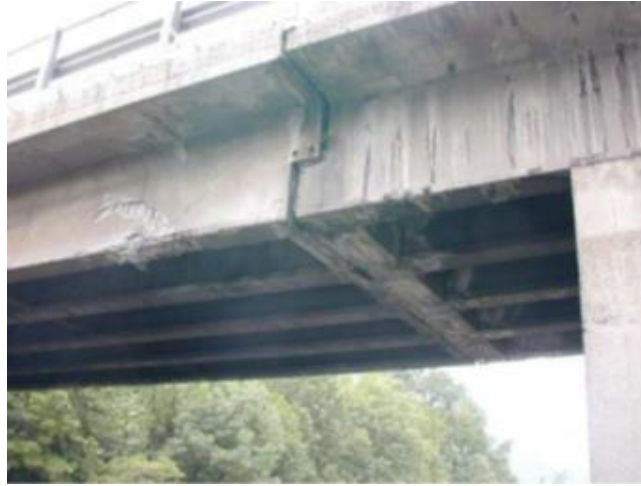
ID-21.4. Lateral impacts occurred in 2006 due to trucks circulating on SS.36 towards Lecco: location (Di Prisco et al, 2018).

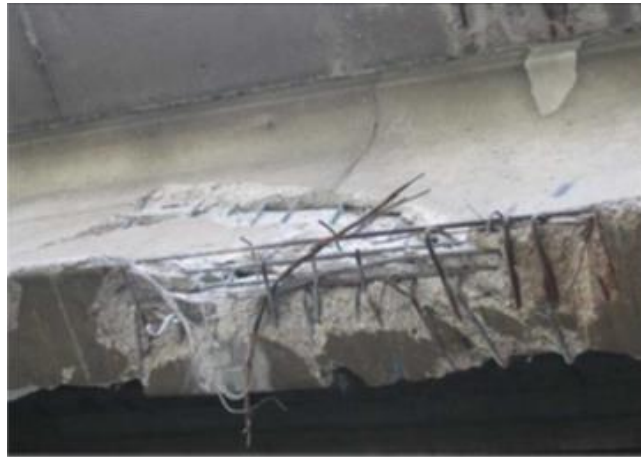
ID-21.5. Lateral impacts occurred in 2006 due to trucks circulating on SS.36 towards Lecco: particular of the damaged zone (Di Prisco et al, 2018).

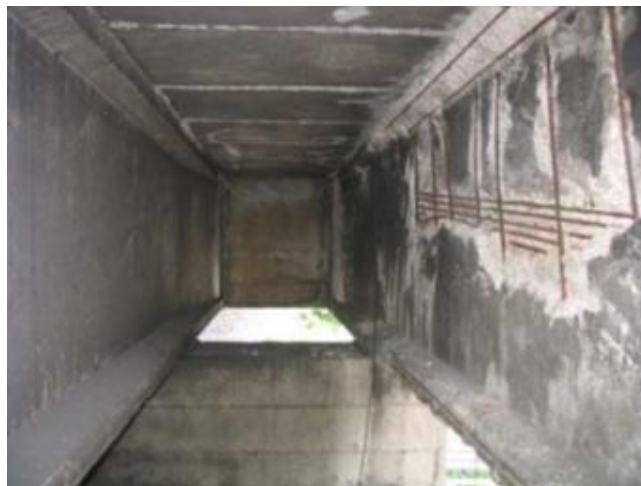
ID-21.6. Damage observed on internal surfaces of the prefabricated beams in 2006 (Di Prisco et al, 2018).

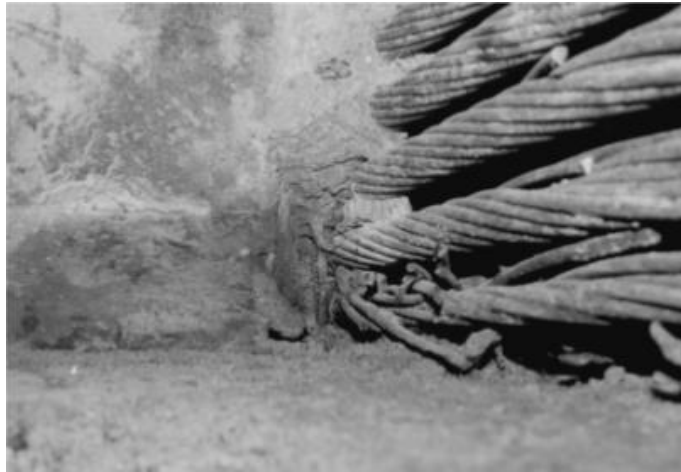
ID-28.1. Corrosion of external tendons that had been encased in concrete (Tilly, 2002).

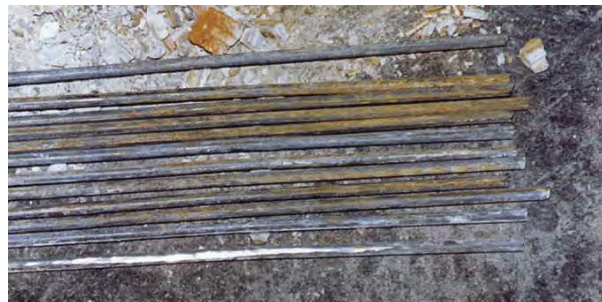
ID-30.2. Typical minor surface corrosion seen on post-tensioning wires removed from duct. No pitting or fractures were noted (Dickson et al, 1993).

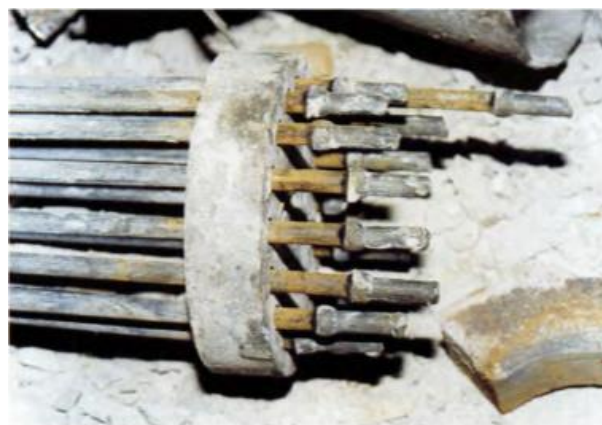
ID-30.3. Corrosion of wires at anchorage plate is greater than that exhibited inside ducts. (Dickson et al, 1993).

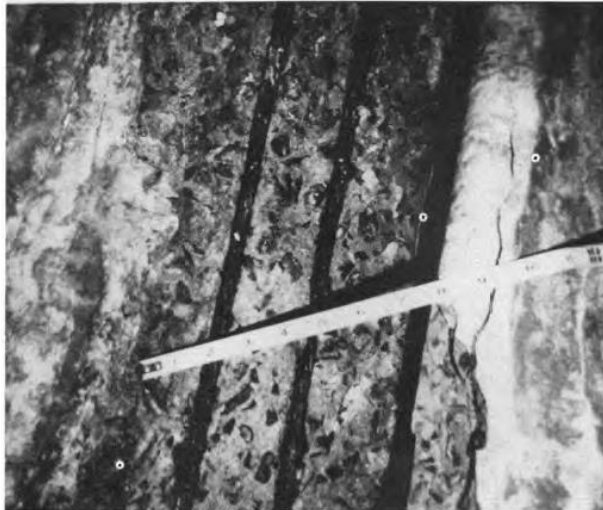
ID-31.4. Spalled concrete and exposed strands in beam 2 (Murray and Frantz, 1992).

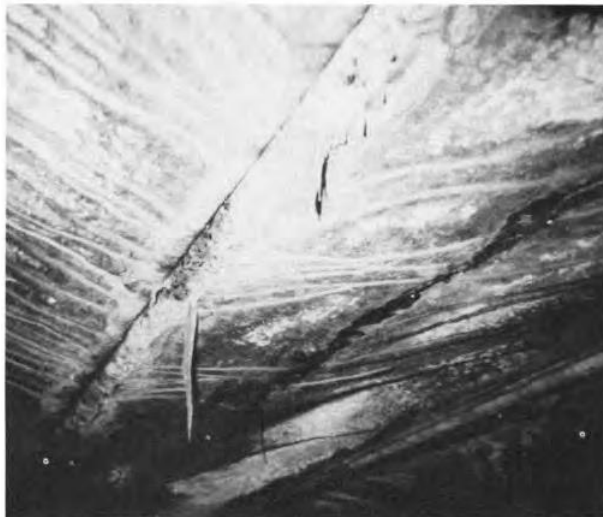
ID-31.5. Stains on beams (Murray and Frantz, 1992).

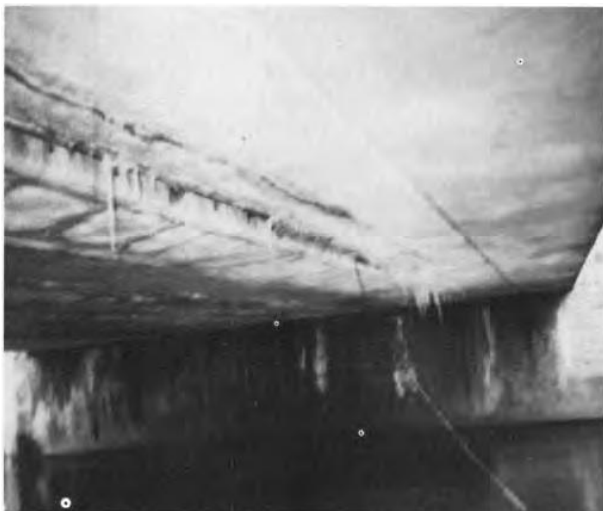
ID-31.6. Ruptured strand hanging down into river (Murray and Frantz, 1992).
