SD Department of Transportation
Office of Research

Highway Rock Slope Reclamation and Stabilization Black Hills Region South Dakota Part II, Guidelines

Study SD94-09-G
Final Report

Prepared by
GeoEngineers, Inc.
8410 154th Avenue Northeast
Redmond, Washington 98052

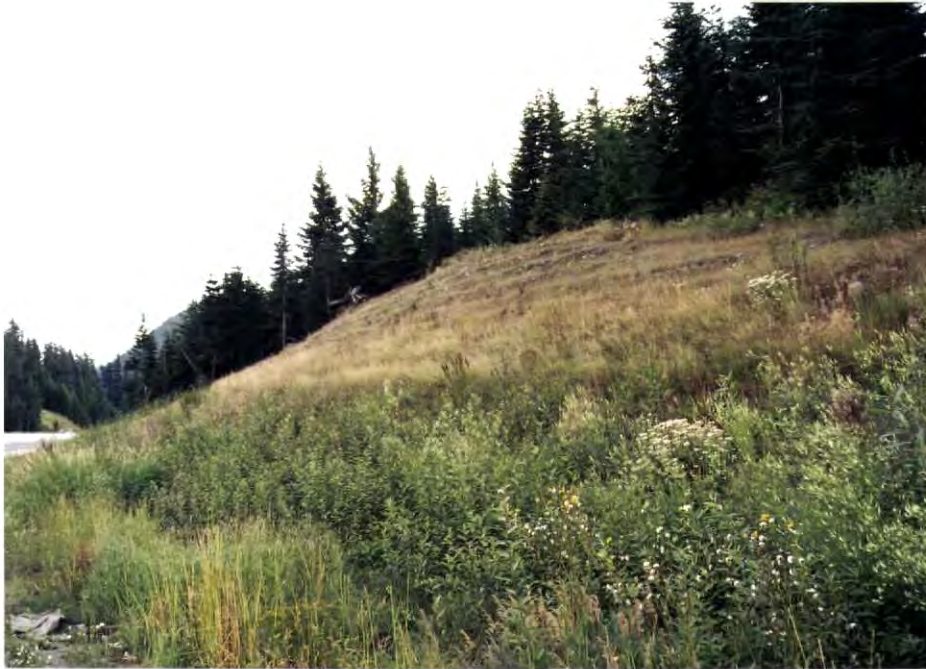
Photos II-1 and II-2 are examples of serrated slopes constructed in ravelling soils. As evident in the photos, the treatment method has been successful in preventing severe ravelling and erosion and encouraging the growth of vegetation.

Photo II-1. Serrated slope in ravelling soils.

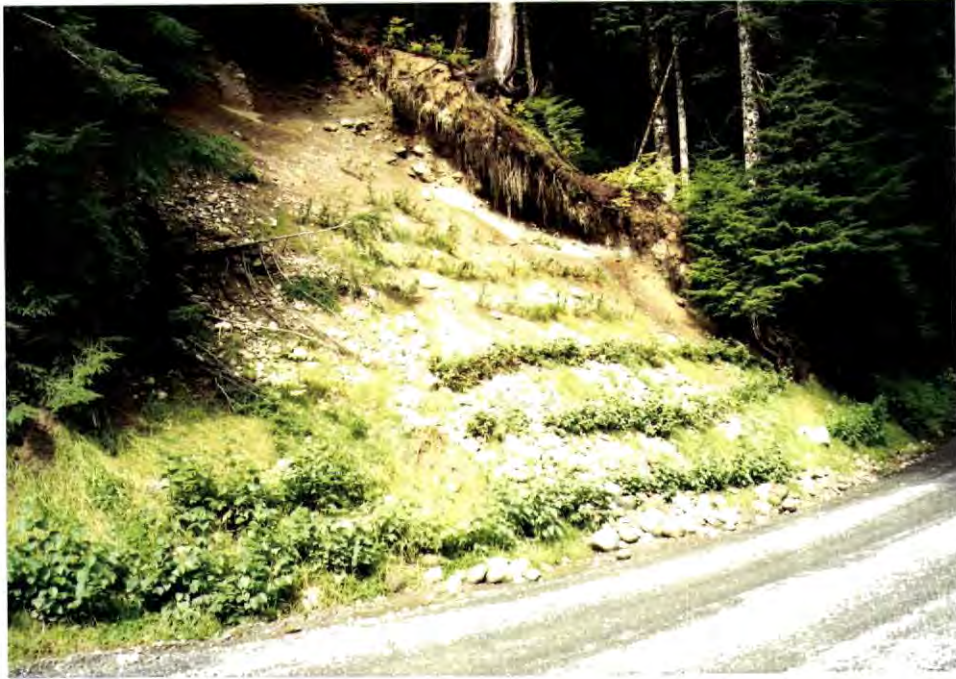
Photo II-25. Terracing with tree seedlings on badly ravelling slope.

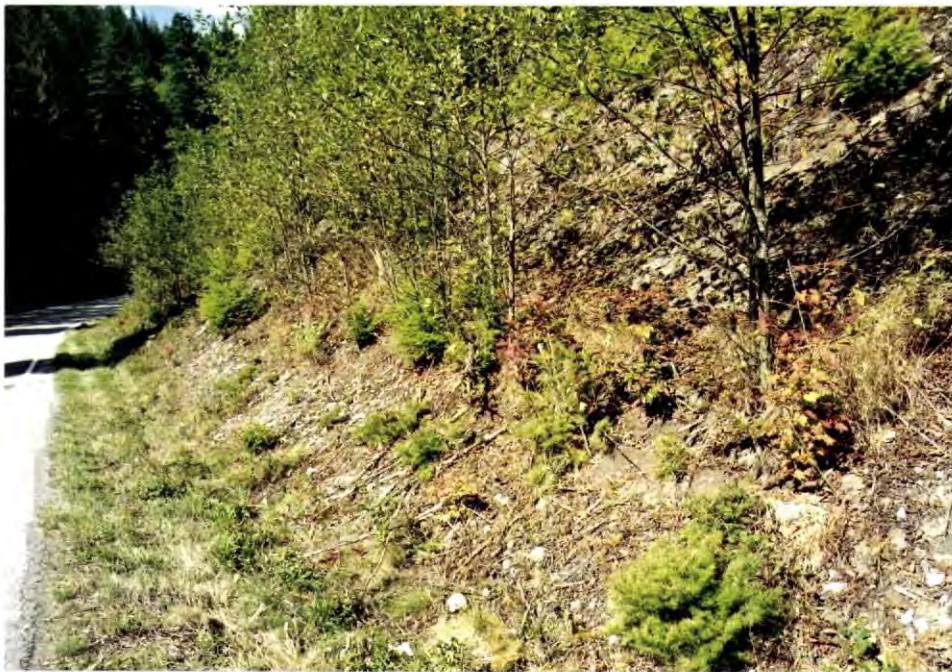
Photo II-26. Successful use of terracing with tree seedlings on ravelling slope.

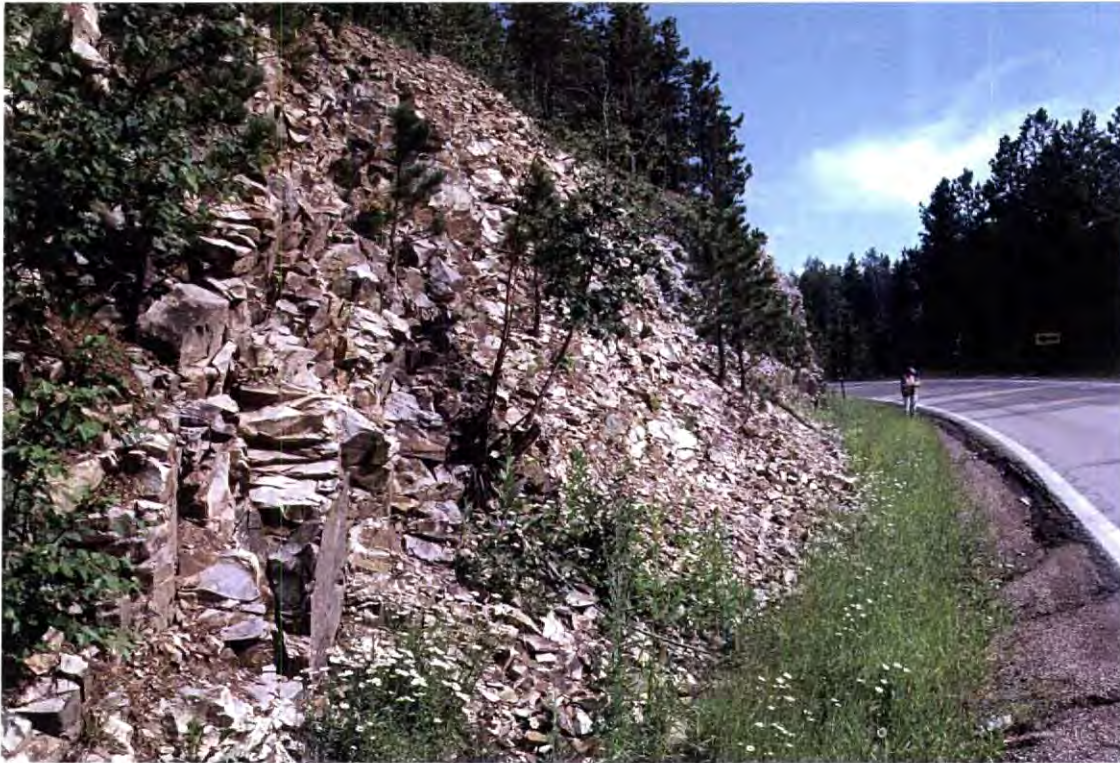
Photo 1: Profile view. Note the blocky weathering of this RUB unit, and the formation of the talus slopes in the ditch.

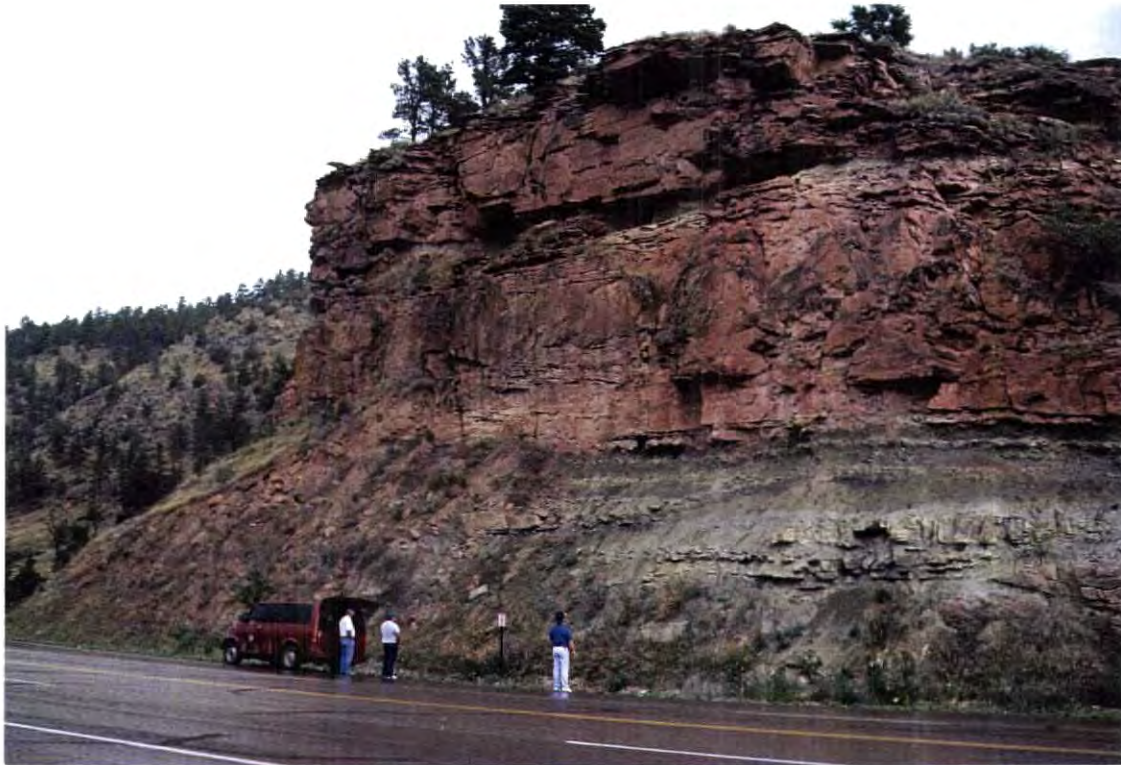
Photo 1: View of cut slope from across the highway.

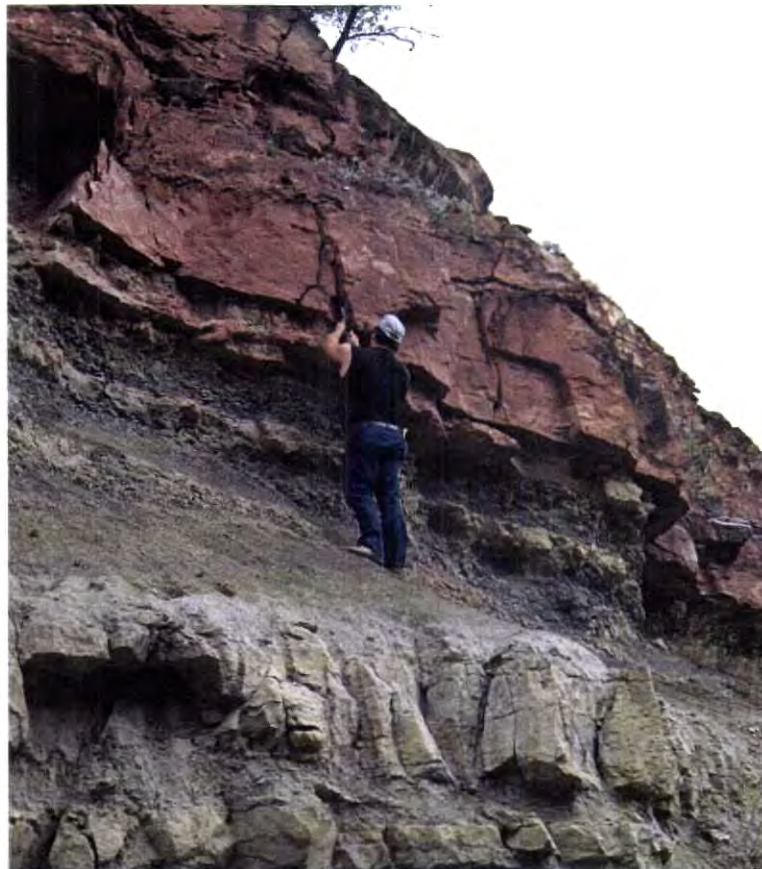
Photo 2: Close-up view of differential weathering.

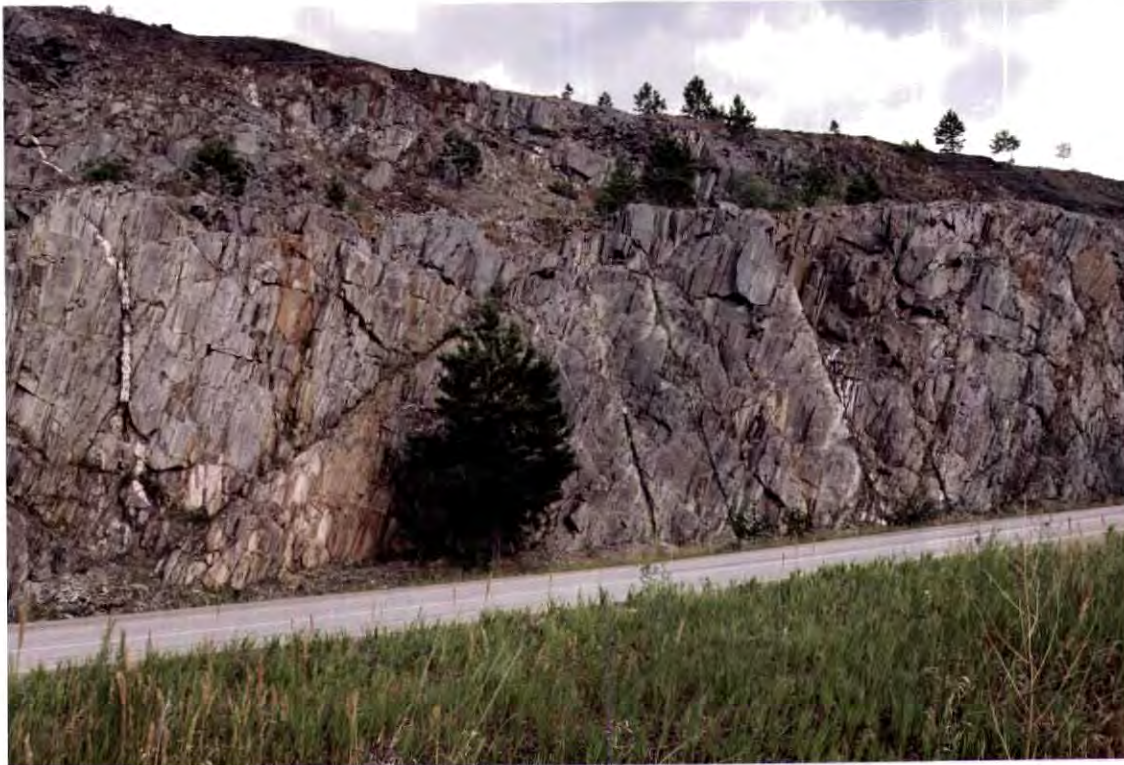
Photo 1: View of slope. Note the large ponderosa pine growing in the ditch and the very small accumulation of rockfall at the base of the slope.

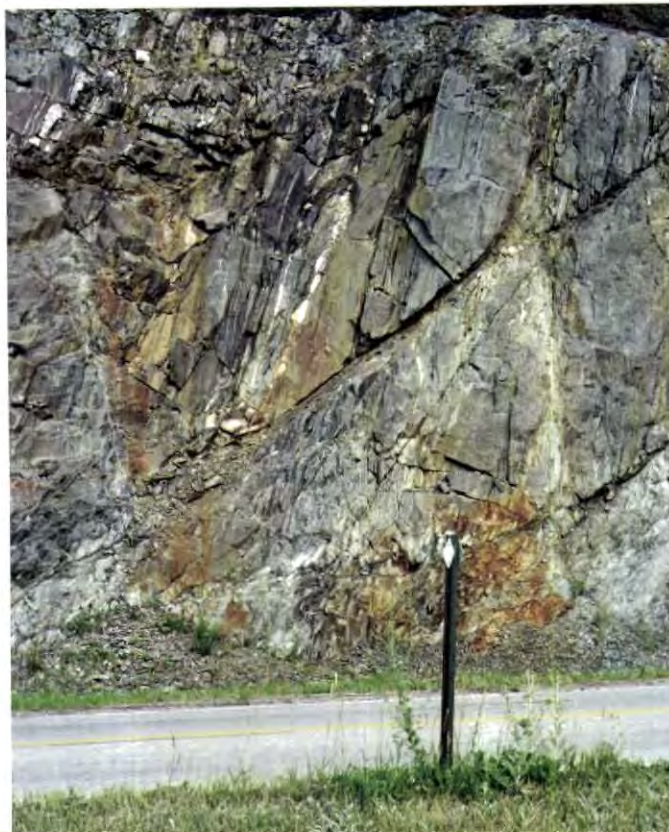
Photo 2: Close-up of the steep-angled discontinuities in the rock section below the bench.

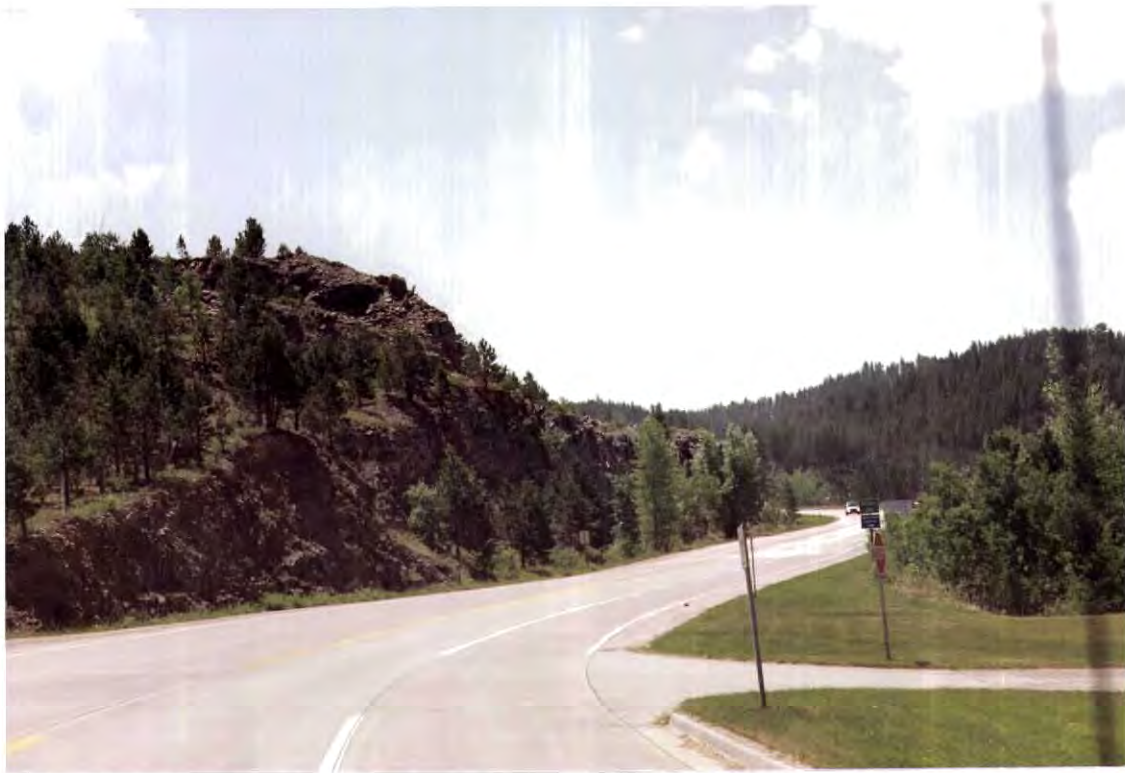
This site was selected to document a site where a large cut was constructed near a recreational area and through benching, construction of stable slopes, and natural revegetation with trees has not created a great impact on the aesthetics of the location (refer to Photos 3 and 4). This site is an excellent candidate for a "Geologic Point of Interest."

Photo 3: View of bench, the well-vegetated upper slope and the ditch from near the entrance to the visitor parking area.

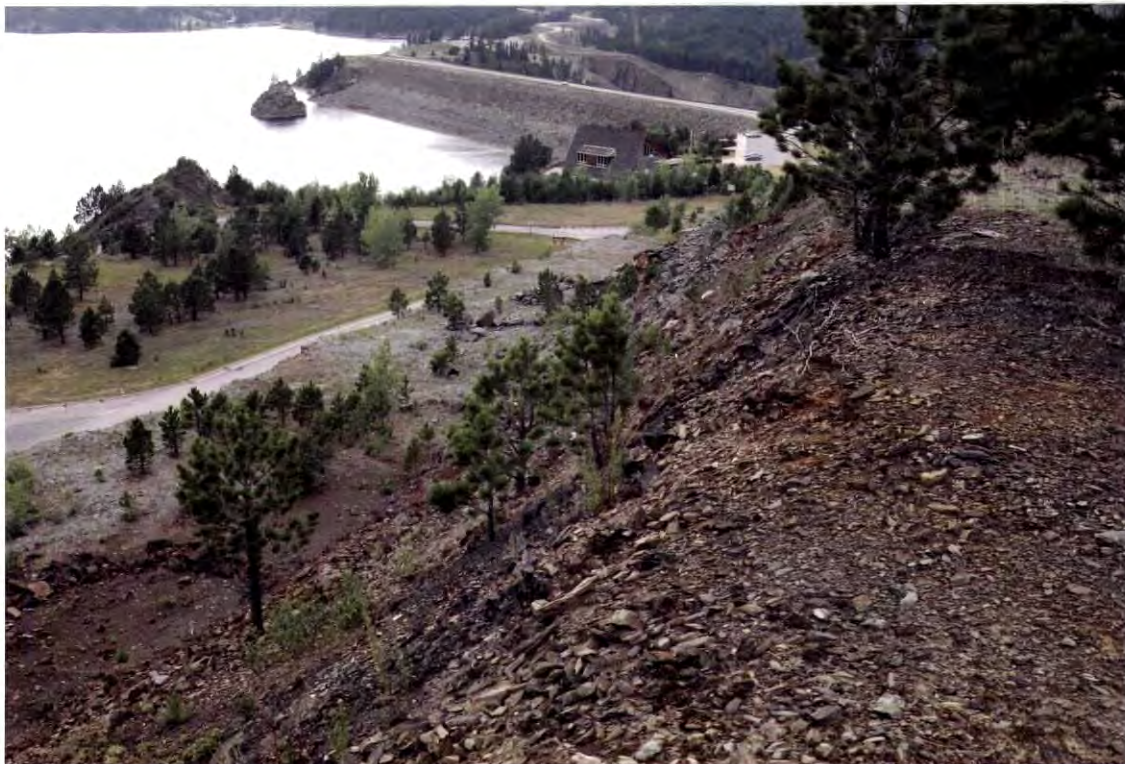
Photo 4: View of slope, bench and dam from above. Note the well-vegetated slopes.

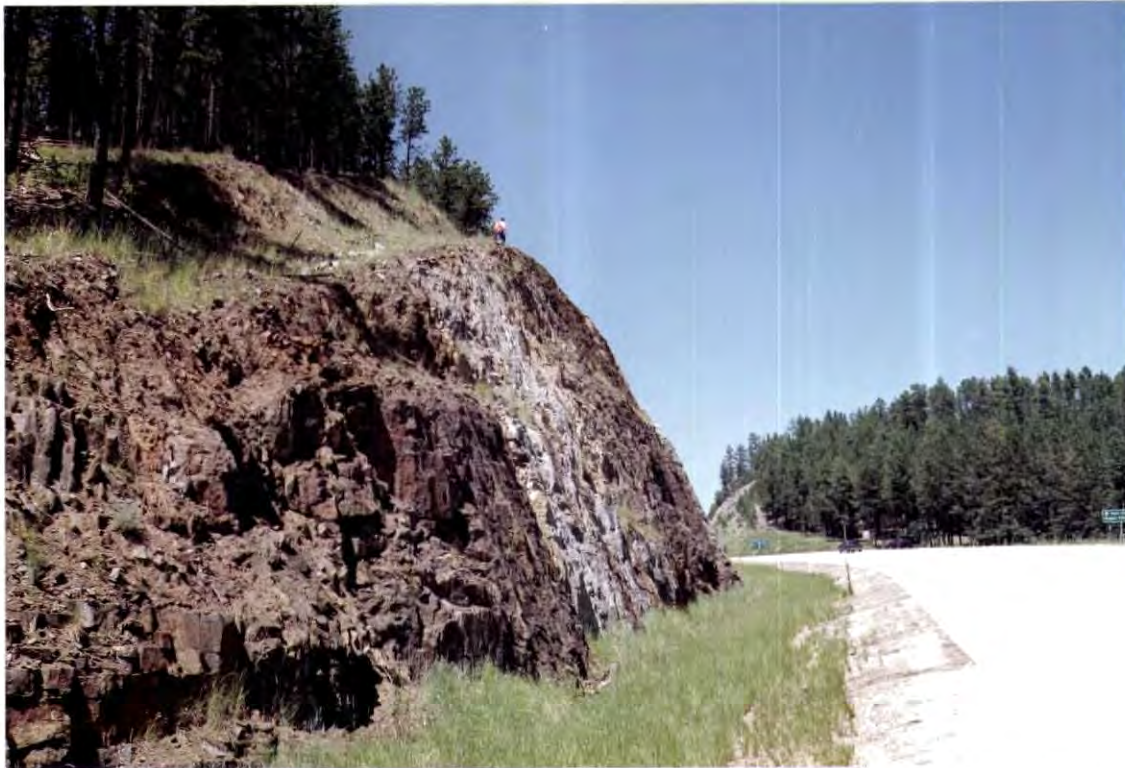
Photo 1: Profile view. Note grass cover and the very small accumulation of rockfall on the bench.

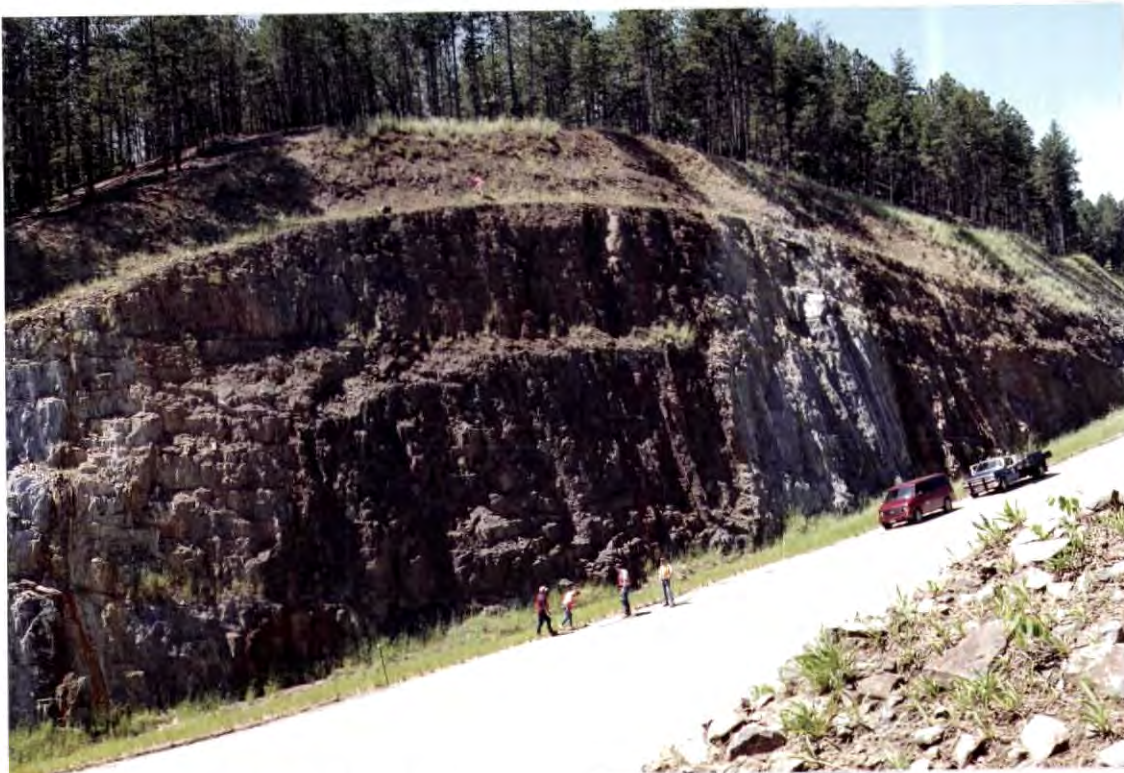
Photo 2: View of slope from across the highway.

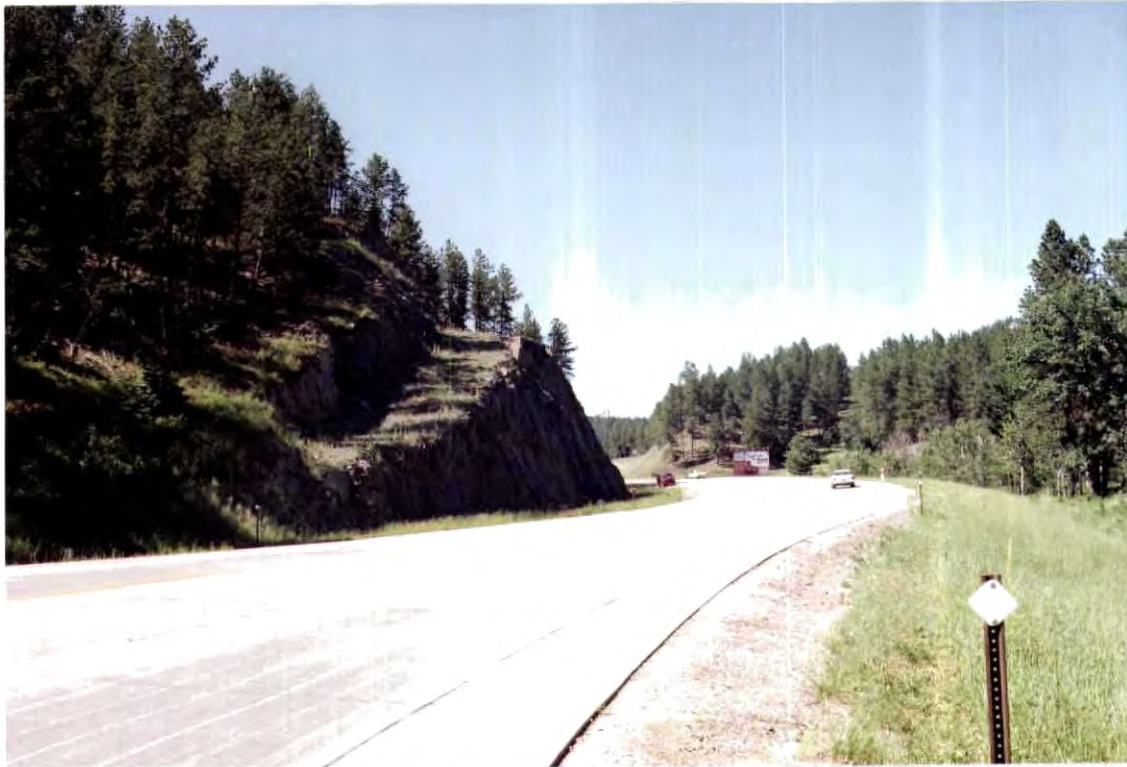
Photo 1: View of slope from across highway.

Observed Slope Failure Mechanism: Surface erosion (rilling and gullyng) in RUD section.

None required at this time; however, the surface erosion of the RUD unit must be monitored. If the size of erosional rills increases, we recommend revegetation techniques such as hydroseed or Soilguard be used to retard erosion.

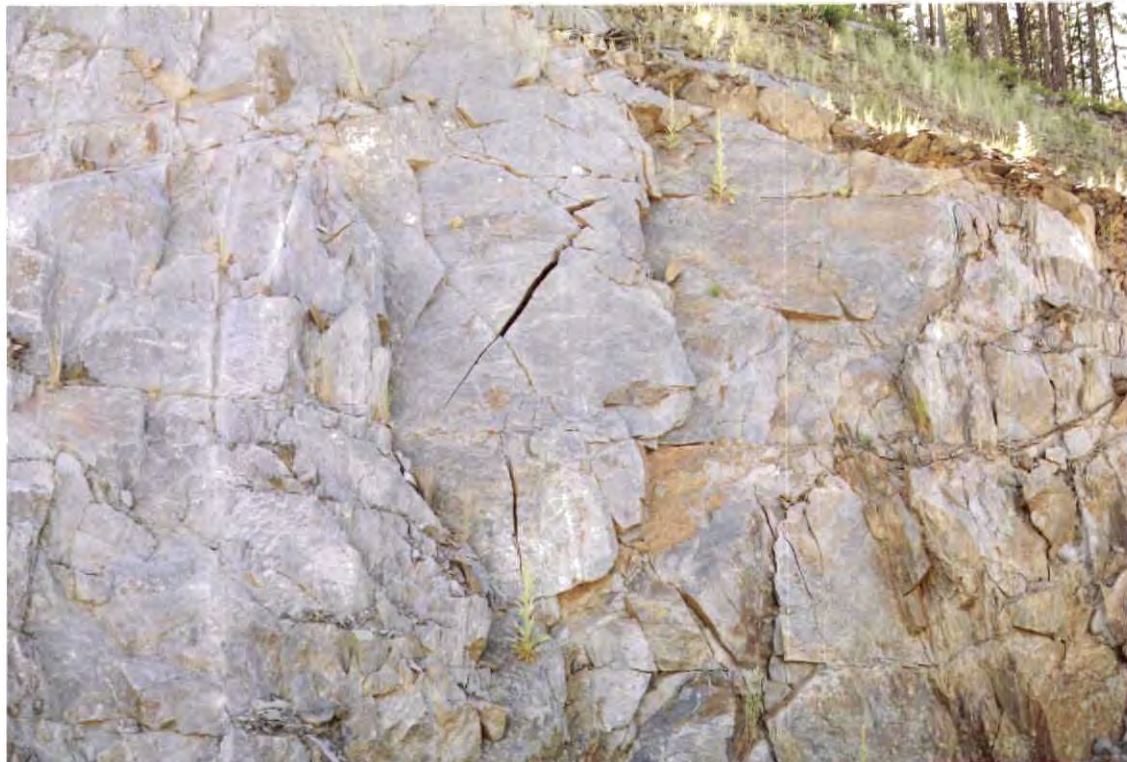
Photo 2: Close-up view of rock discontinuities in RUA.

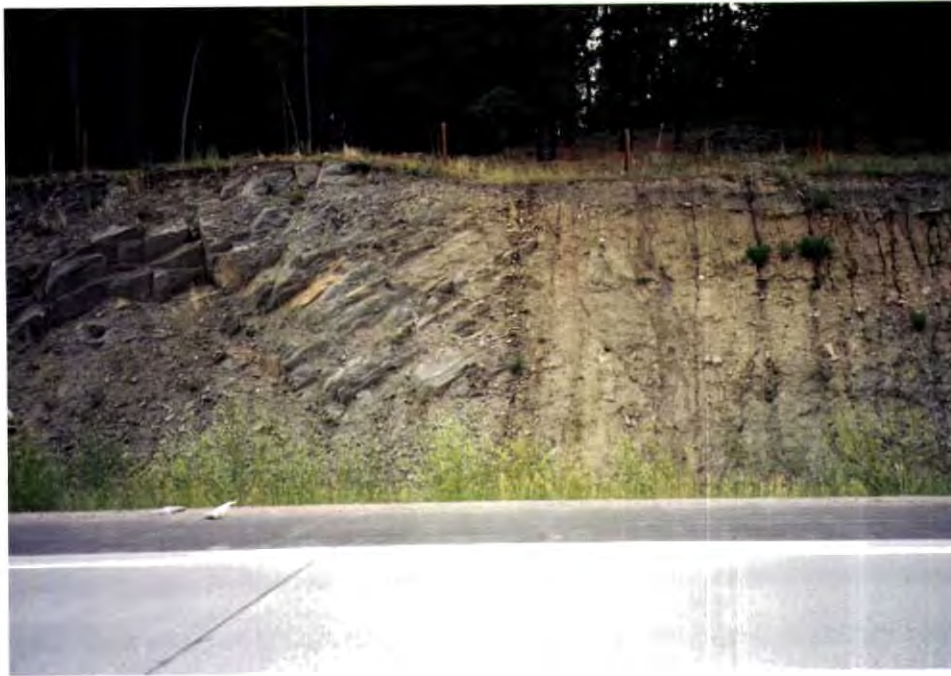
Photo 1: View of slope from across the highway. Note the sharp change from RUA on left to RUD on right.

Observed Slope Failure Mechanism: Minor plane failures.

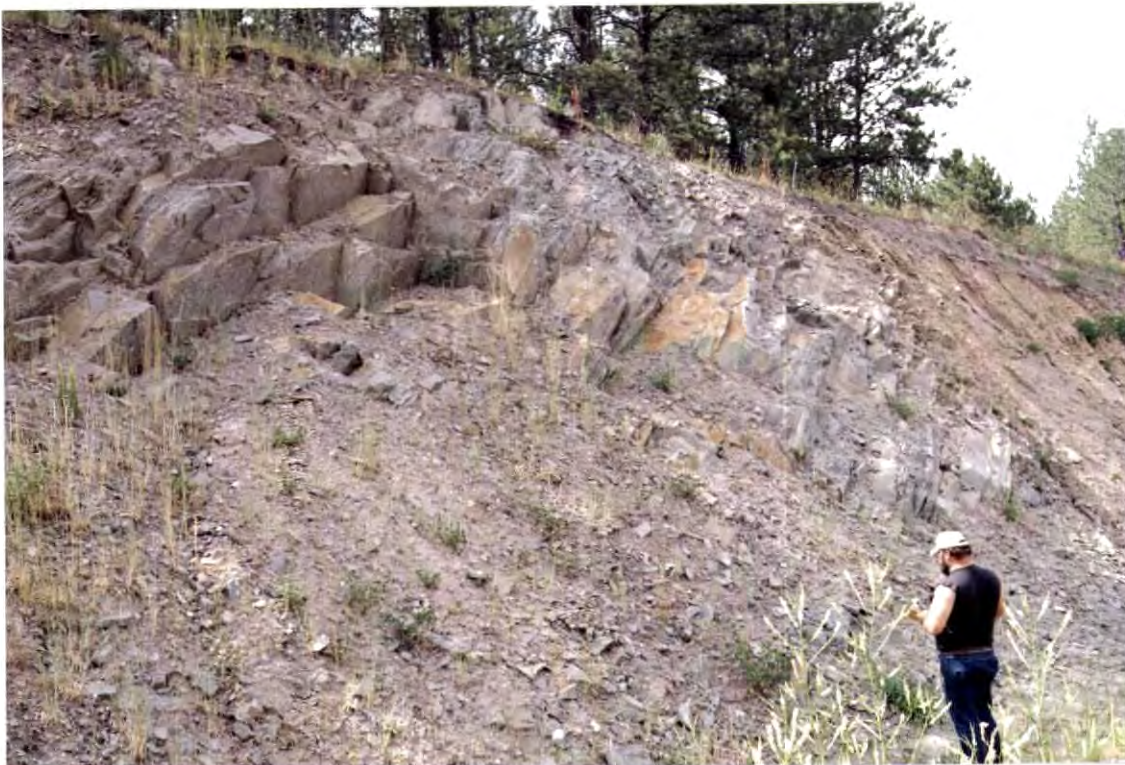
Photo 2: Close-up of RUA. Note the favorable discontinuity of dip angle with respect to the slope.

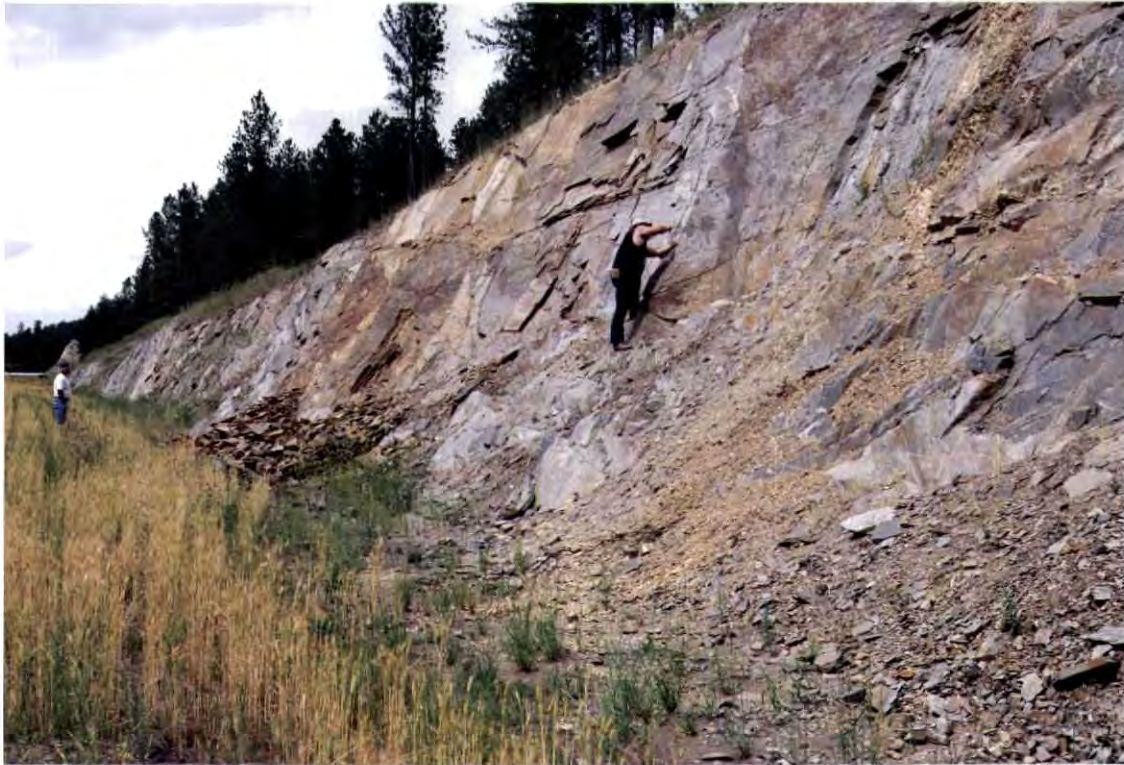
Photo 1: Profile view. Note the talus accumulation at base of slope and the dense growth of wheat resulting from revegetation efforts.

Observed Slope Failure Mechanism: Ravelling. The rock unit is extensively jointed and prone to root and frost wedging. Rockfall material accumulates in the ditch as talus (see Photo 1).

"Root and frost wedging" are probably the primary cause of rockfall on this slope. The slope is not high and natural slope above is relatively flat (about 13°). Regrading the slope to 1:1 and widening the ditch should eliminate the rockfall hazard and improve the sight distance in this section of highway.

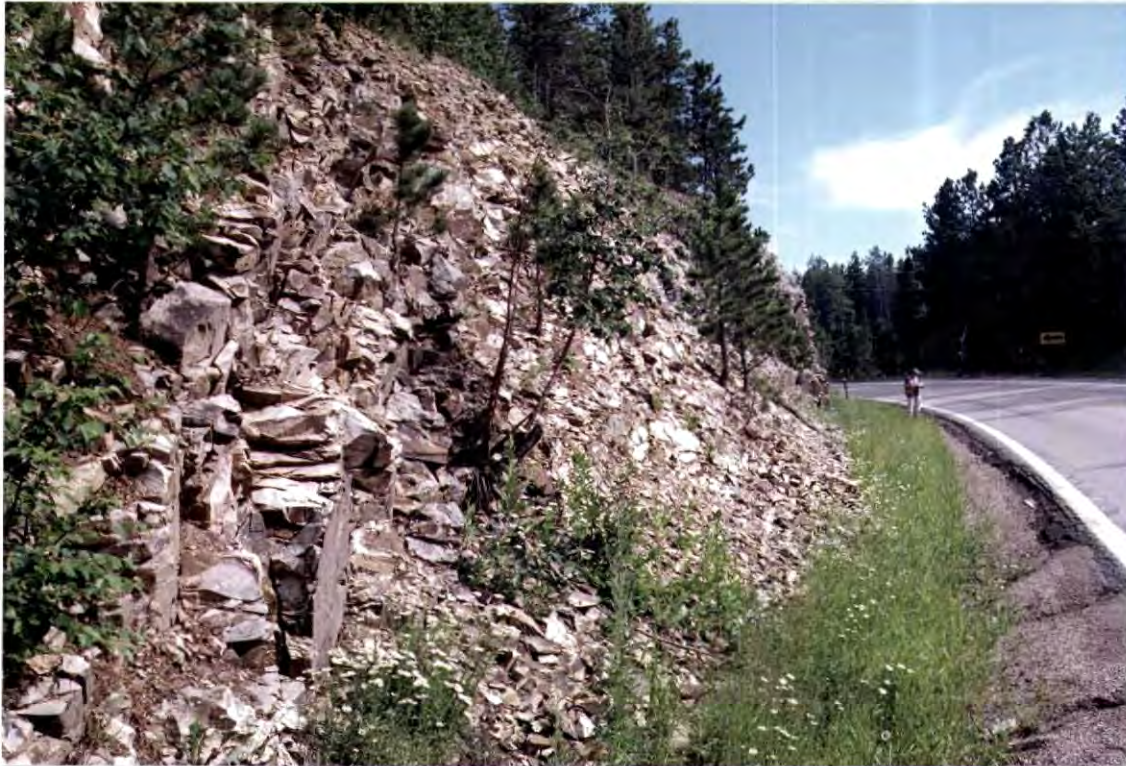
Photo 1: Profile view. Note the blocky weathering of this RUB unit, and the formation of the talus slopes in the ditch.

Observed Slope Failure Mechanism: Ravelling and rockfall. The RUB unit is composed of broken rock caused by structural deformation. Rockfall material is accumulating in the ditch as a talus slope (see Photo 1).

Recommended treatment method: Regrade slope to 1:1. Revegetate slope using hydroseed or Soilguard treatment methods and widen ditch.

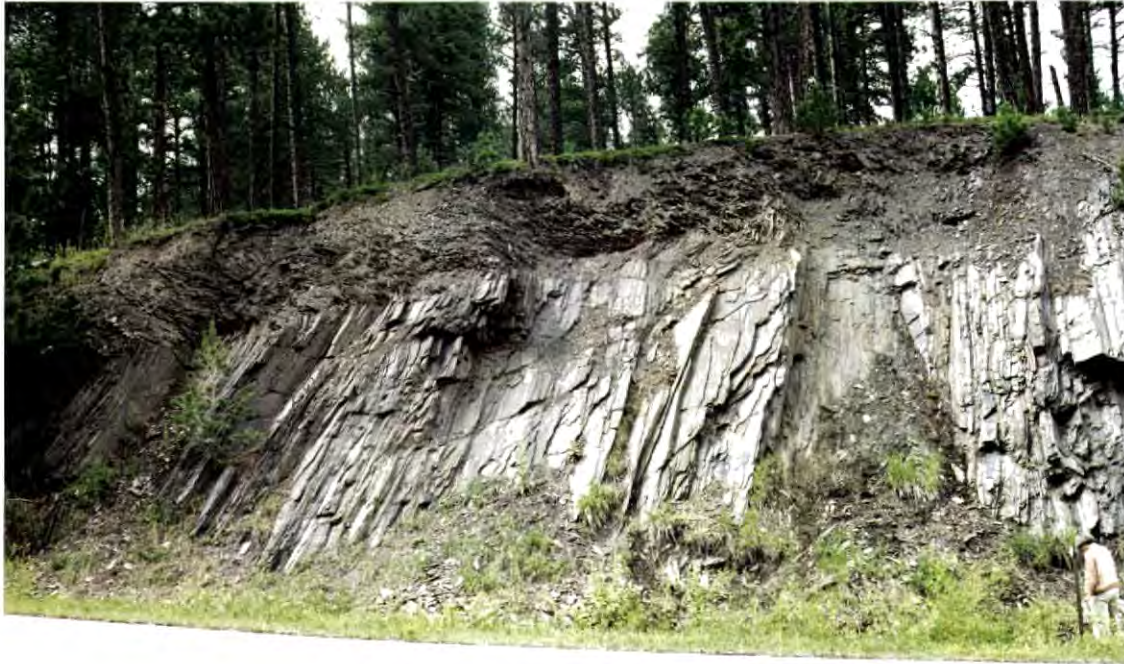
Photo 1: View of slope. Note the overturned structure in RUB and the formation of talus slopes in the ditch.

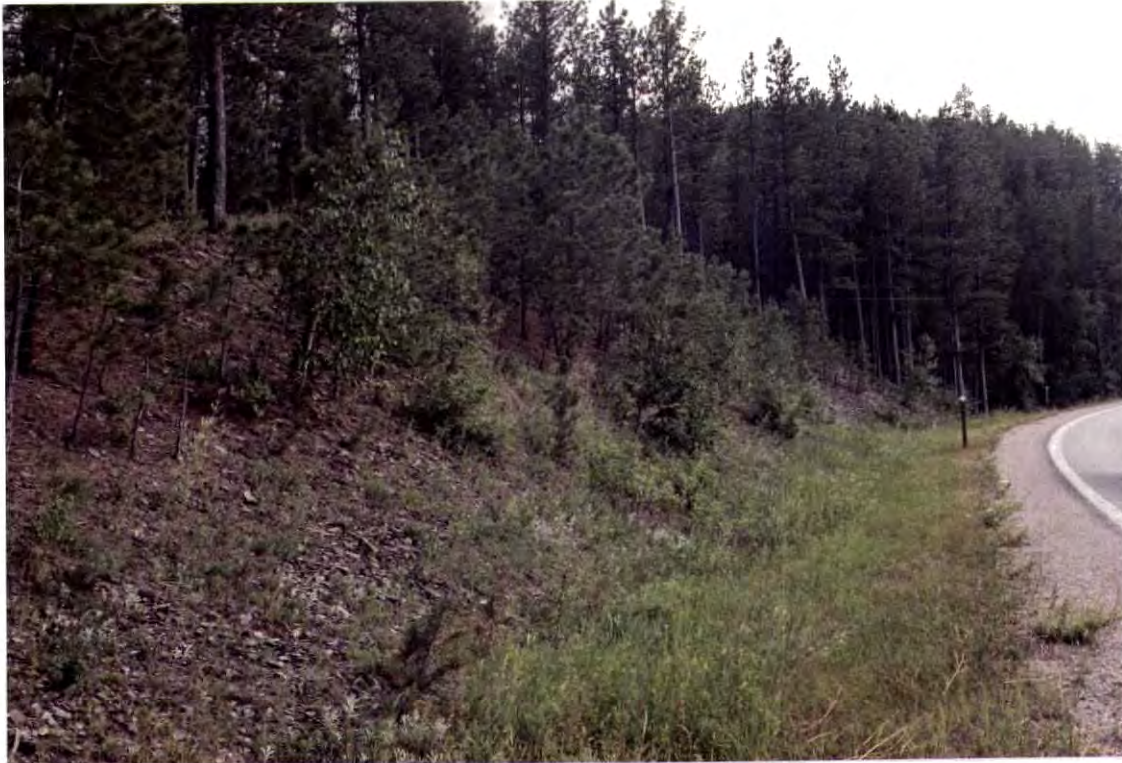
Photo 1: Profile view showing tree growth on the slope and grass in ditch.

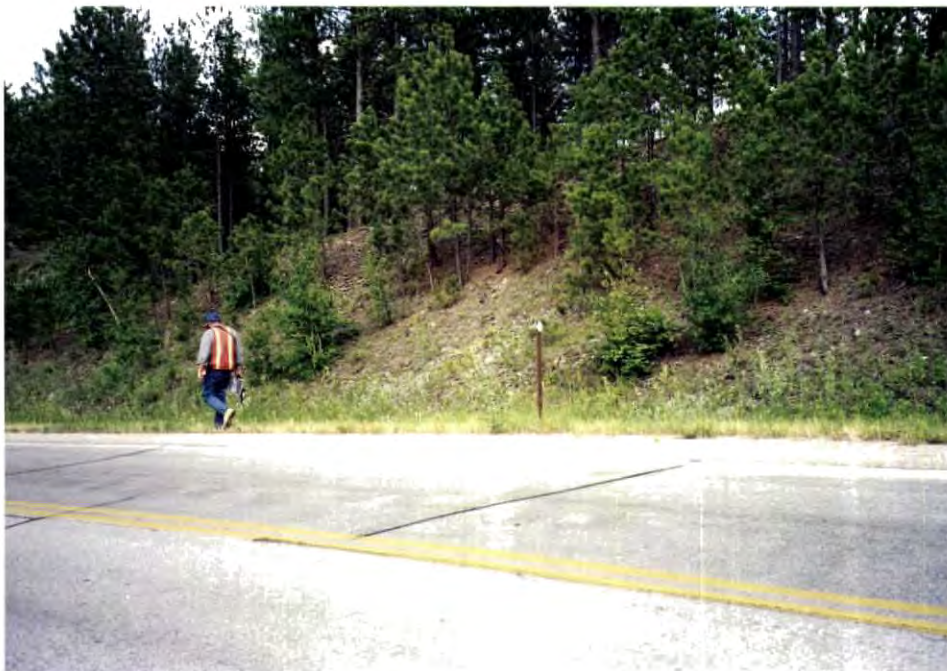
Photo 2: View of slope.

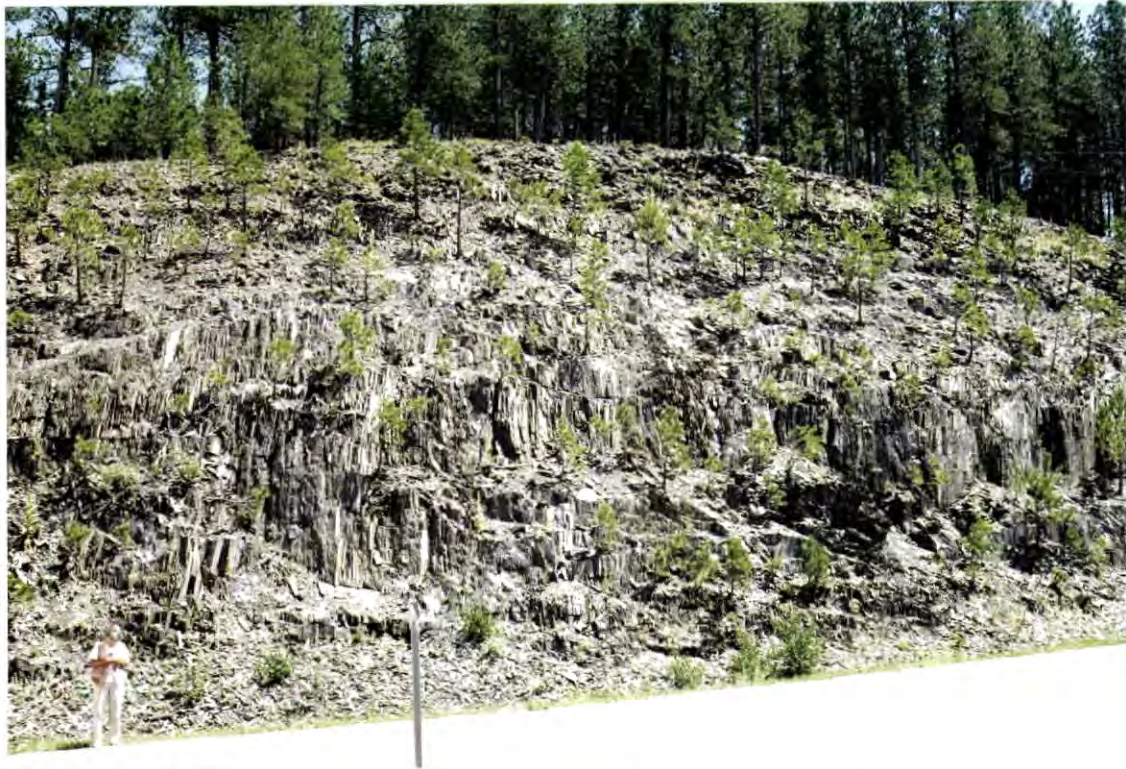
Photo 1: View of slope.

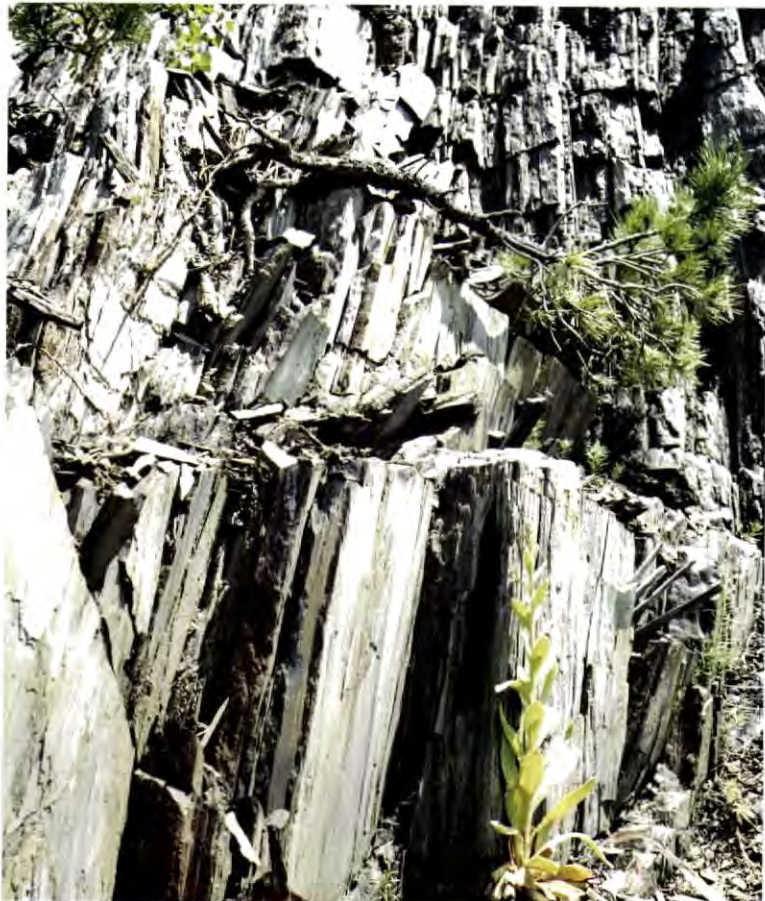
Photo 2: Close-up of "root wedging" and "toppled" tree.

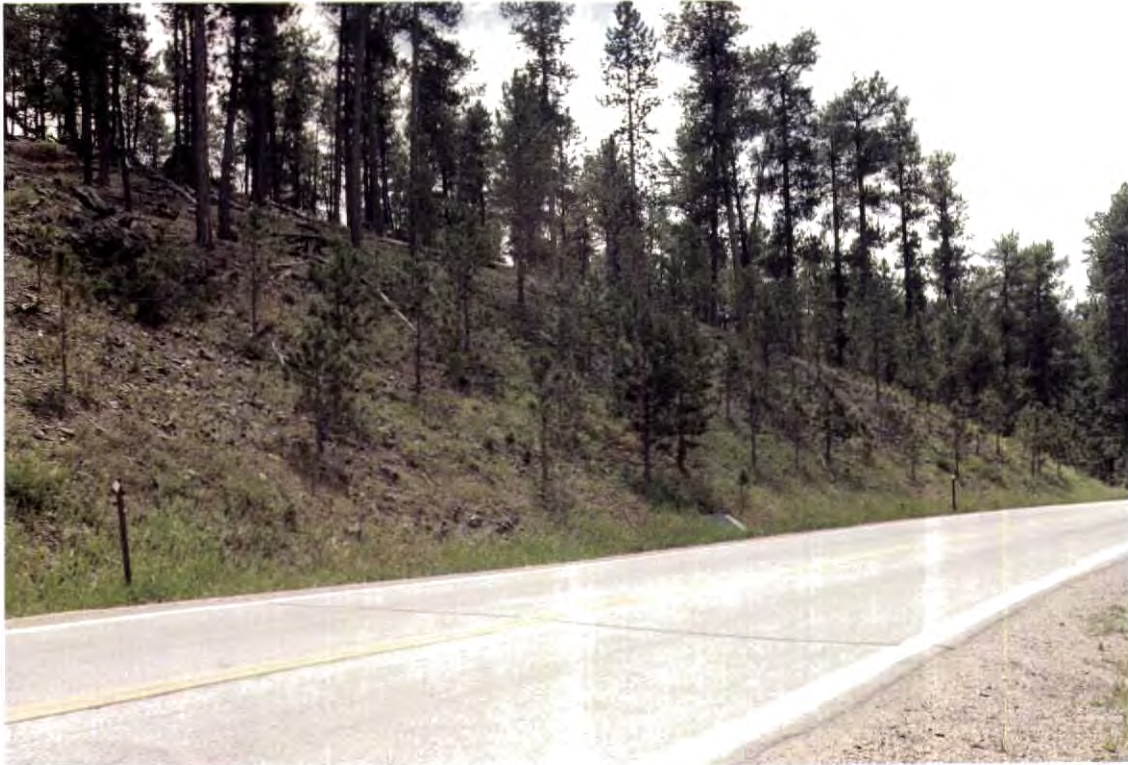
Photo 1: View of slope from across the road.

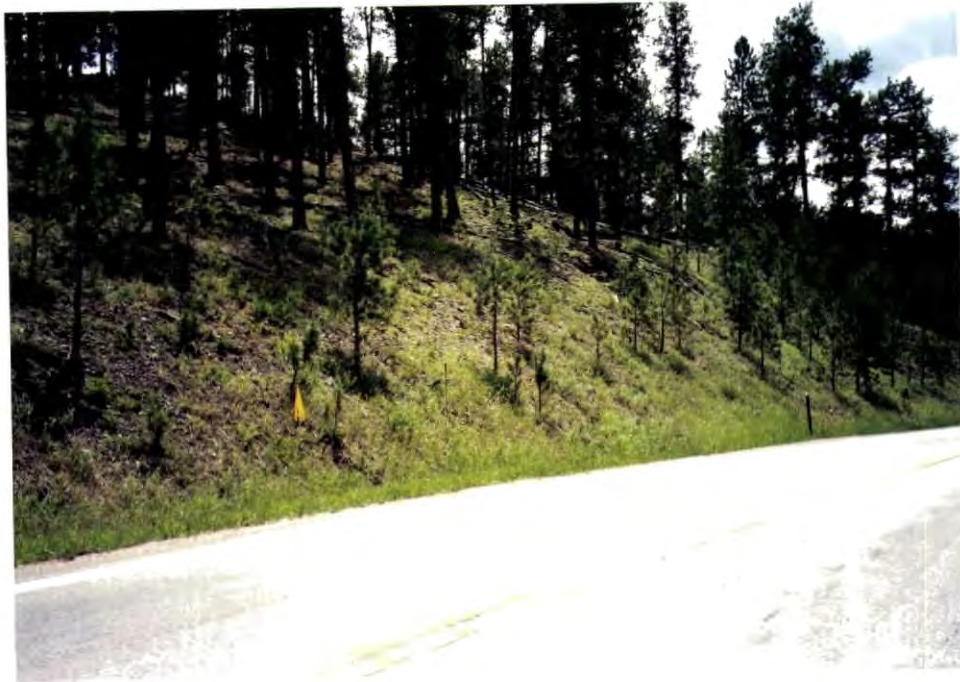
Photo 2: View of slope showing grass cover in ditch and on cut slope.

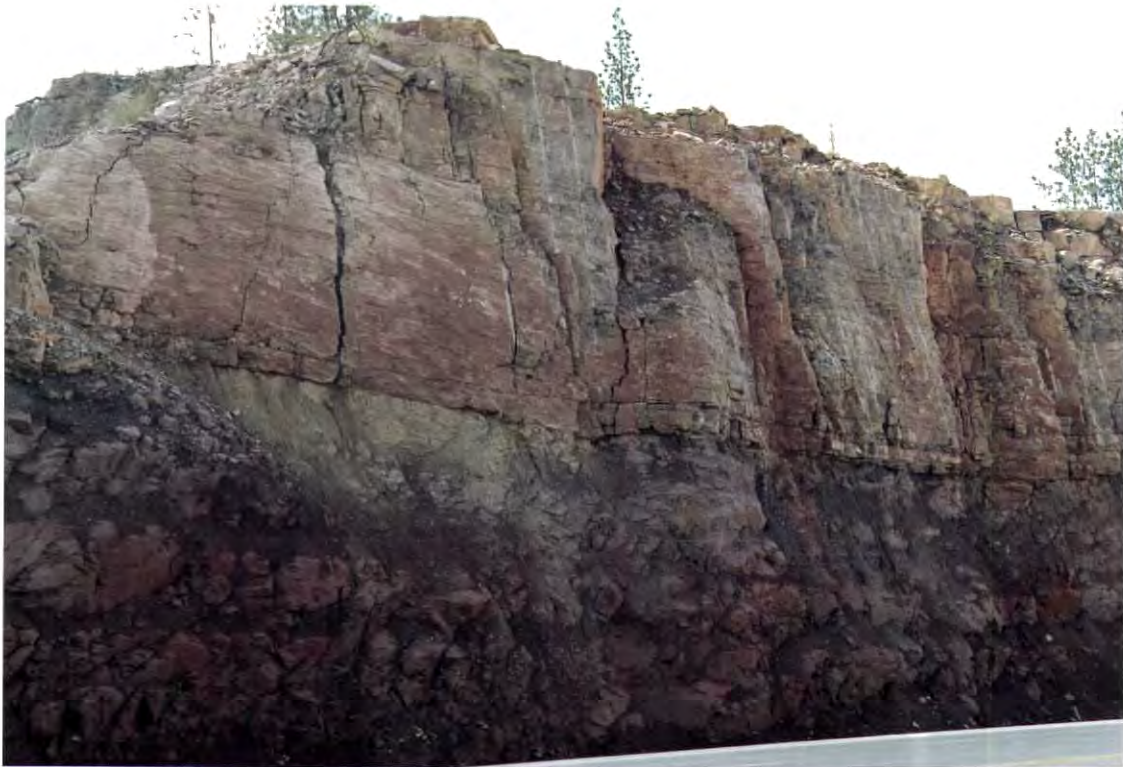
Photo 1: View of open-jointed, massive, competent rock overlying less competent rock.

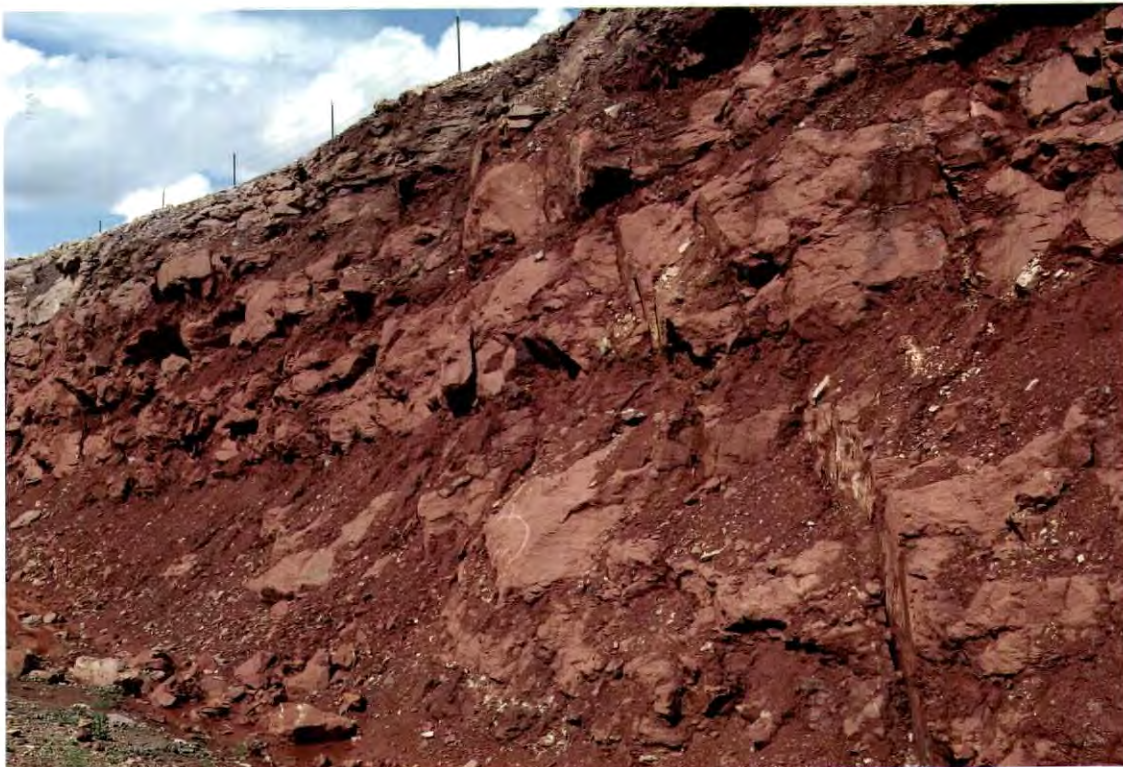
Photo 2: View of differential weathering in lower, less competent rock.

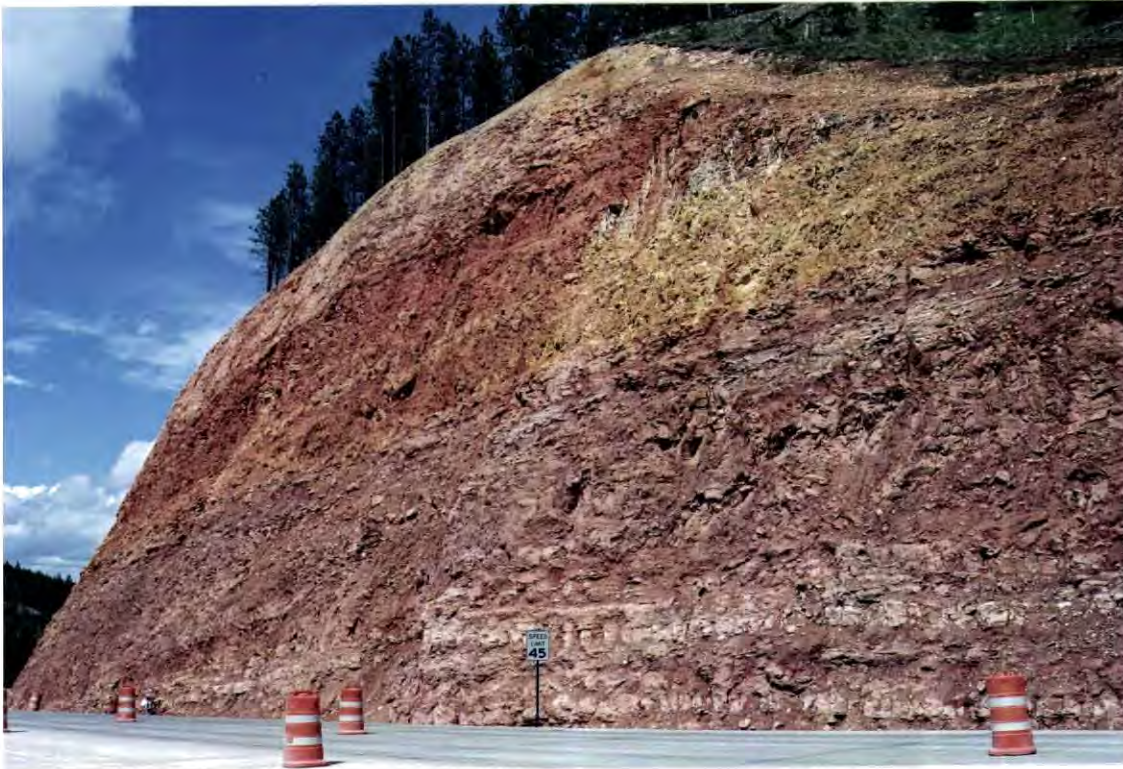
Photo 1: View of competent caprock (RUC) overlying less competent rock.
