SD Department of Transportation
Office of Research

Highway Rock Slope Reclamation and Stabilization Black Hills Region South Dakota Part II, Guidelines

Study SD94-09-G
Final Report

Prepared by
GeoEngineers, Inc.
8410 154th Avenue Northeast
Redmond, Washington 98052

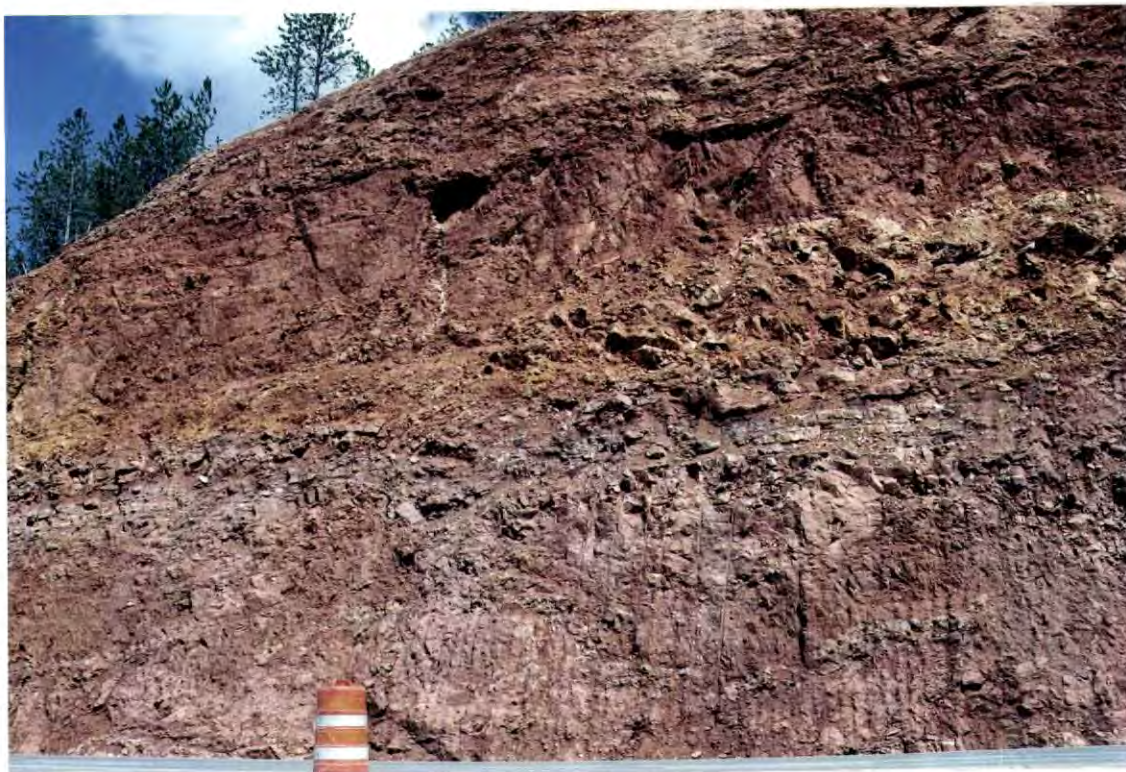
Photo 2: Close-up view showing less competent lower rock units.

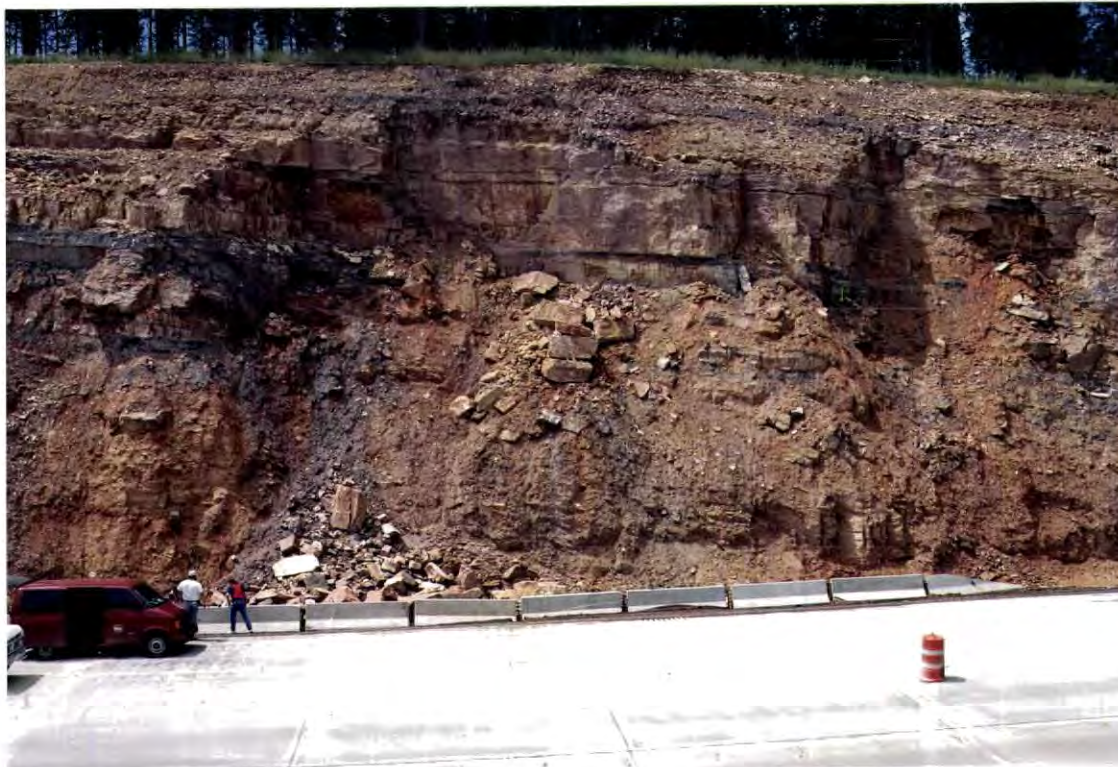
Photo 1: View of slope. The horizontal SUC clay layer at the base of the competent caprock (tan).

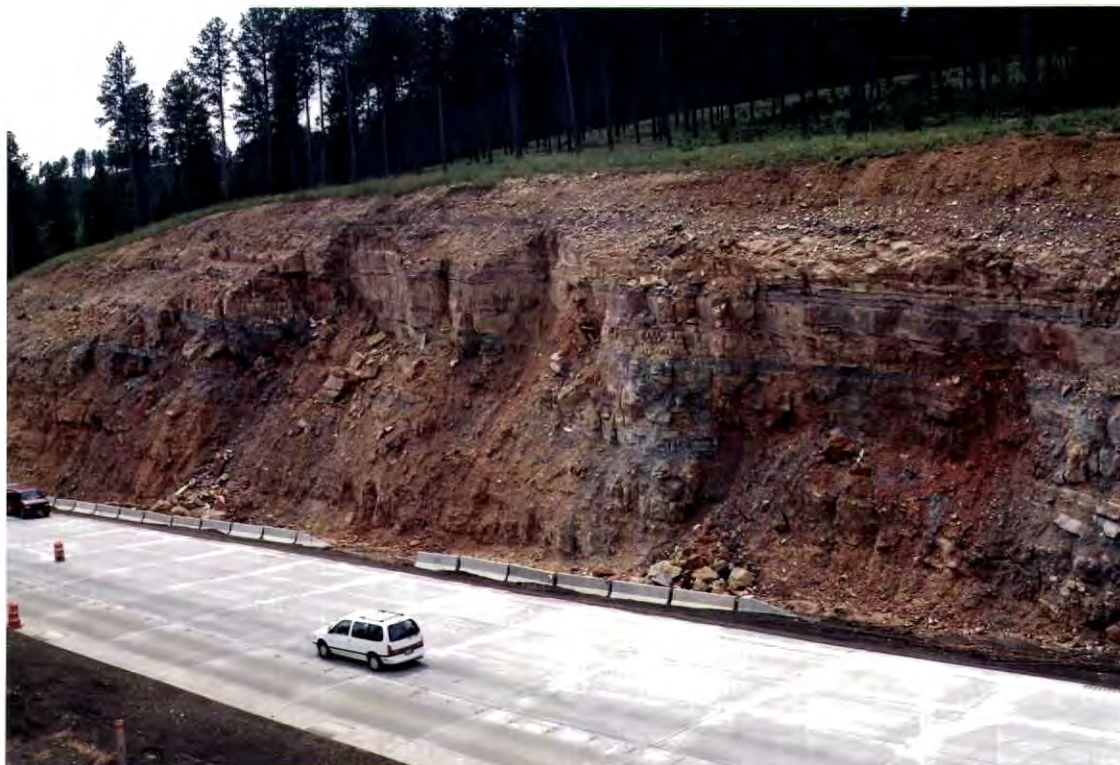
Photo 2: Distance view of site. Note continuity of the horizontal gray SUC clay layer.

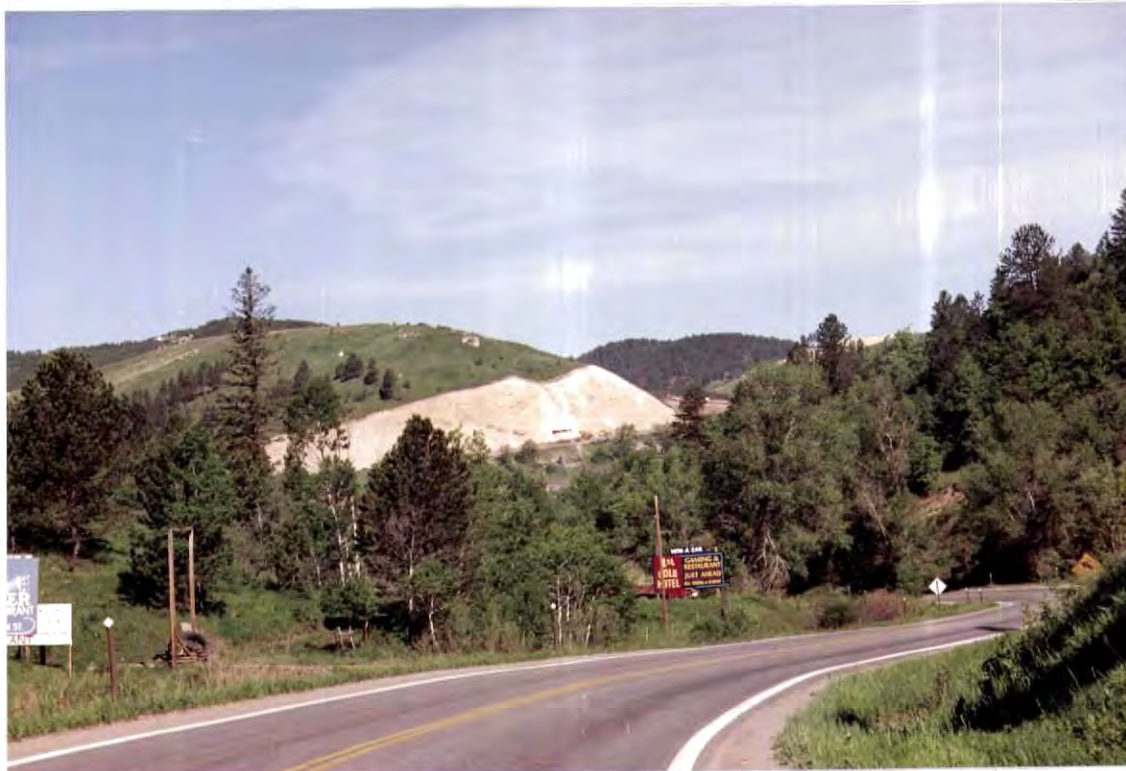
Photo 1: View of slope from across canyon. Measured profile is near the left side of the cut, below the tree-covered slope.

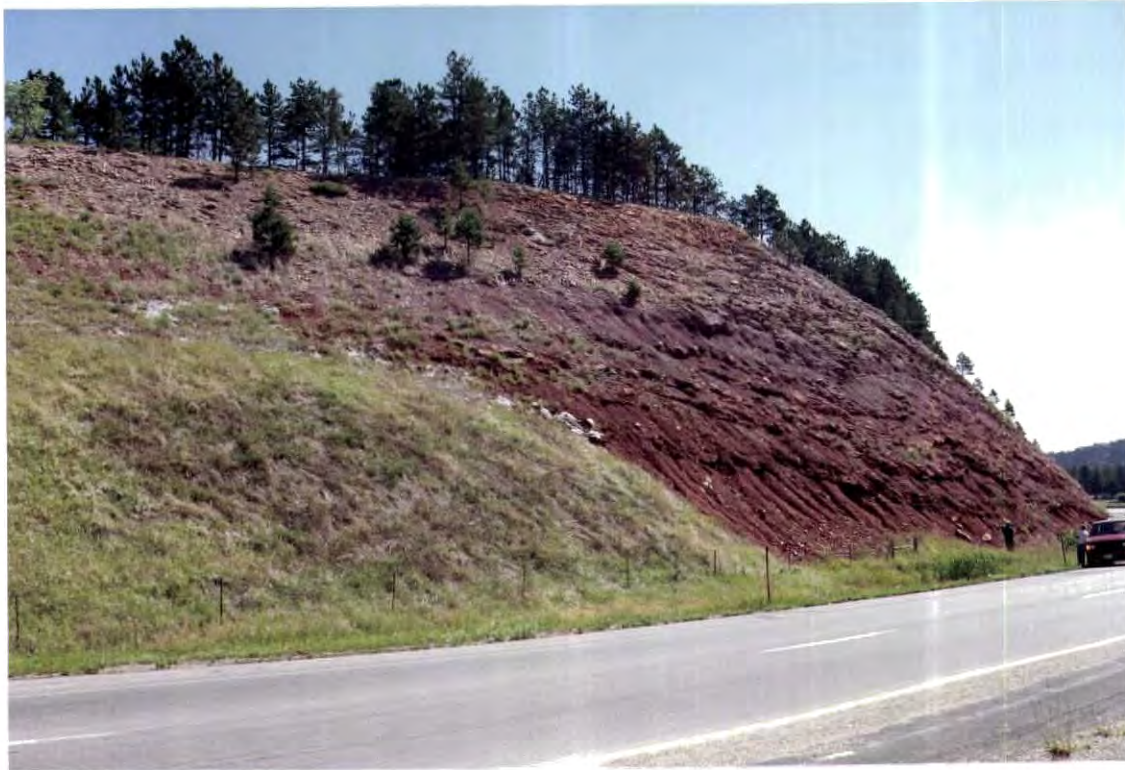
Photo 1: View of the slope from across highway. Note effectiveness of revegetation in controlling weathering of lower red shale beds.

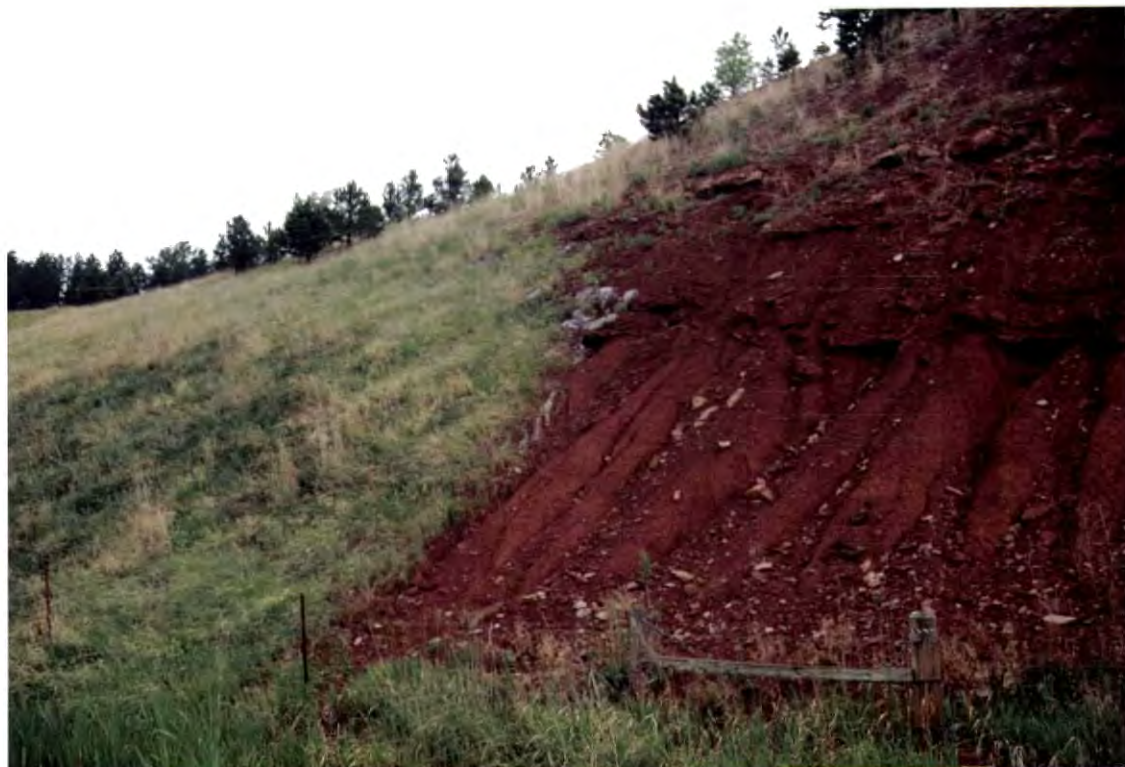
Photo 2: View showing contrast between revegetated and weathering sections of the slope.

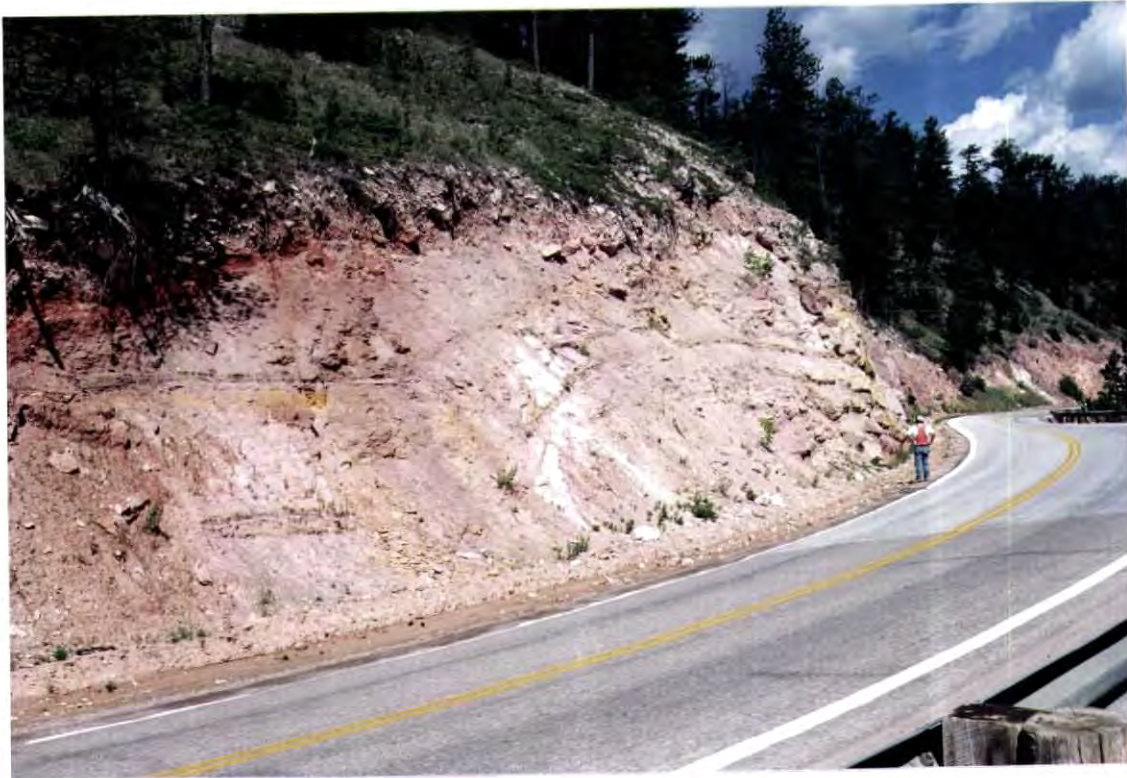
Photo 1: View of slope from across the highway.

Observed Slope Failure Mechanism: Collapse failure of the more competent rock as a result of erosion and undermining of less competent rocks.

Recommended treatment for rockfall and differential weathering: scaling overhangers, screening, rock barriers, shotcrete or buttressing, and vegetation treatment (wattling) applied to less competent beds.

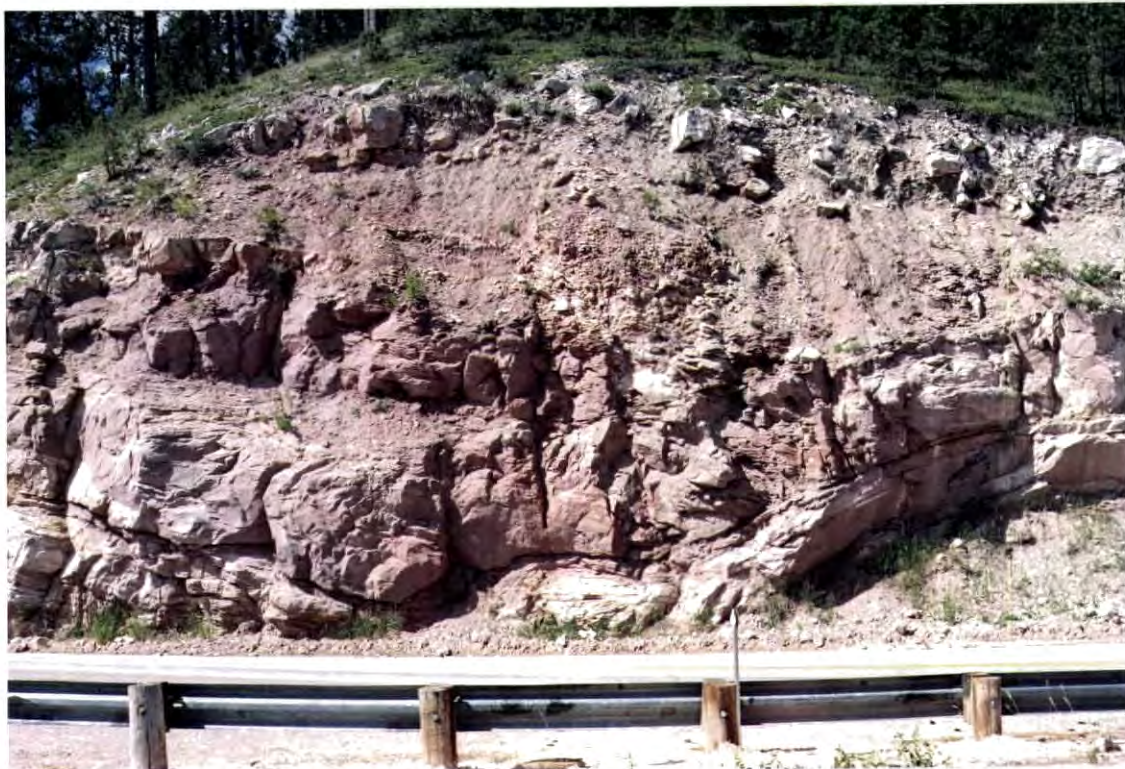
Photo 2: View of slope; note the thick colluvial deposit overlying the RUC unit.

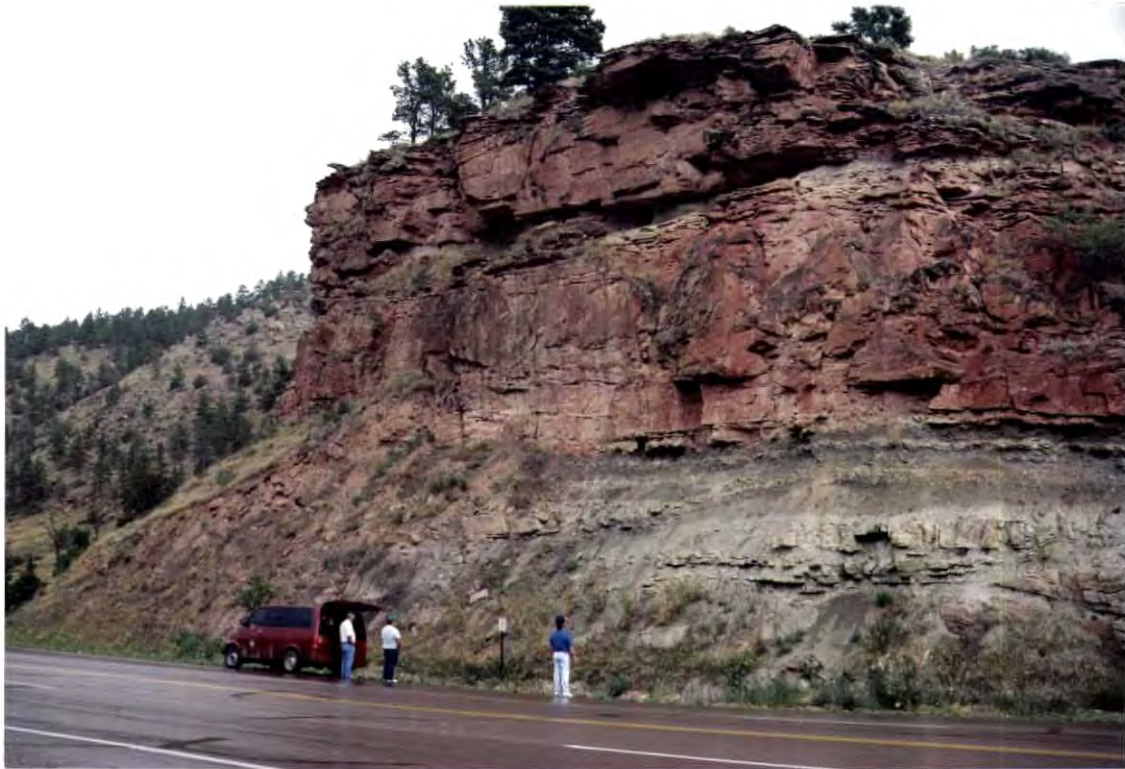
Photo 1: View of cut slope from across the highway.

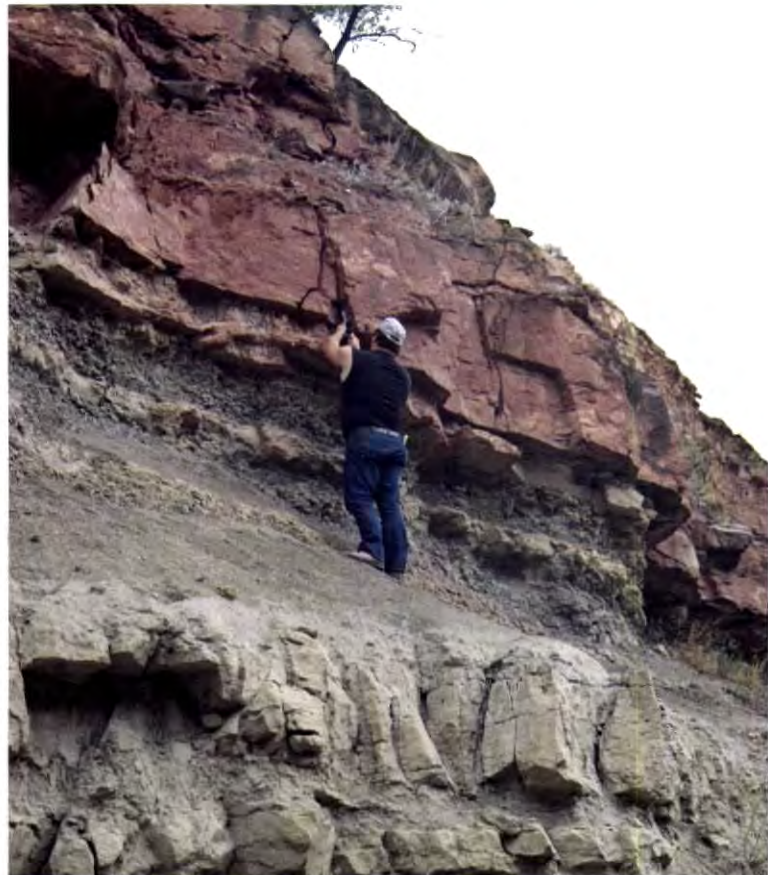
Photo 2: Close-up view of differential weathering.

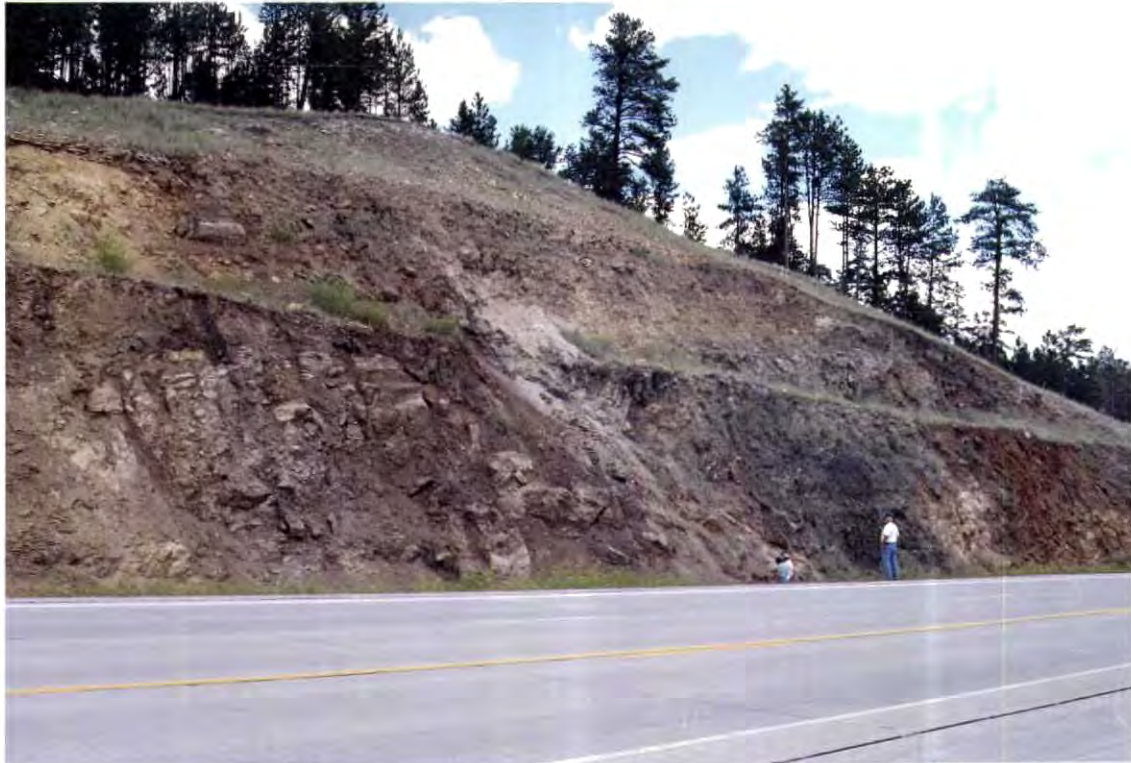
This slope was reconstructed in 1989. The slope was cut at 1/2:1, with a bench about halfway up slope. The slope has failed back to 48° at one location and is ravelling throughout.

Observed Slope Failure Mechanism: Slumping and mass failure of decomposed rock. Slumping may have occurred along a discontinuity at the failure surface.

Photo 1: View of slope from across the highway.

Recommended treatment methods: regrade slope to 48° or flatter, or install a rock buttress below the existing bench.

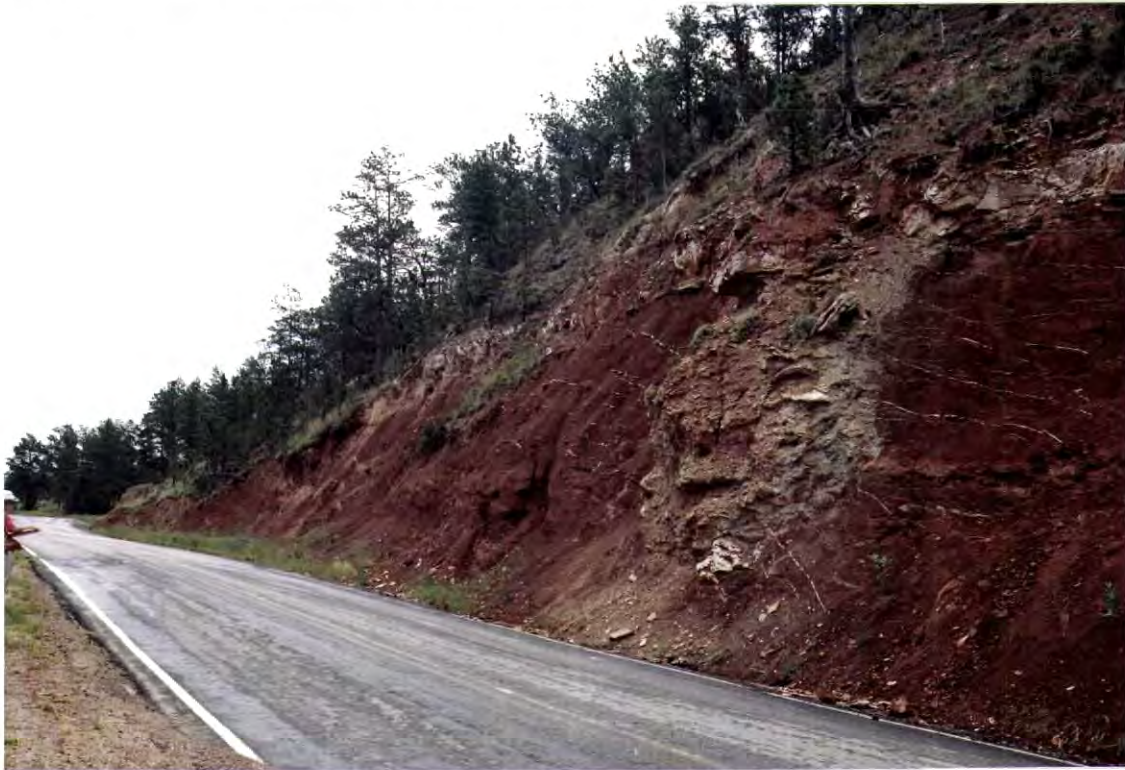
Photo 1: View of the slope from across the highway. Note the collapse of gypsum beds (white) in the red shale beds.

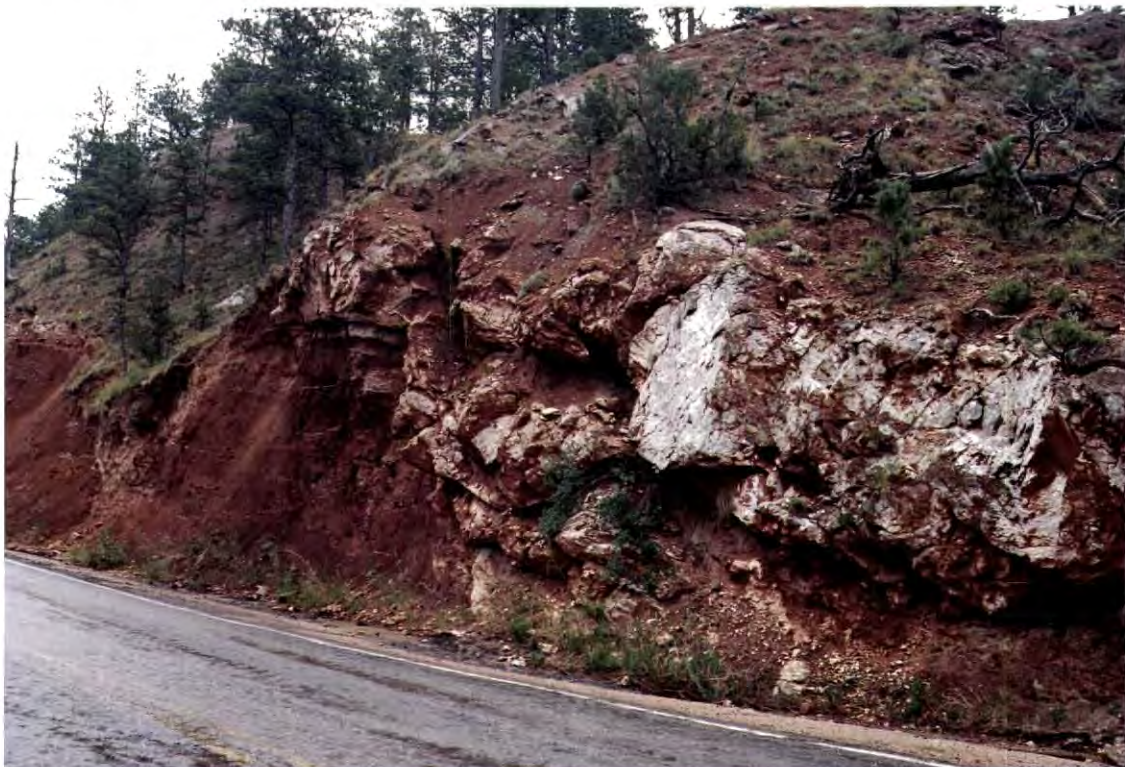
Photo 2: Close-up view of gypsum collapse features. Note the variable thickness of the gypsum beds. Also note the thick colluvium deposit in the draw on the left side of photo.

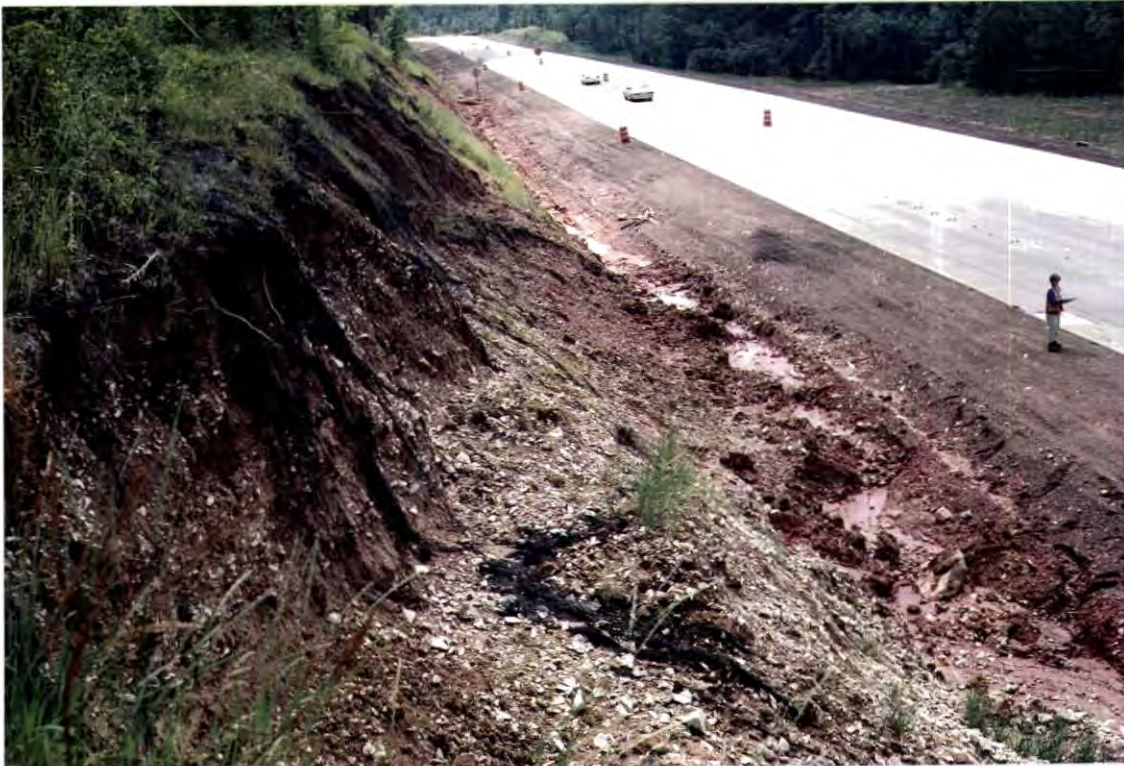
The slope was recently constructed and revegetated via hydroseed and fiberglass roving; the slope failed during construction and colluvium and shale filled the ditch. Slumped material was removed at a later time.

Photo 1: Close-up view of sandy SUS slump. Note red shale and water seepage in ditch.

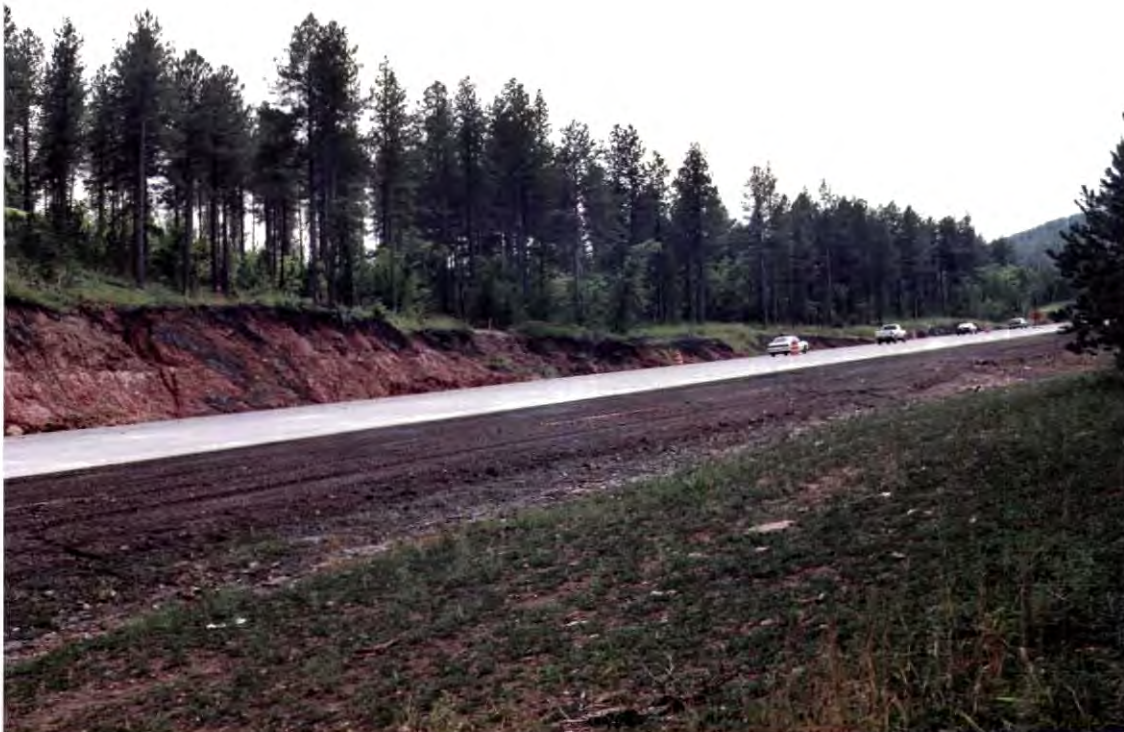
Photo 2: View of cut slope from across the highway. Note trace of the thin SUC clay (tan) at the top of the red shale unit.

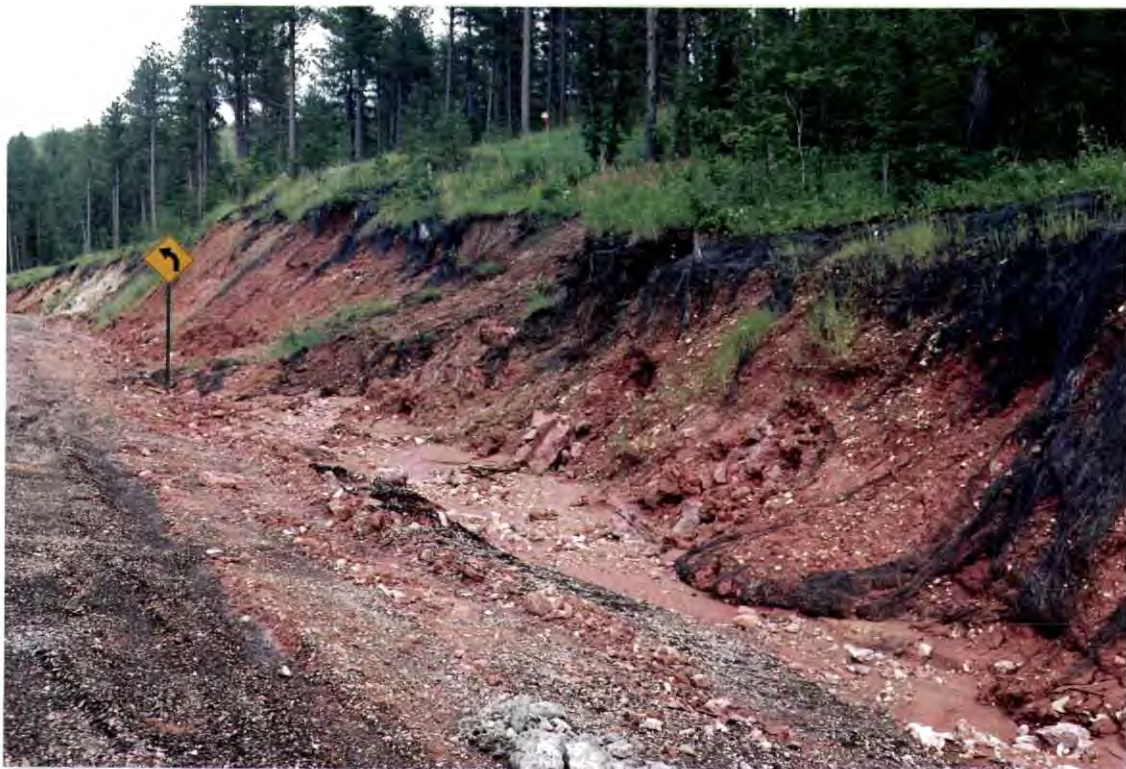
Photo 4: Profile view showing slumped SUS colluvium over red shale. Note the damaging effects of the slump on fiberglass roving.
