CN R924060

**Zuni Bowl and One Rock Check Dam Research –
Phase 1**

Final Report

Rio Grande Return for the New Mexico Department of Transportation Research Bureau

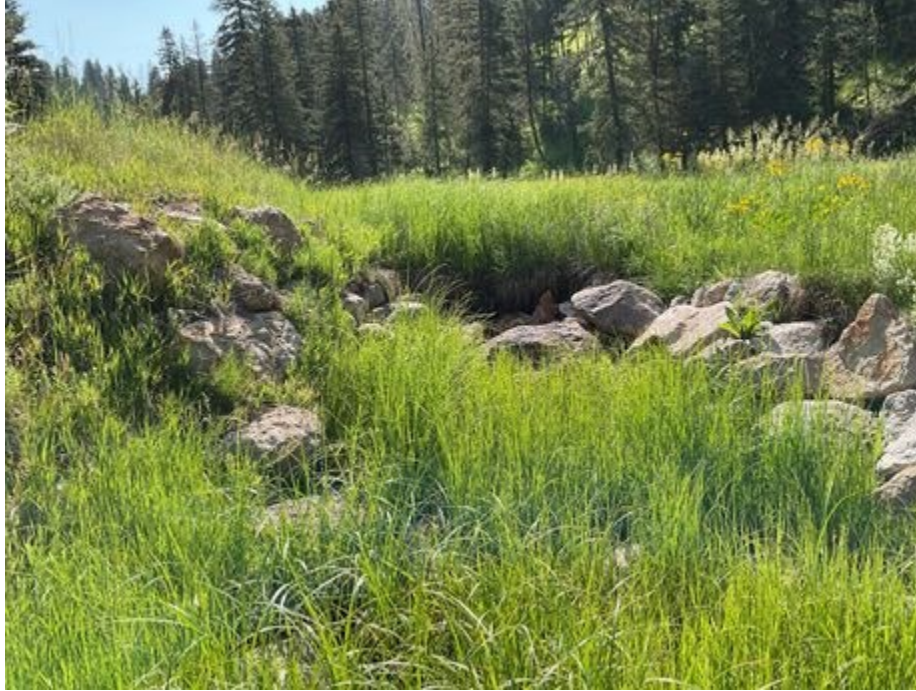
The majority of structures surveyed (68%) were entirely intact, whereas the remainder (32%) had at least one rock dislodged or broken. This is shown in Figure 3-3. This means that most of the structures have become integrated with the landscape and are likely functioning to arrest erosion. Dislodged rocks were deemed to be caused by water in all cases except one that was identified as human interference. RGR did not identify or survey any significantly deteriorated structures. Figure 3-4 shows a structure where some rocks were dislodged by water.

Figure 3-4. Example of some rocks dislodged or broken. Rocks were displaced from the Zuni Bowl Pour-Over shown in the center of the photo. Sulphur Creek #2. Object ID 51 in survey. Location: -106.6014258, 35.9241155. Photo looking upslope.

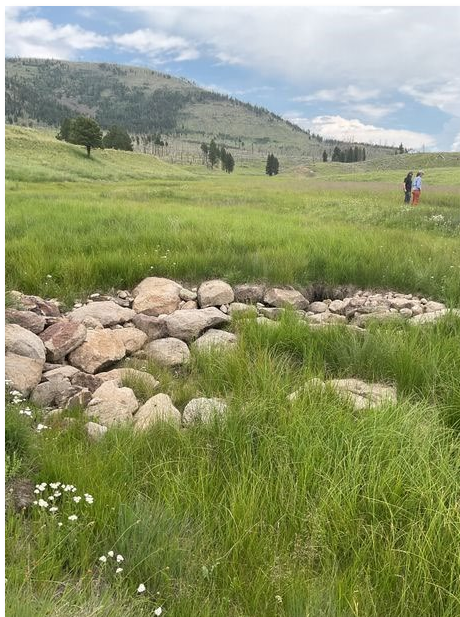
The majority of the structures (75%) exhibited no new erosion. This is shown in Figure 3-5. Some structures experienced undercutting (or piping) around the rocks (14%). Fewer show signs of erosion around the sides of the structure (8%). At the remaining (3%) of survey points, erosion was observed between the Zuni Bowl and One Rock Dam due to steep slopes. Figure 3-6 shows an example of a structure where undercutting or piping has occurred.

Figure 3-6. Undercutting or piping through the rocks is seen on the far side of the Zuni Bowl wall on the right. Santa Rosa #6, Object ID 55 in survey. Location: -106.5974051, 35.92597653. Looking toward valley left.

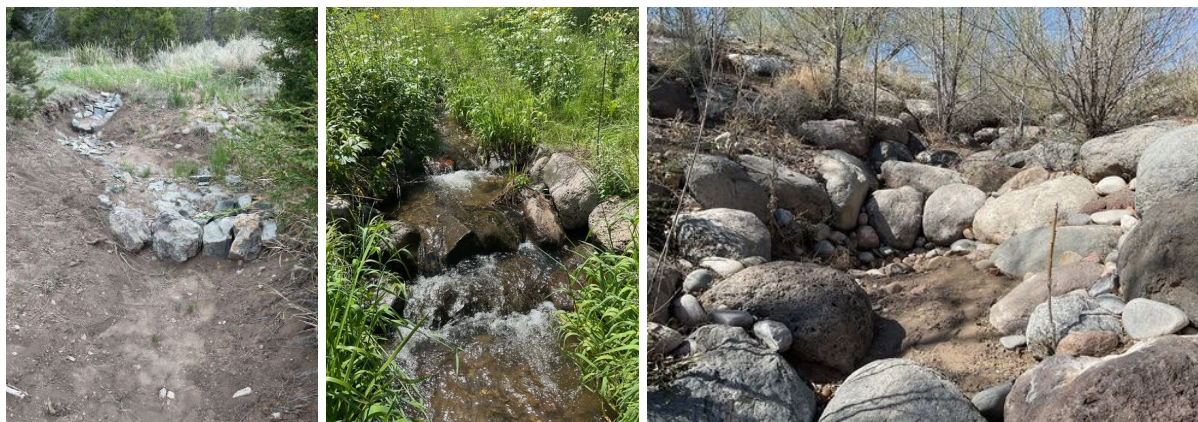
means some edges and flat surfaces. Round means all rounded. Using rocks that are partially angular to angular is desirable because these rocks will interlock and reduce pore space in the structure. Figure 3-9 shows examples of structures with different rock angularity.

Figure 3-9. Examples of angular (left), partially angular (middle) and round (right) rocks. Locations: -106.3531756, 35.0482939; -106.5187878, 35.86520847; and -105.97 27933, 35.68119967, respectively.

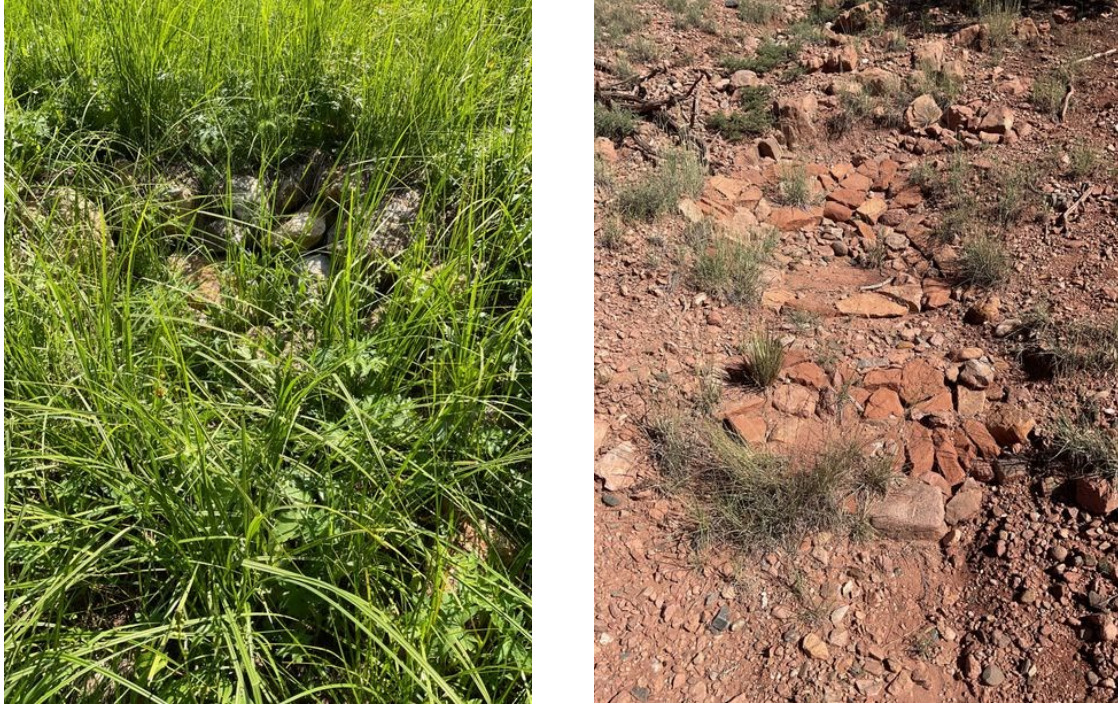
*Figure 3-15. Examples of 76-100% vegetated (left) and 1-24% vegetated (right).
Locations: -106.6013747, 35.9240822; and -105.942457, 35.44432338, respectively.*

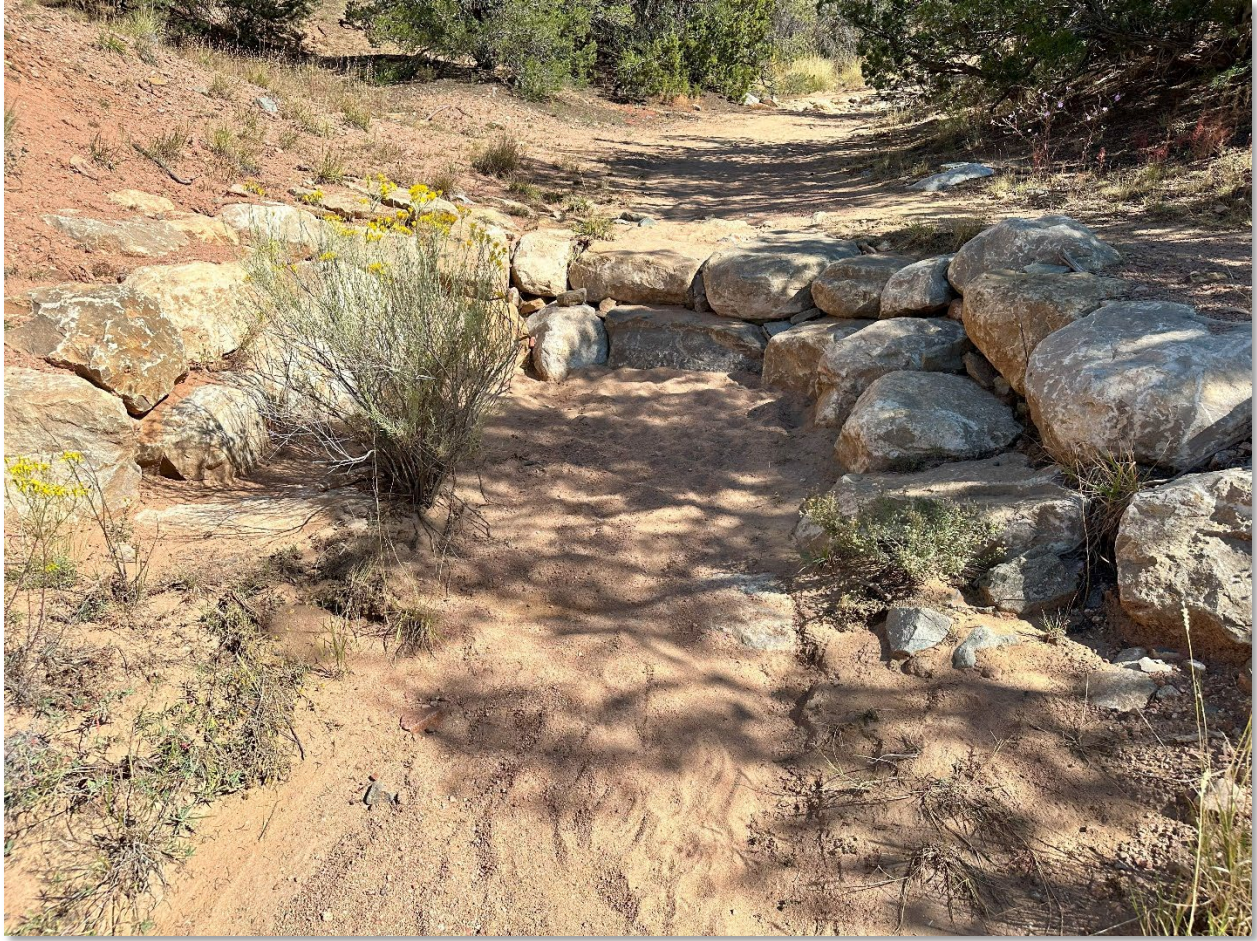
The field trip site has numerous examples of rock structures built by Watershed Artisans, Inc., The RainCatcher Inc, and Southwest Urban Hydrology, LLC in approximately 2014. The structures are intact and embedded with little evidence of new erosion or displacement. Workshop participants were able to see two Zuni Bowl/One Rock Dam structures, several rock rundowns, plunge pools (similar to successive Zuni Bowls on a steep slope, and 1930s-era gabion baskets in the arroyo, before the snow began to obscure the structures. This is shown in Figure 4-4. Because of the deteriorating weather, the field trip itinerary was truncated. Participants were advised that they could come back to the arroyo to see structures at another time as it is public property. A Zuni Bowl in the arroyo is shown in Figure 4-5. There are several other rock structures visible in the arroyo downstream to just beyond the culvert under Camino Corrales.

Figure 4-5. Zuni Bowl in the arroyo at Santa Fe Botanical Gardens. Photo taken on a clear day prior to the field trip. Location: -105.928595, 35.665349.

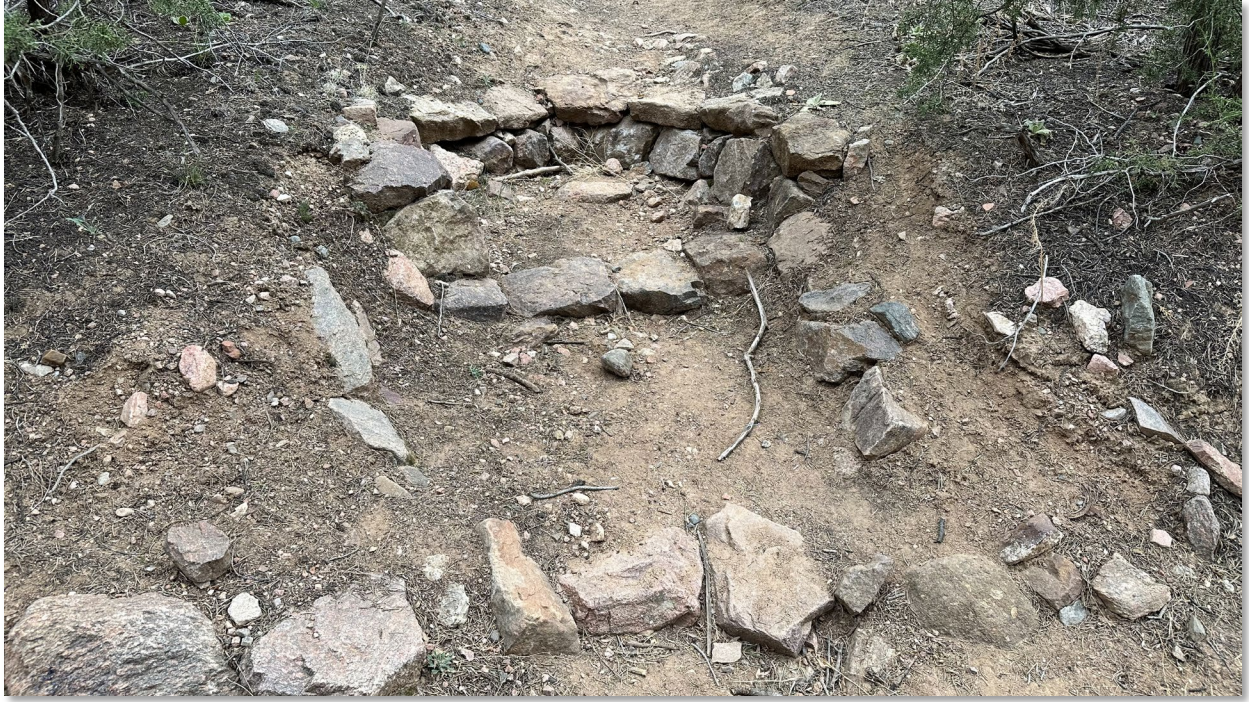
Figure 5-1. Santa Fe Botanical Gardens 10. Object ID 1 in the survey. Location: -105.93051, 35.664118. Photo looking upslope.

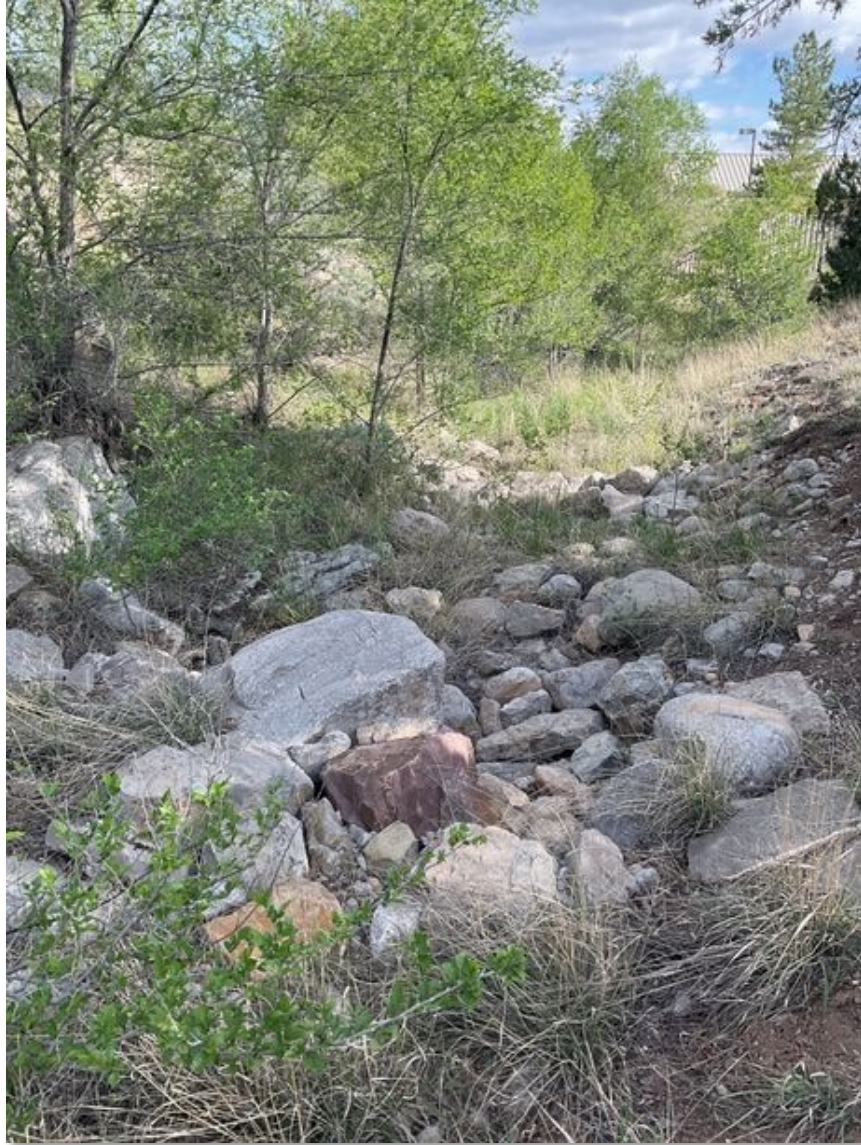
Figure 5-2. Cedro Creek #1. Object ID 3 in the survey. Location: -106.38461, 35.074242. Photo looking downslope.

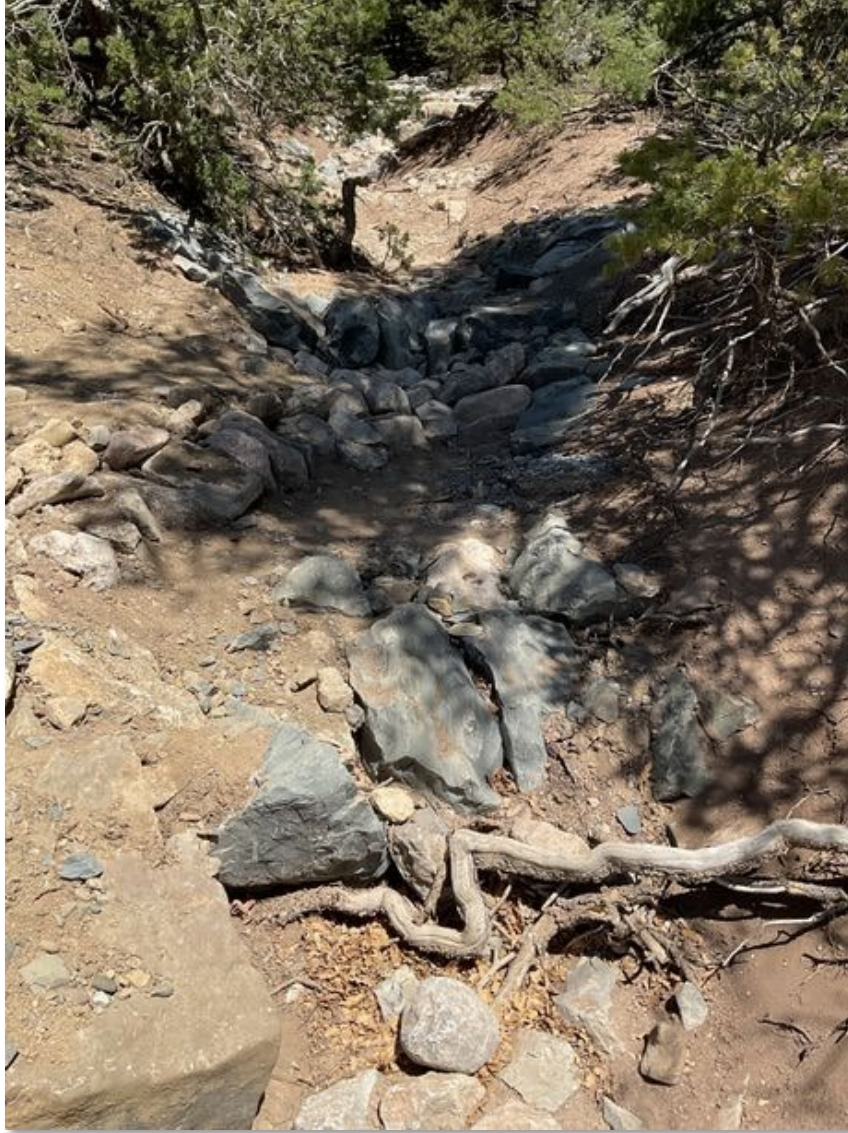
Figure 5-3. Juan Tomas #13, Rio Mora NWR. Object ID 14 in the survey. Location: -106.35365, 35.04917. Photo looking upslope.

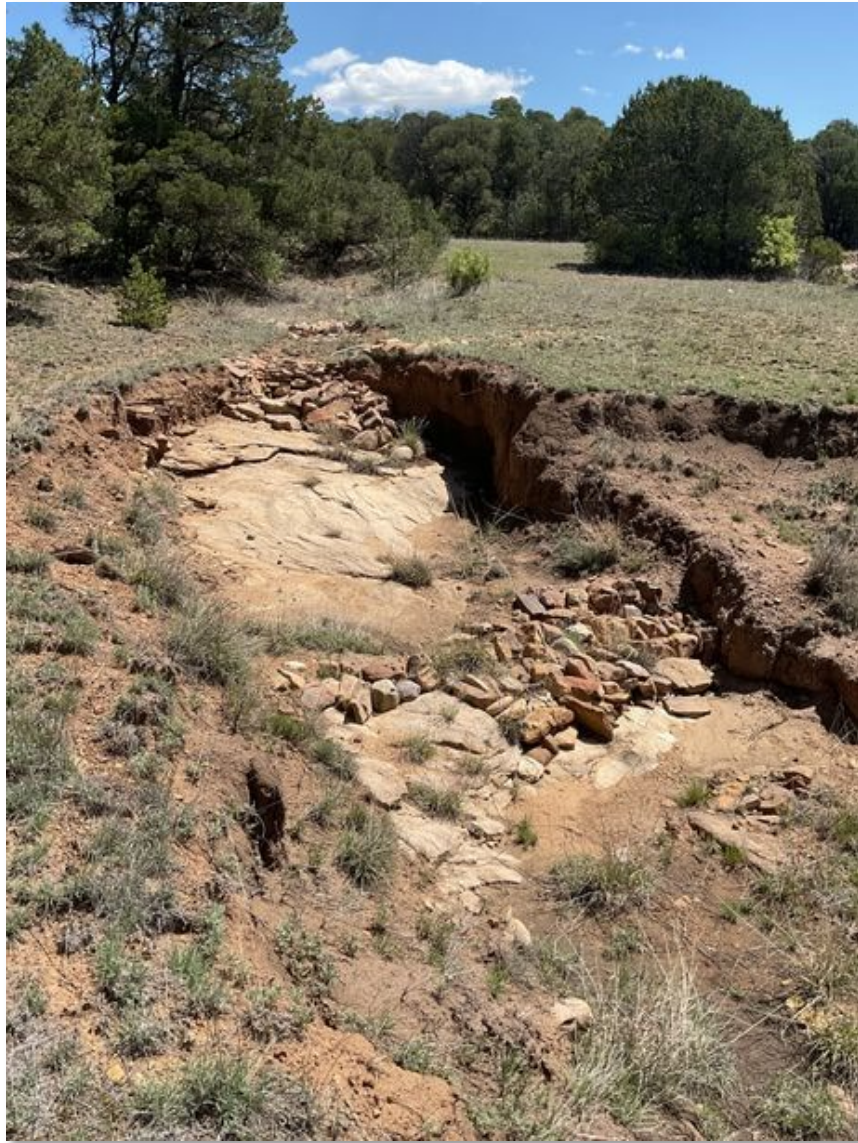
Figure 5-4. Rio Mora NWR #2. Object ID 35 in the survey. Location: -105.0570489, 35.83039503. Photo looking upslope.

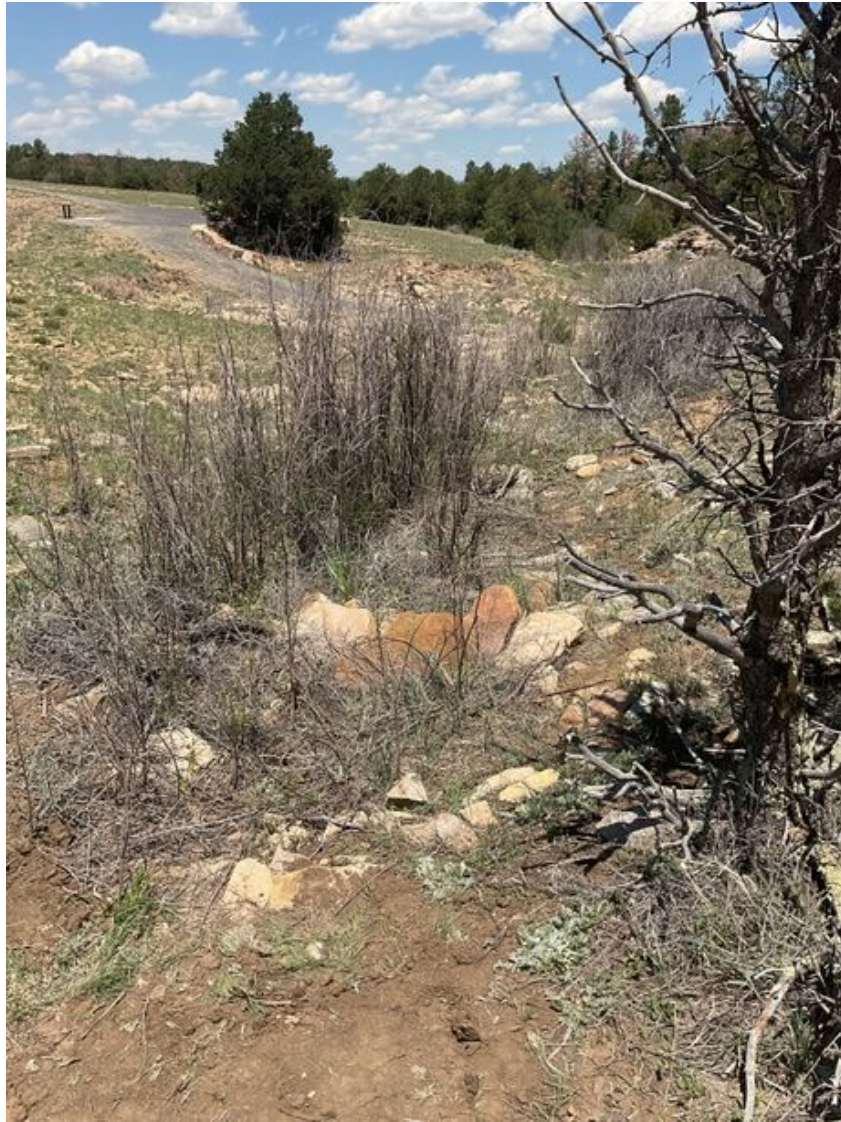
Figure 5-5. Rio Mora NWR #12. Object ID 38 in the survey. Location: -105.073796, 35.83369238. Photo looking downslope.

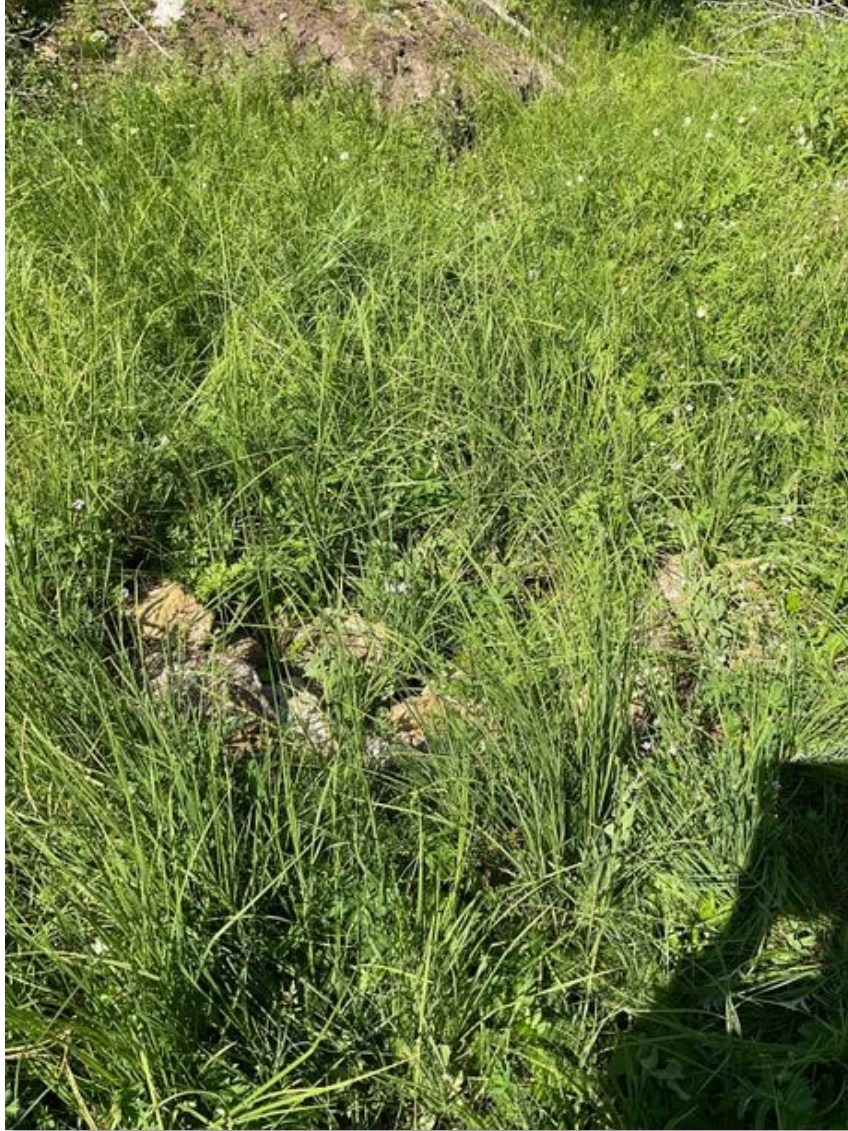
Figure 5-6. Sulphur Creek #3. Object ID 52 in the survey. Location: -106.6013747, 35.9240822. Photo looking downslope. Structure is obscured by vegetation.

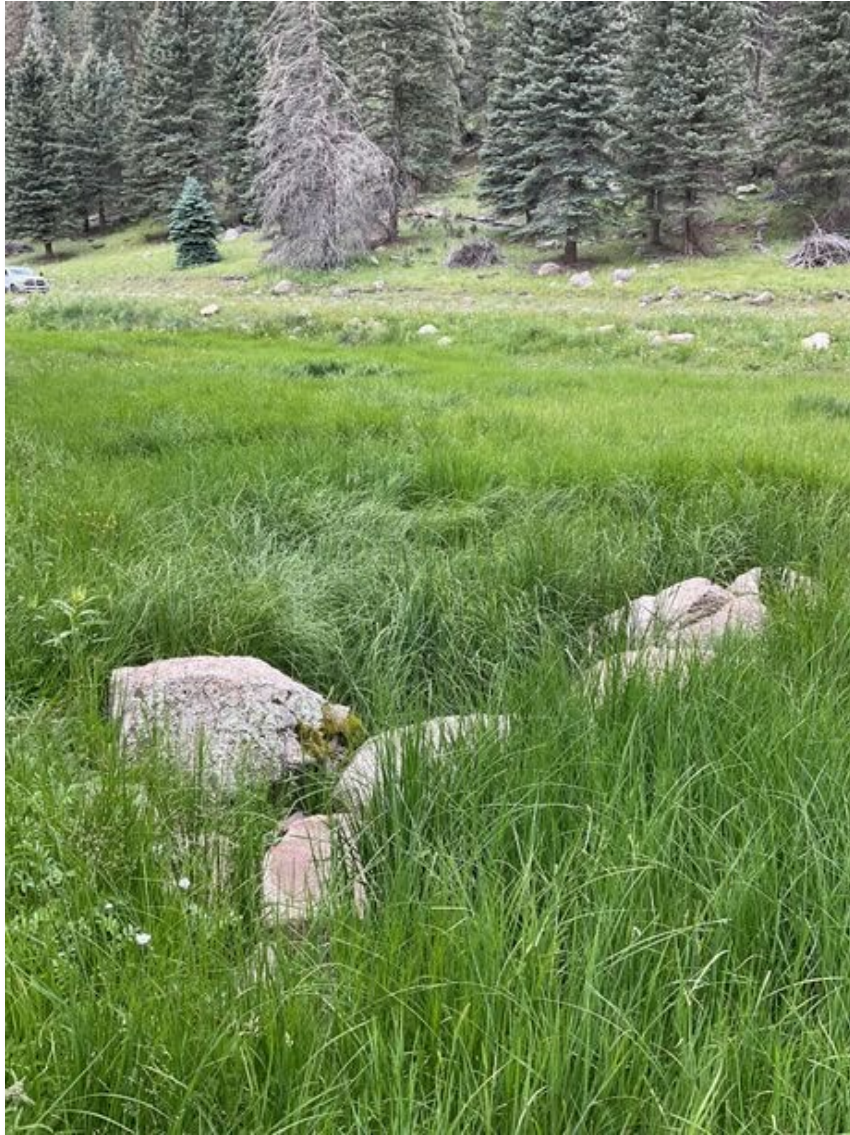
Figure 5-7. Sulphur Creek #14. Object ID 63 in the survey. Location: -106.5914269, 35.93480662 Photo looking downslope. Much of the structure is obscured by vegetation.

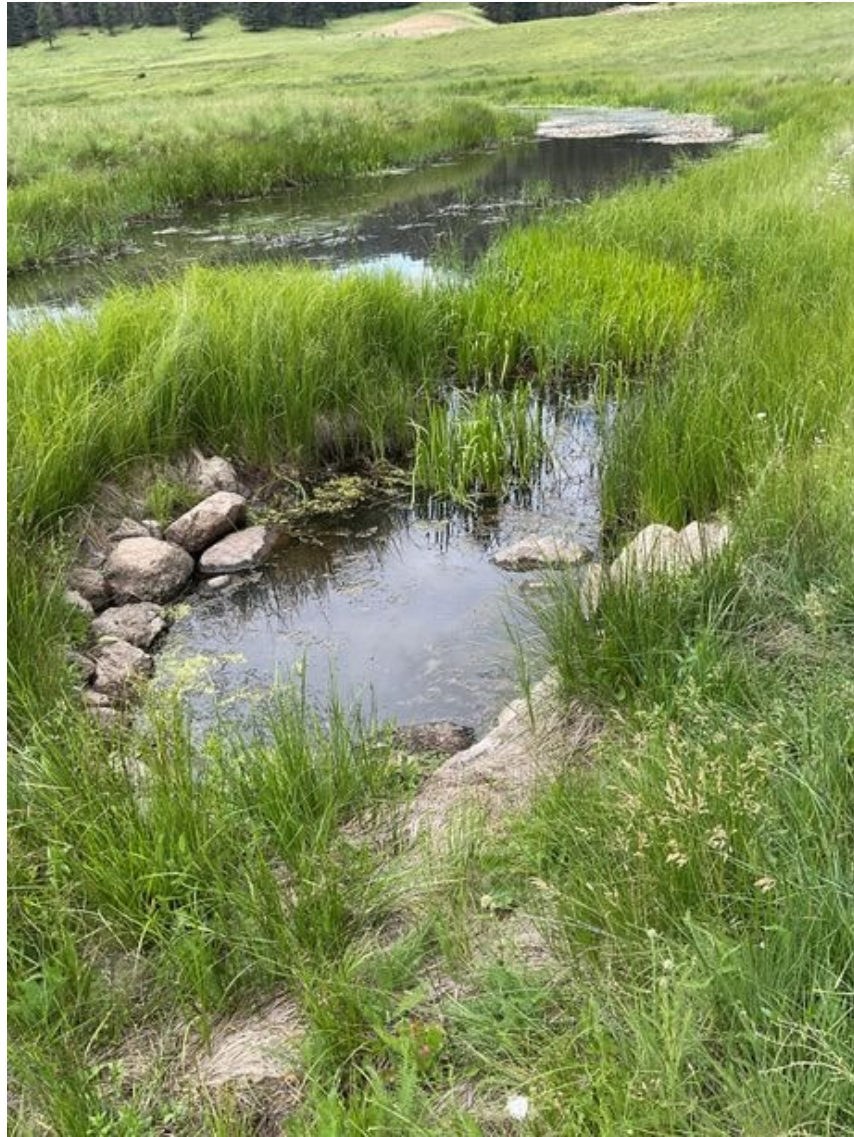
Figure 5-8. Sulphur Creek #15. Object ID 64 in the survey. Location: -106.588288, 35.93802508. Photo looking downslope.

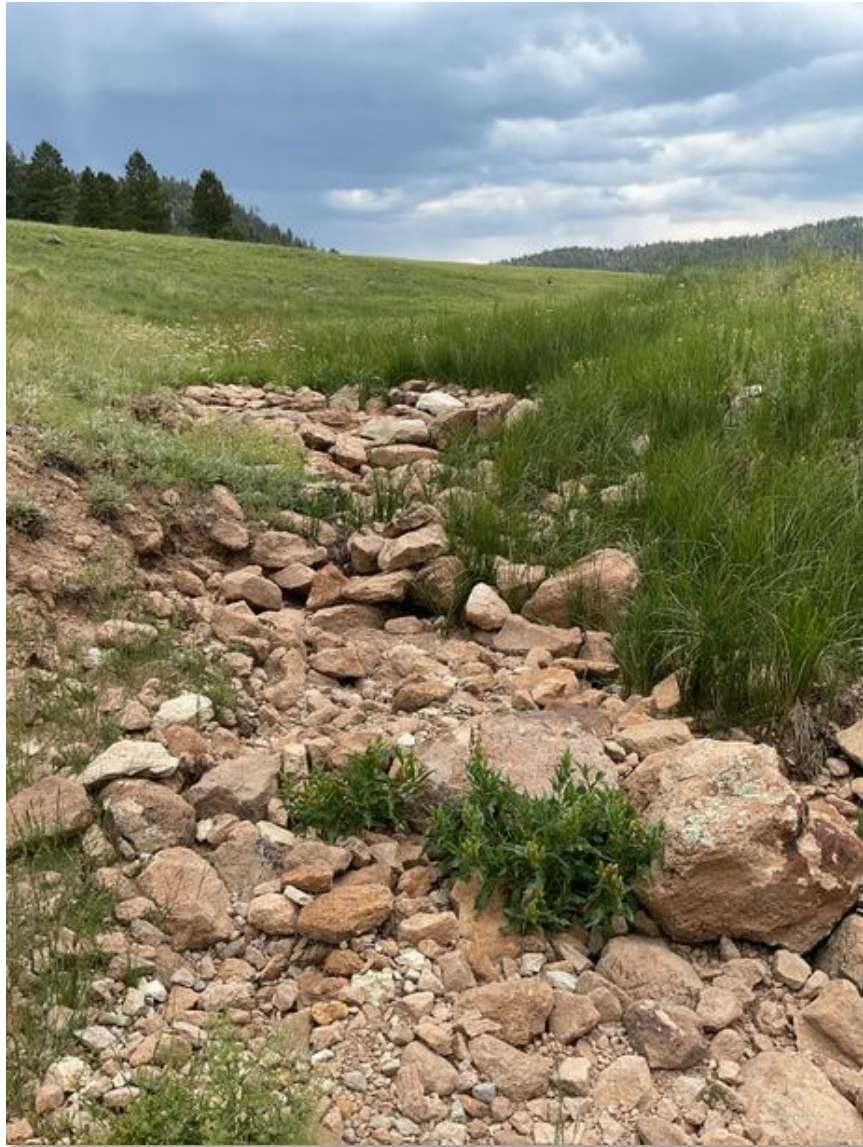
Figure 5-9. Sulphur Creek #17. Object ID 66 in the survey. Location: -106.5808215, 35.9372305. Photo looking upslope.

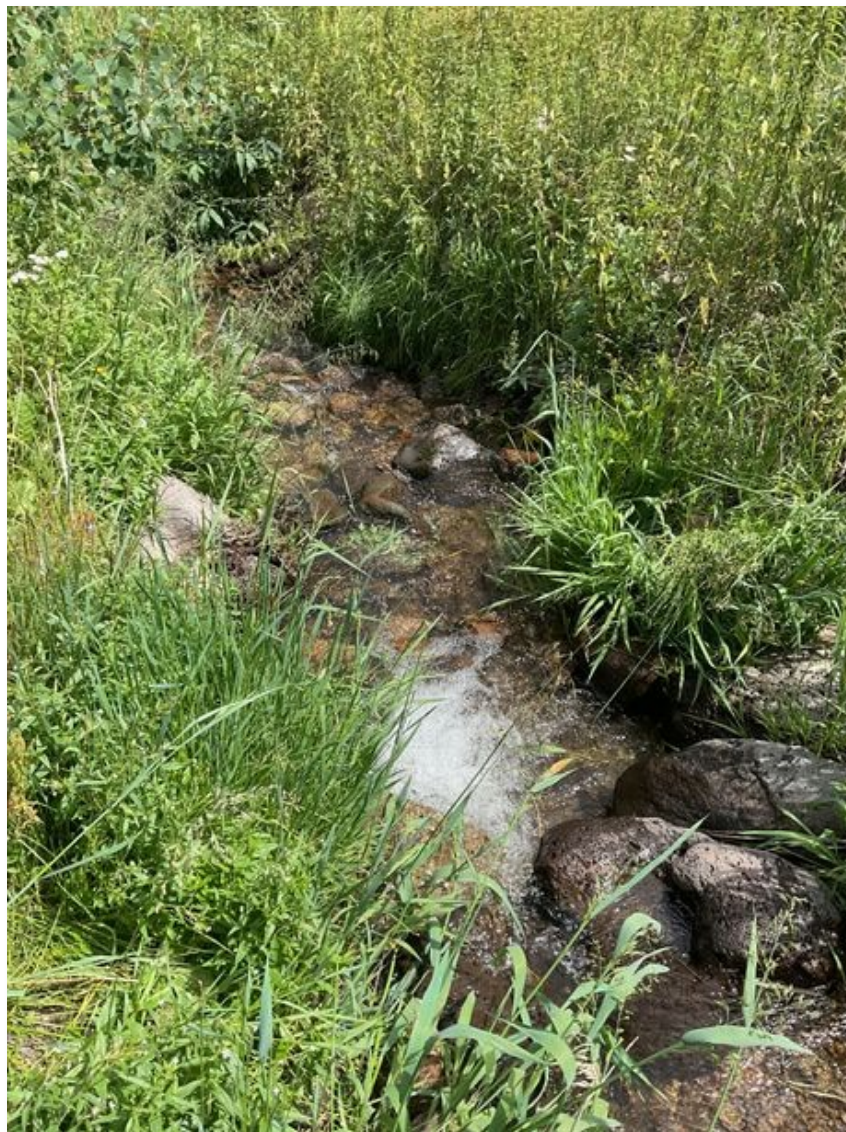
Figure 5-10. La Jara Creek #1. Object ID 79 in the survey. Location: -106.518787235.8651939. Photo looking downslope.

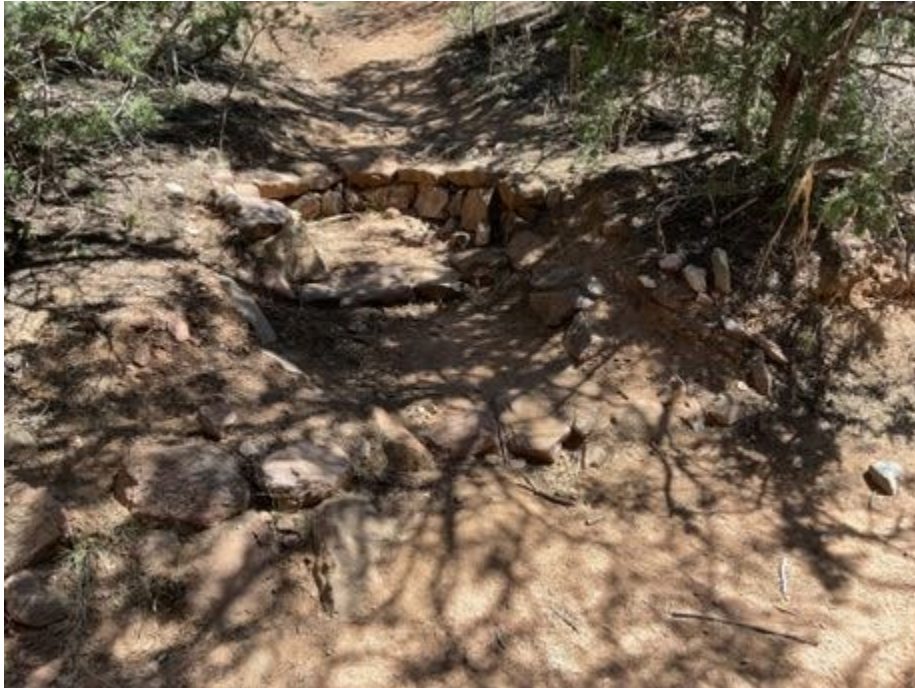
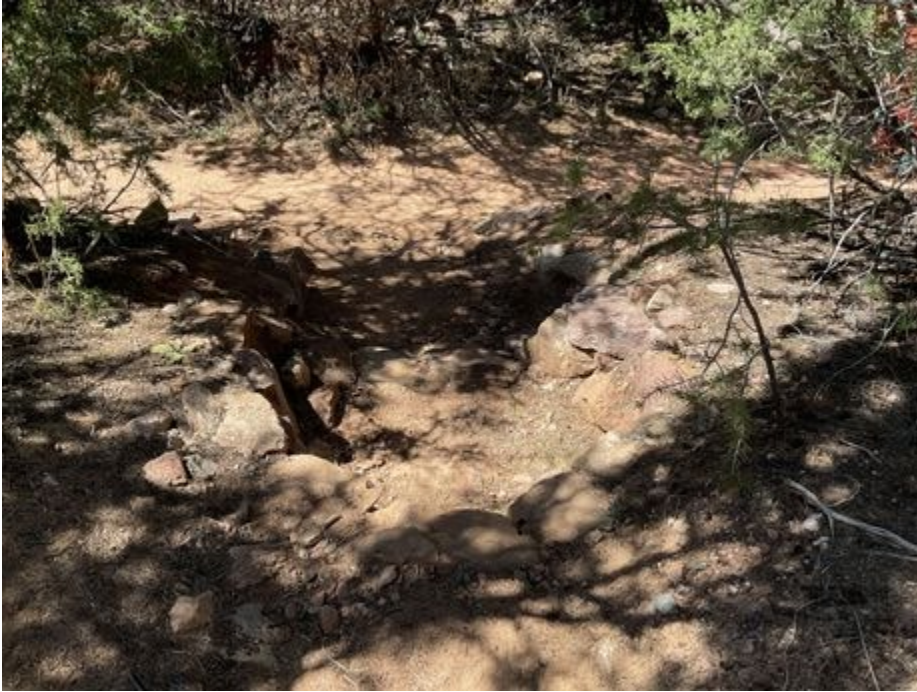
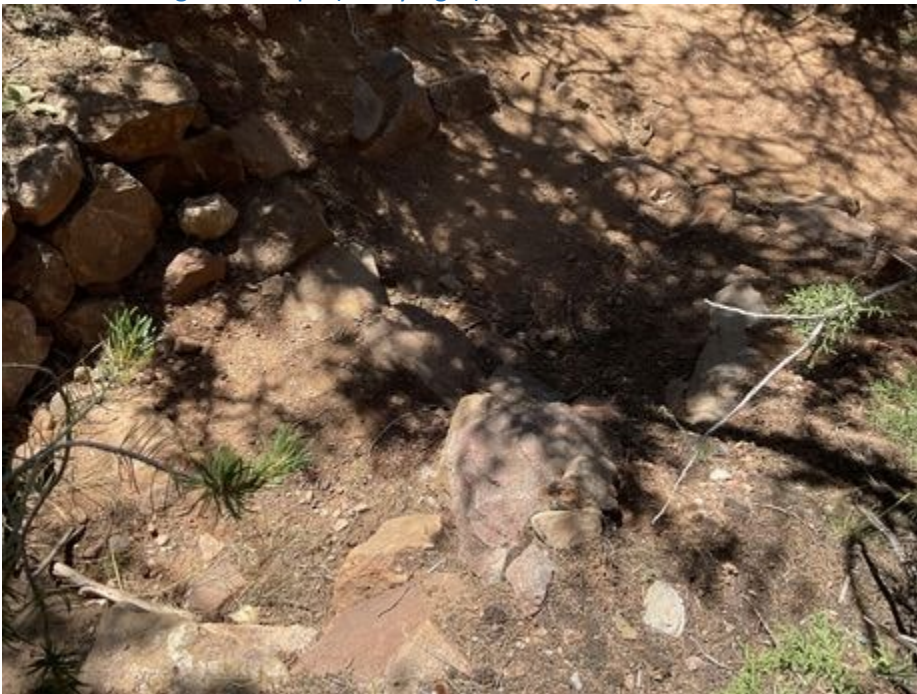
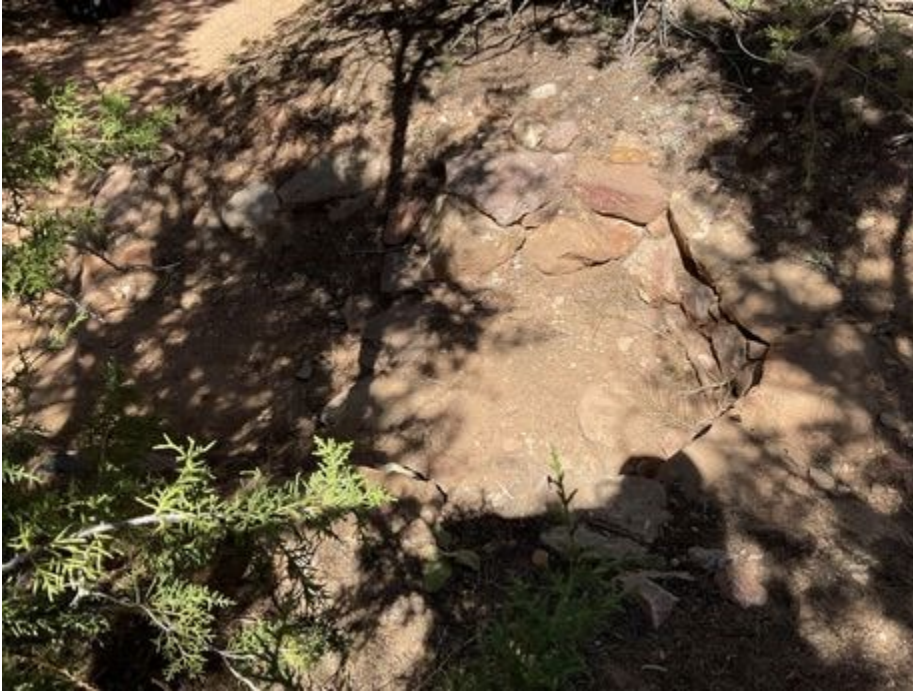
All rocks intact

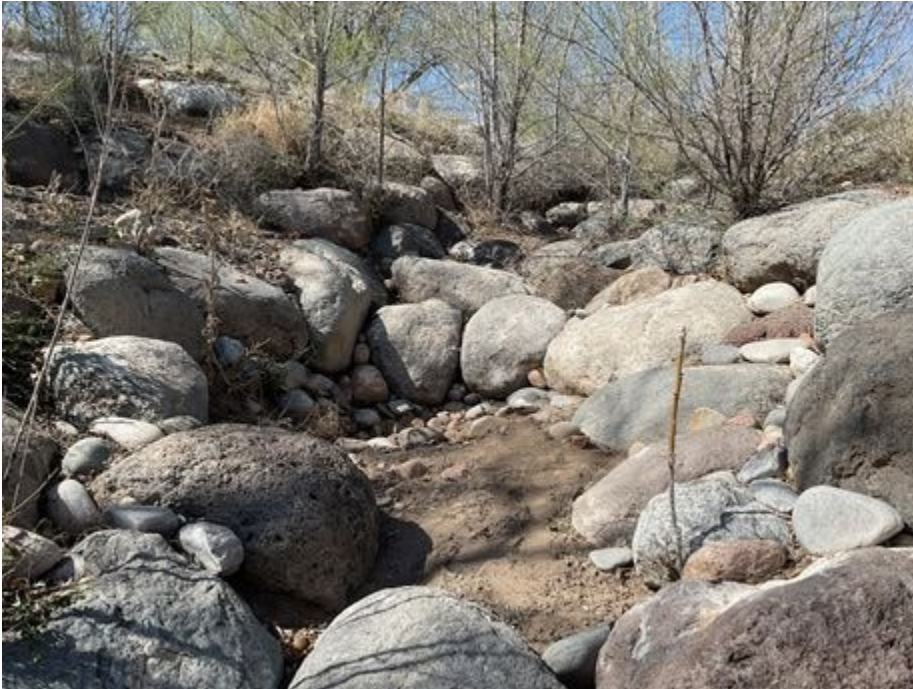
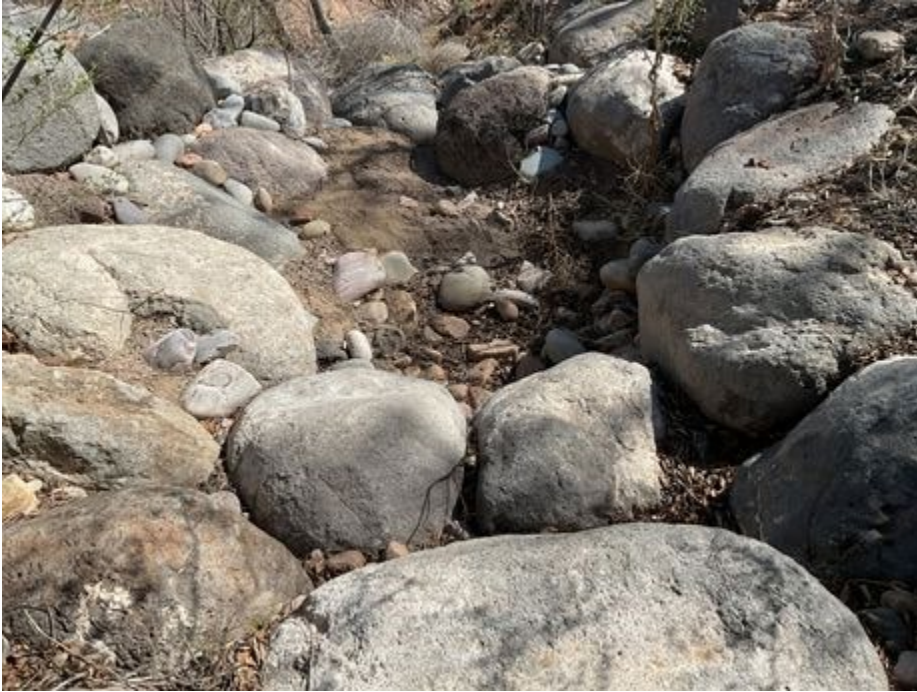
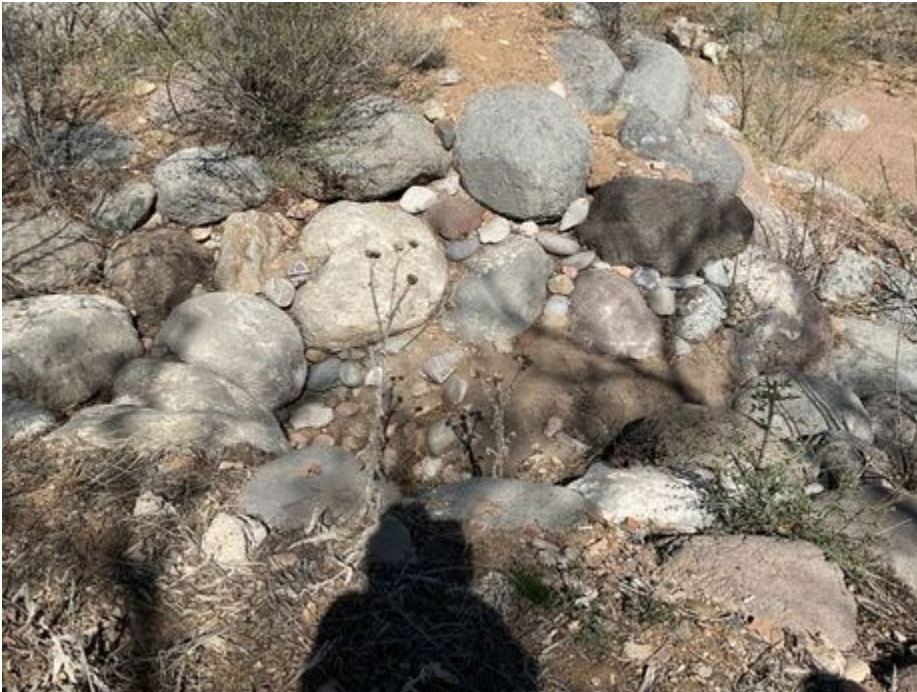
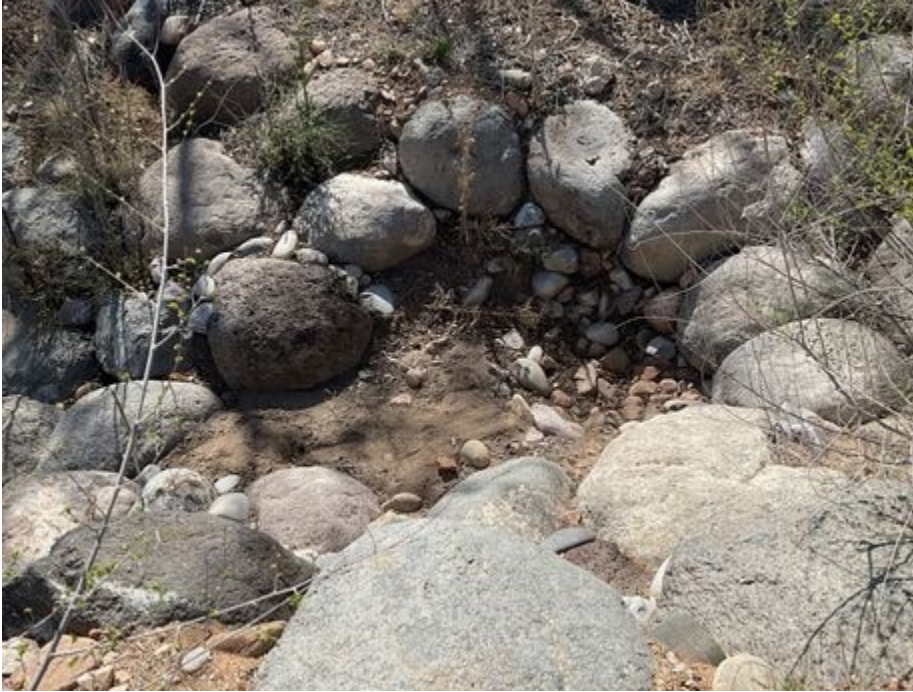
All rocks intact

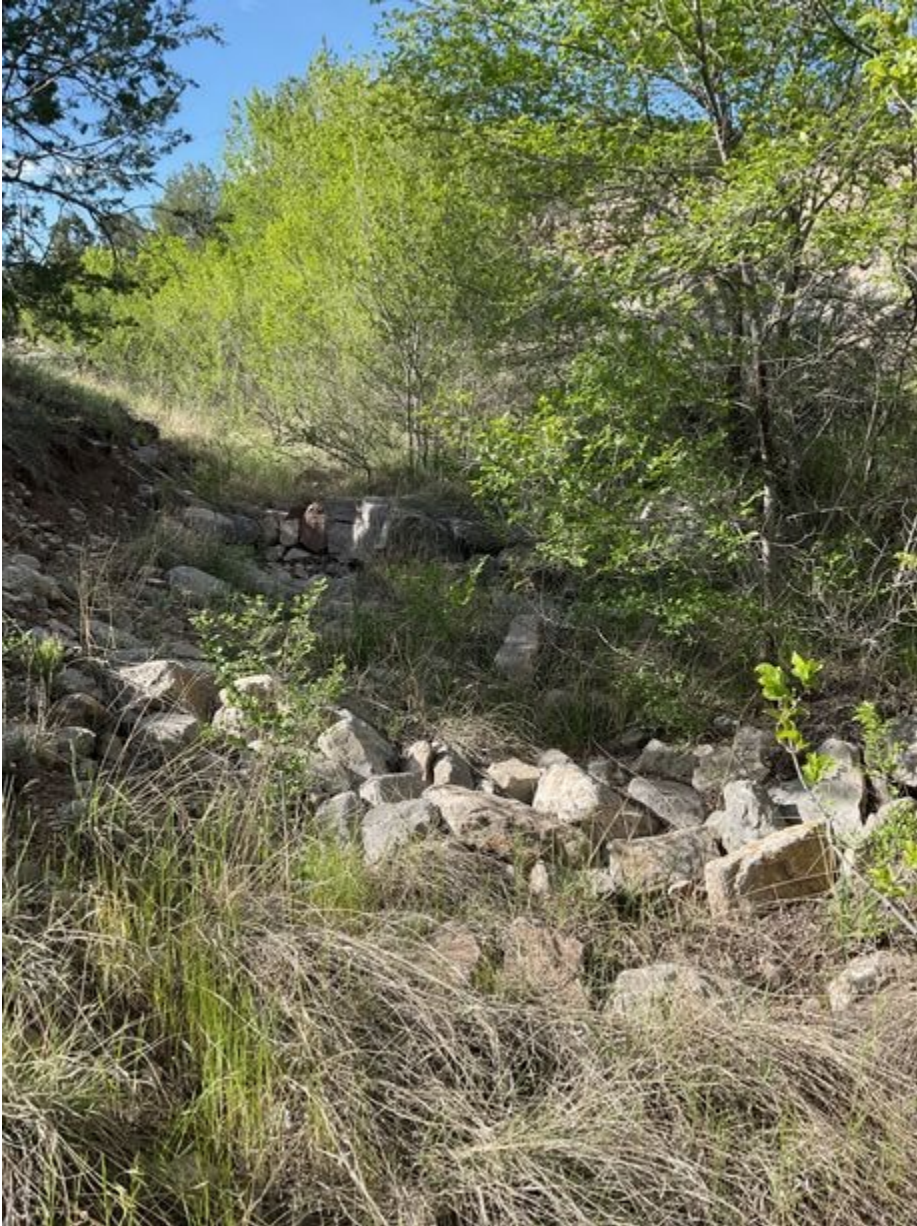
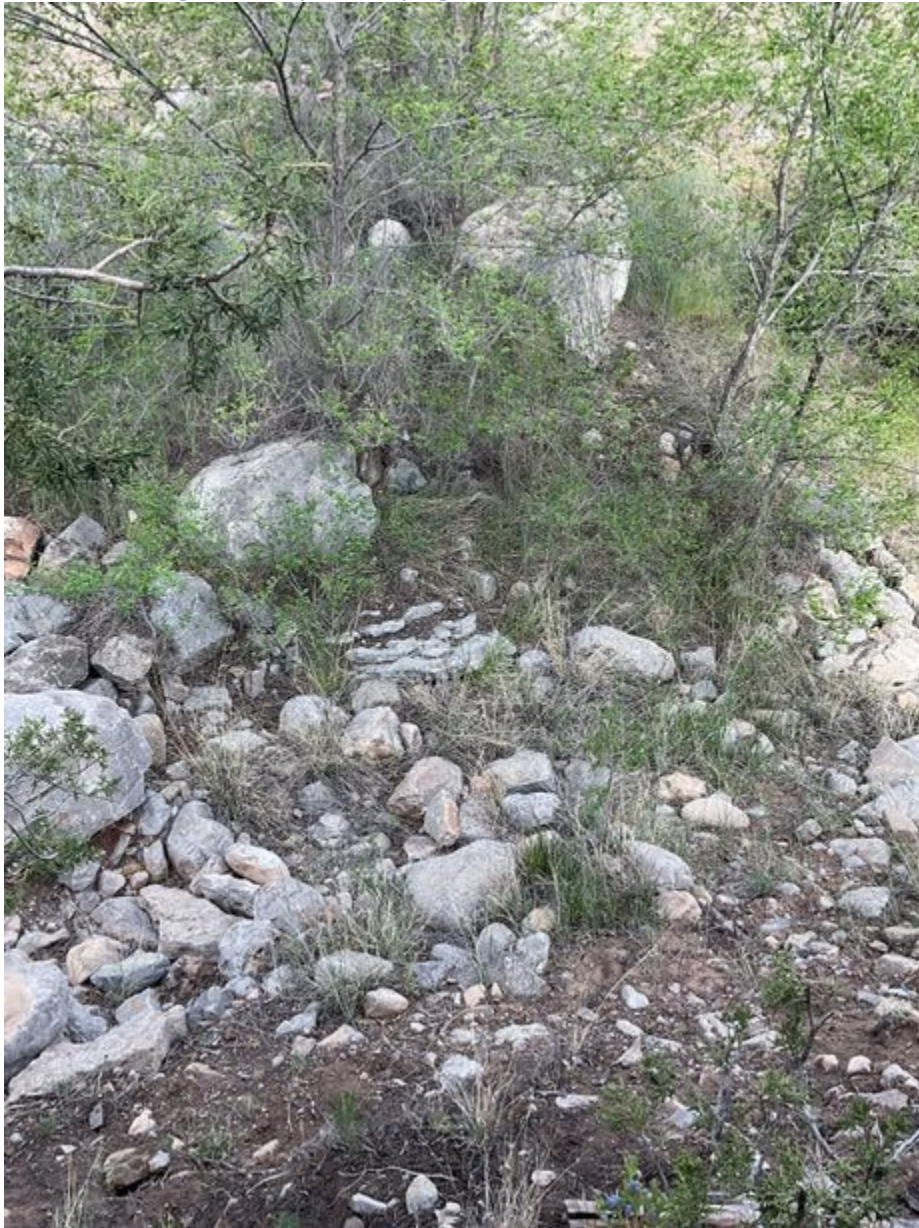
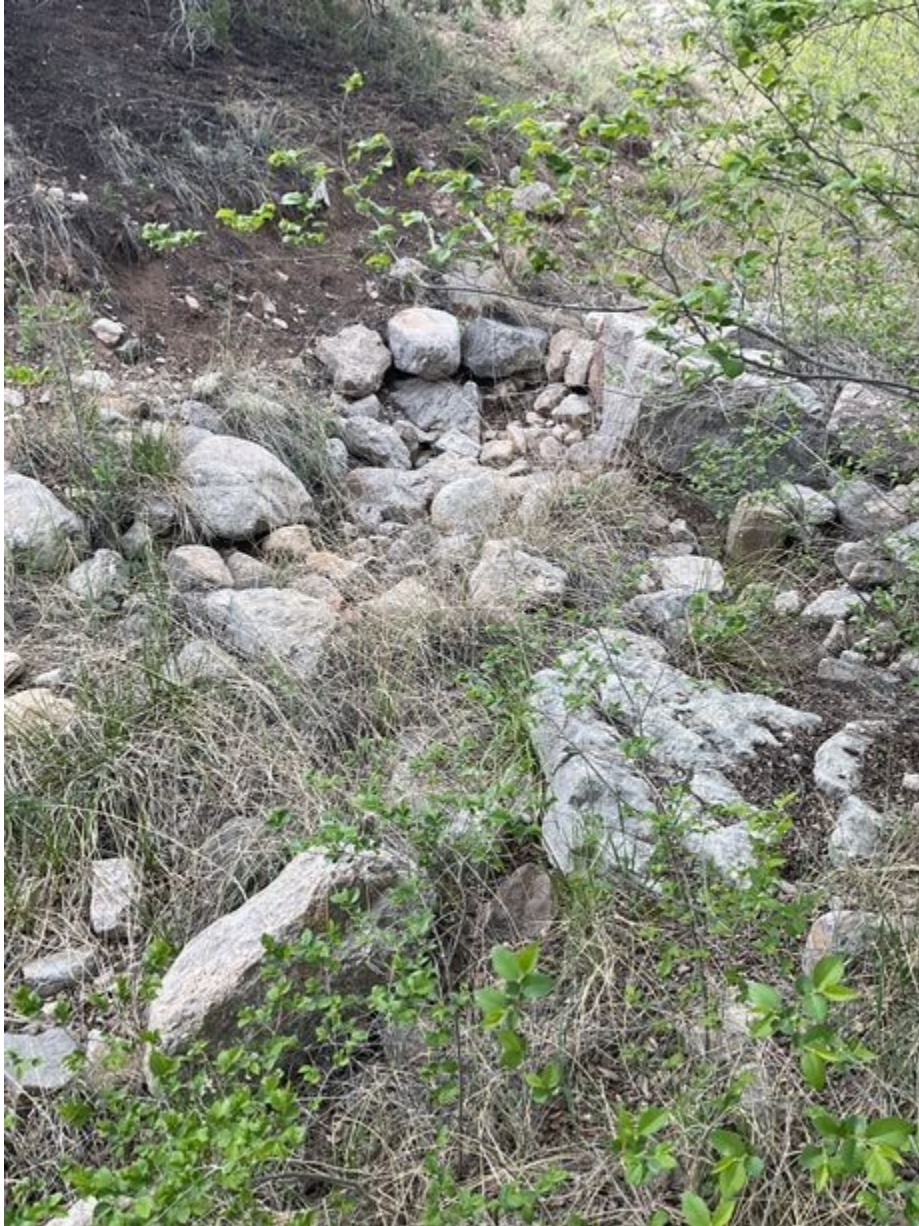
All rocks intact
