CN R924060

**Zuni Bowl and One Rock Check Dam Research –
Phase 1**

Final Report

Rio Grande Return for the New Mexico Department of Transportation Research Bureau

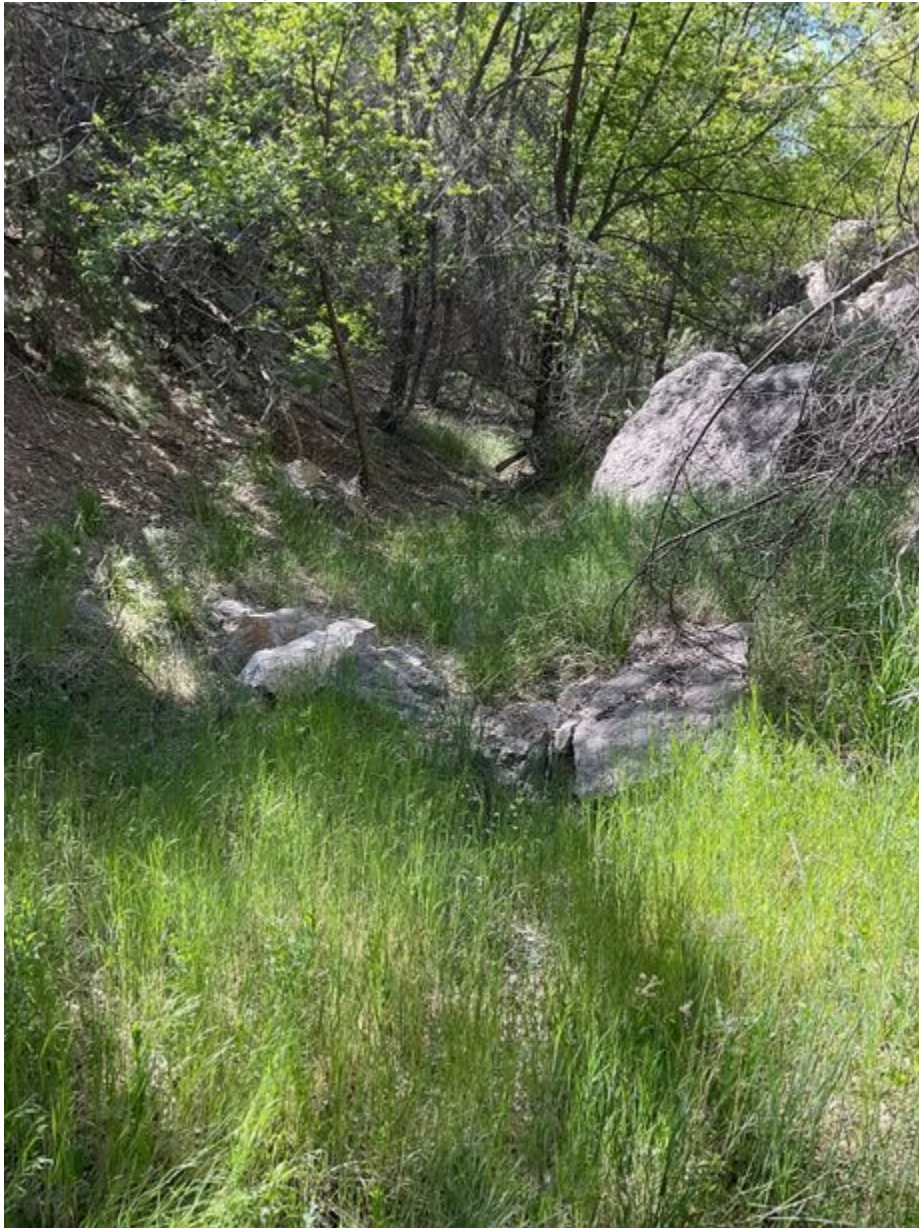
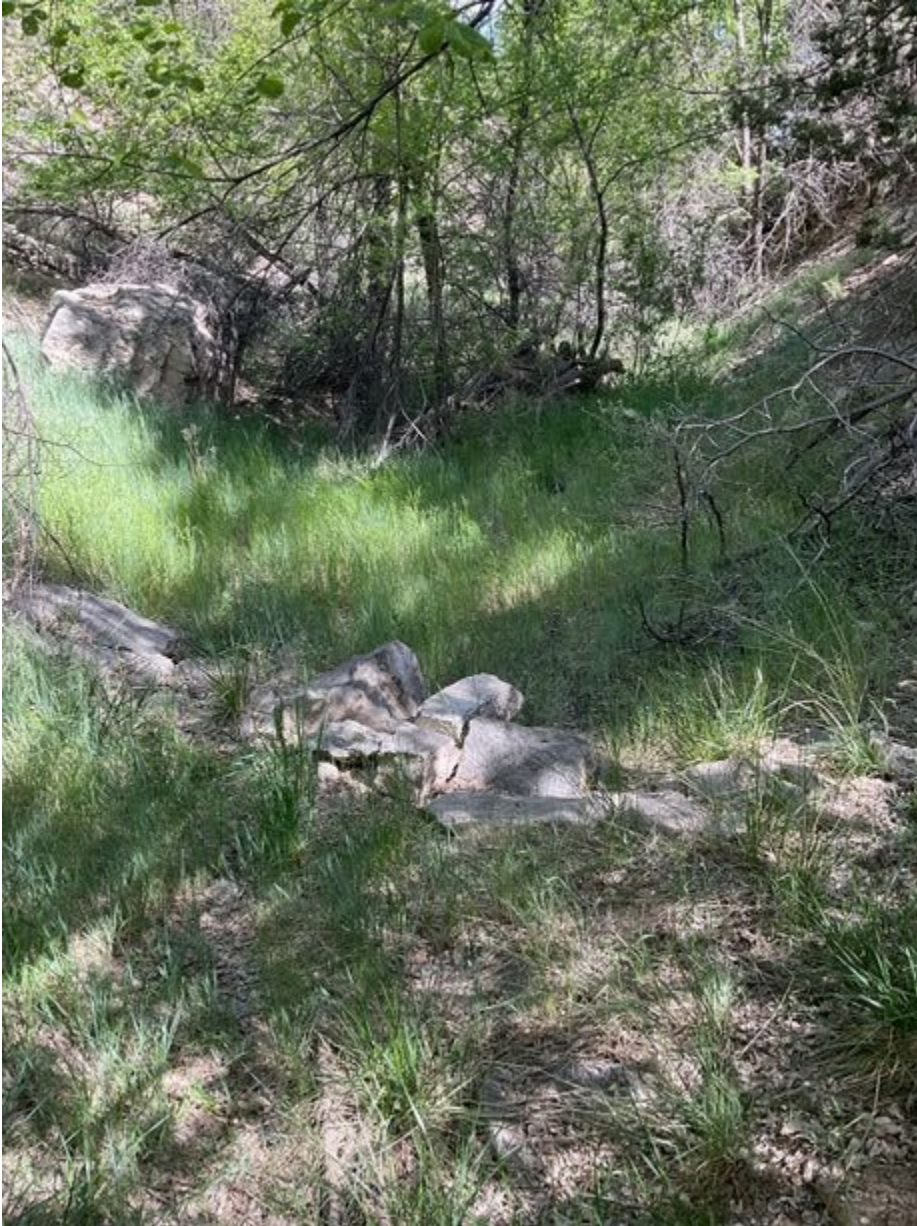
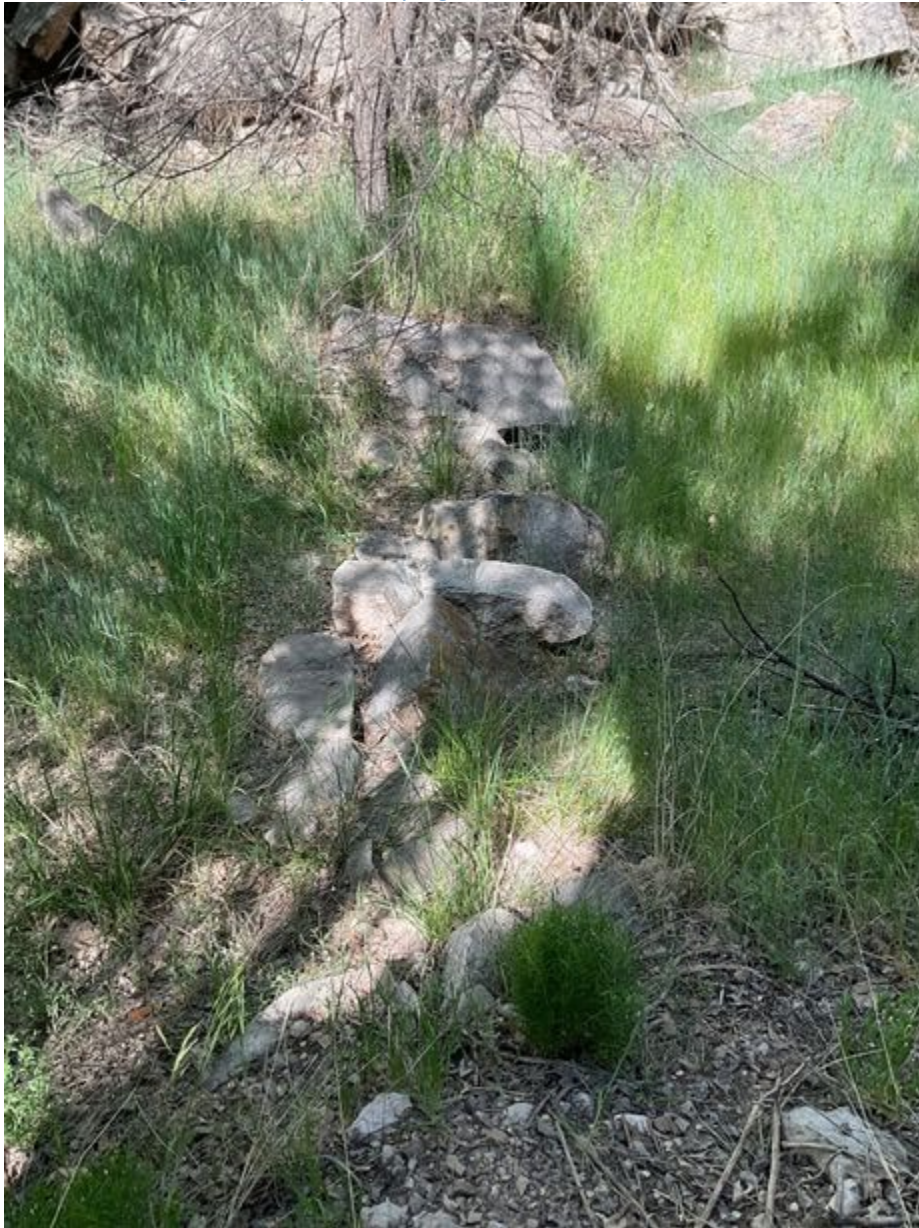
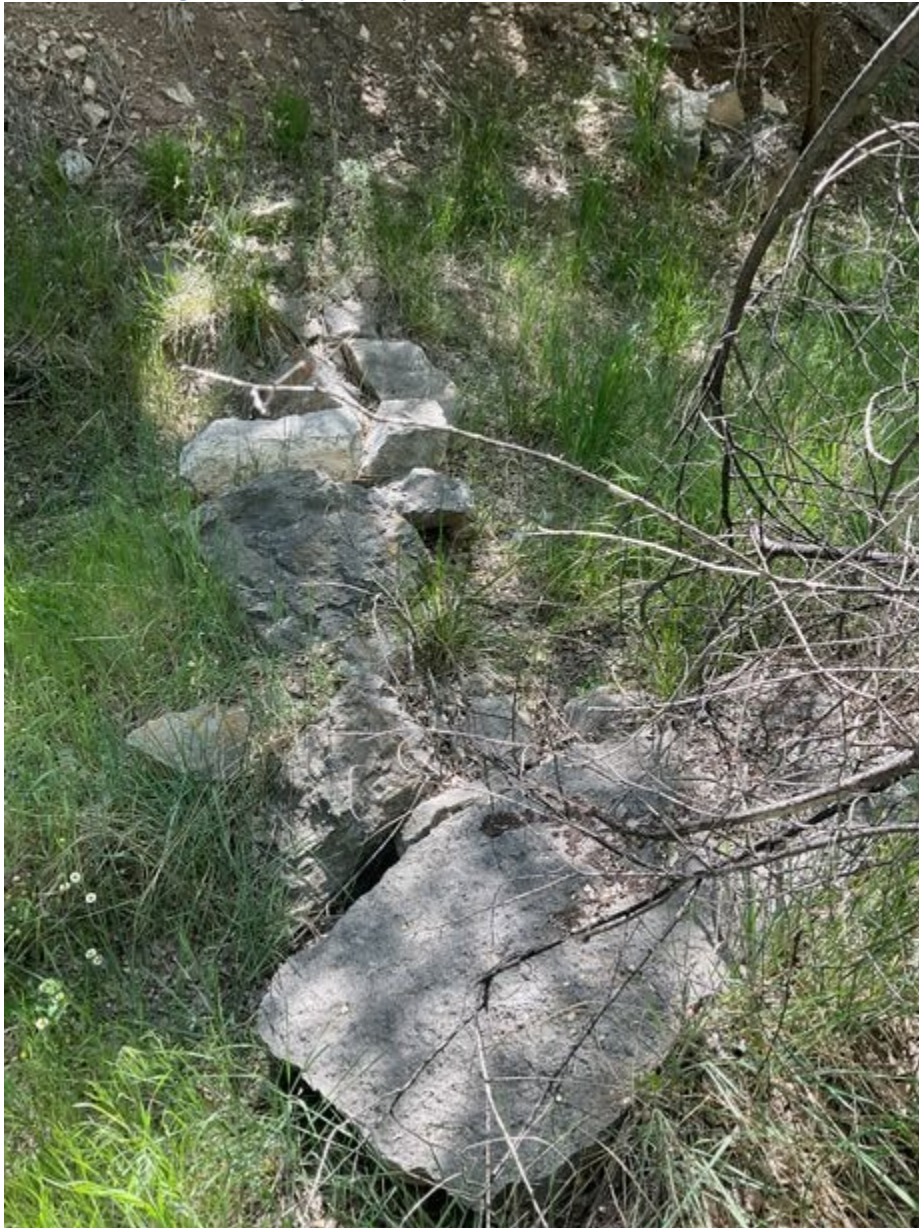
All rocks intact

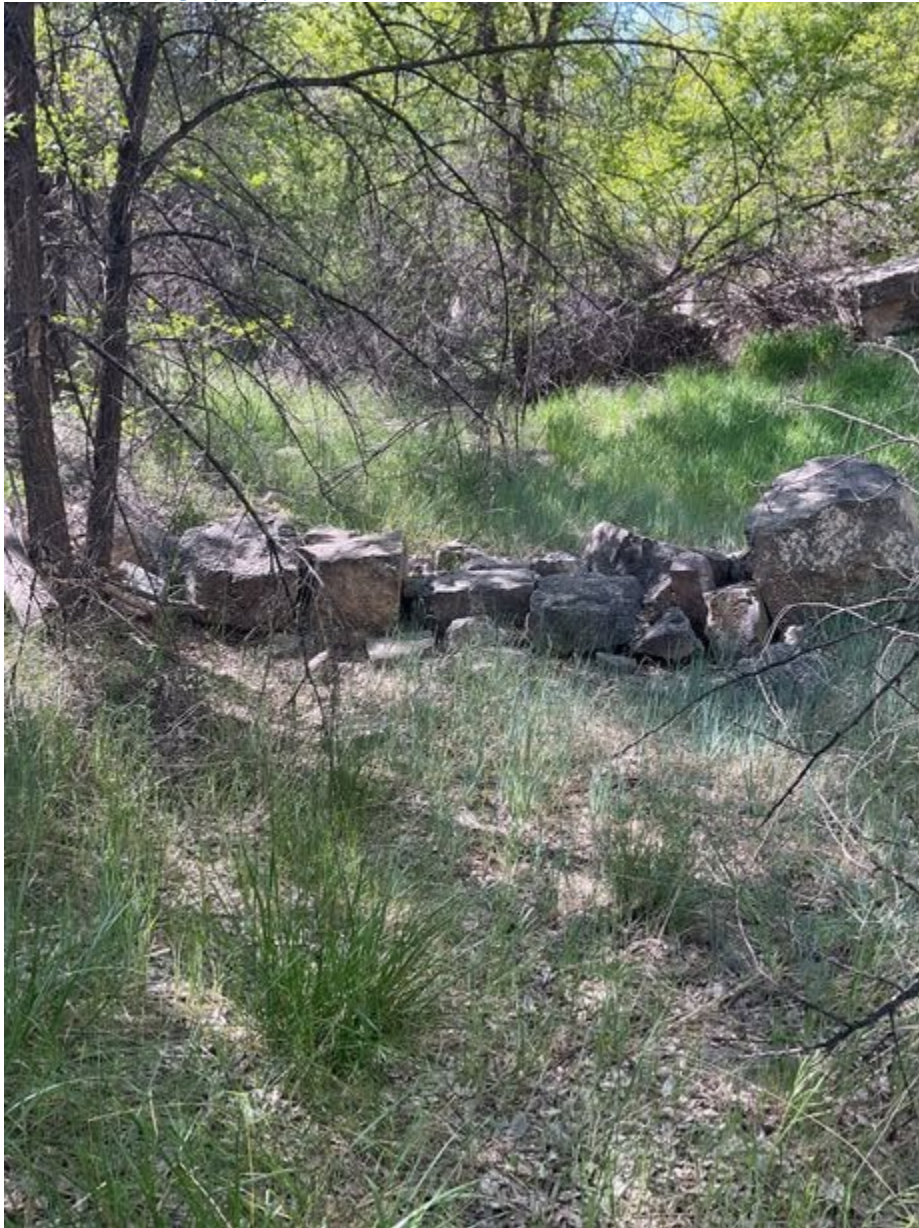
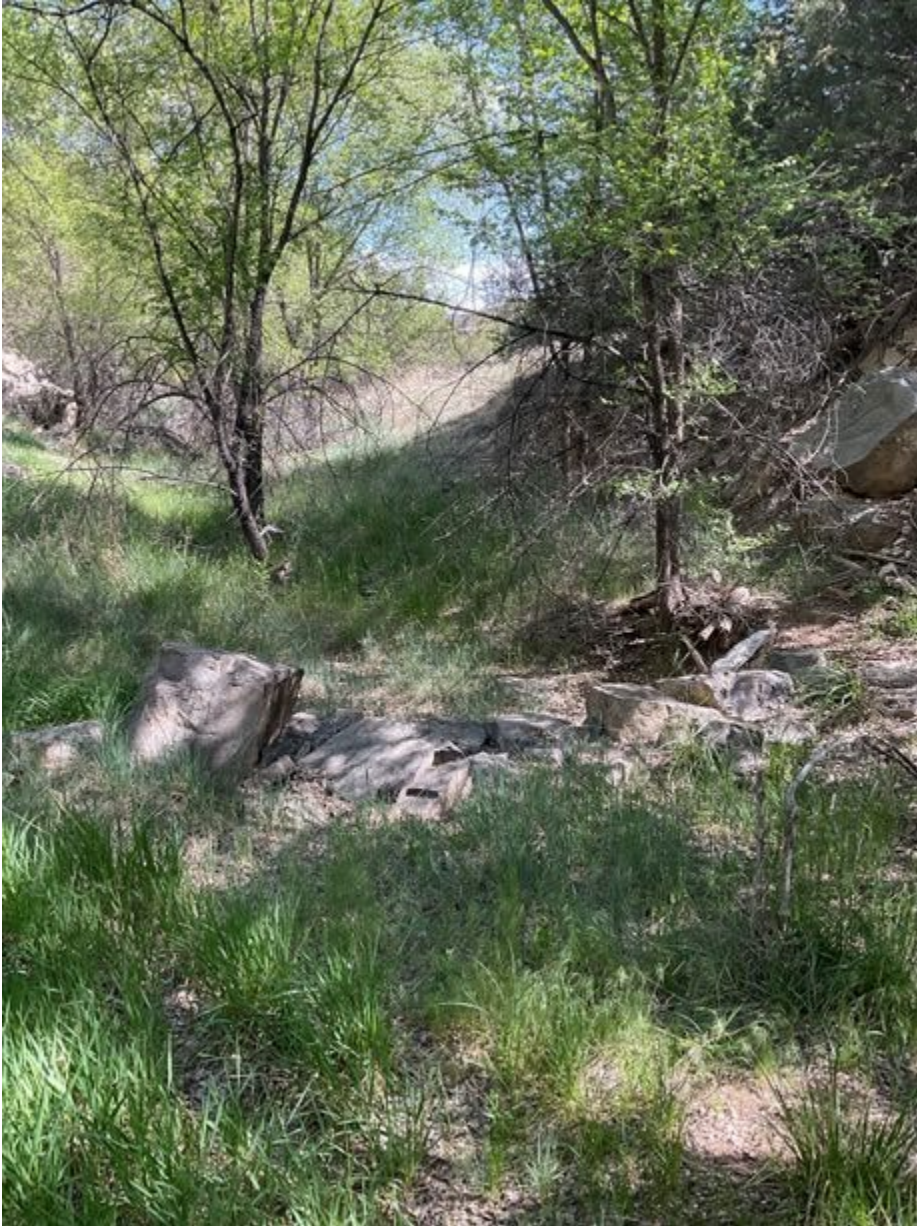
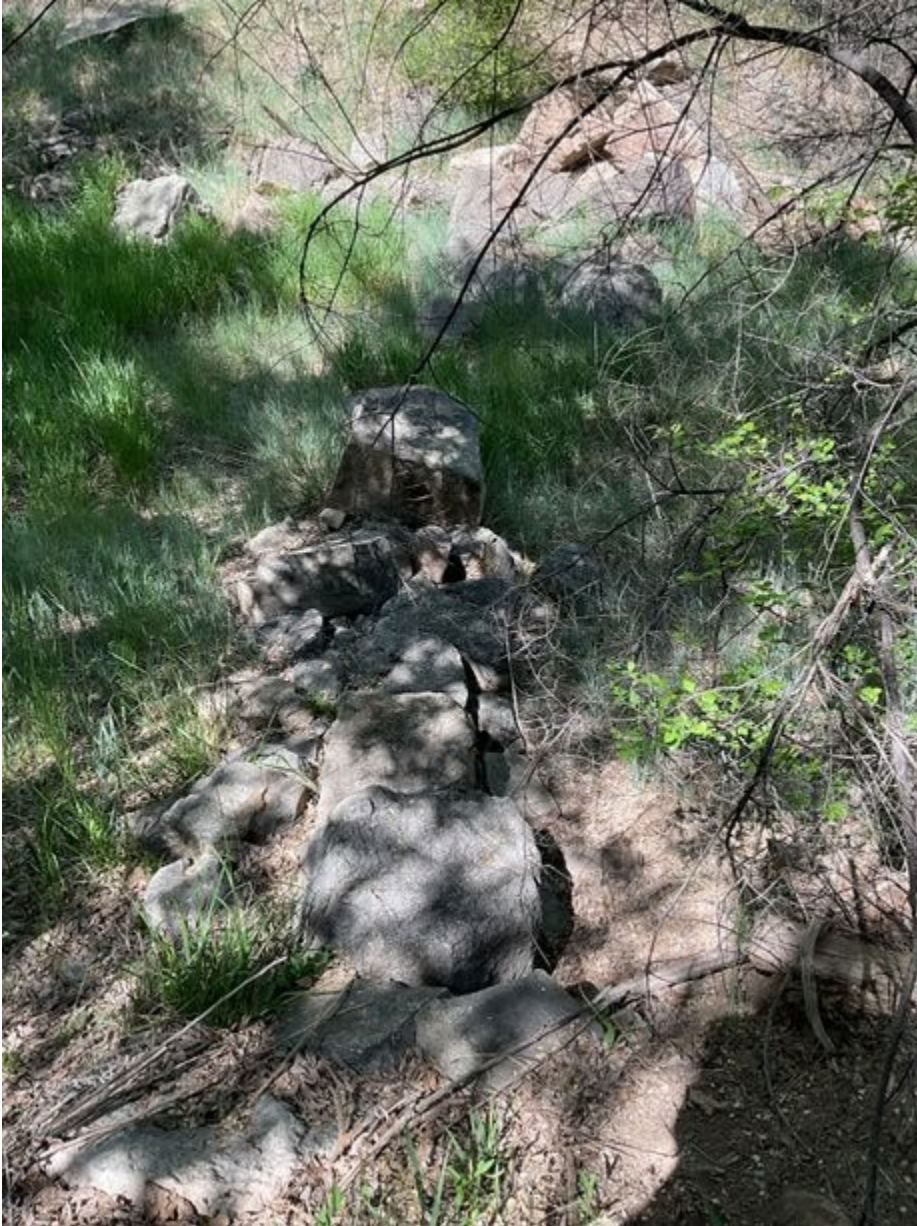
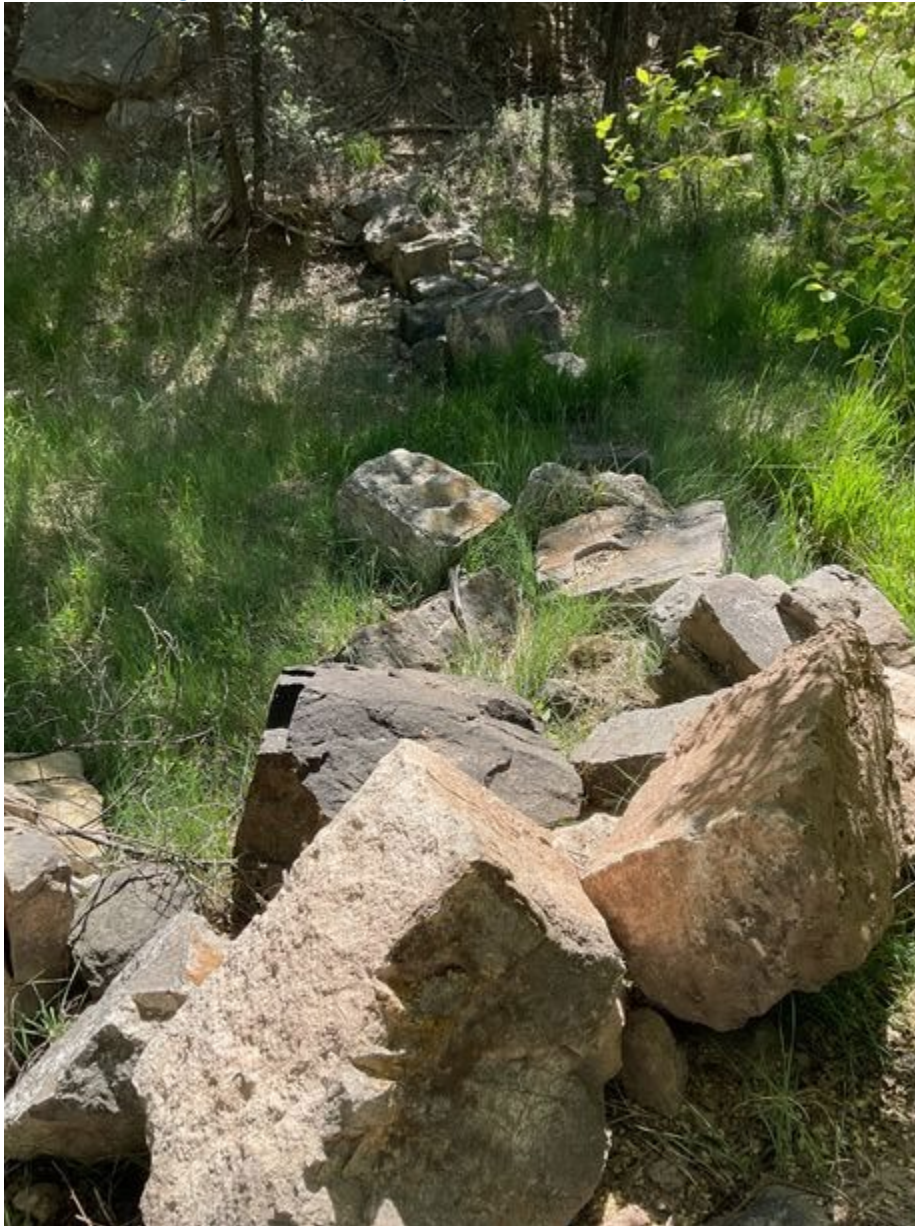
All rocks intact

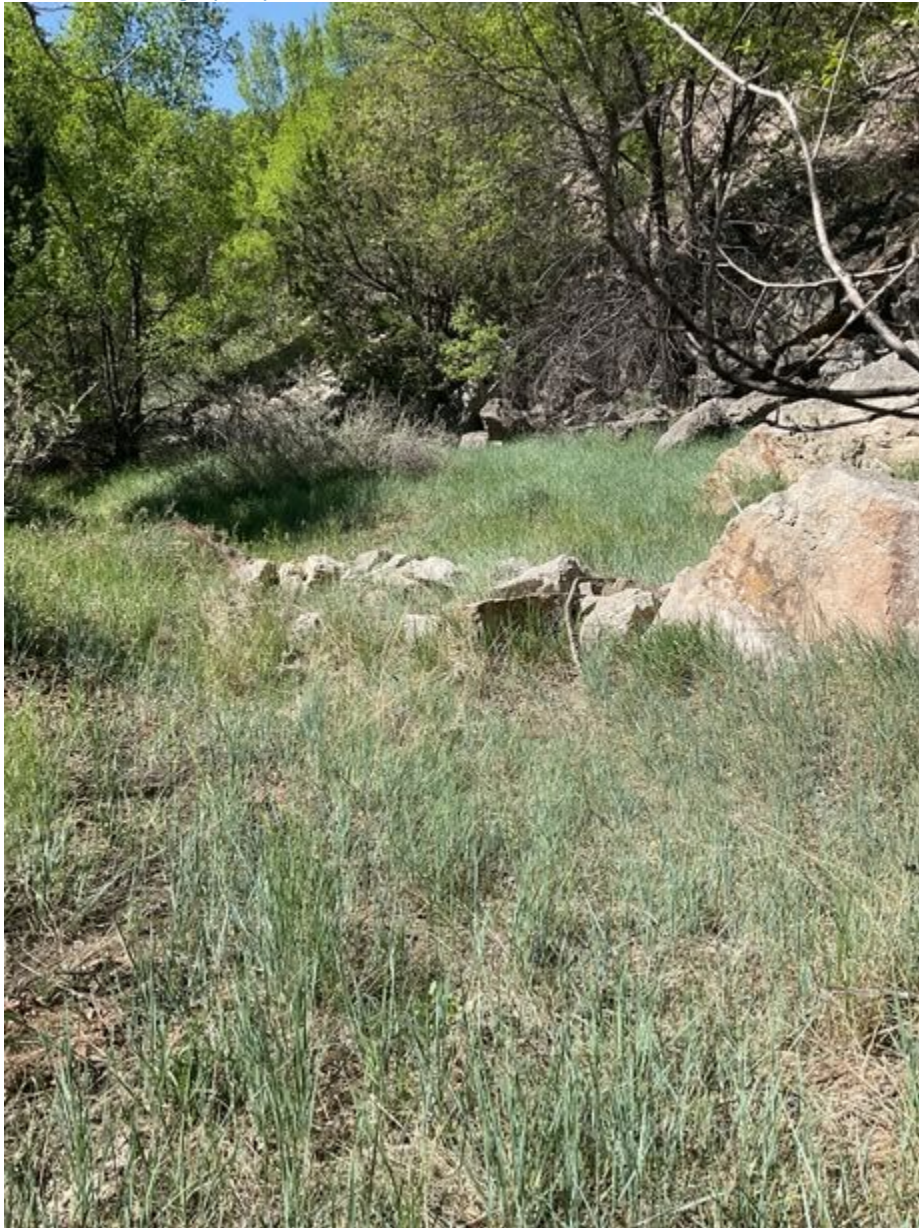
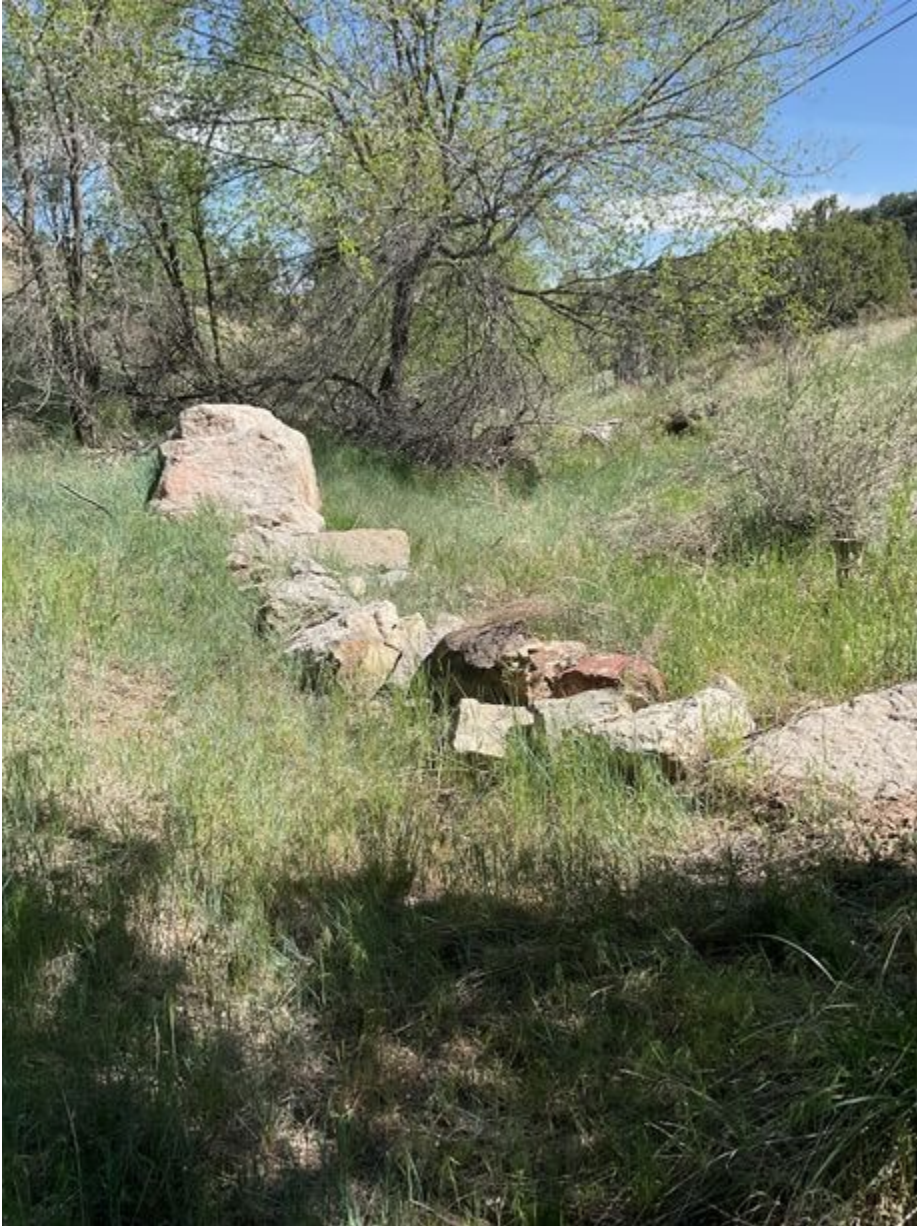
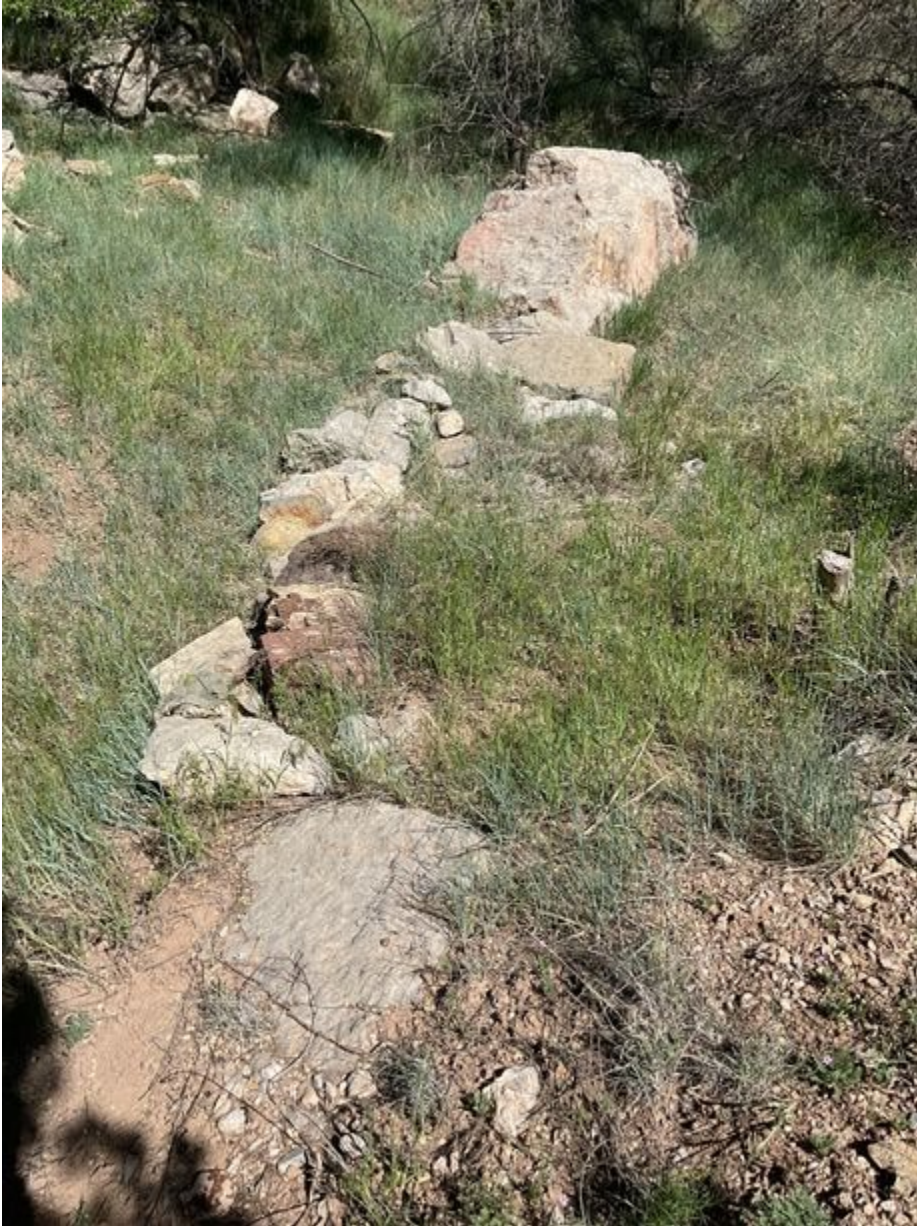
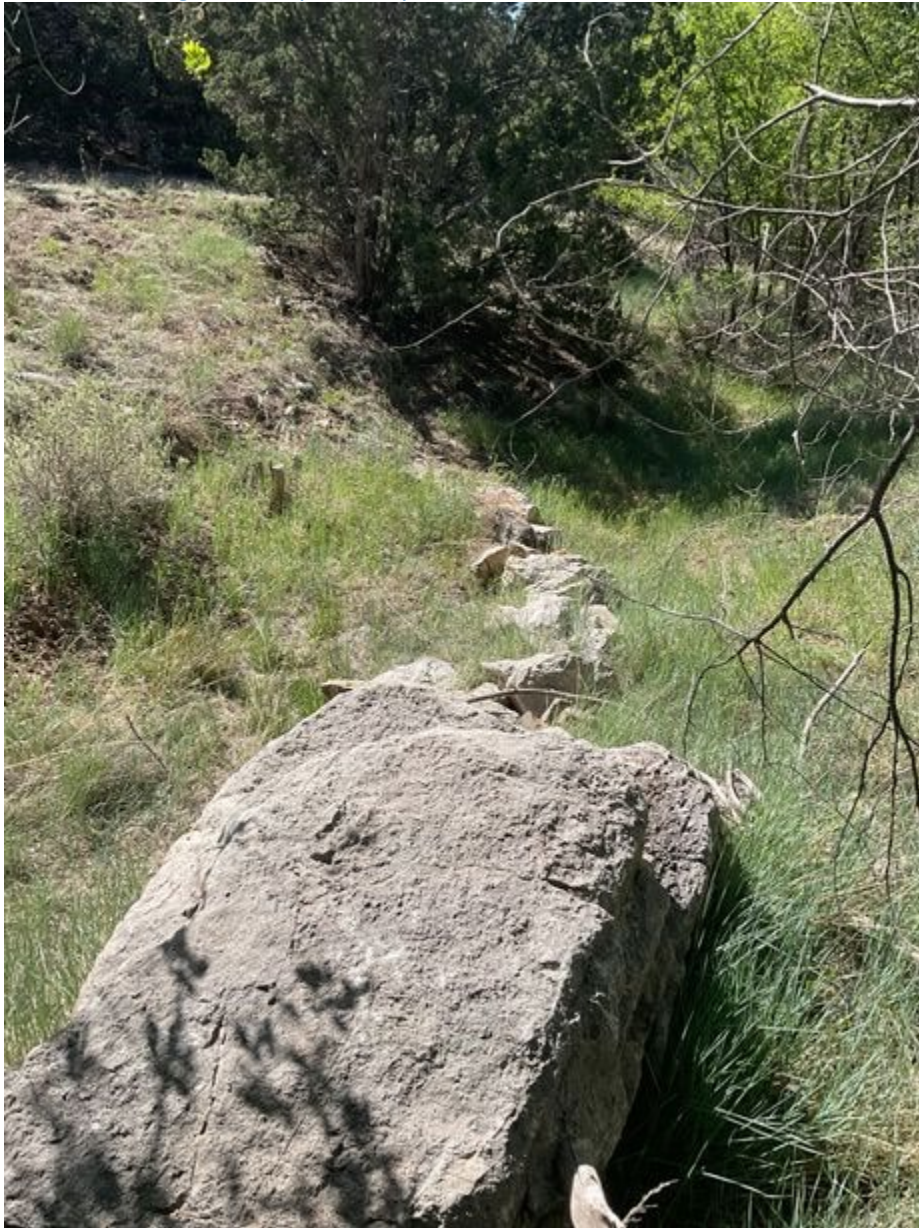
All rocks intact

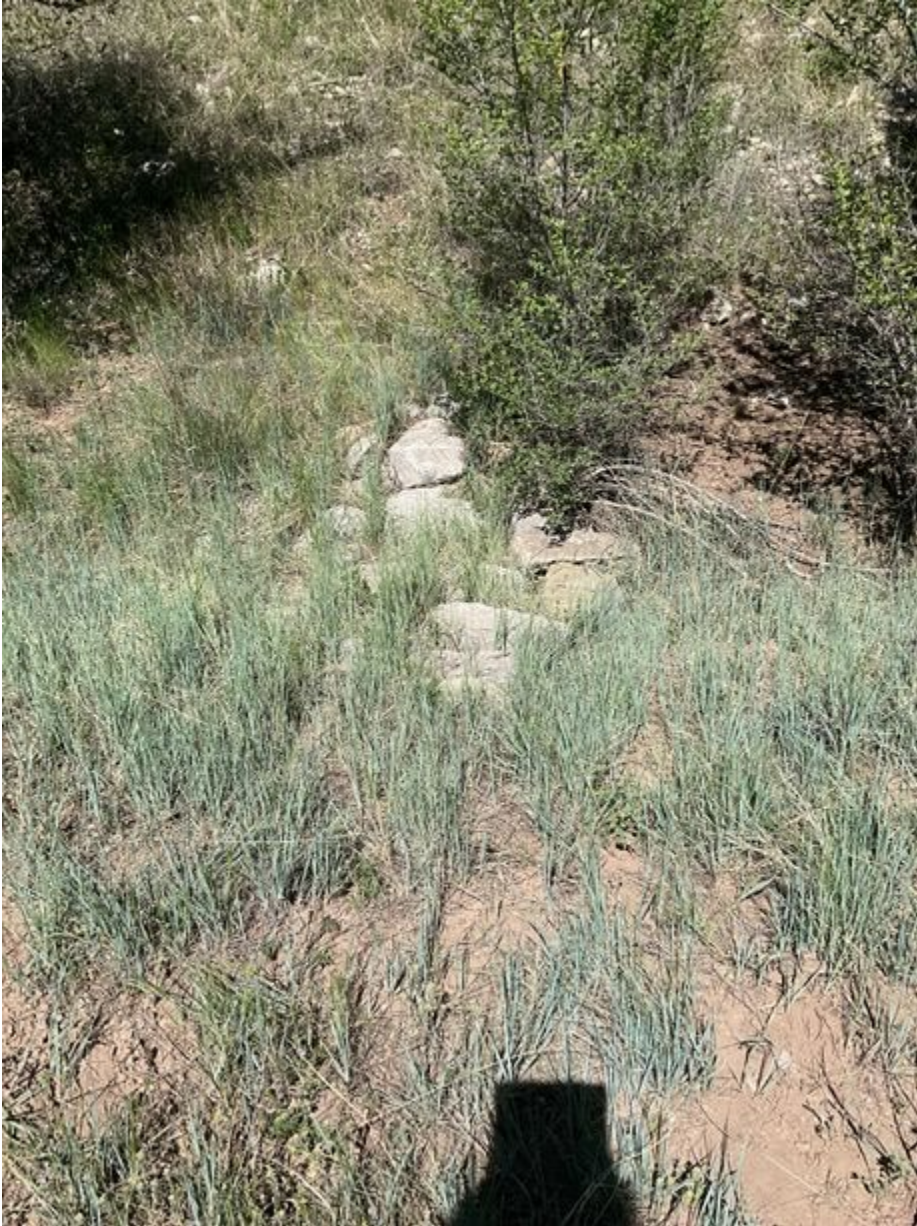
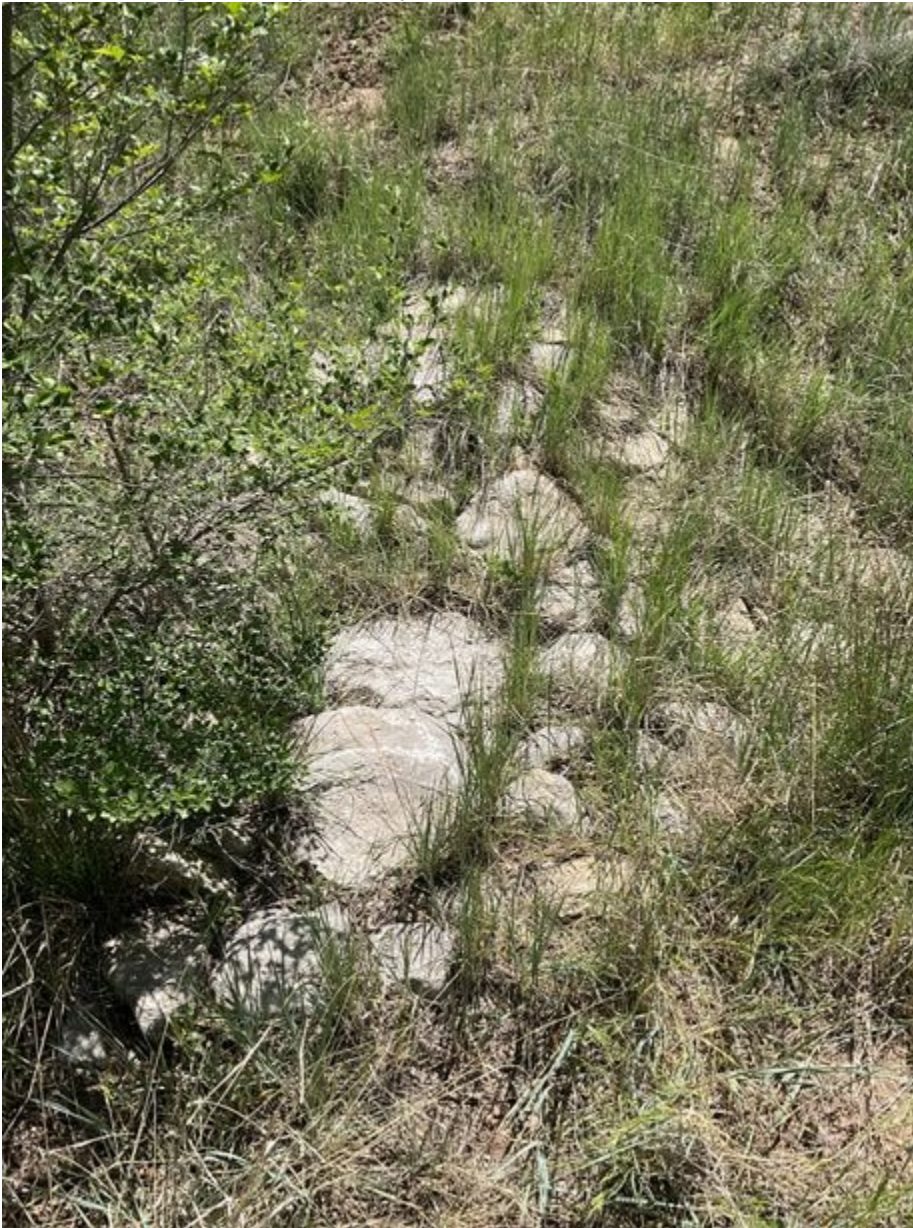
All rocks intact

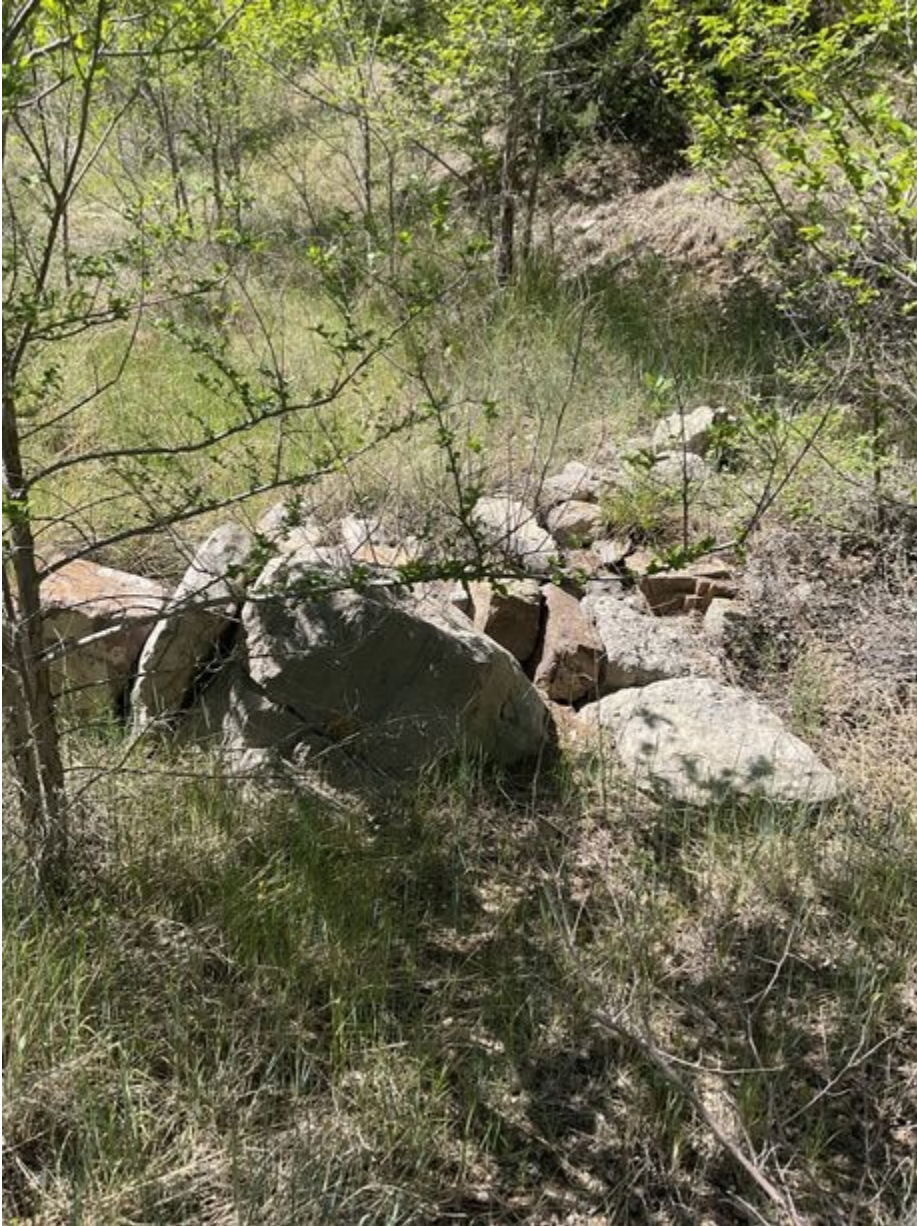
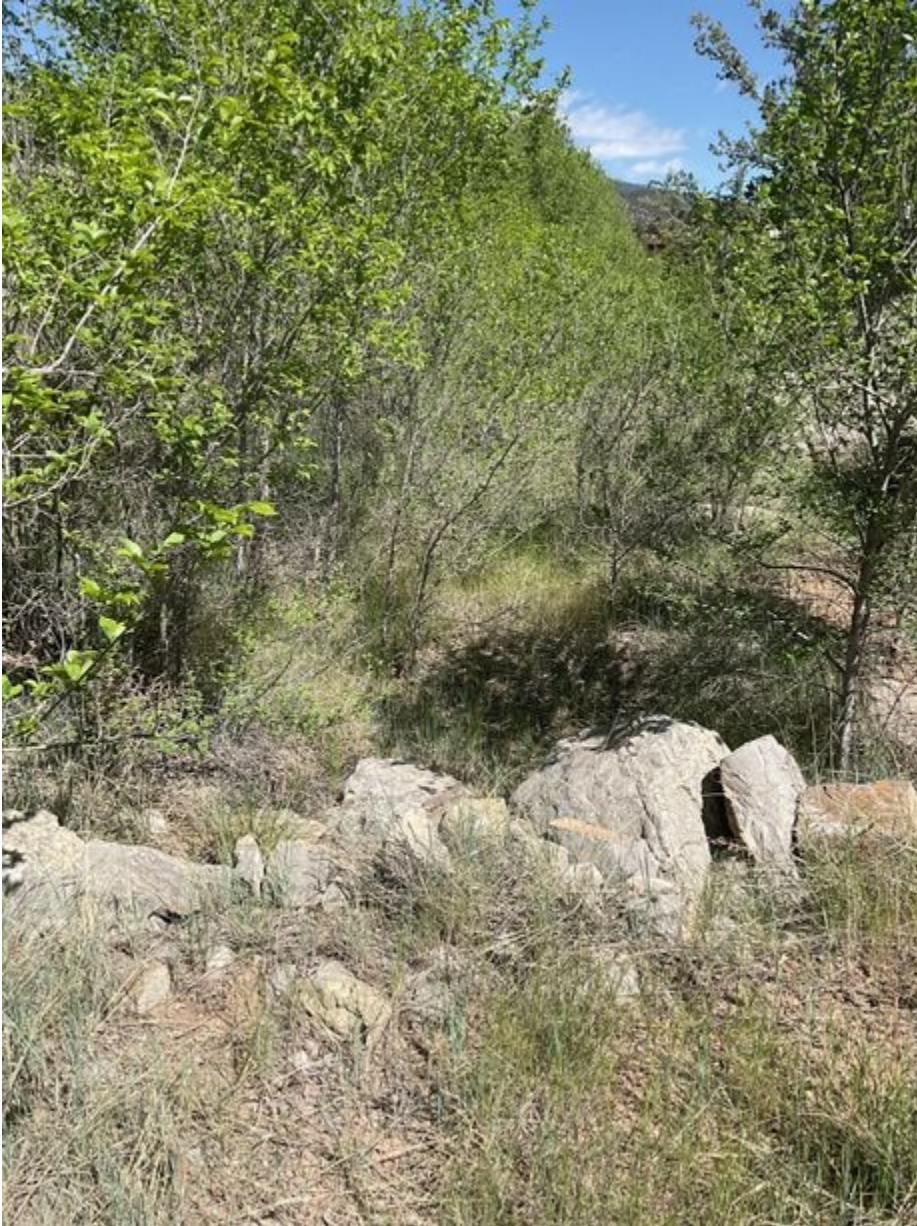
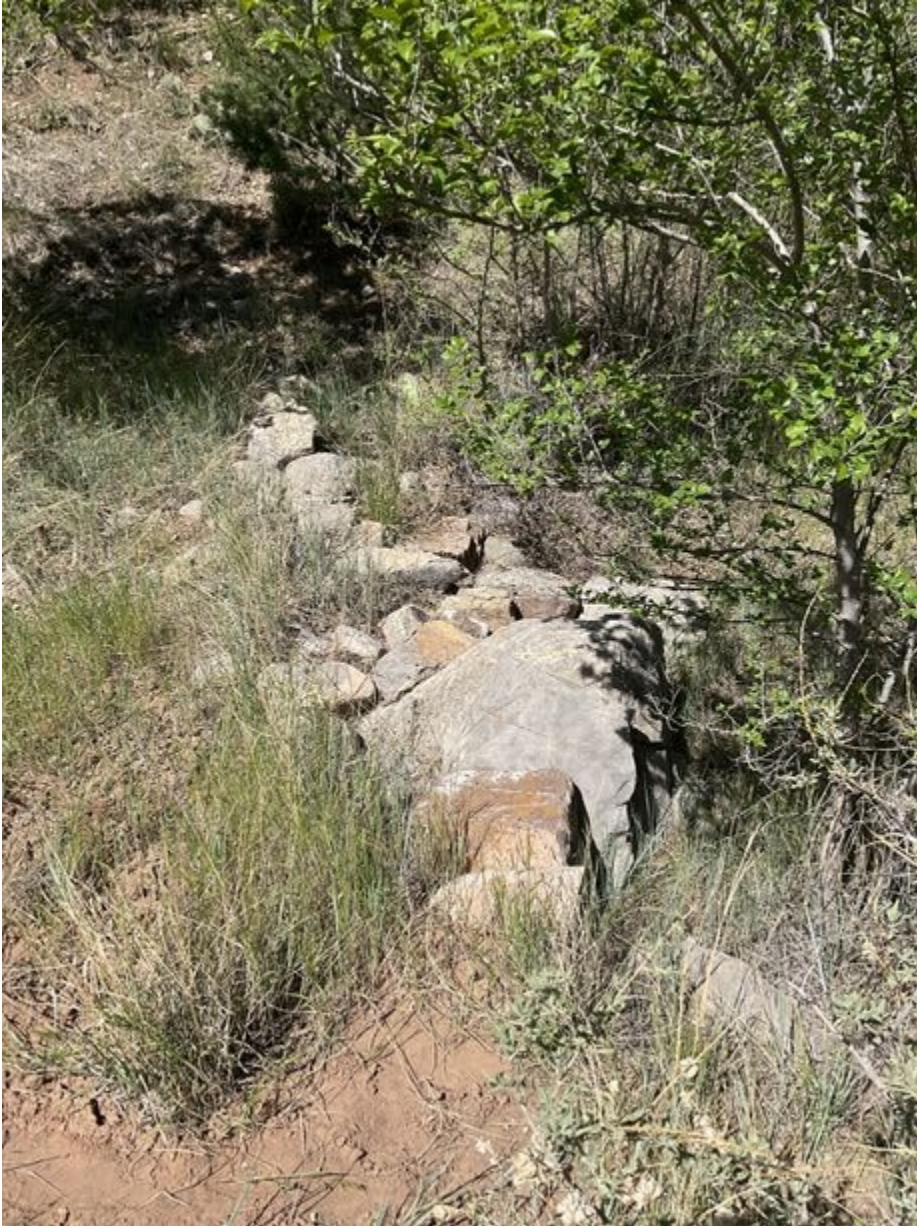
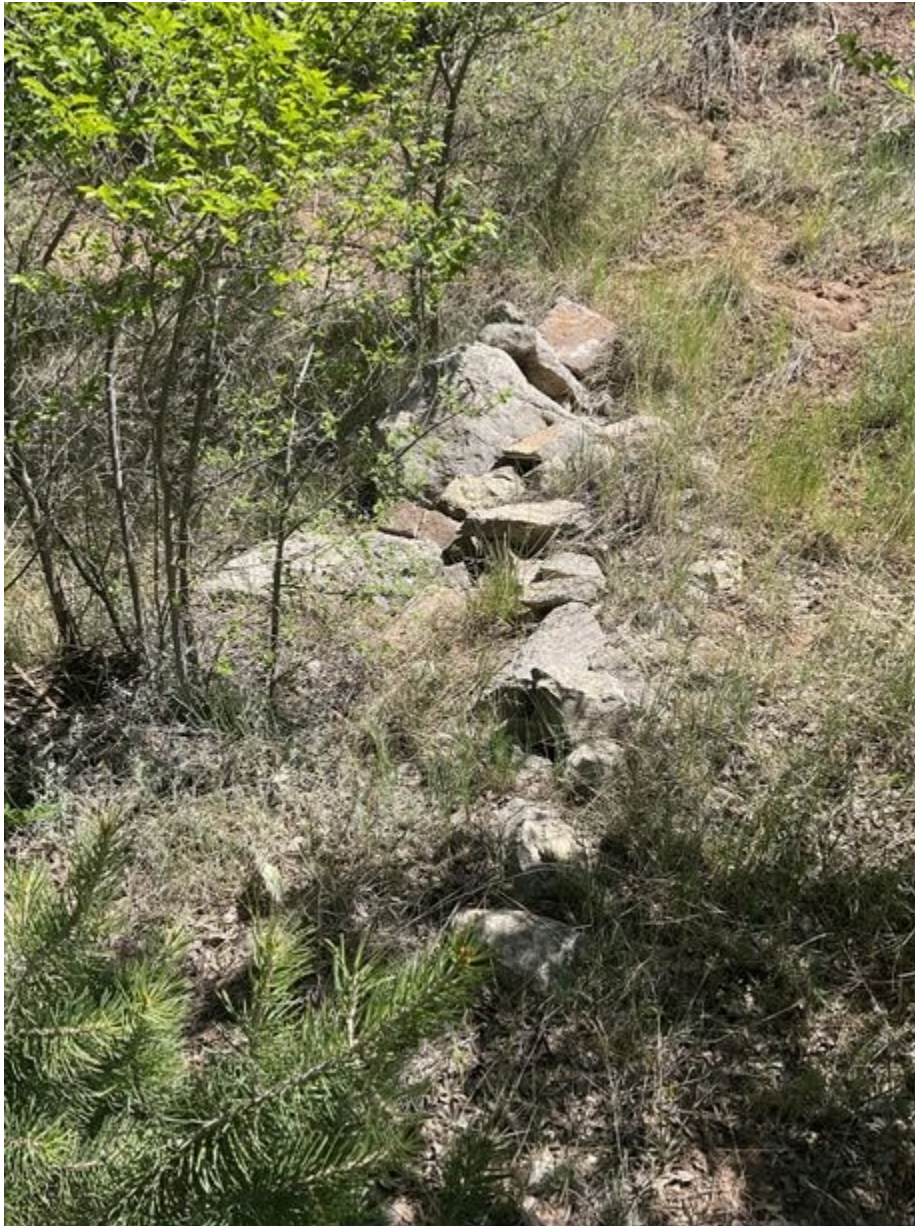
All rocks intact
