CN R924060

**Zuni Bowl and One Rock Check Dam Research –
Phase 1**

Final Report

Rio Grande Return for the New Mexico Department of Transportation Research Bureau

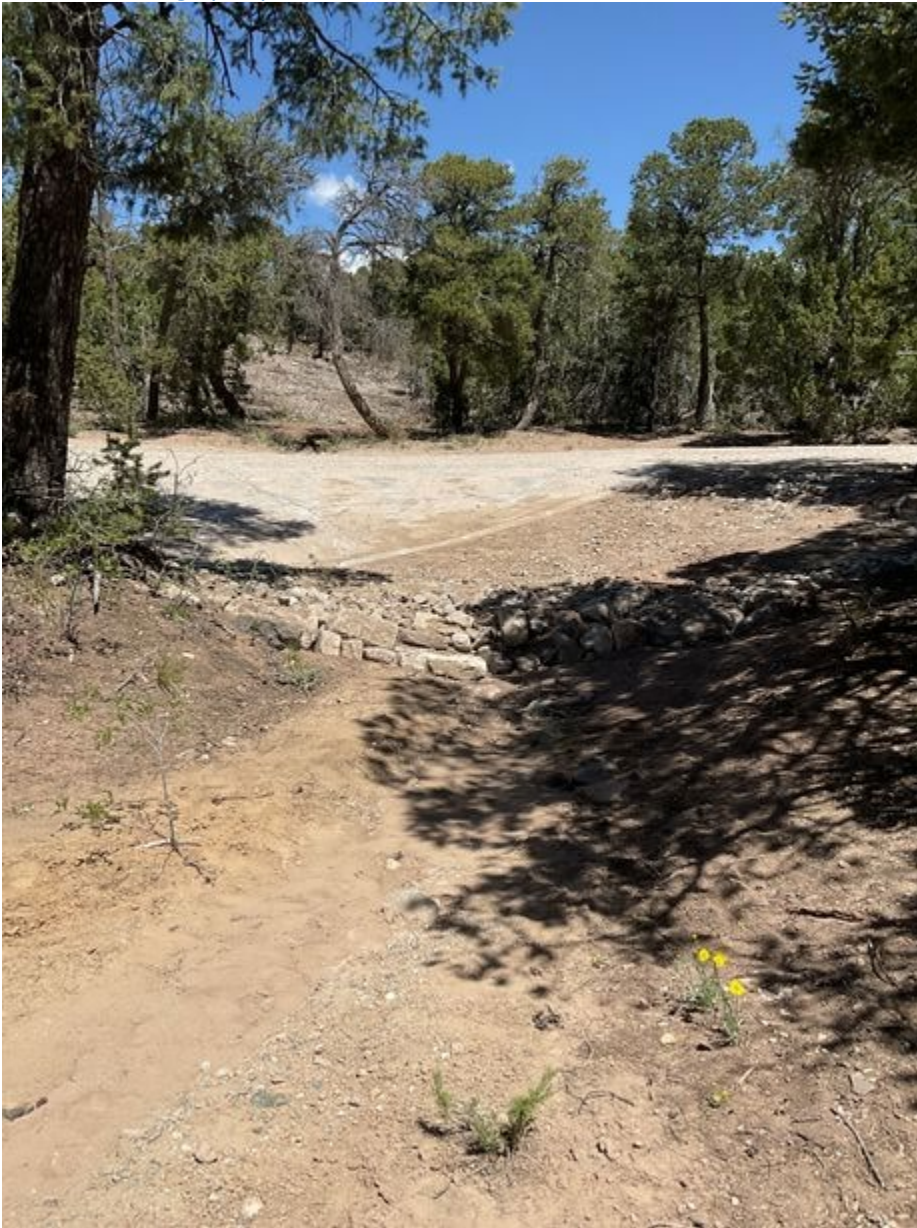
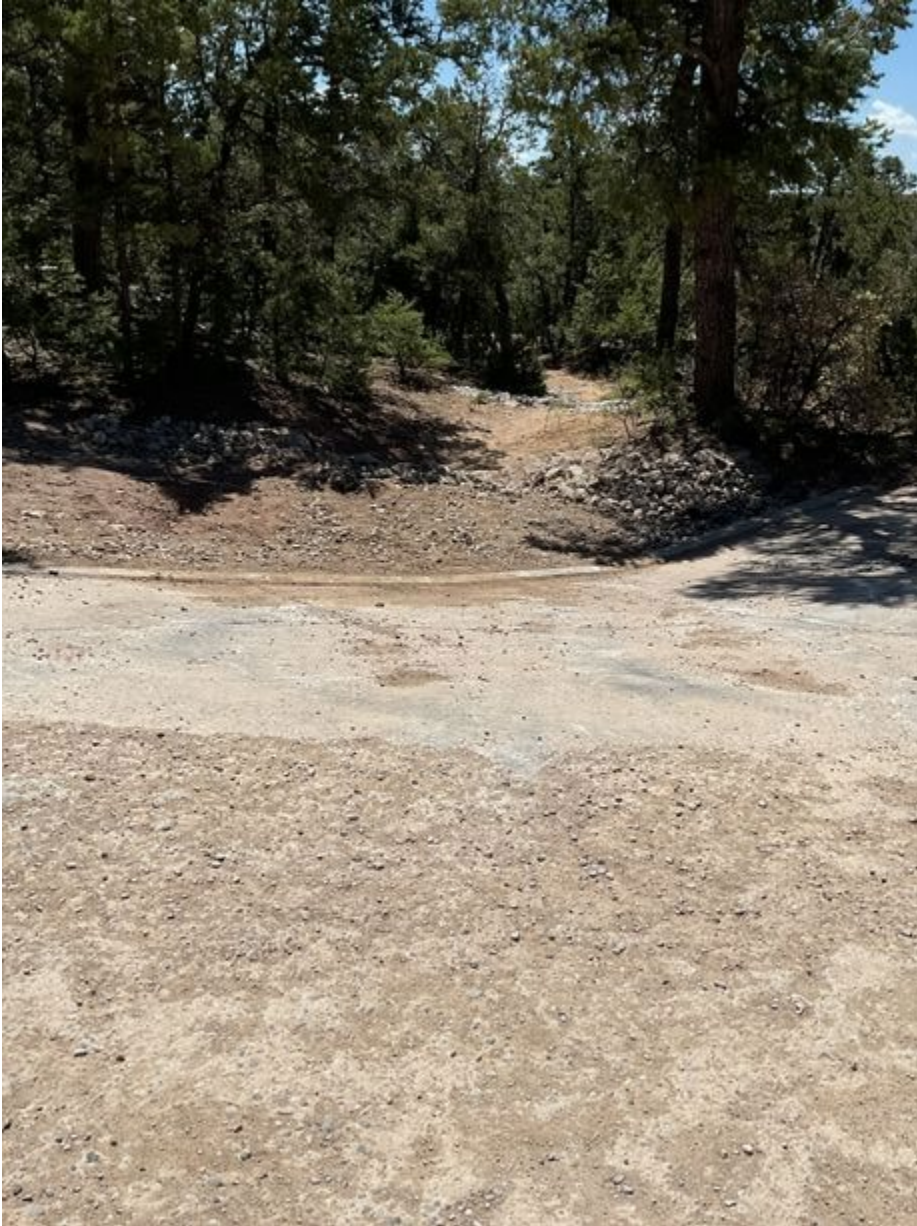
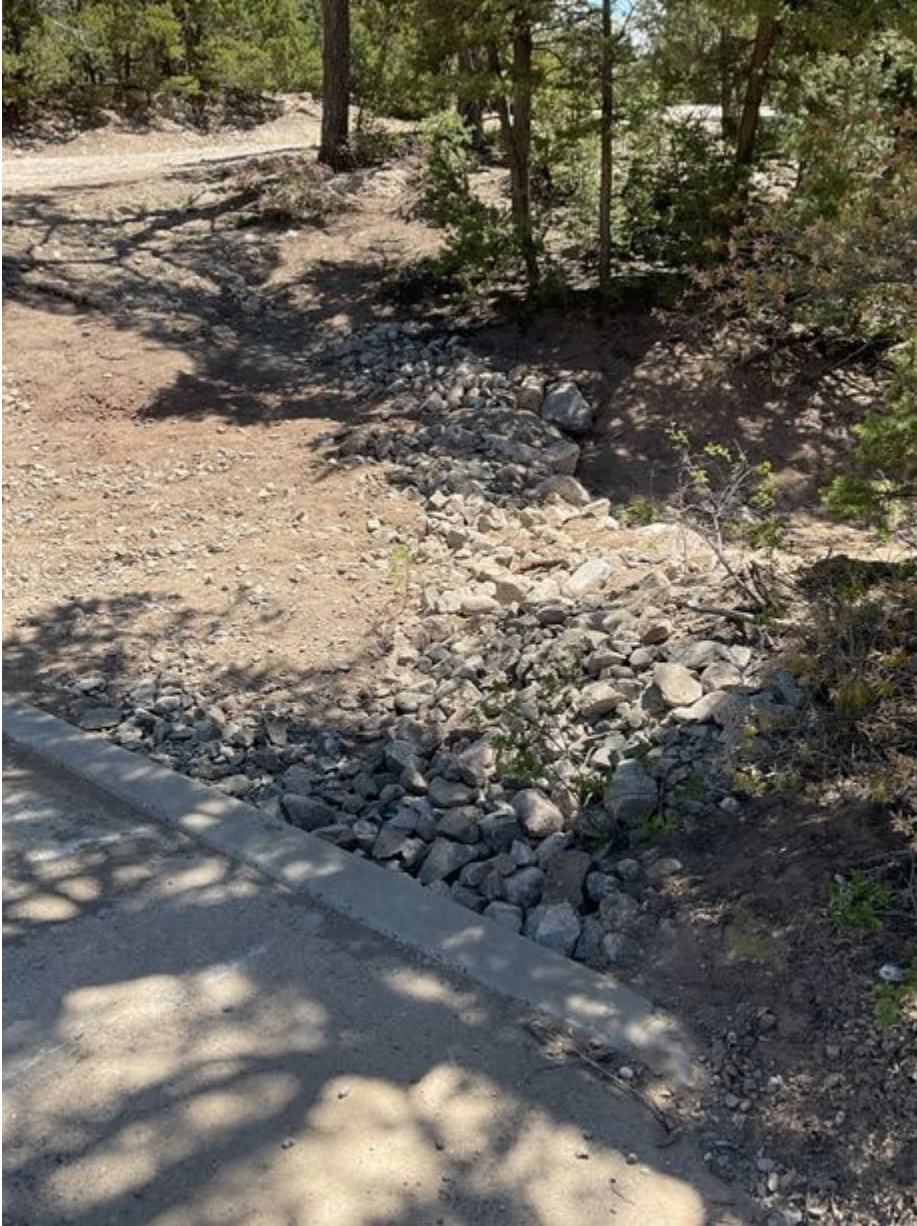
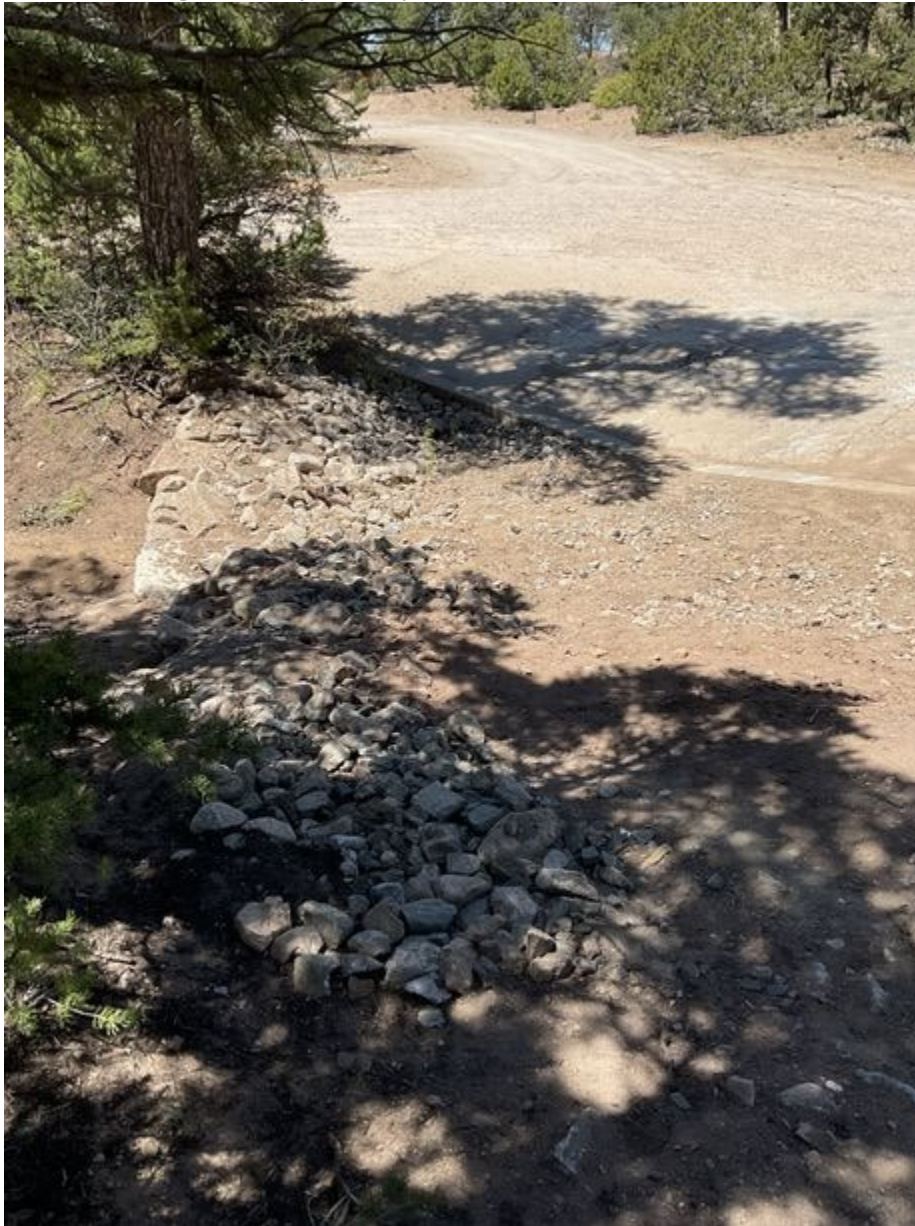
All rocks intact

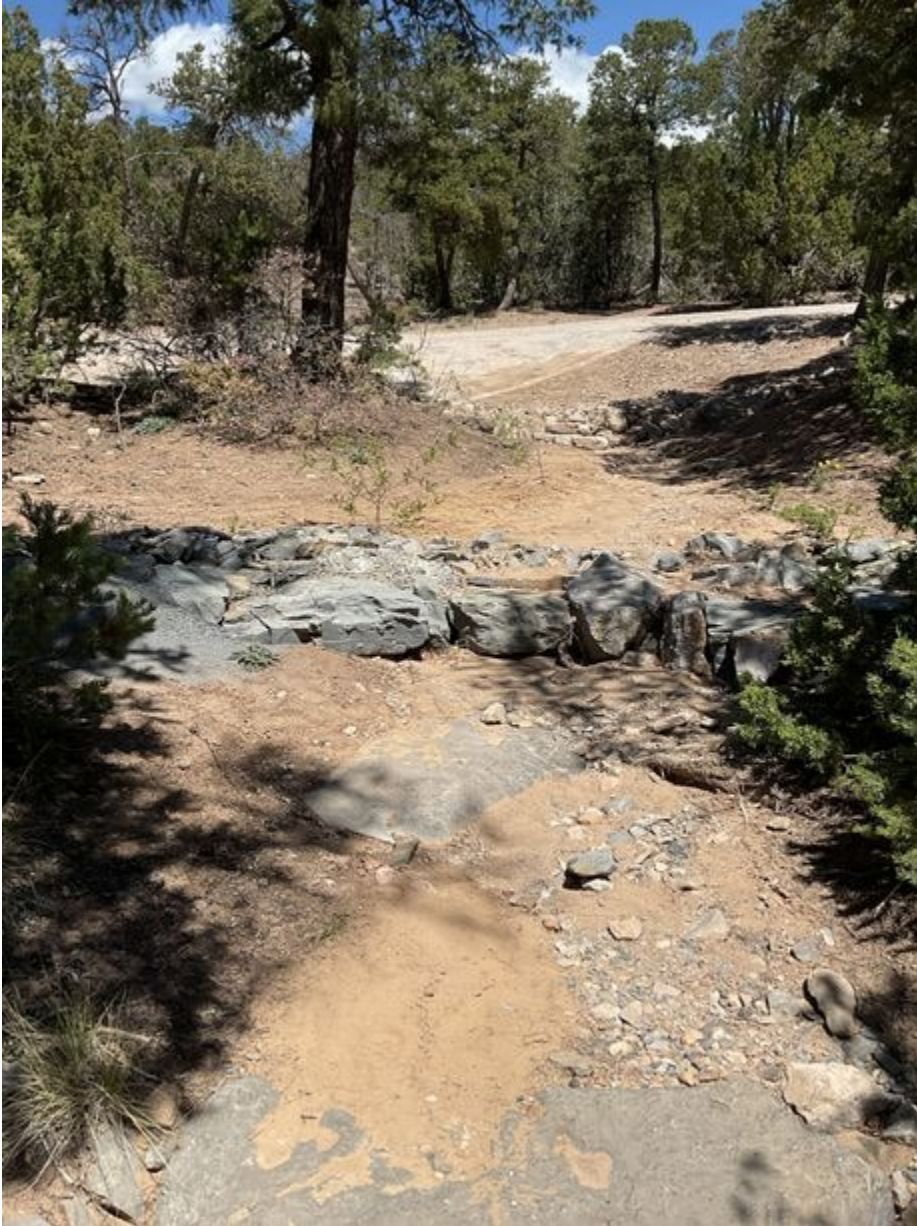
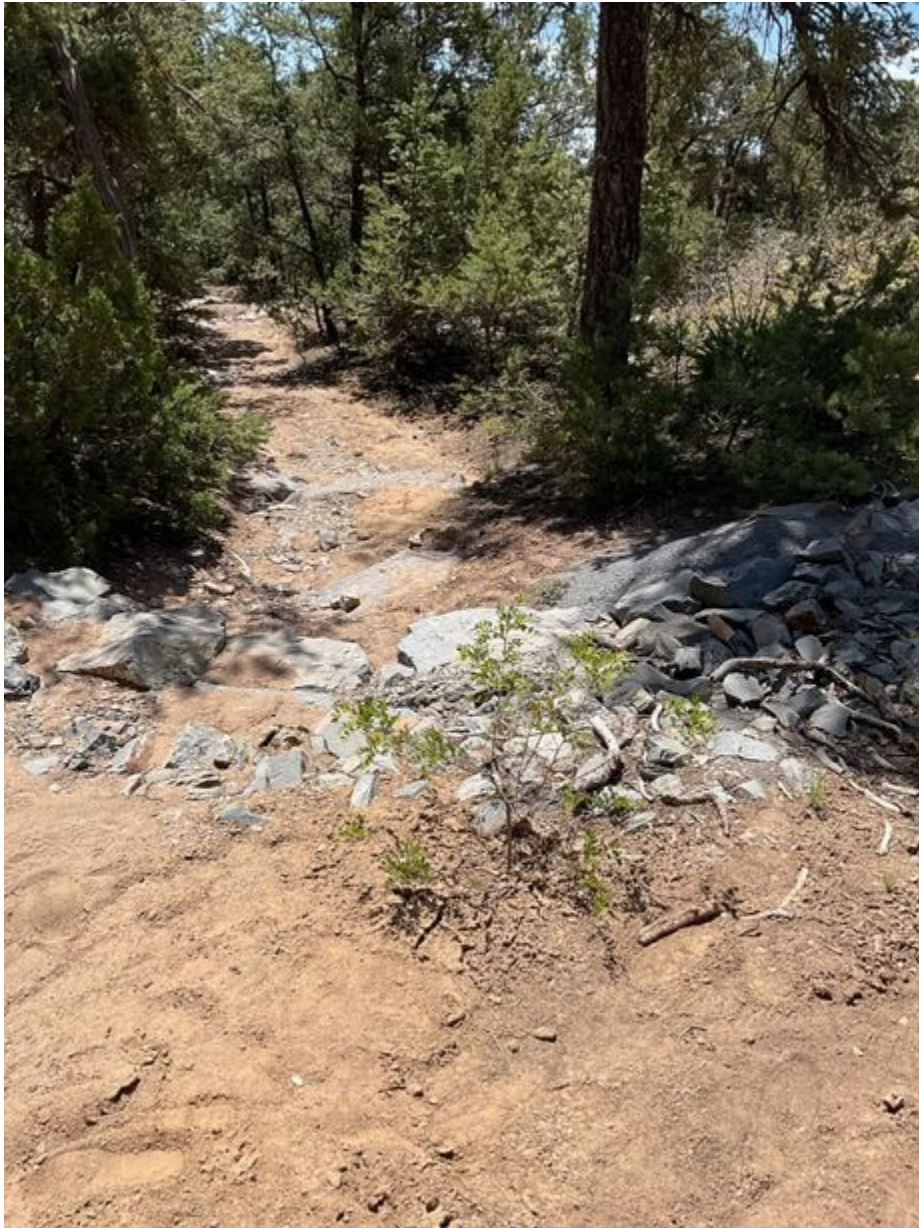
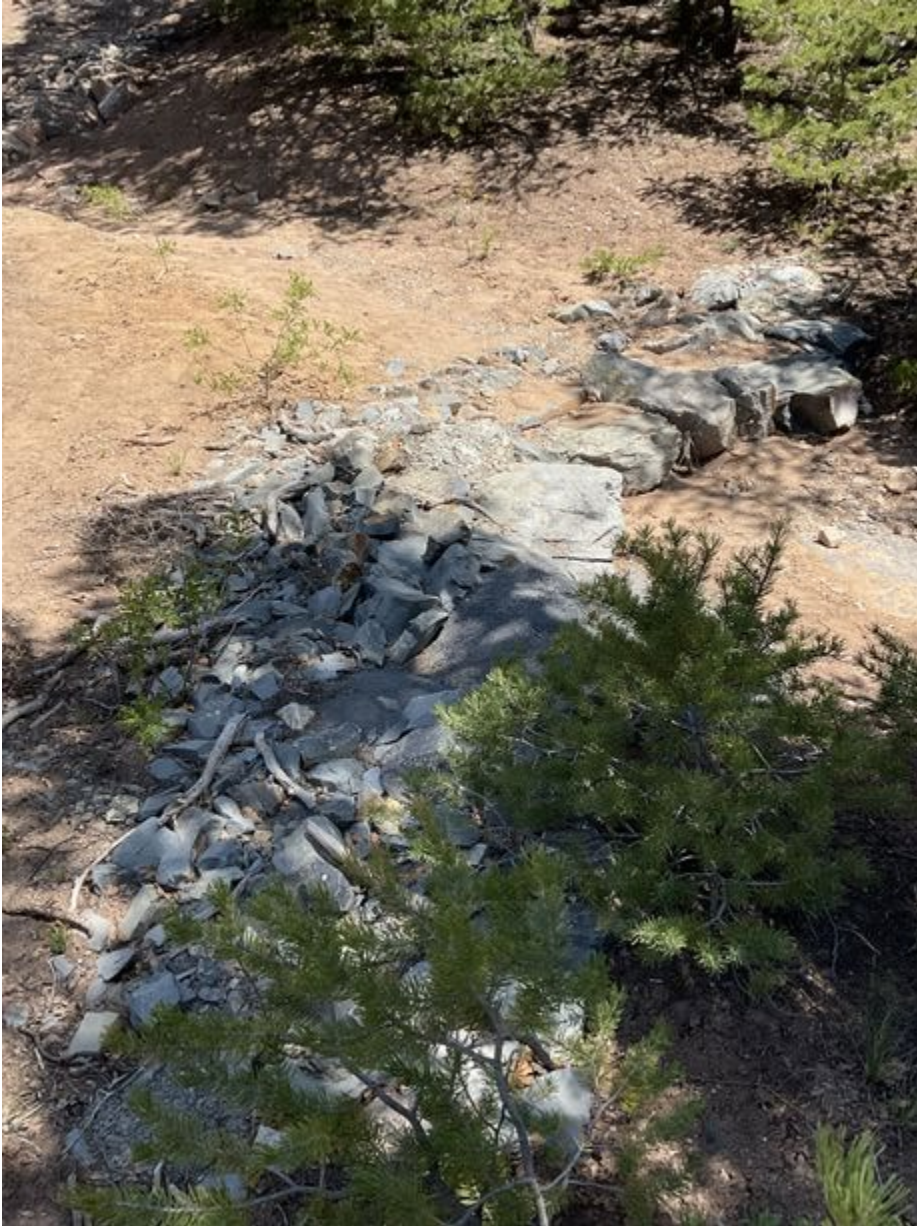
Some rocks dislodged or broken

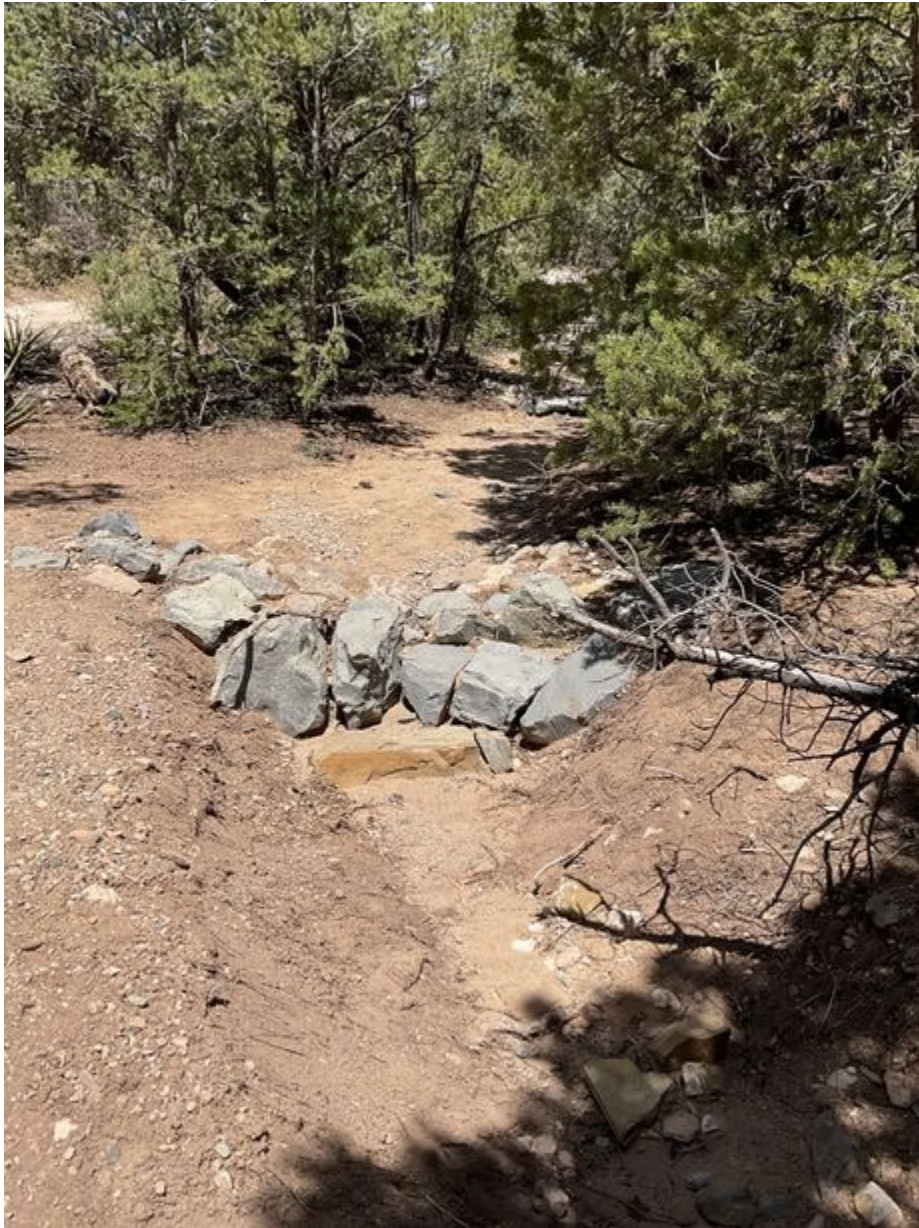
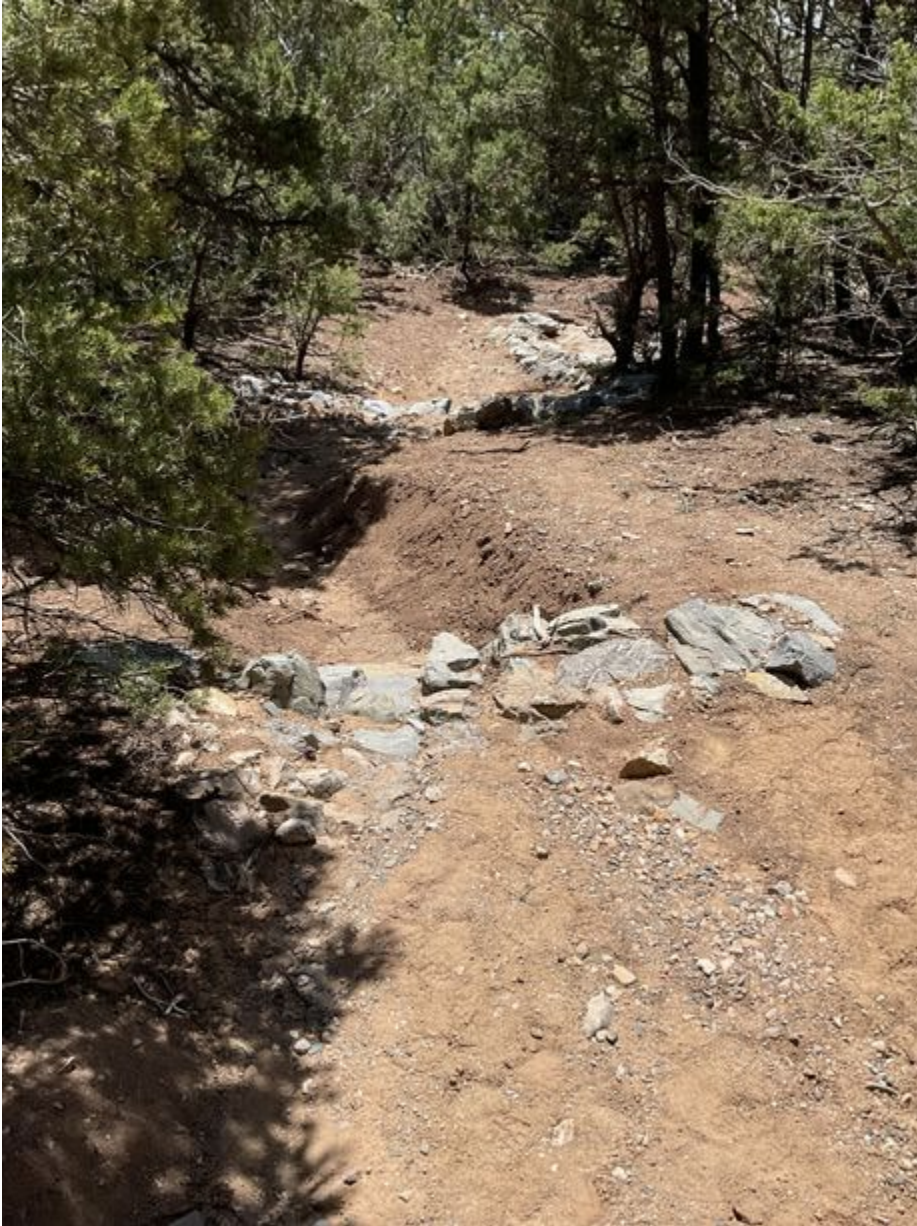
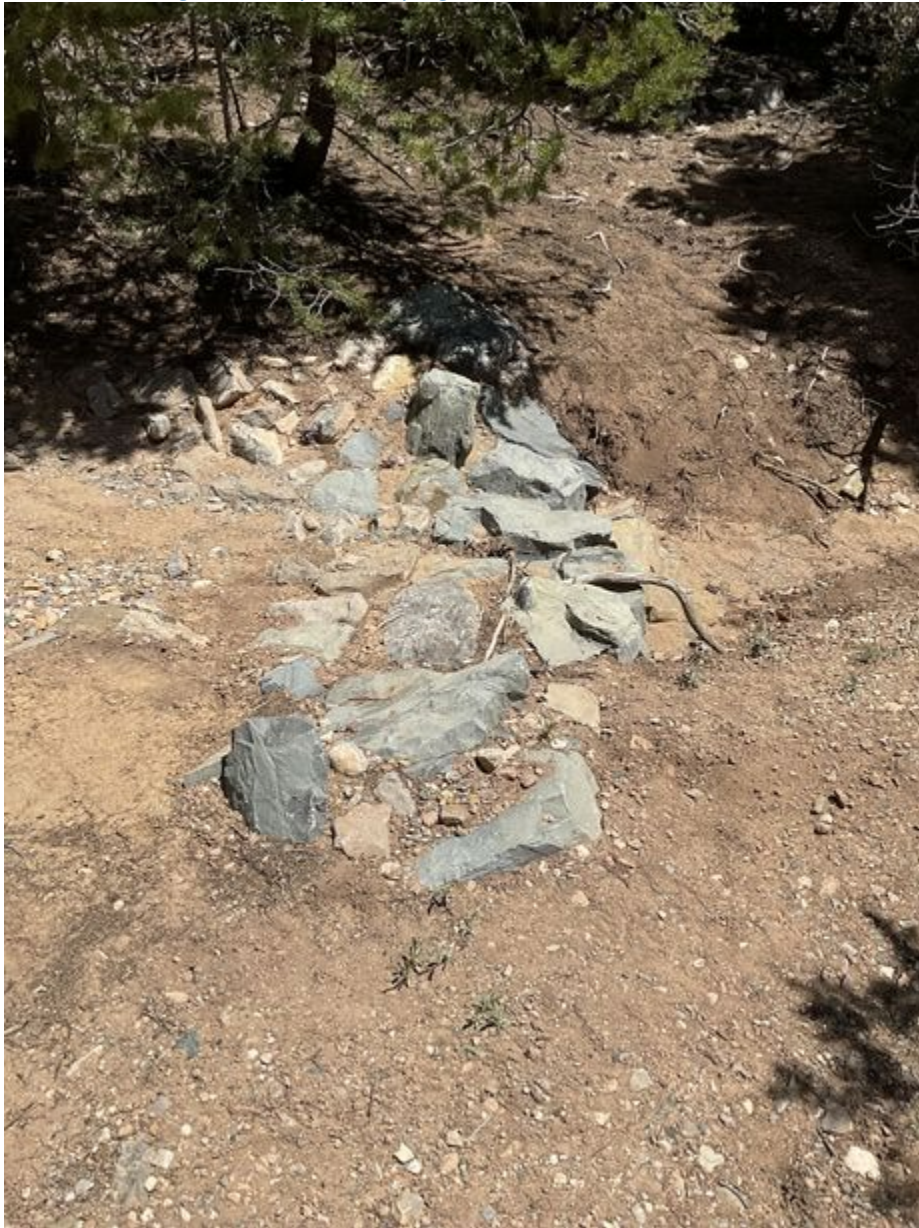
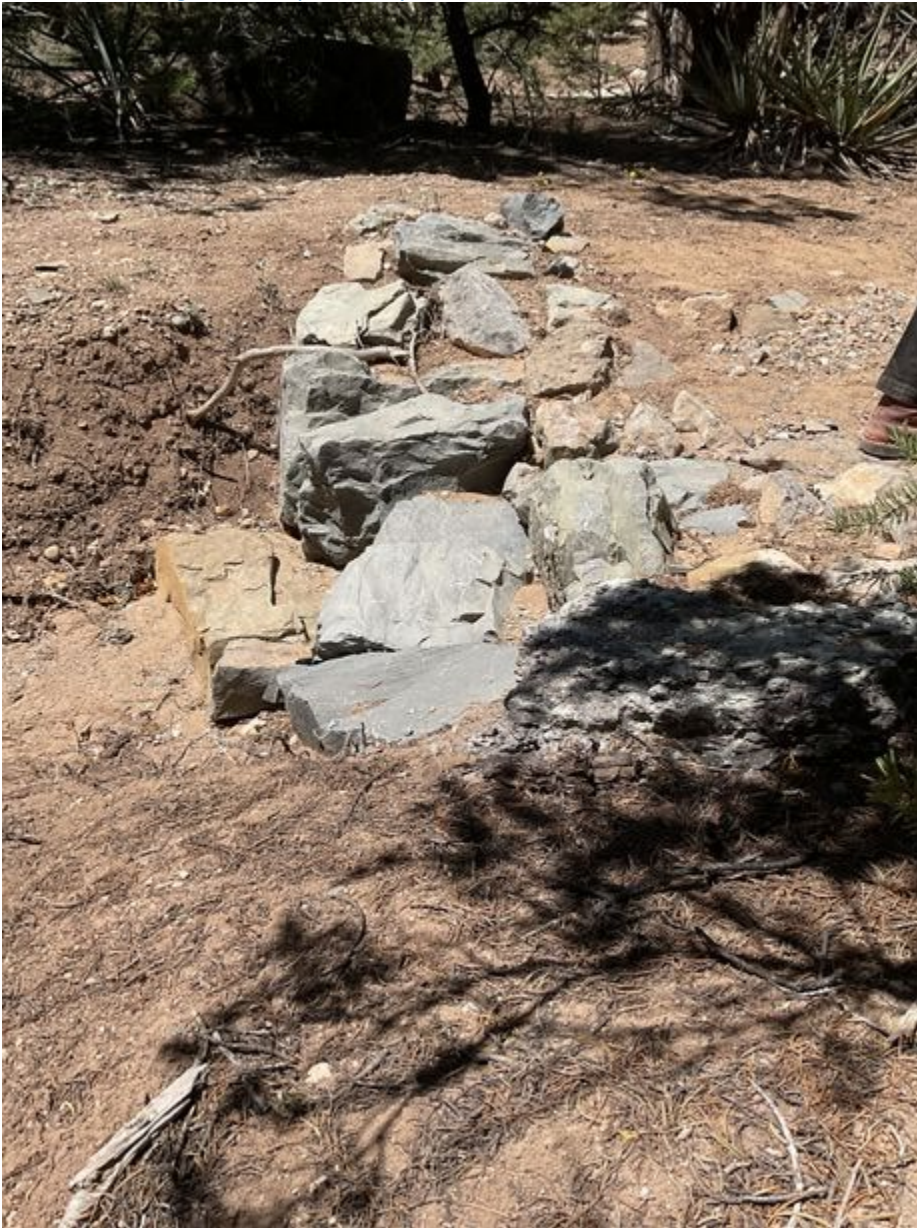
All rocks intact

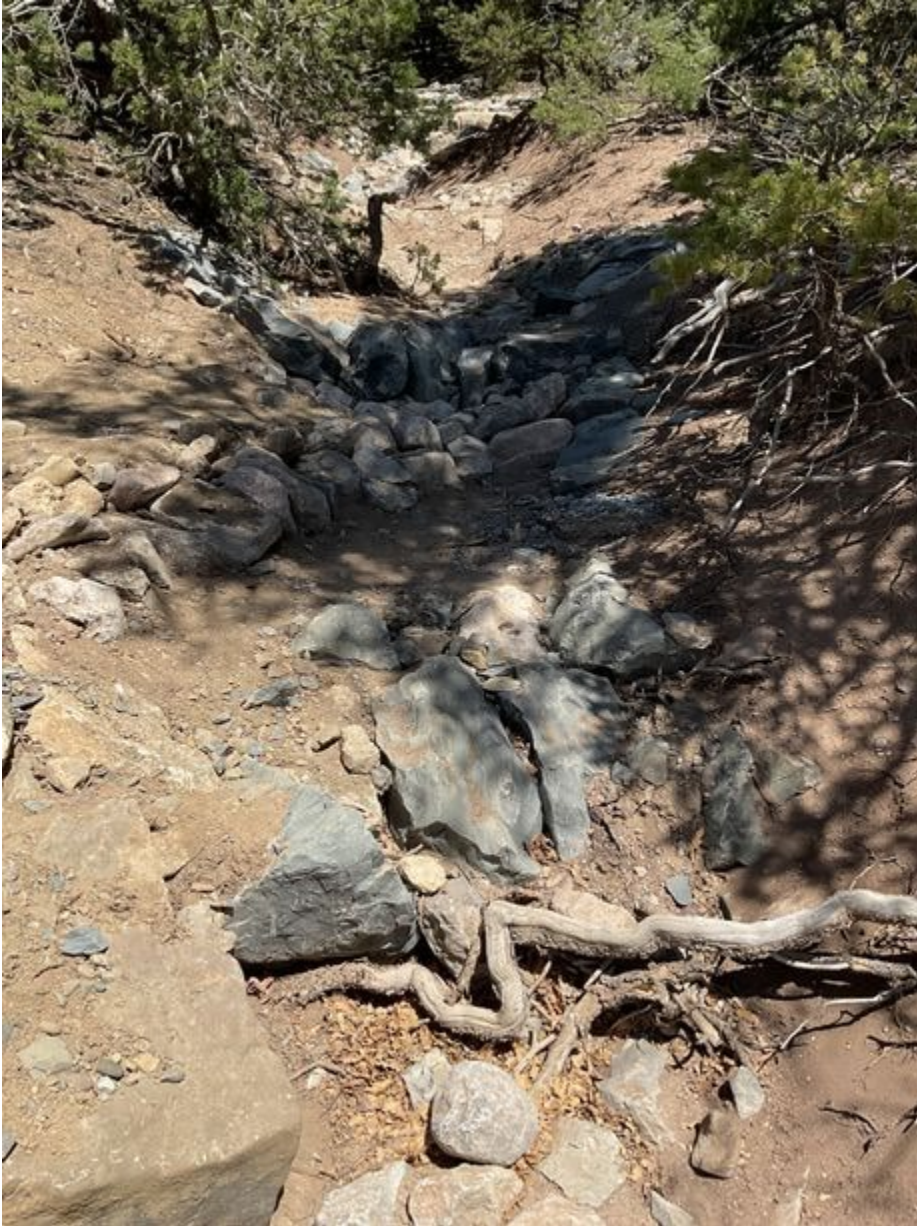
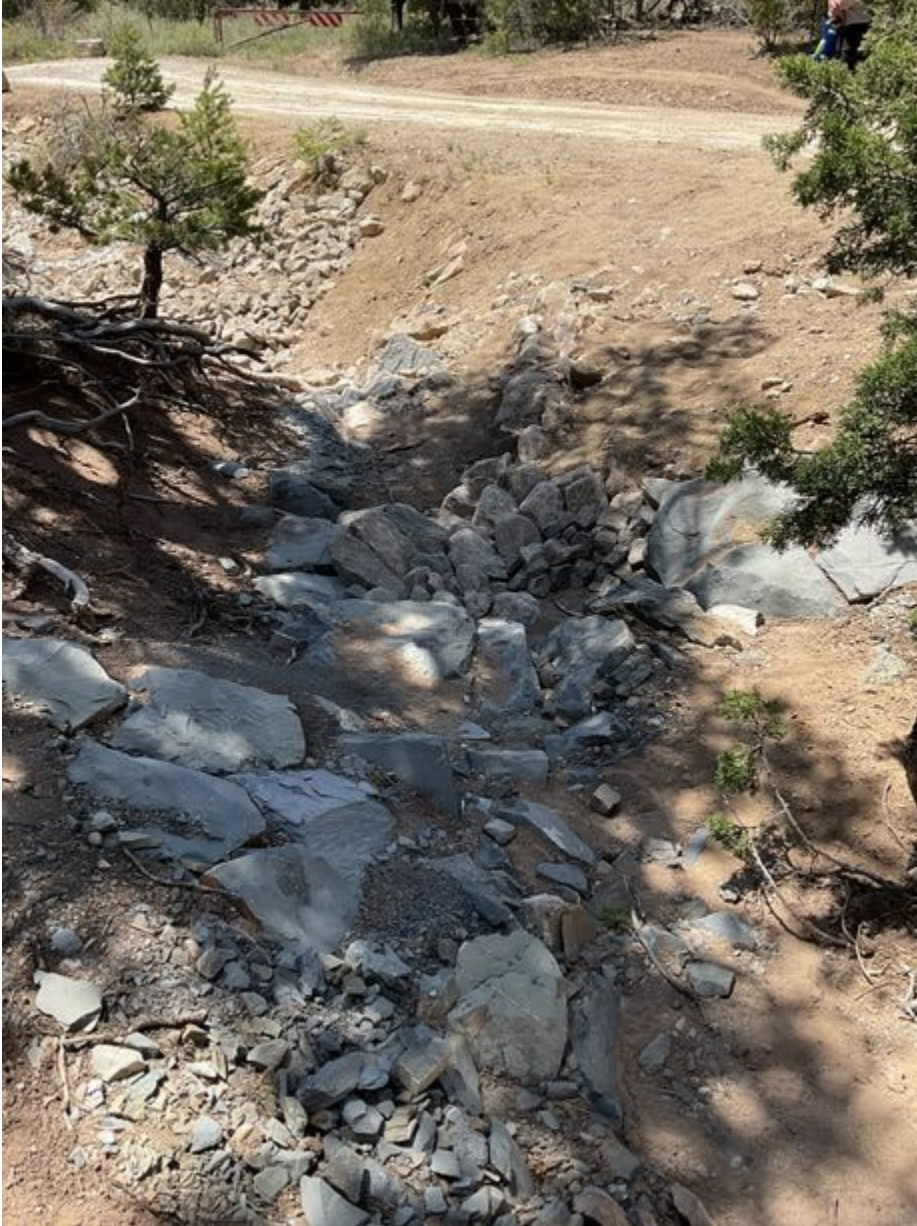
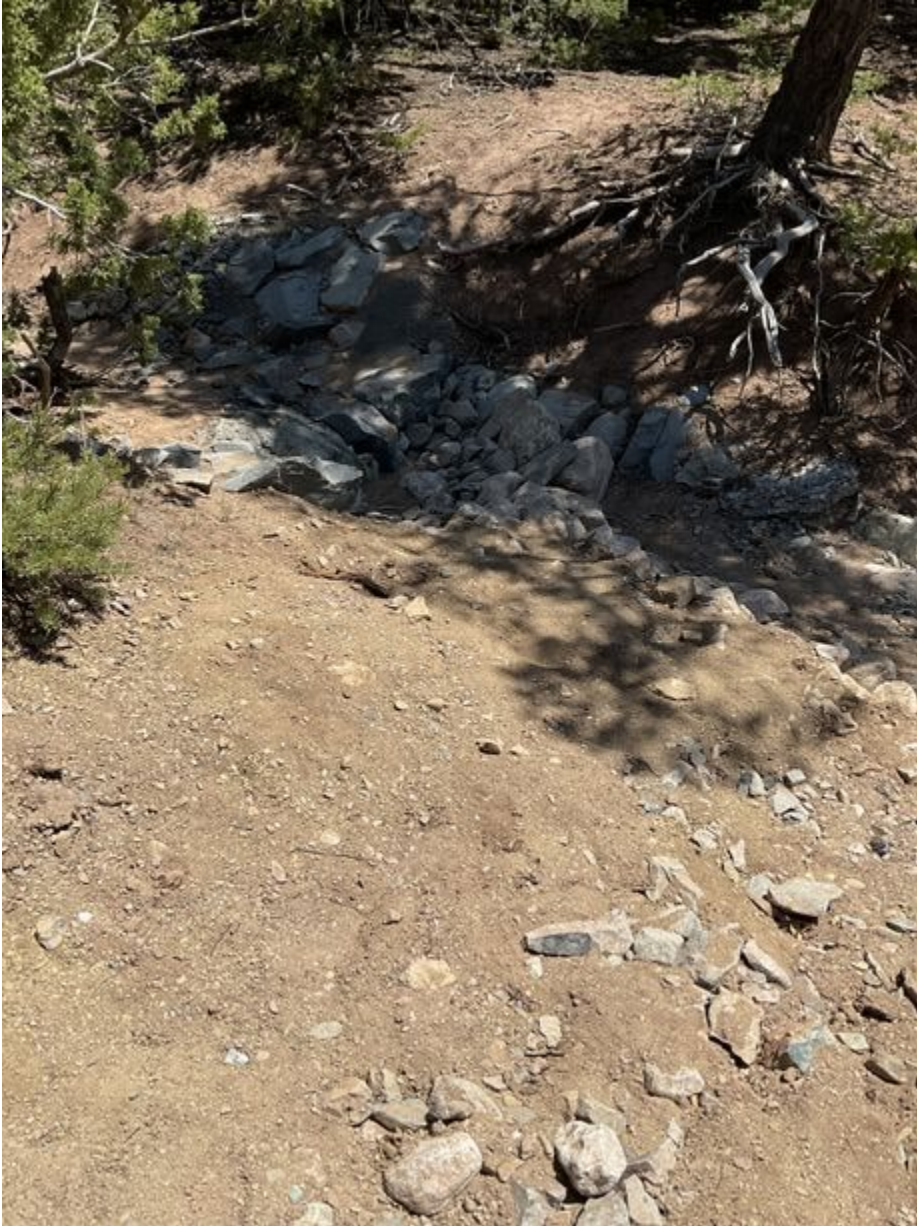
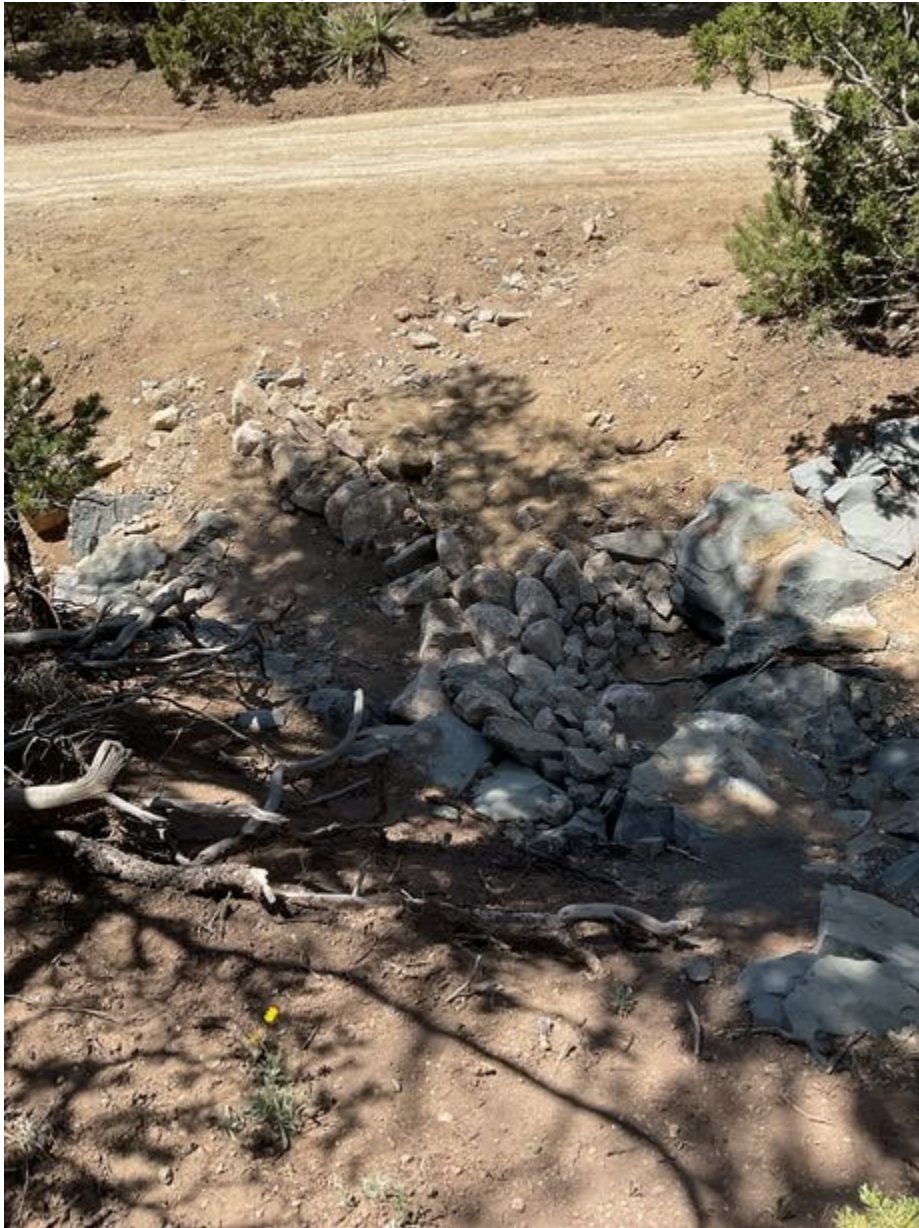
All rocks intact

Difference between ZB and ORD Condition
ORD downstream edge erosion

Additional Notes
Very recent repair

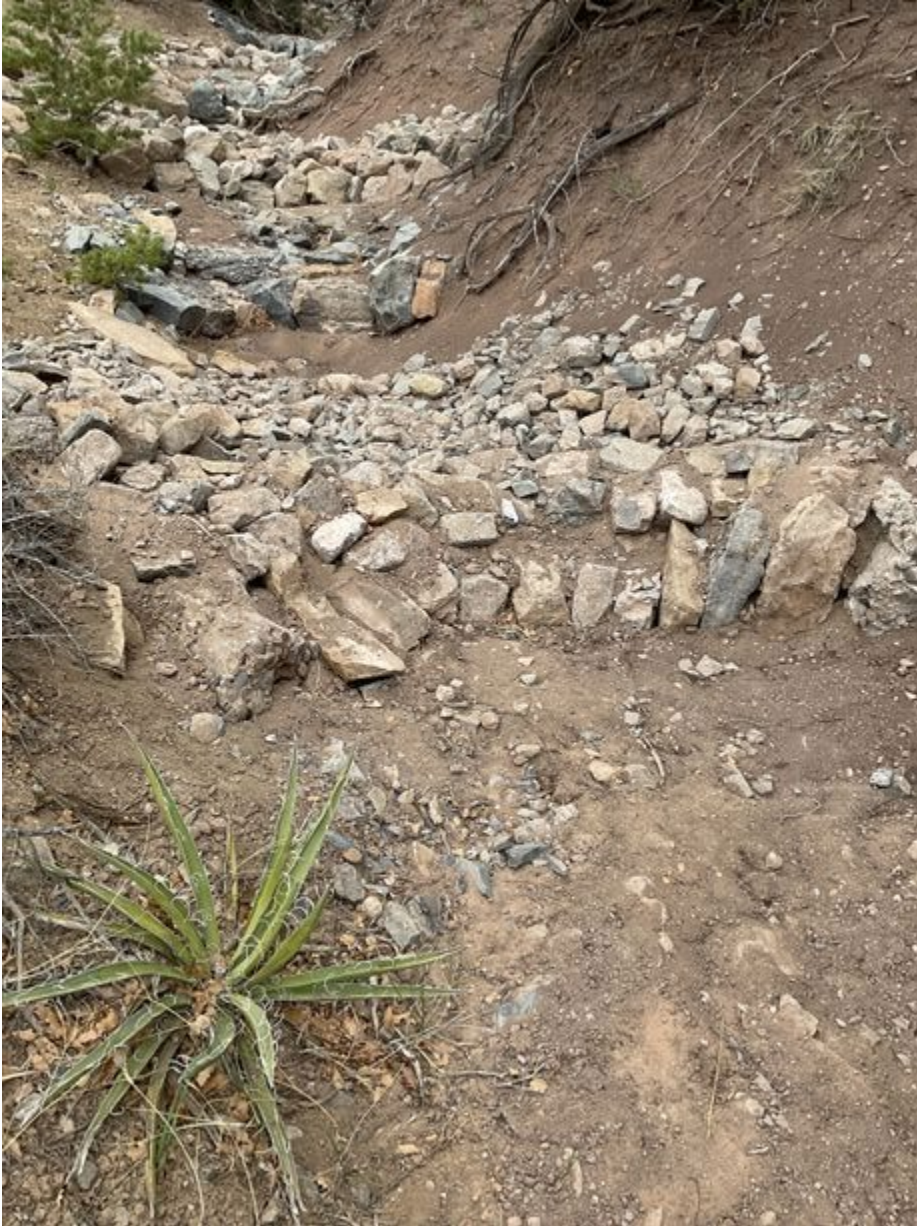
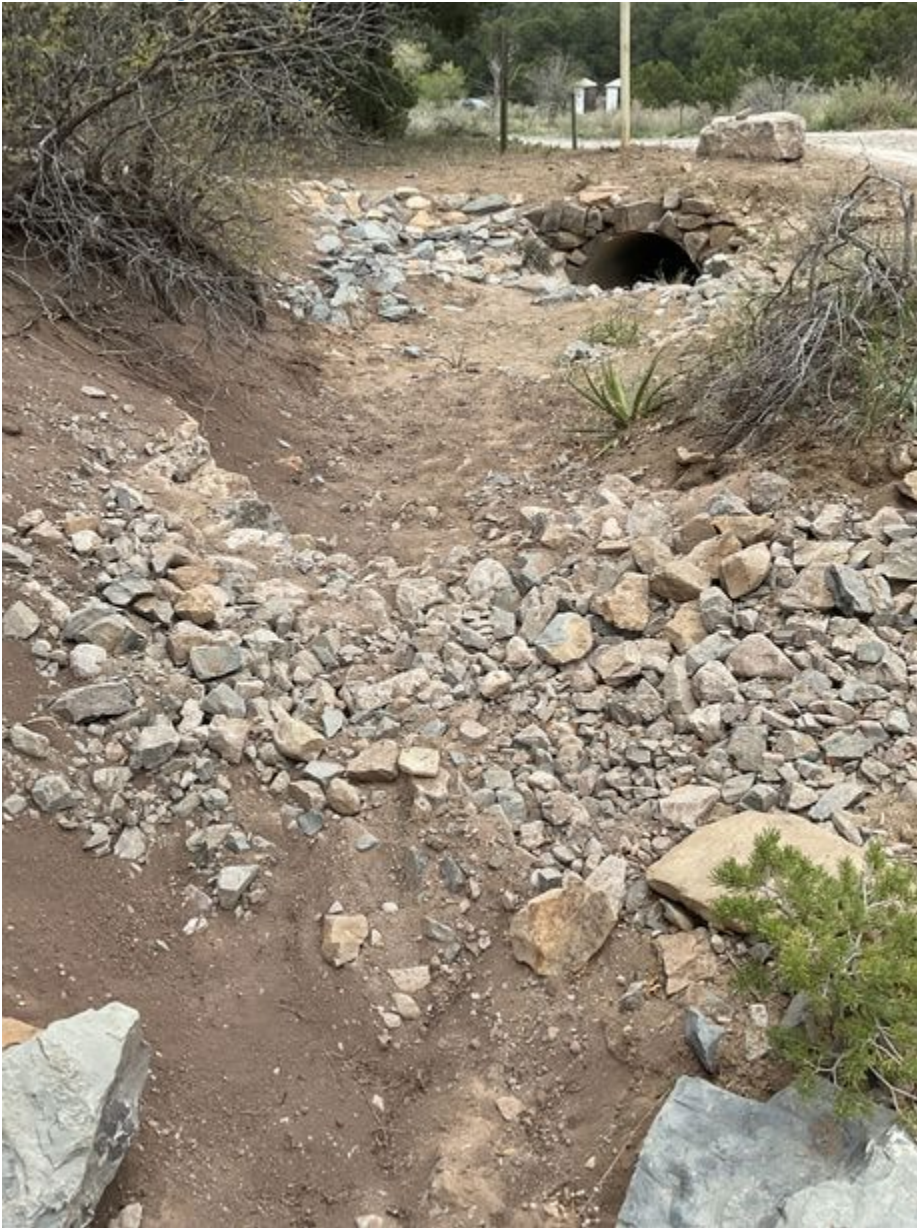
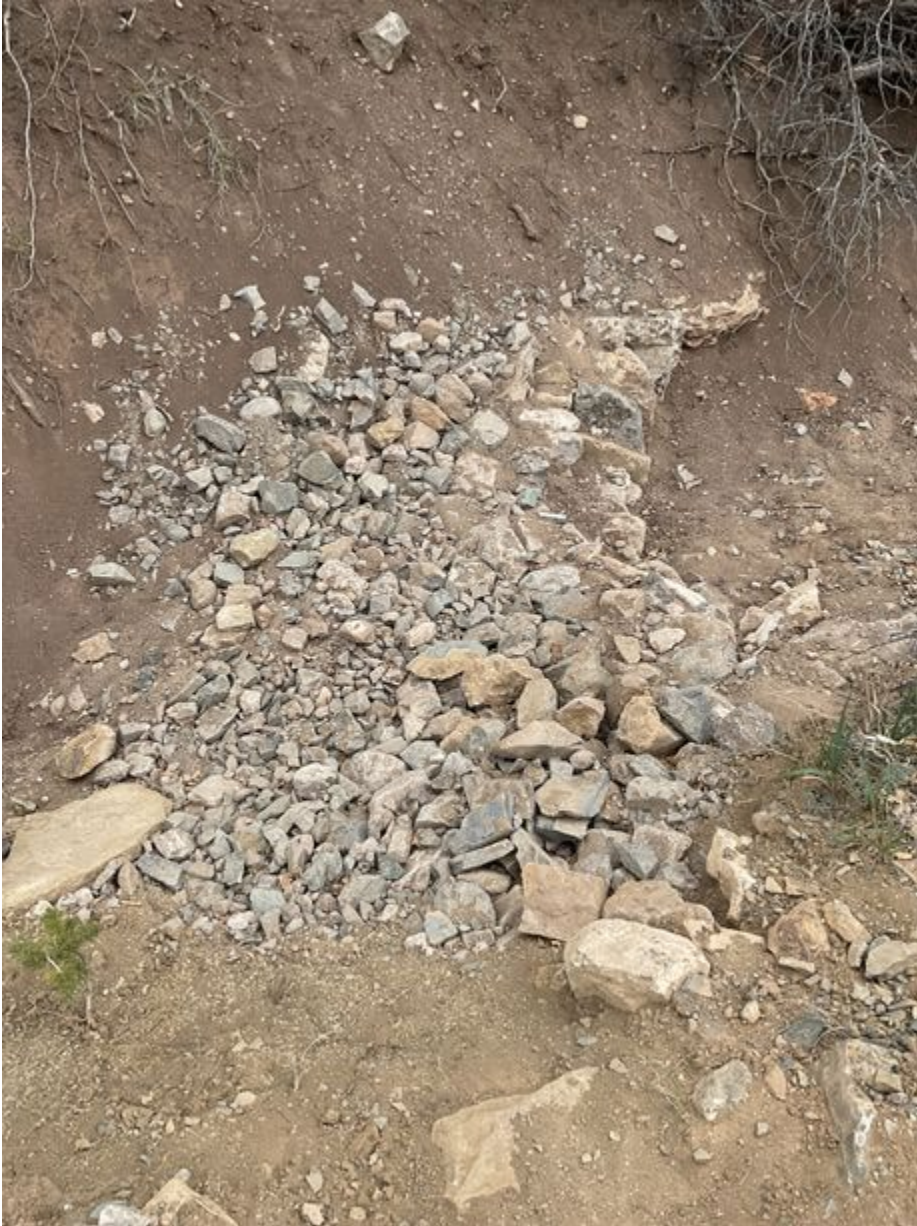
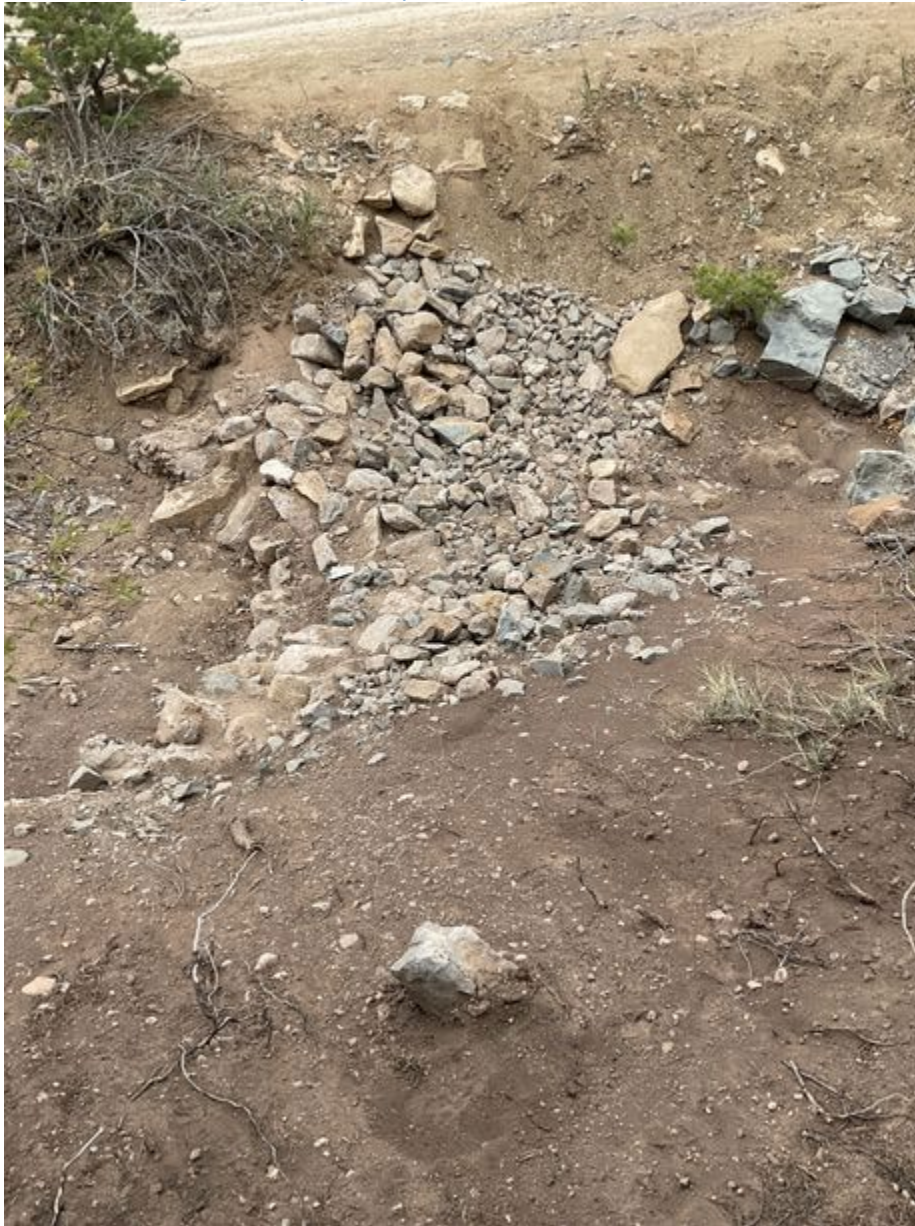
All rocks intact
