CN R924060

**Zuni Bowl and One Rock Check Dam Research –
Phase 1**

Final Report

Rio Grande Return for the New Mexico Department of Transportation Research Bureau

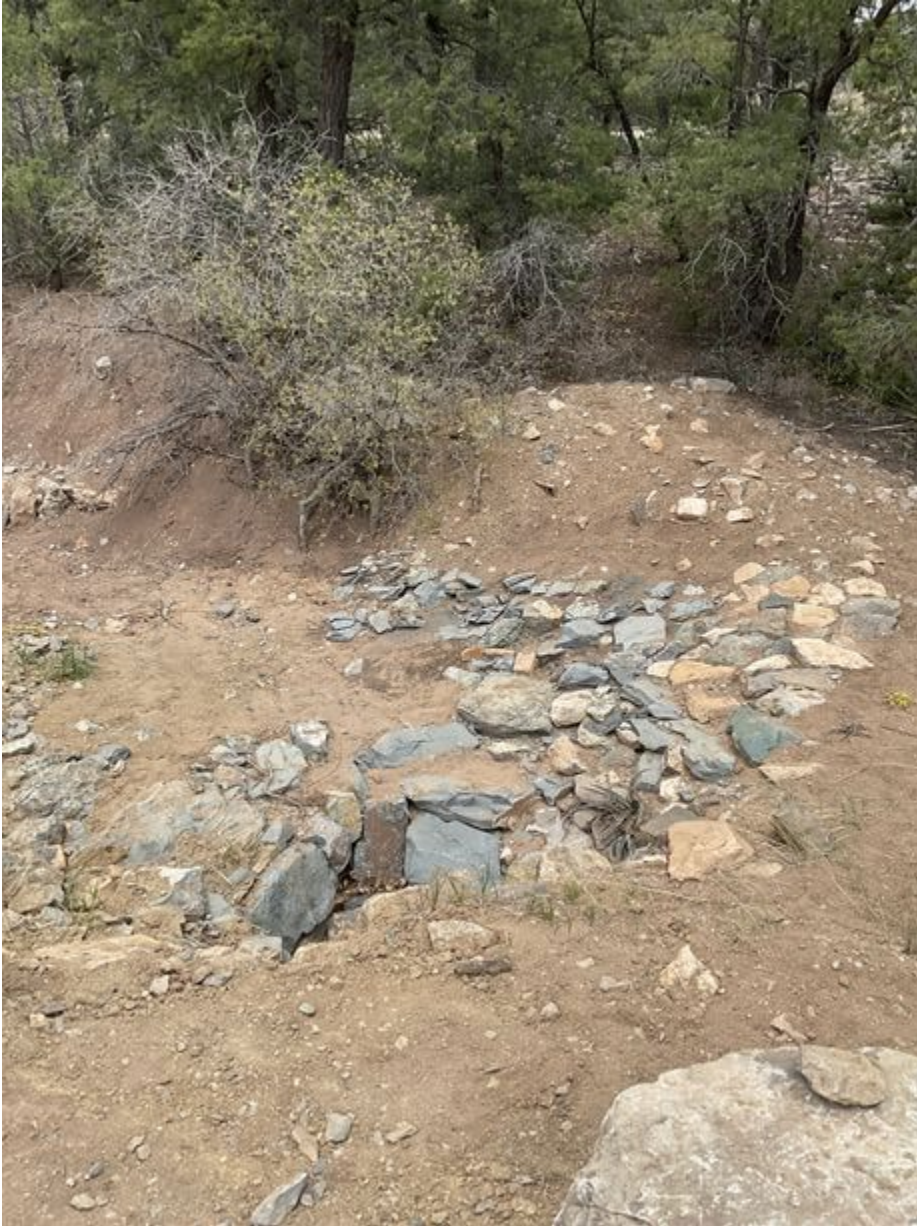
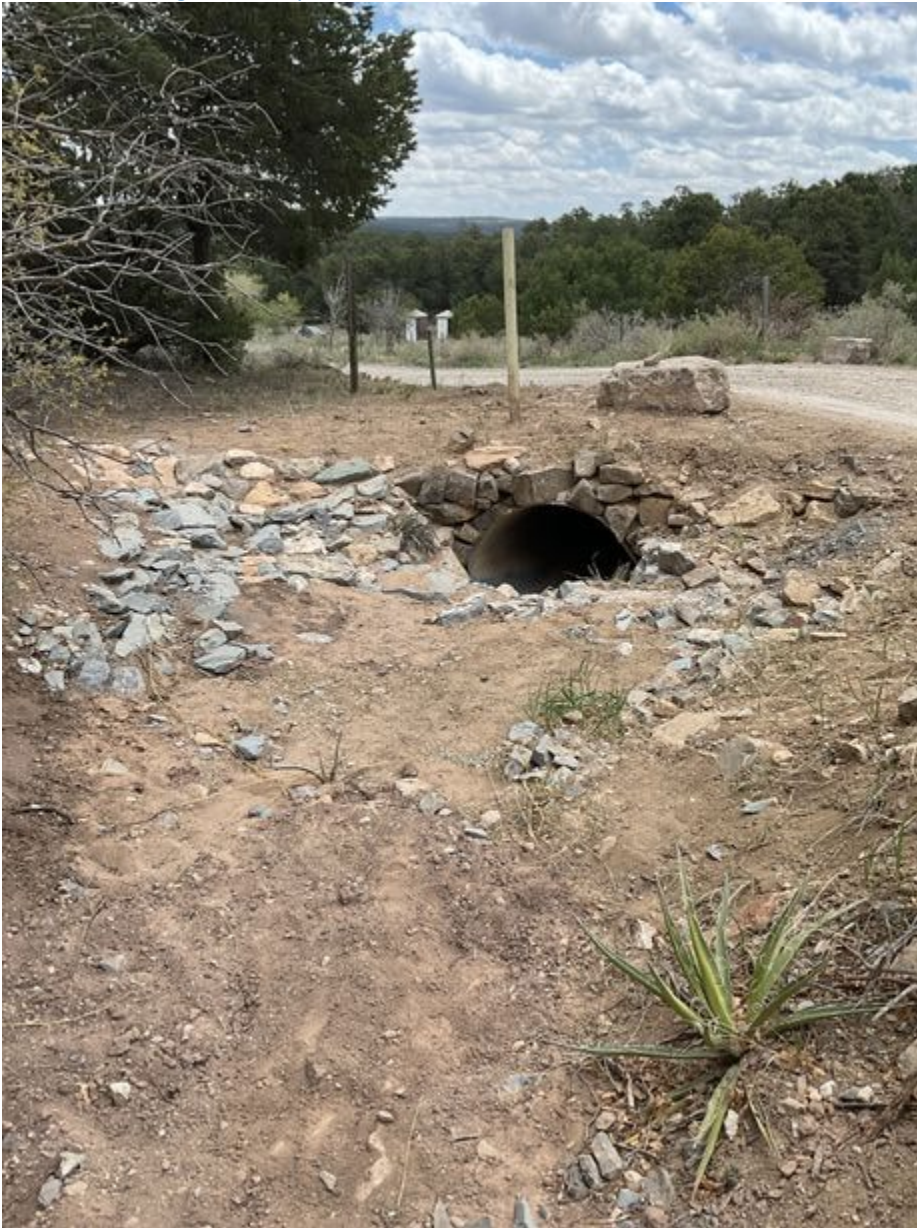
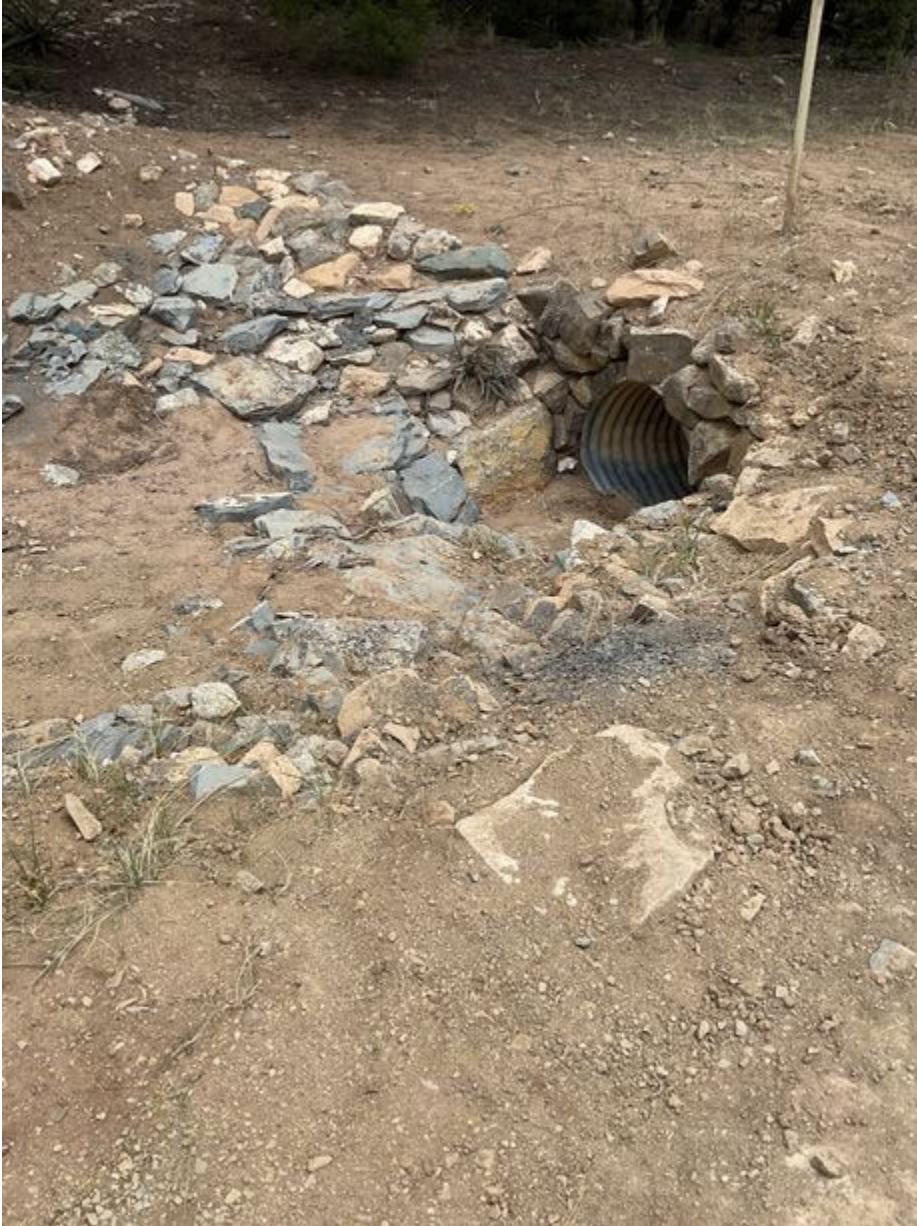
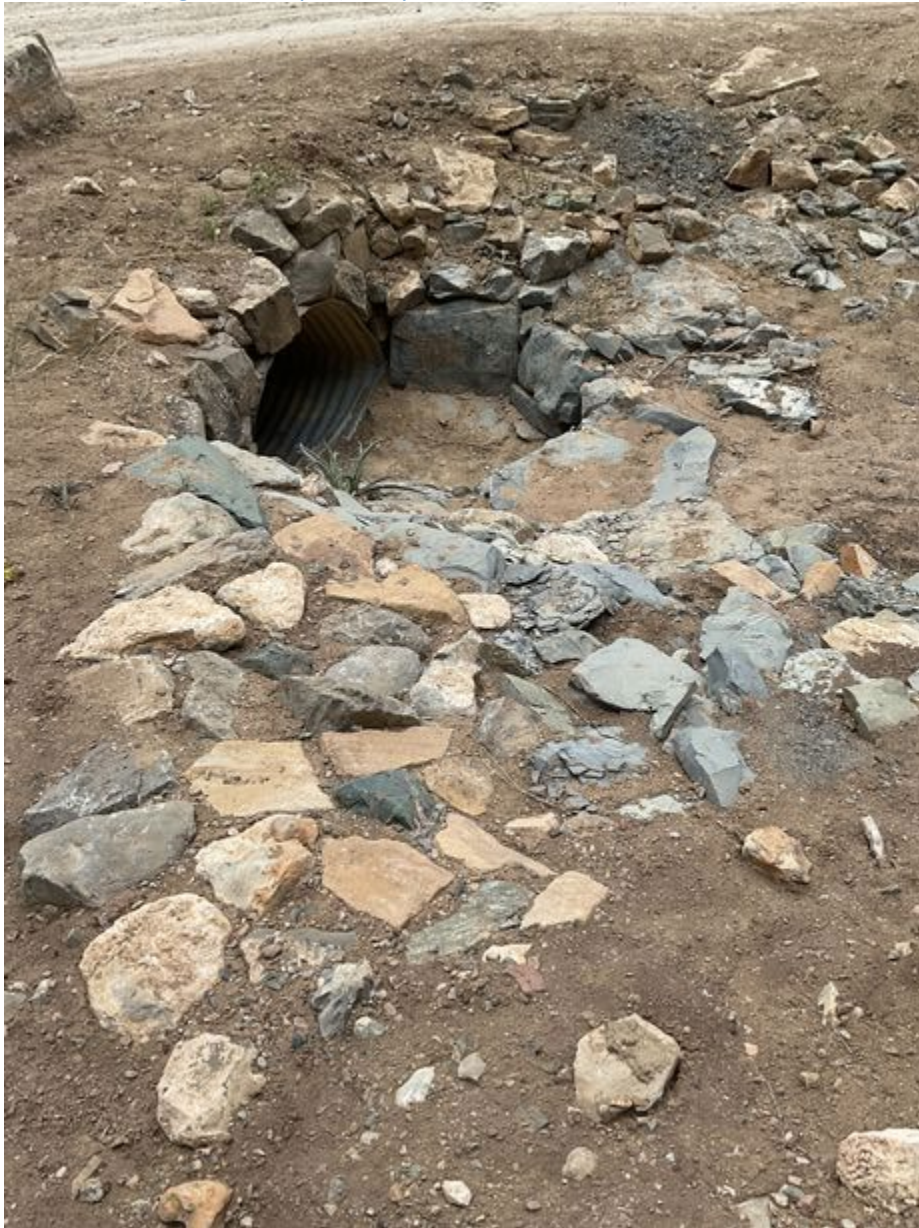
All rocks intact

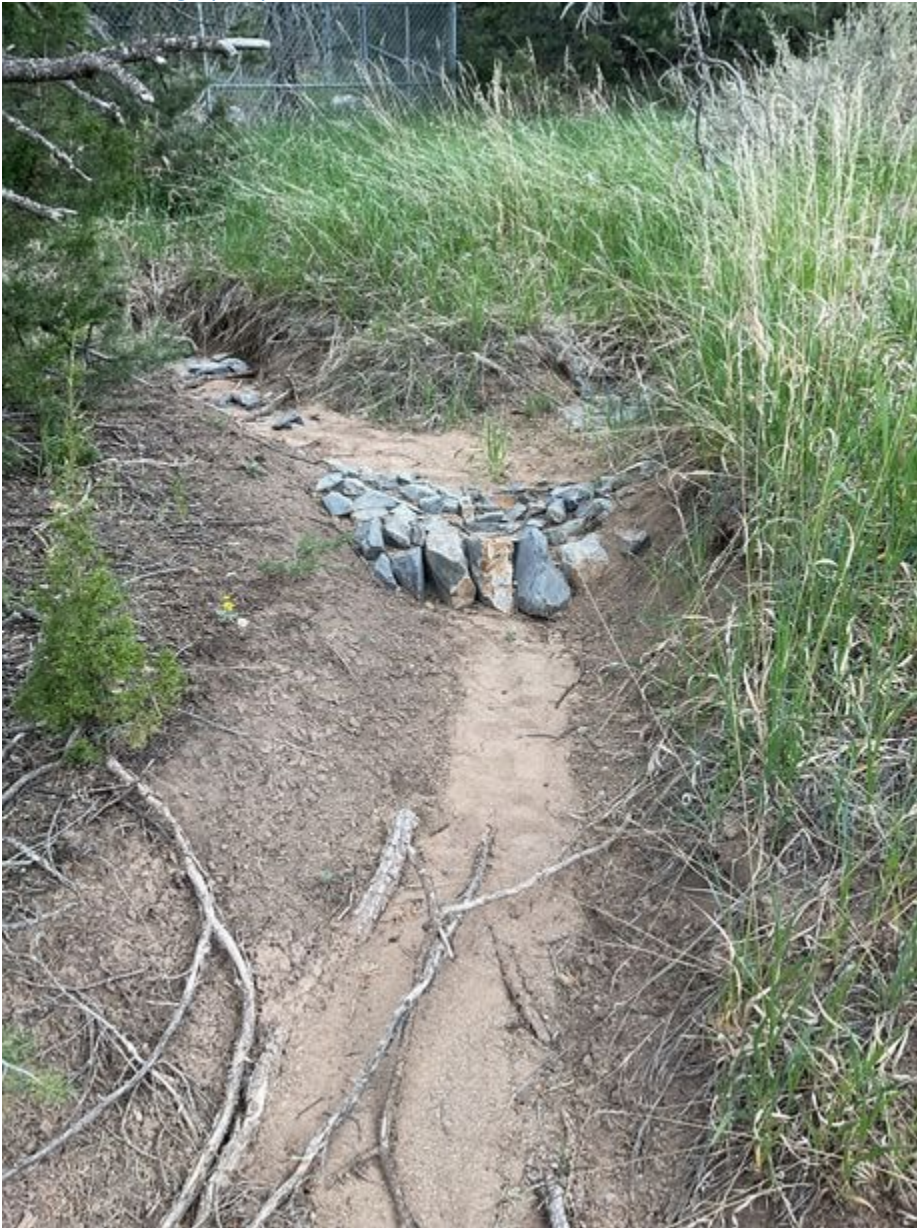
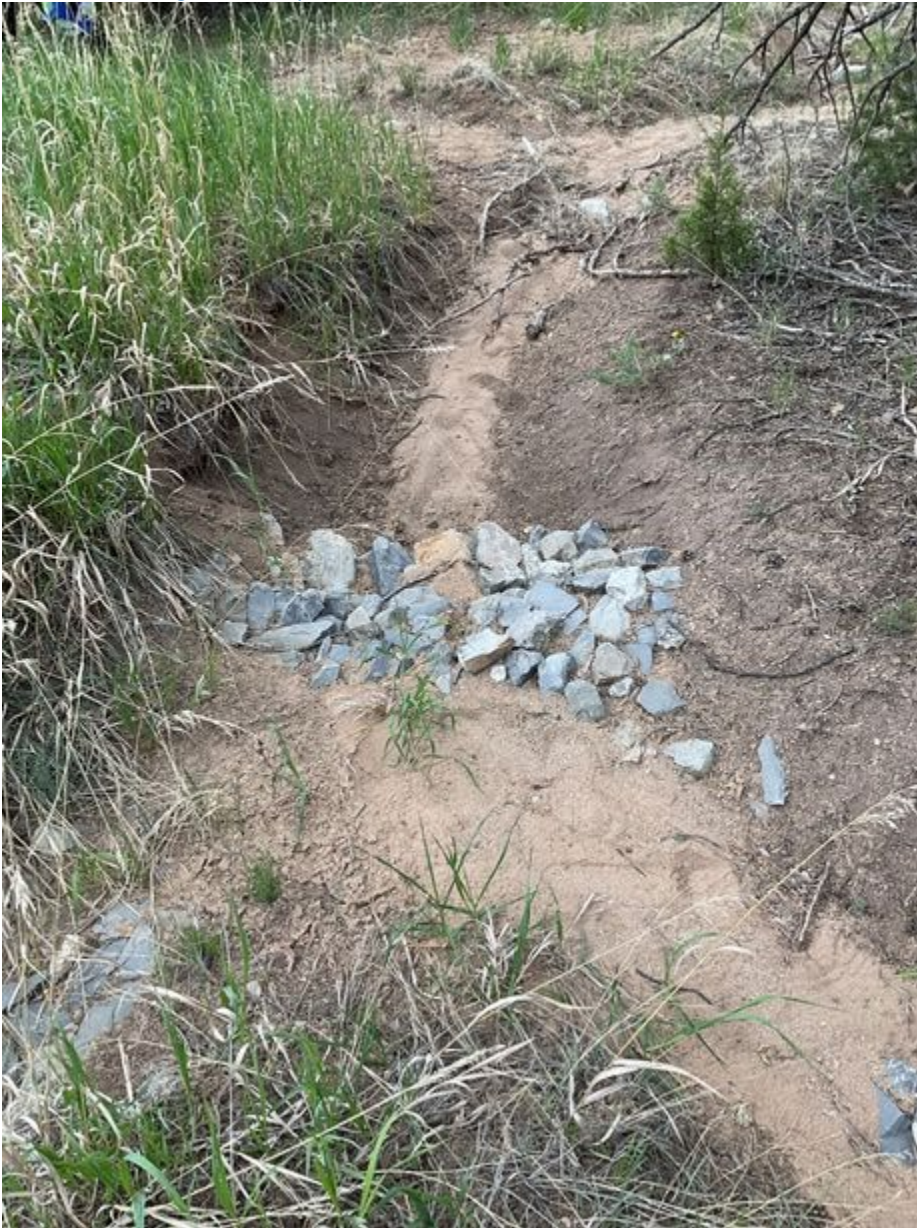
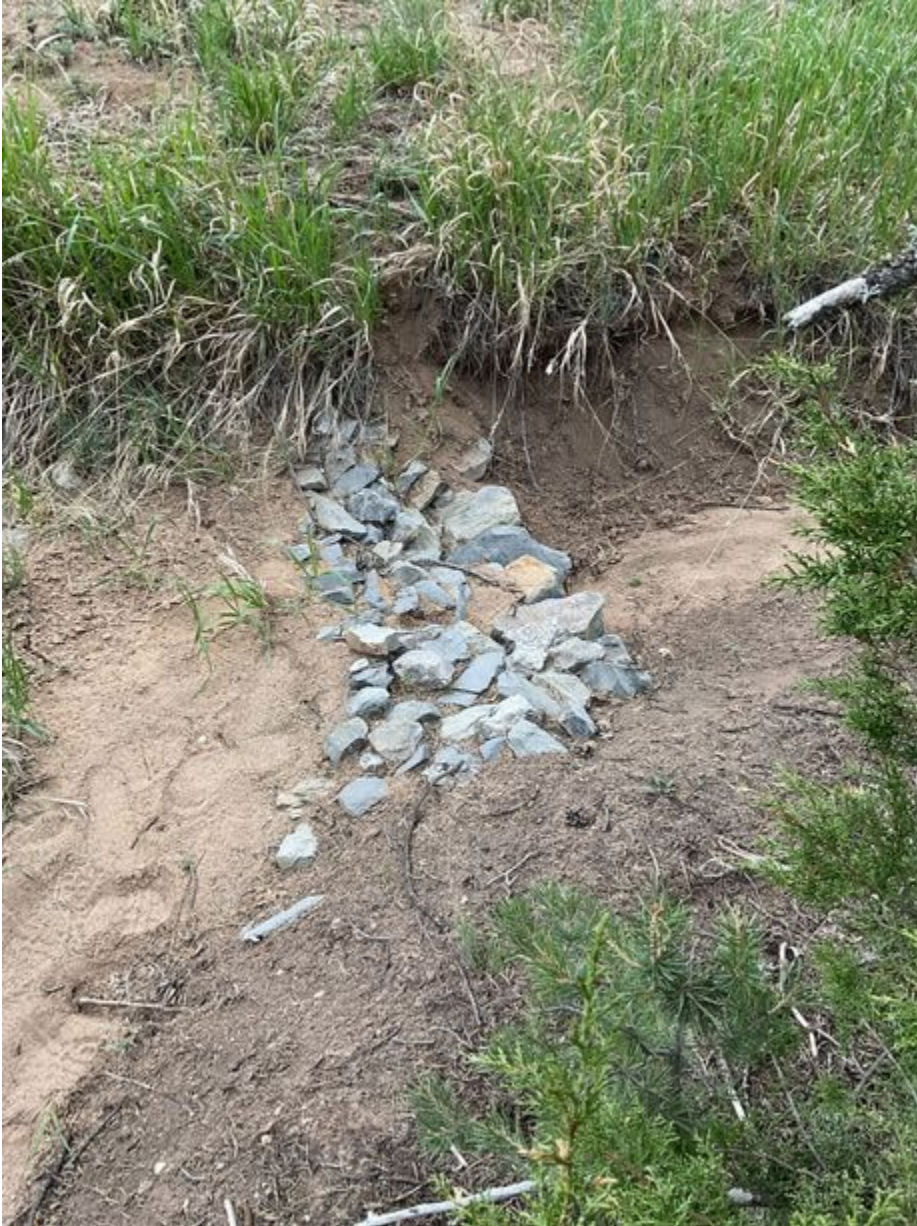
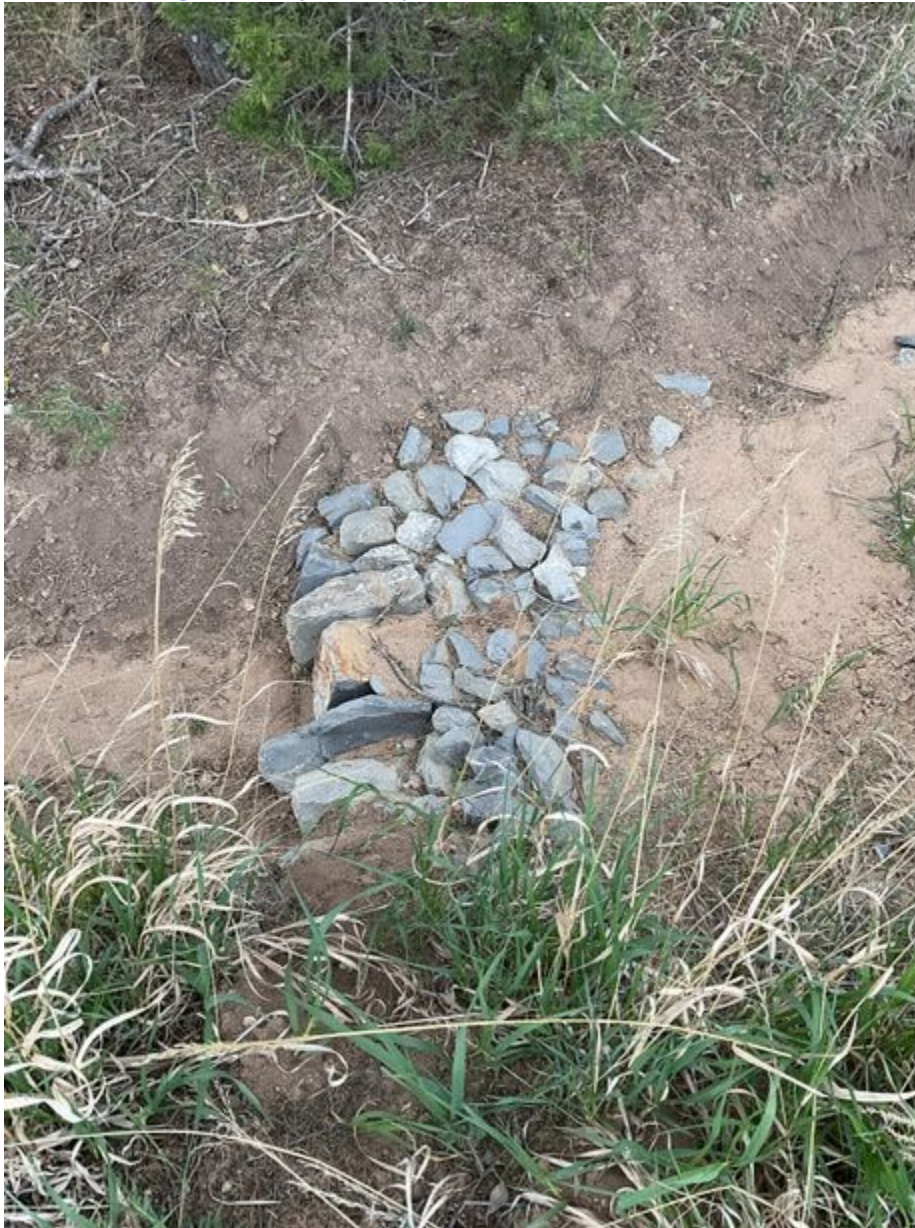
All rocks intact

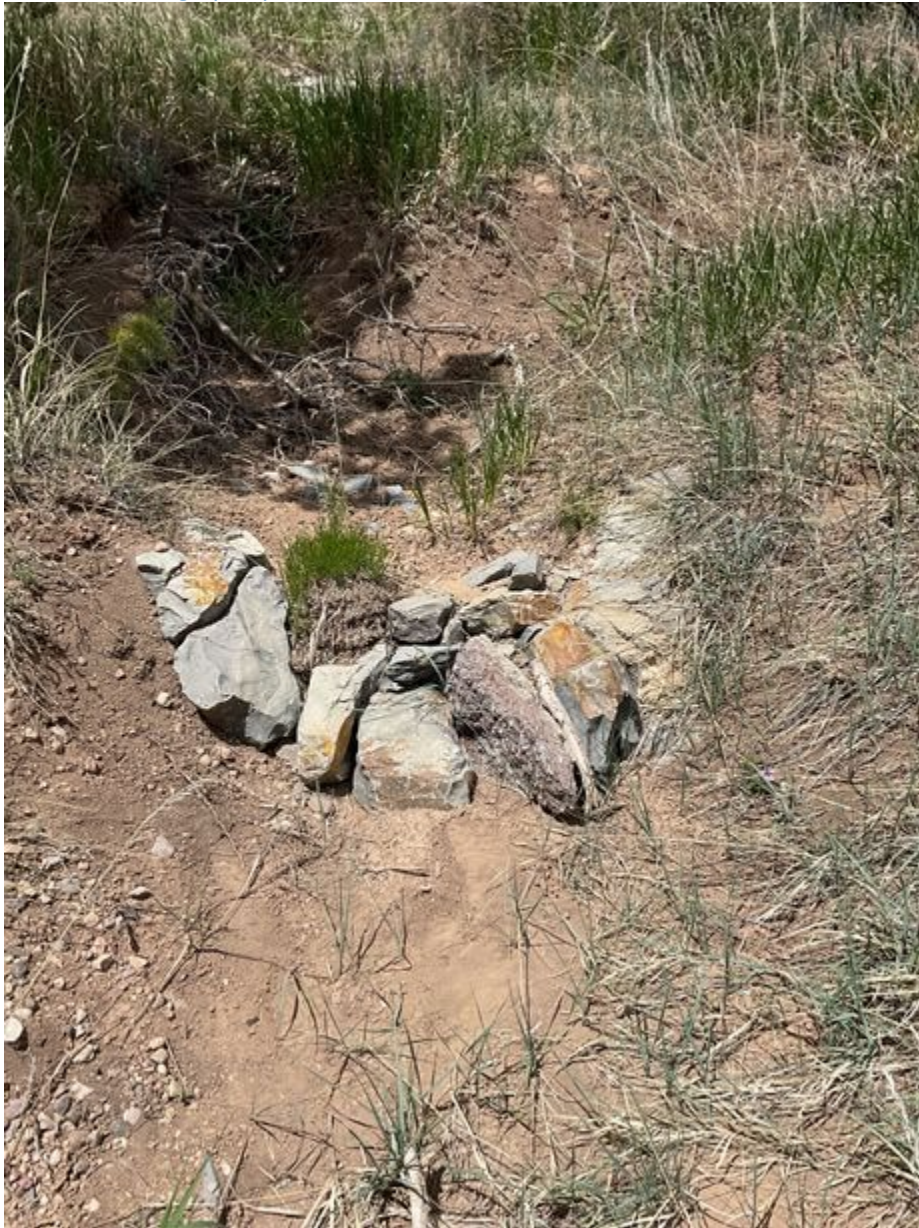
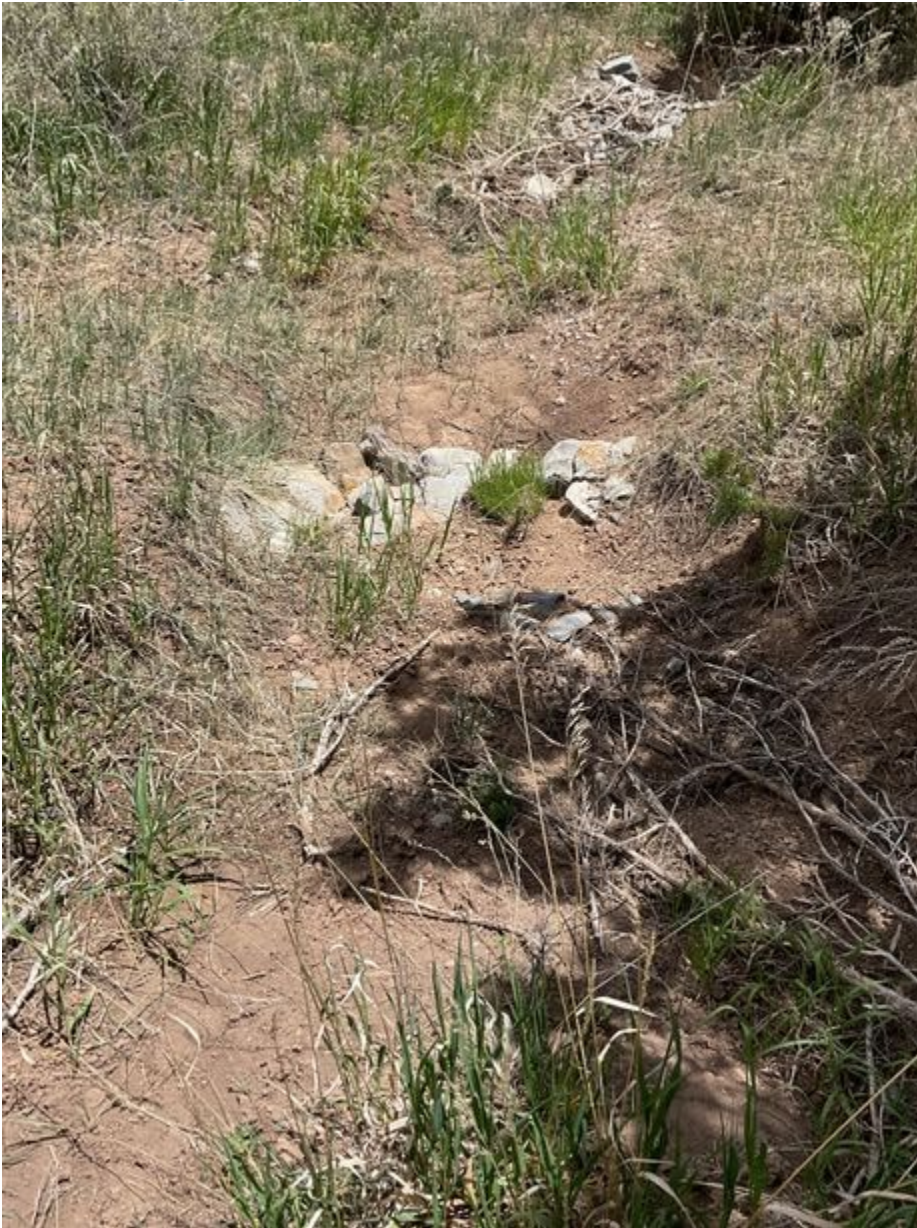
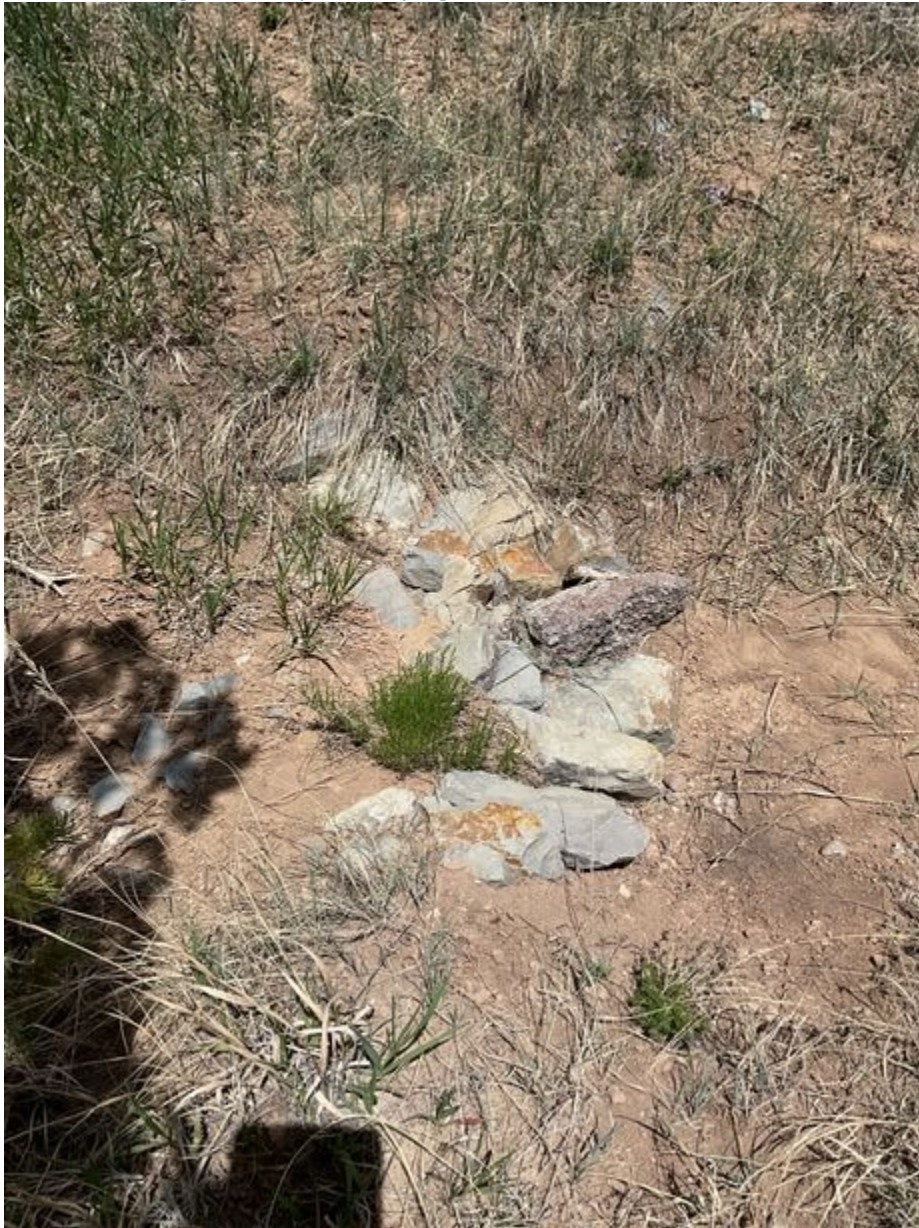
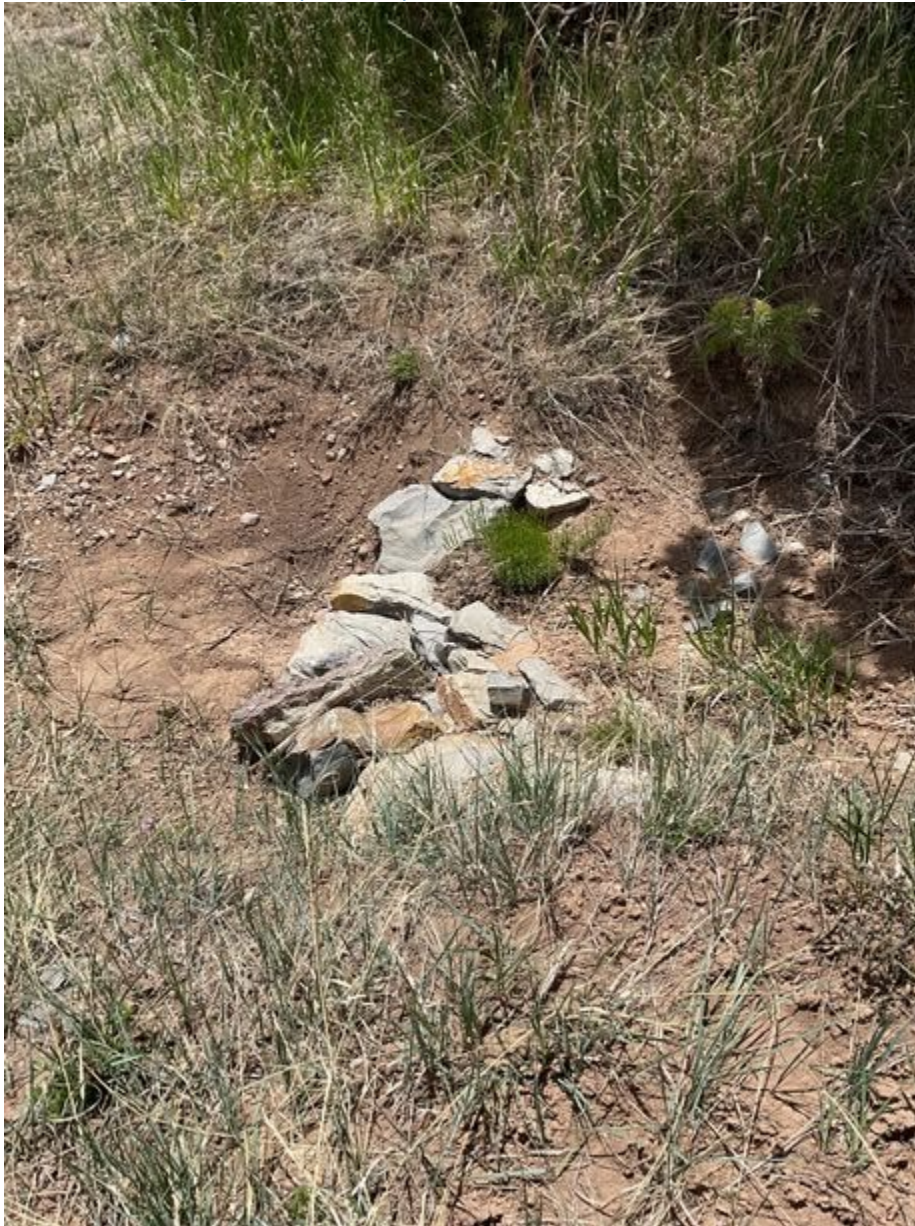
All rocks intact

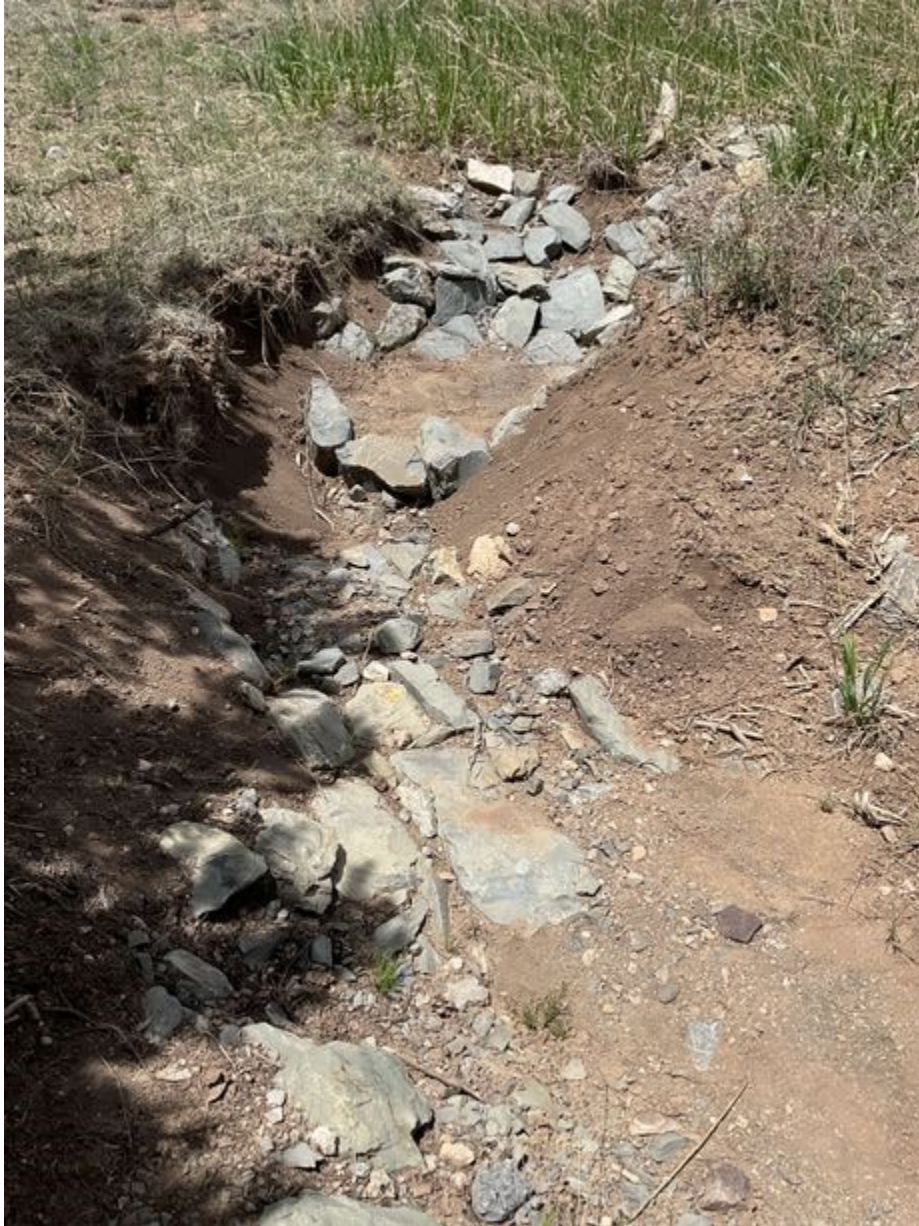
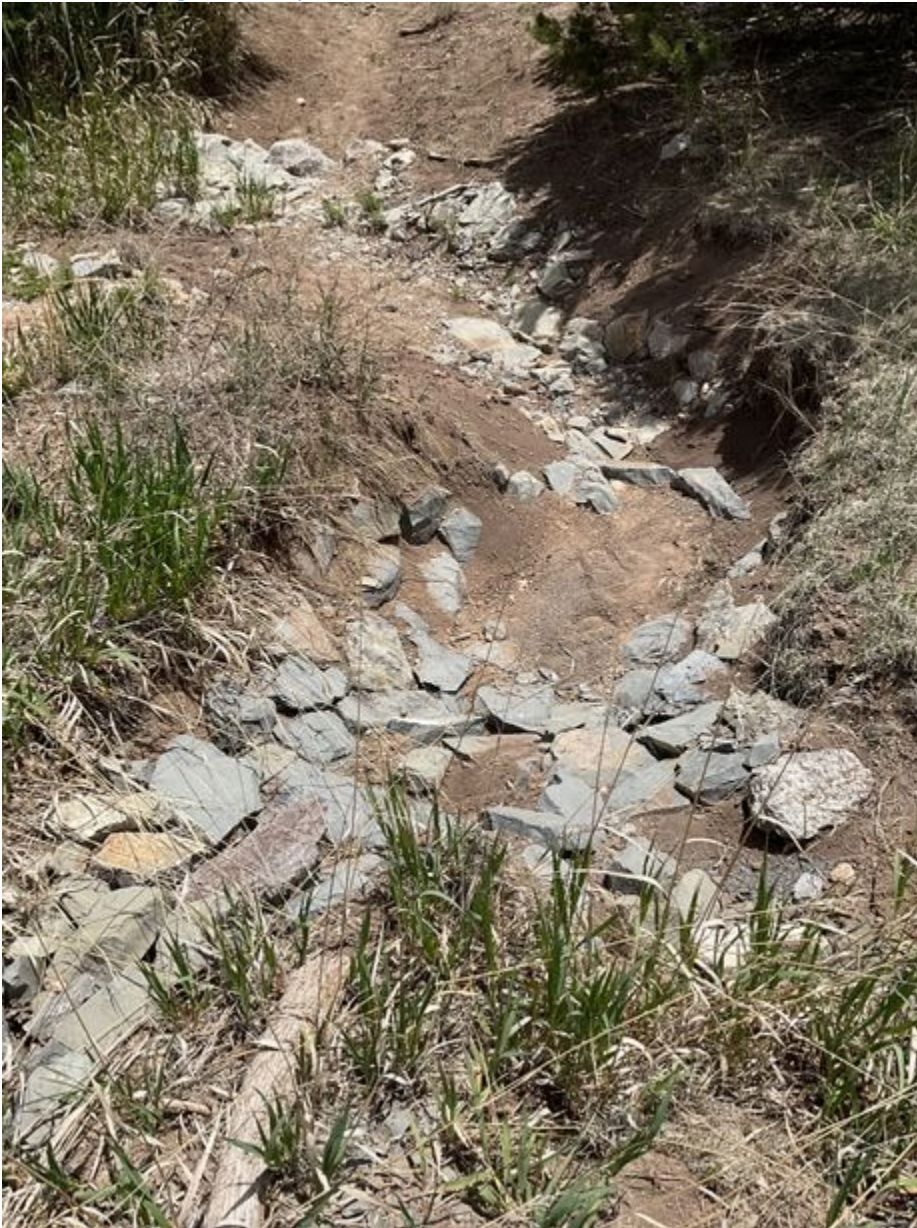
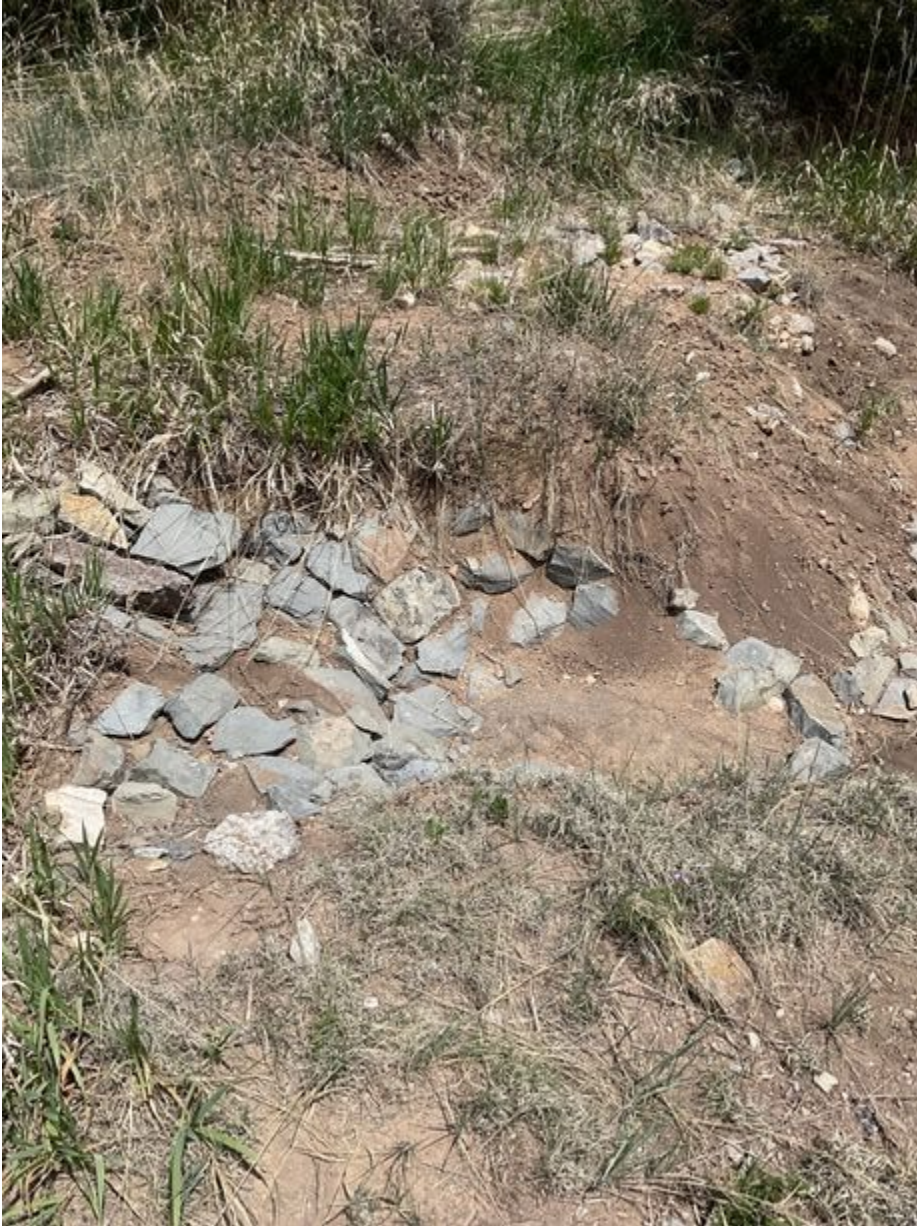
Some rocks dislodged or broken

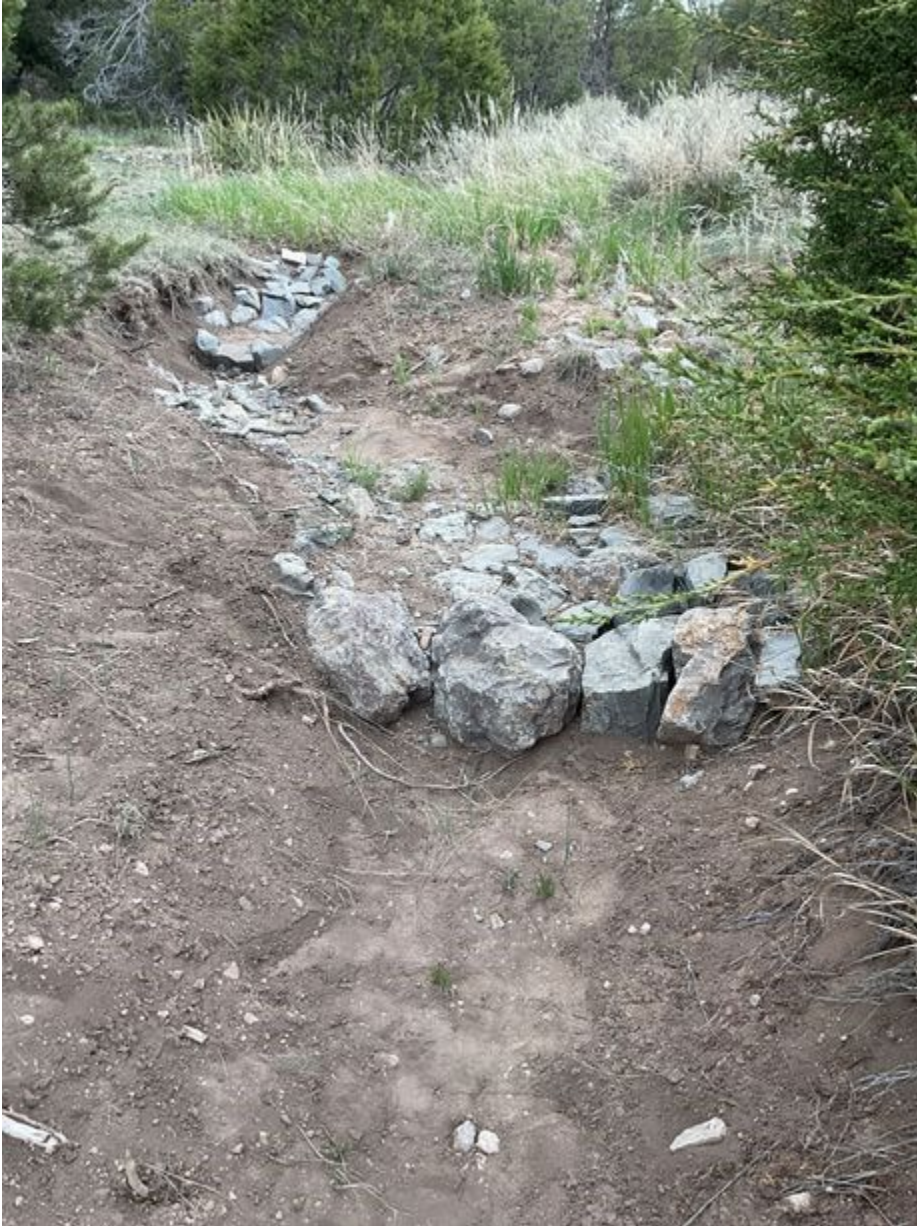
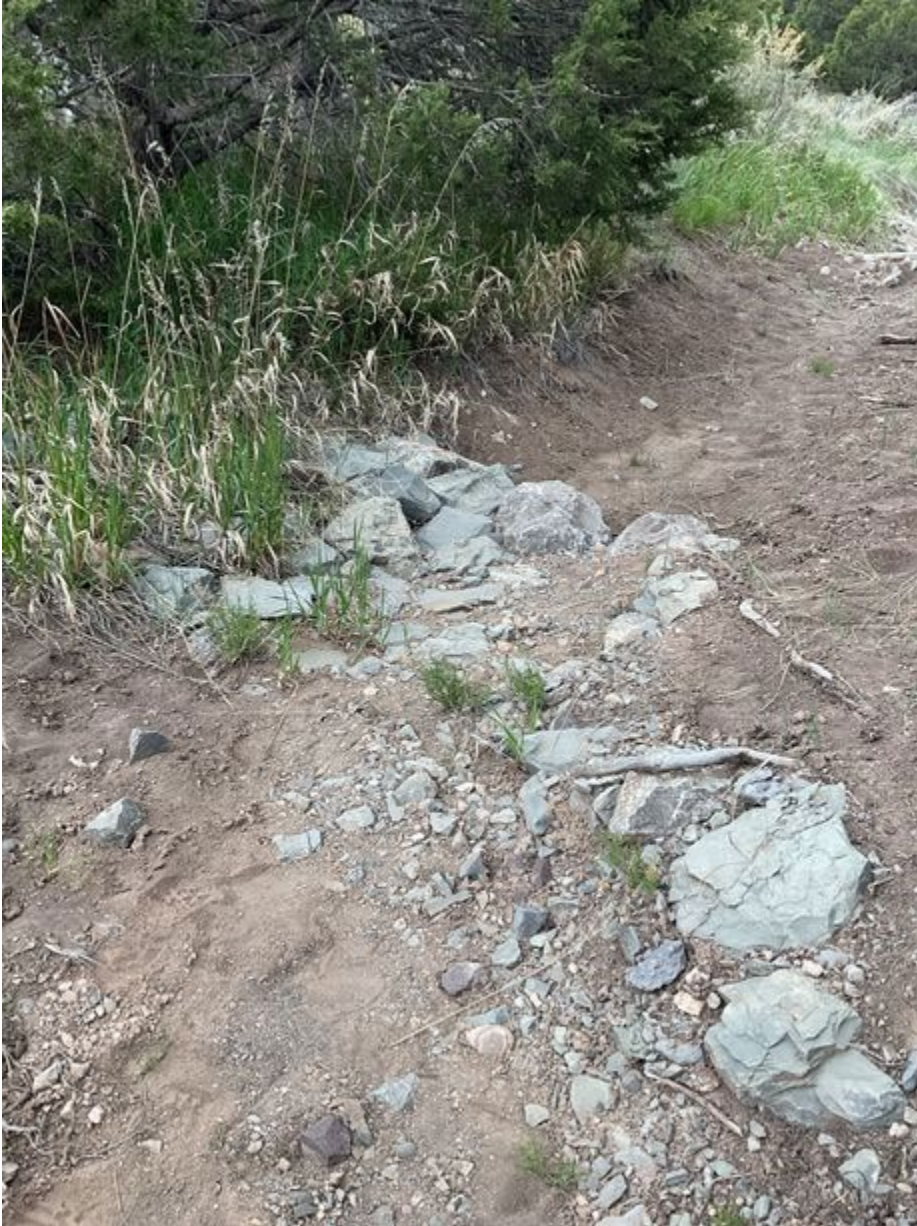
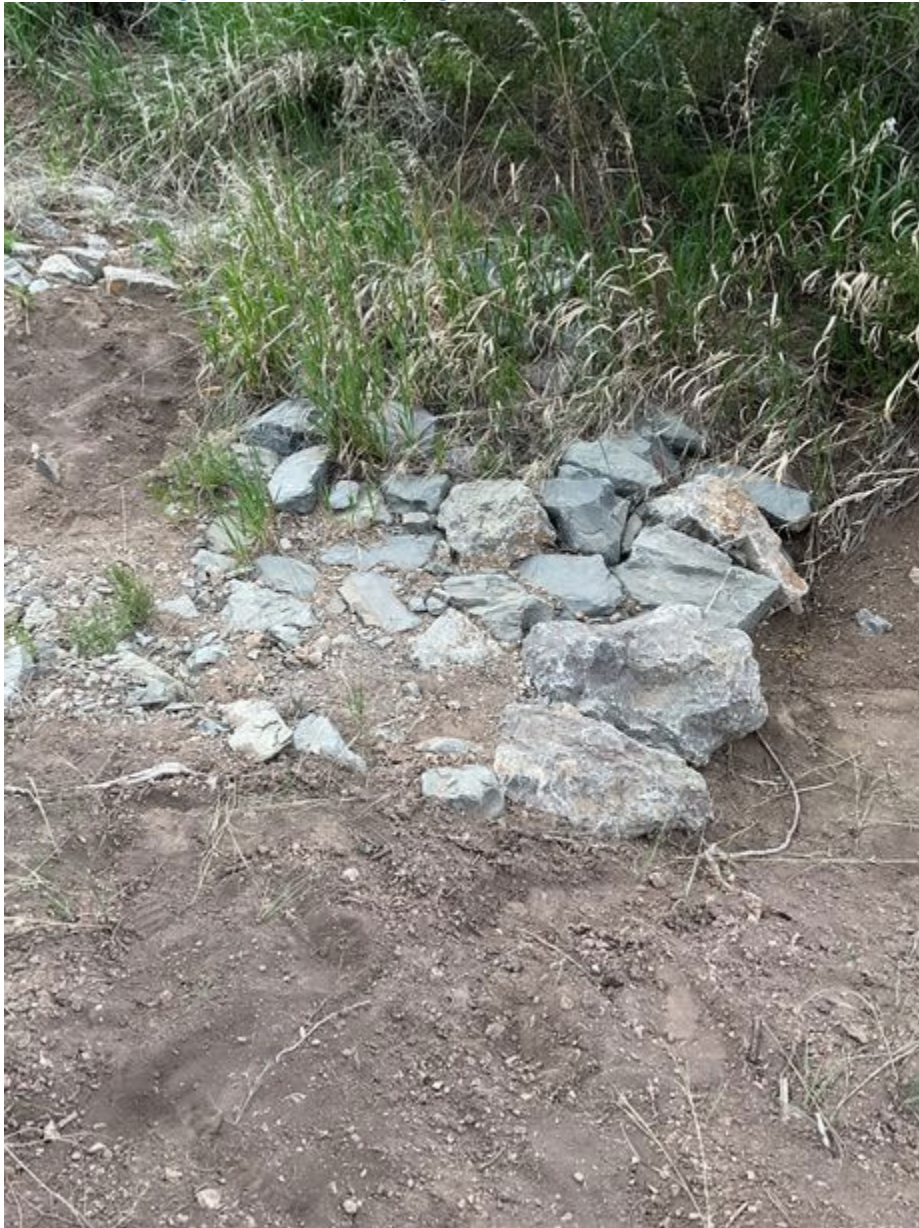
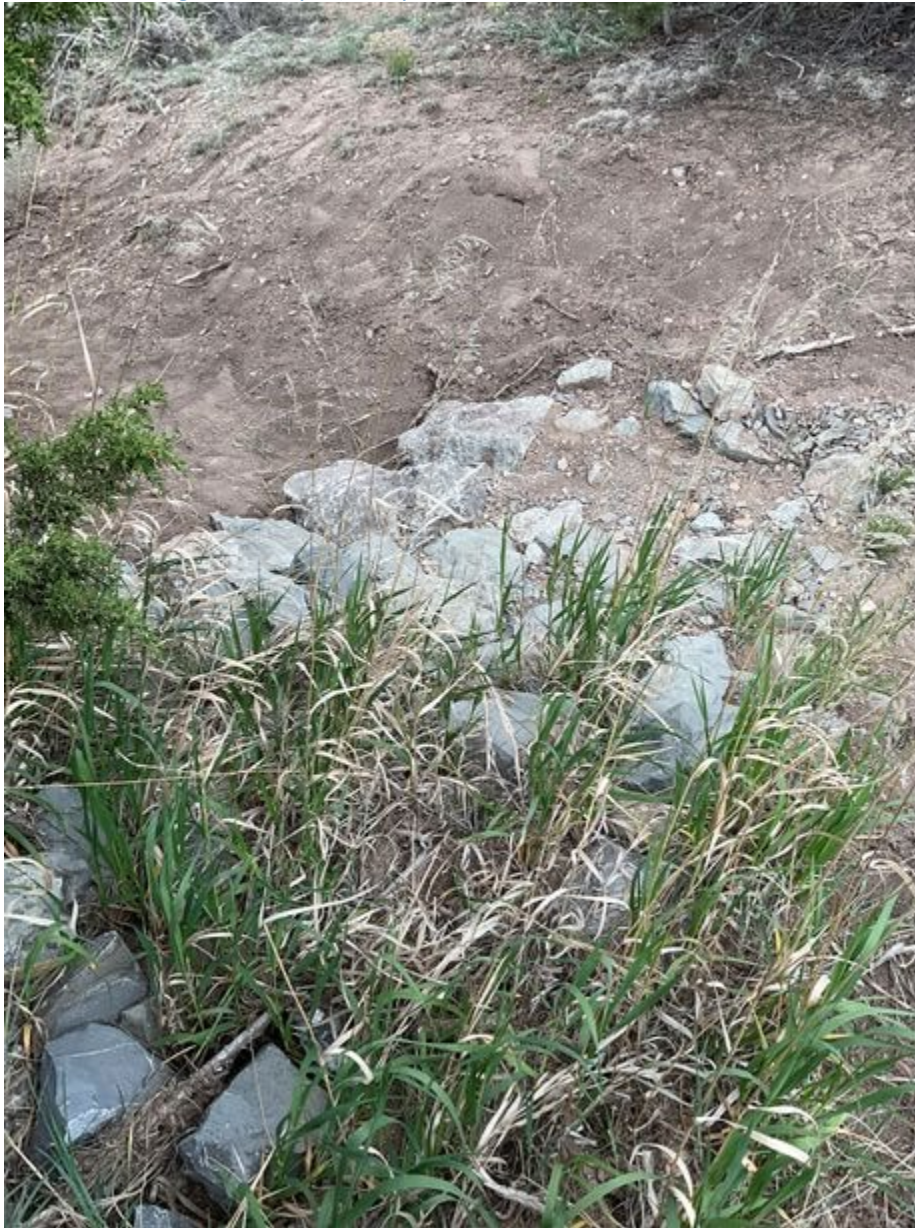
All rocks intact
