CN R924060

**Zuni Bowl and One Rock Check Dam Research –
Phase 1**

Final Report

Rio Grande Return for the New Mexico Department of Transportation Research Bureau

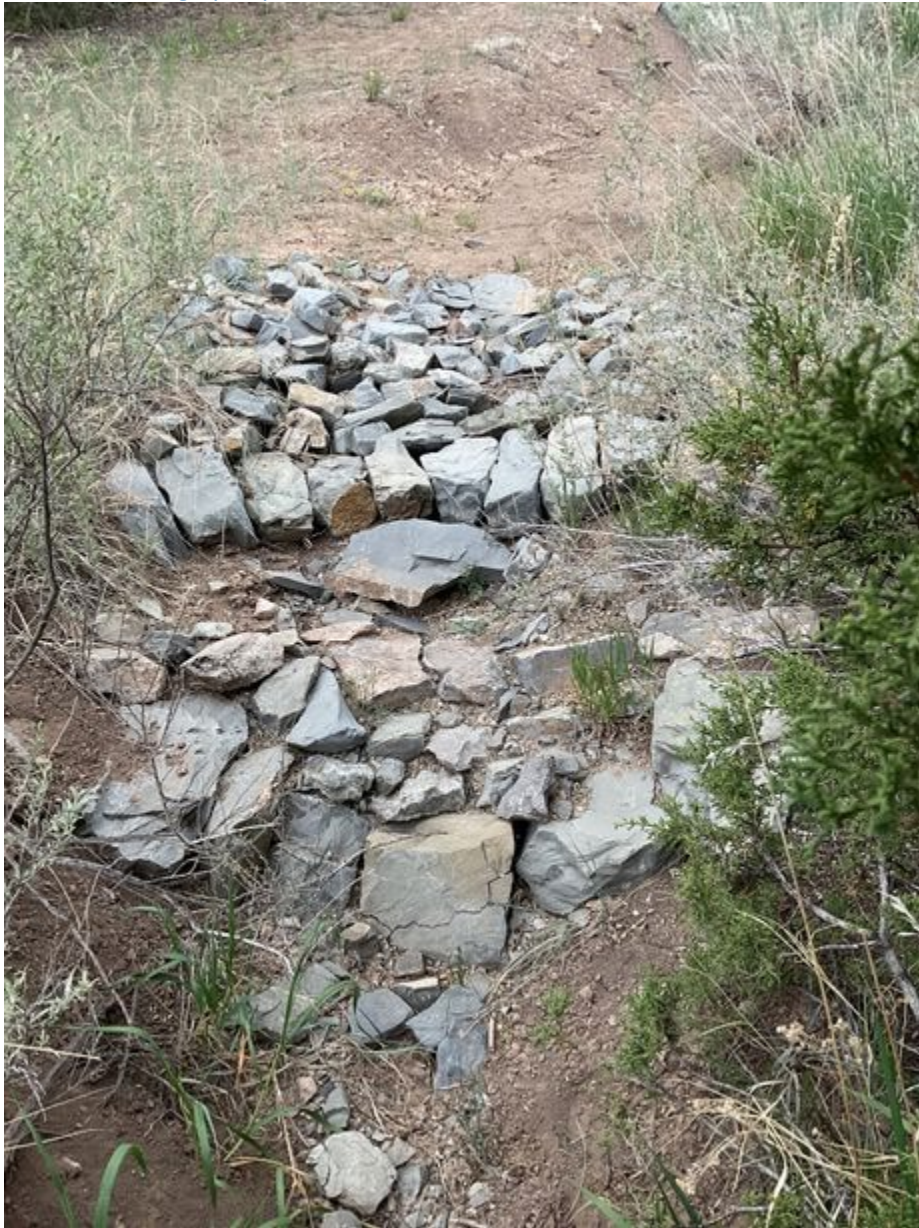
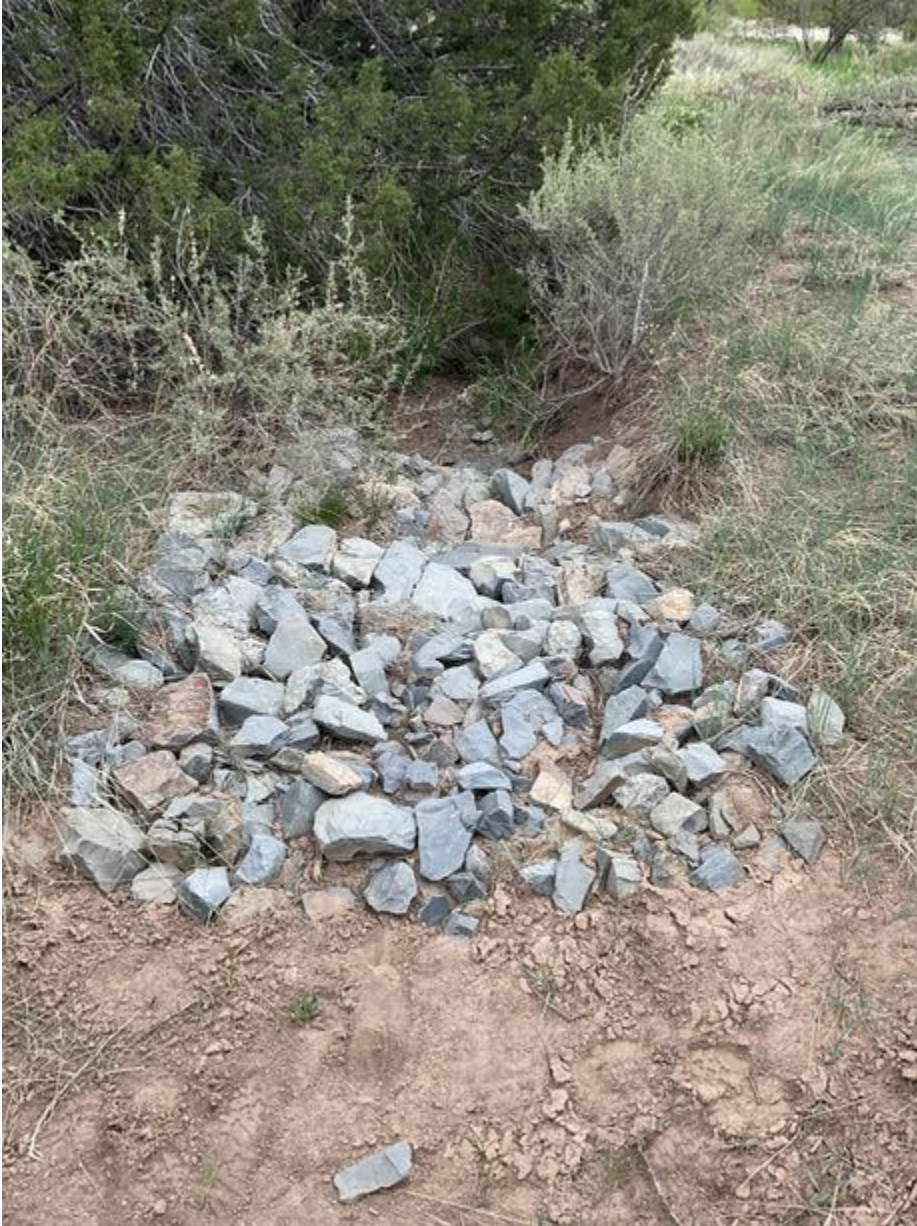
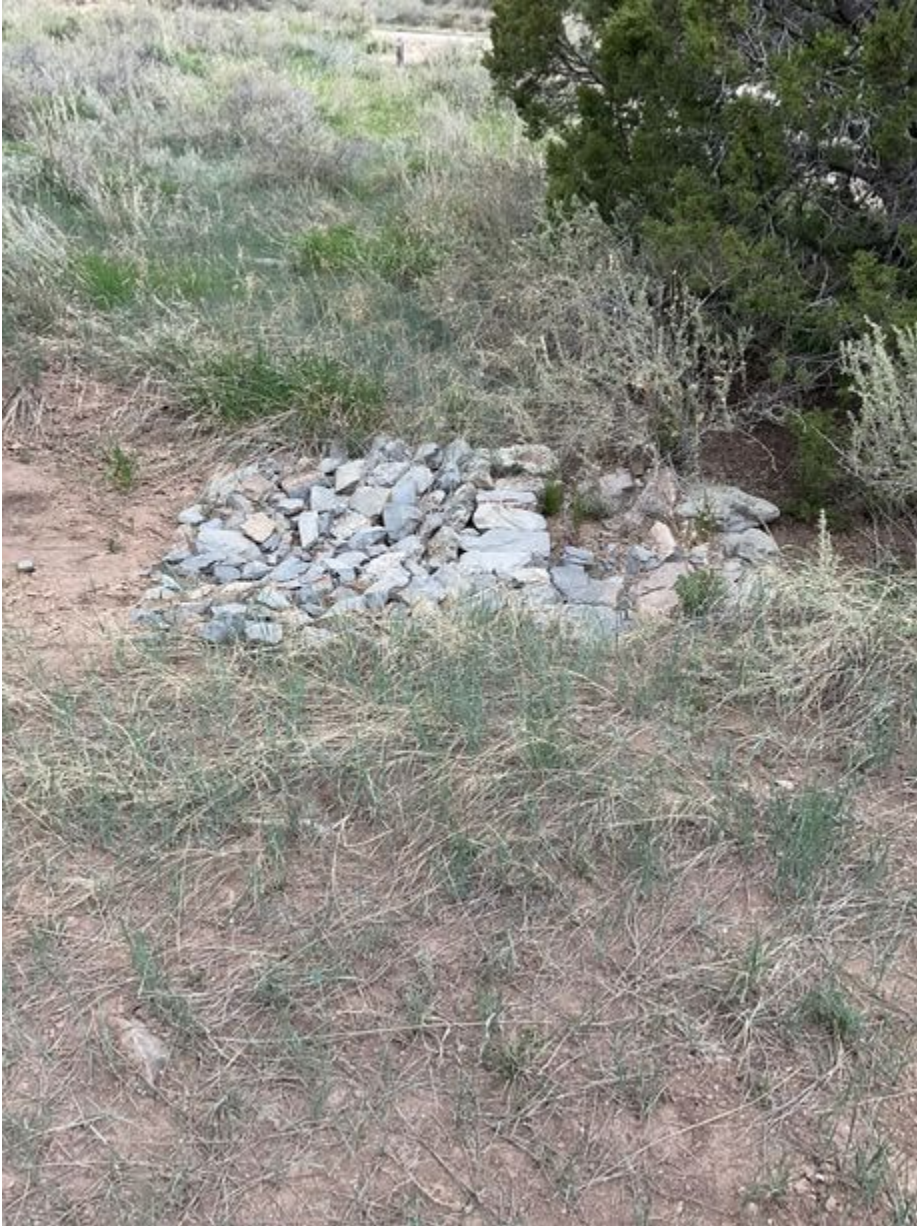
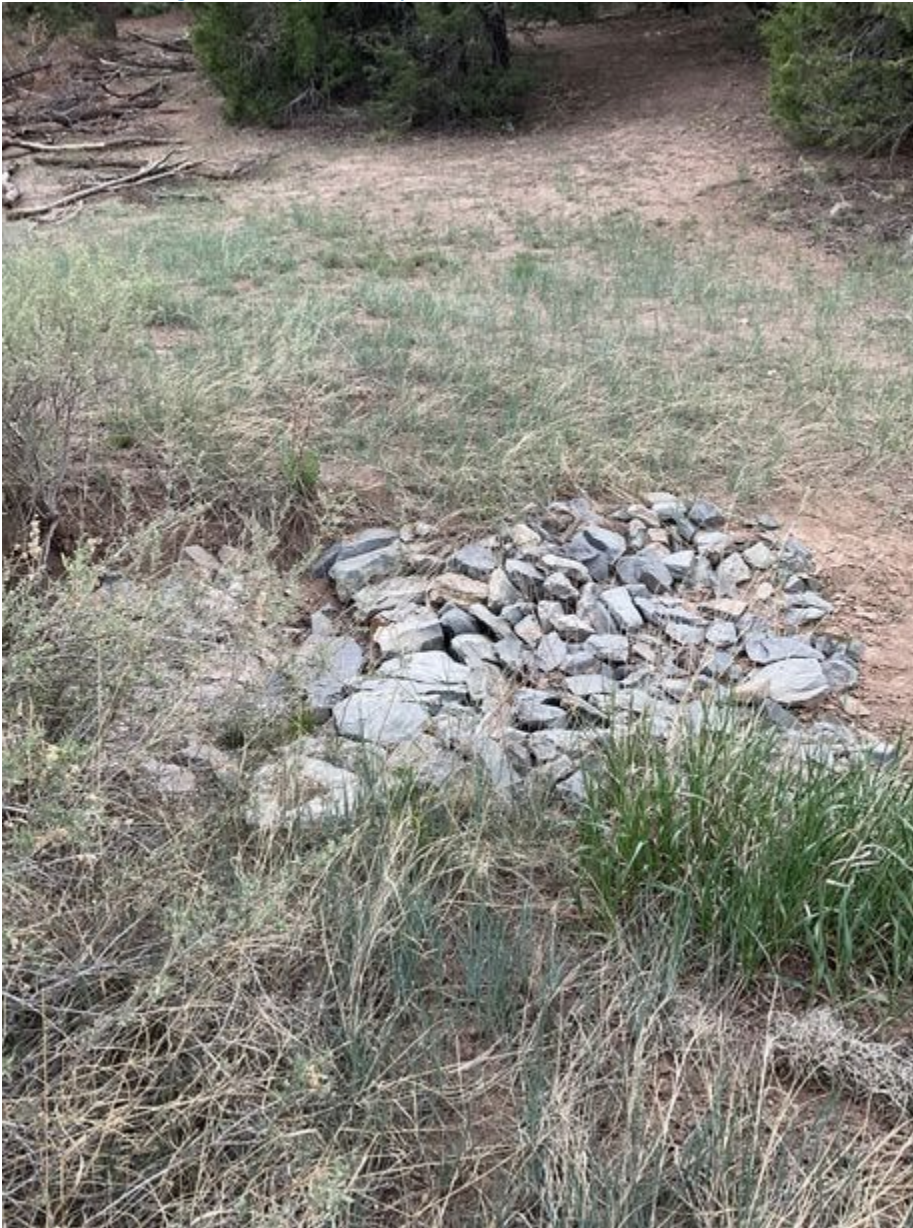
All rocks intact

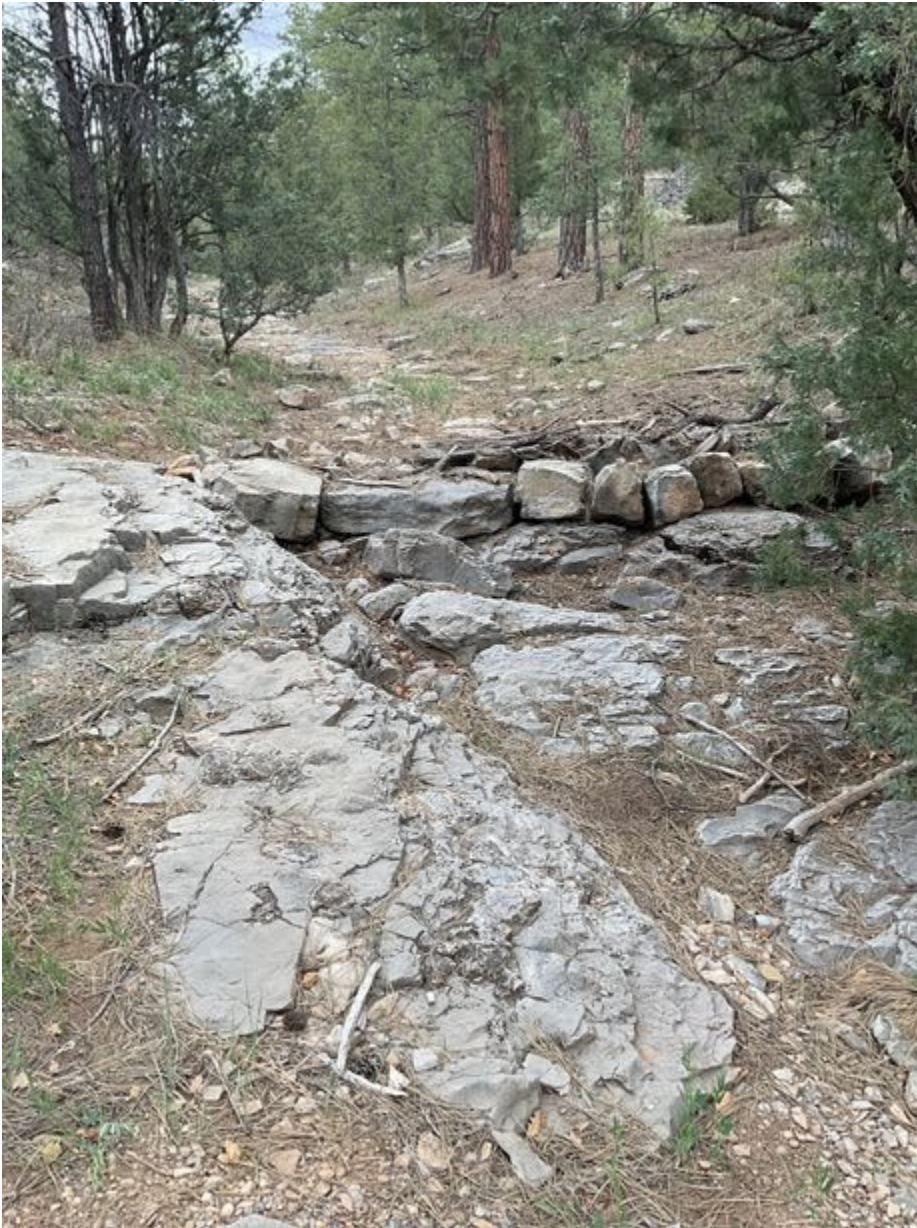
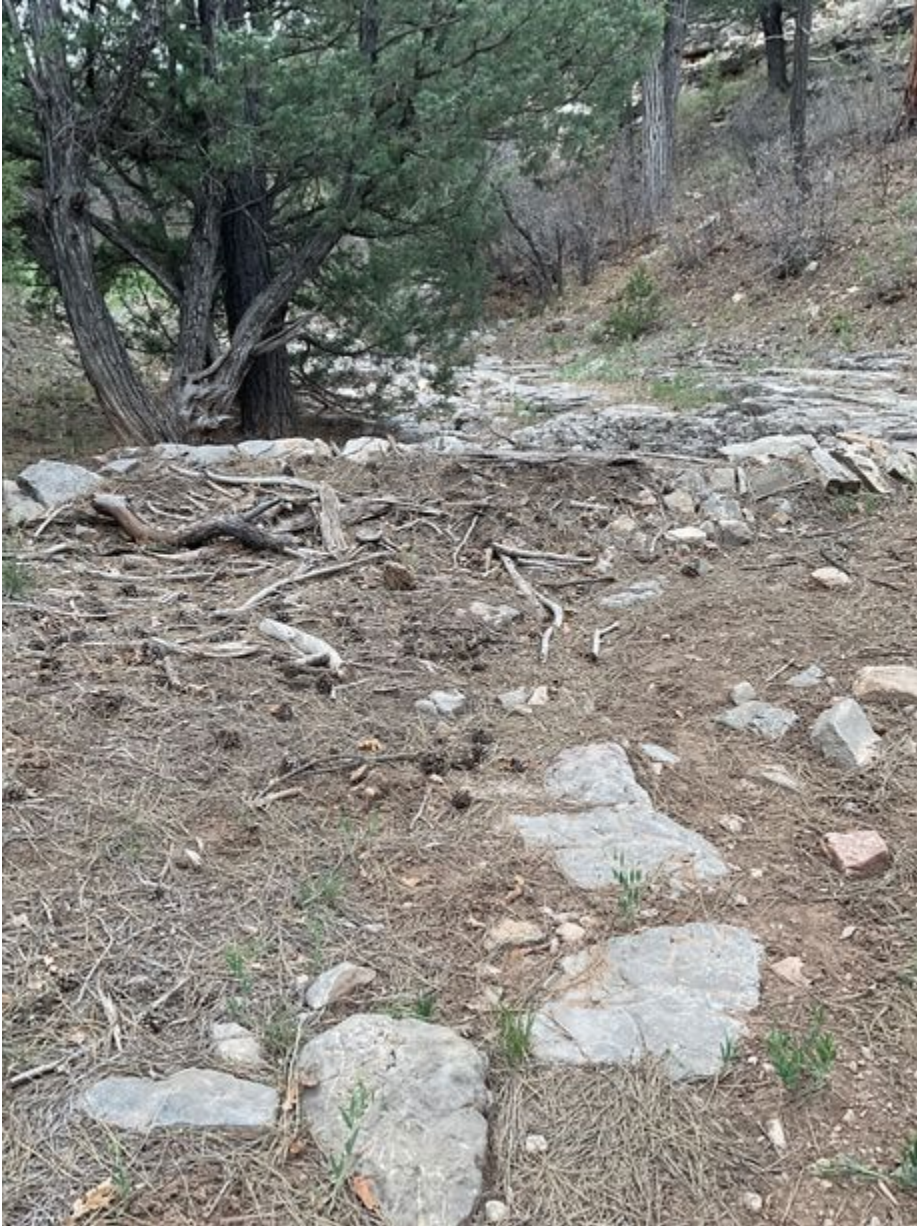
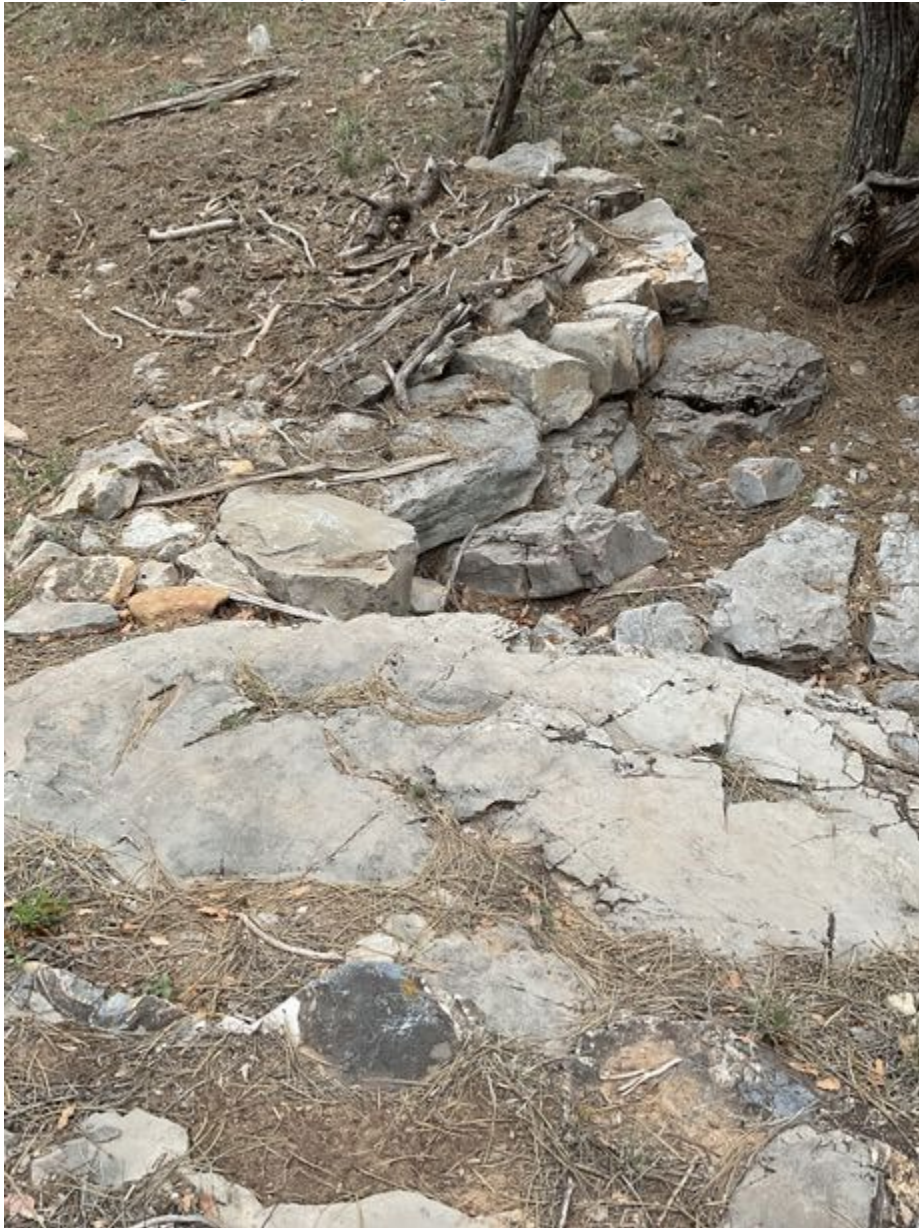
All rocks intact

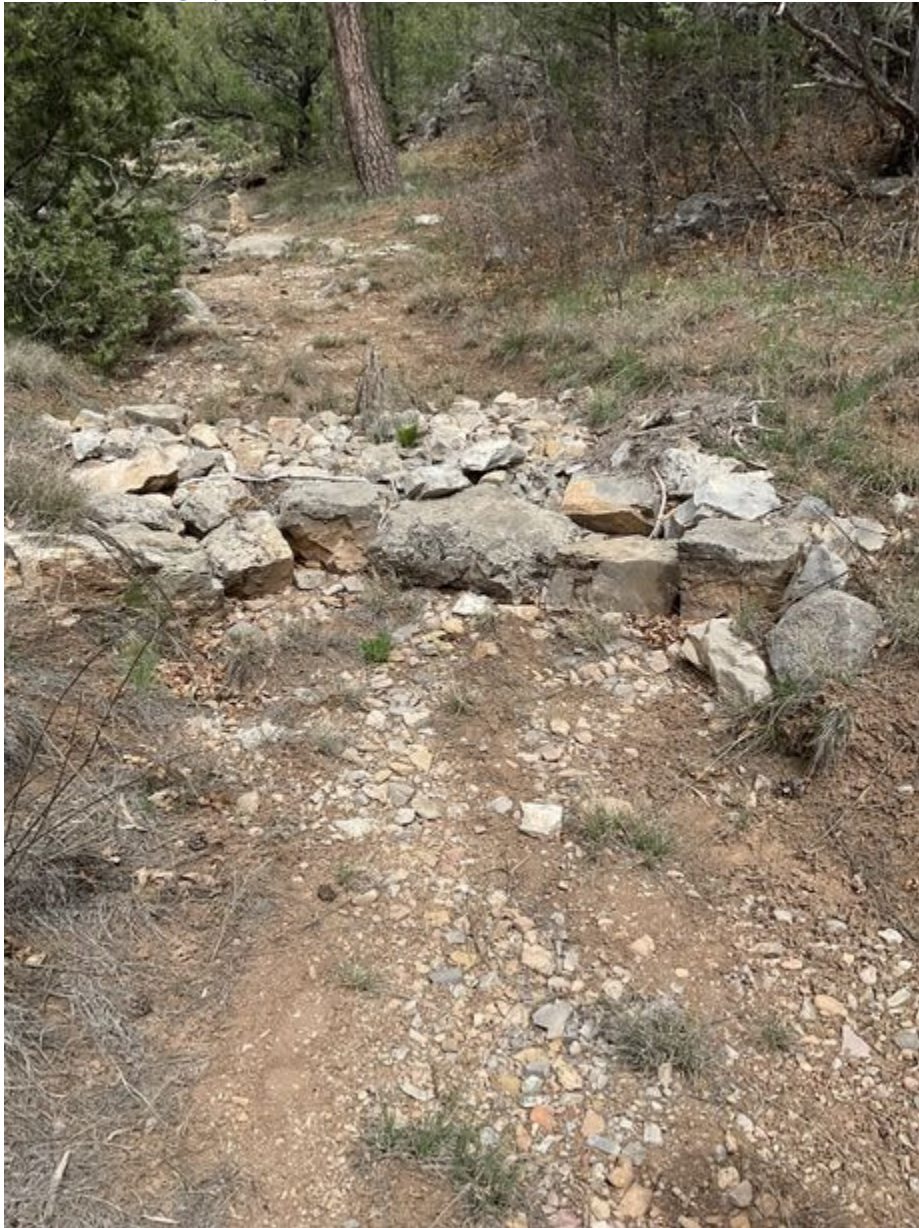
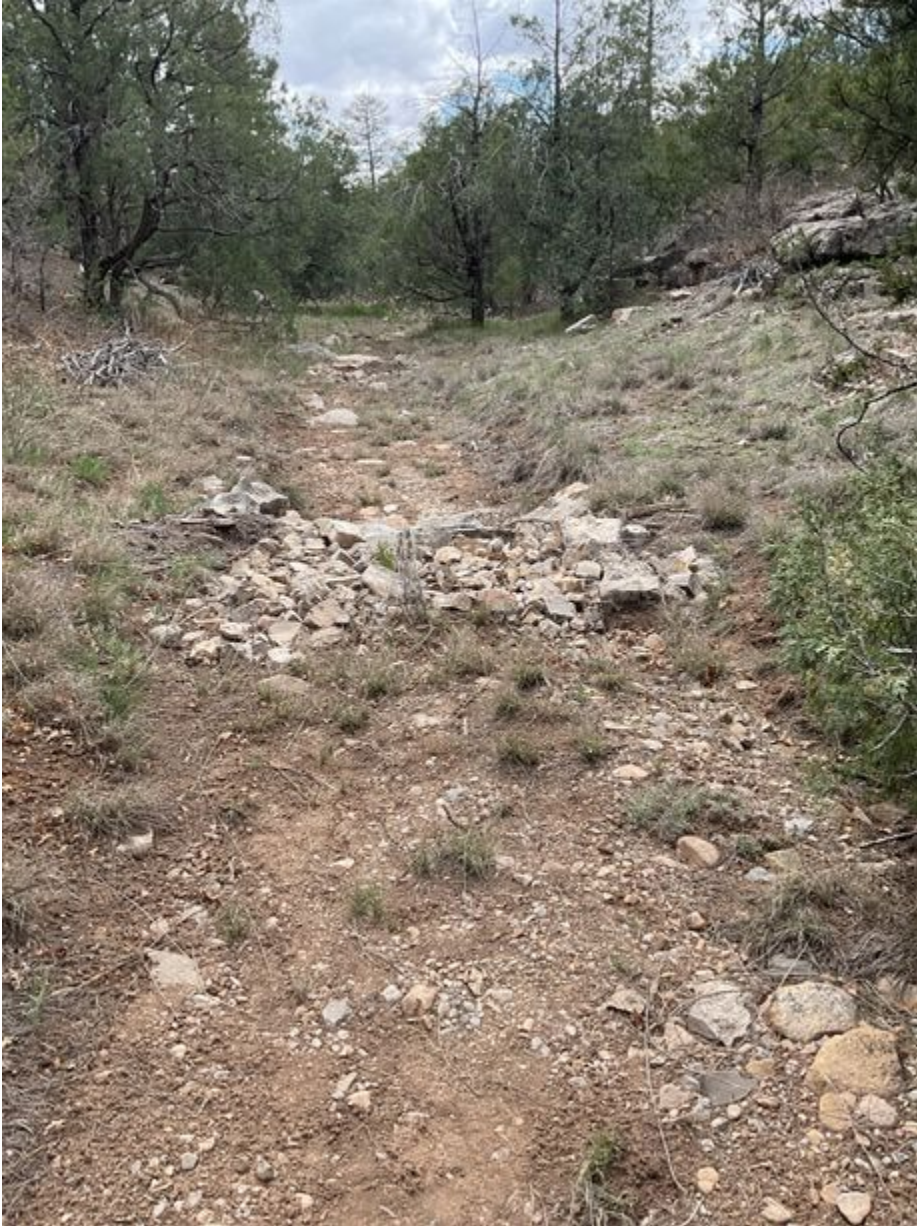
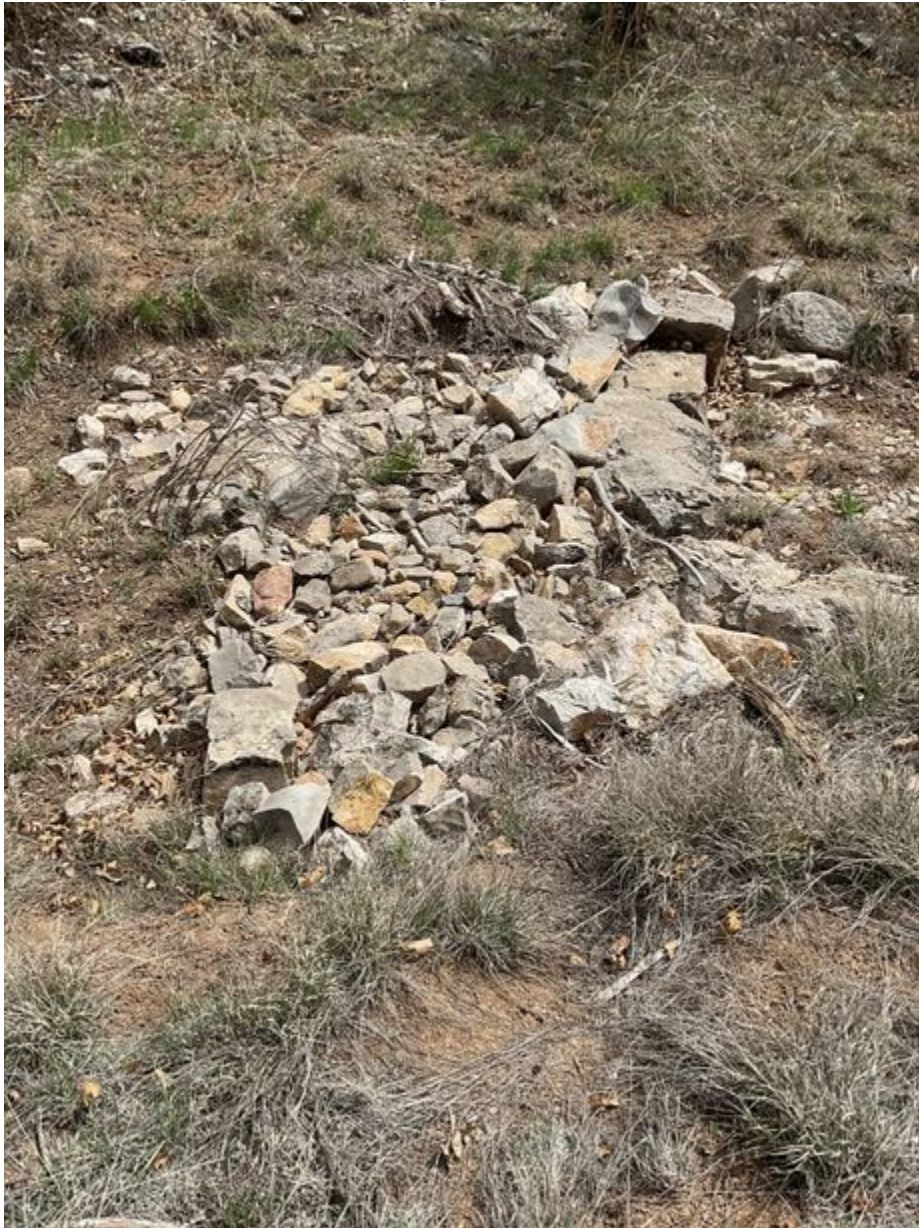
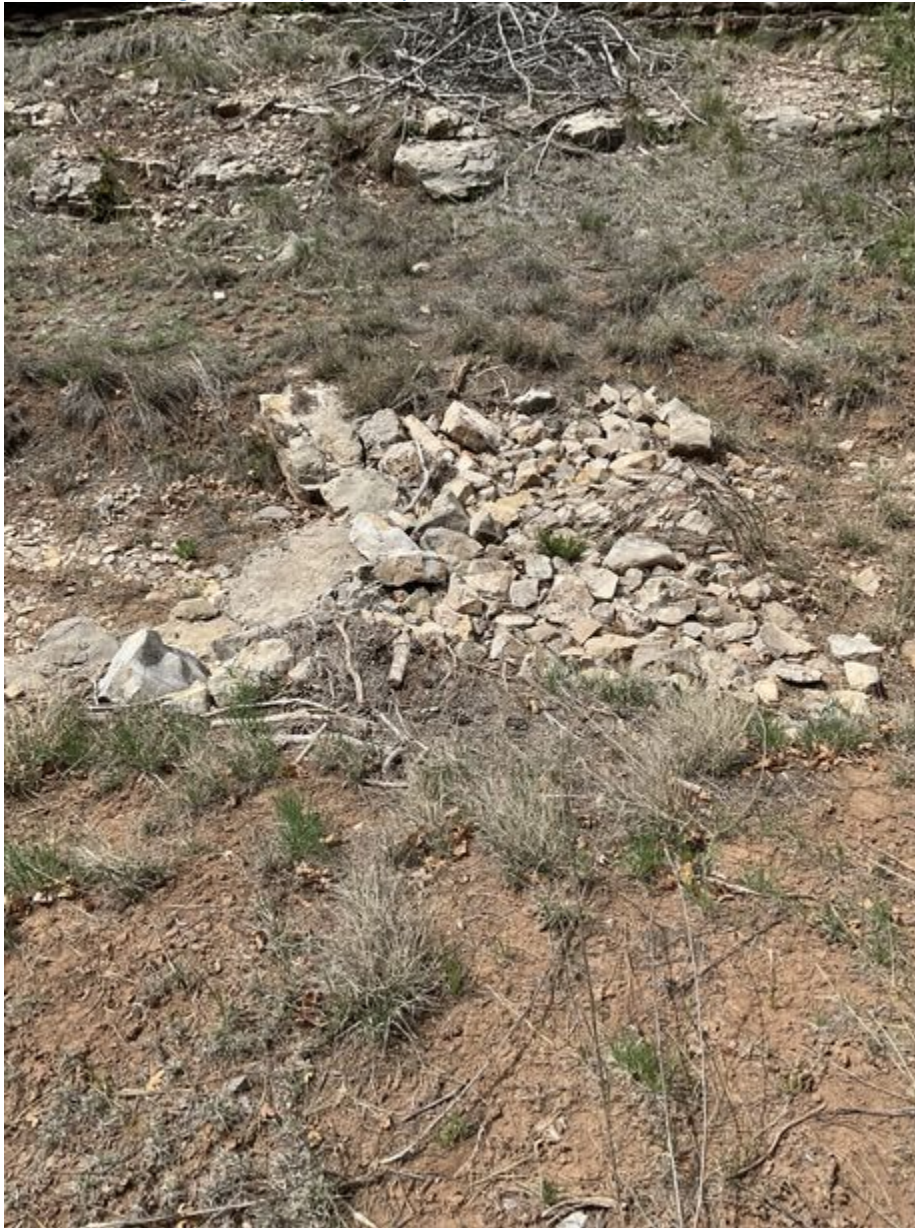
All rocks intact

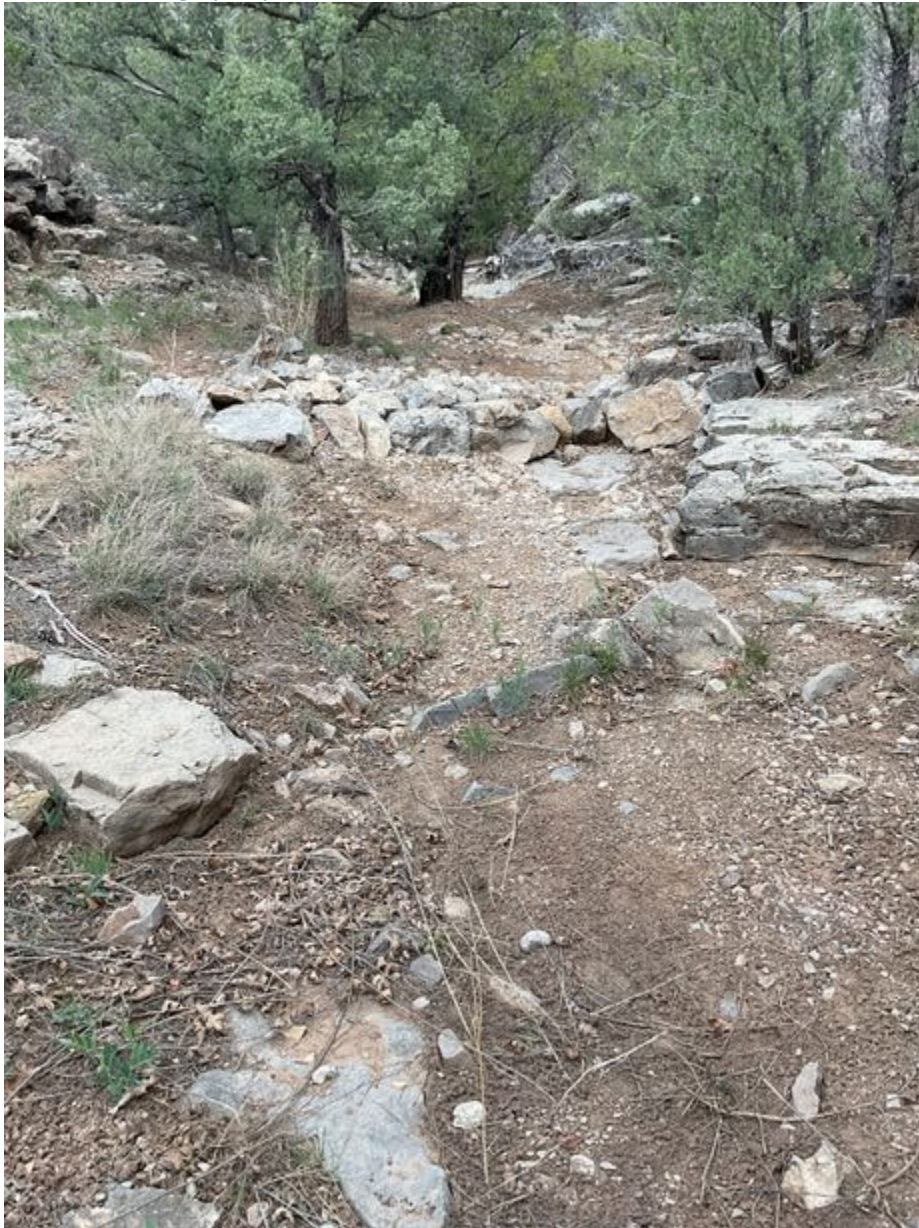
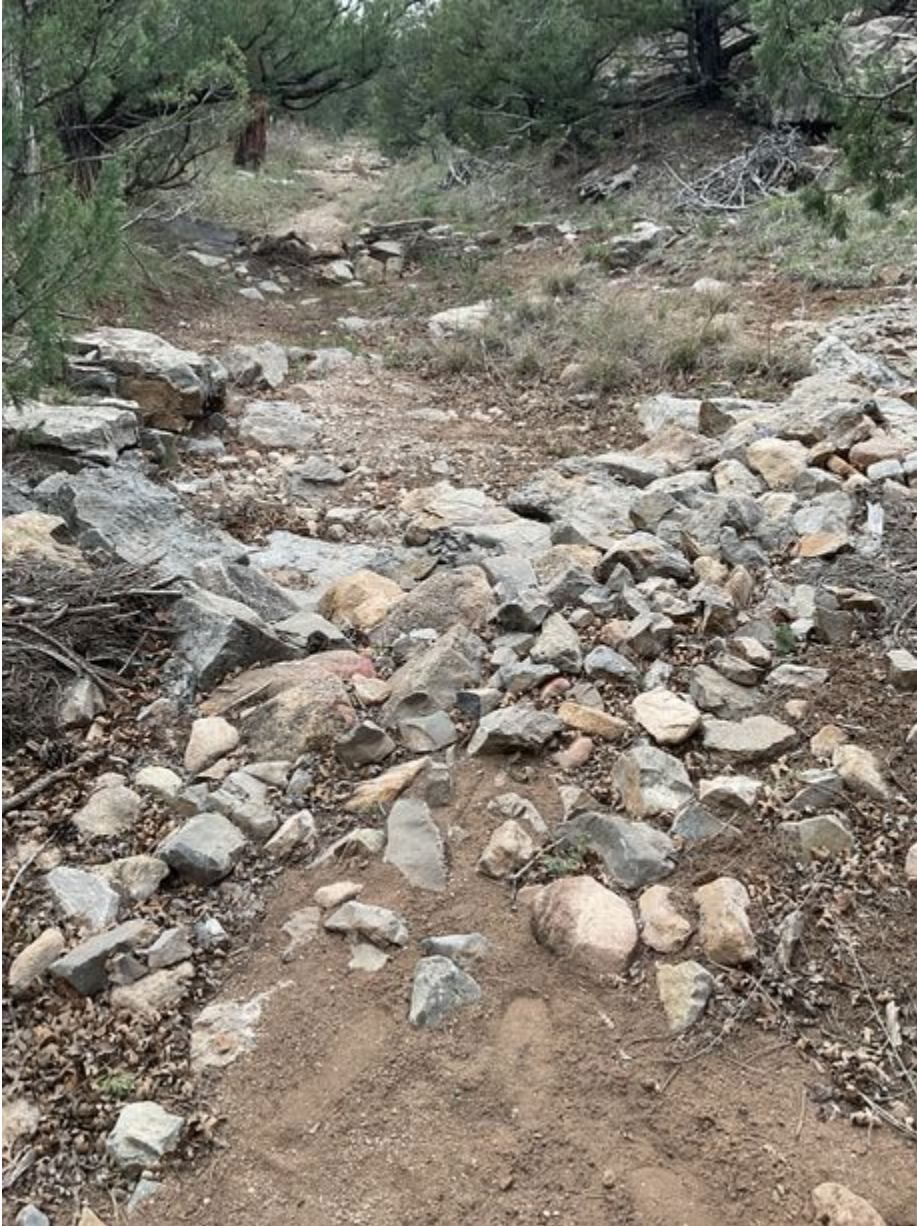
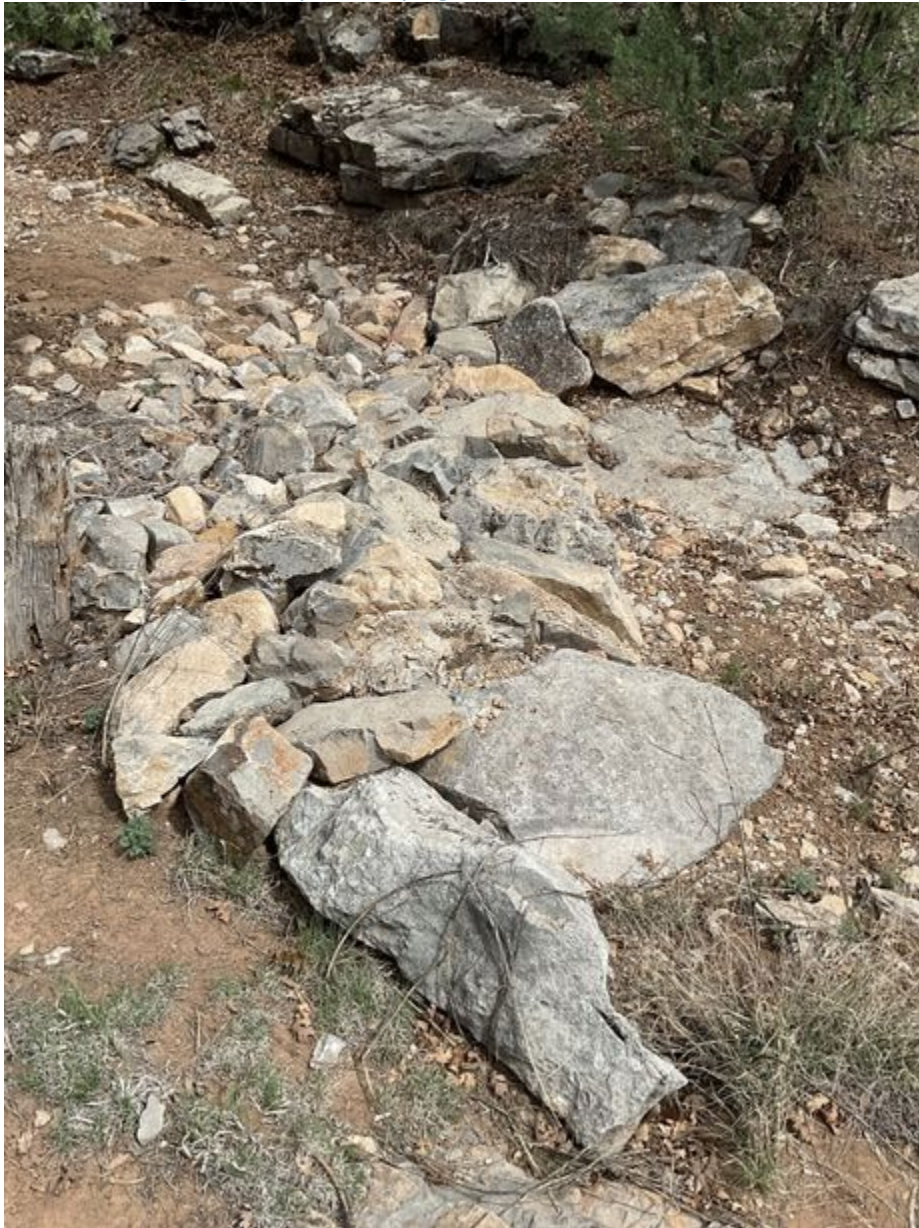
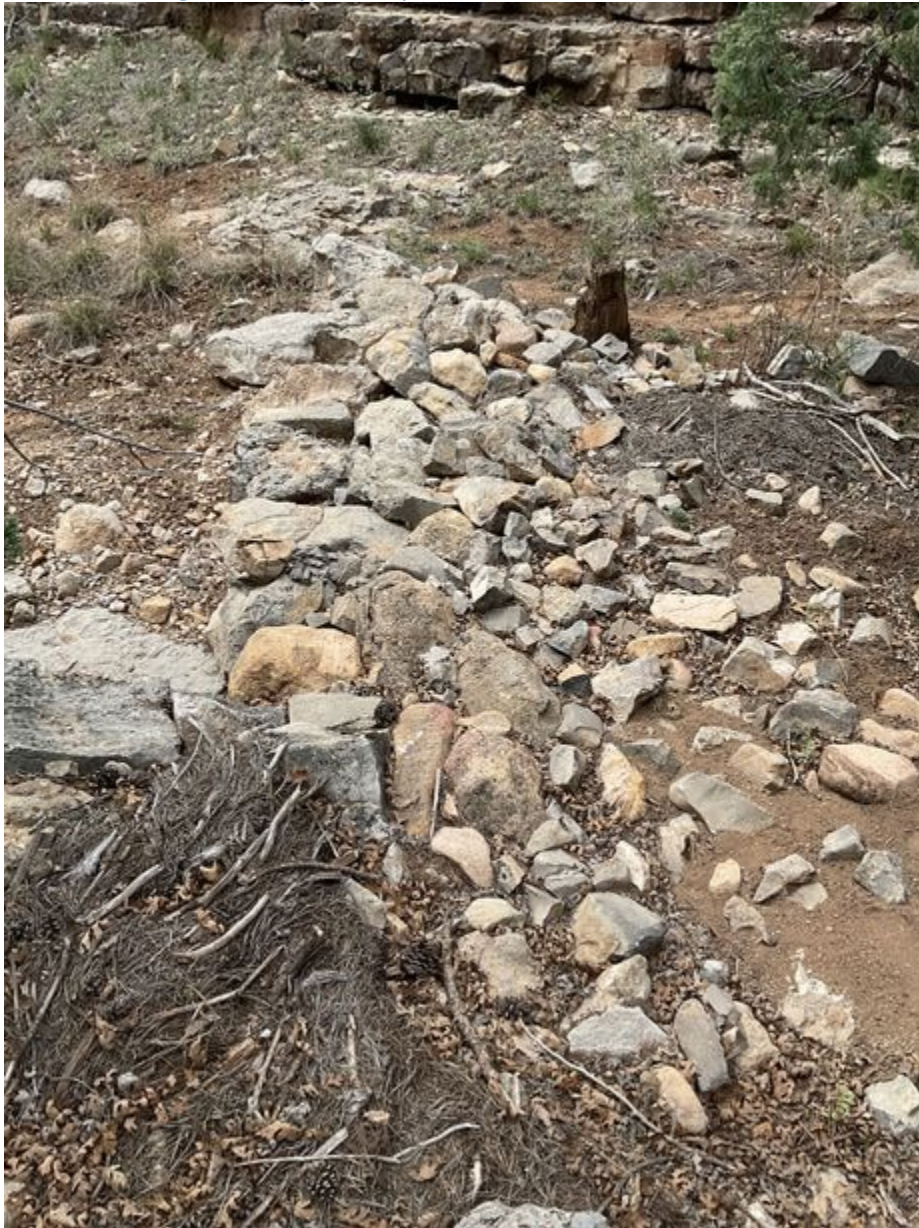
All rocks intact

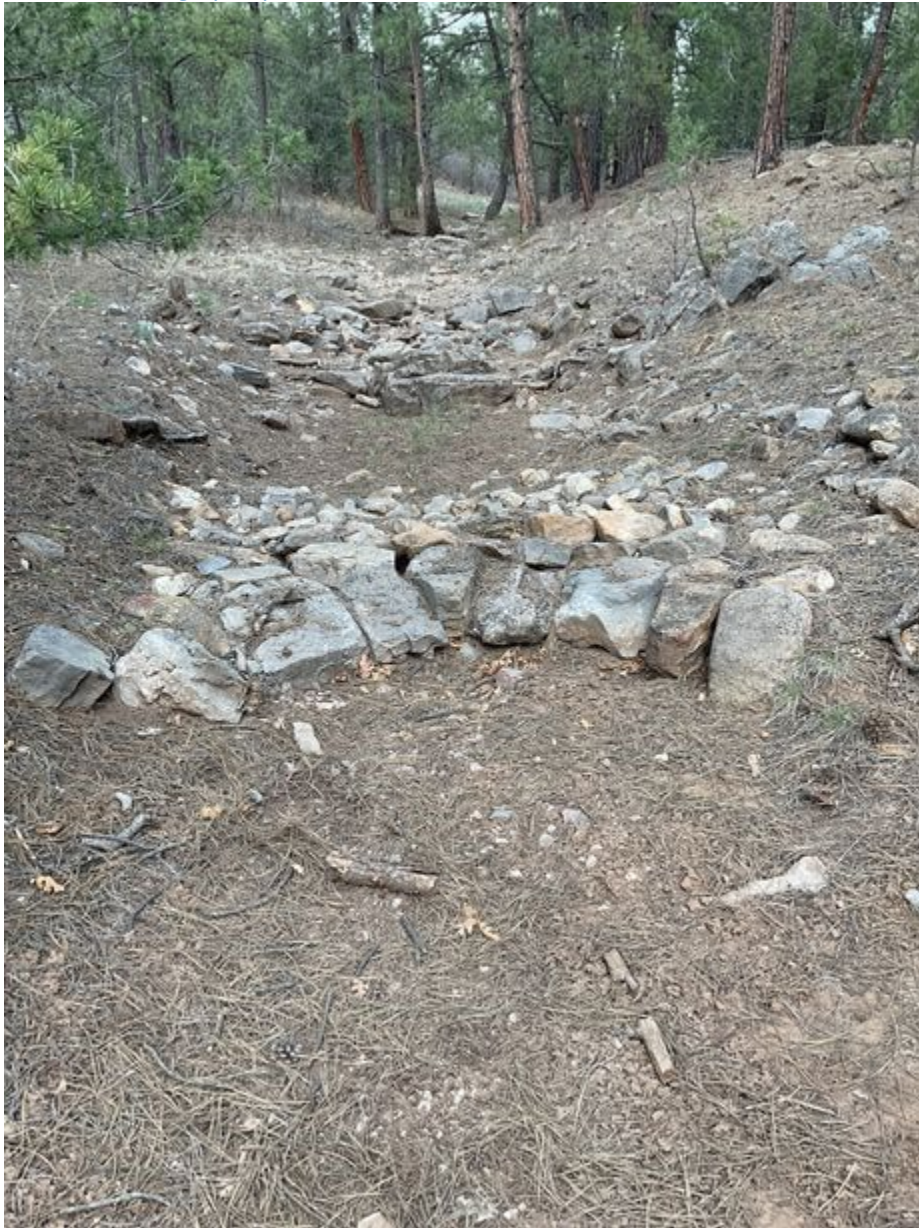
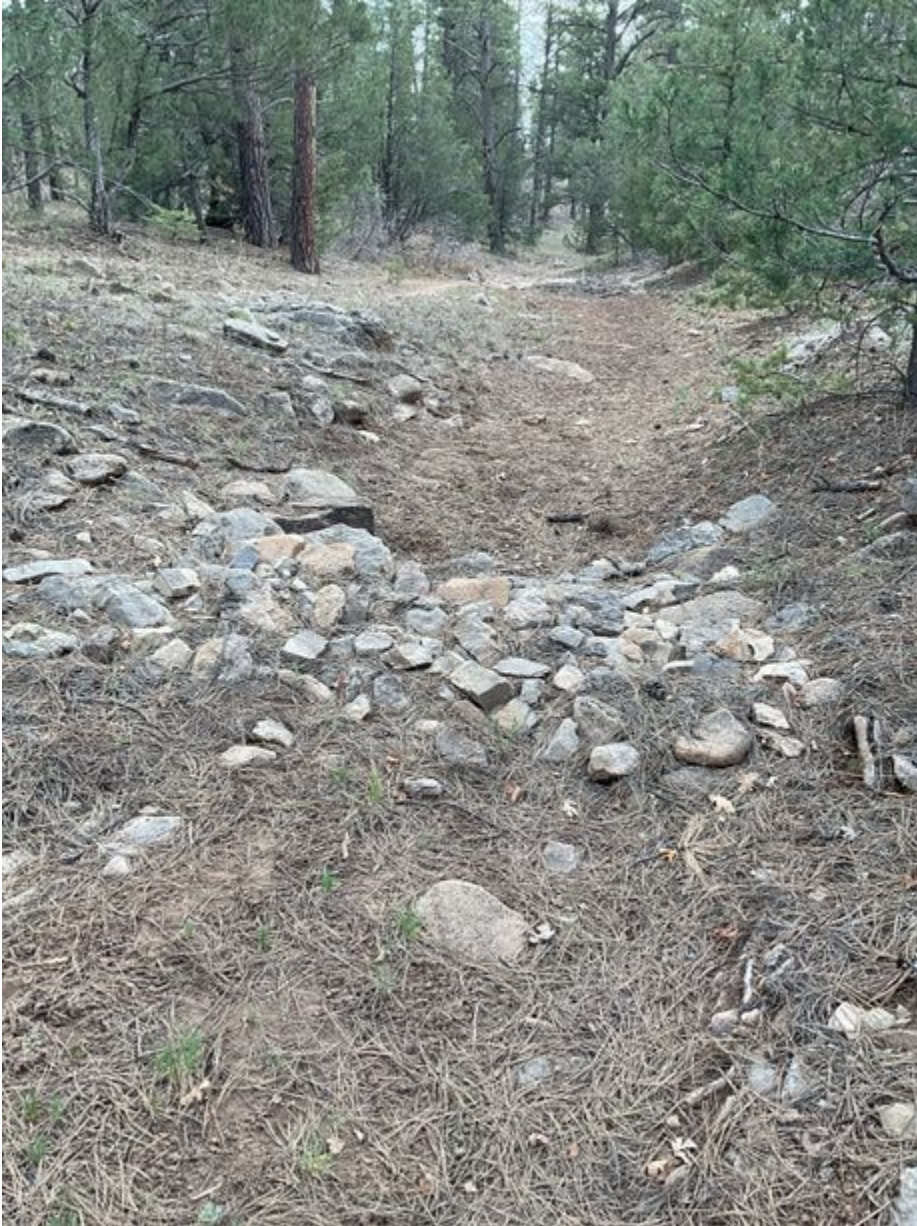
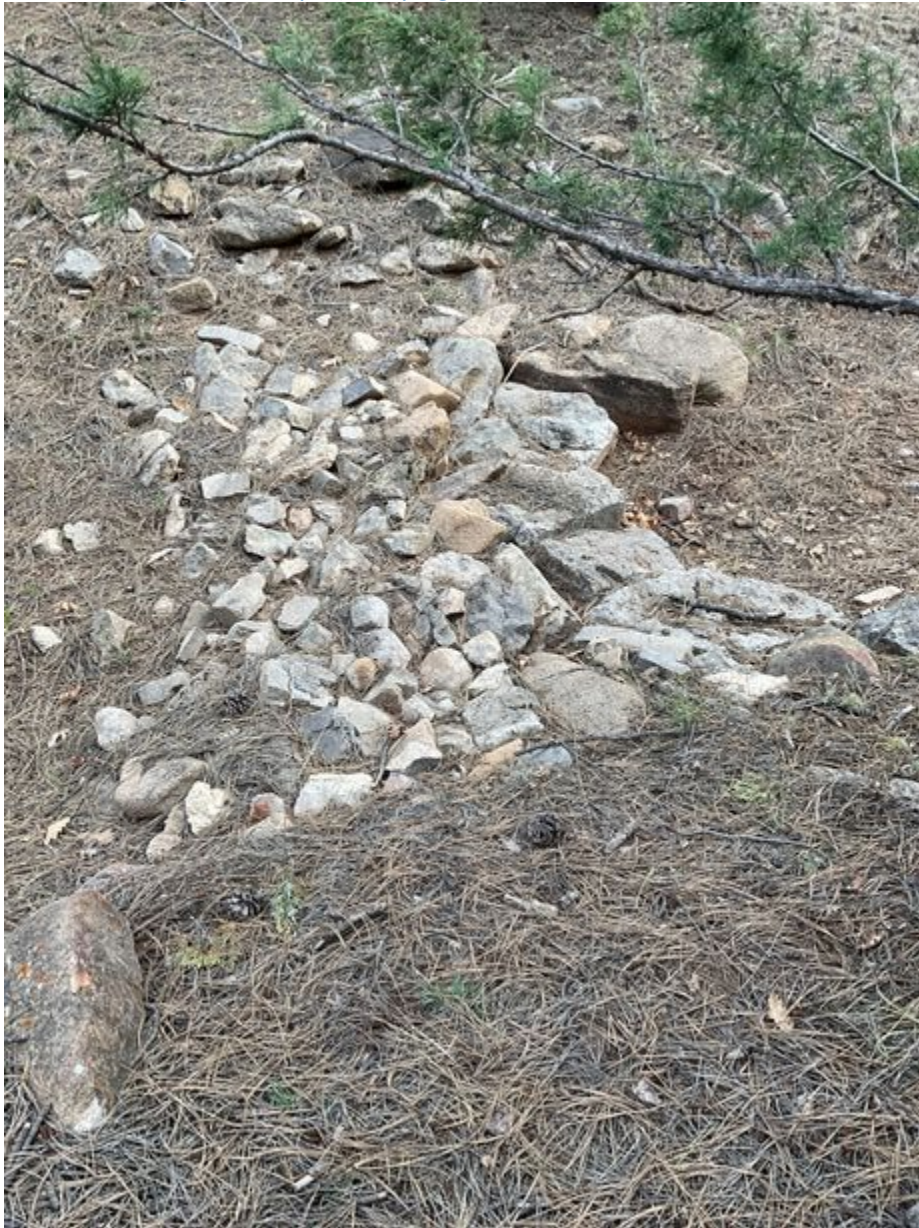
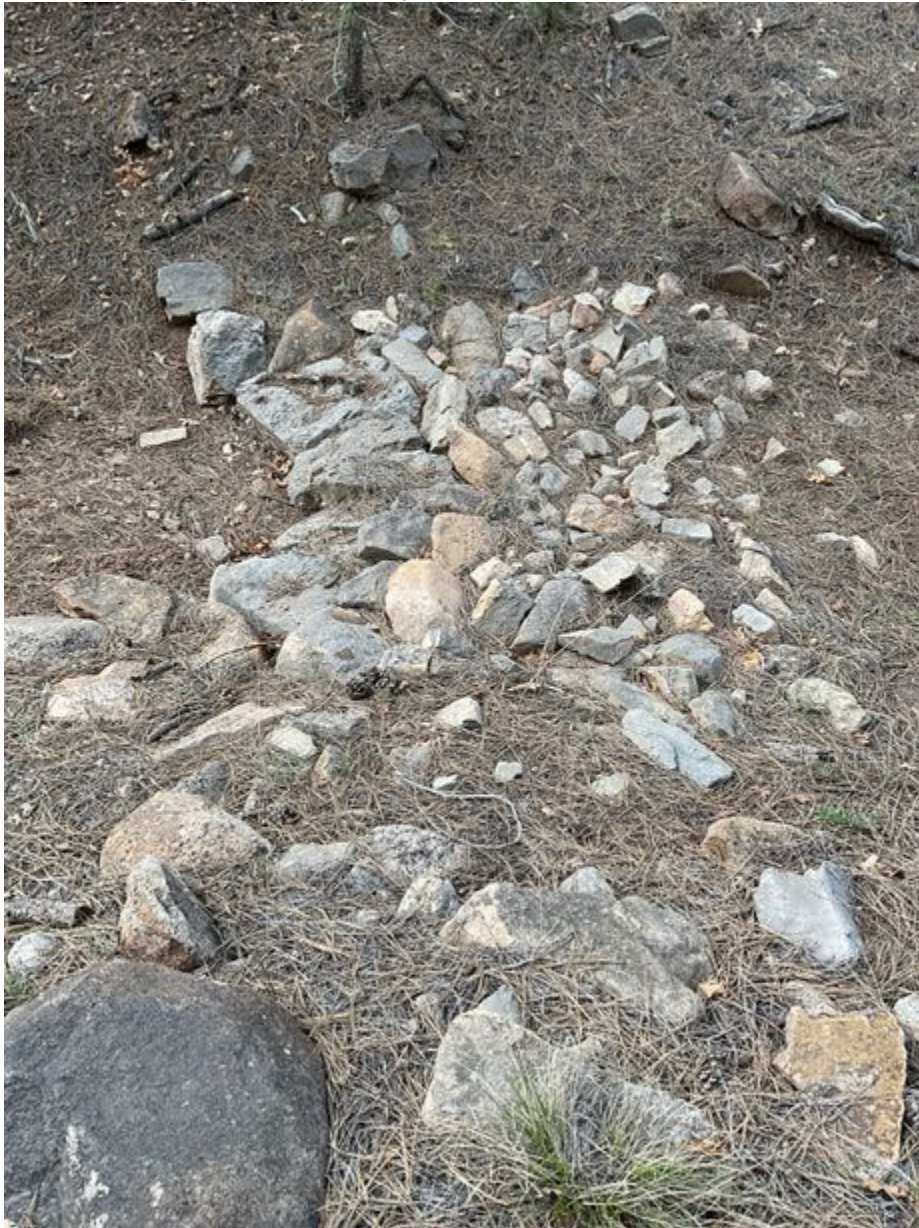
All rocks intact
