CN R924060

**Zuni Bowl and One Rock Check Dam Research –
Phase 1**

Final Report

Rio Grande Return for the New Mexico Department of Transportation Research Bureau

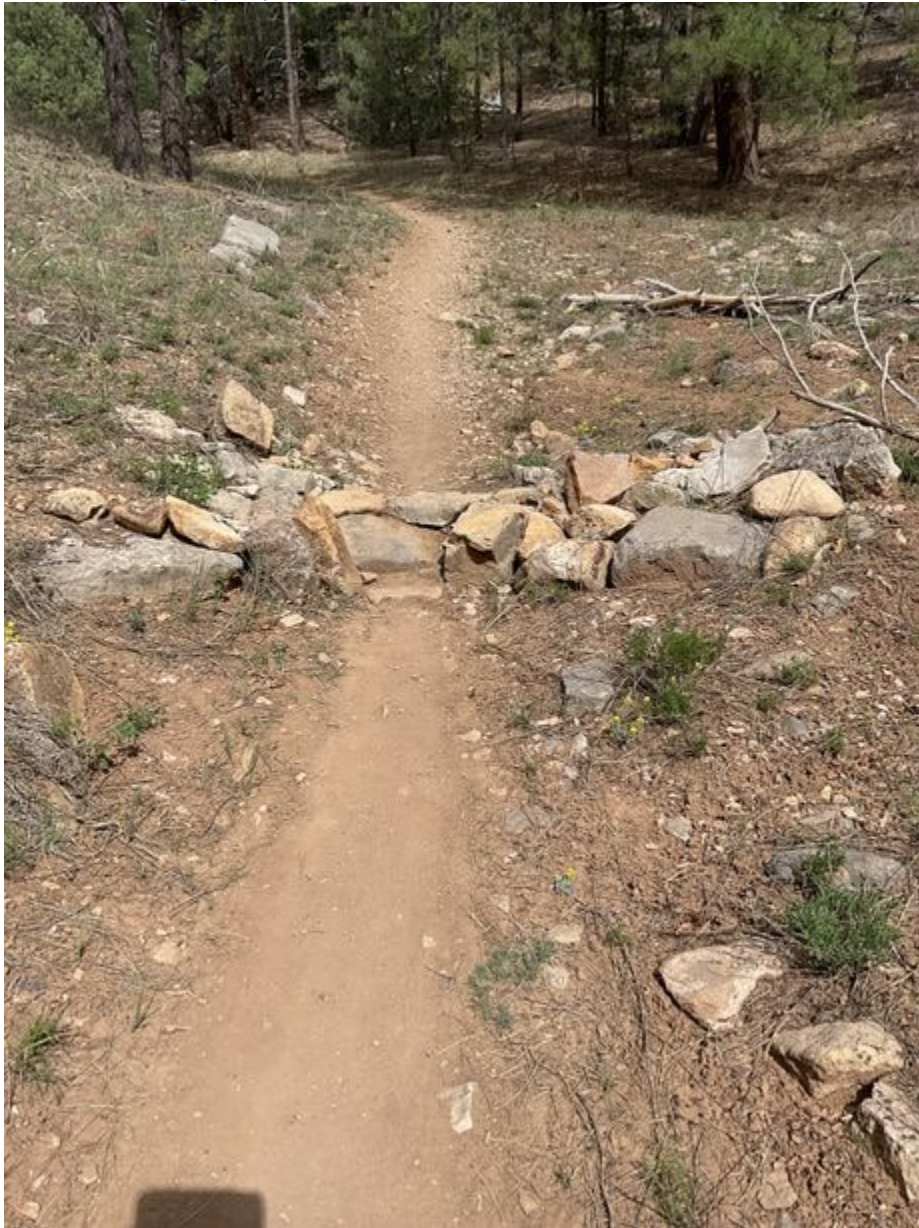
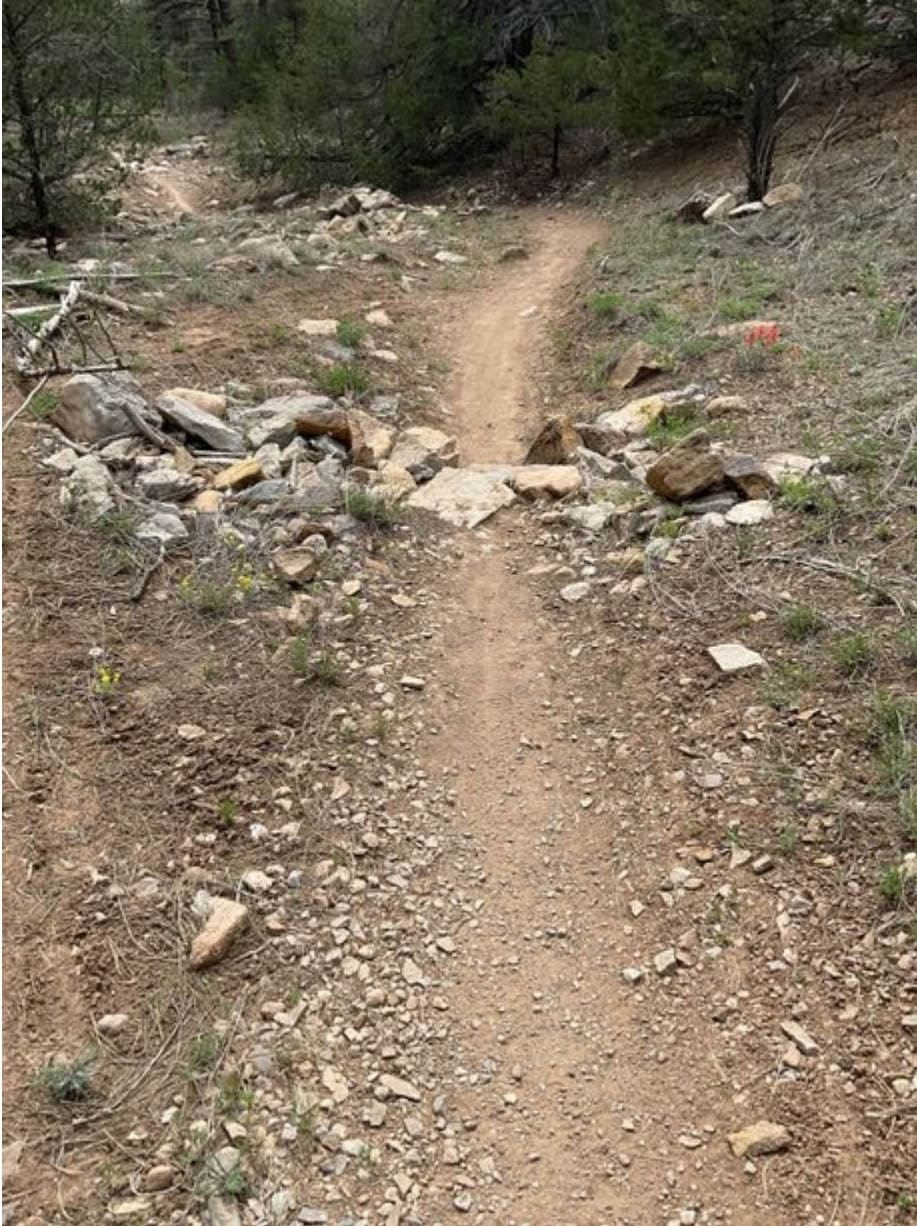
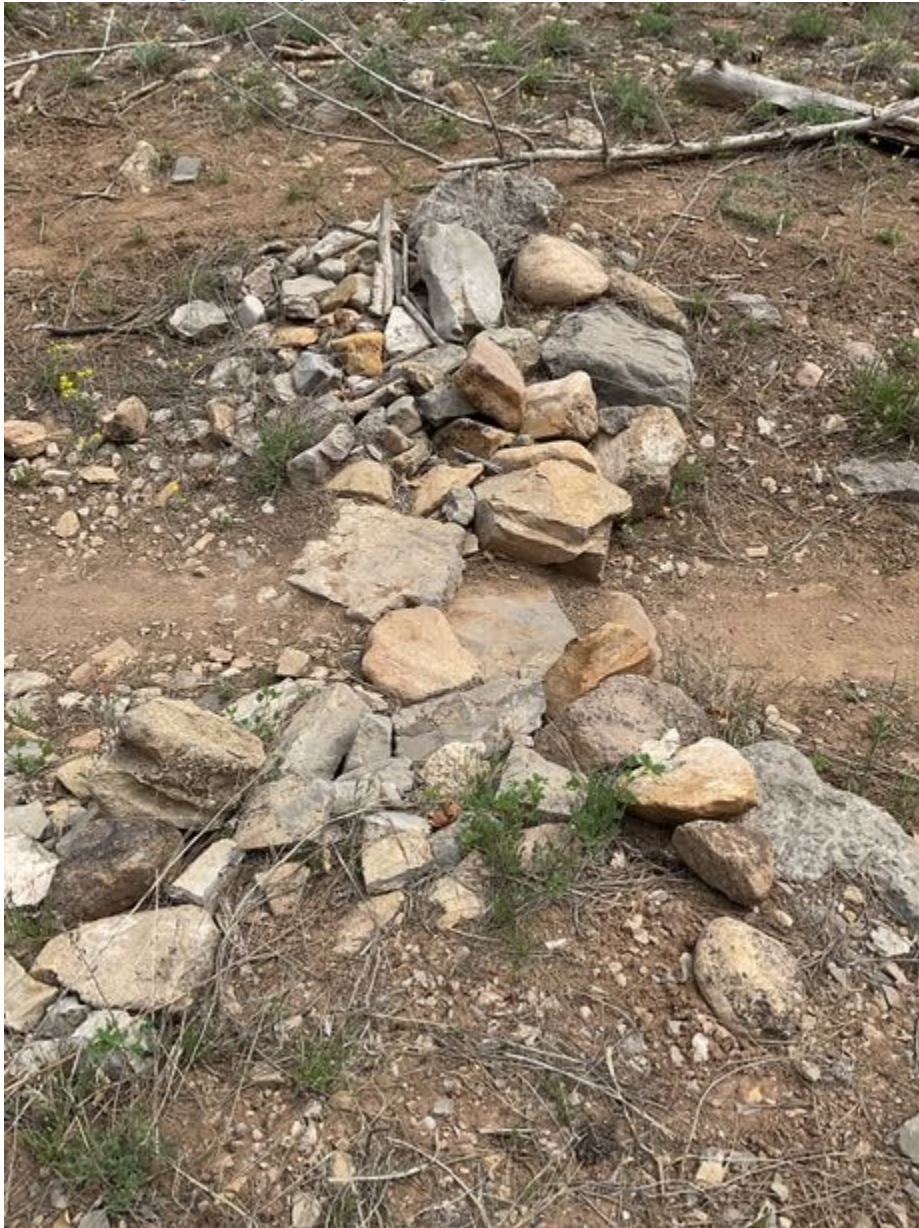
Some rocks dislodged or broken

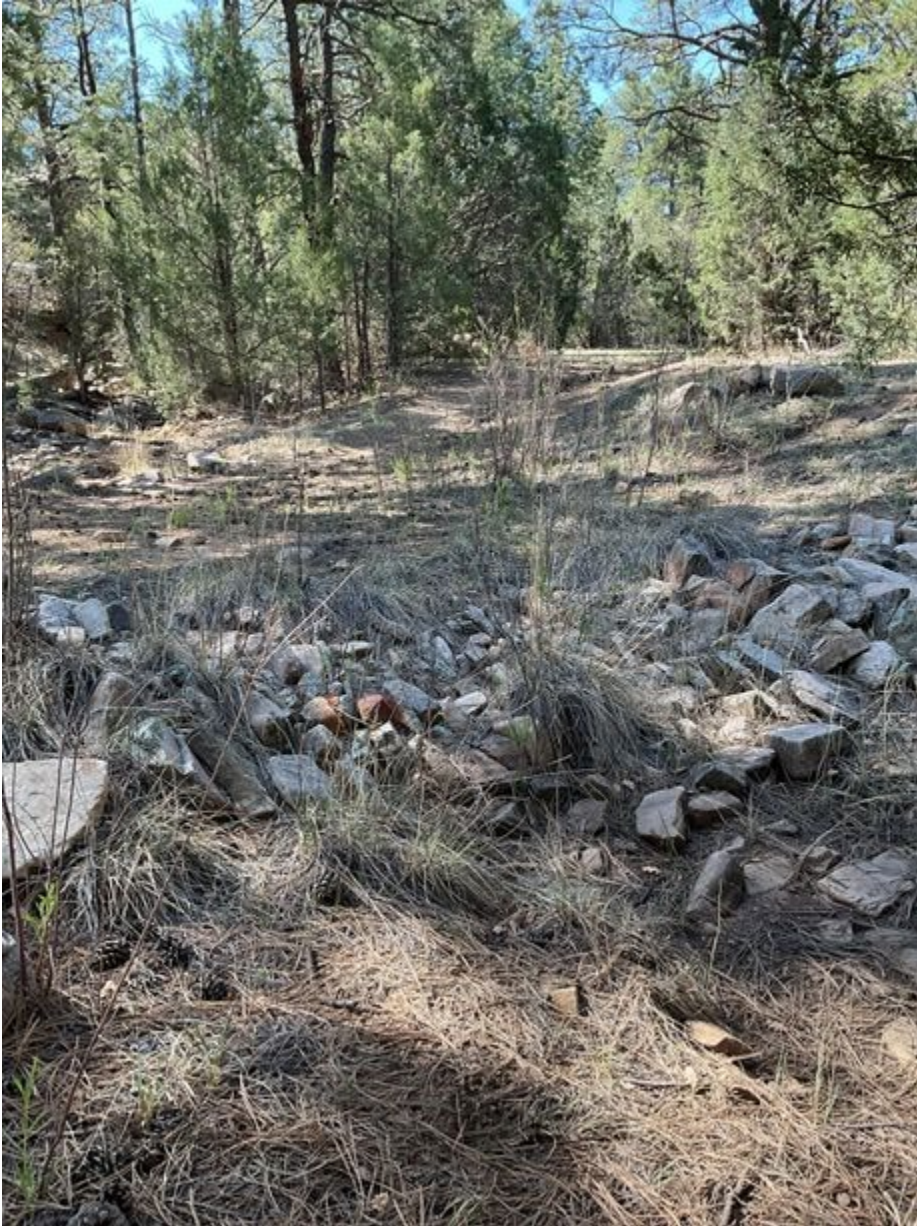
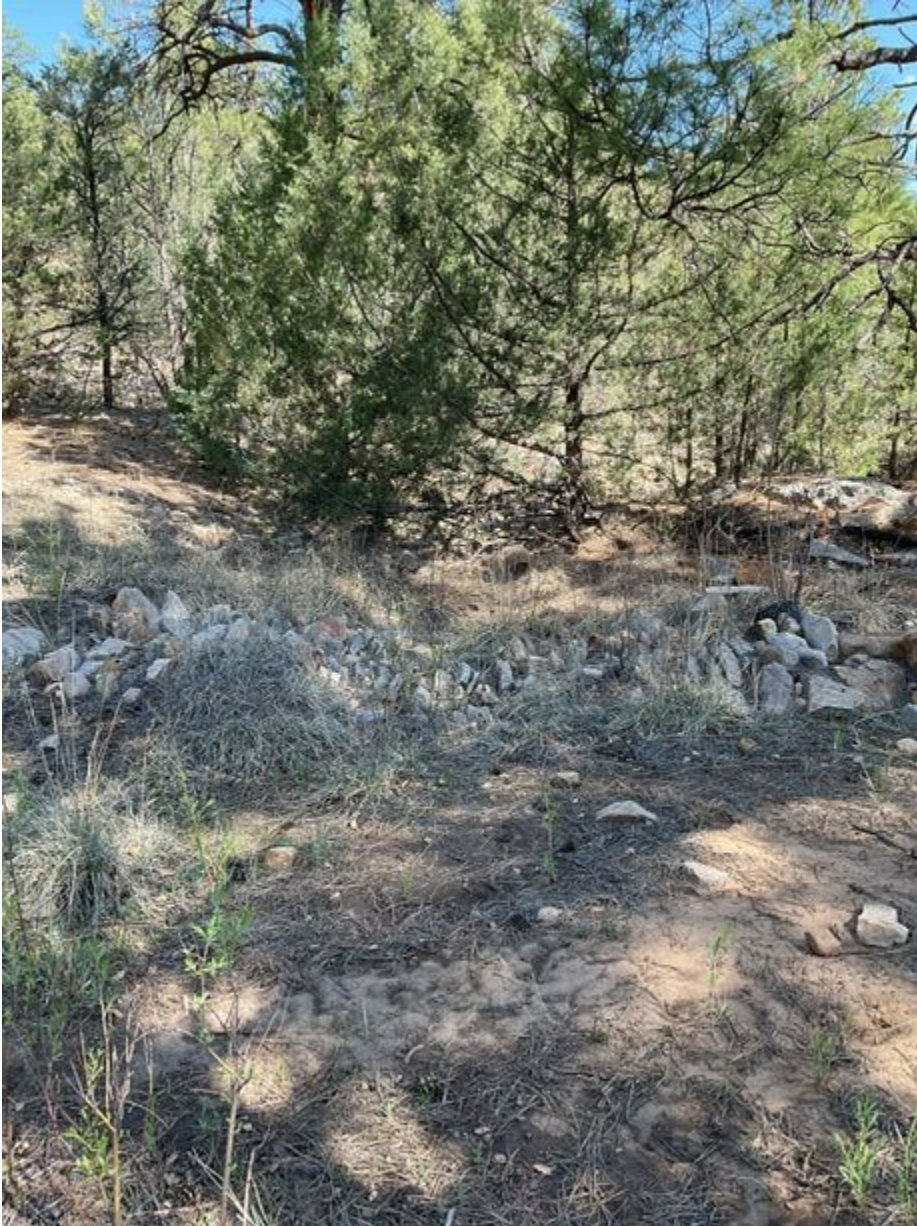
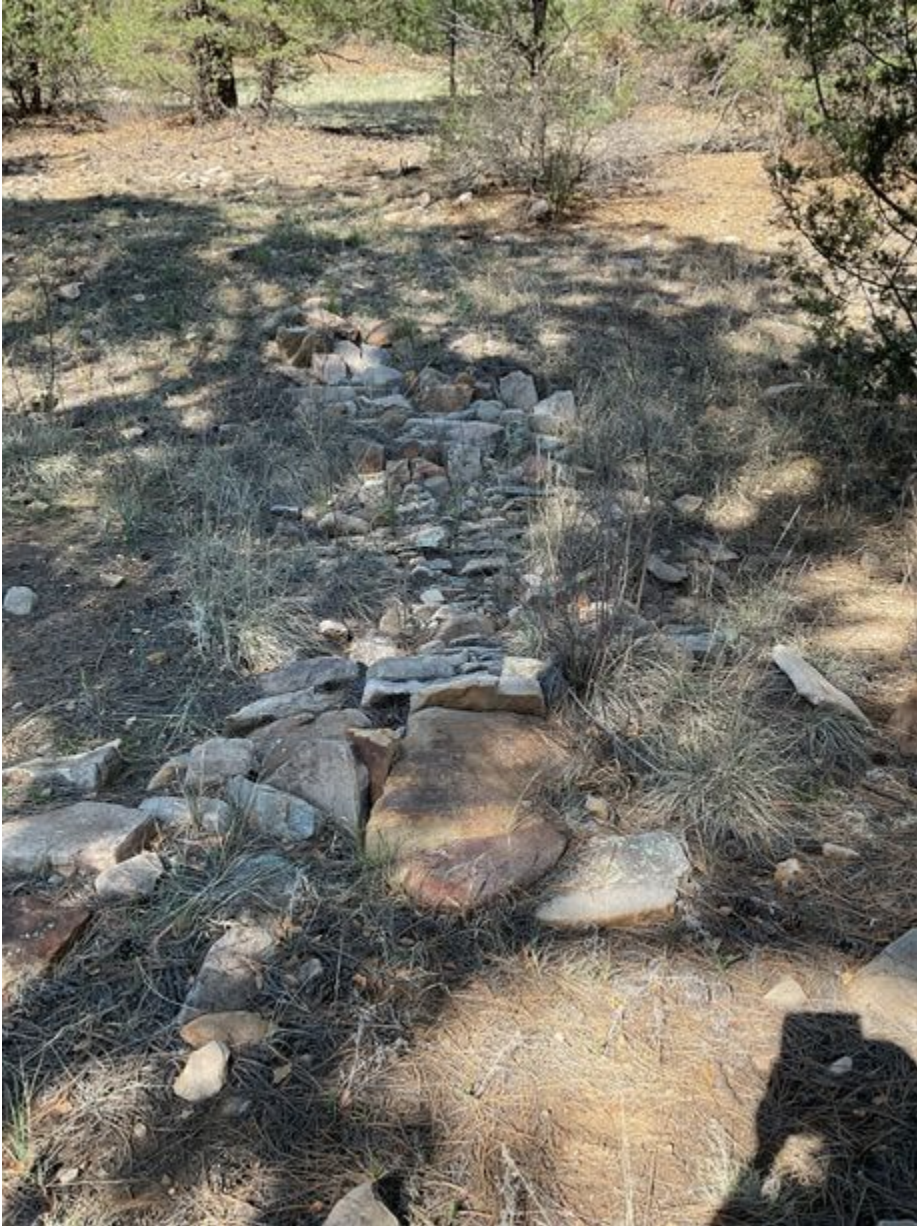
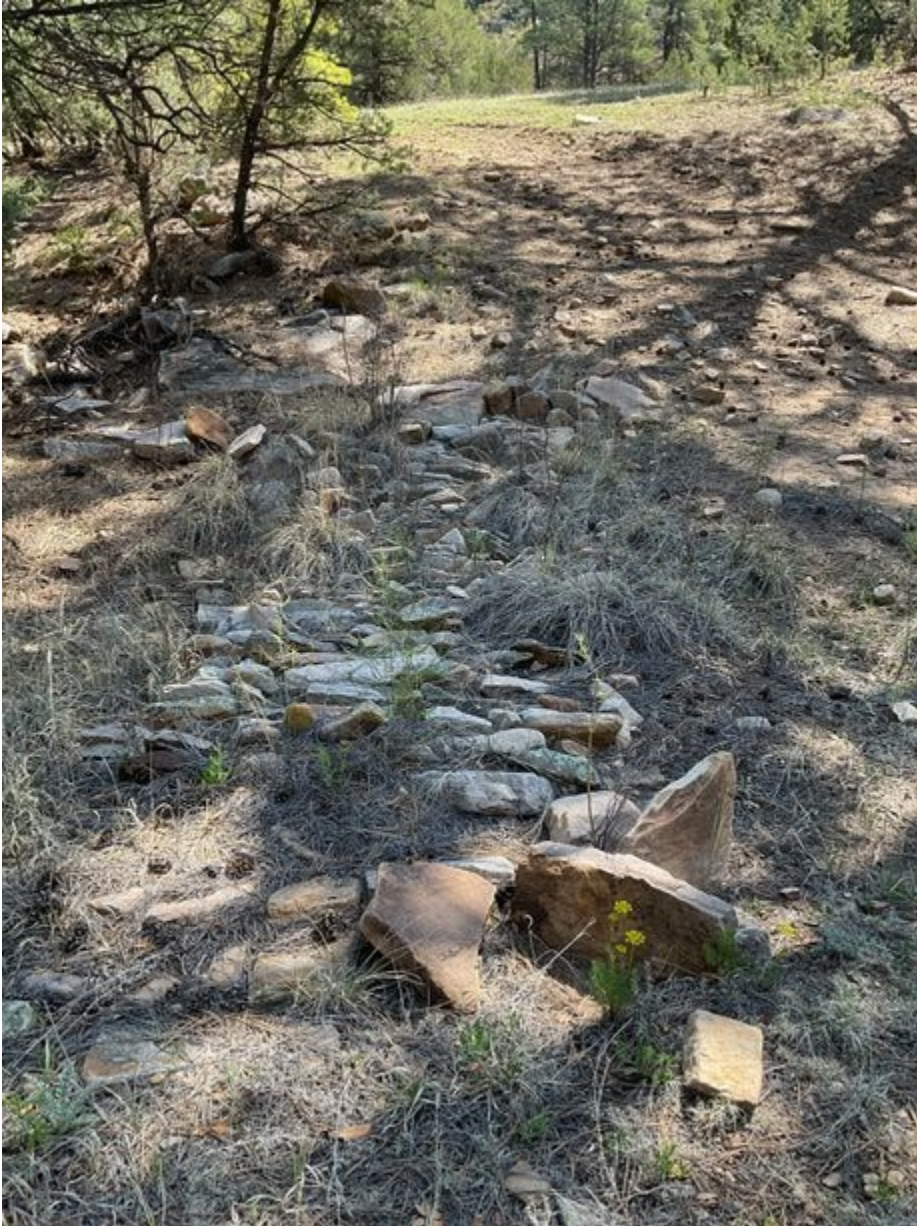
All rocks intact

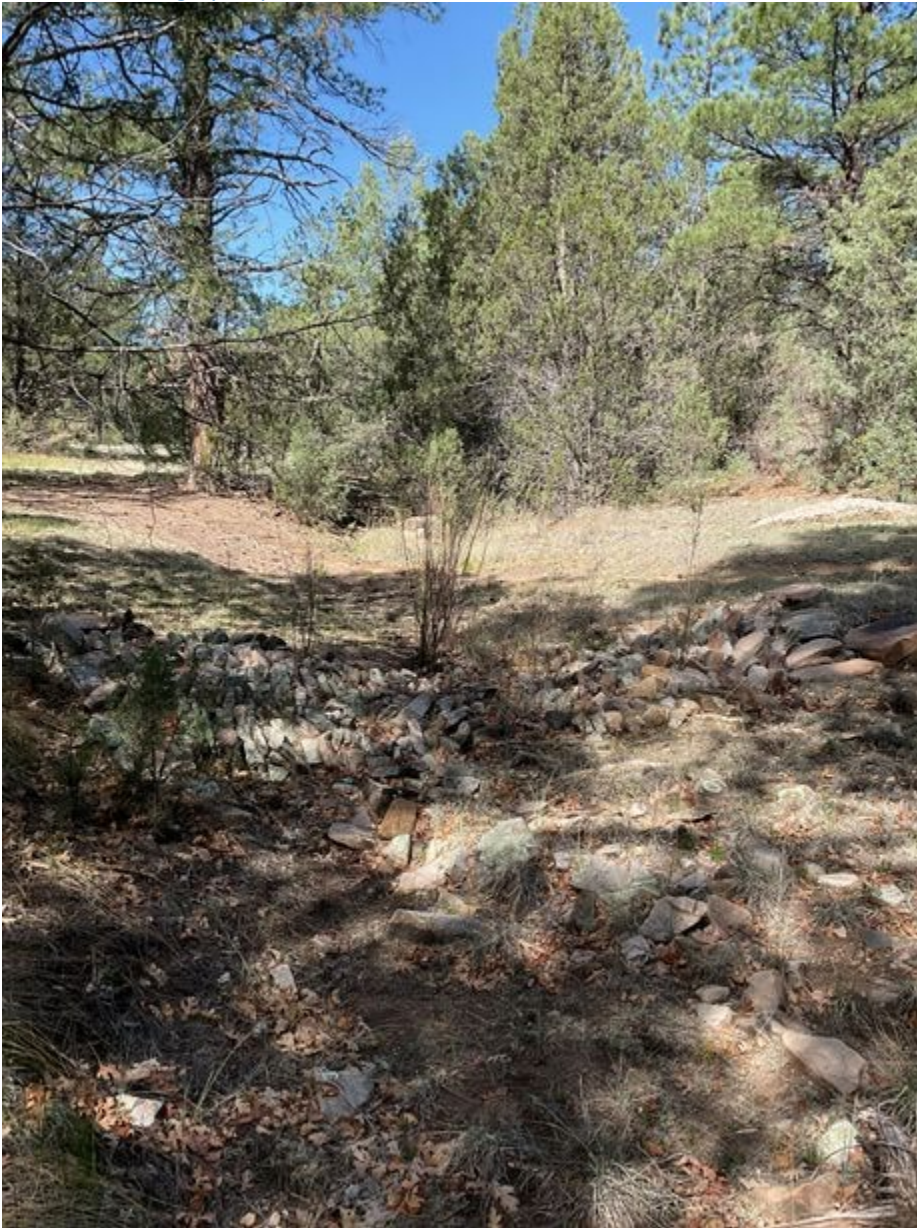
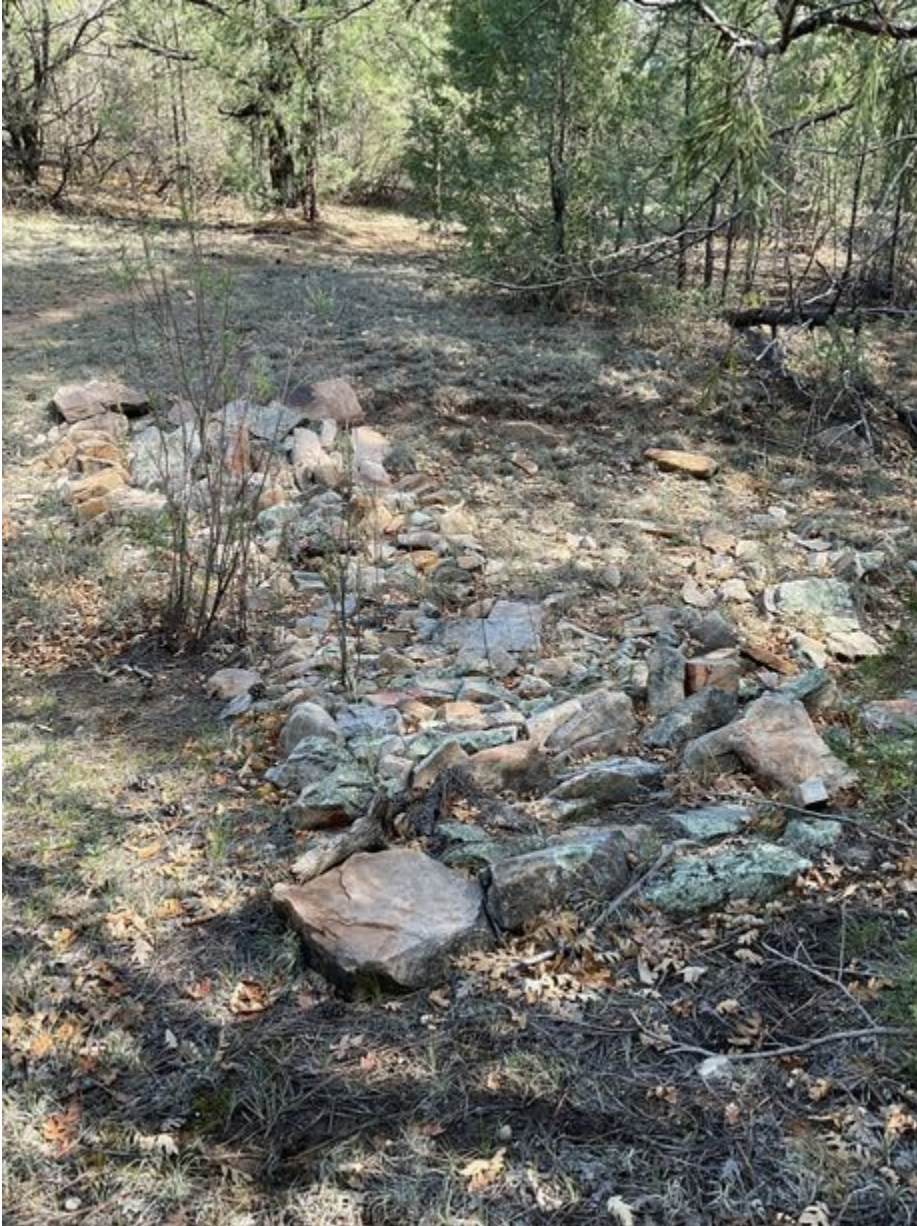
Some rocks dislodged or broken

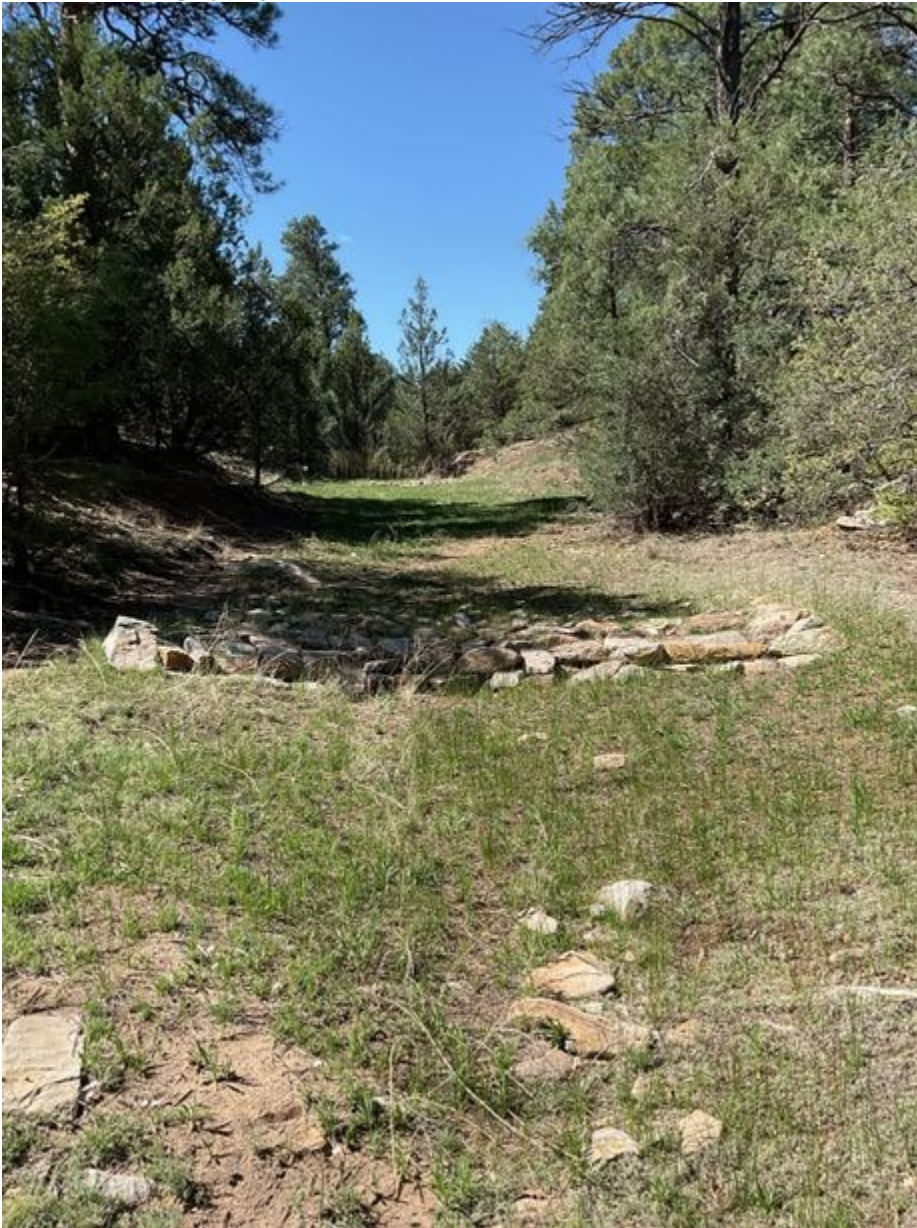
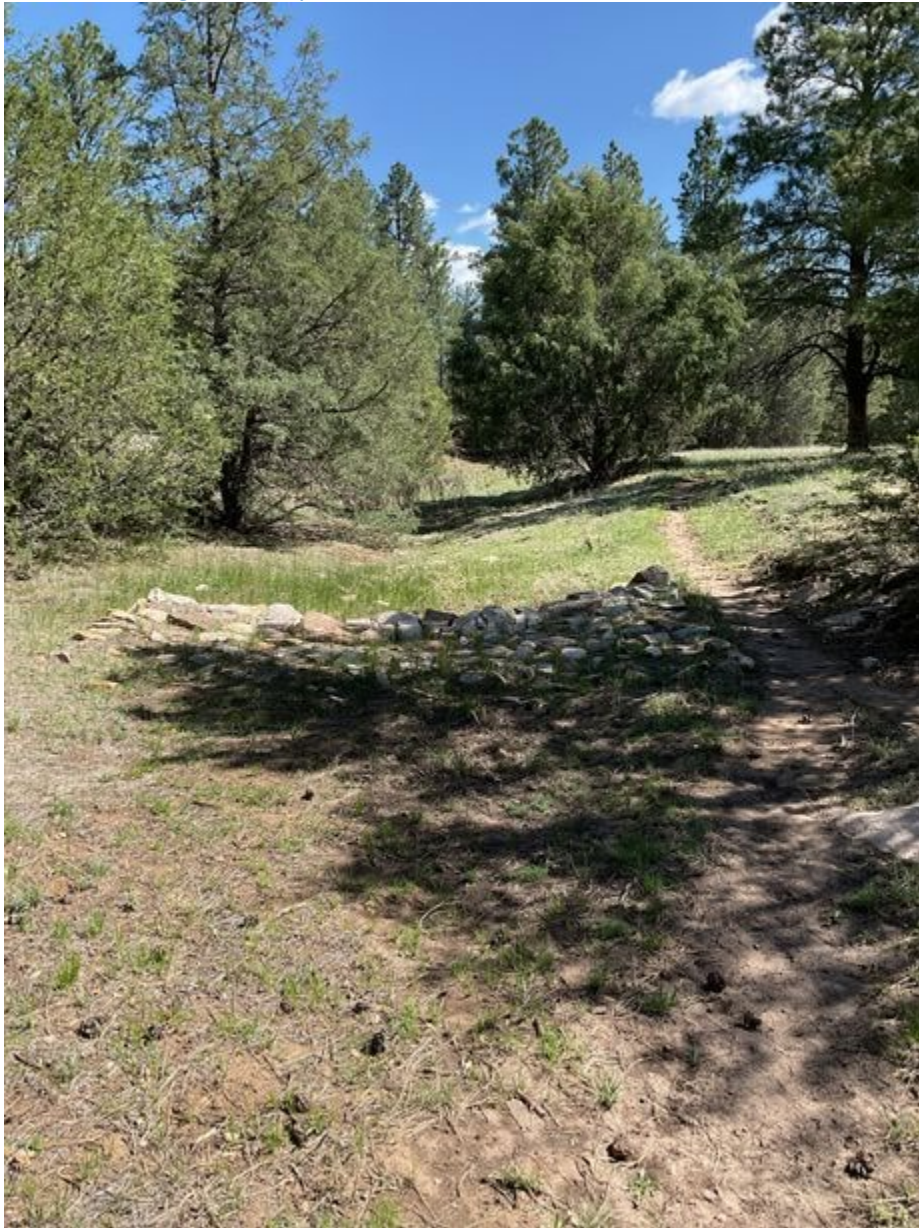
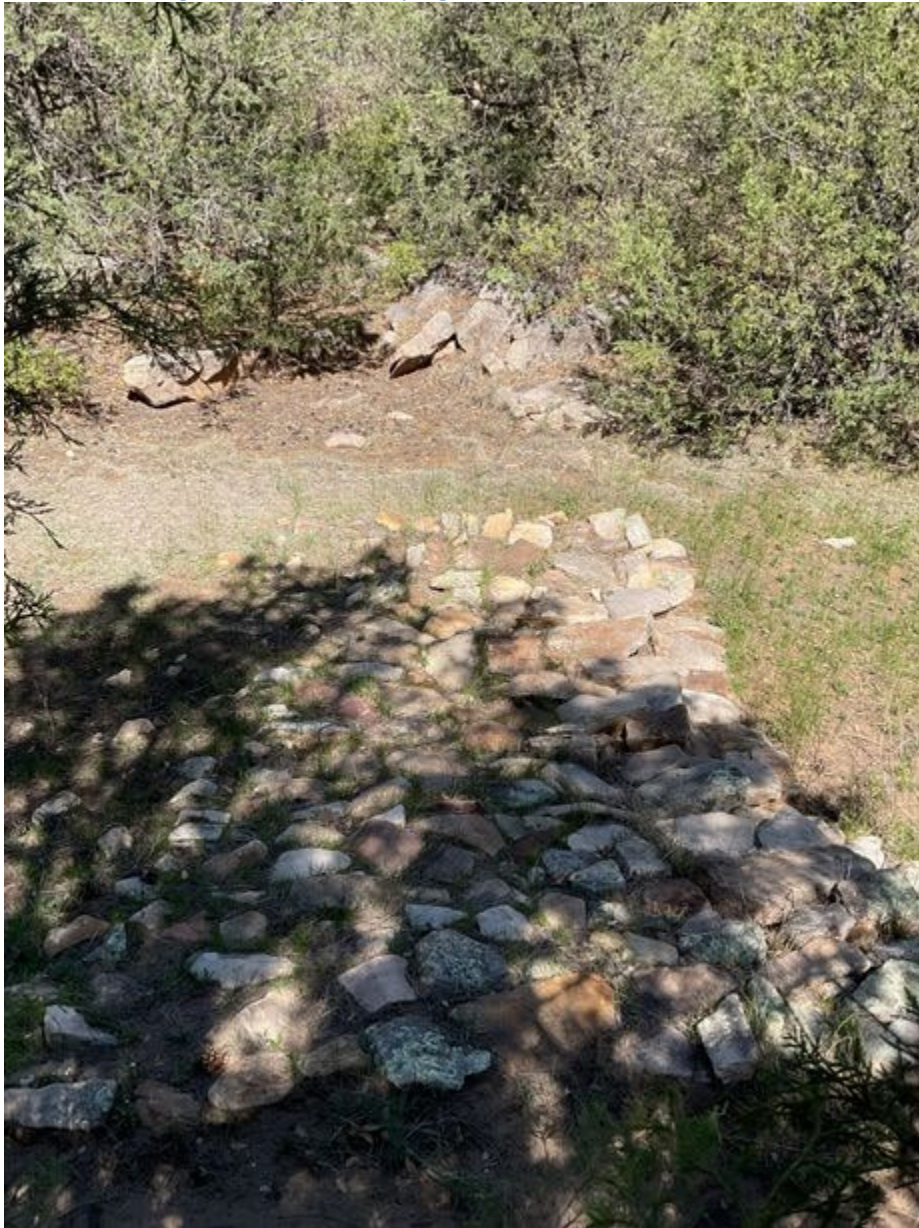
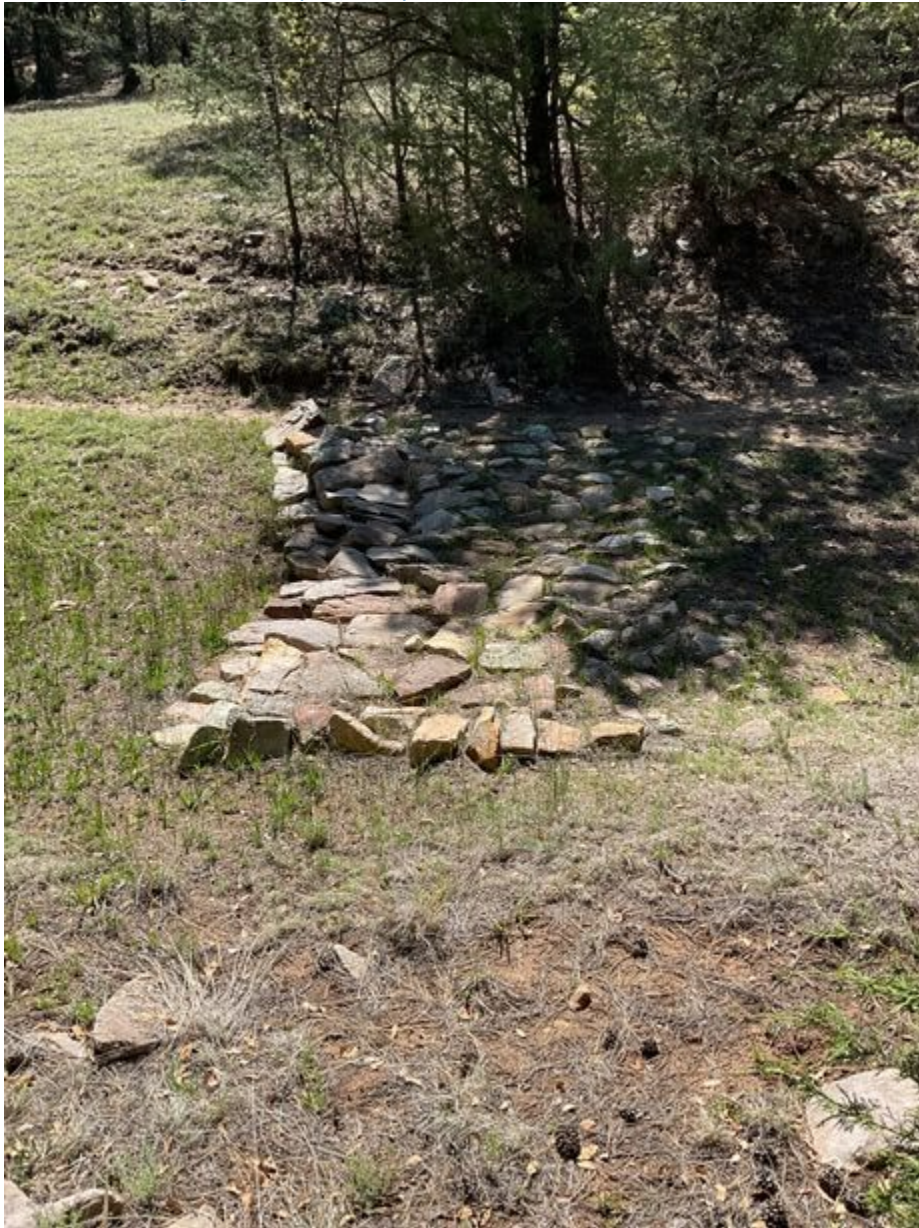
All rocks intact

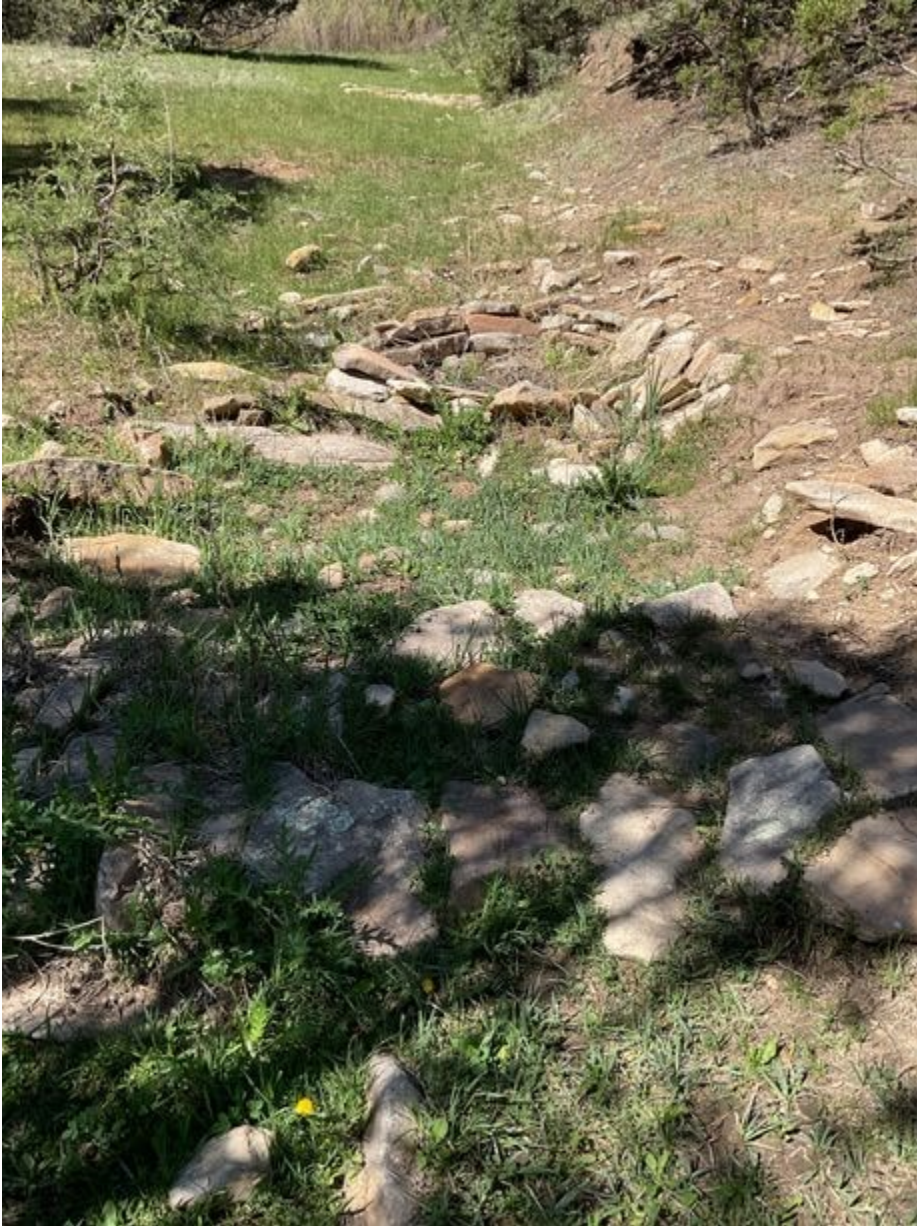
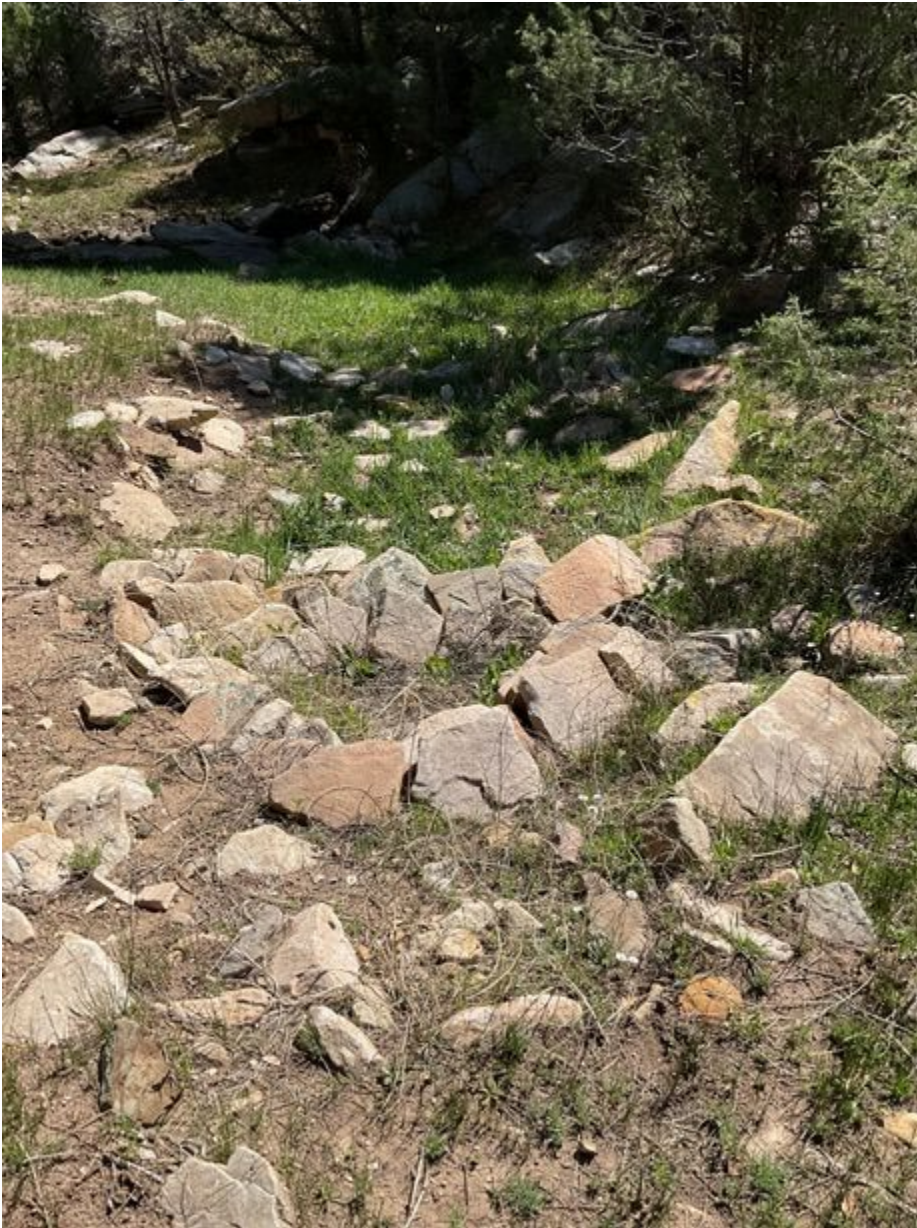
Some rocks dislodged or broken

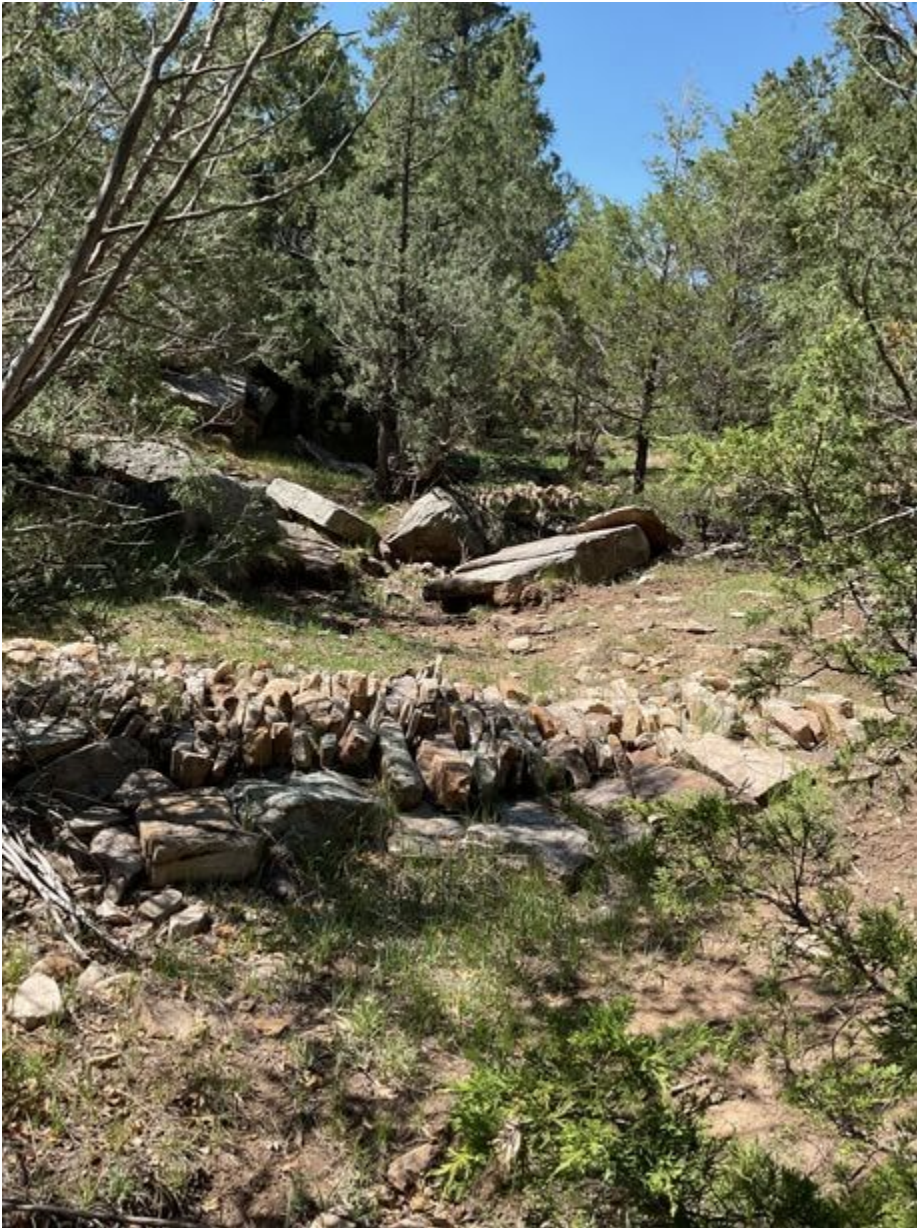
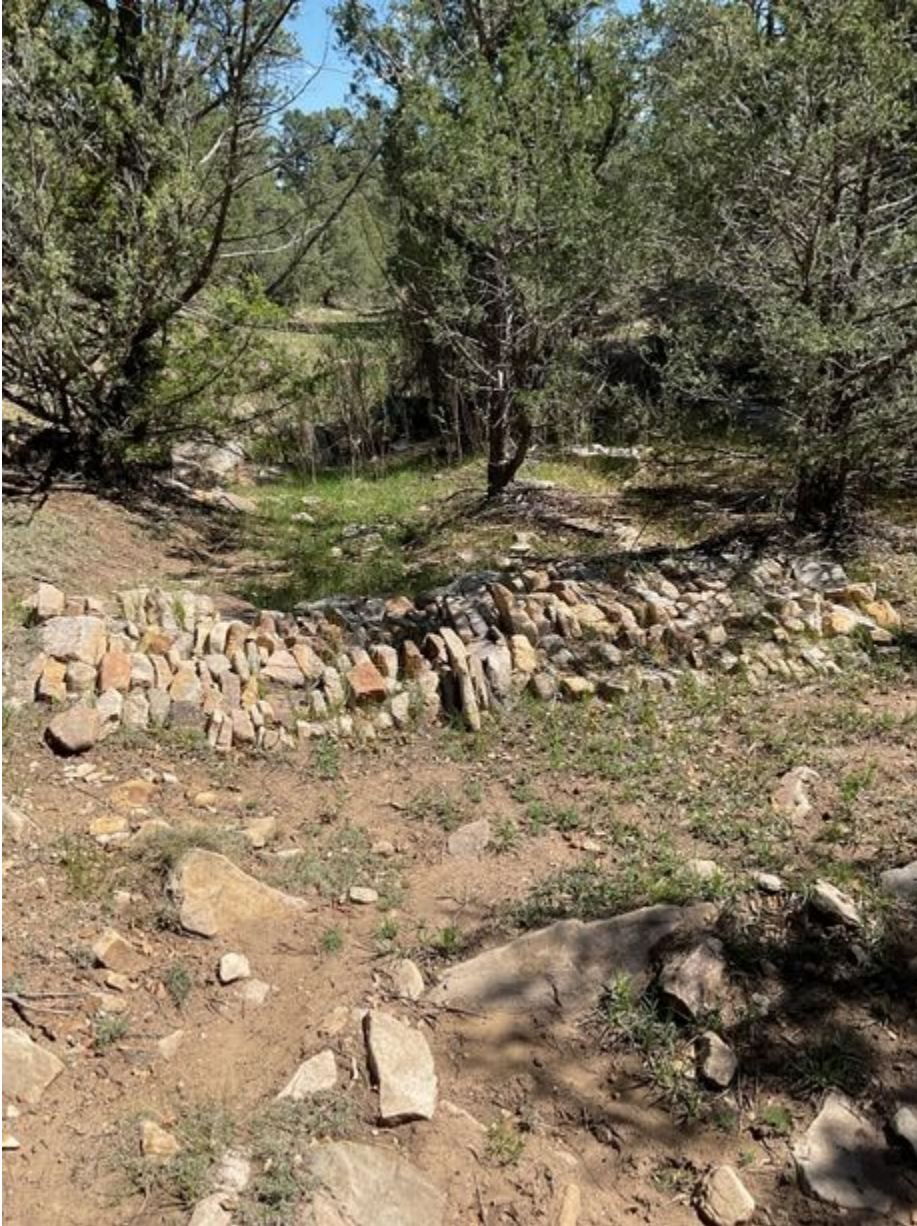
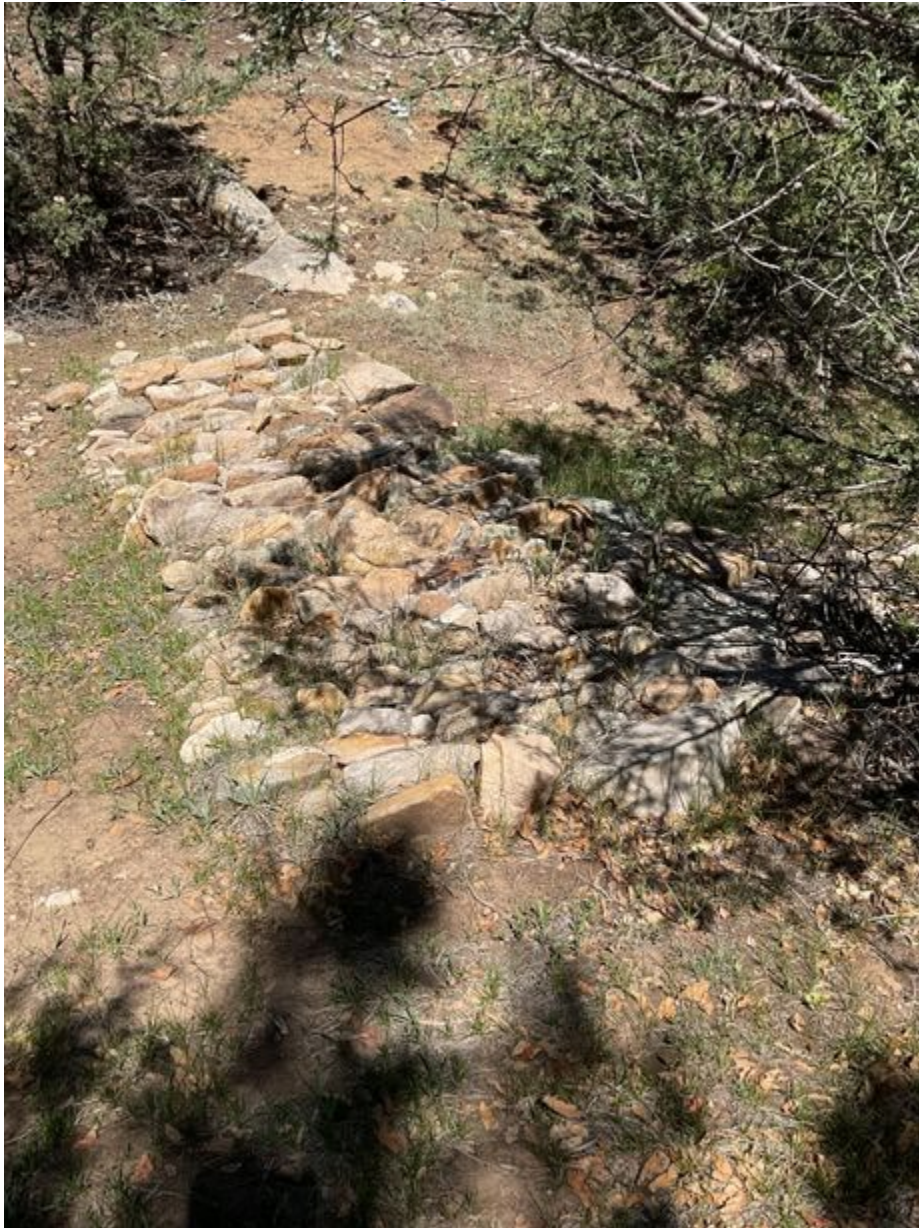
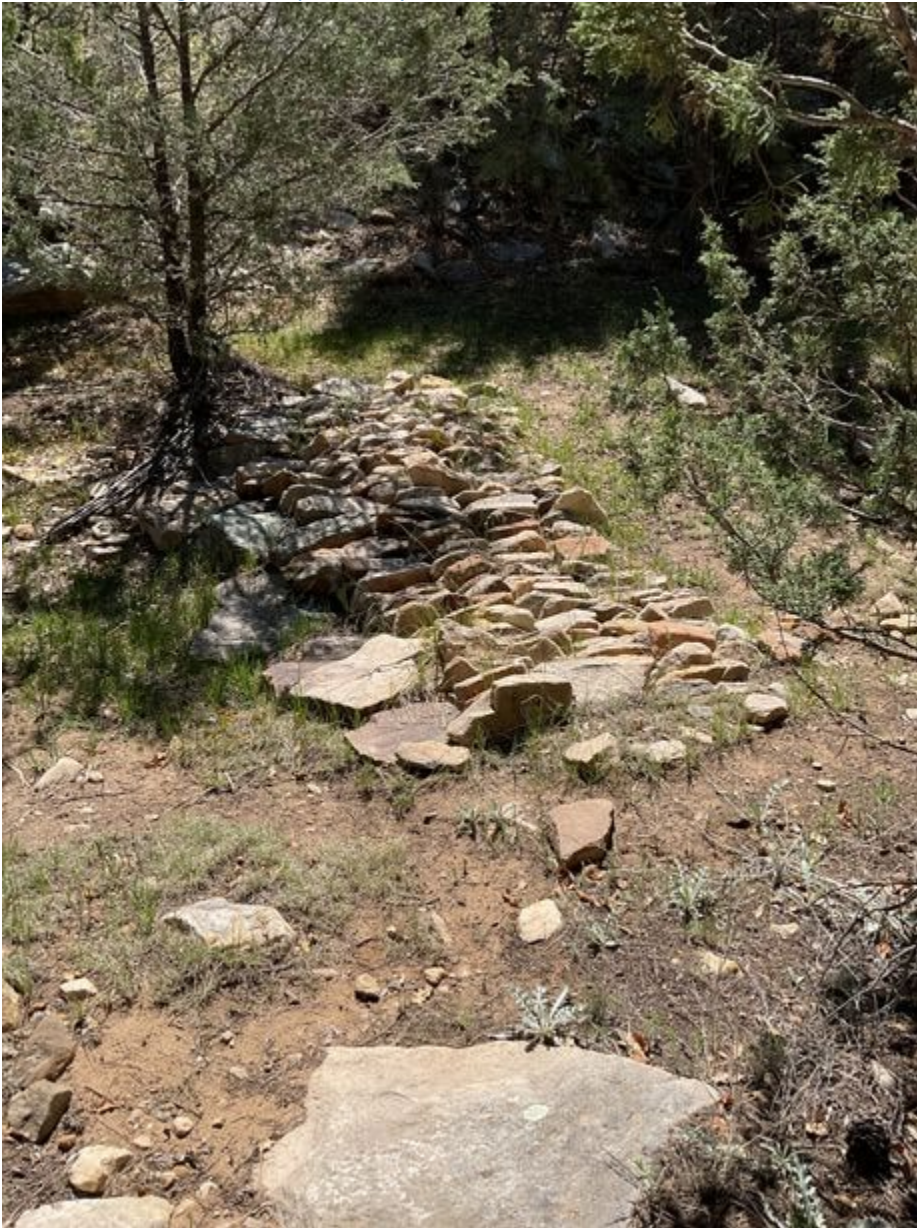
-105.0625779 35.83105572

All rocks intact
