CN R924060

**Zuni Bowl and One Rock Check Dam Research –
Phase 1**

Final Report

Rio Grande Return for the New Mexico Department of Transportation Research Bureau

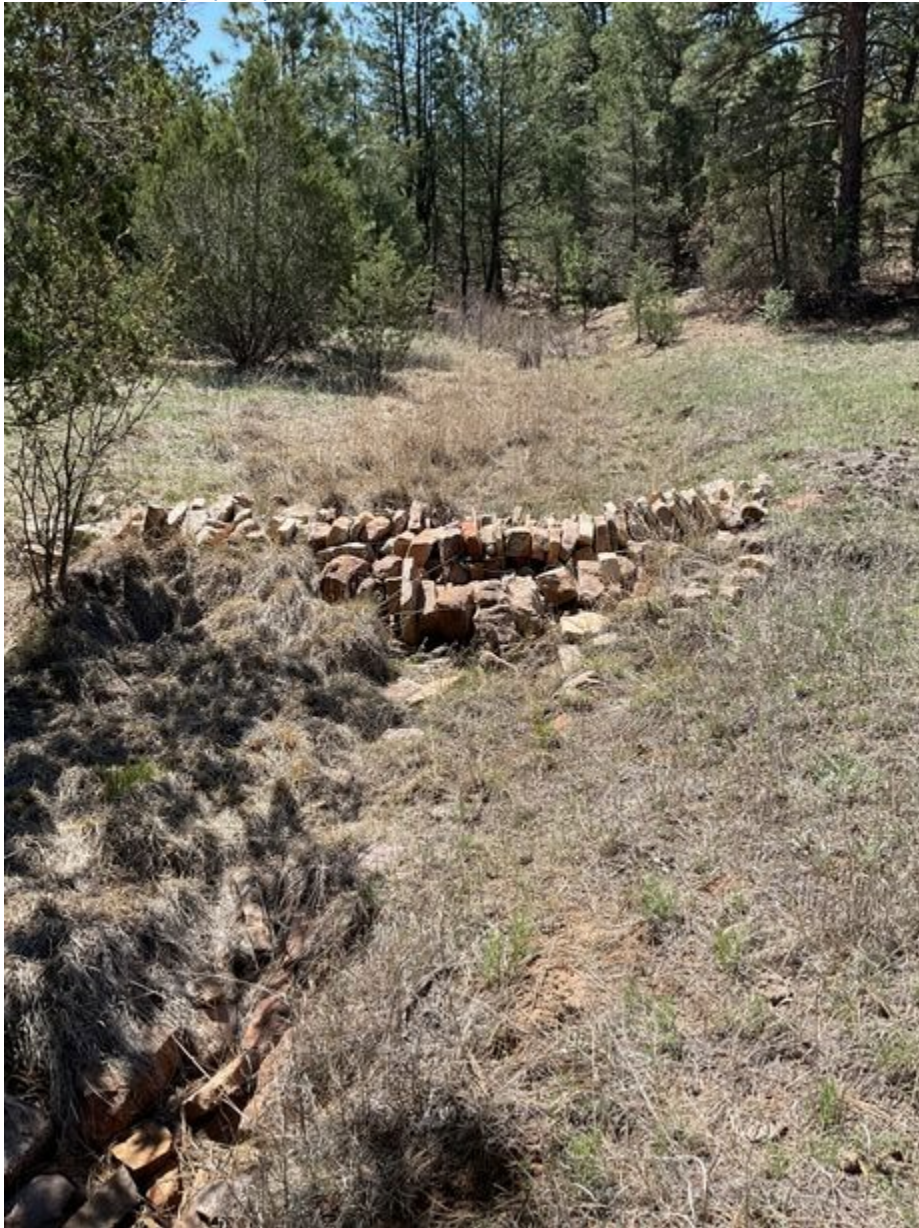
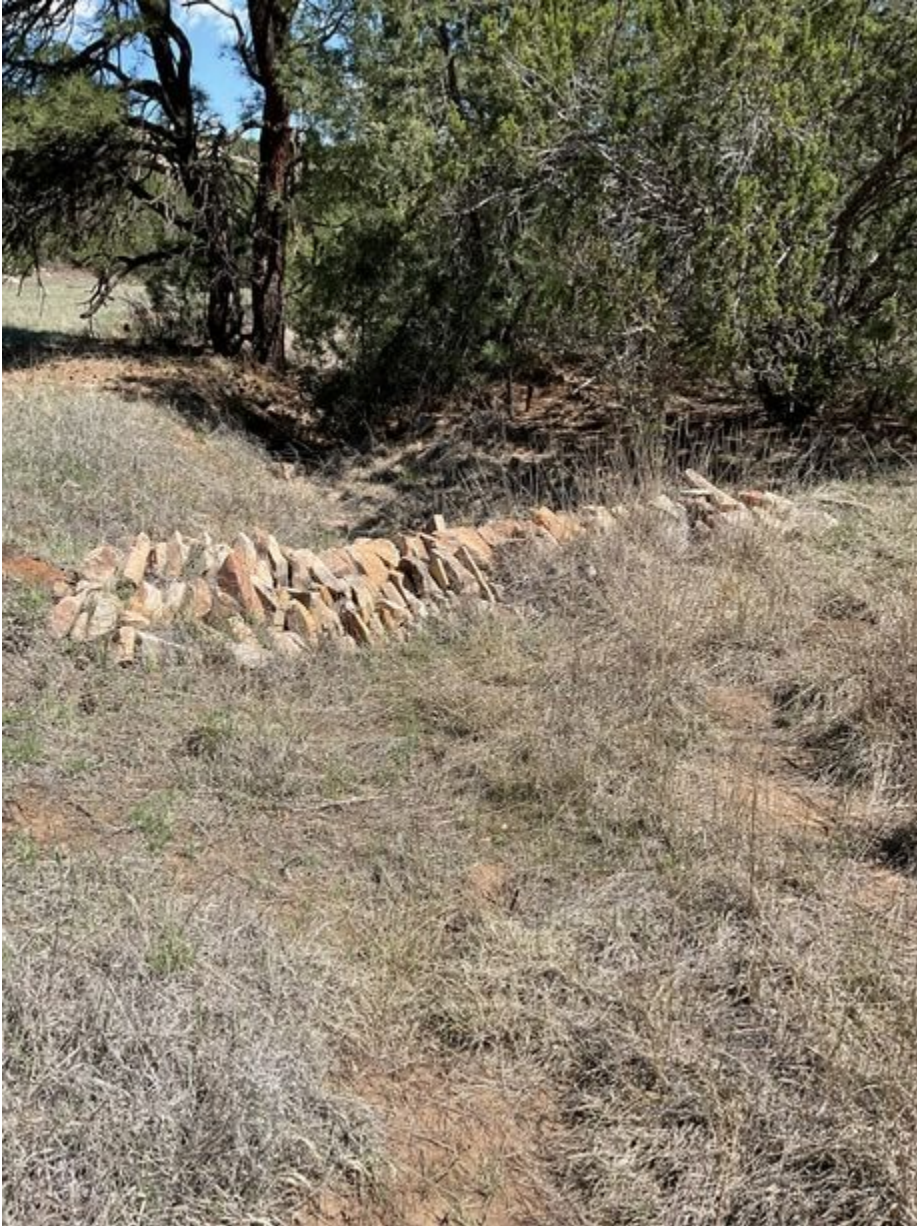
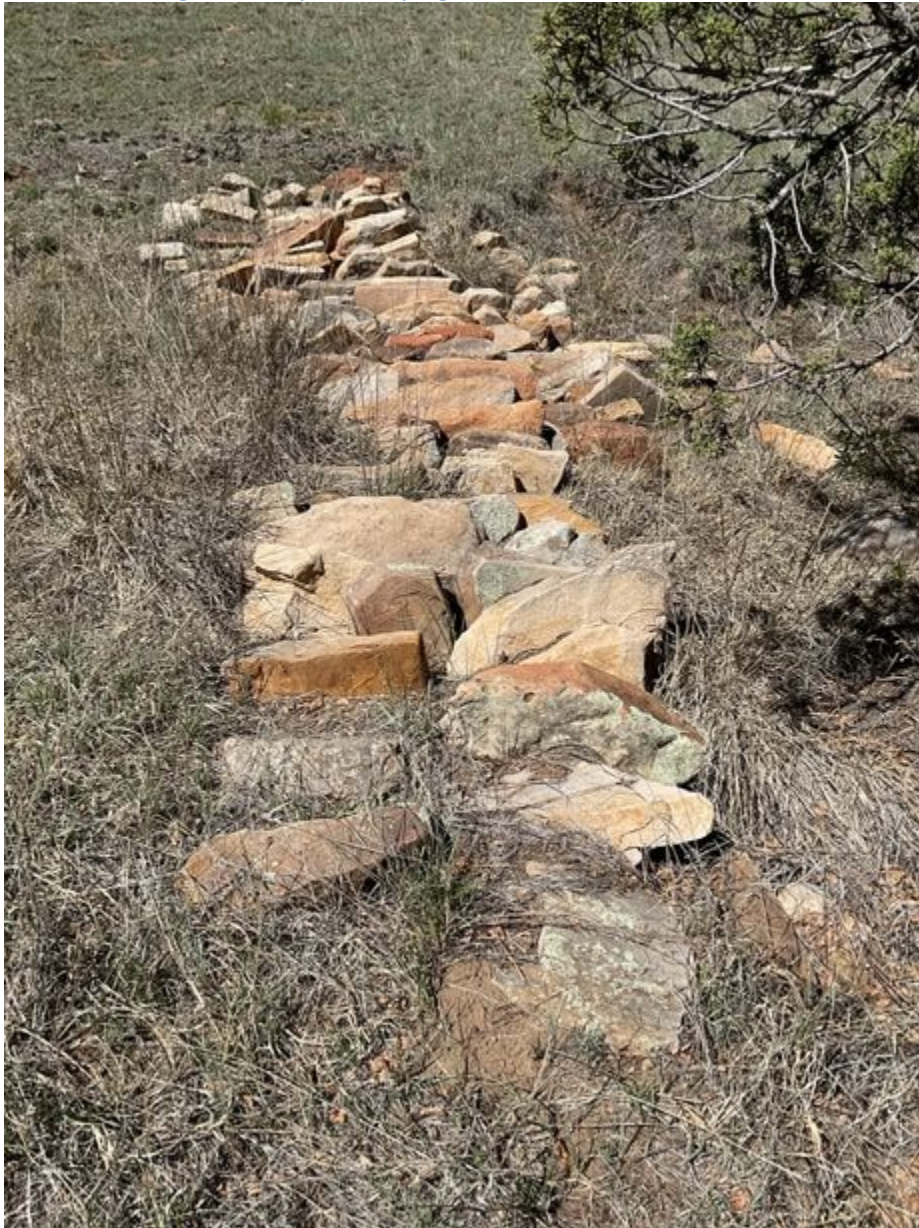
-105.0609064 35.83294335

Some rocks dislodged or broken

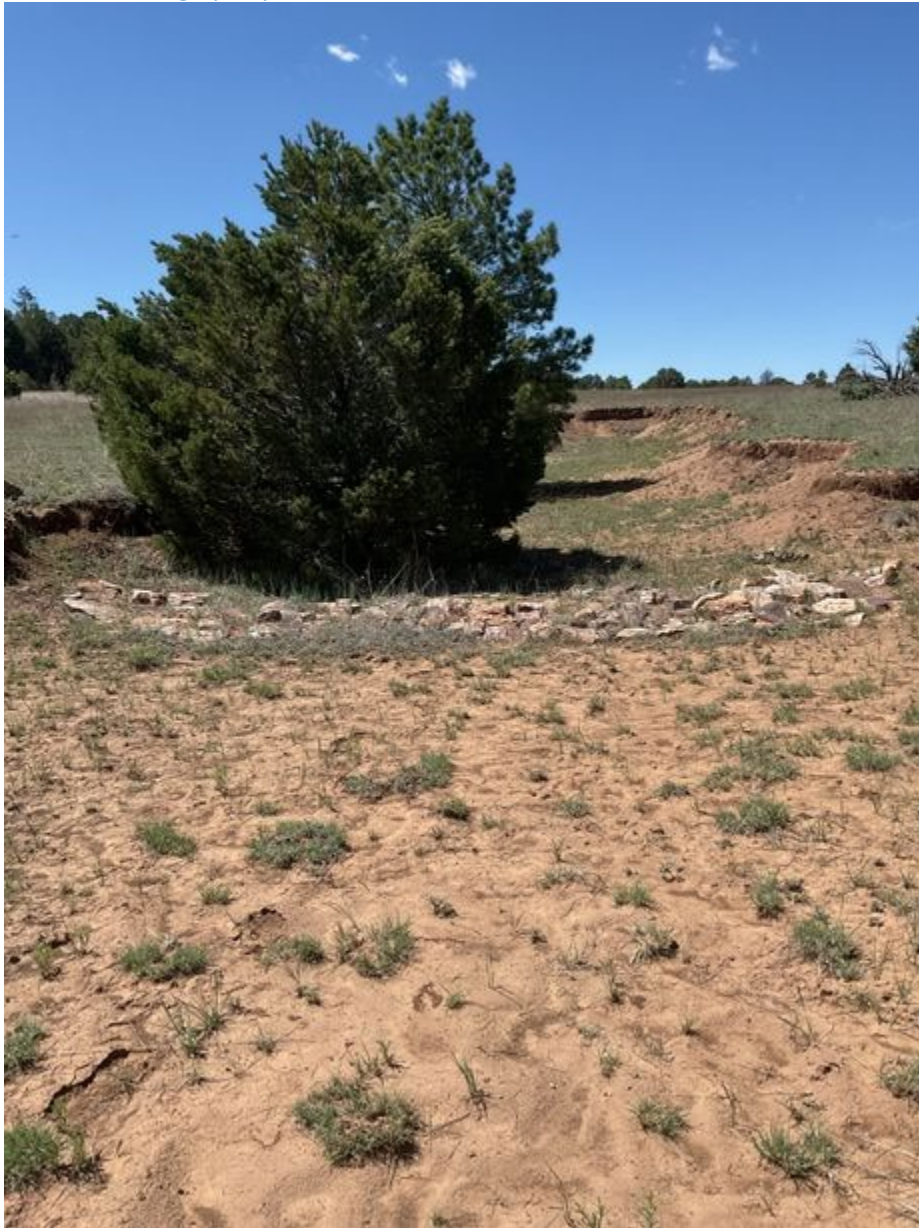
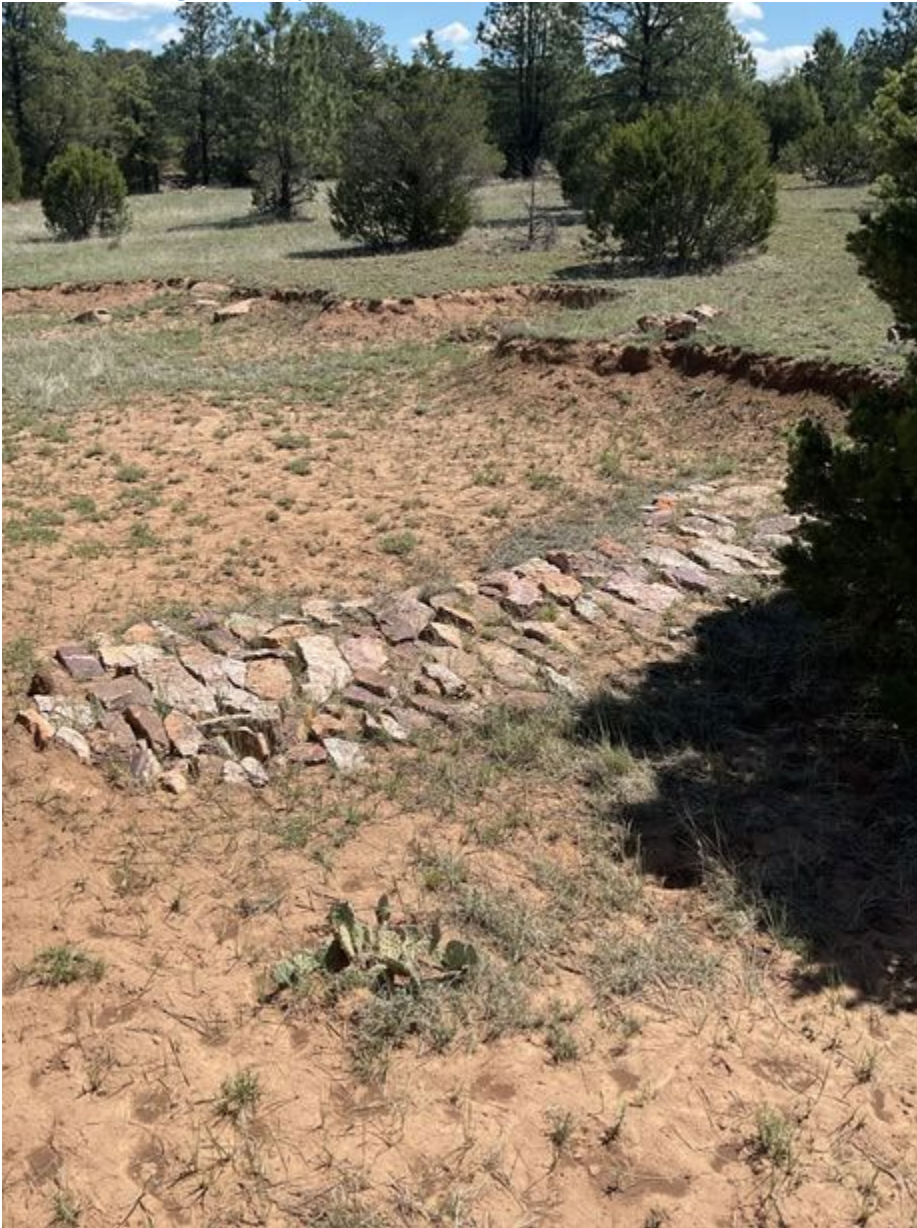
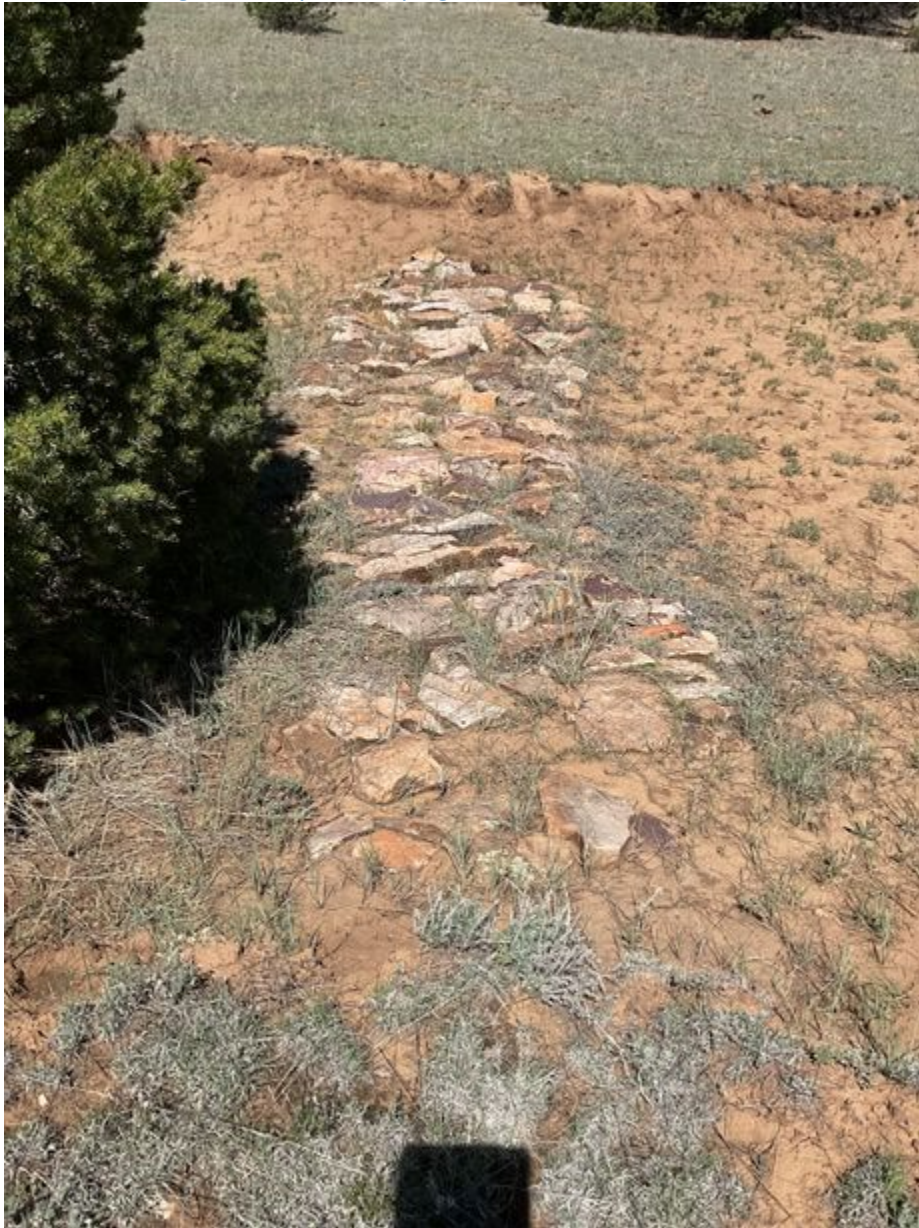
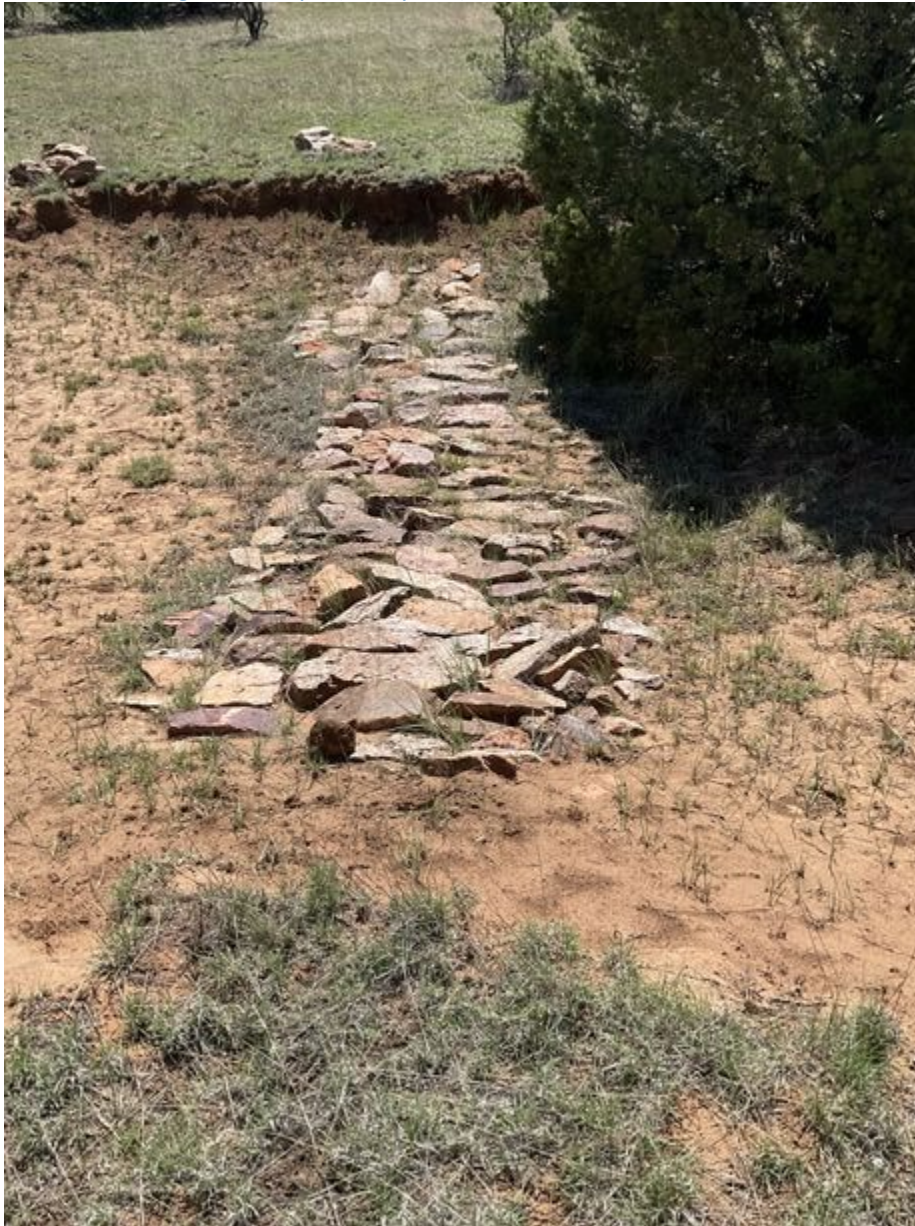
-105.0591178 35.82943648

All rocks intact

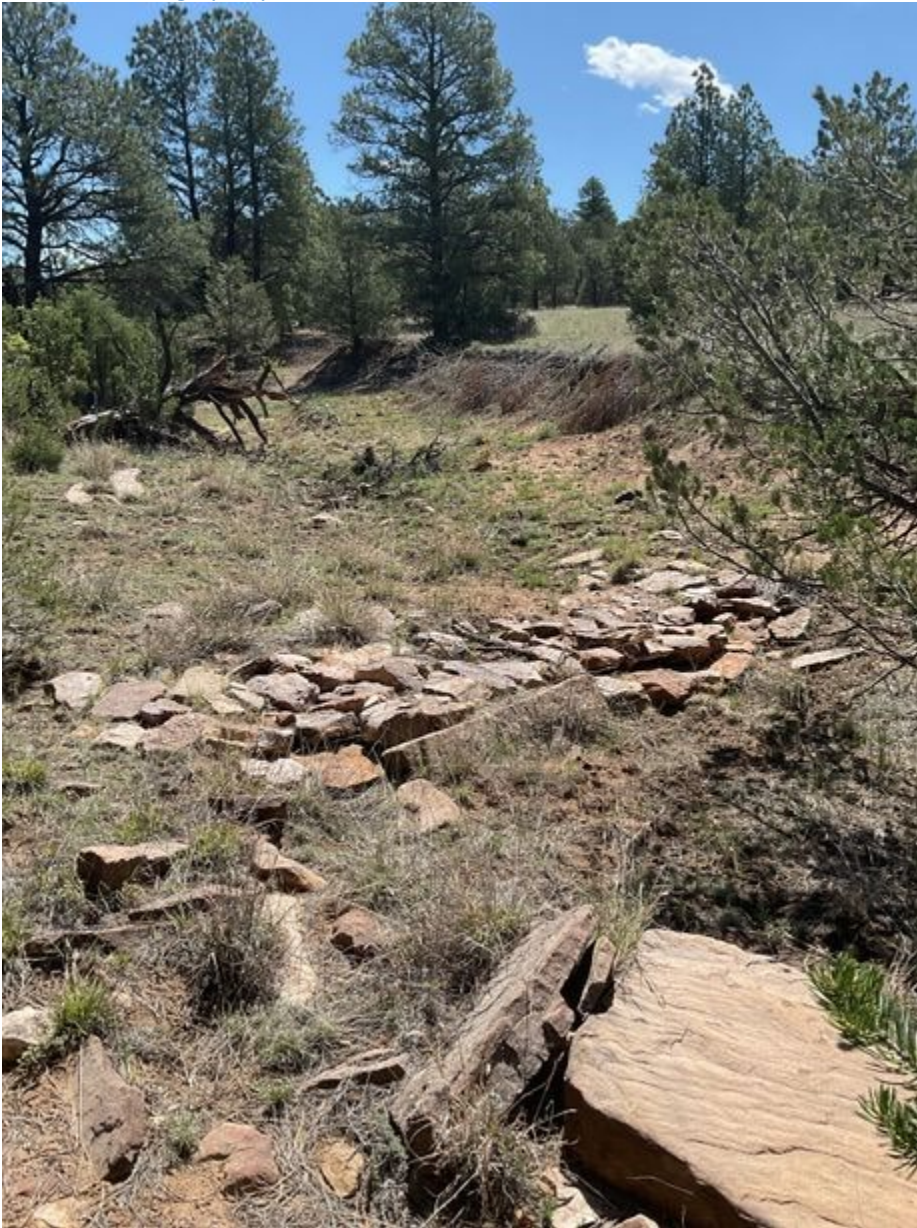
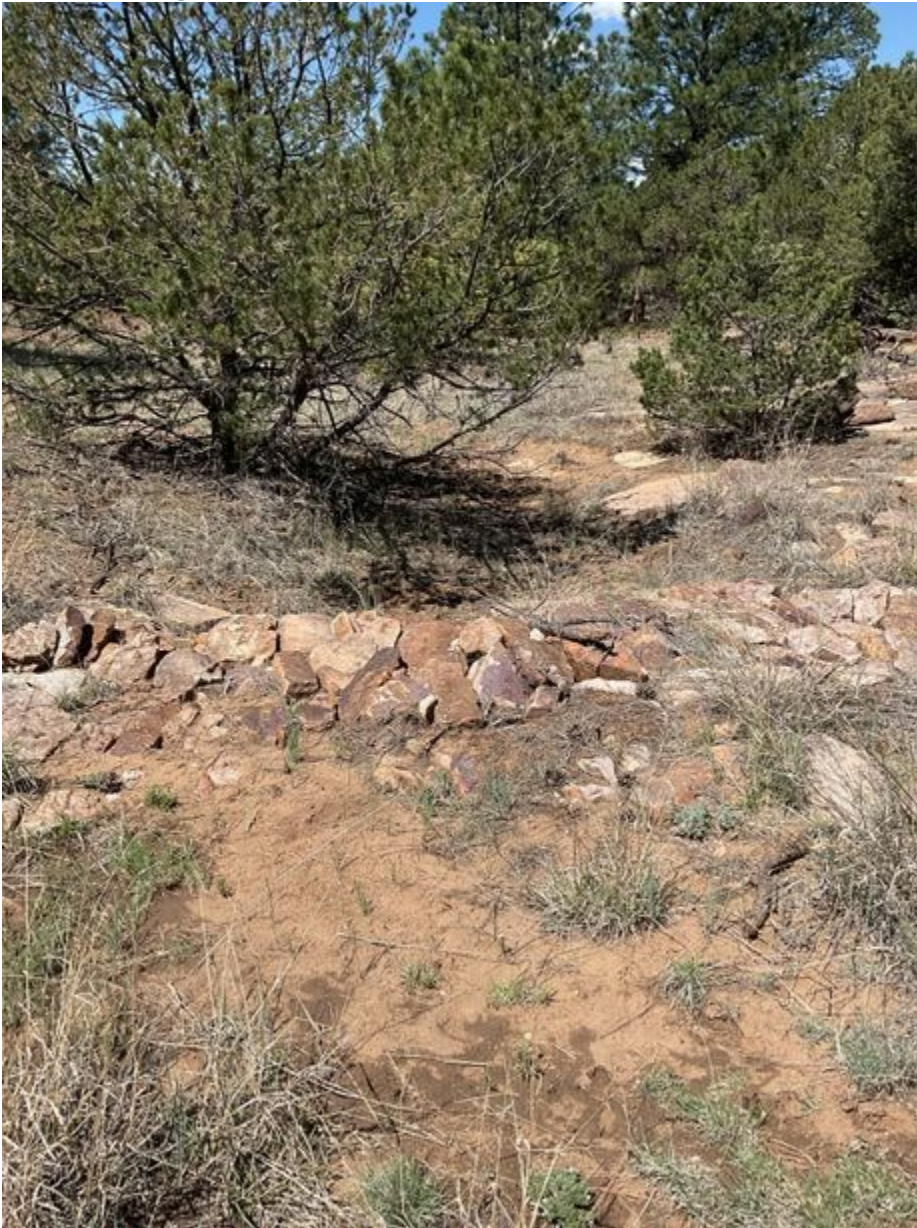
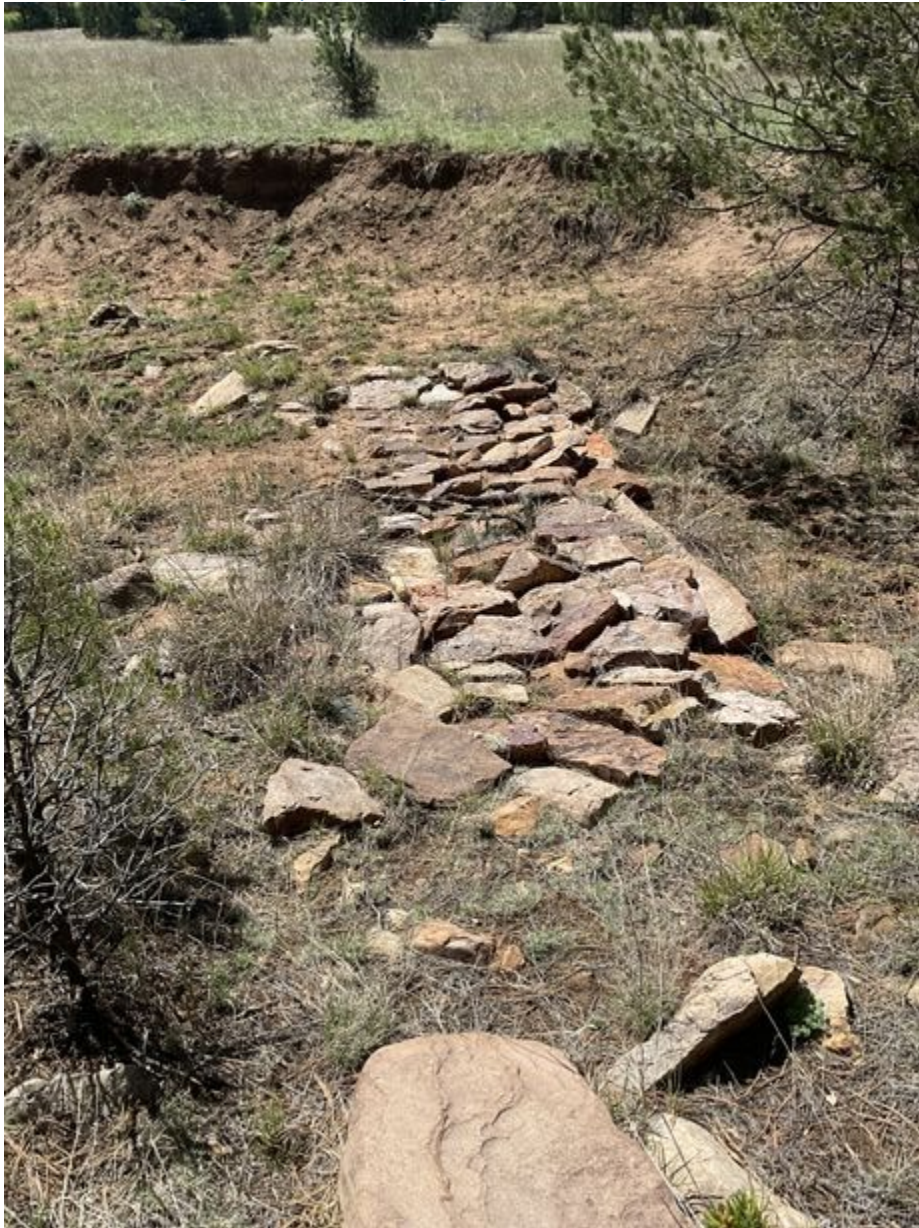
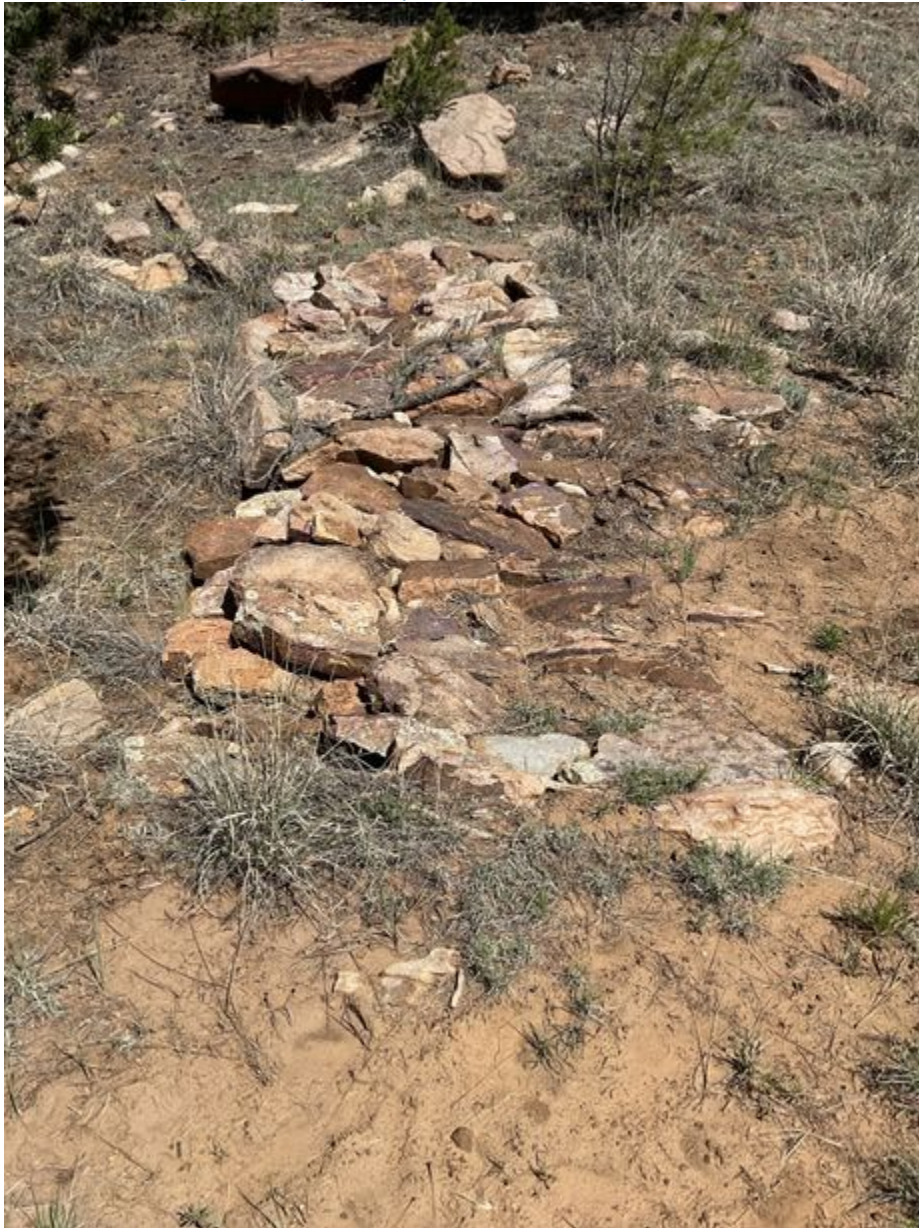
-105.058157 35.8298955

All rocks intact

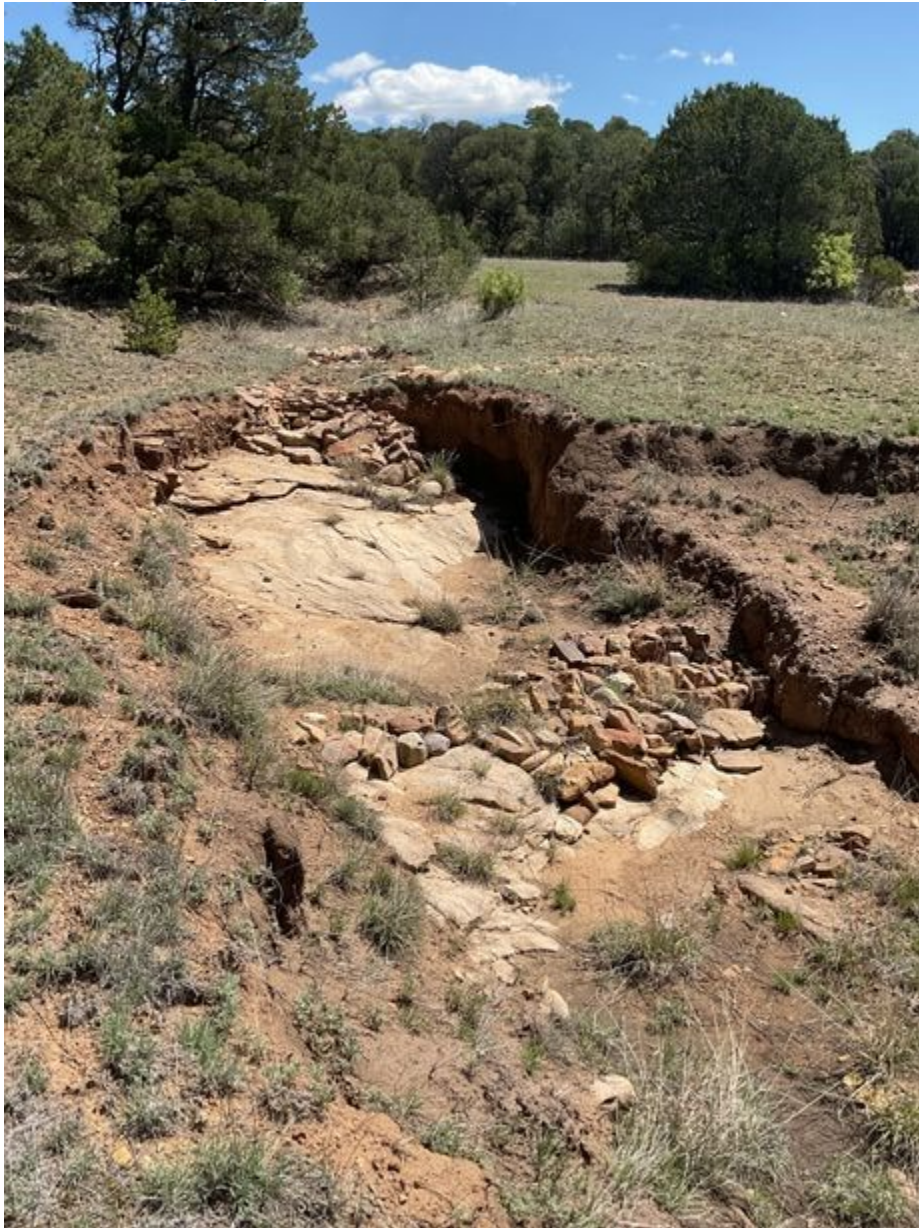
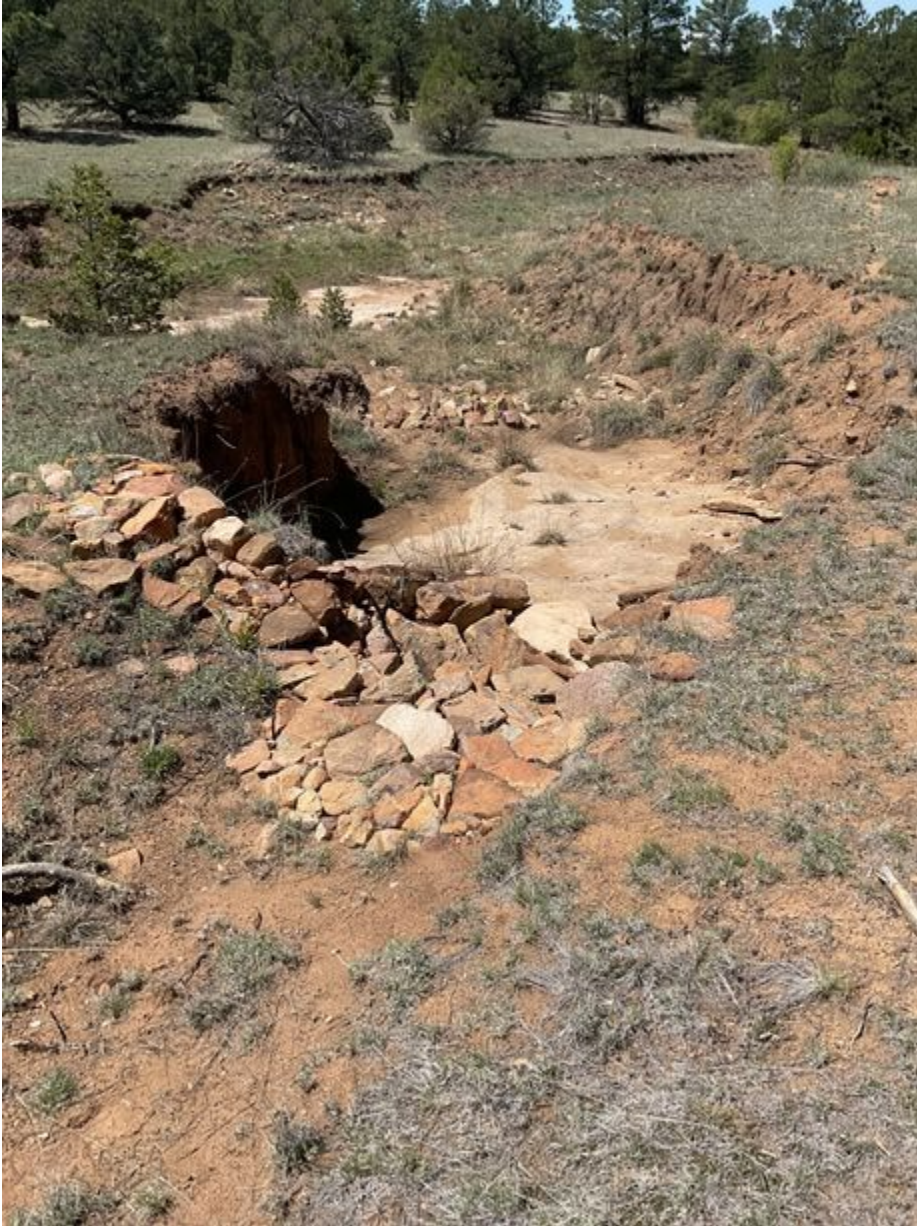
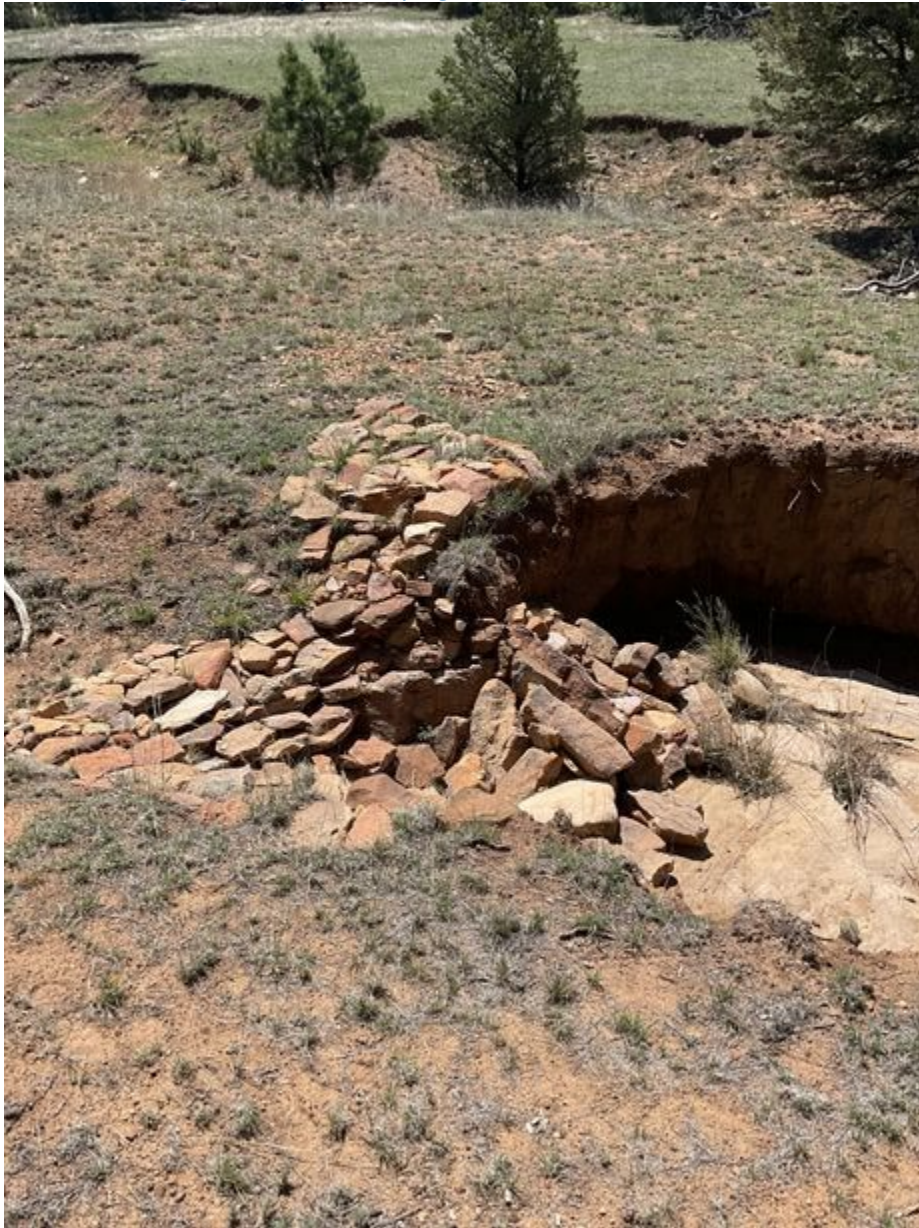
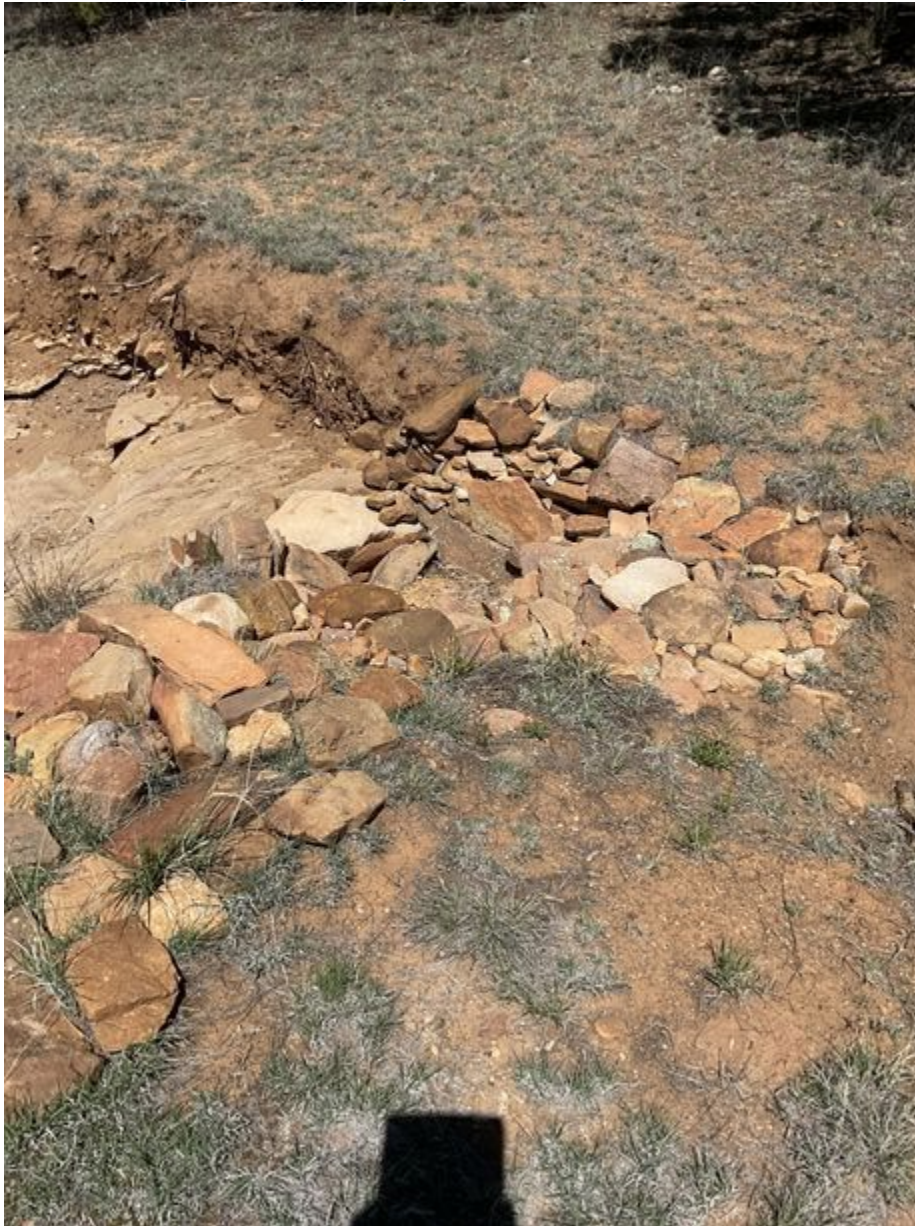
-105.0570489 35.83039503

All rocks intact

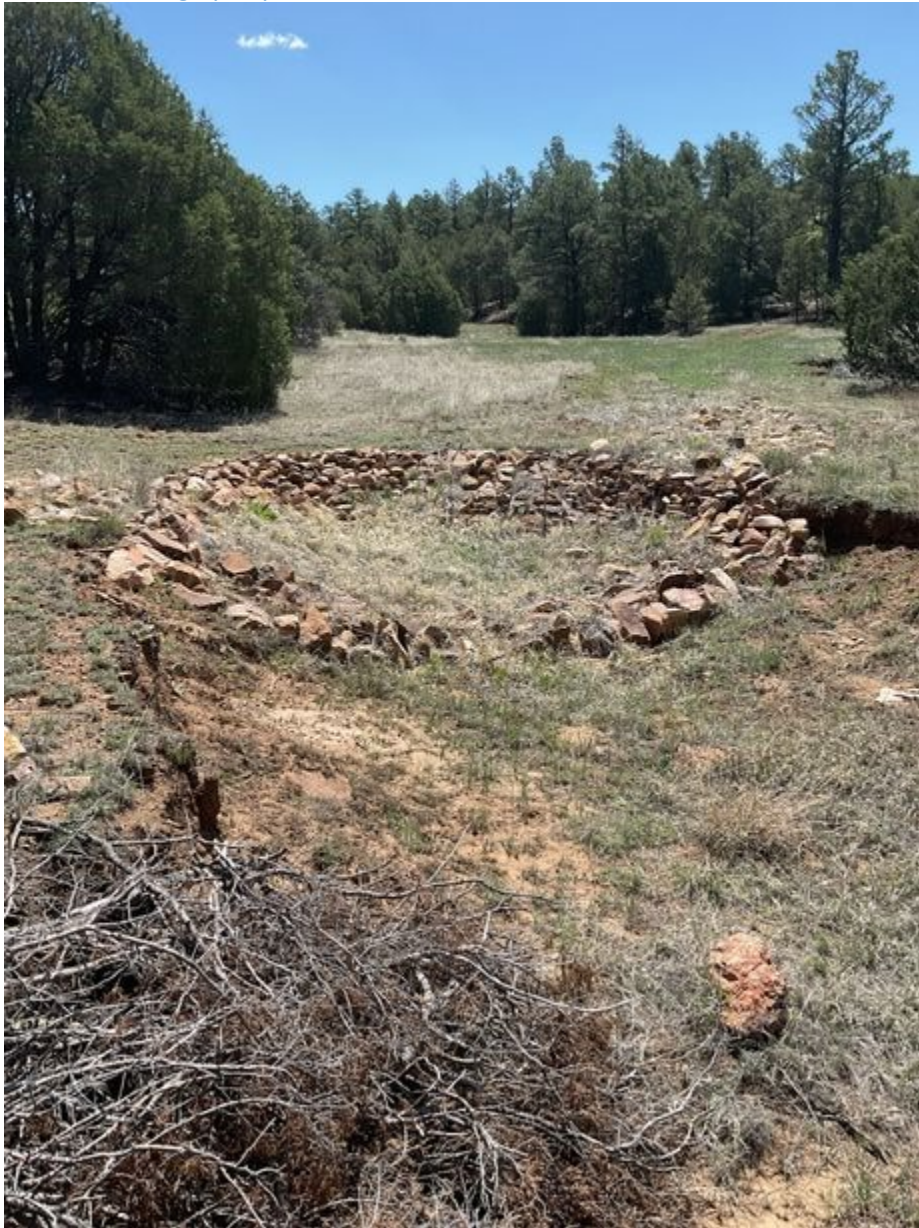
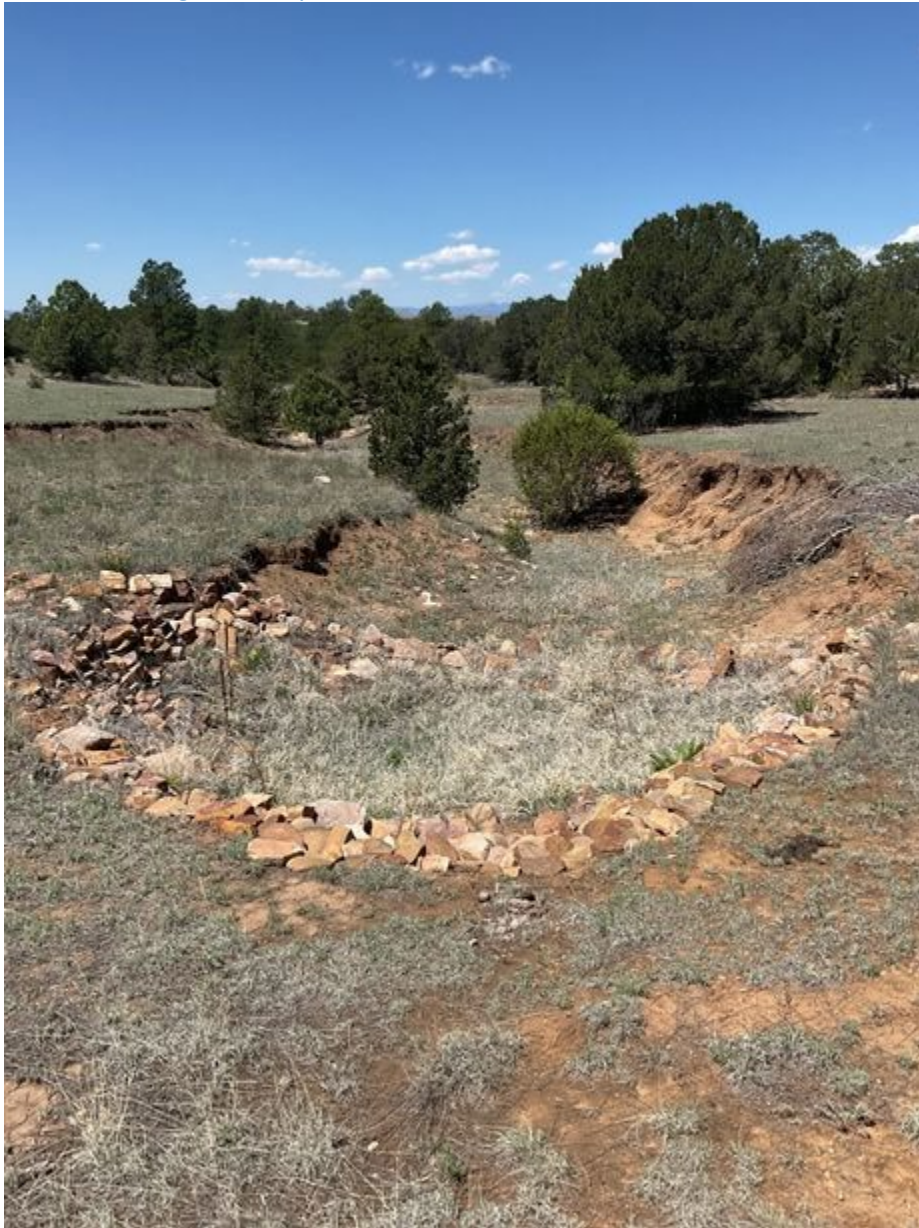
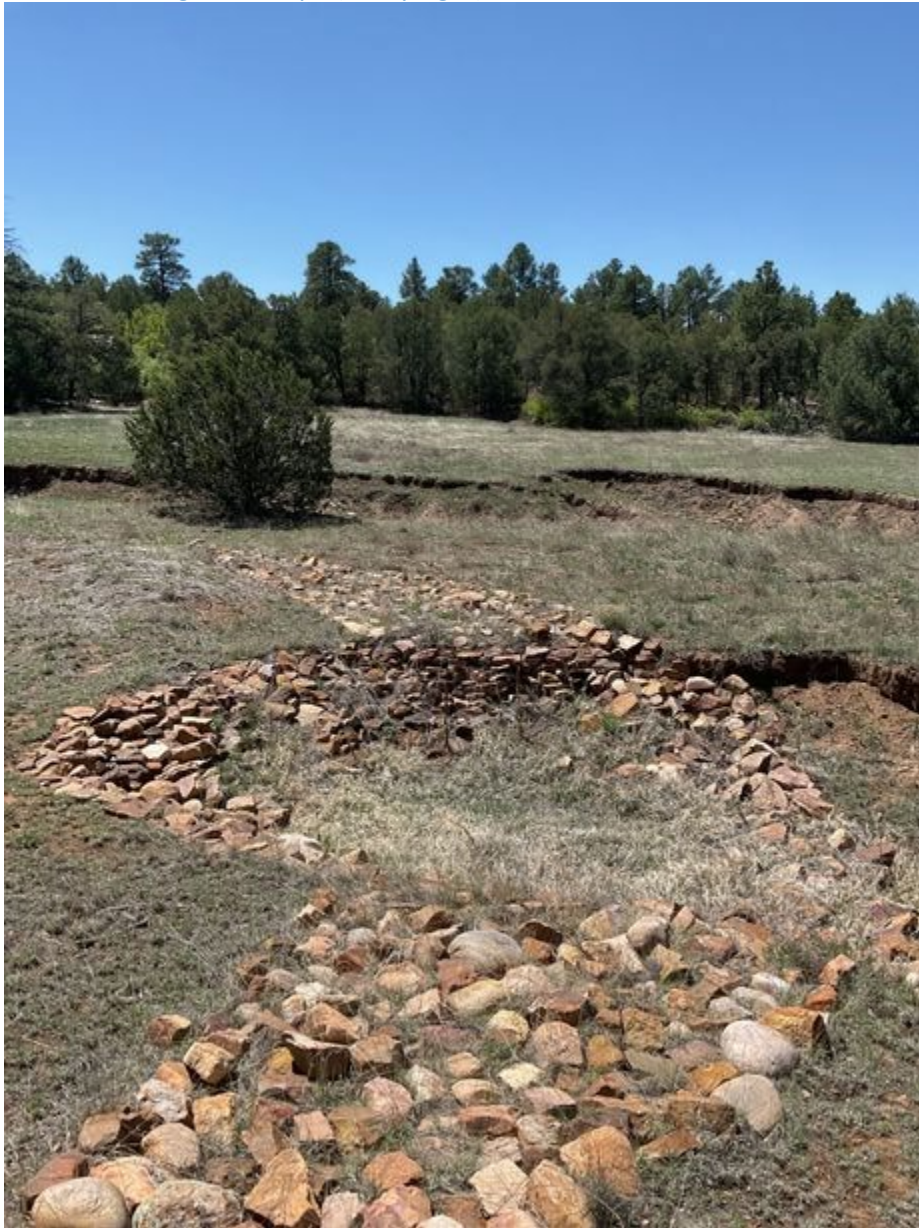
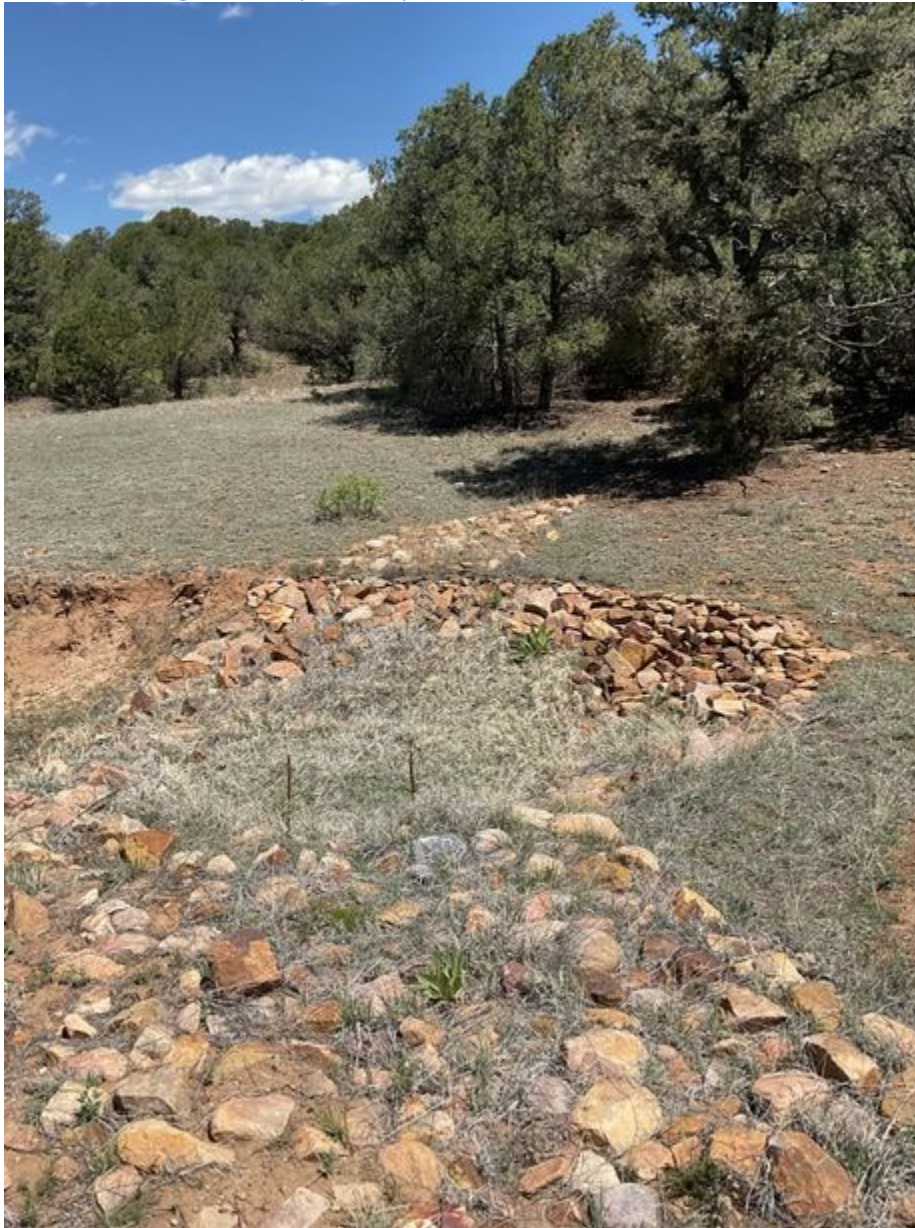
-105.0564703 35.83043095

All rocks intact
