CN R924060

**Zuni Bowl and One Rock Check Dam Research –
Phase 1**

Final Report

Rio Grande Return for the New Mexico Department of Transportation Research Bureau

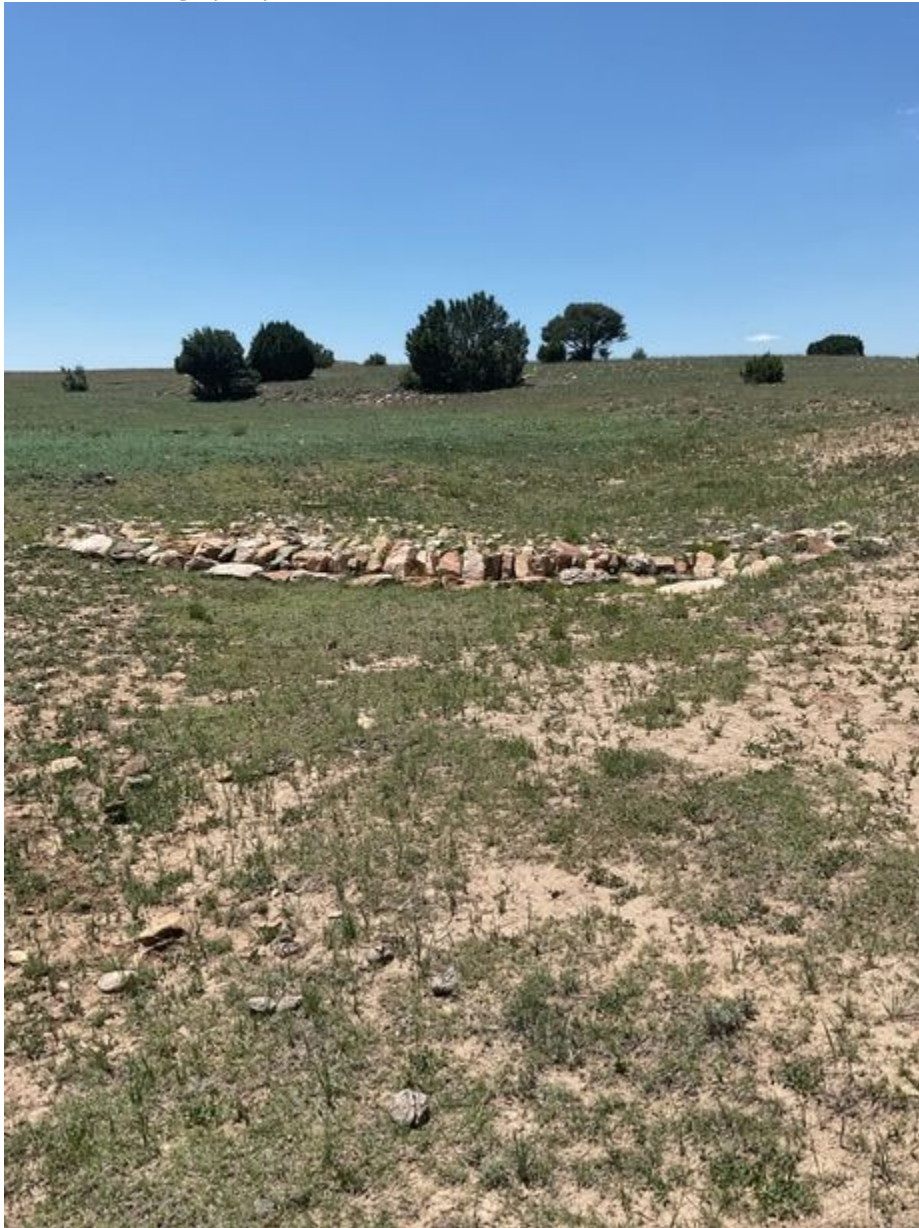
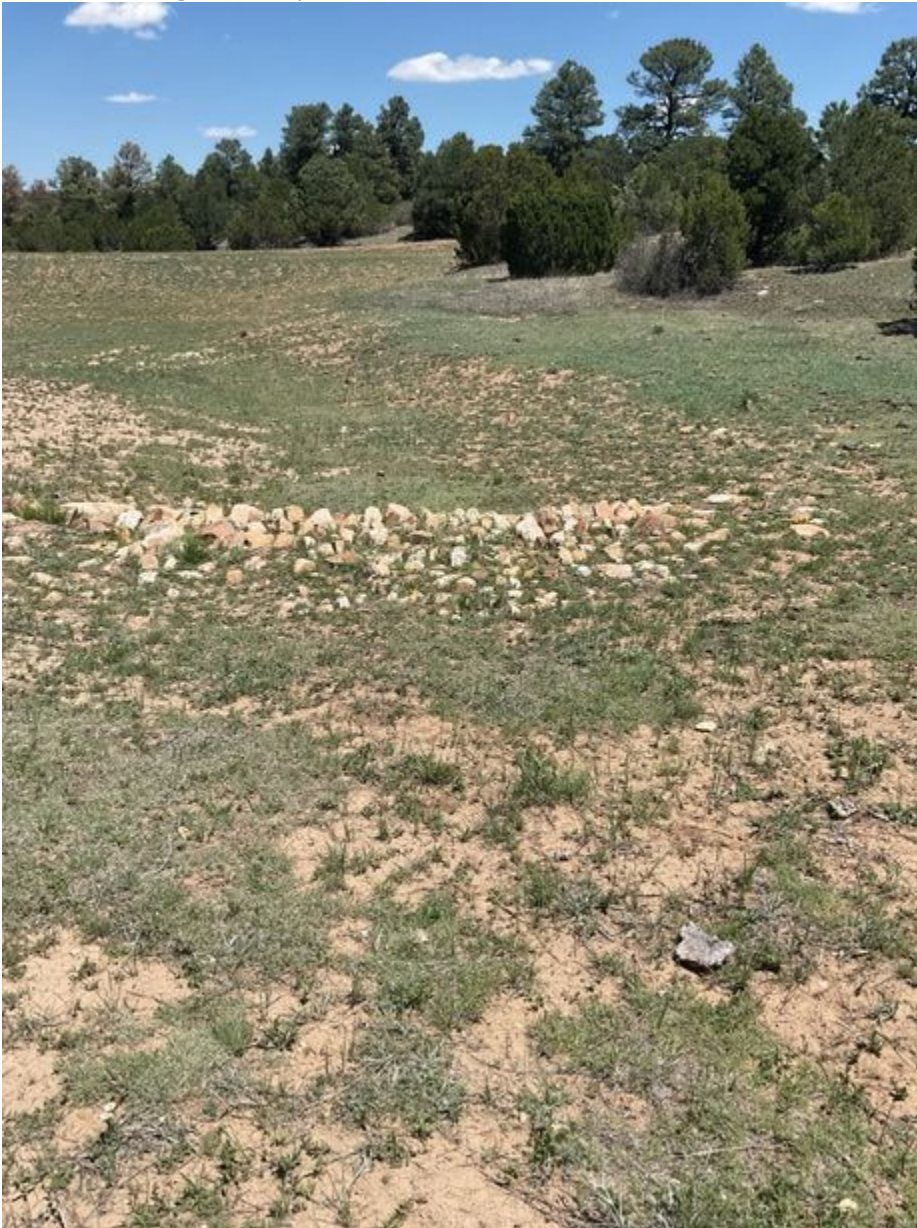
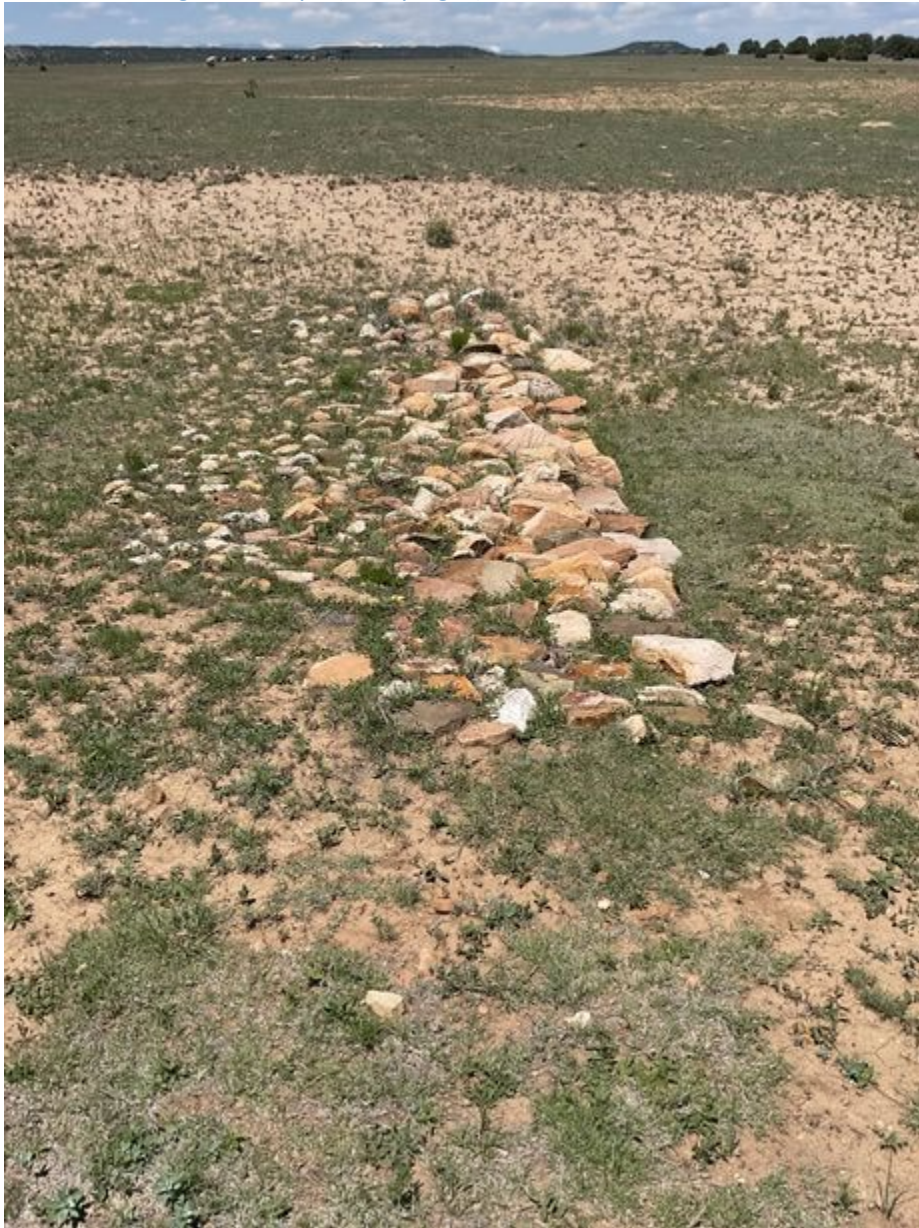
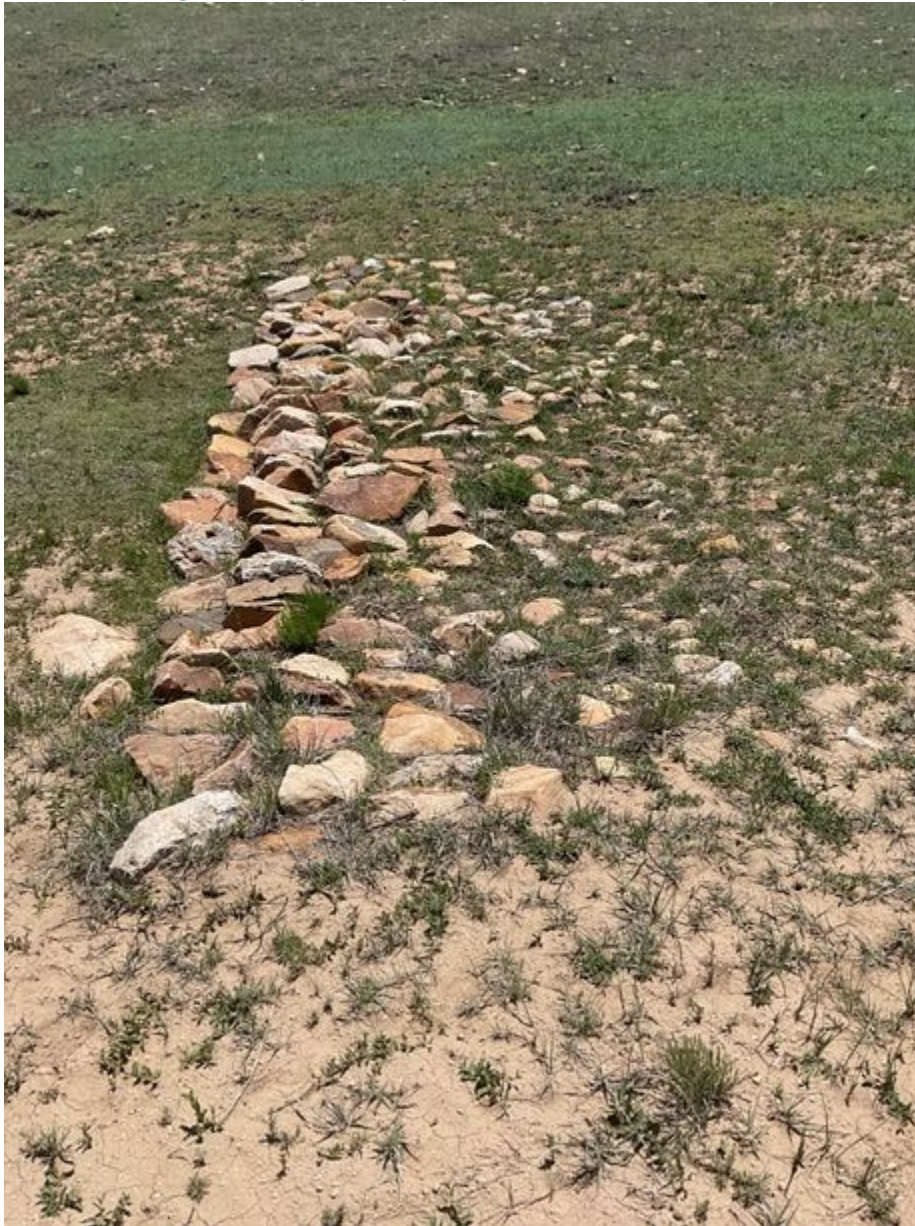
-105.0739468 35.83258072

All rocks intact

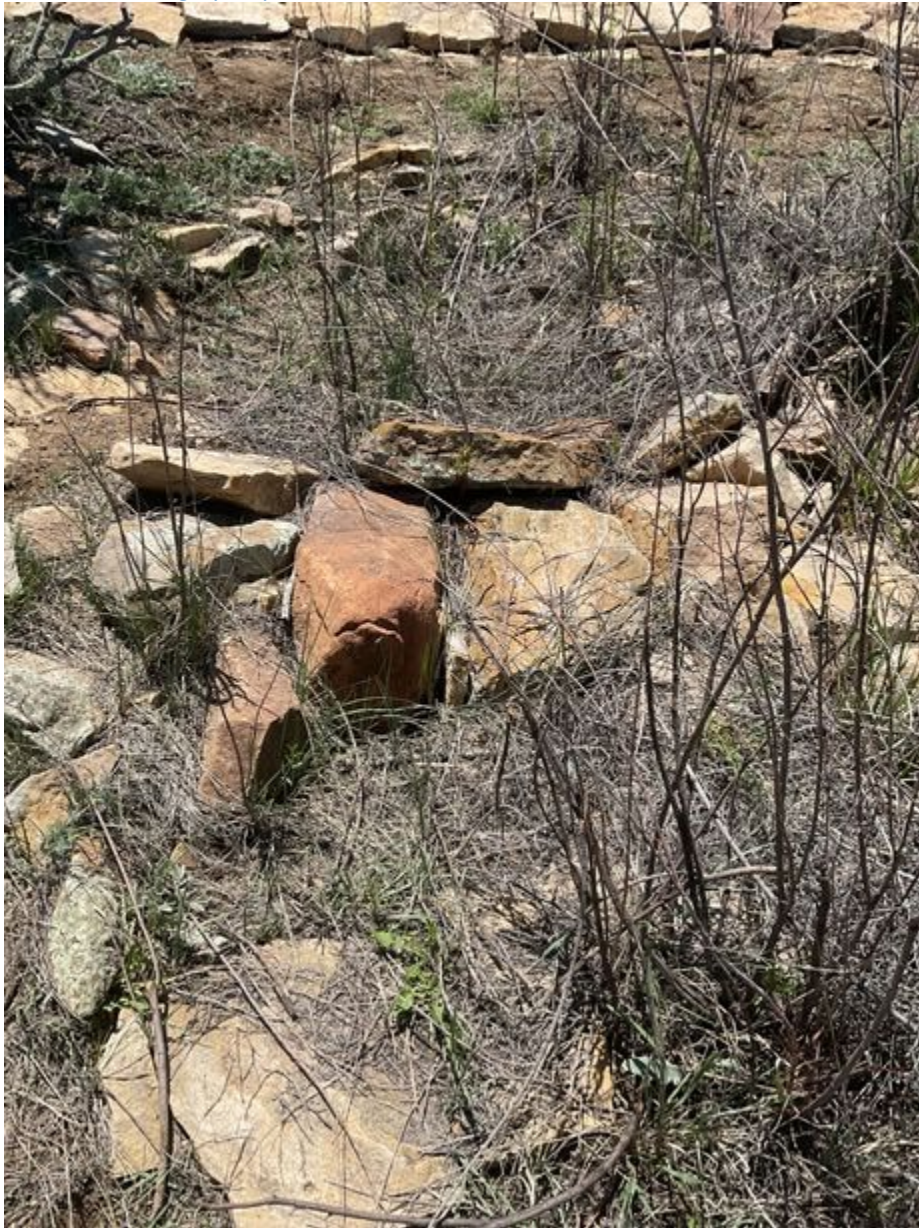
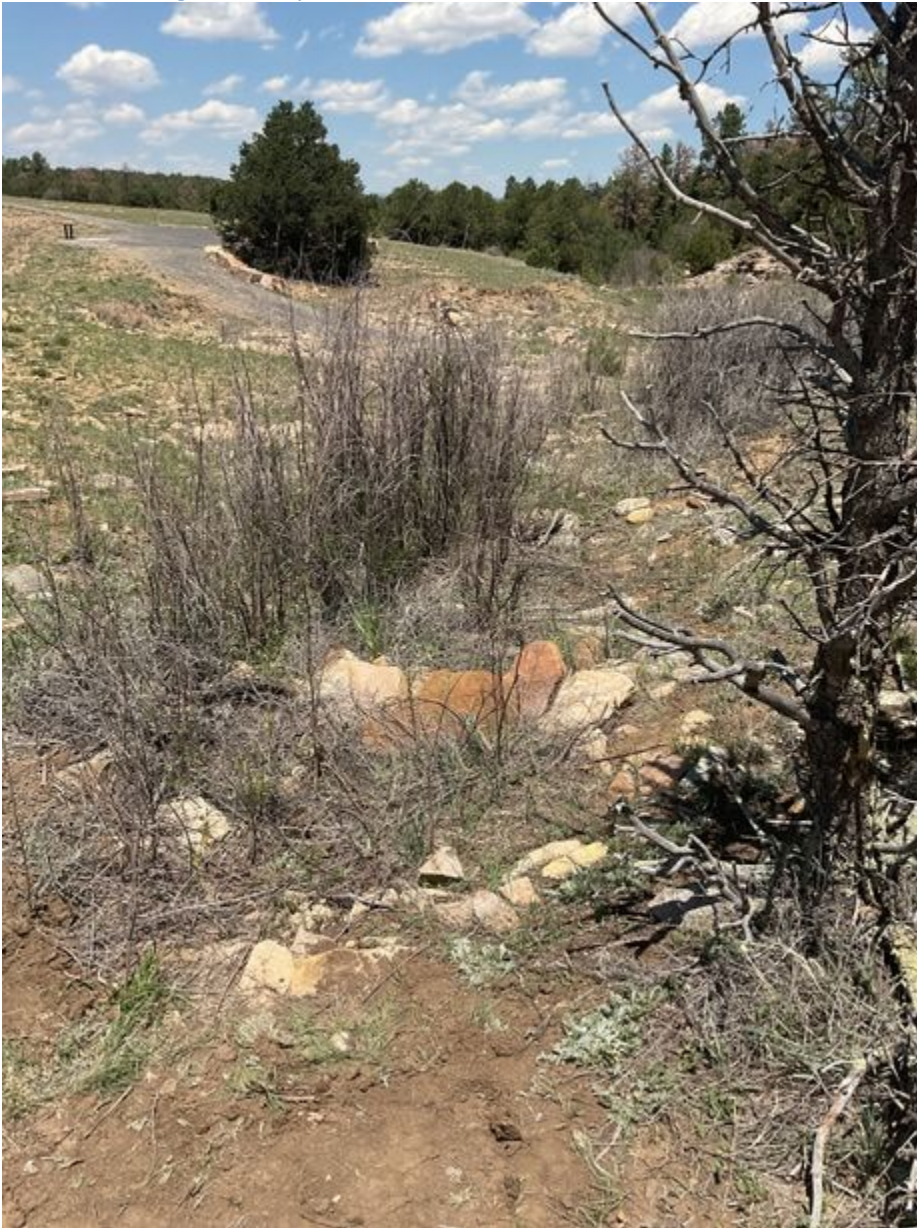
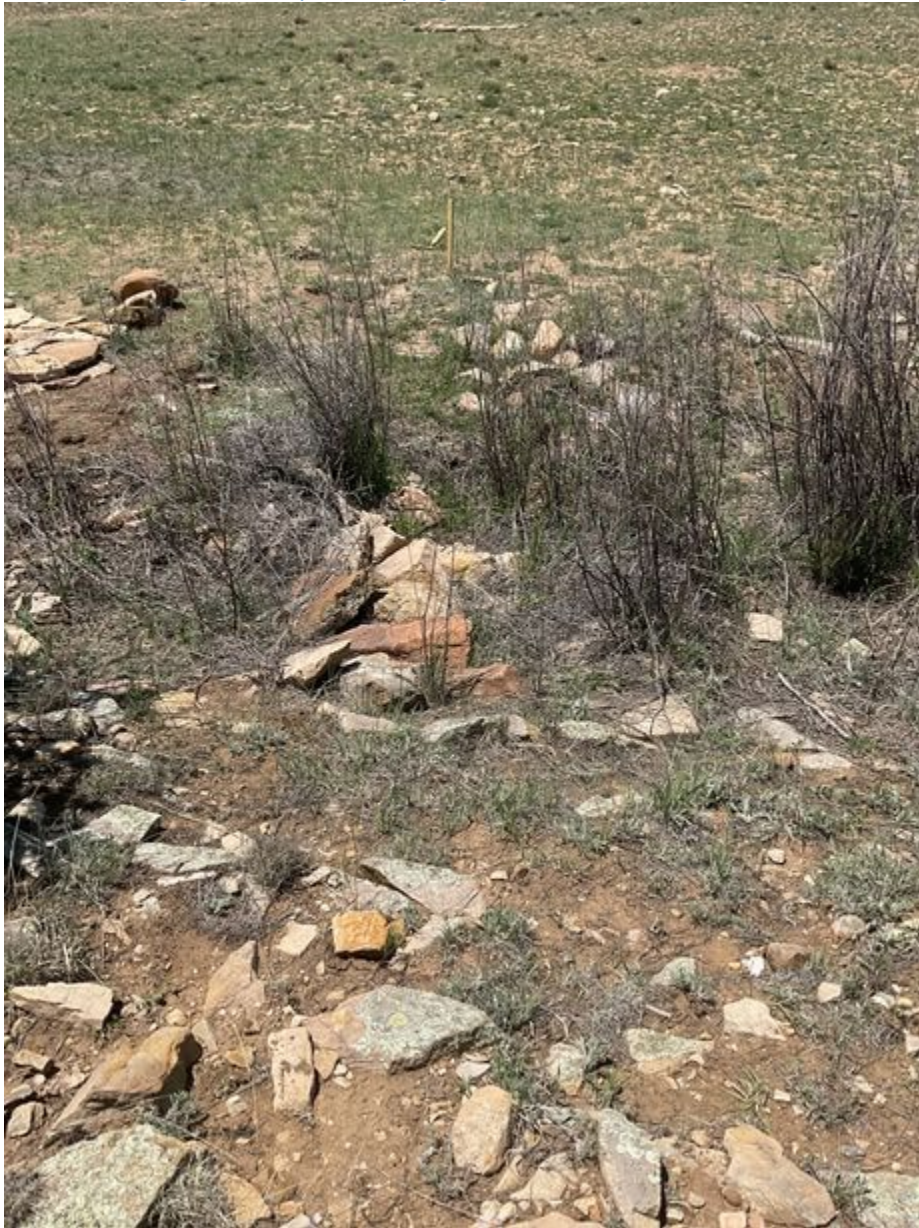
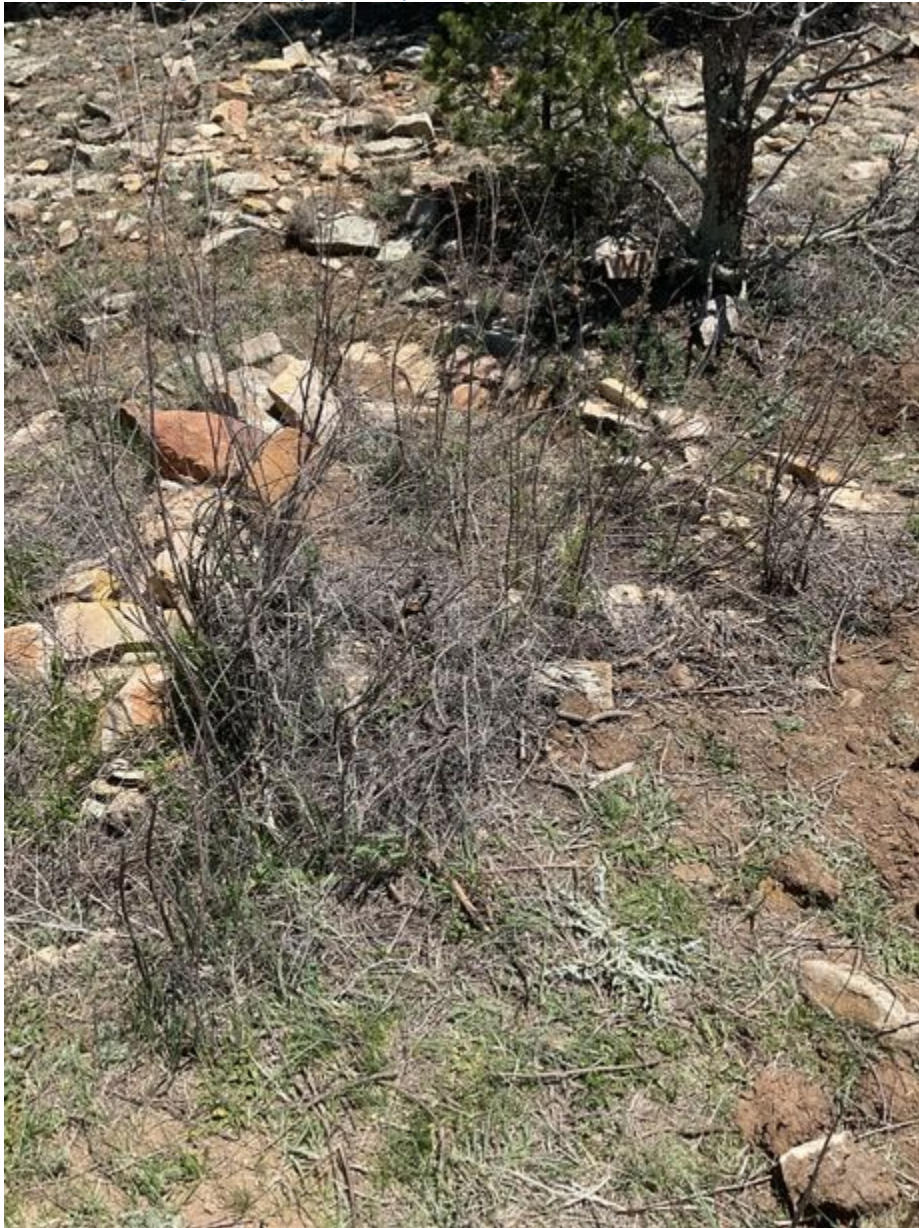
-105.073796 35.83369238

All rocks intact

Difference between ZB and ORD Condition
ORD buried and willow recruitment

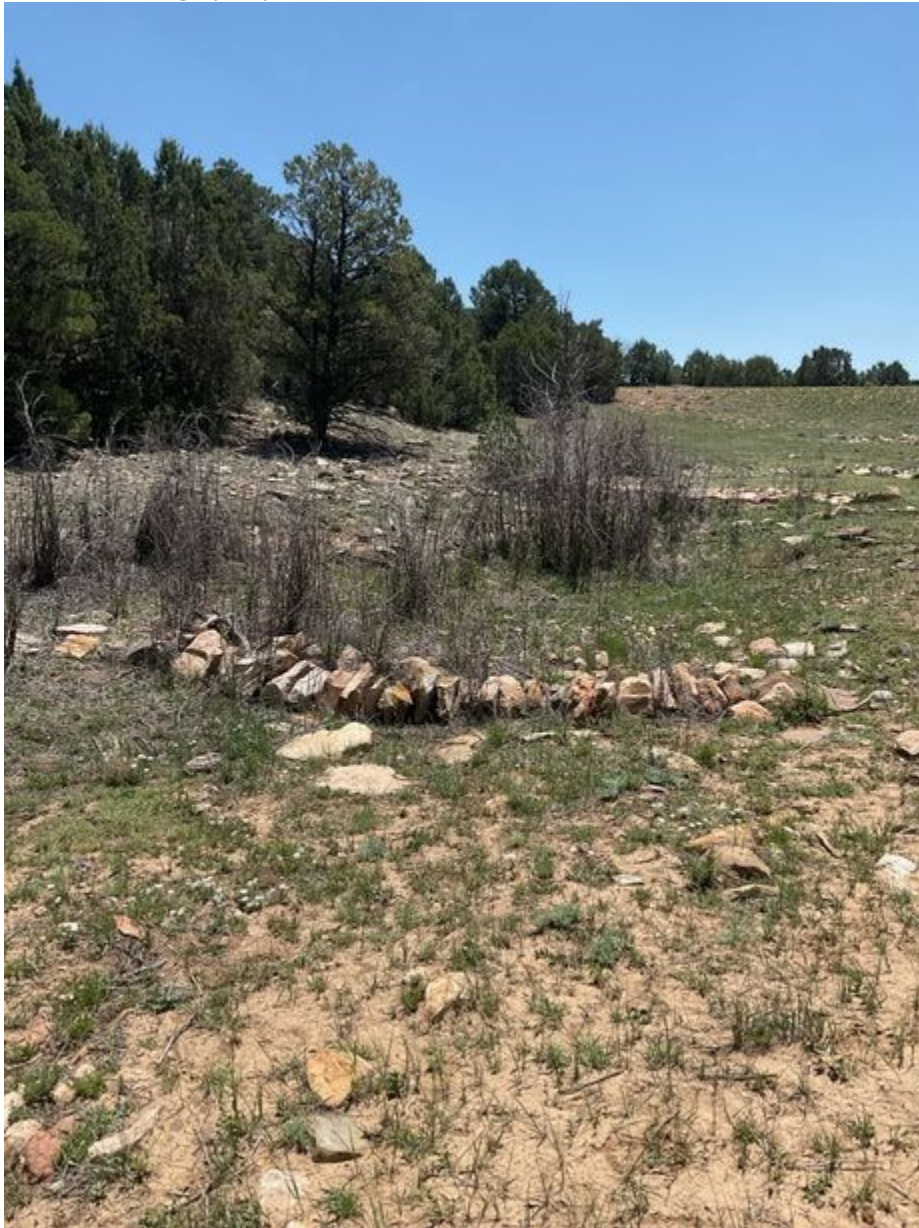
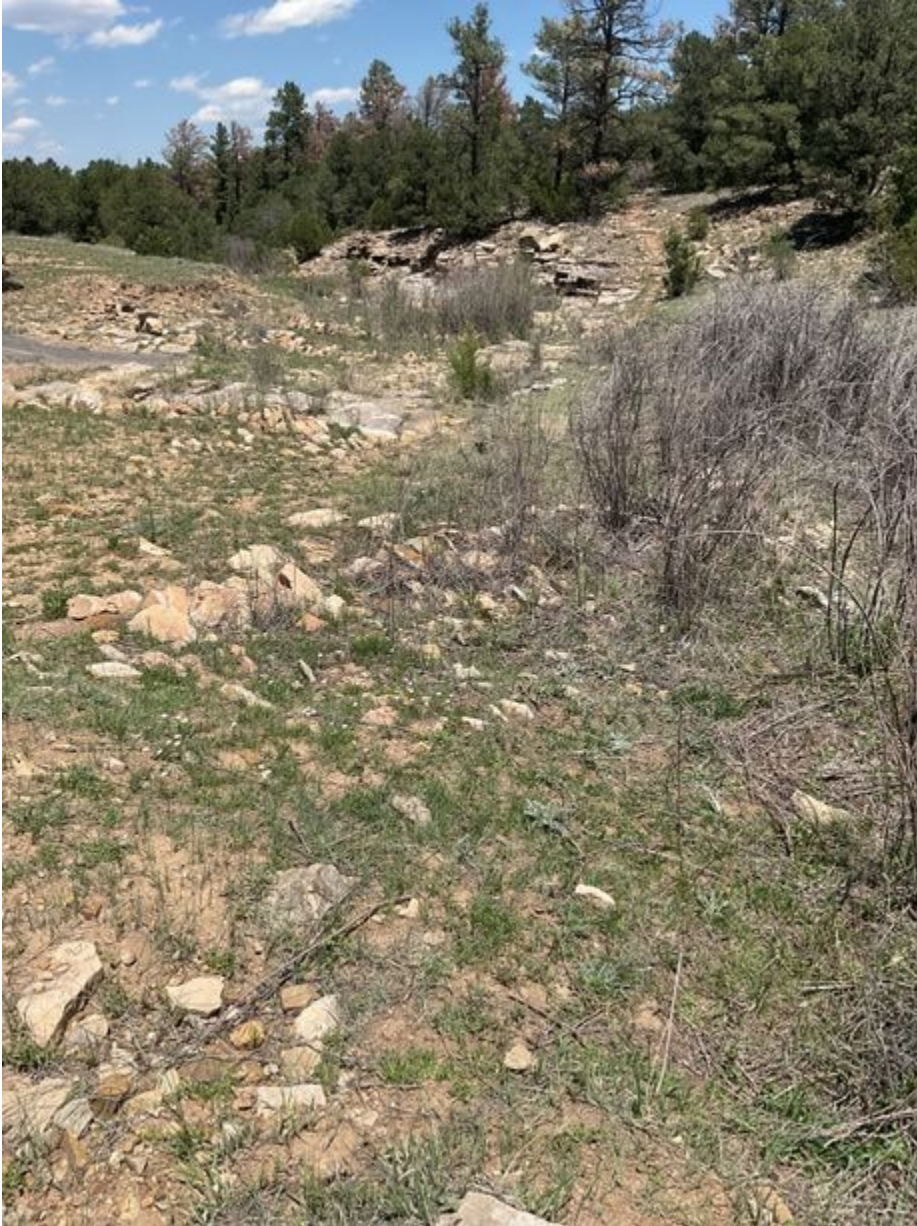
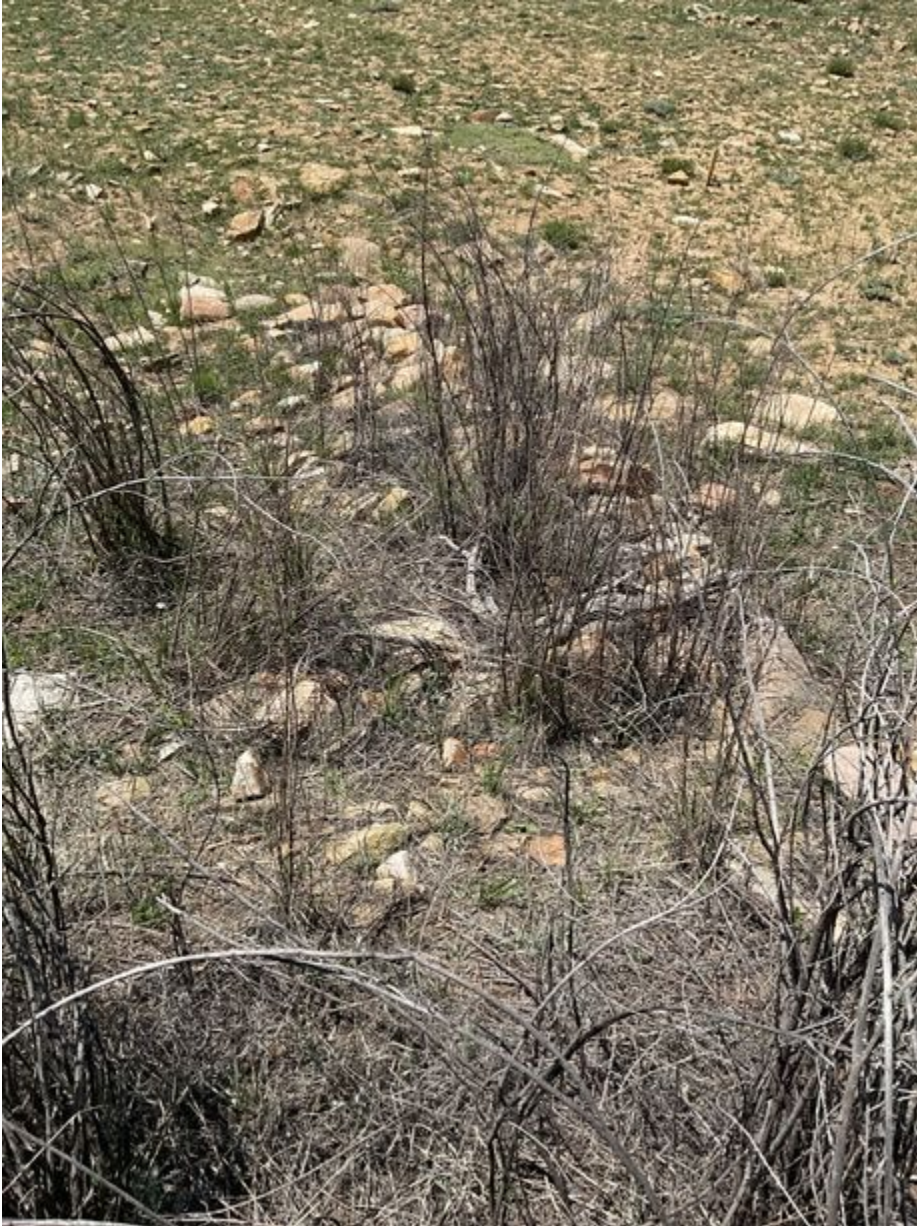
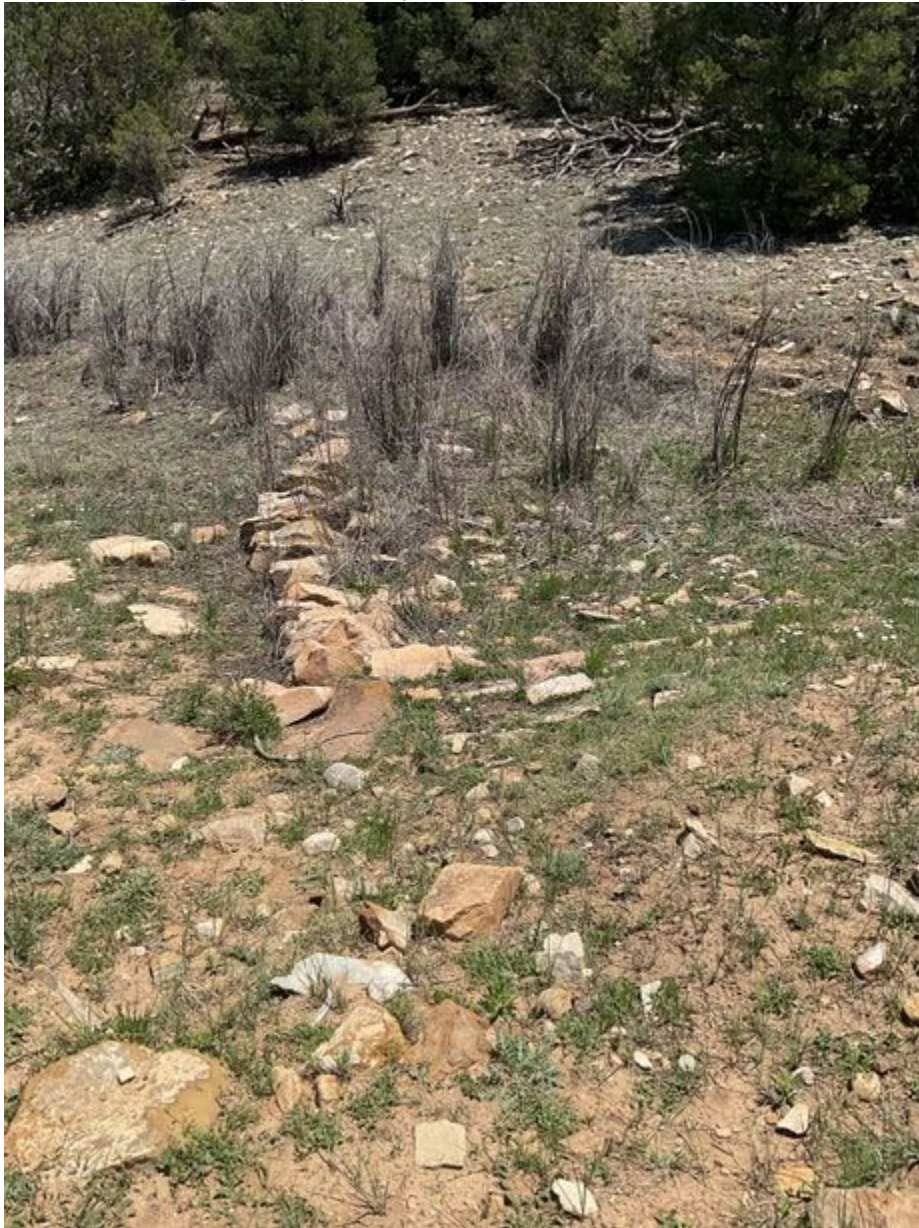
-105.0738315 35.83372785

All rocks intact

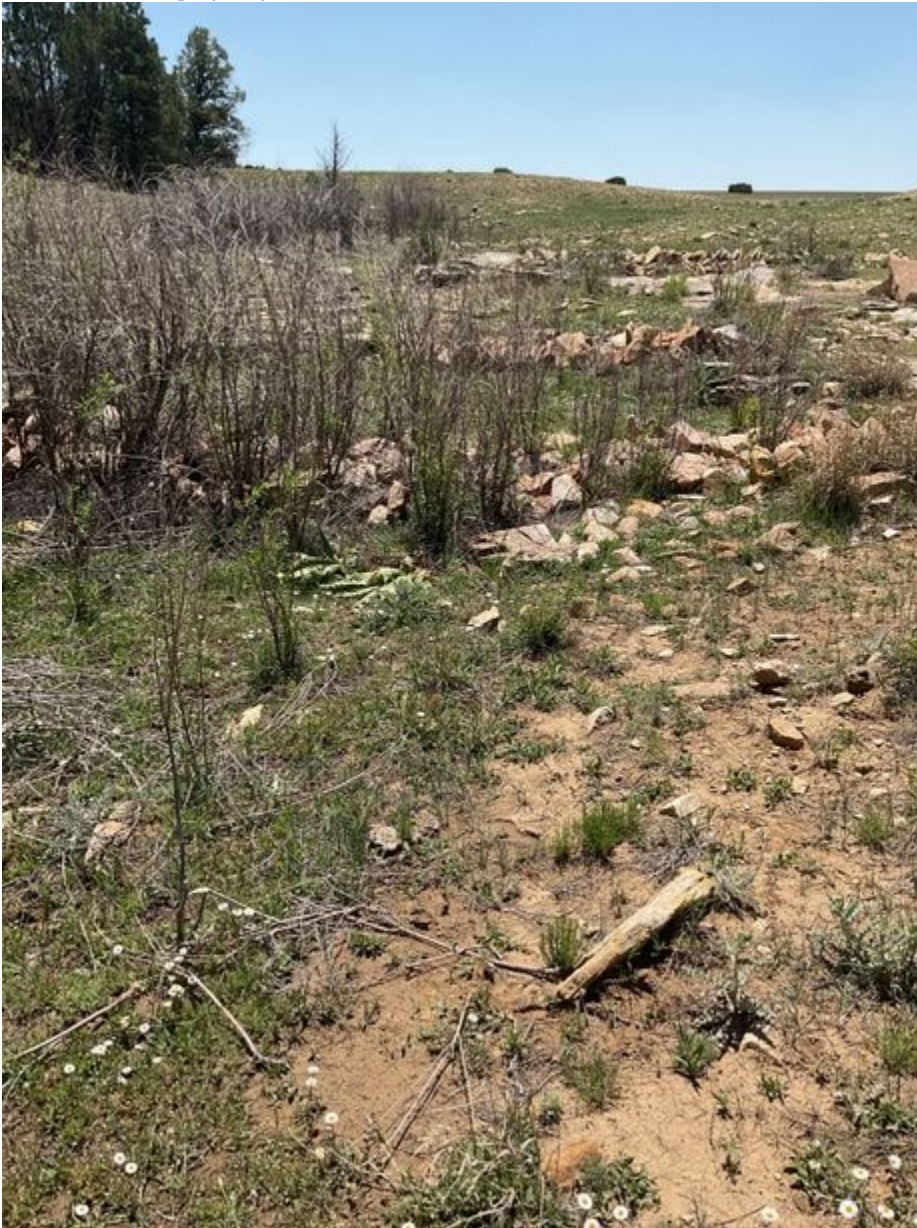
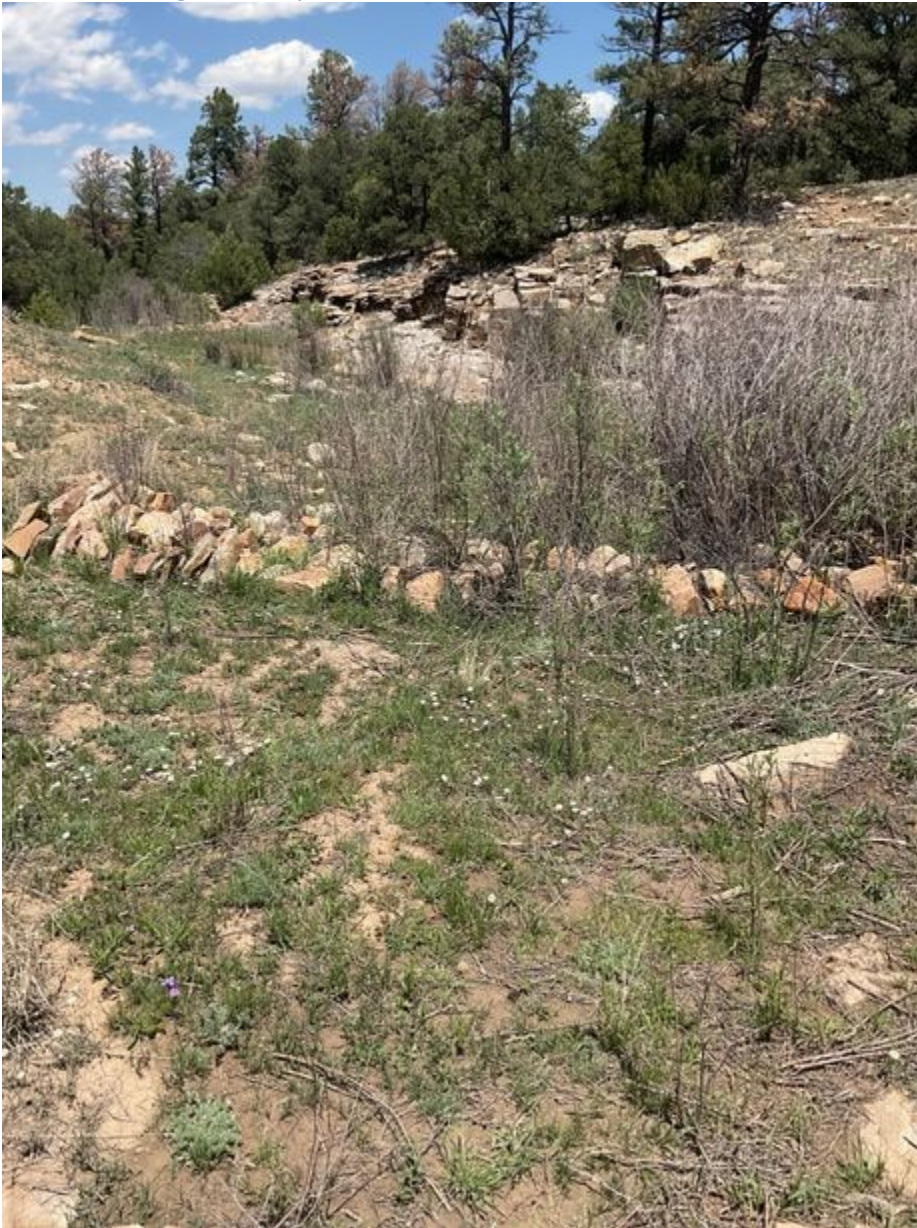
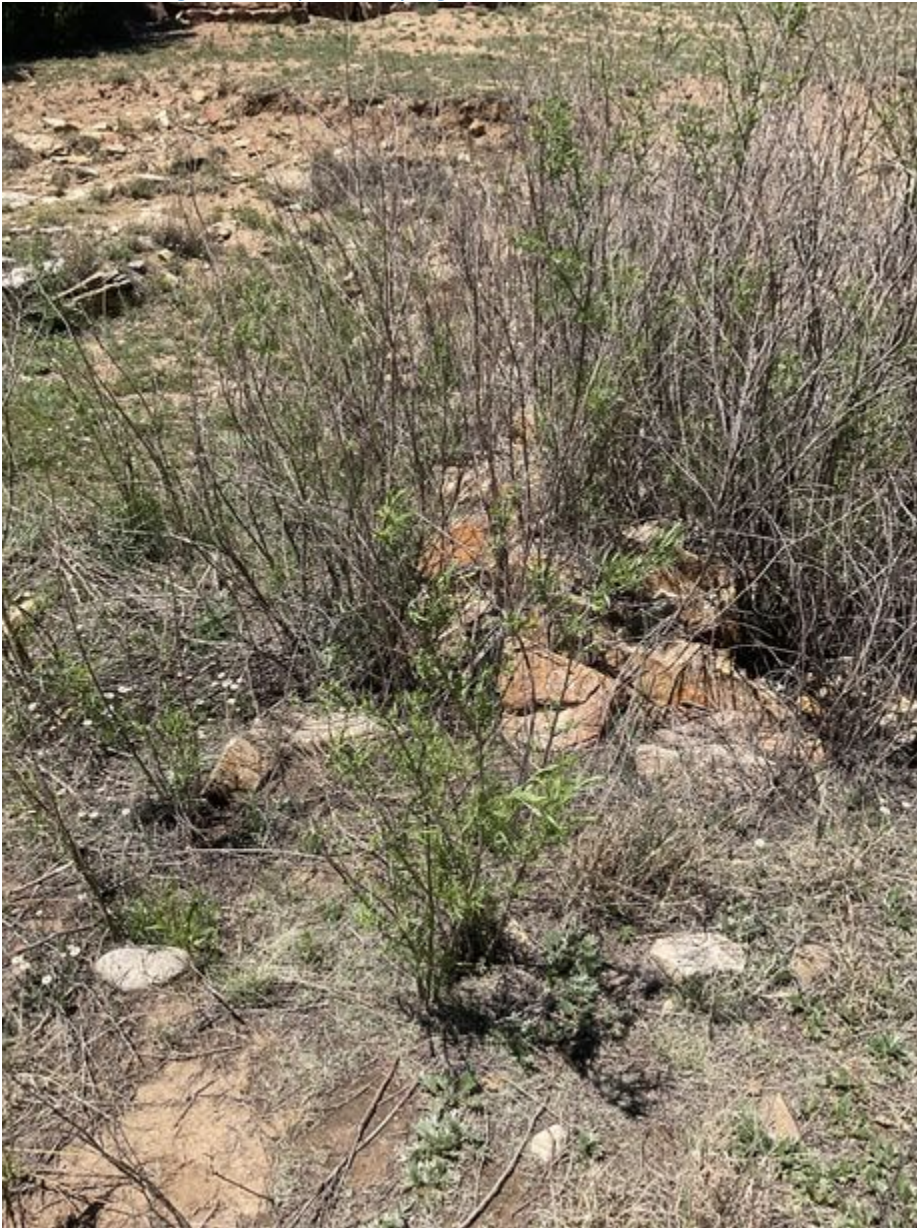
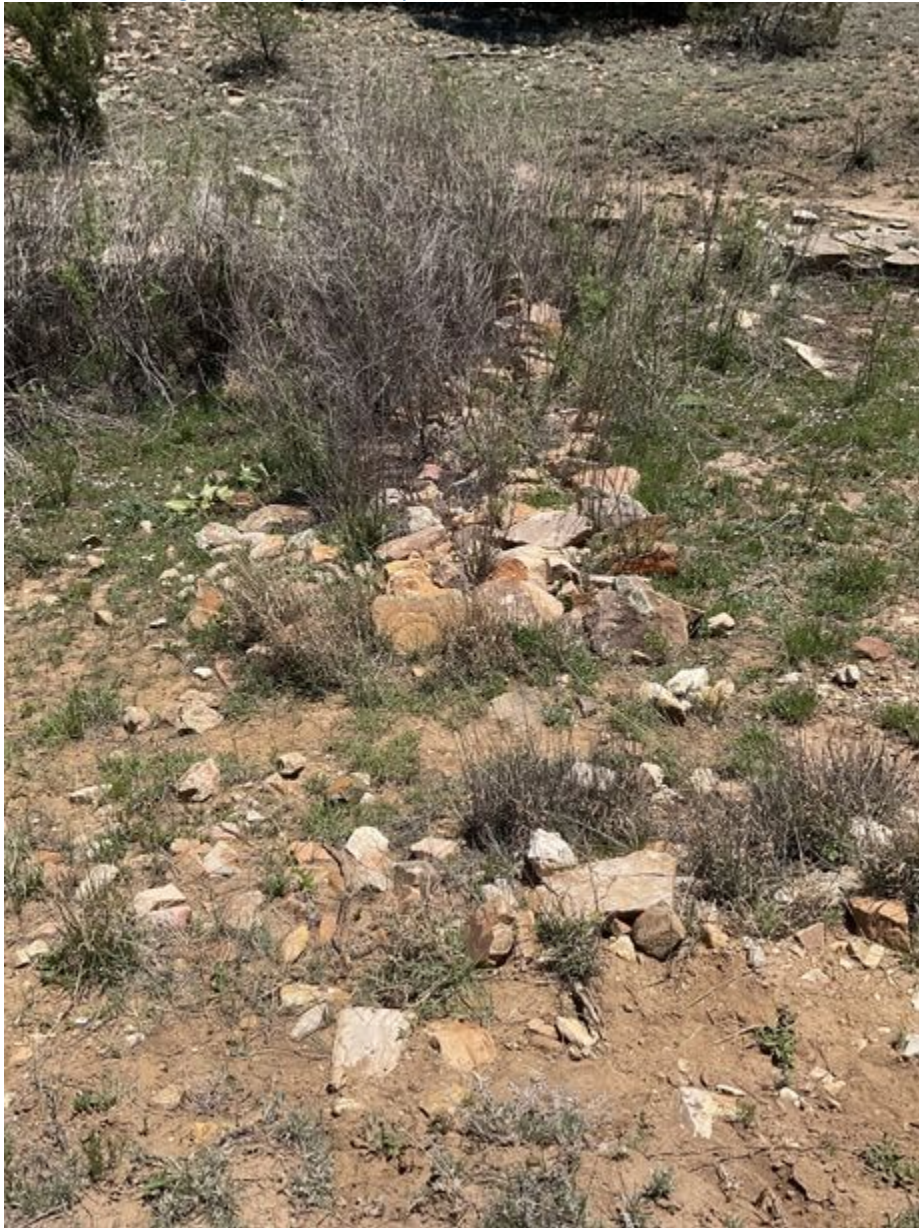
-105.0737952 35.83389832

All rocks intact

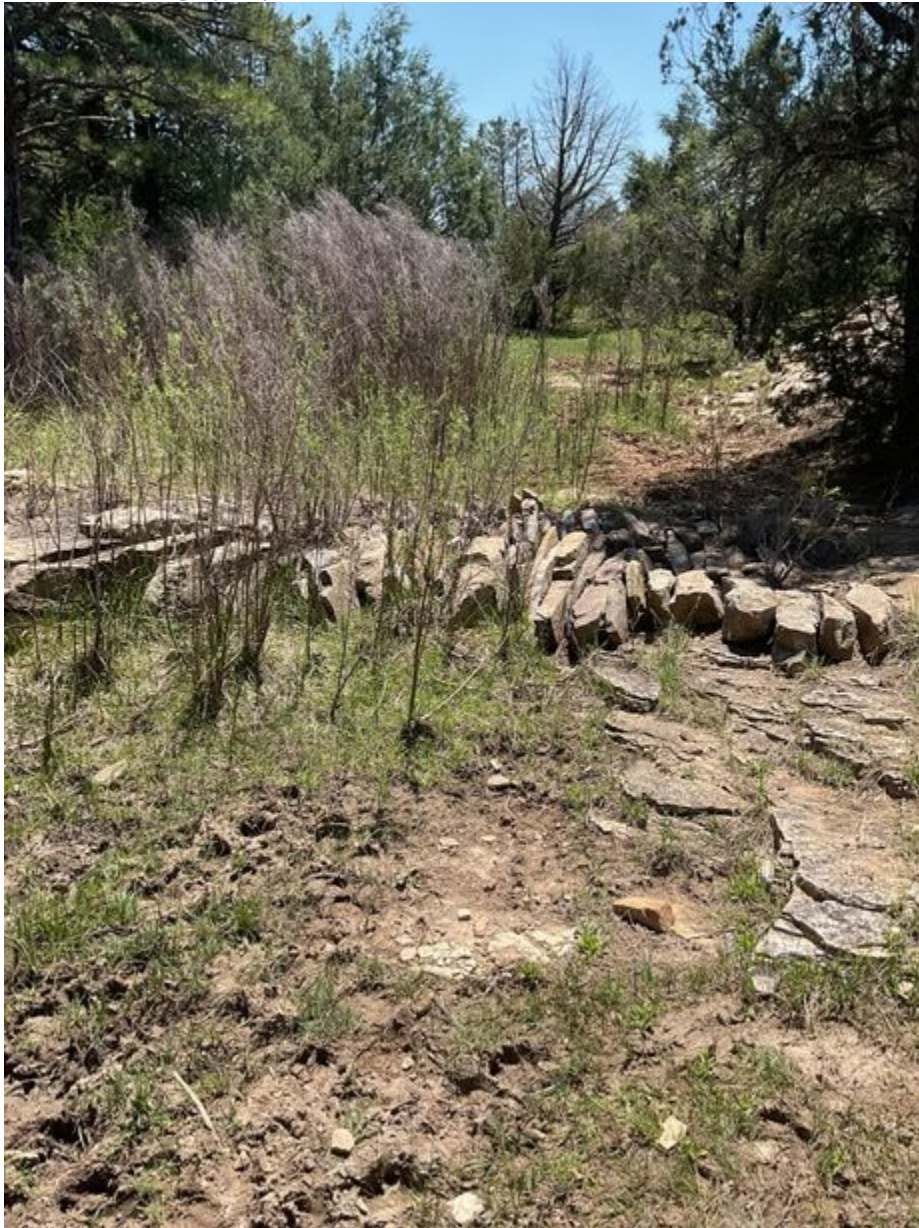
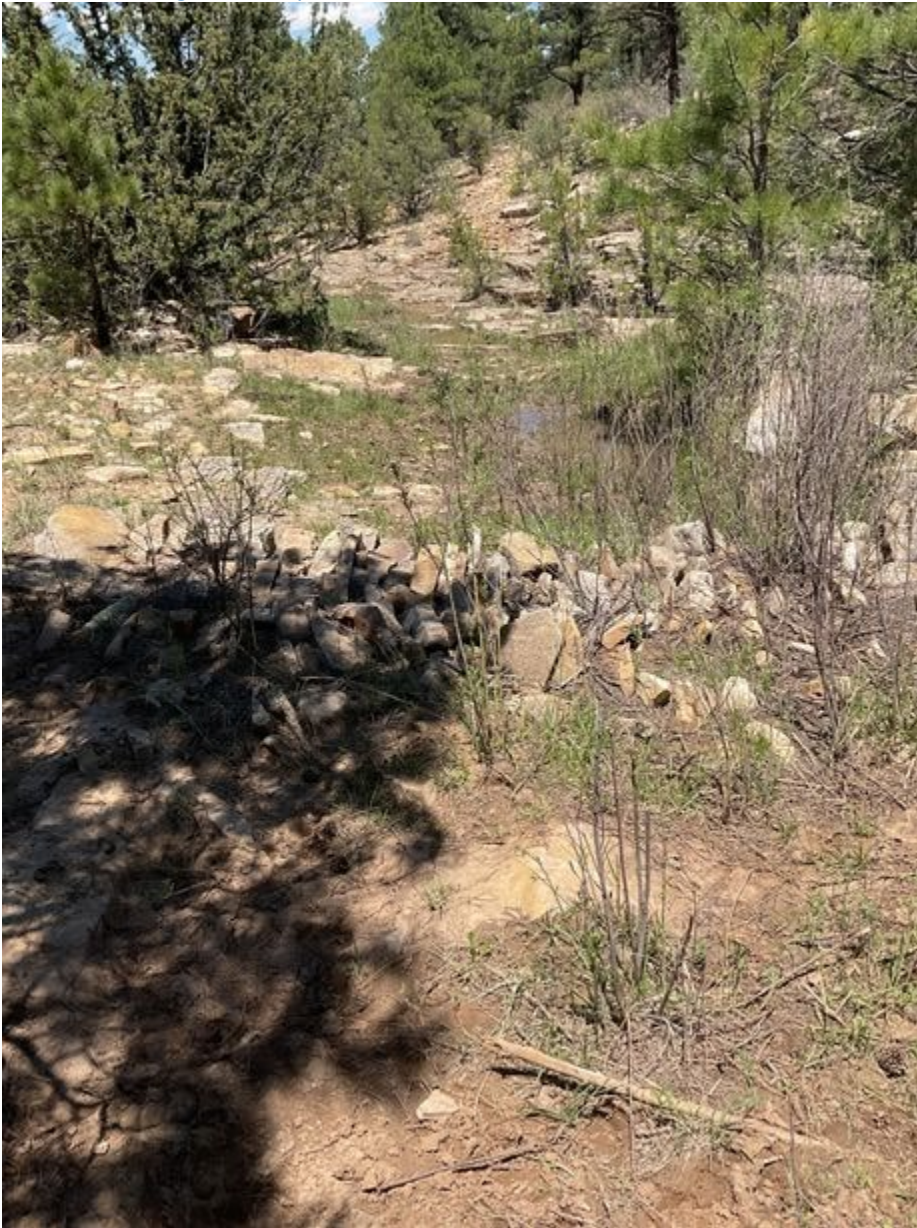
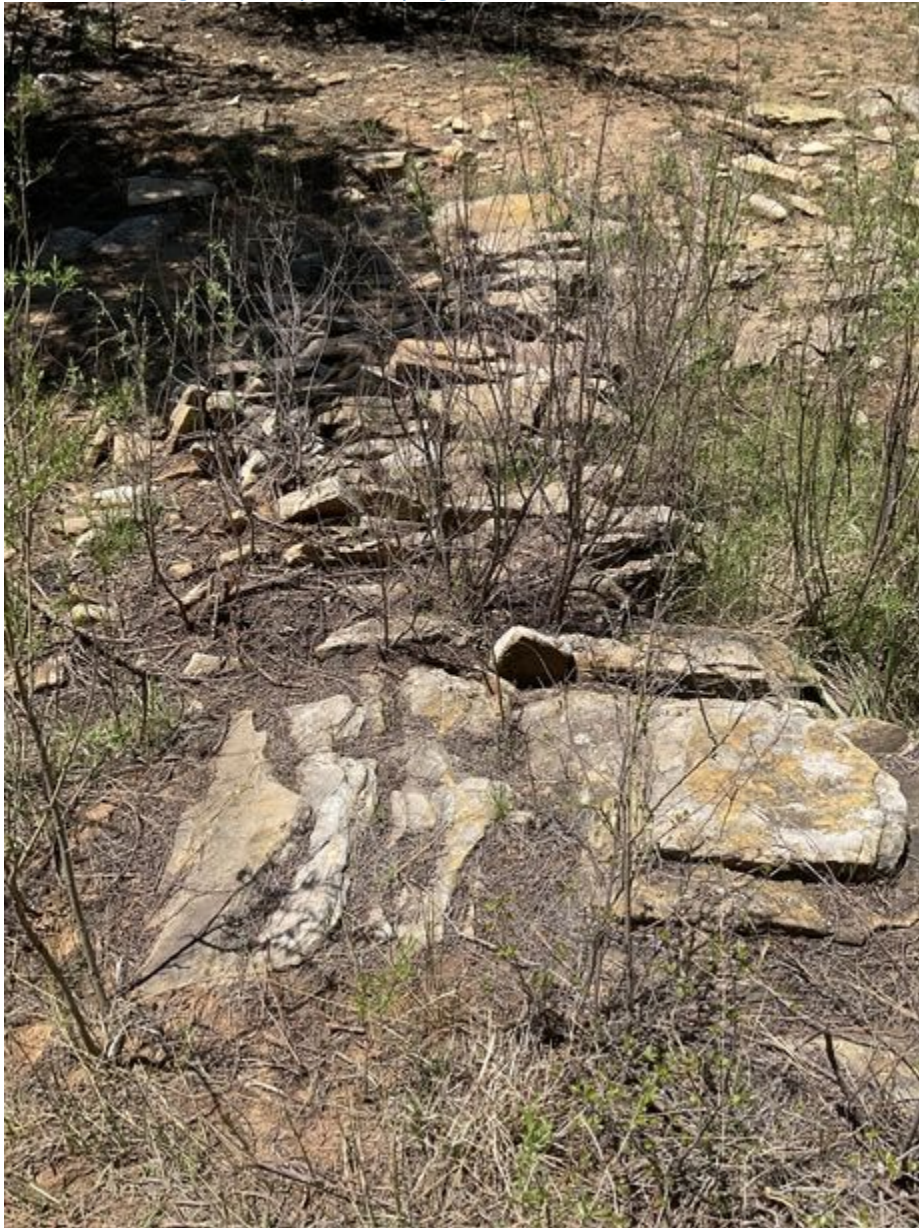
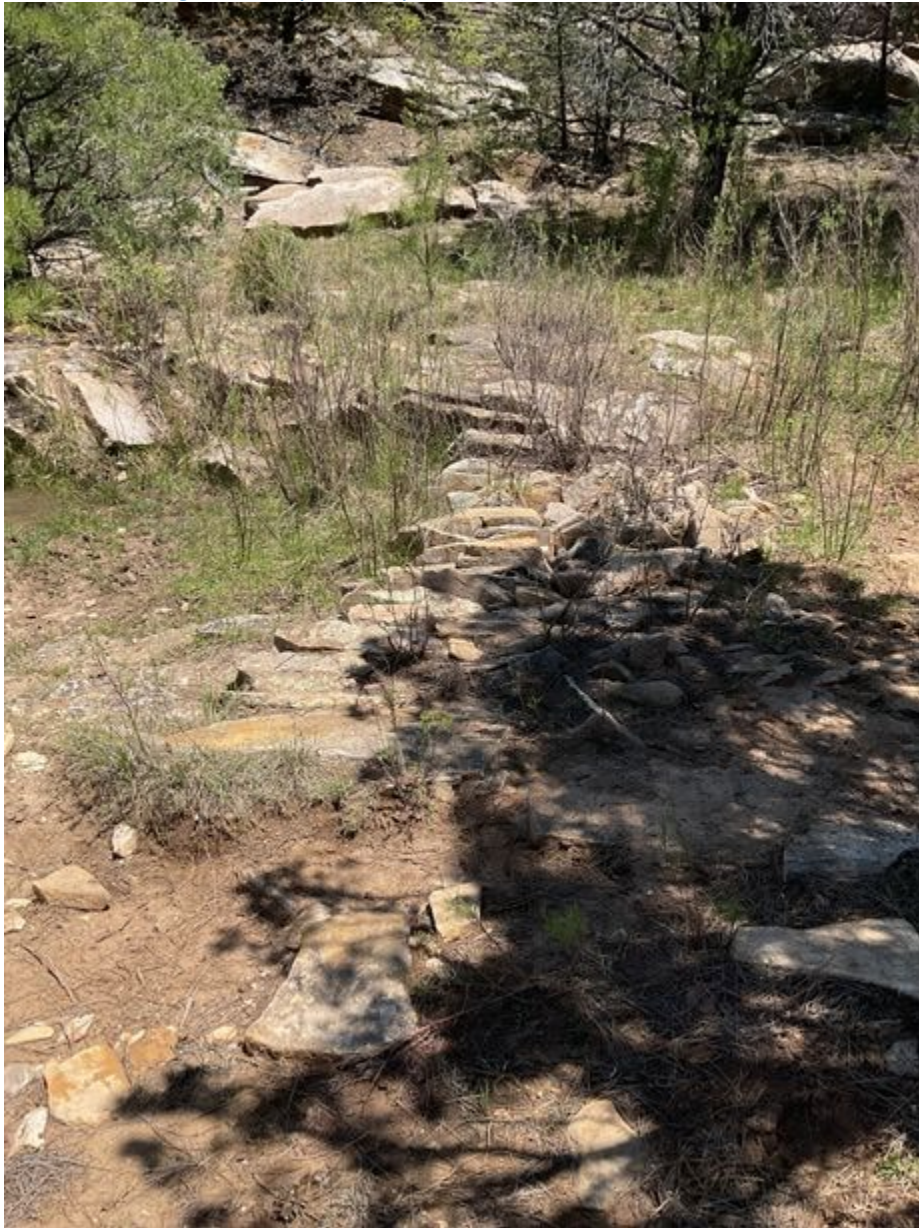
All rocks intact
