CN R924060

**Zuni Bowl and One Rock Check Dam Research –
Phase 1**

Final Report

Rio Grande Return for the New Mexico Department of Transportation Research Bureau

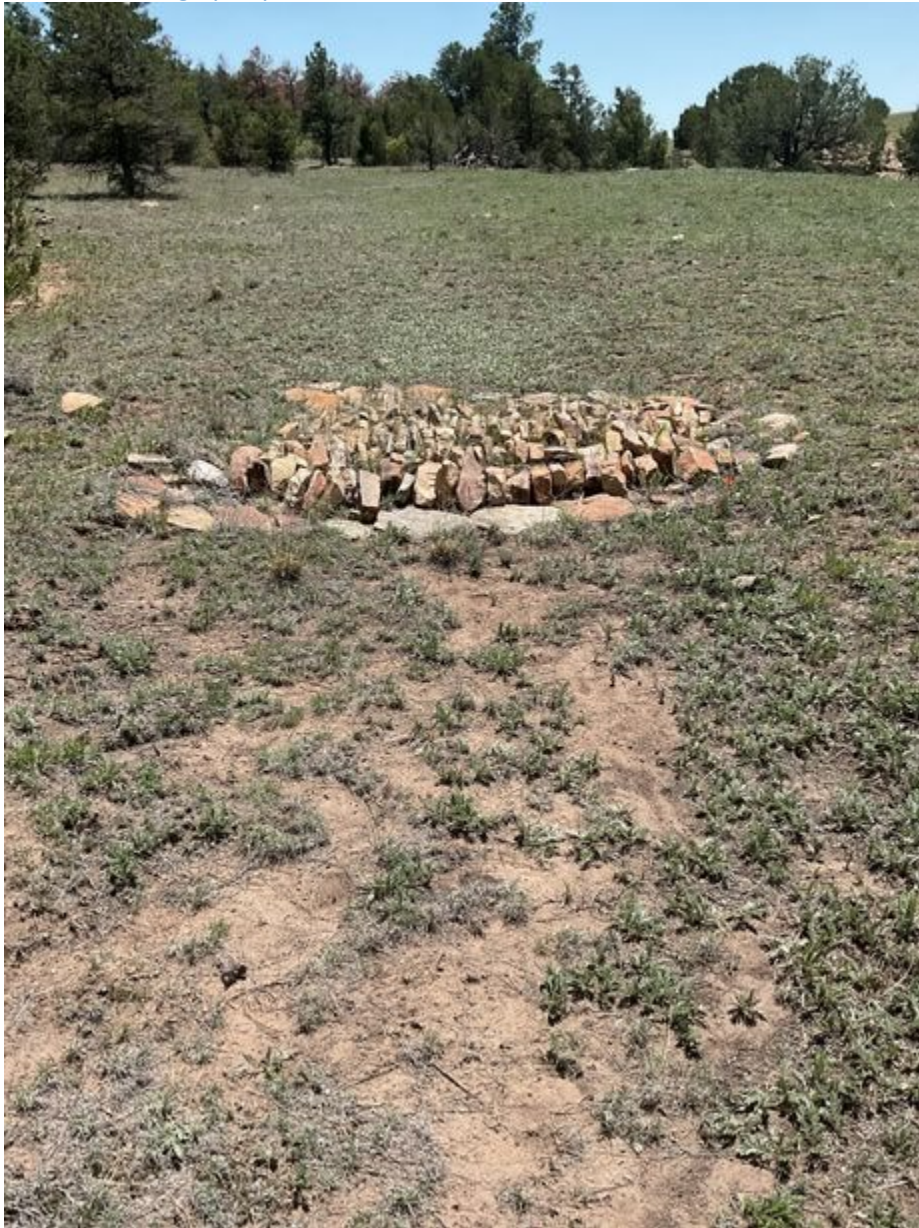
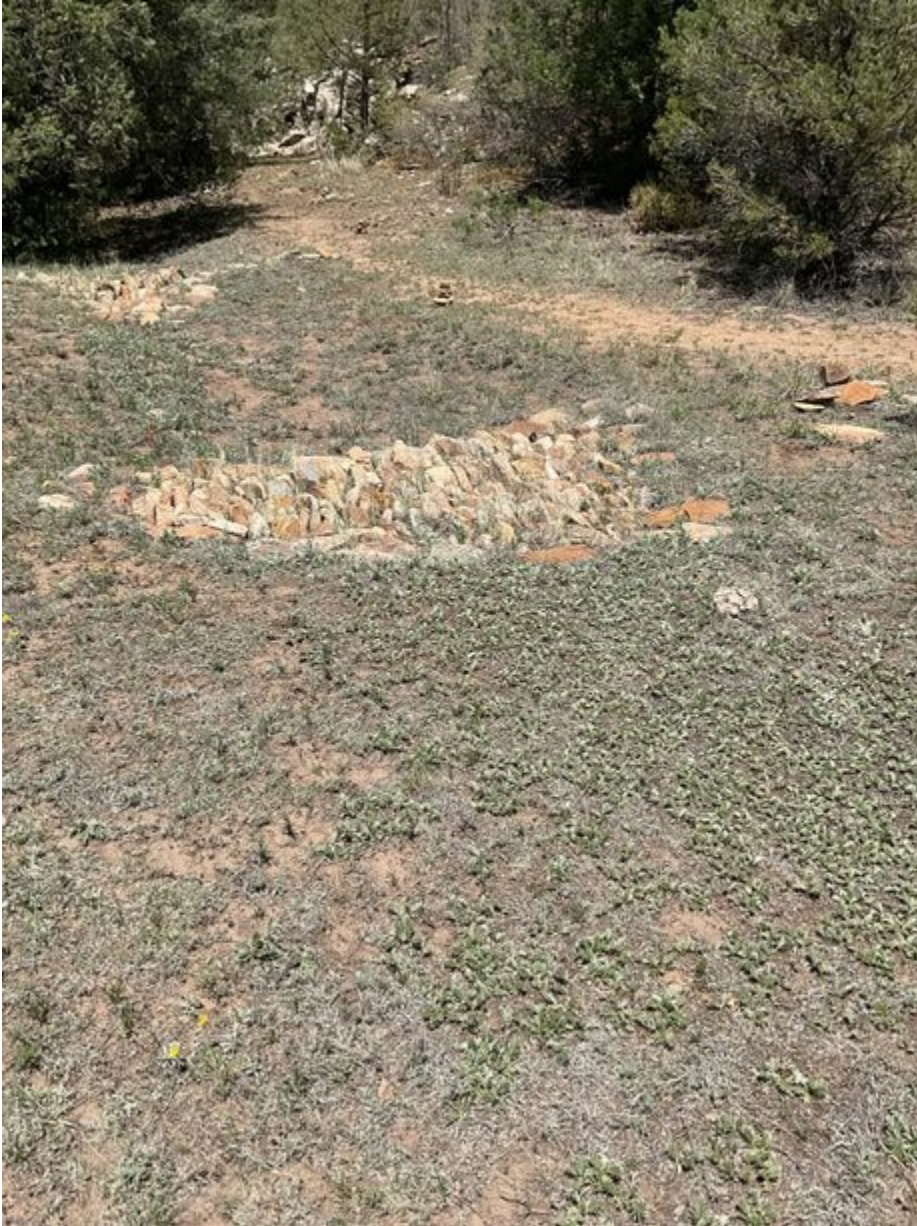
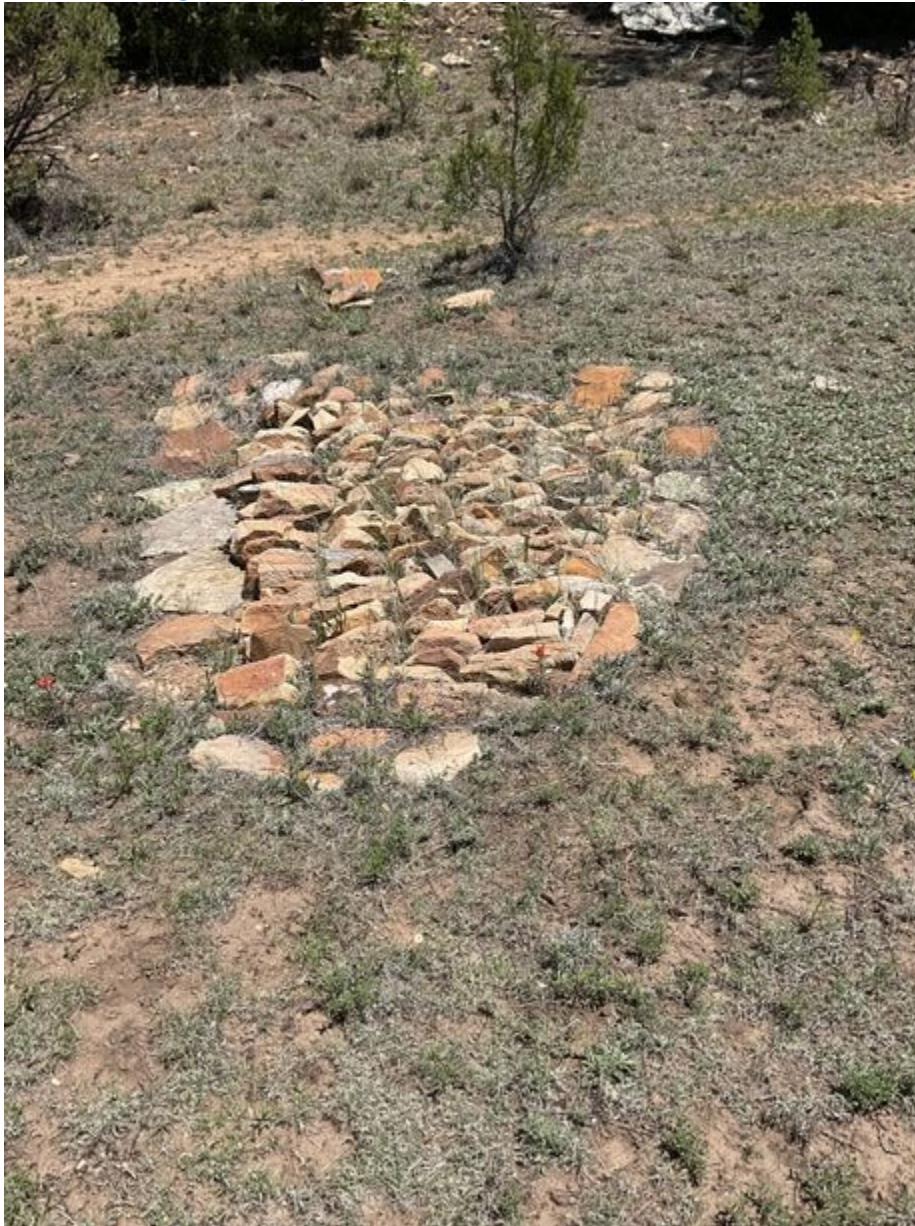
All rocks intact

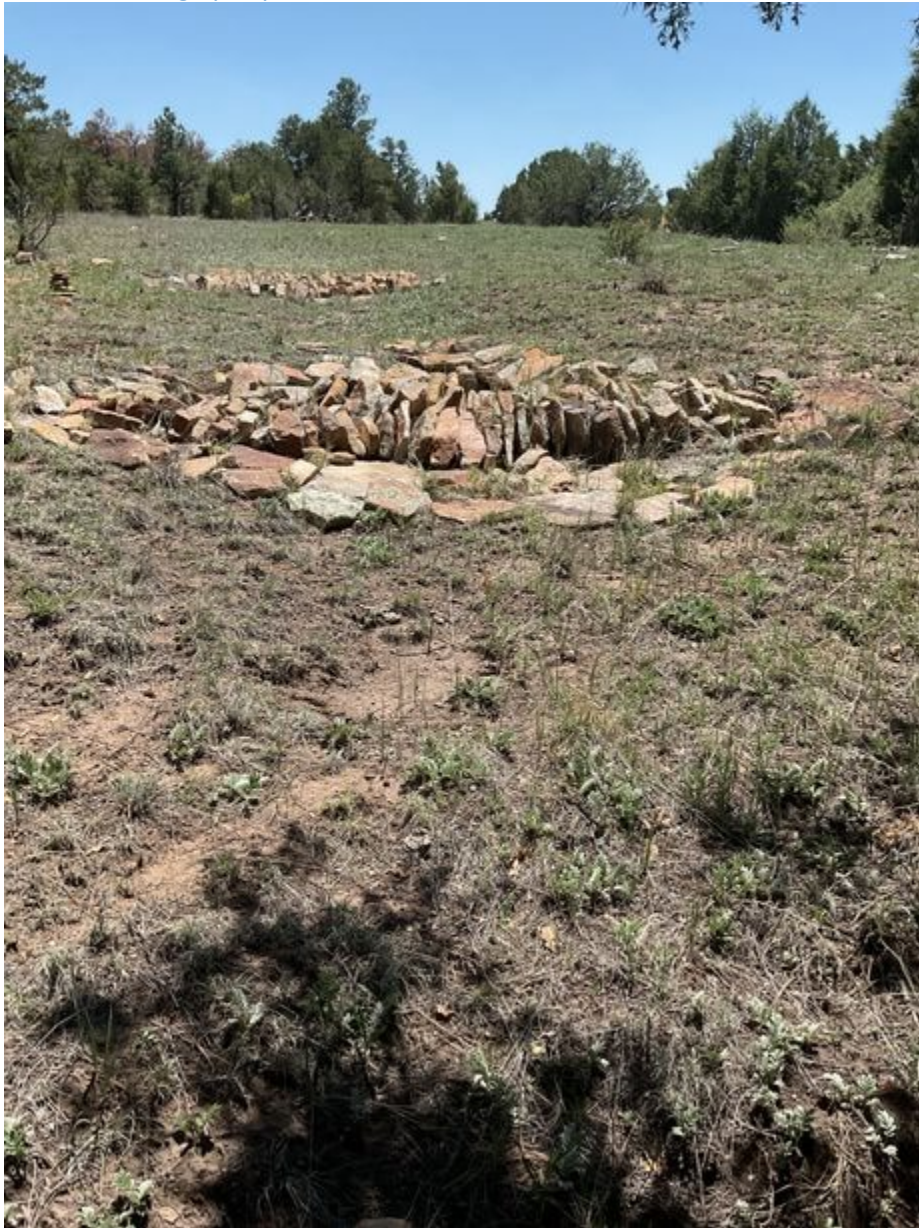
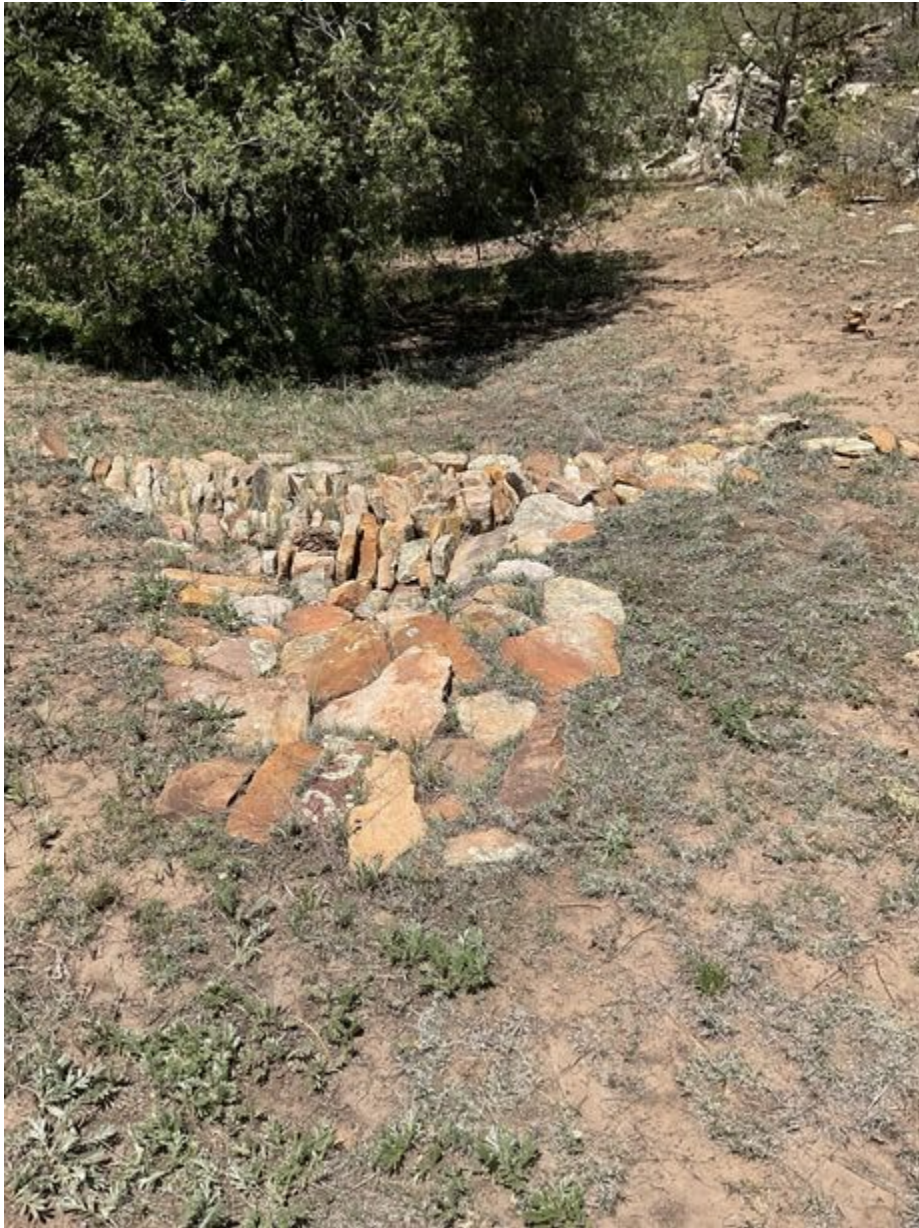
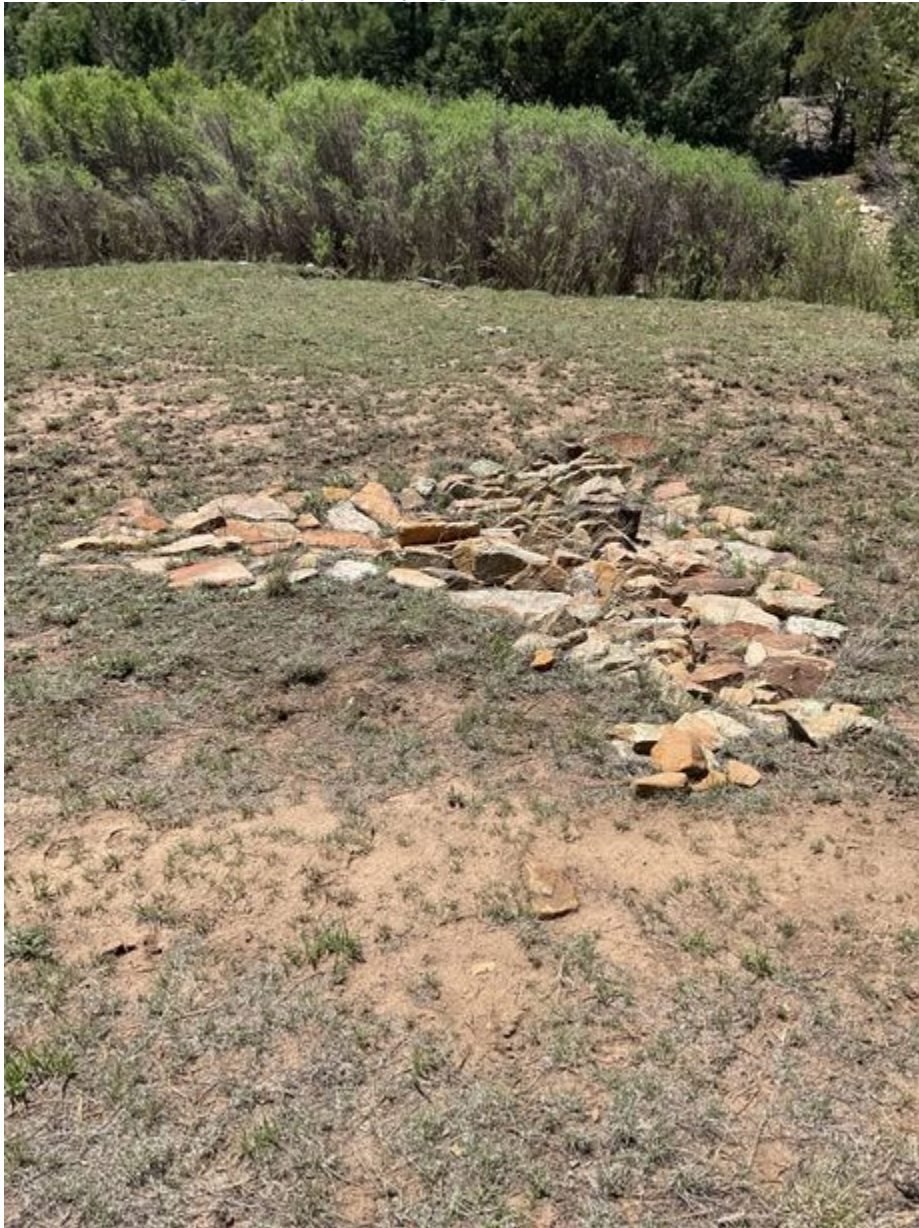
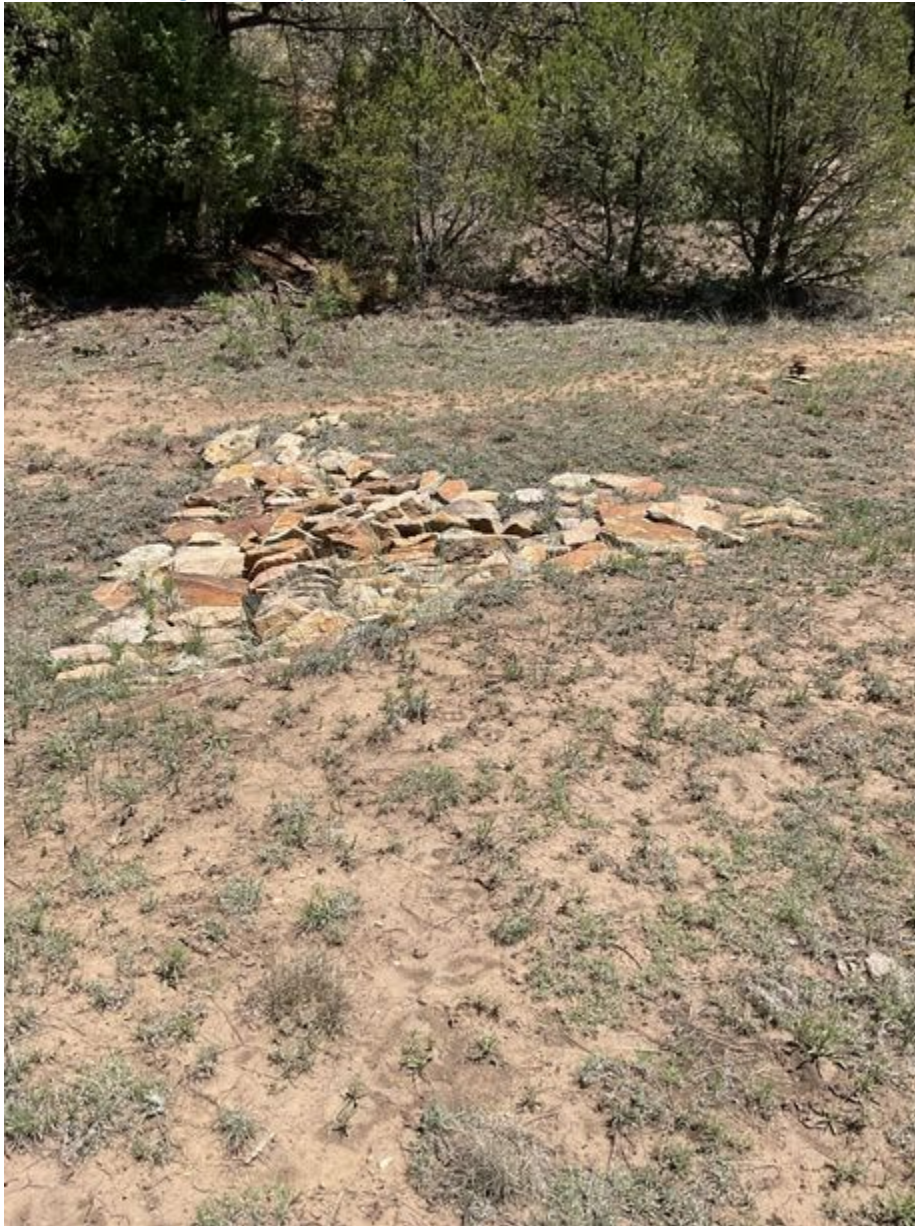
All rocks intact

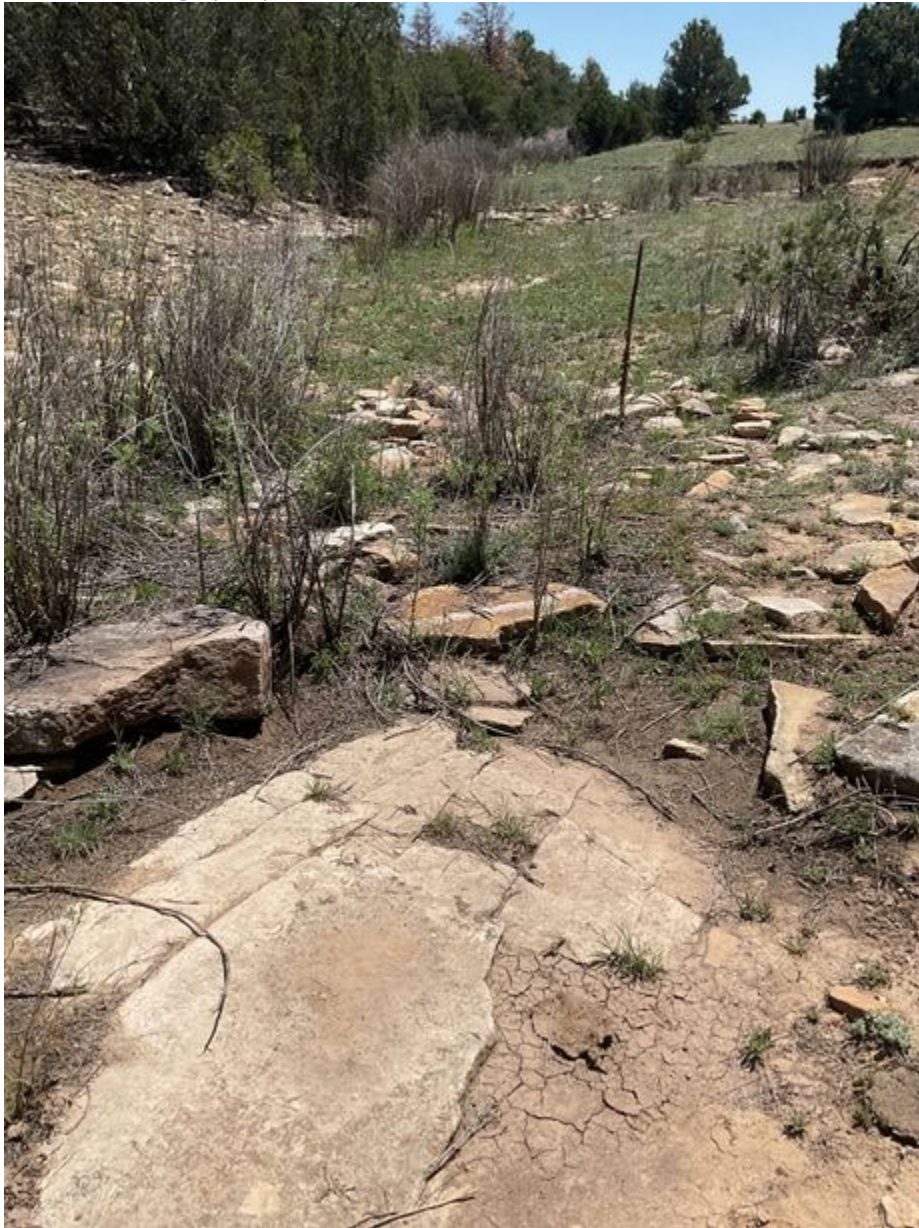
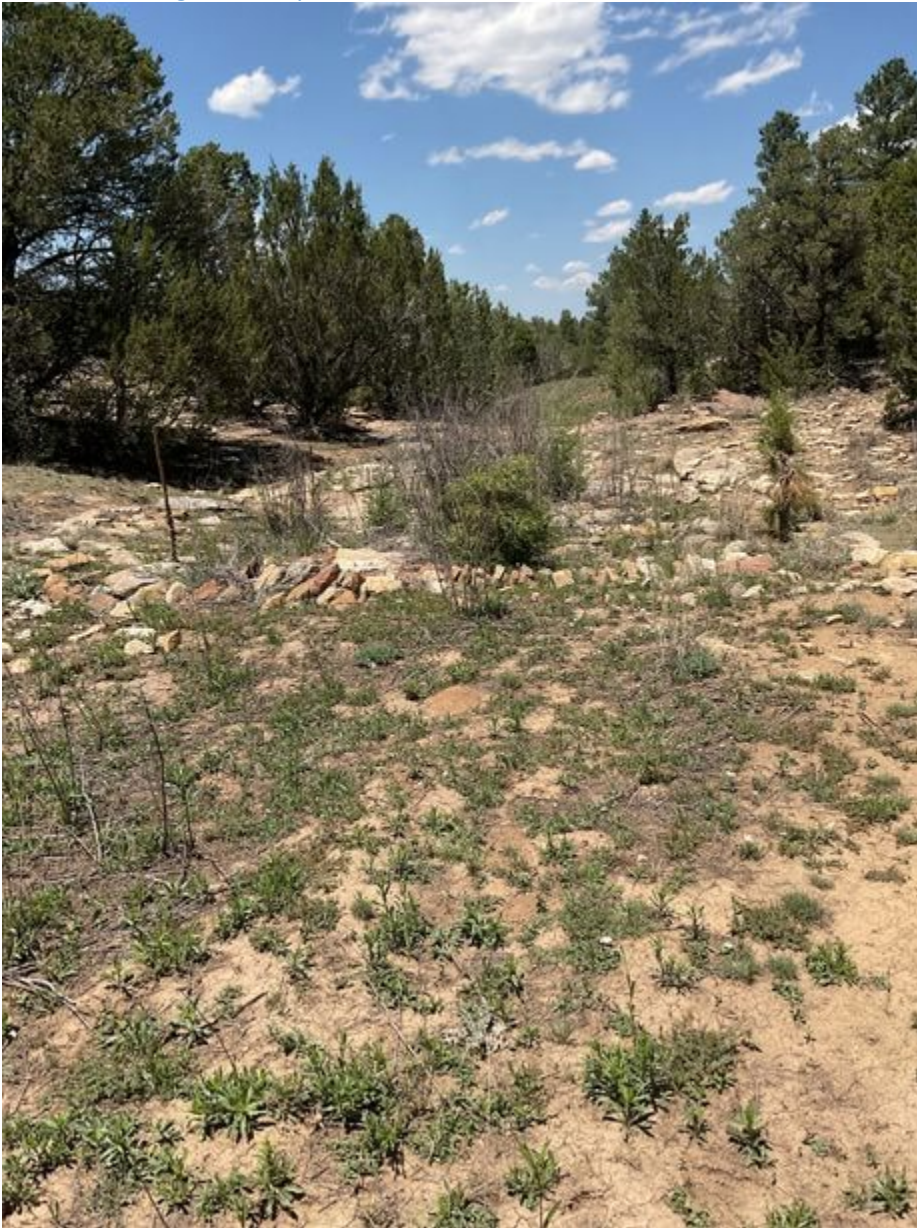
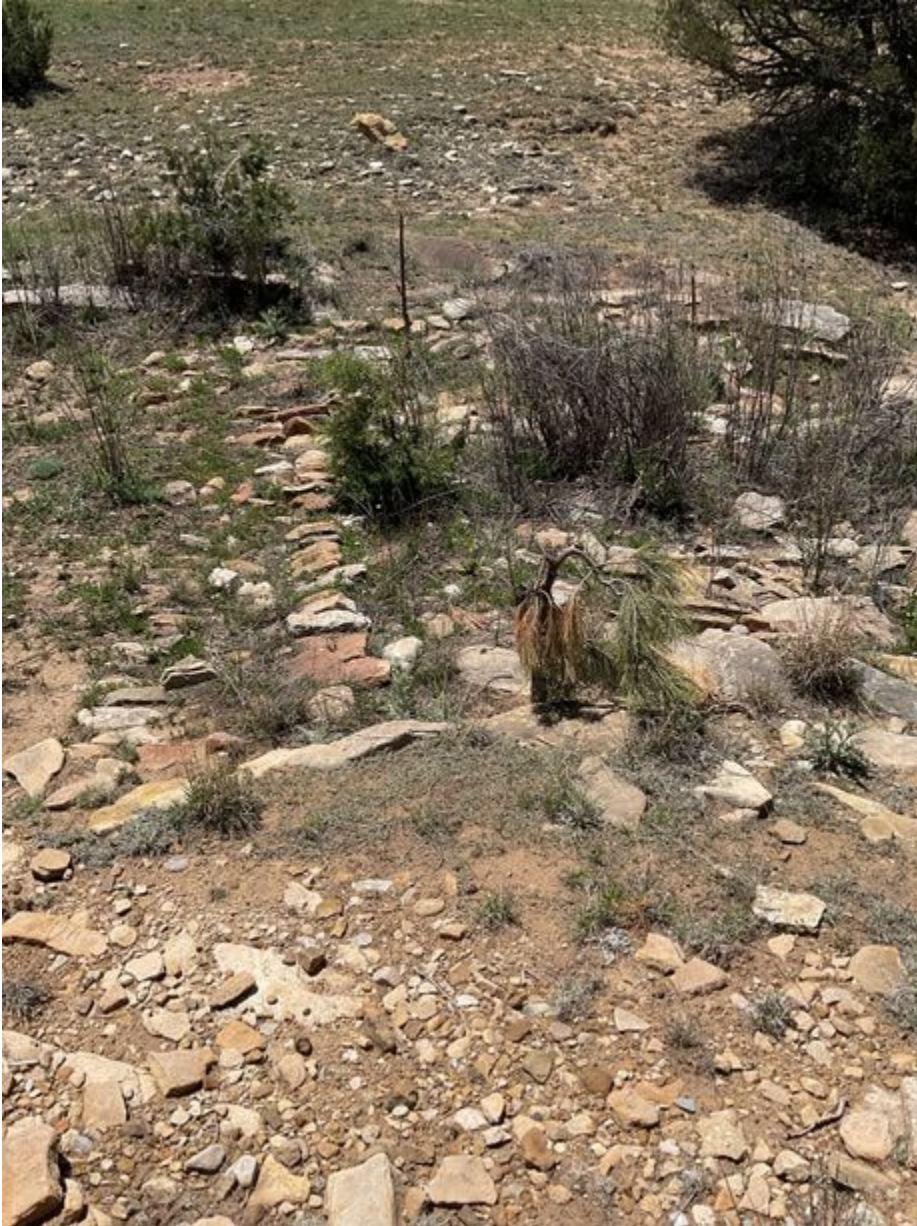
Some rocks dislodged or broken

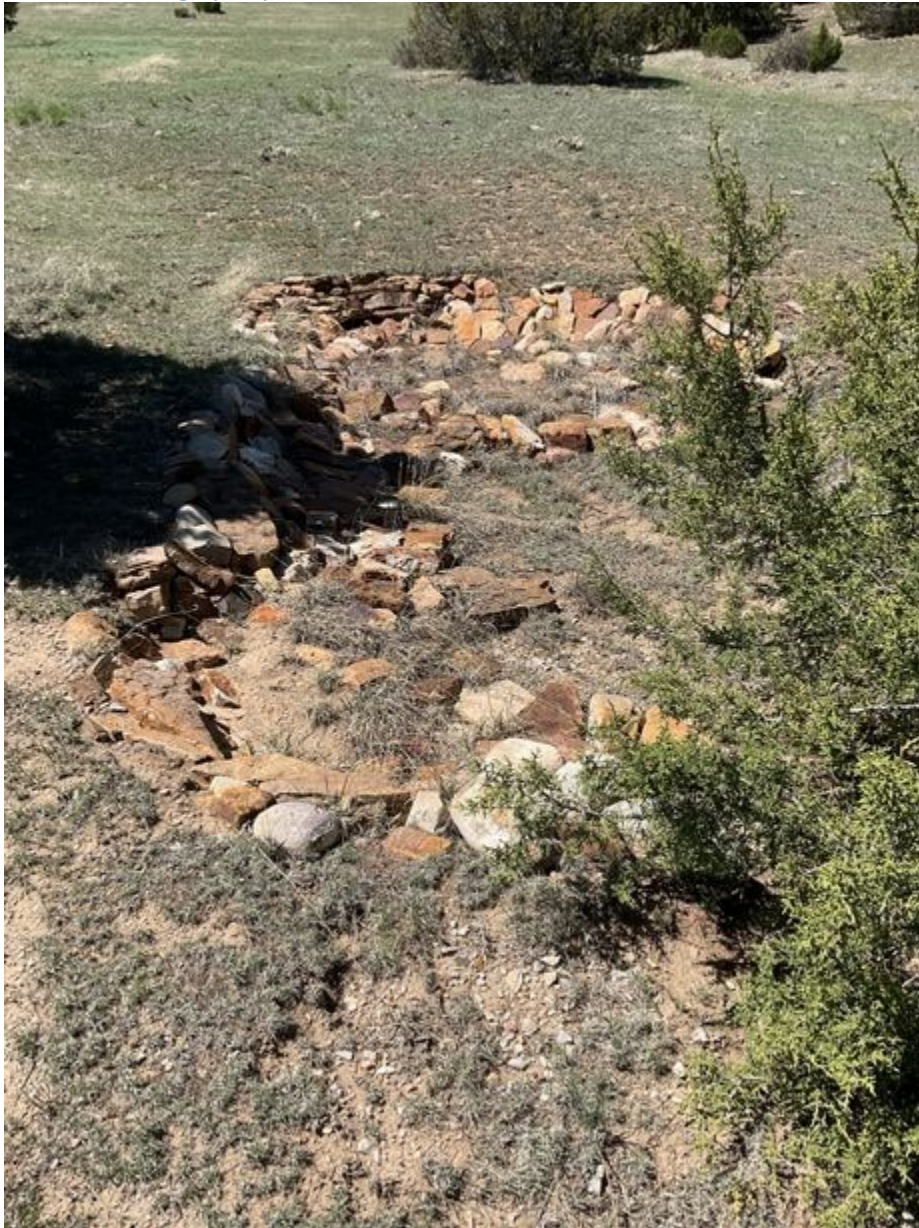
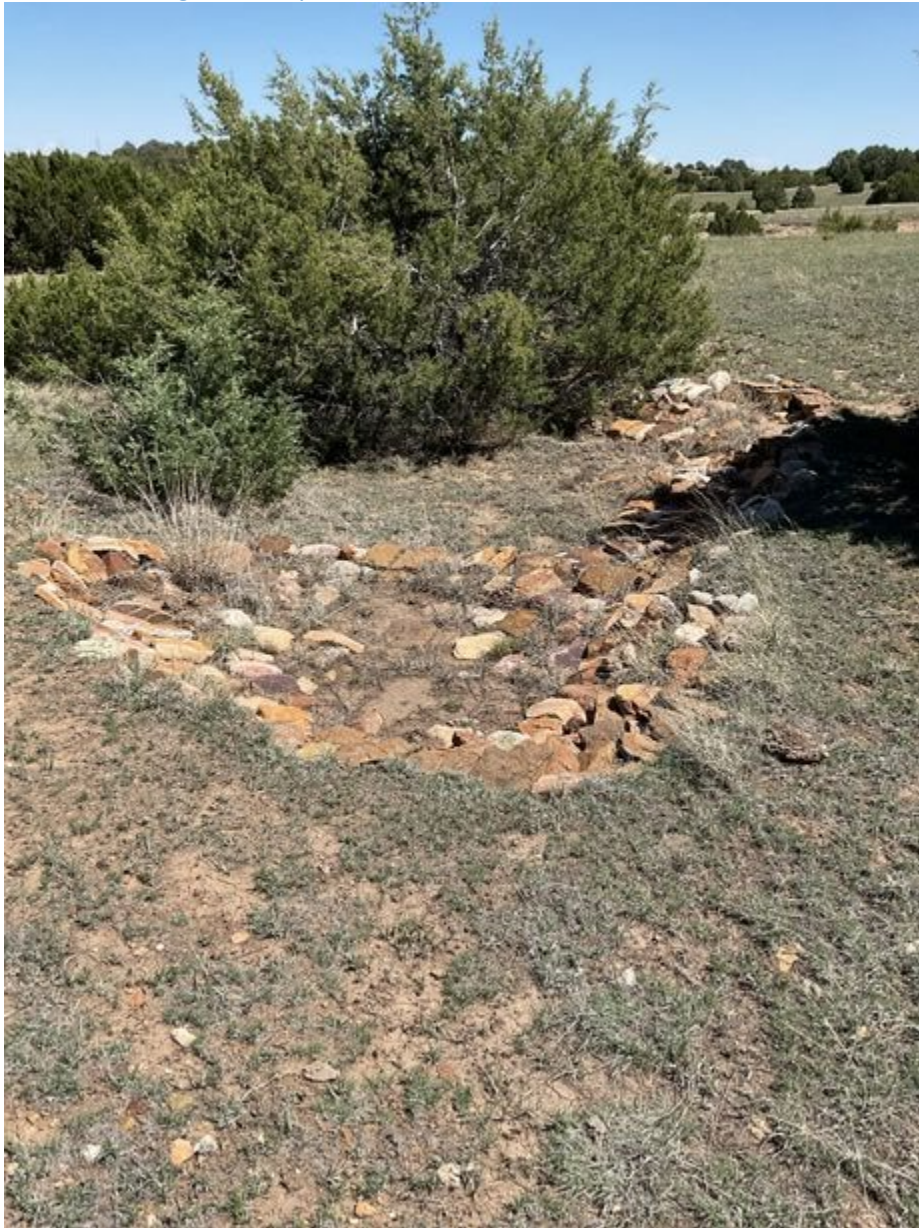
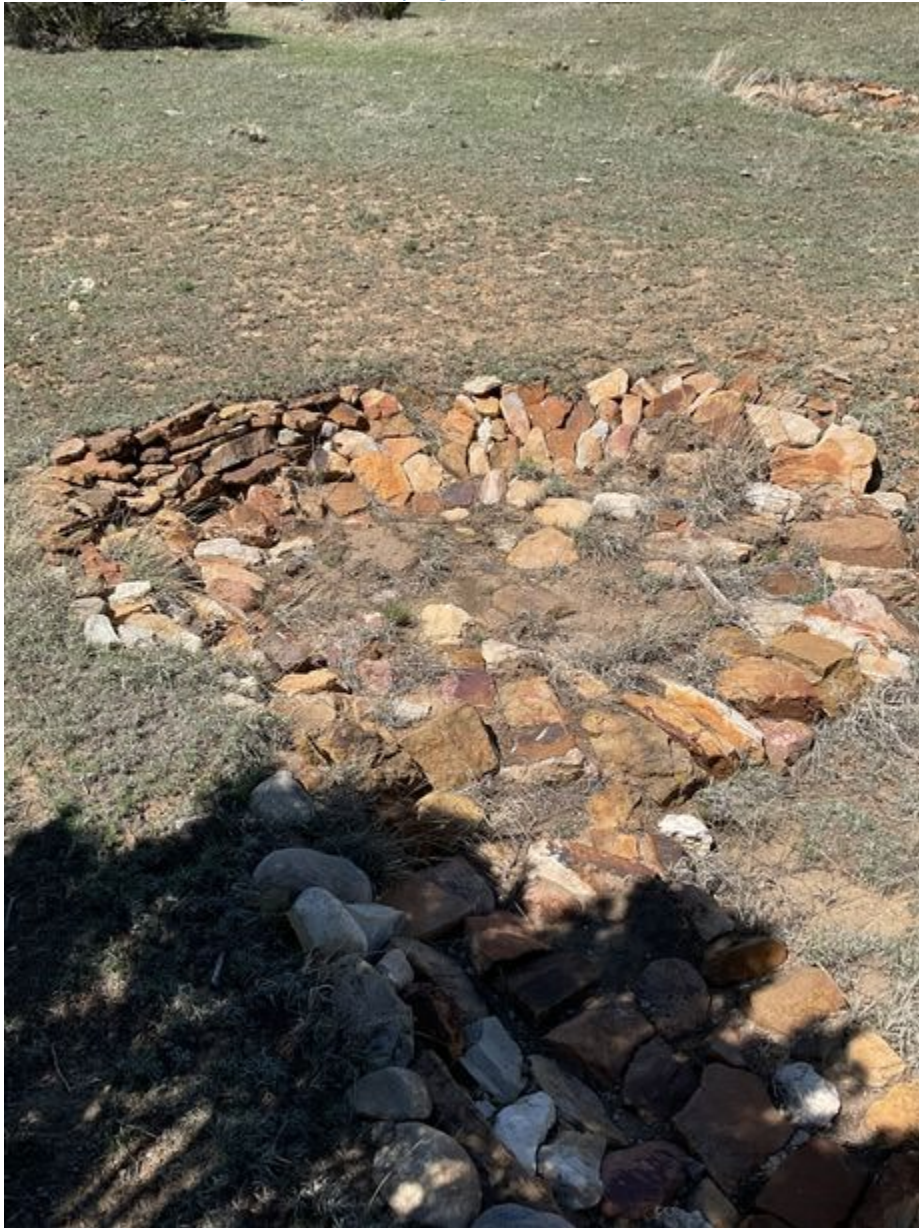
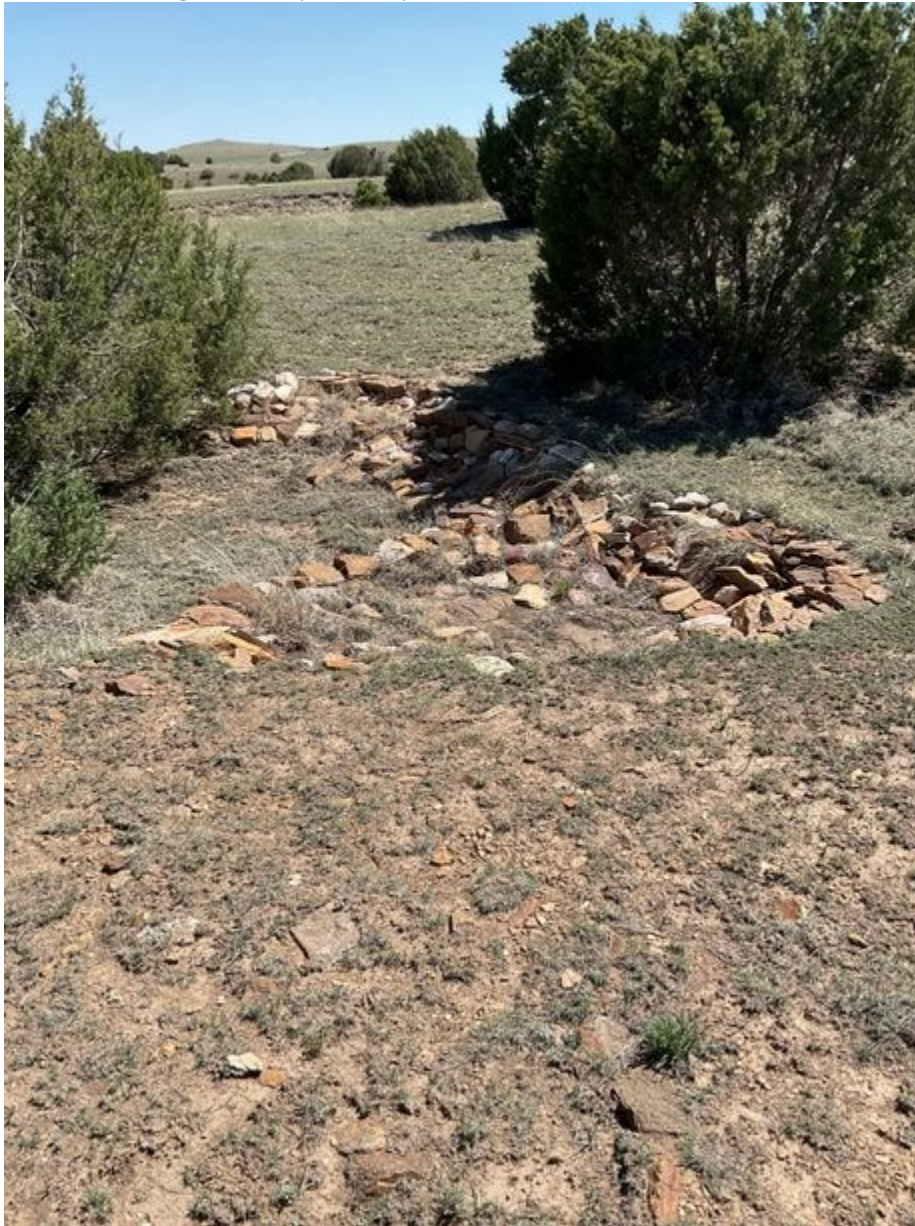
All rocks intact

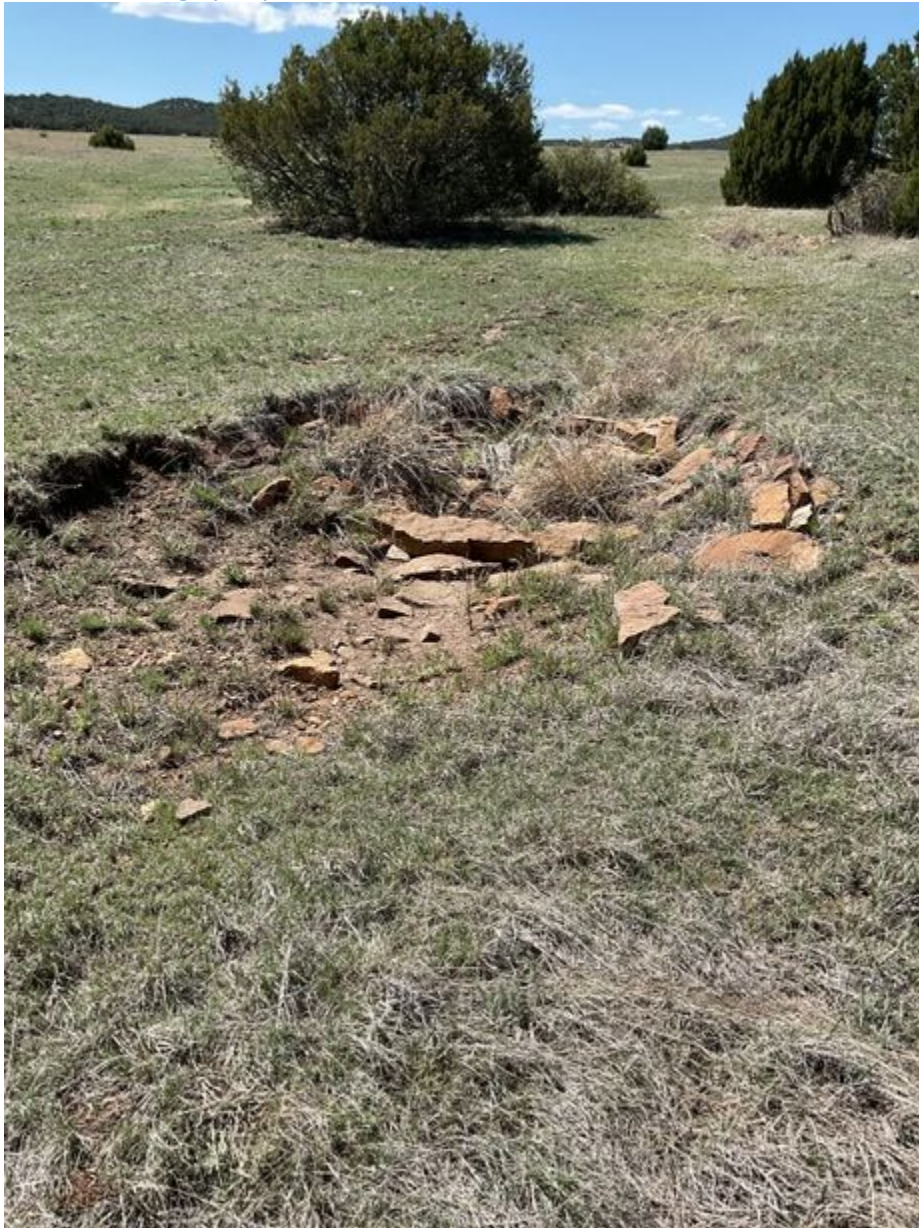
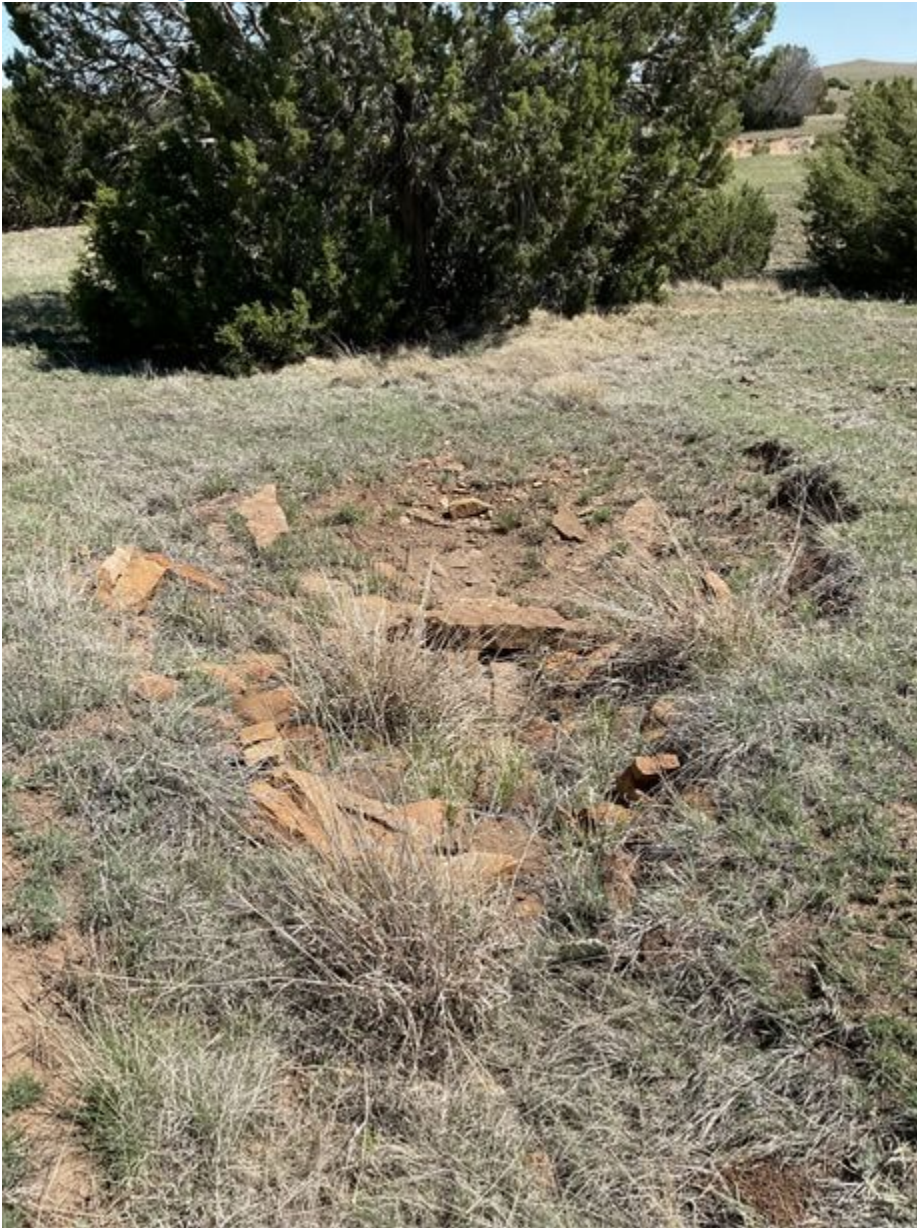
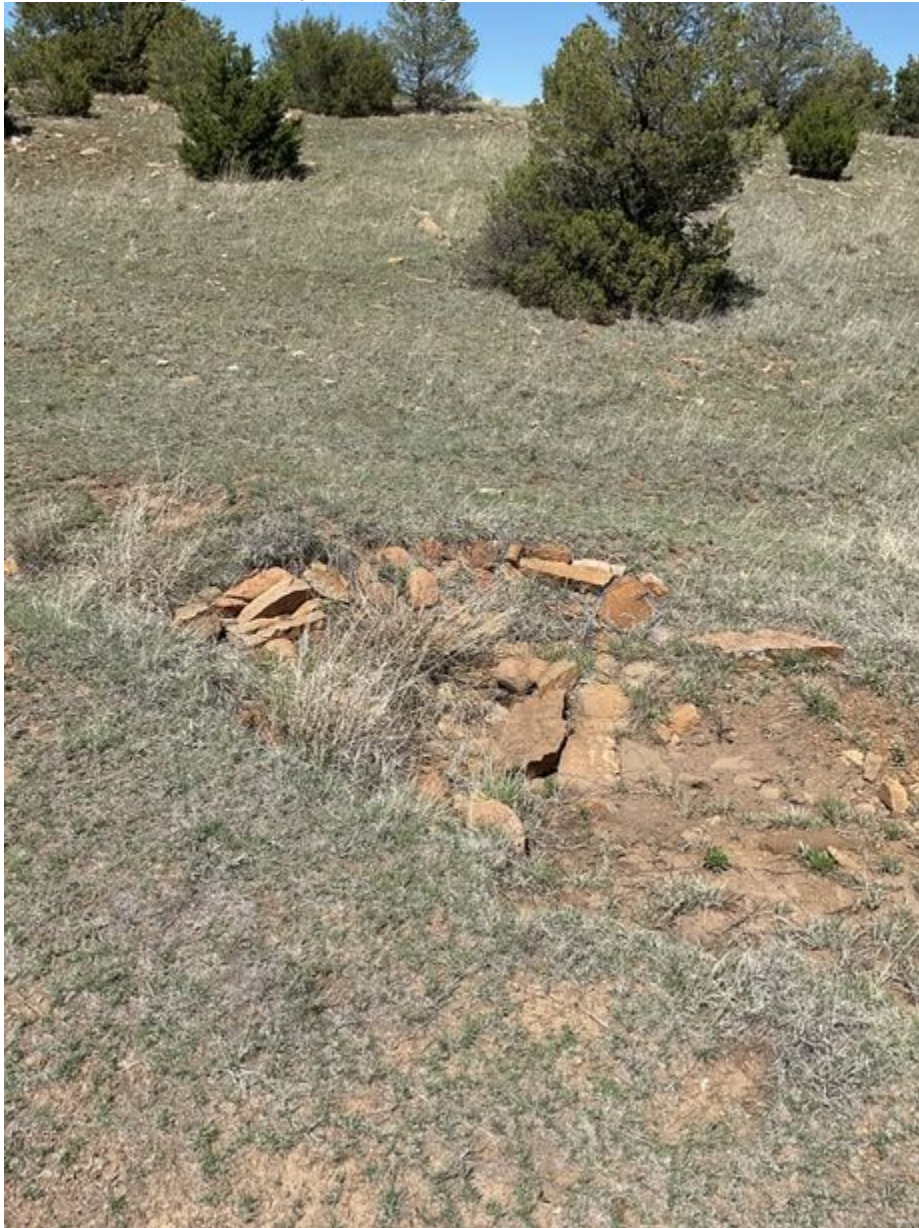
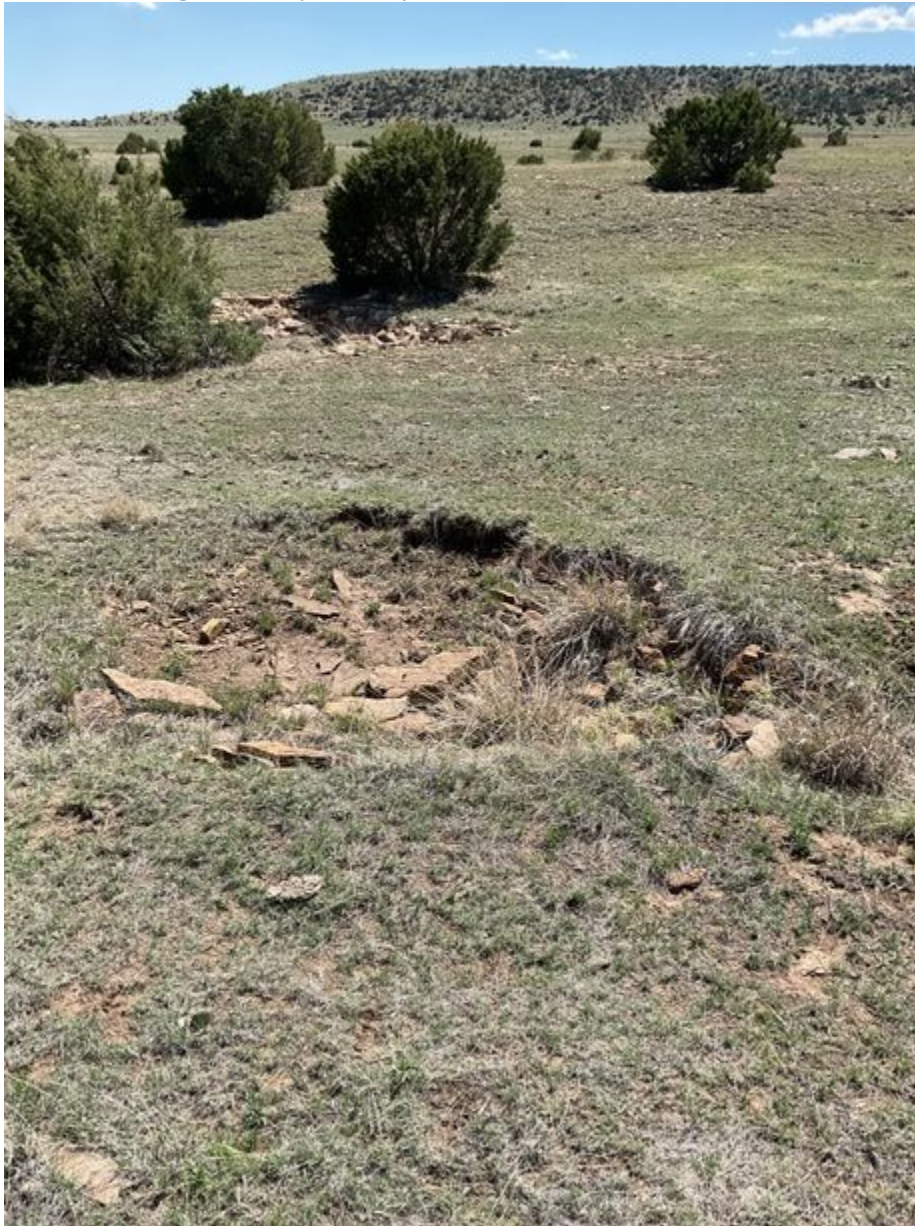
All rocks intact
