CN R924060

**Zuni Bowl and One Rock Check Dam Research –
Phase 1**

Final Report

Rio Grande Return for the New Mexico Department of Transportation Research Bureau

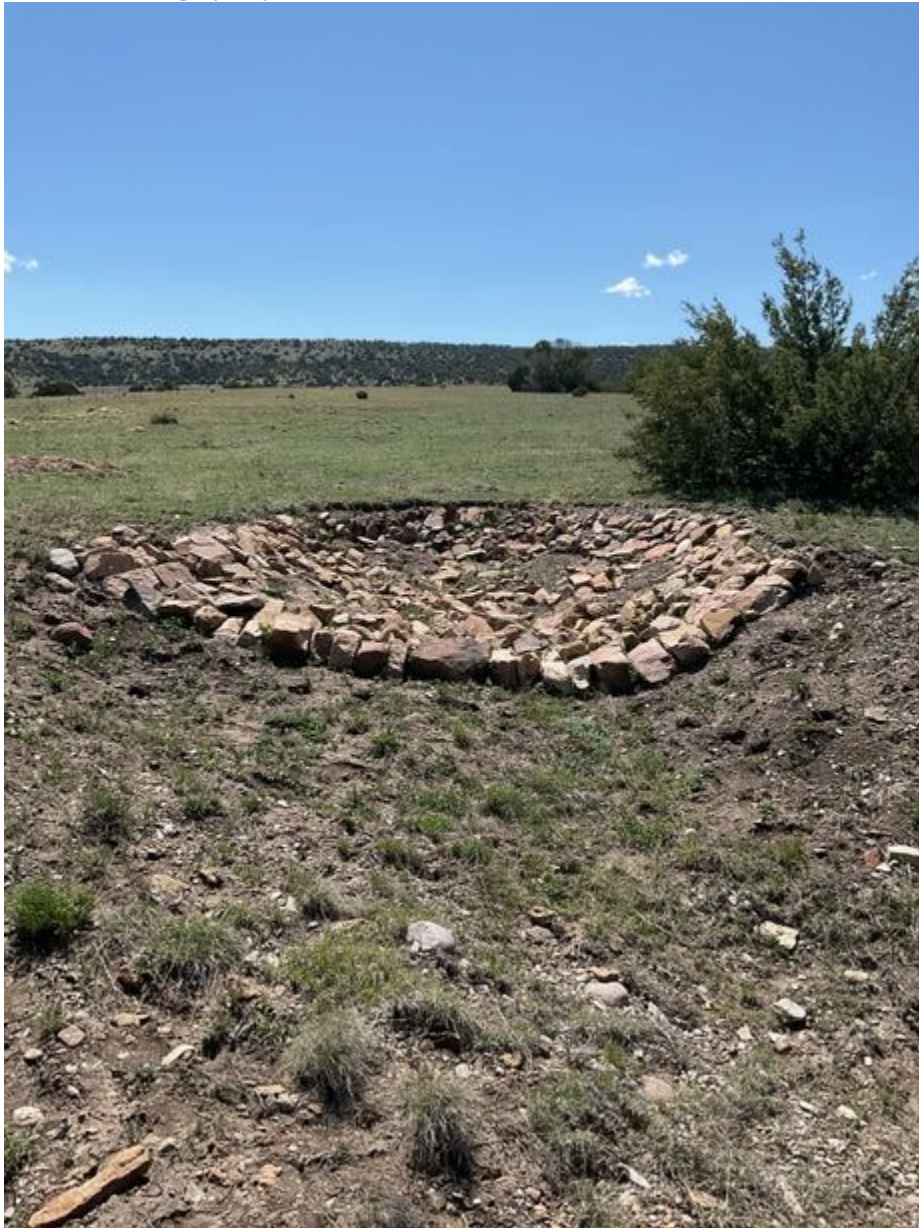
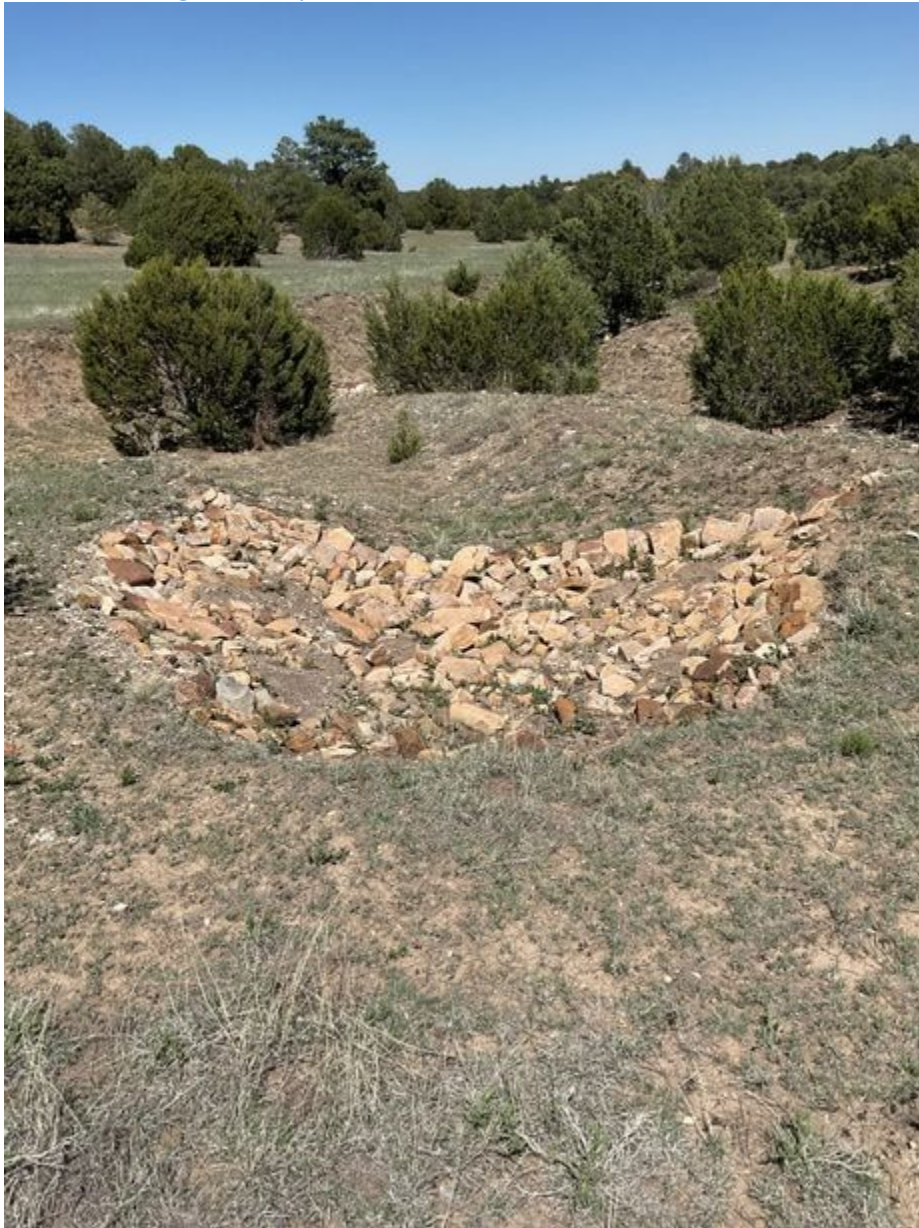
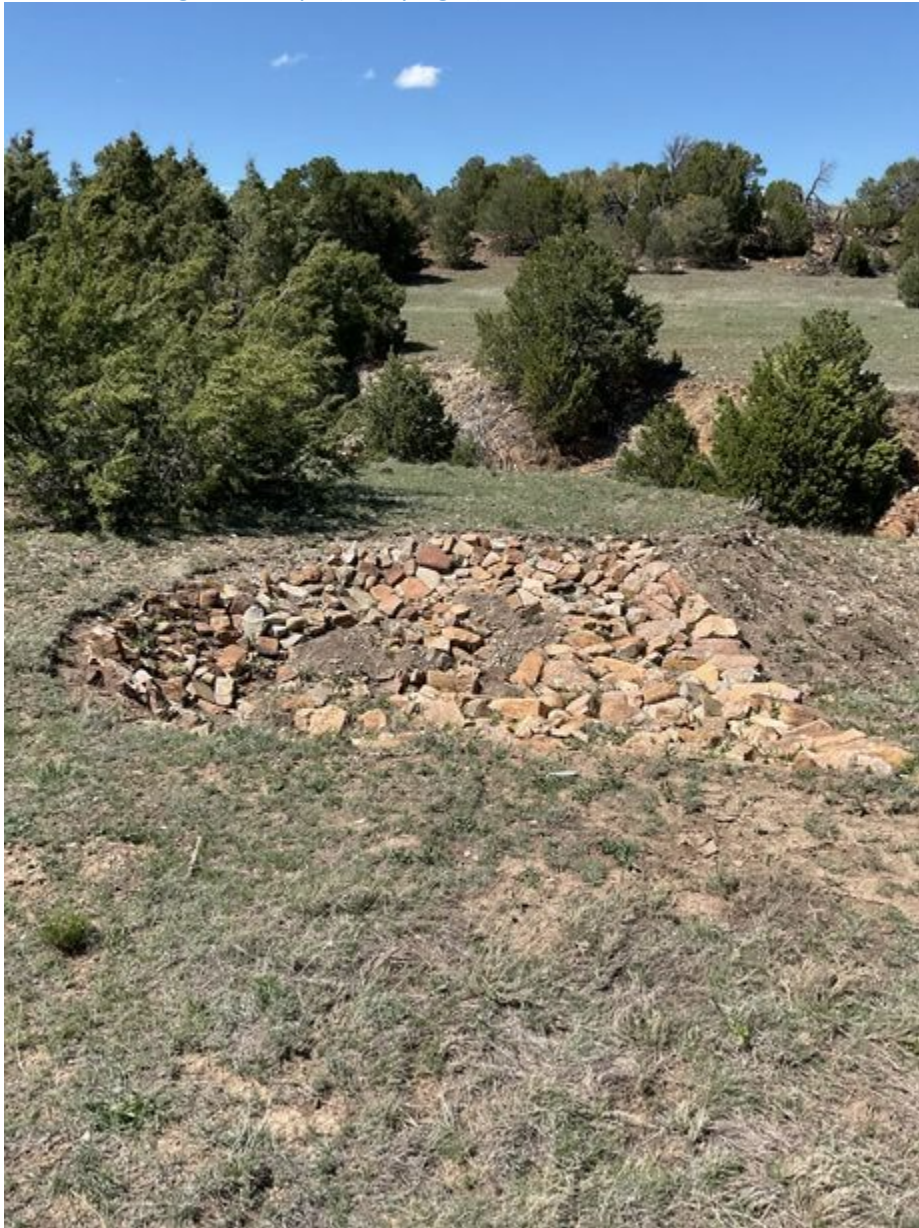
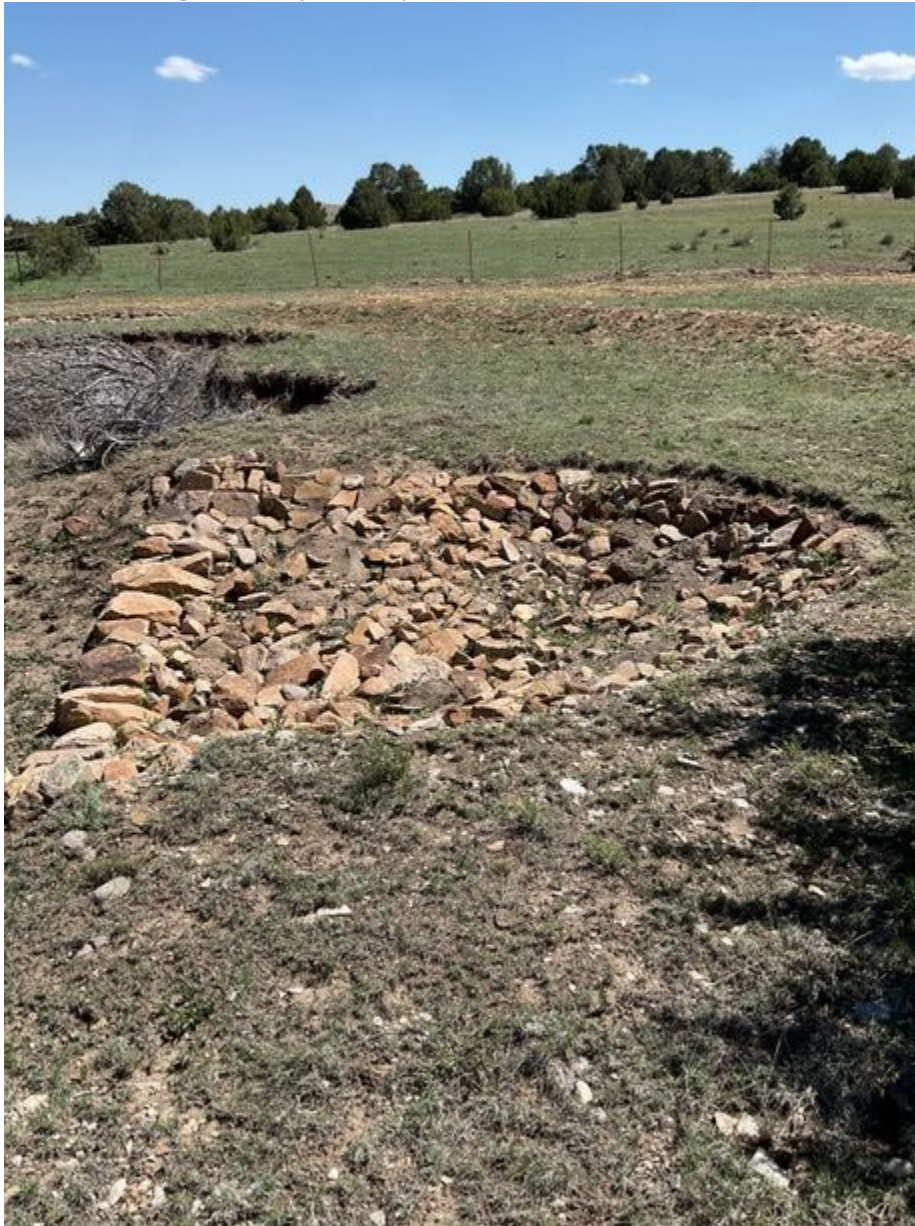
All rocks intact

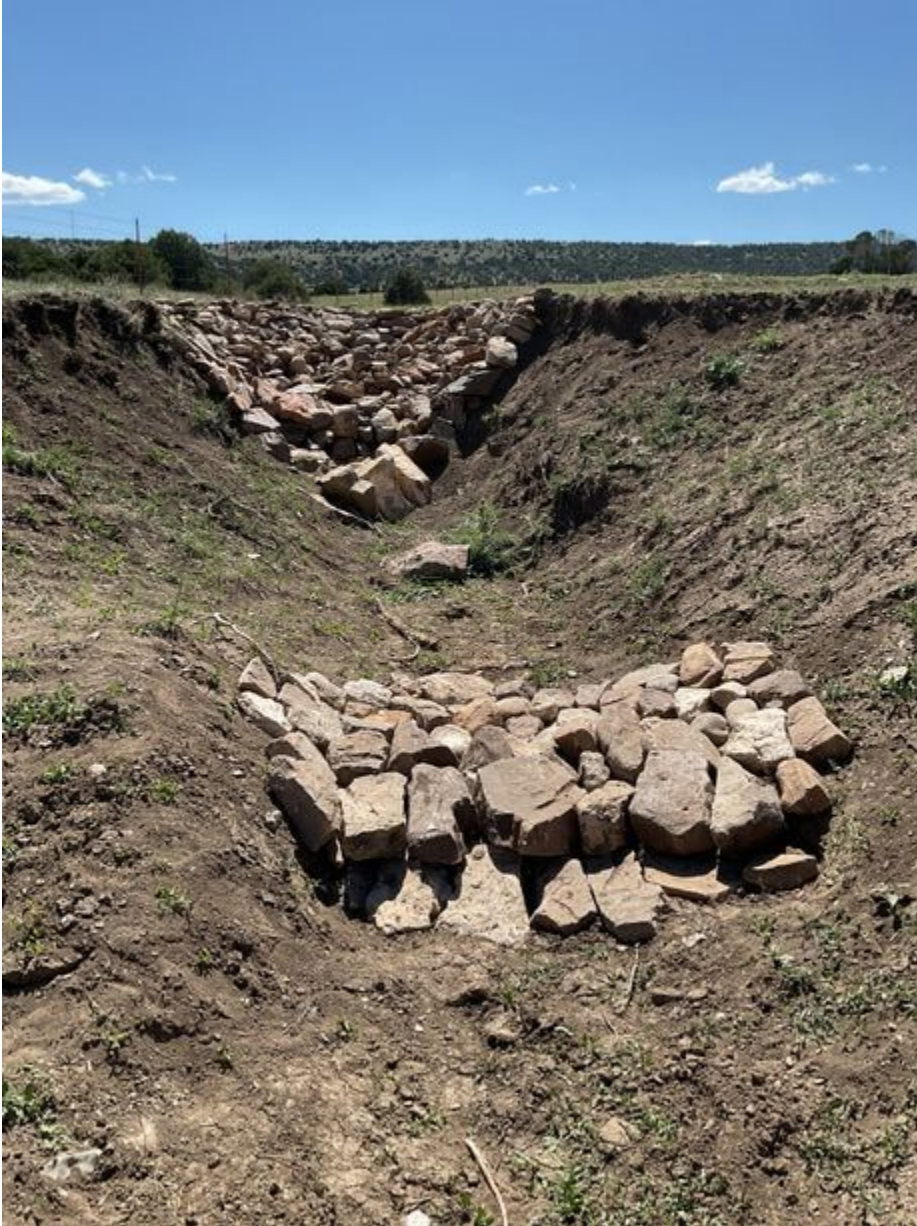
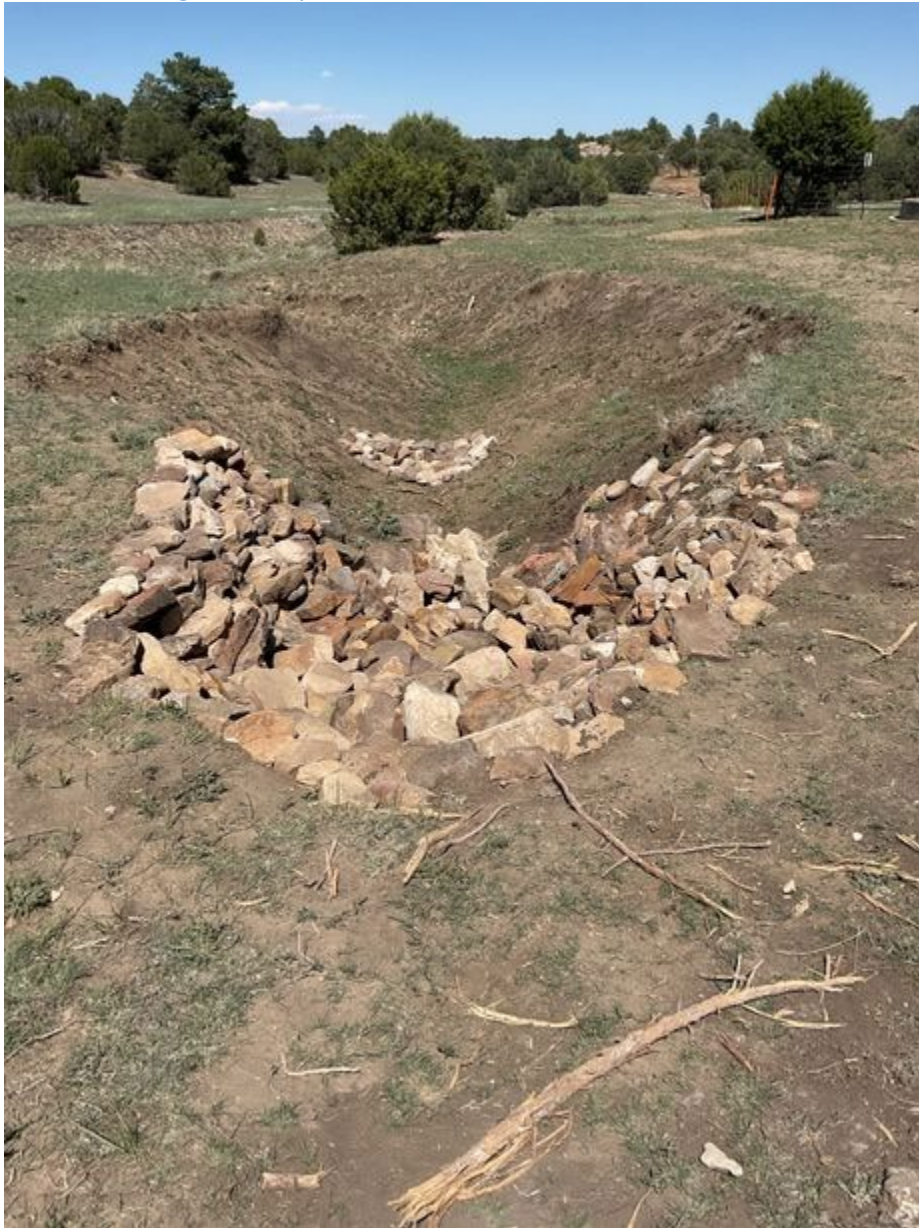
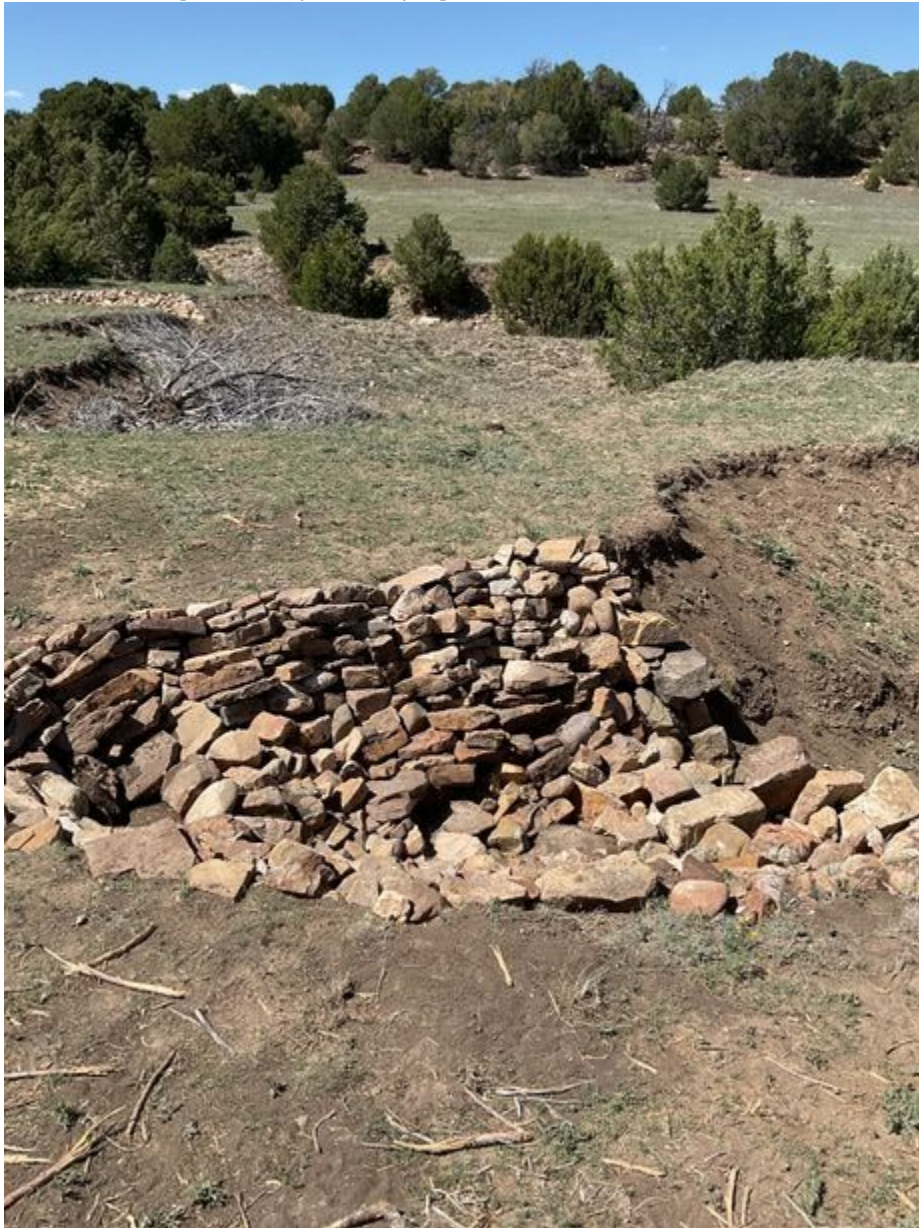
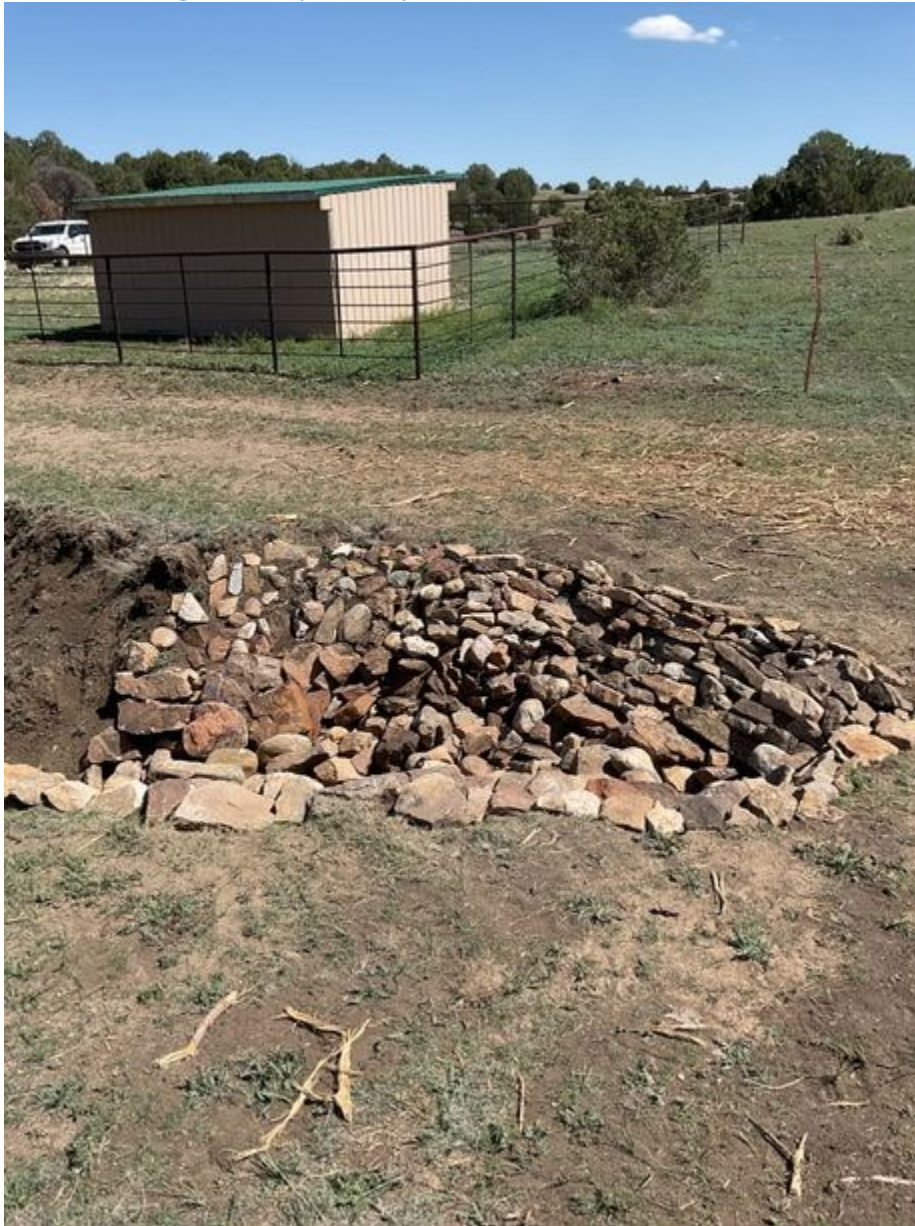
Some rocks dislodged or broken

Original ZB repaired in 2024

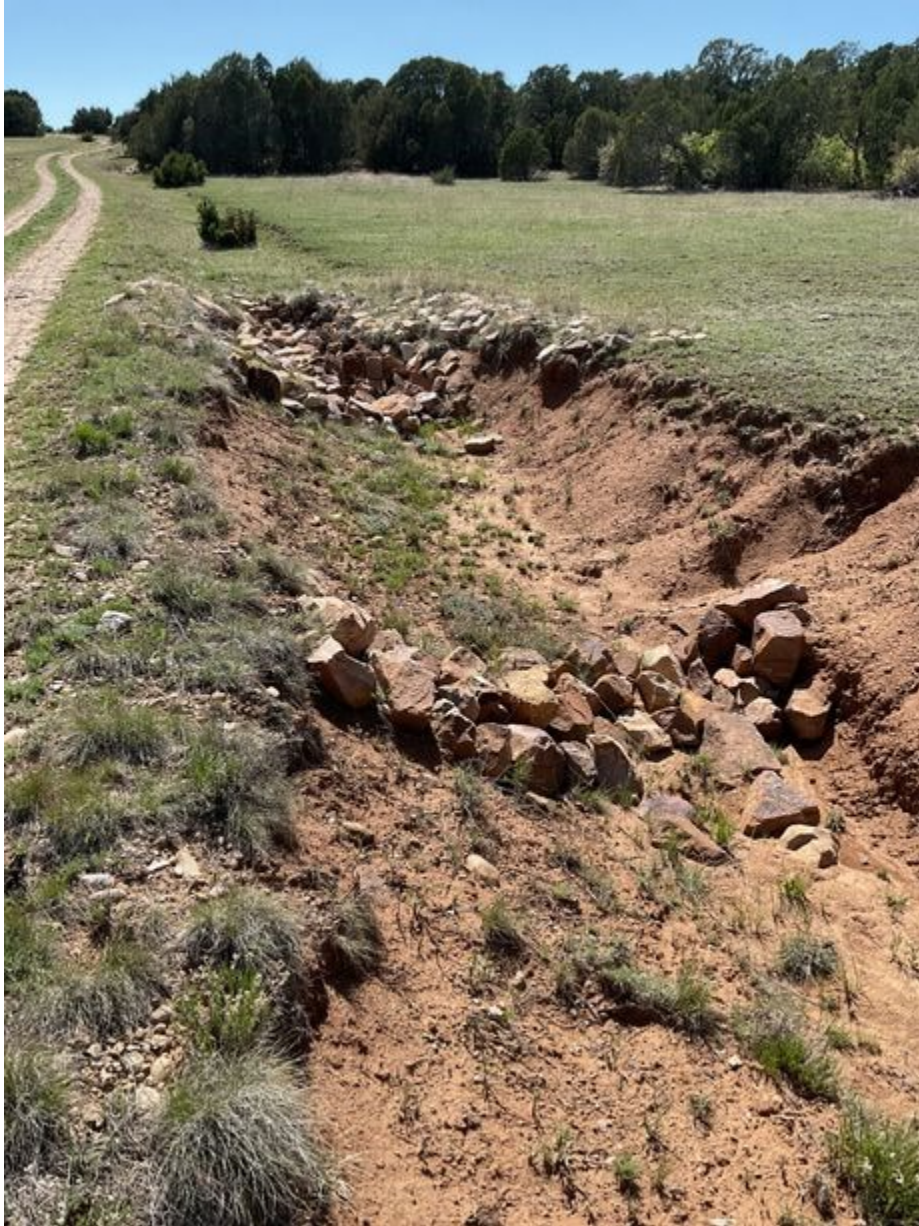
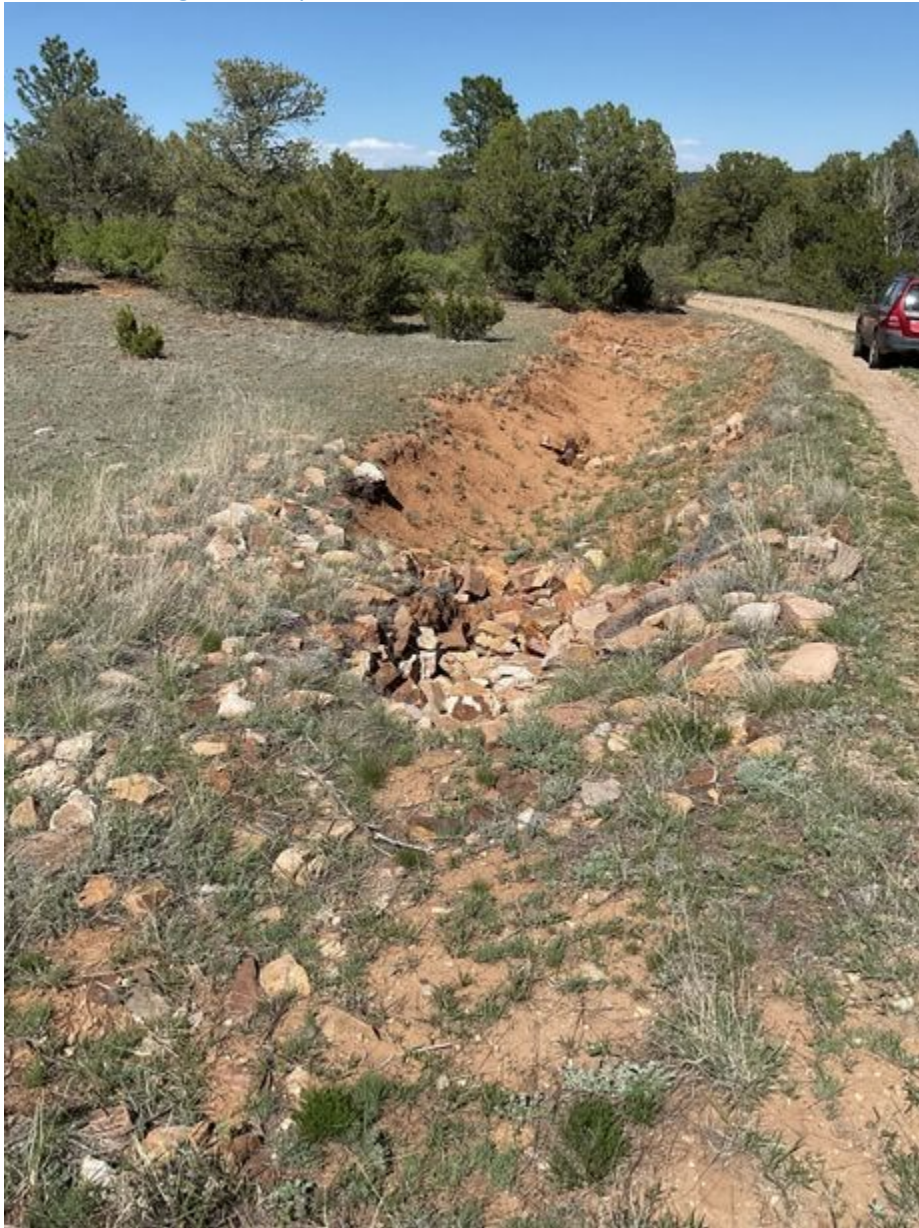
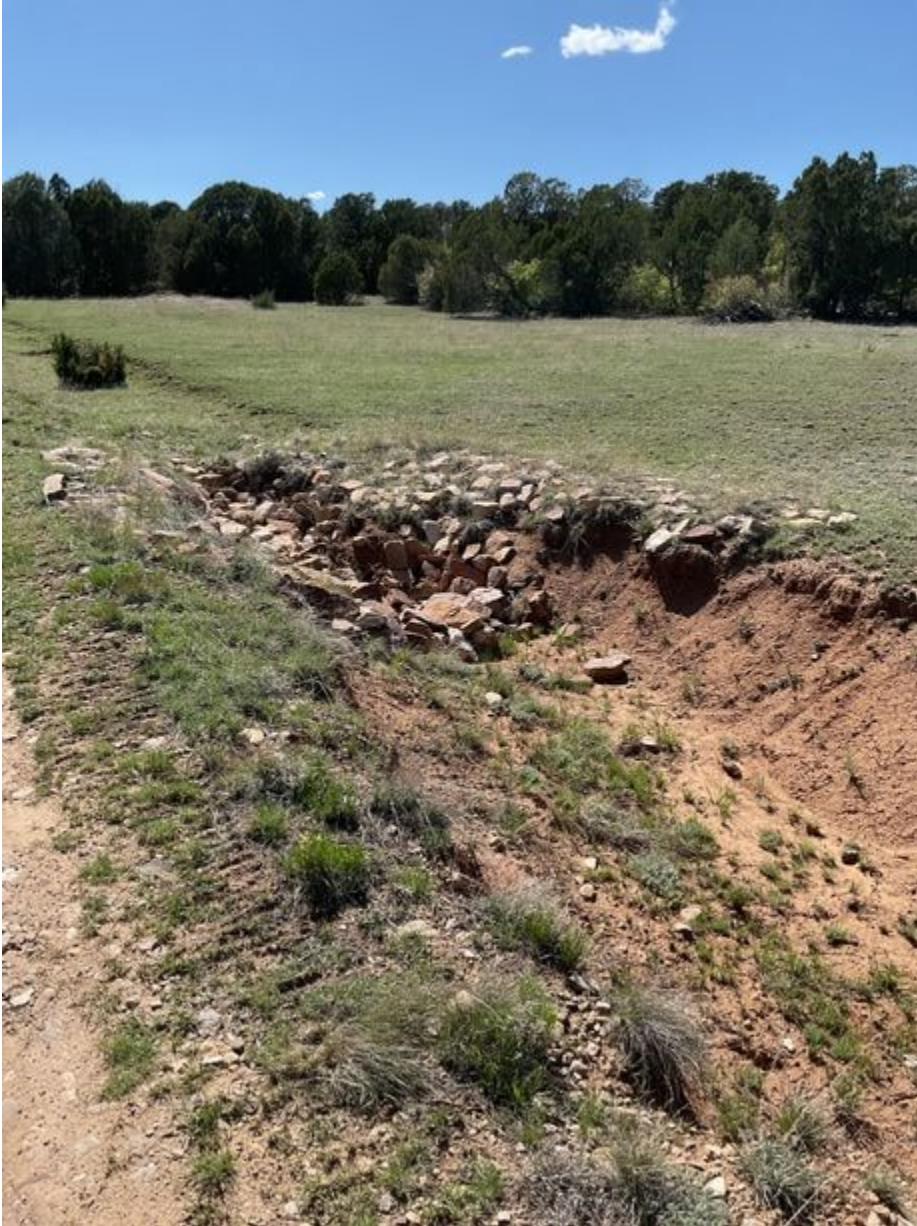
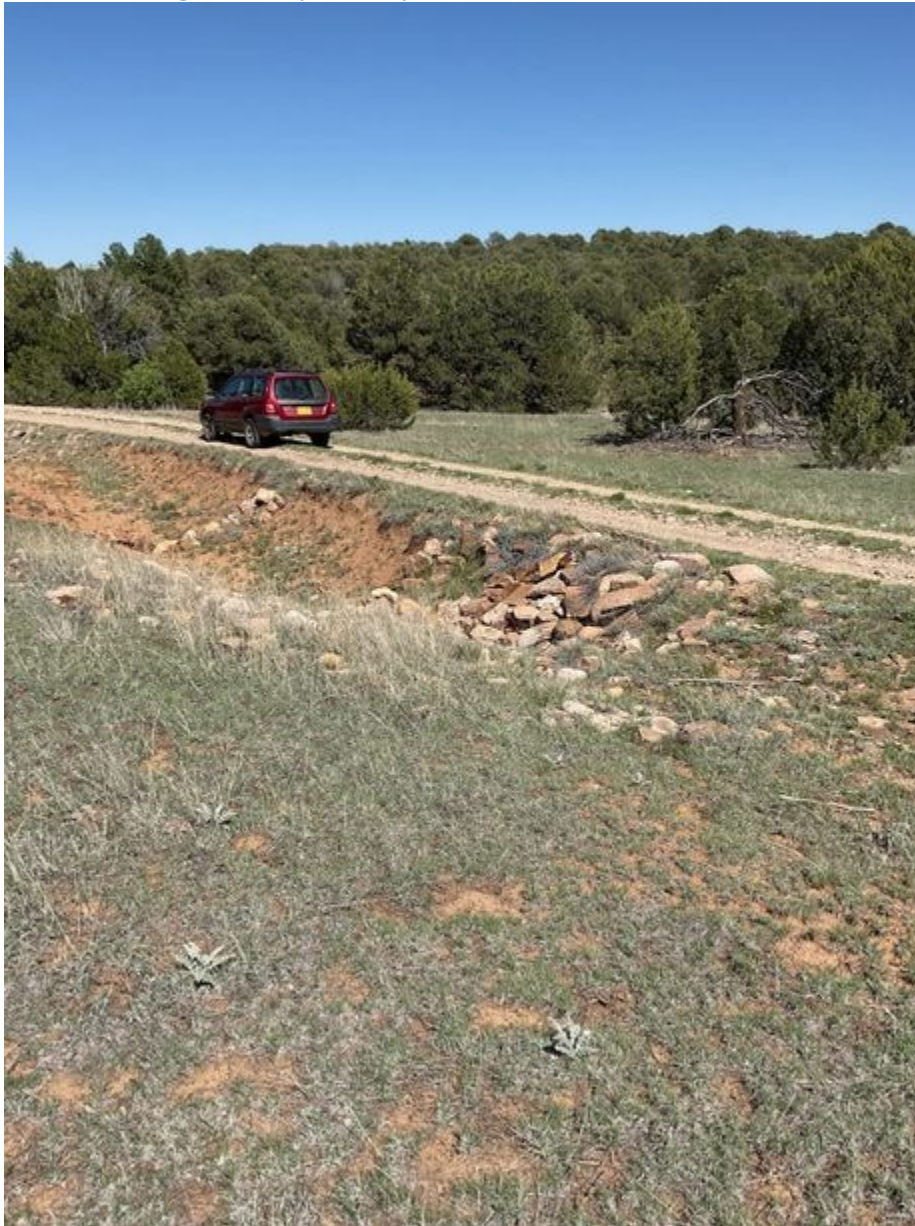
Some rocks dislodged or broken

Appears repairs made after original structure eroded

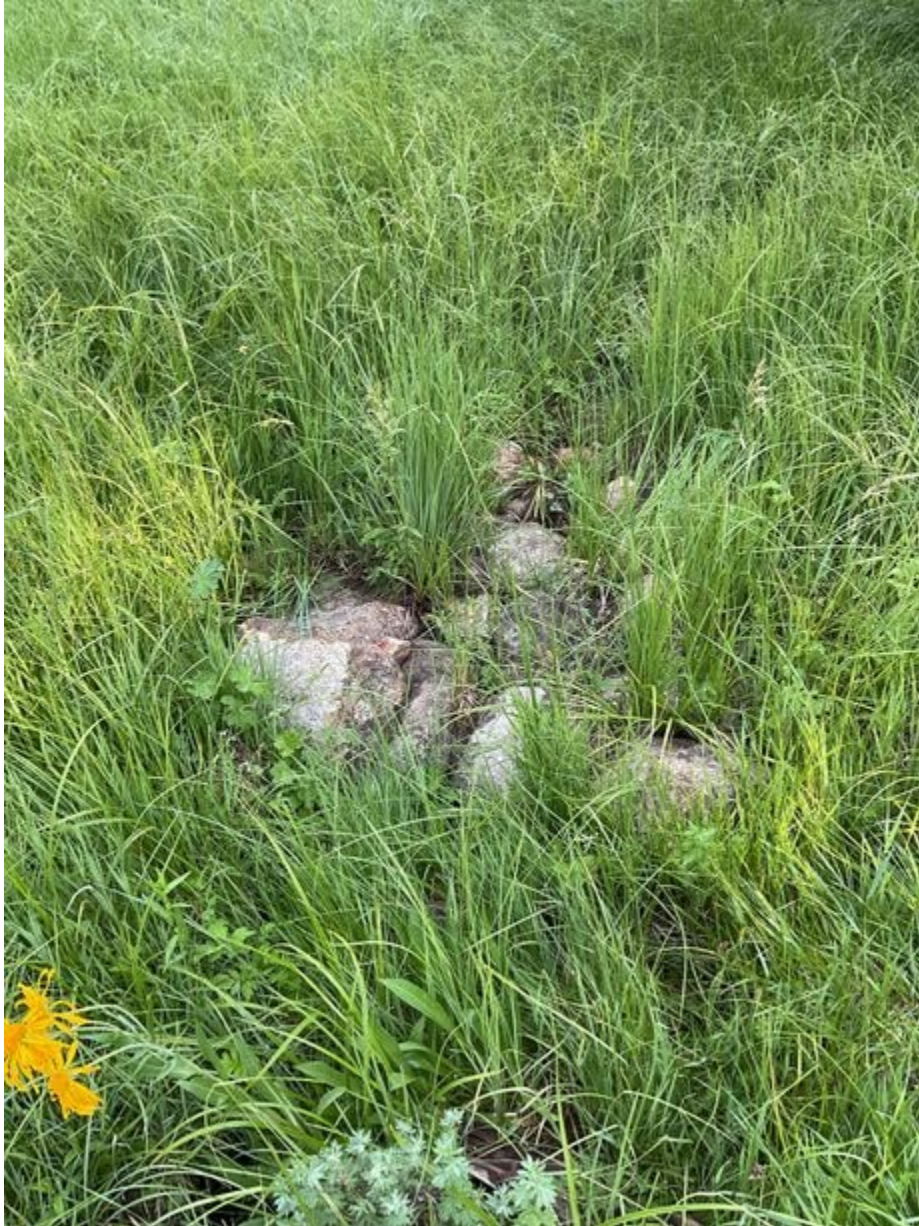
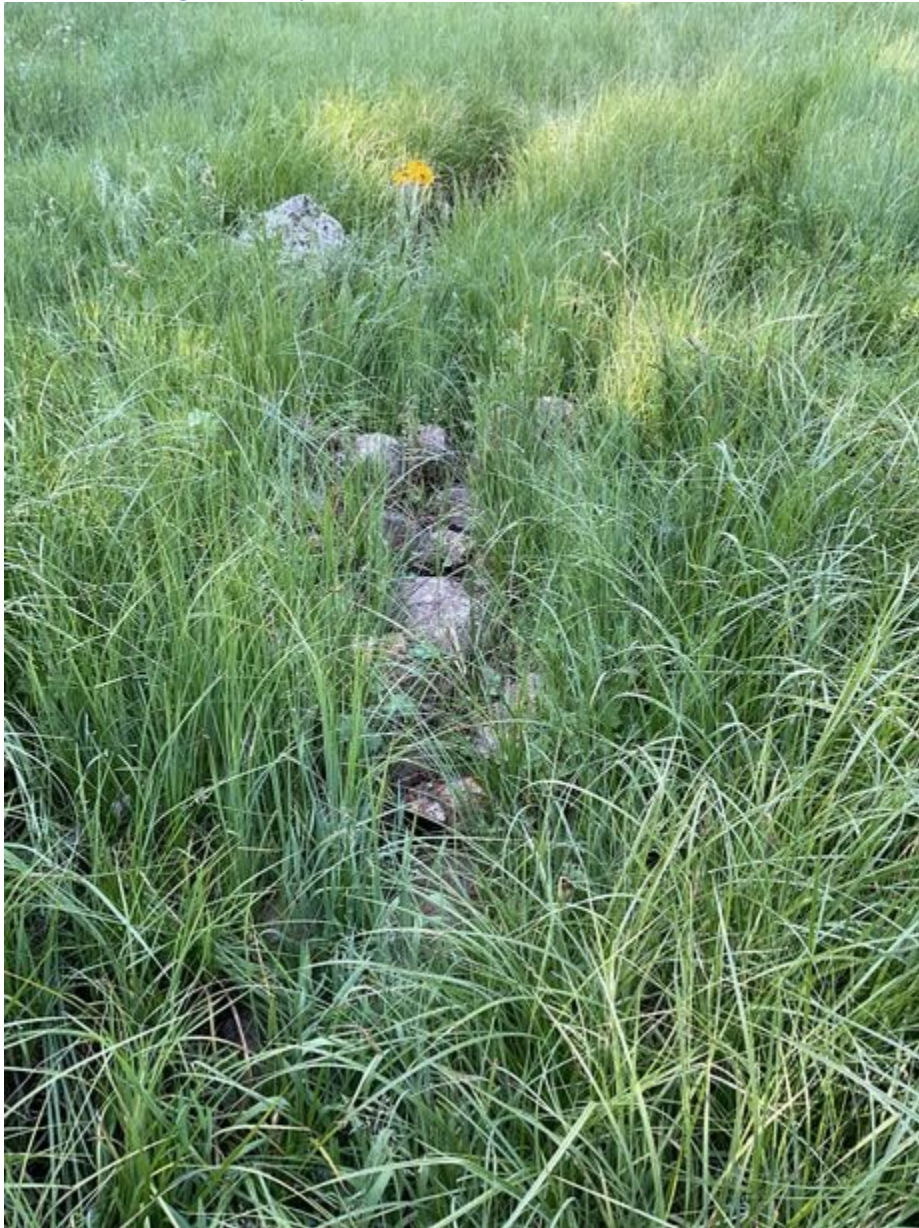
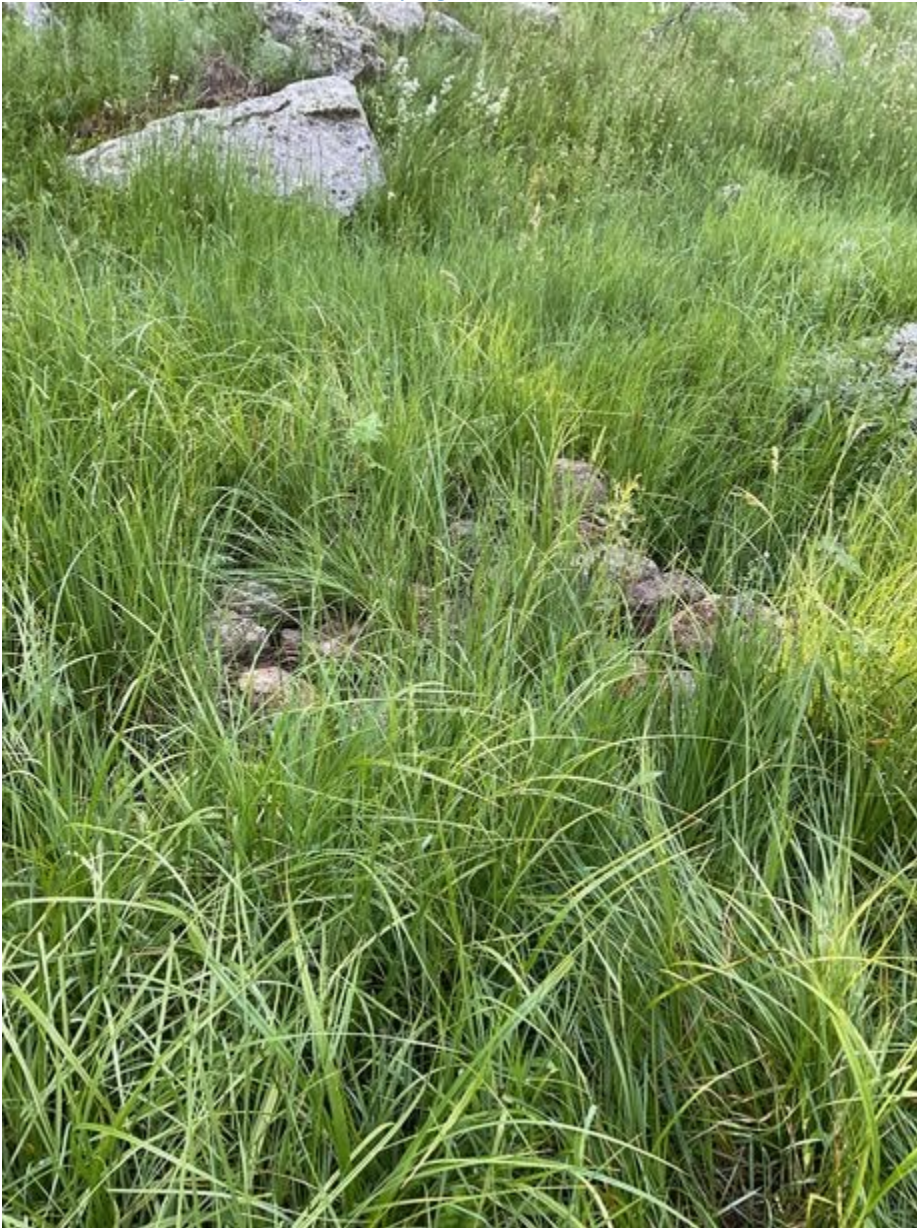
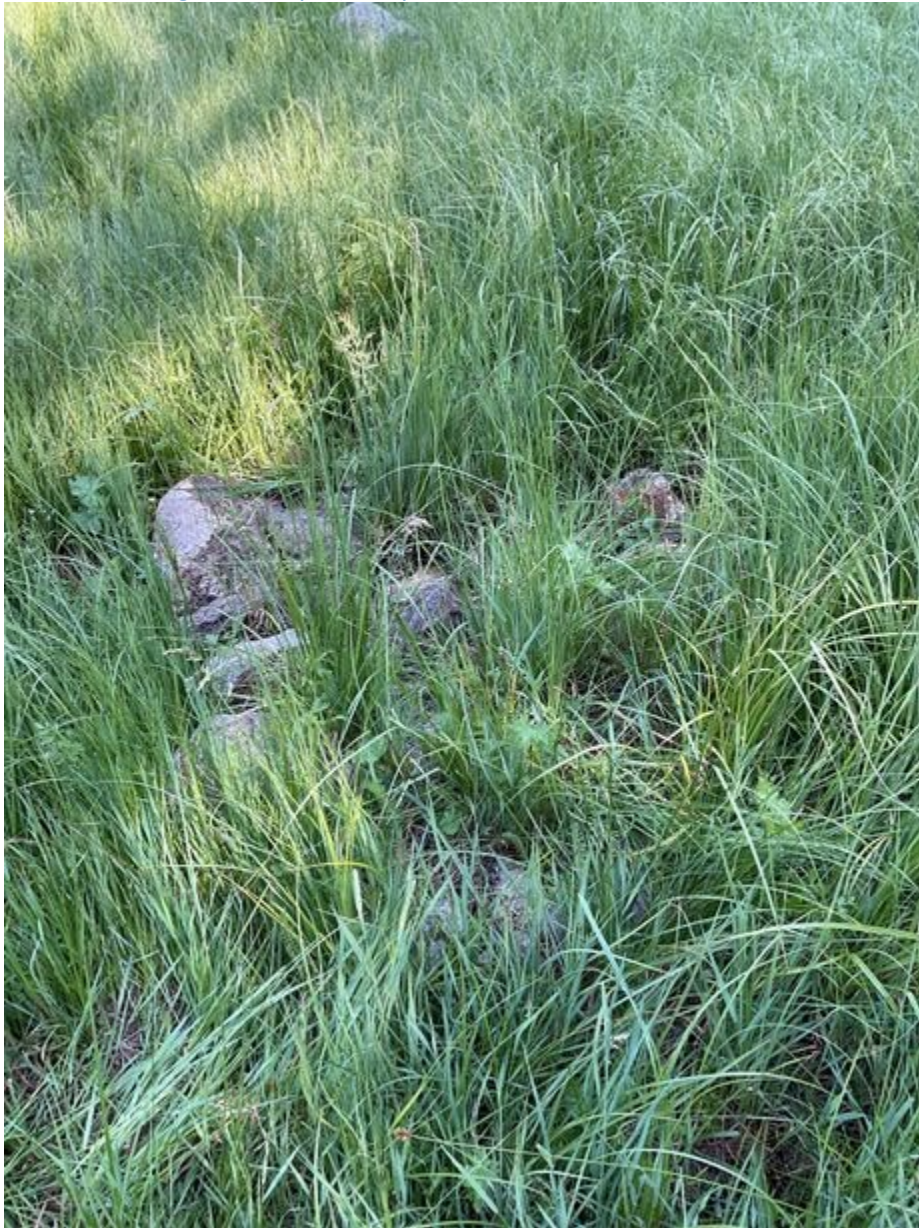
All rocks intact

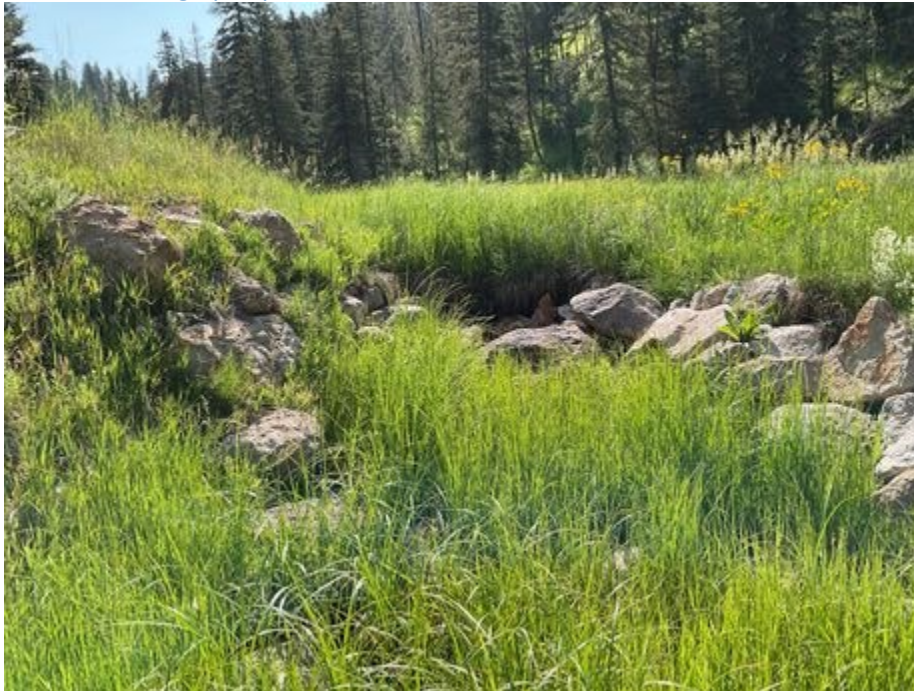
Some rocks dislodged or broken

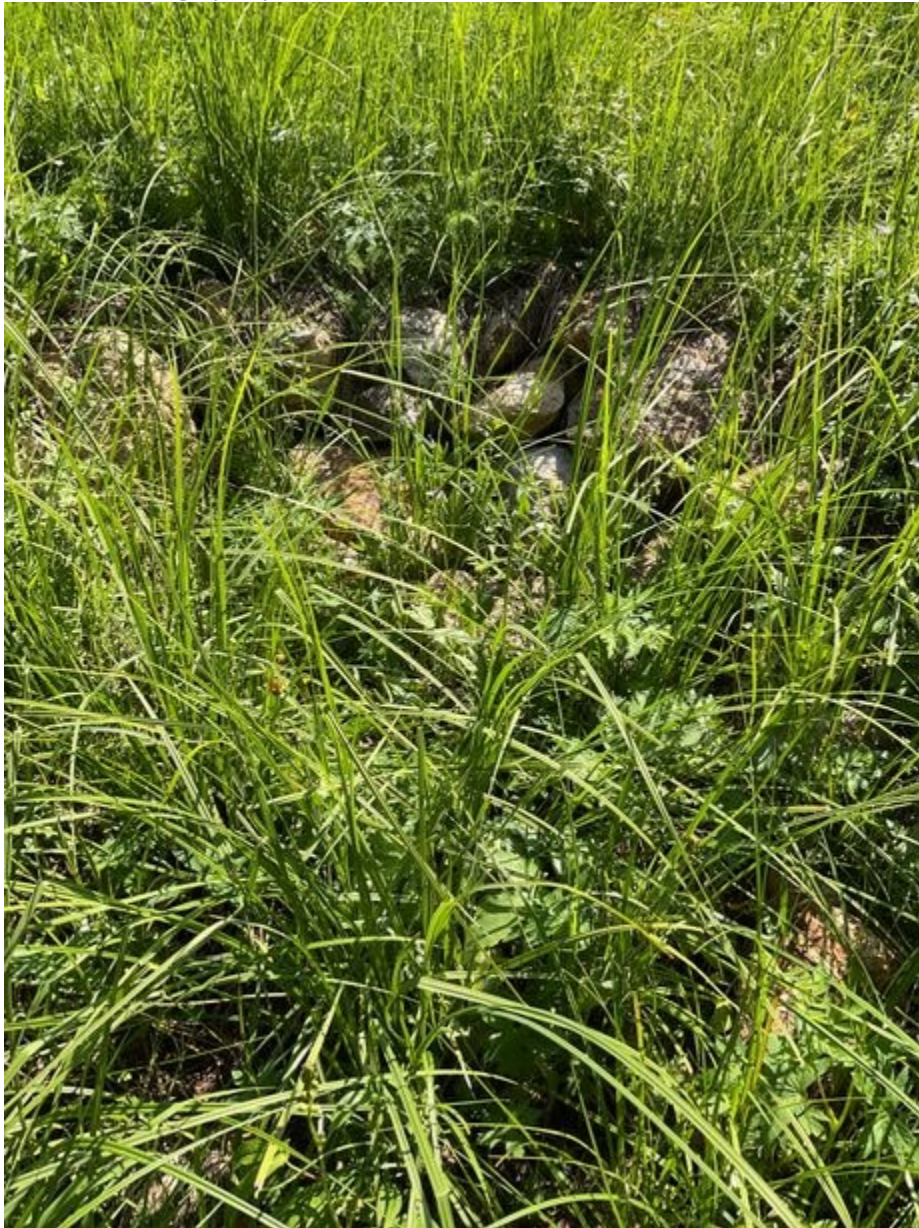
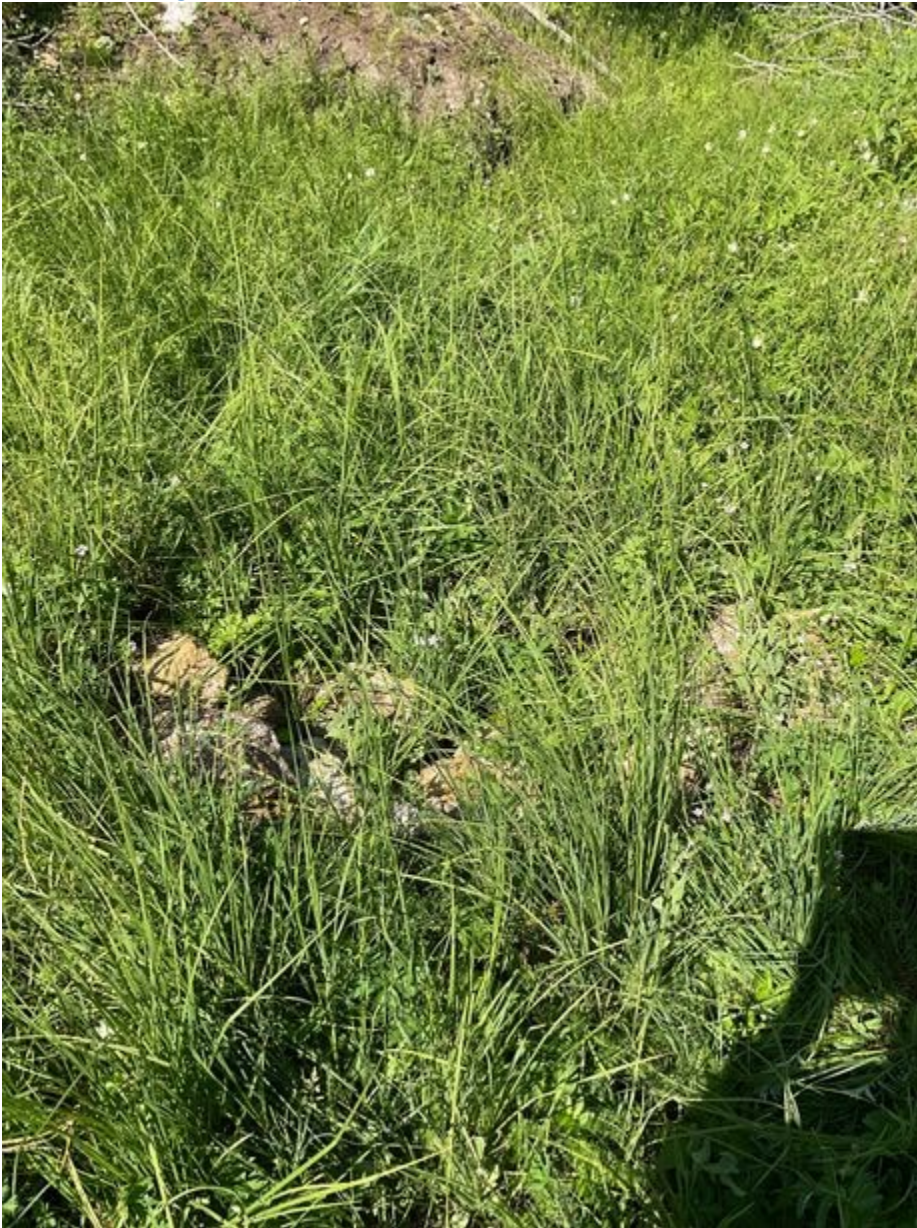
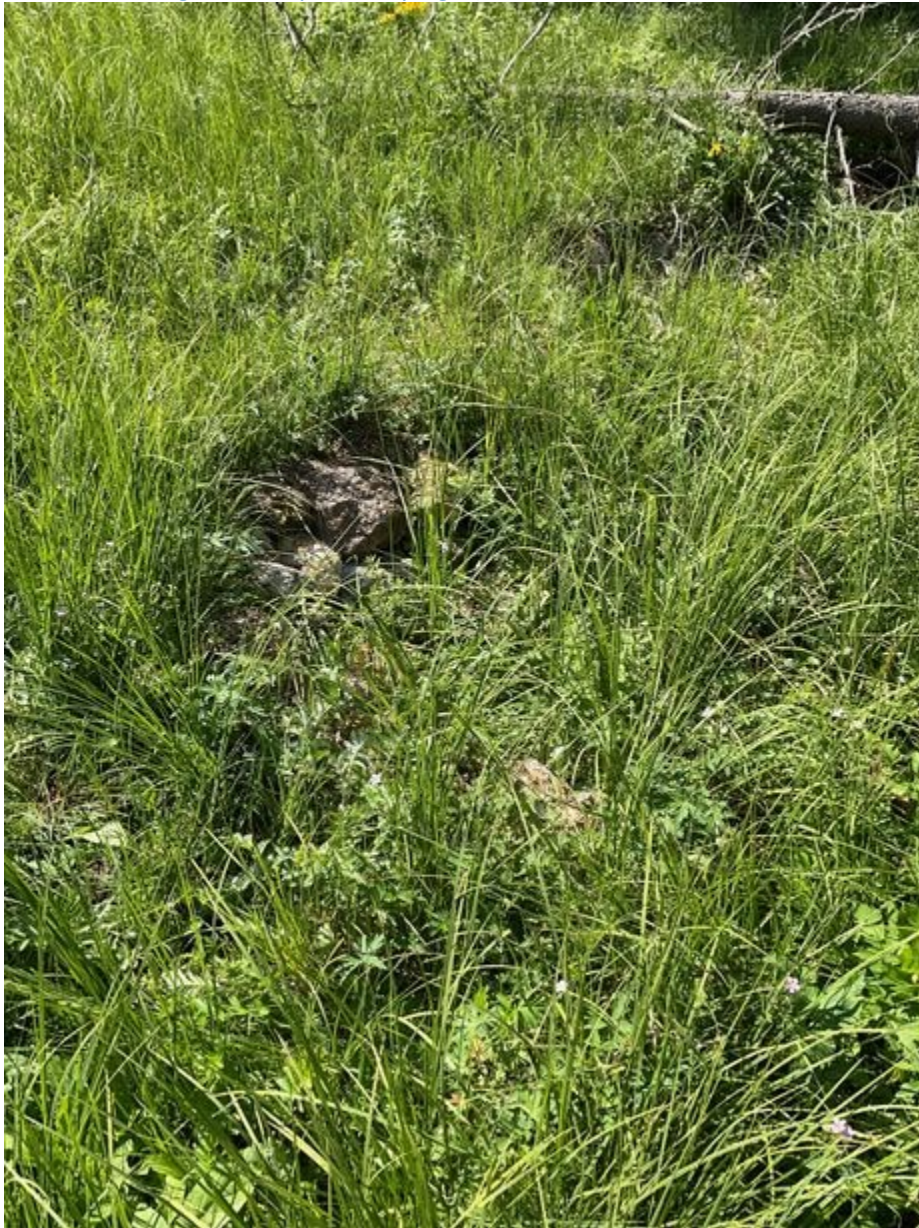
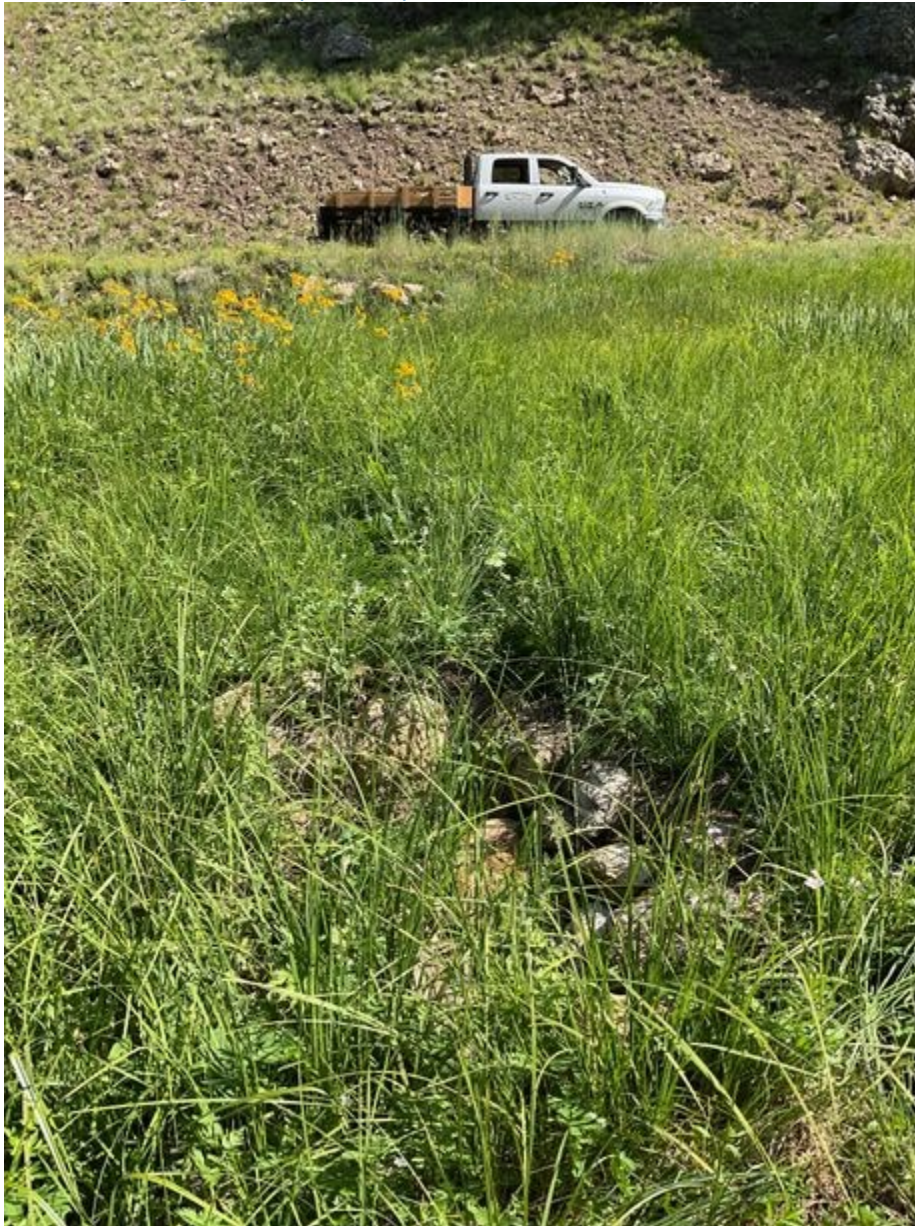
-106.6013747 35.9240822

All rocks intact
