CN R924060

**Zuni Bowl and One Rock Check Dam Research –
Phase 1**

Final Report

Rio Grande Return for the New Mexico Department of Transportation Research Bureau

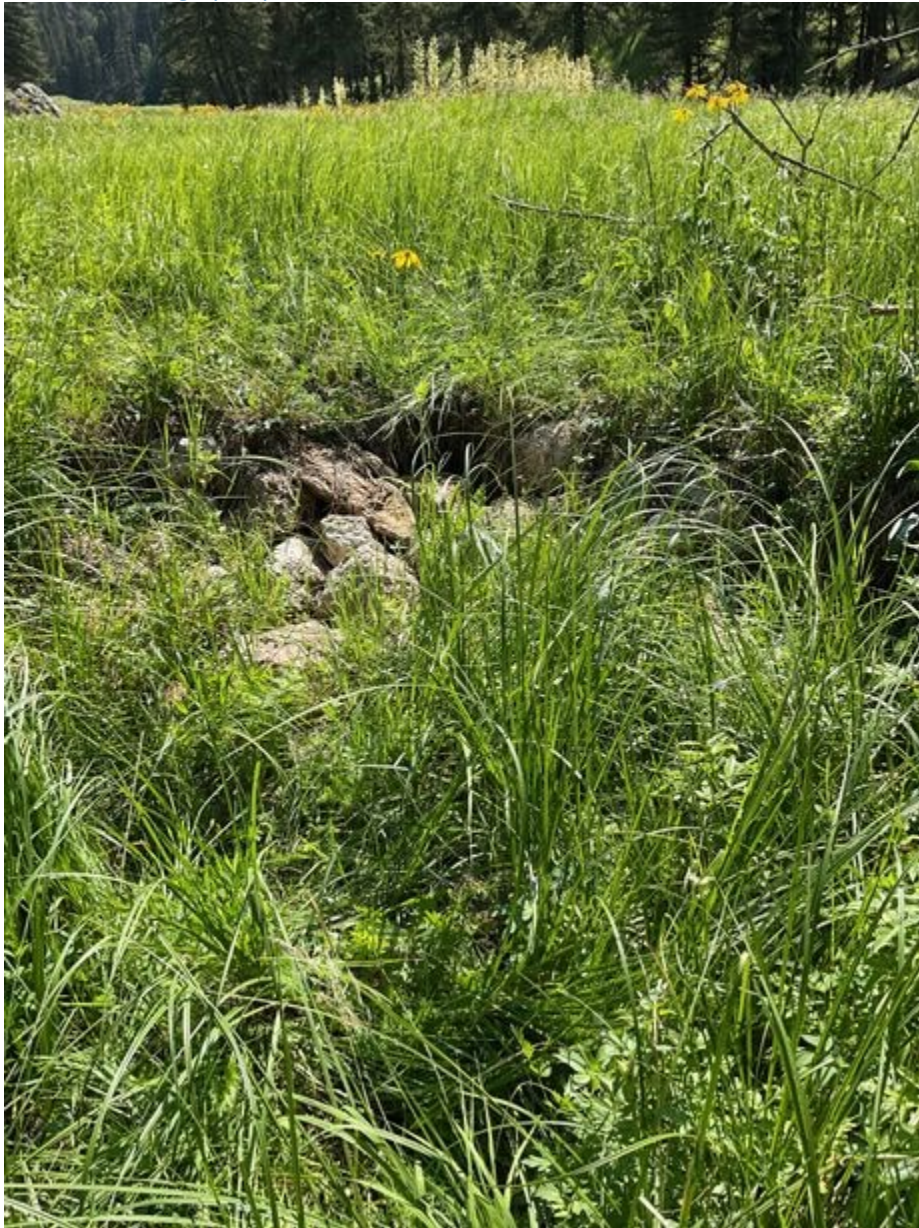
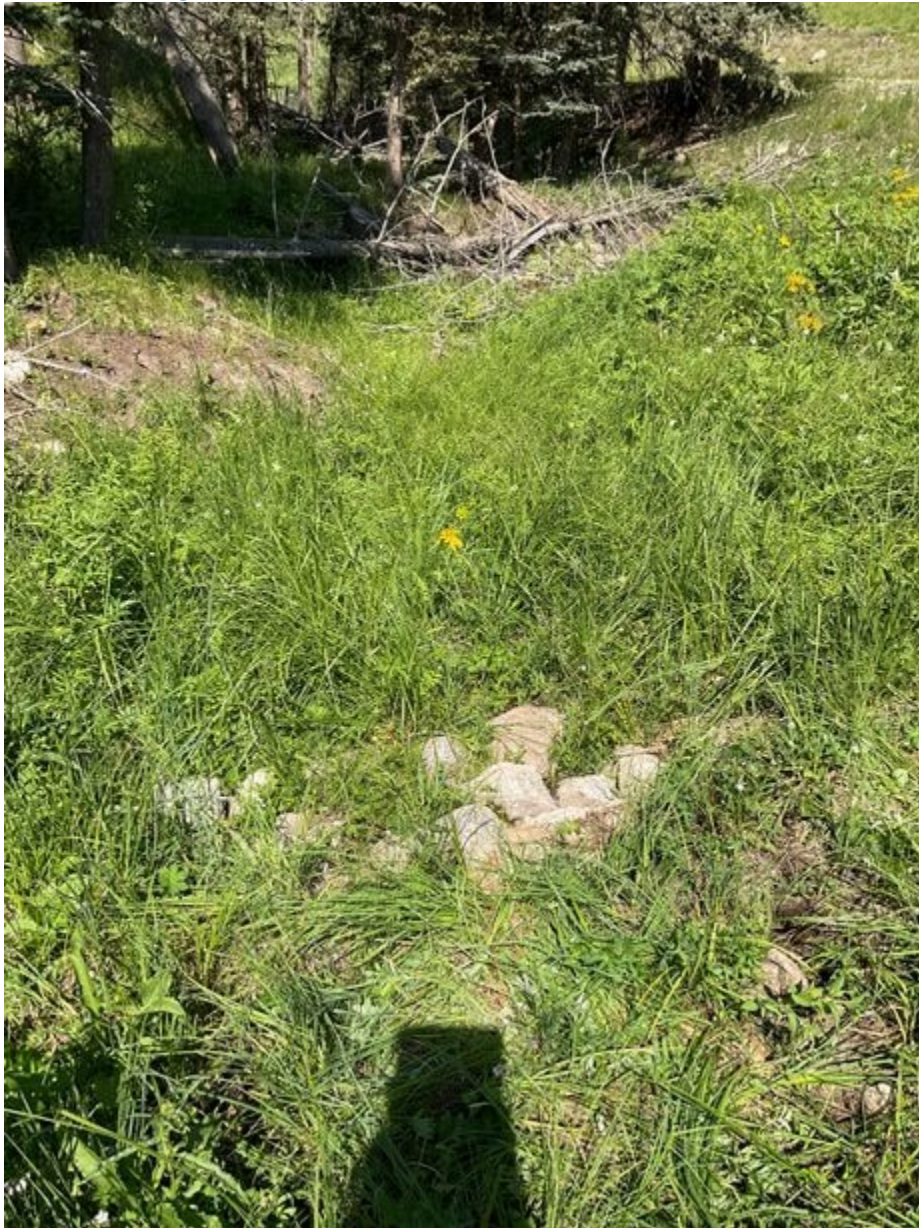
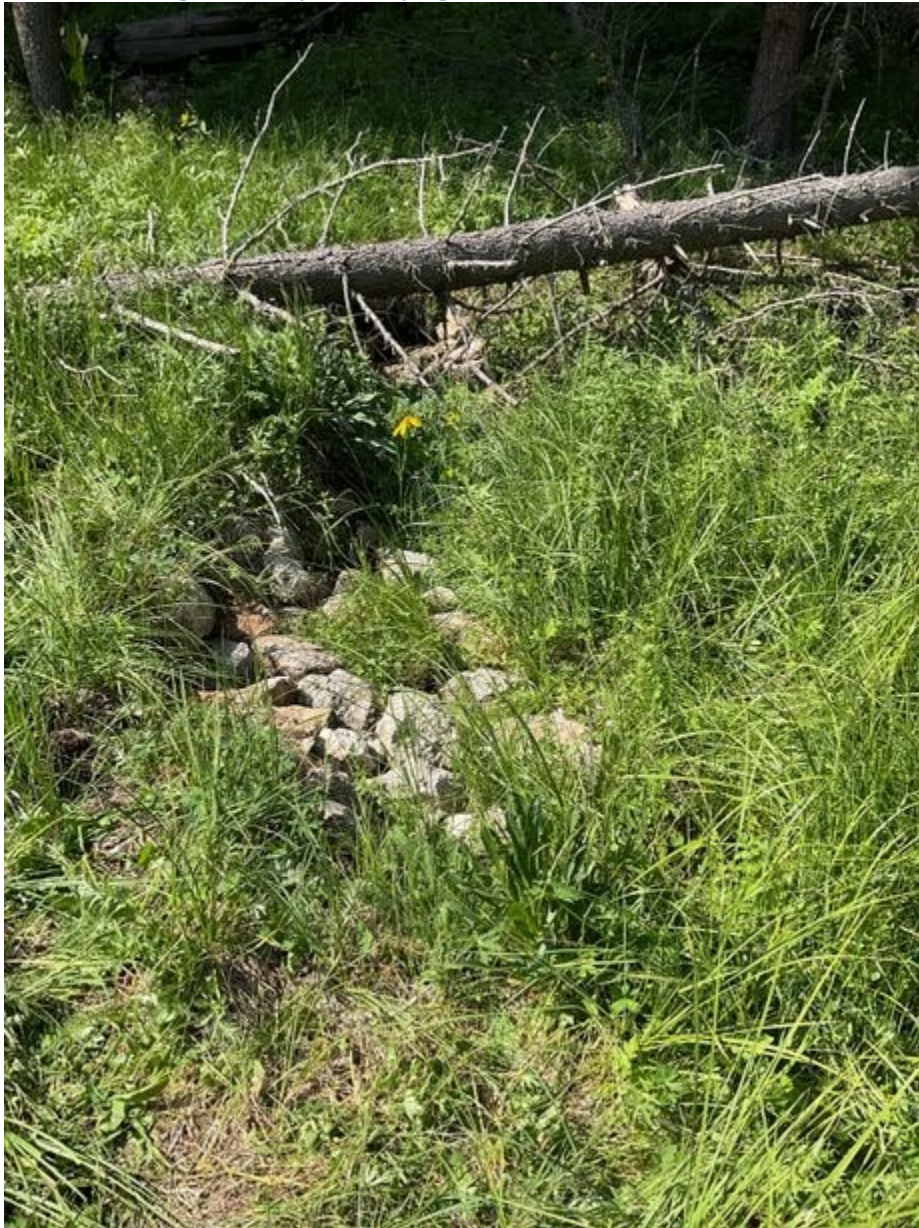
-106.6013722 35.9239816

Some rocks dislodged or broken

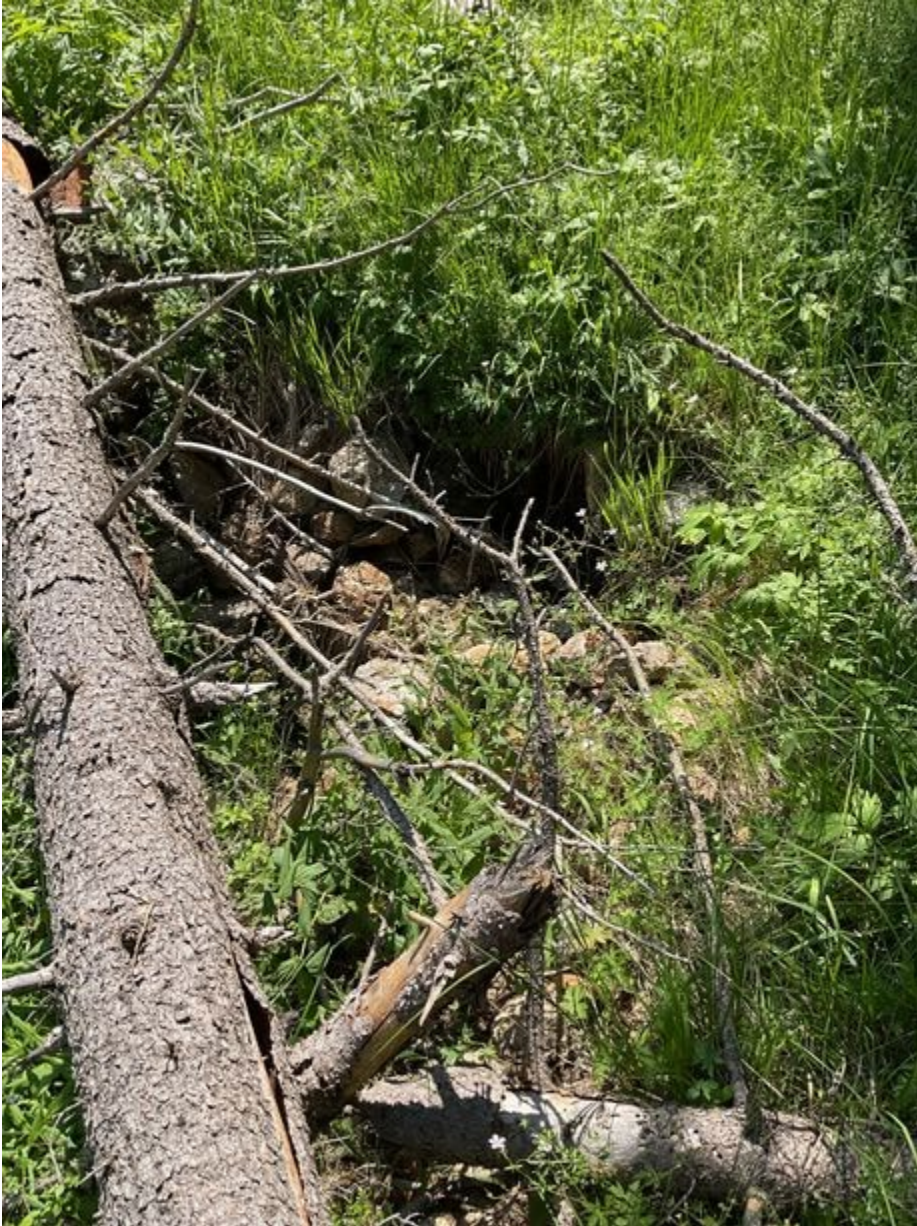
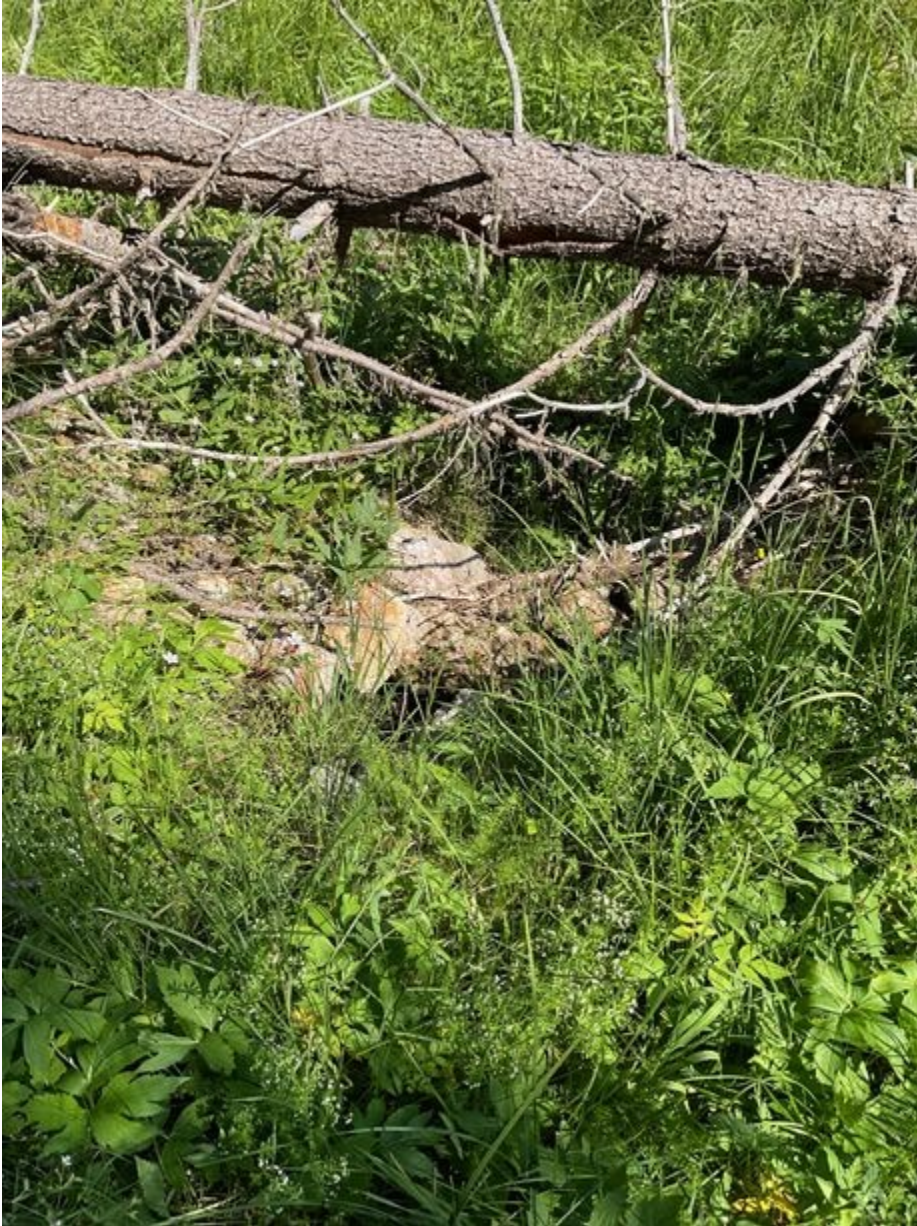
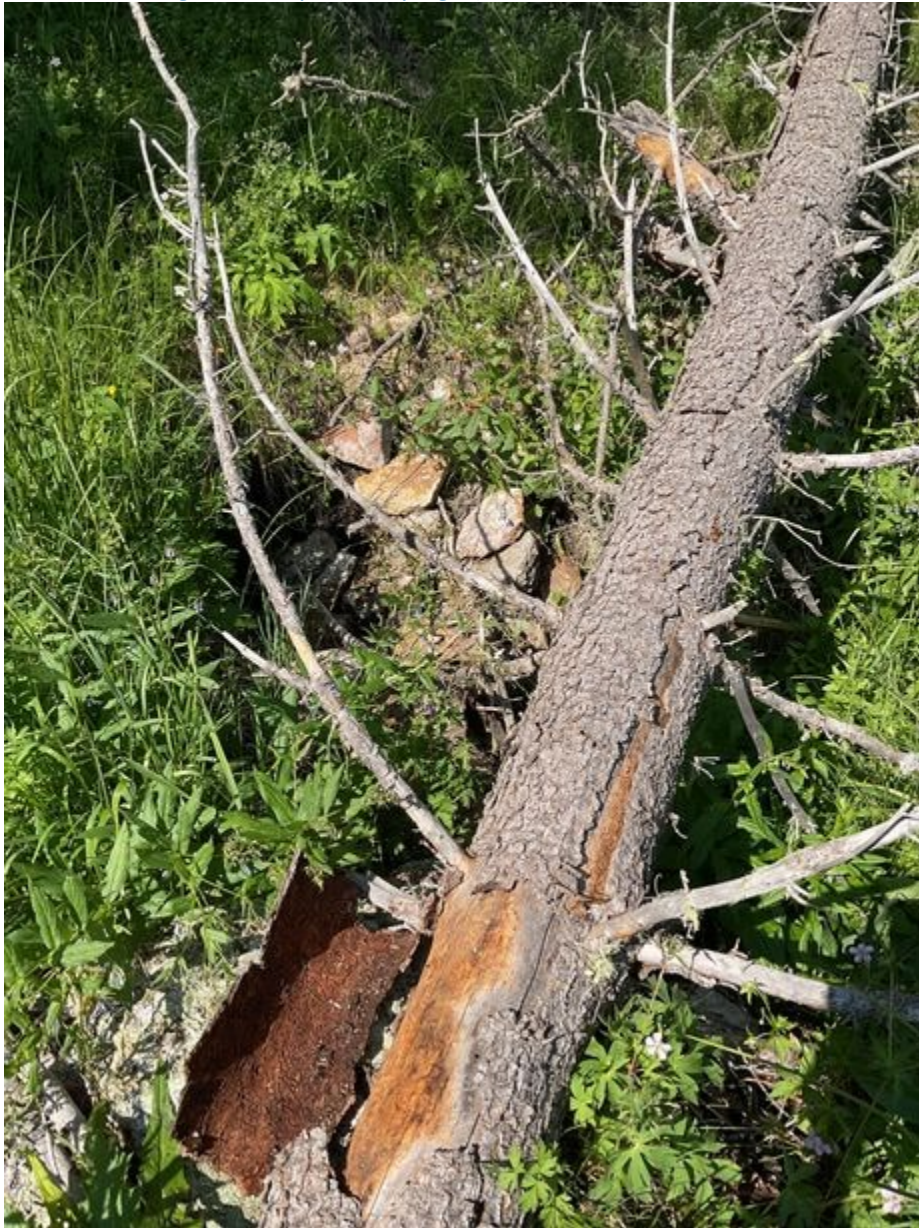
-106.6013507 35.92396522

Some rocks dislodged or broken

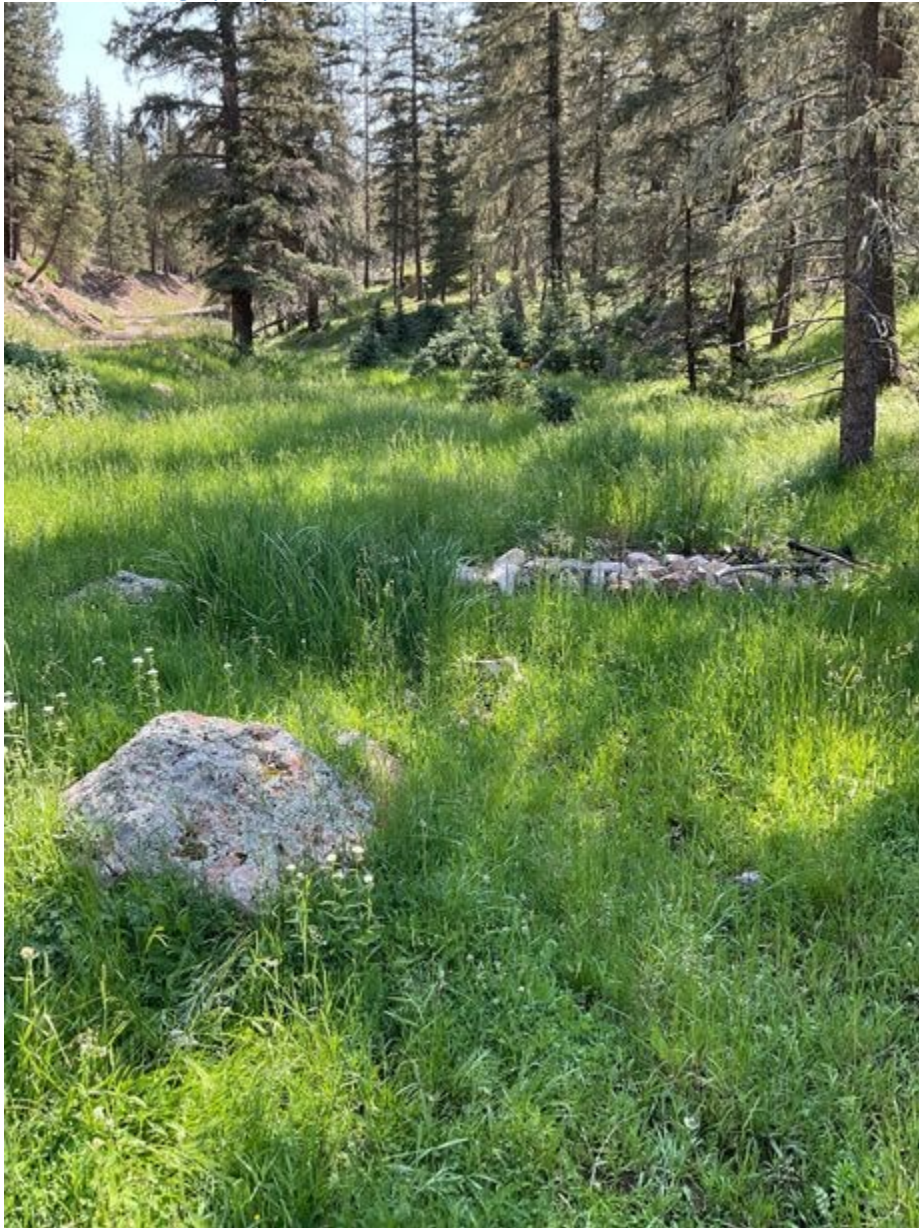
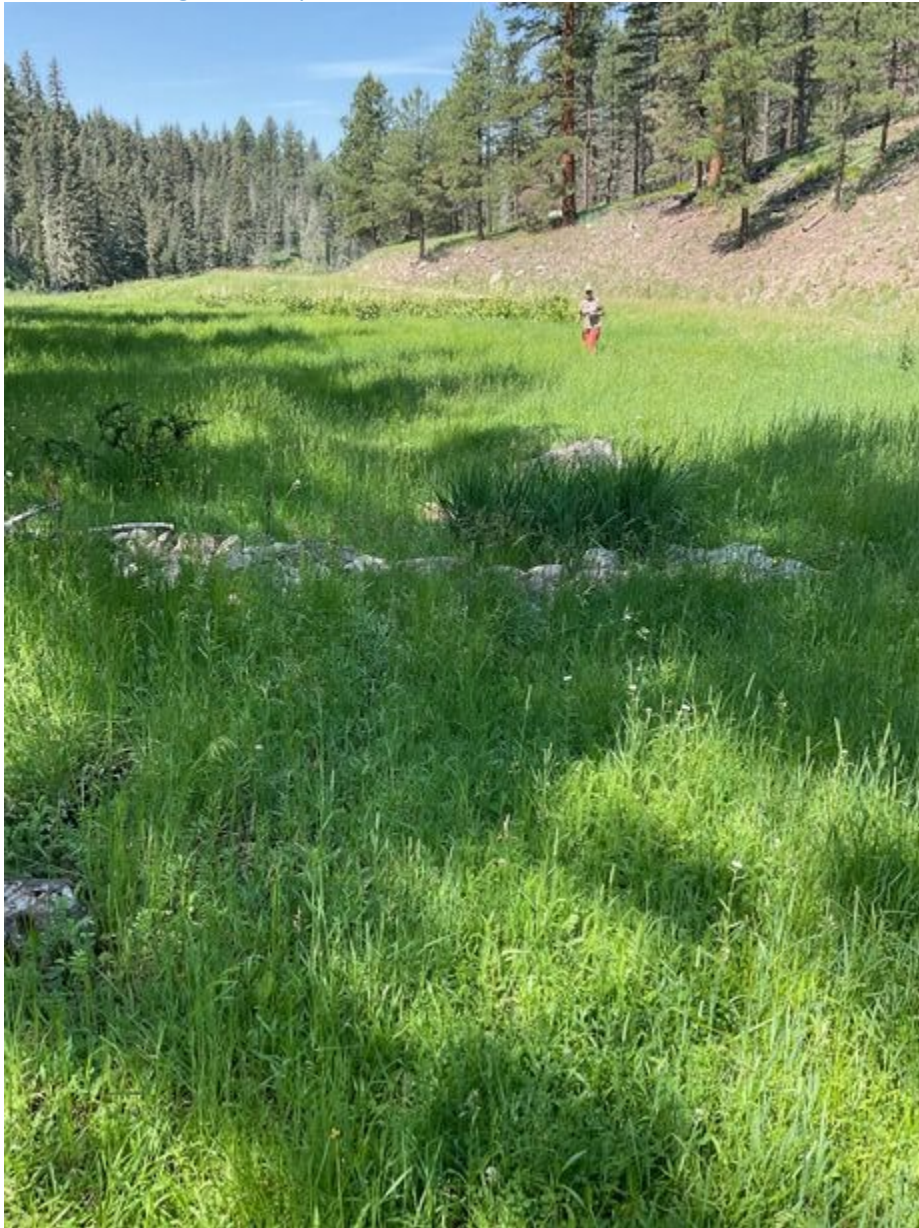
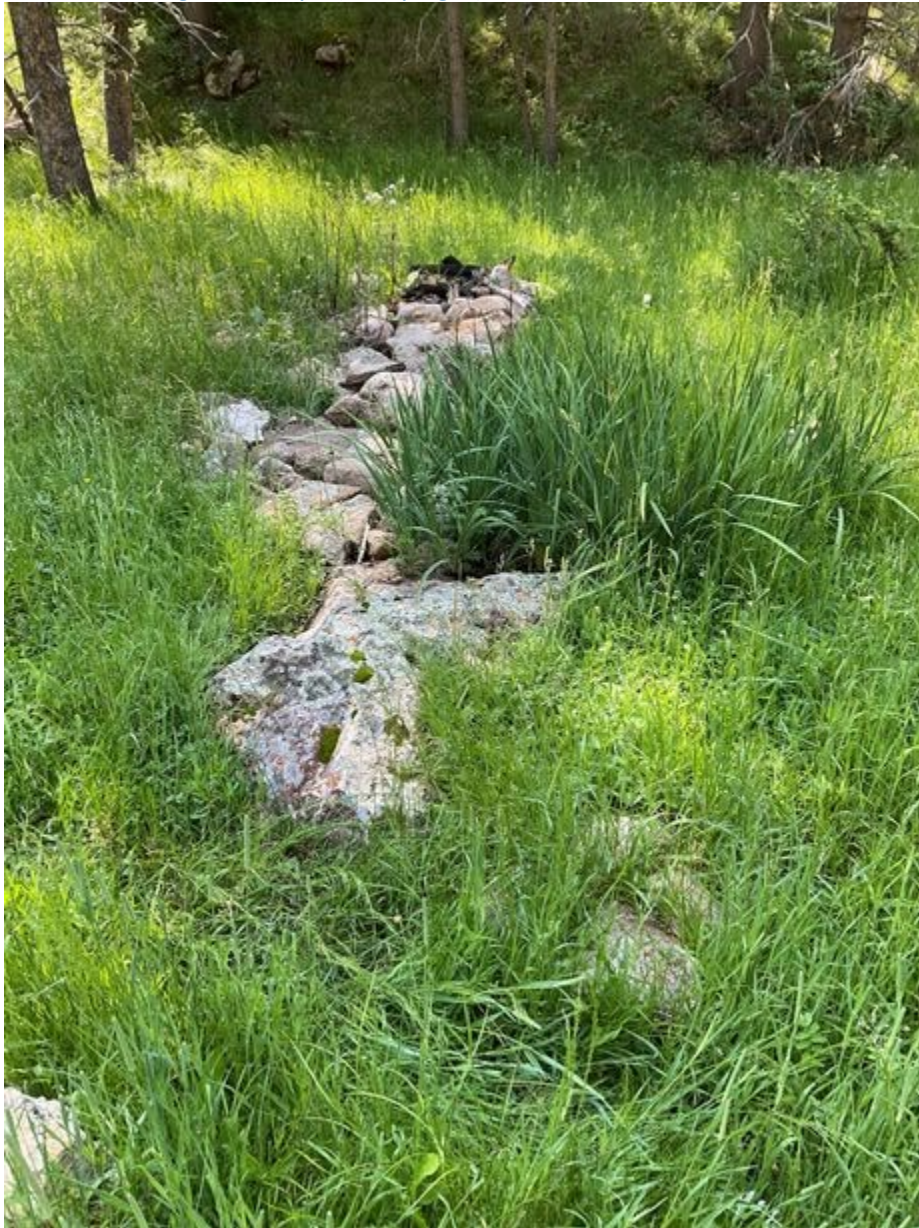
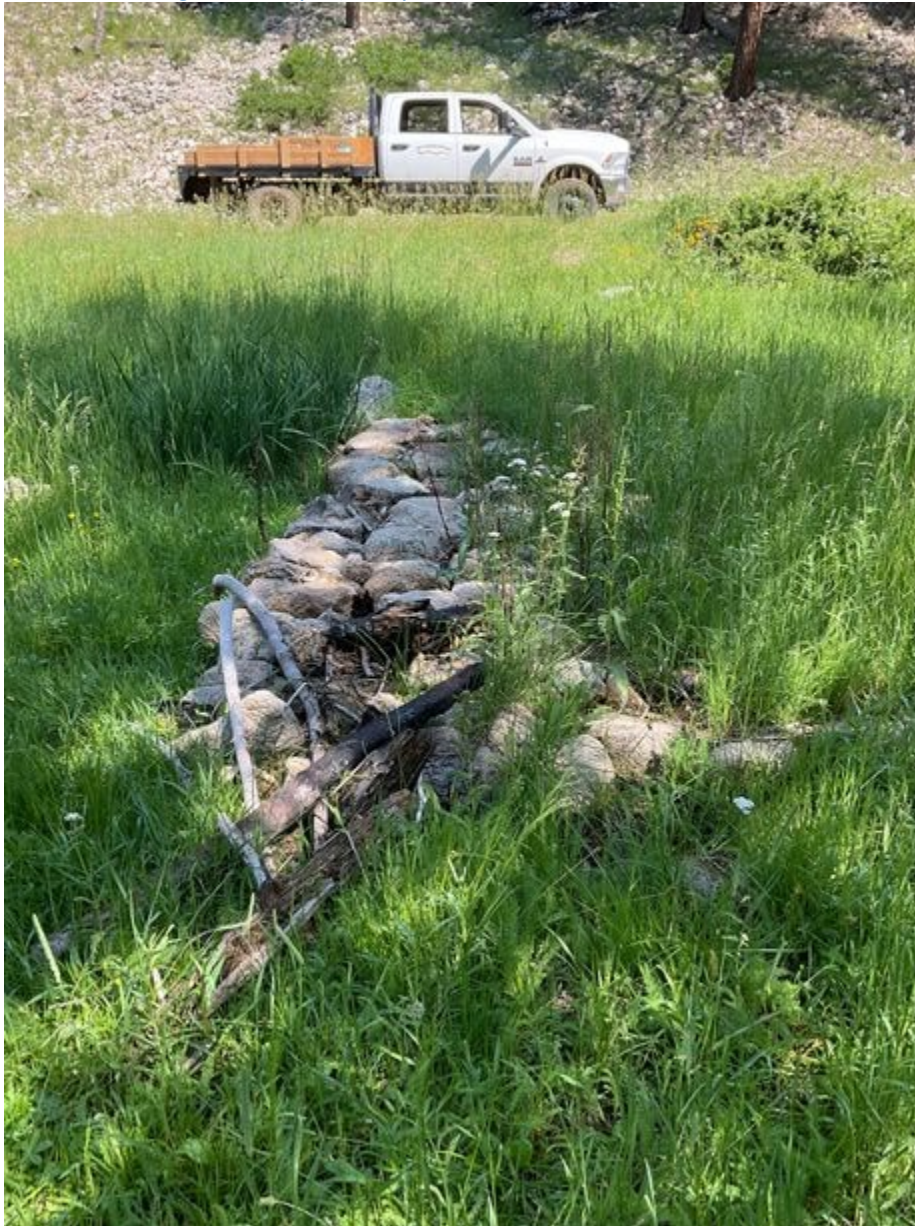
-106.5974051 35.92597653

All rocks intact

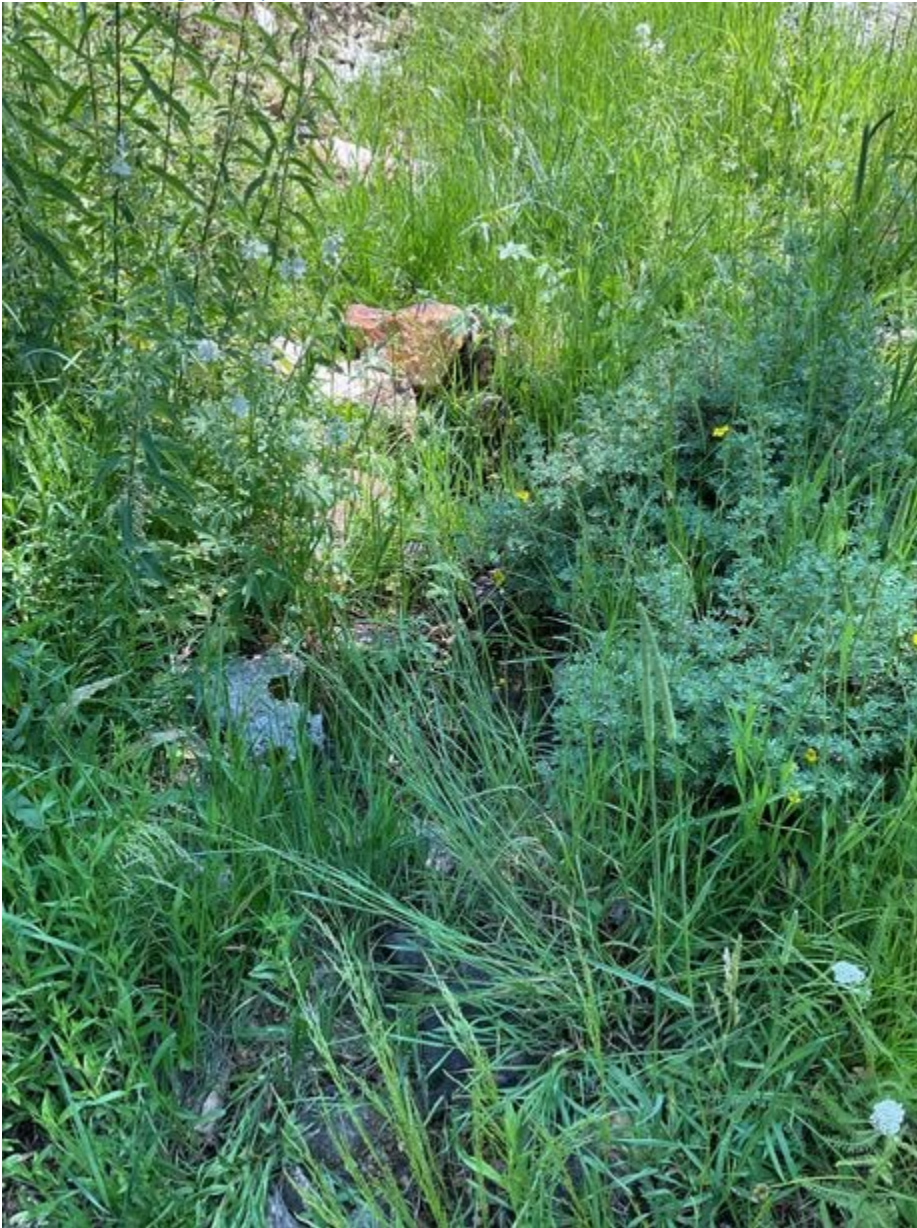
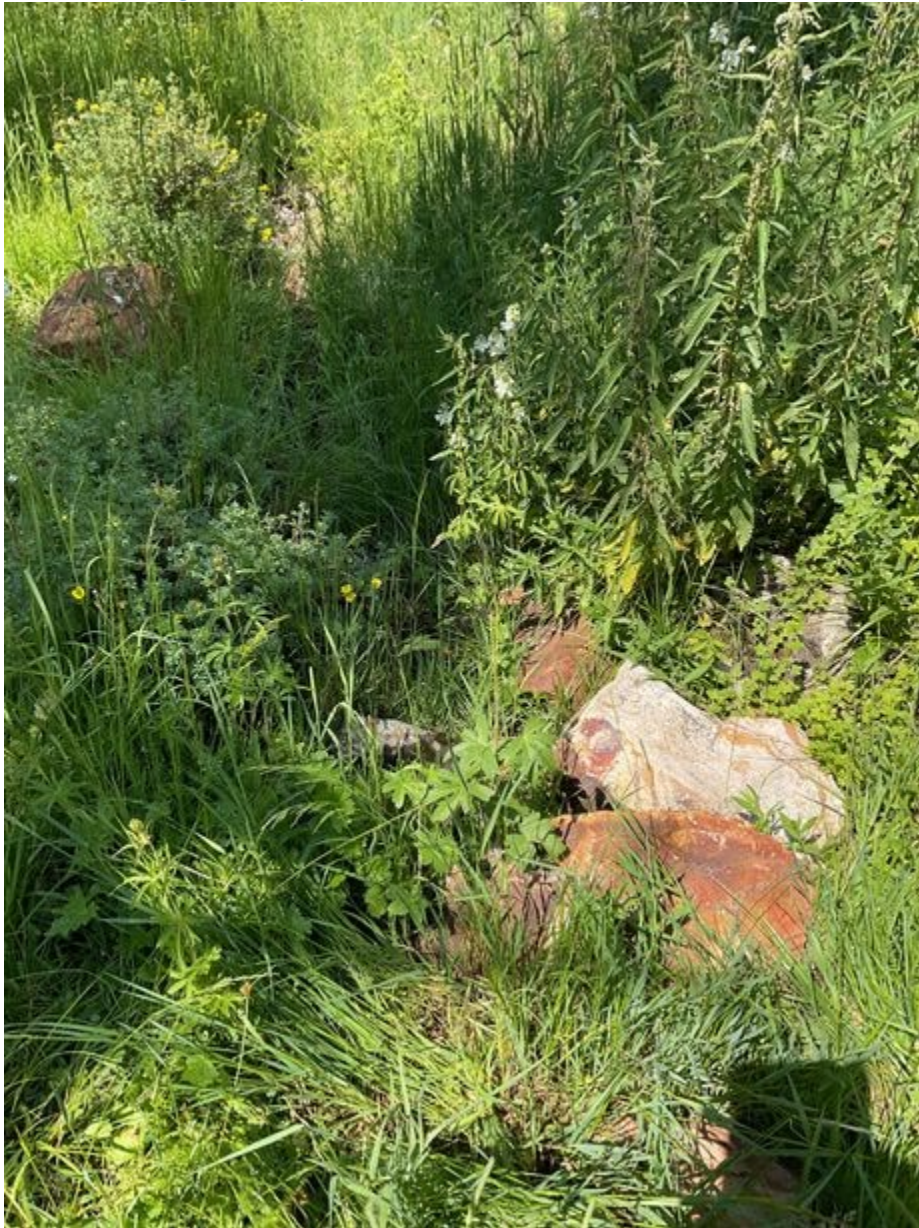
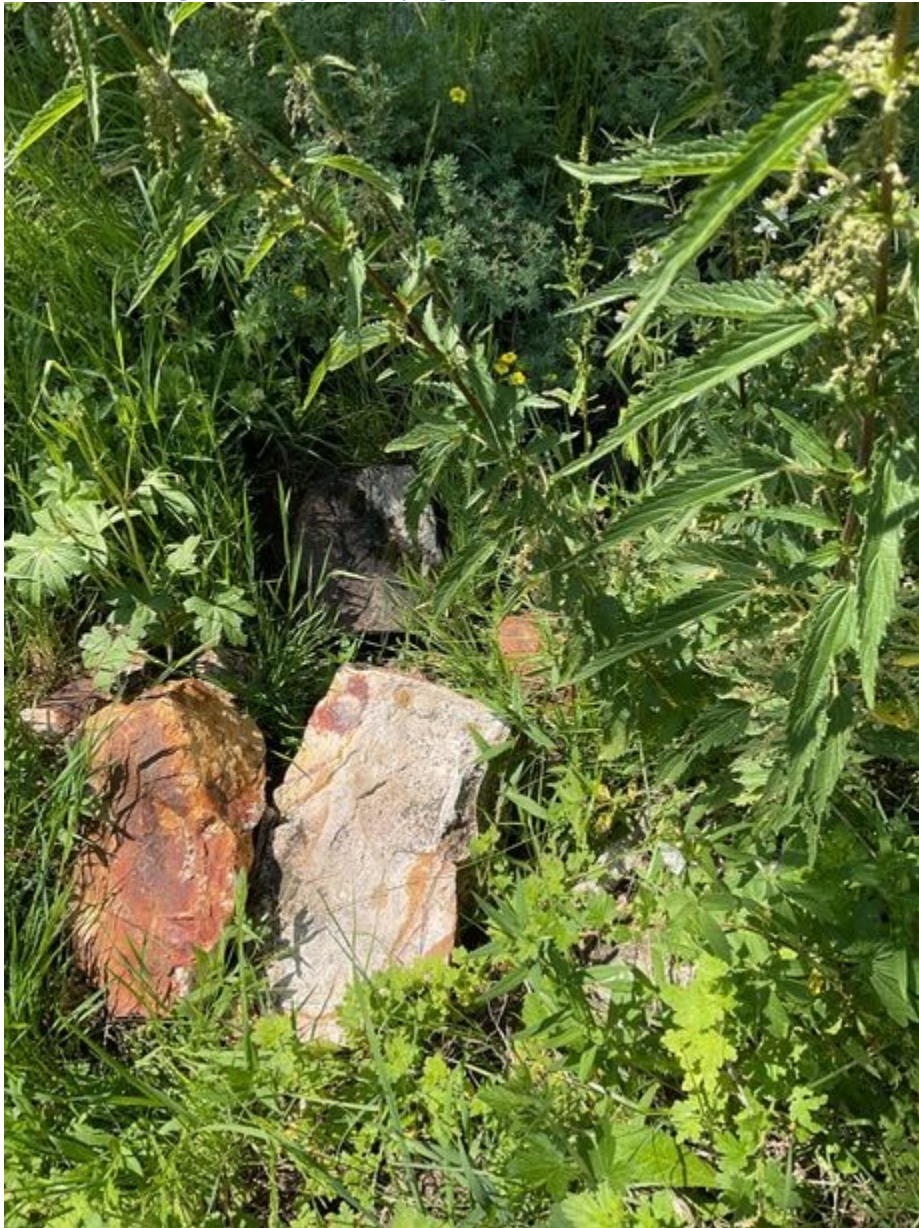
-106.596739 35.92636523

Some rocks dislodged or broken

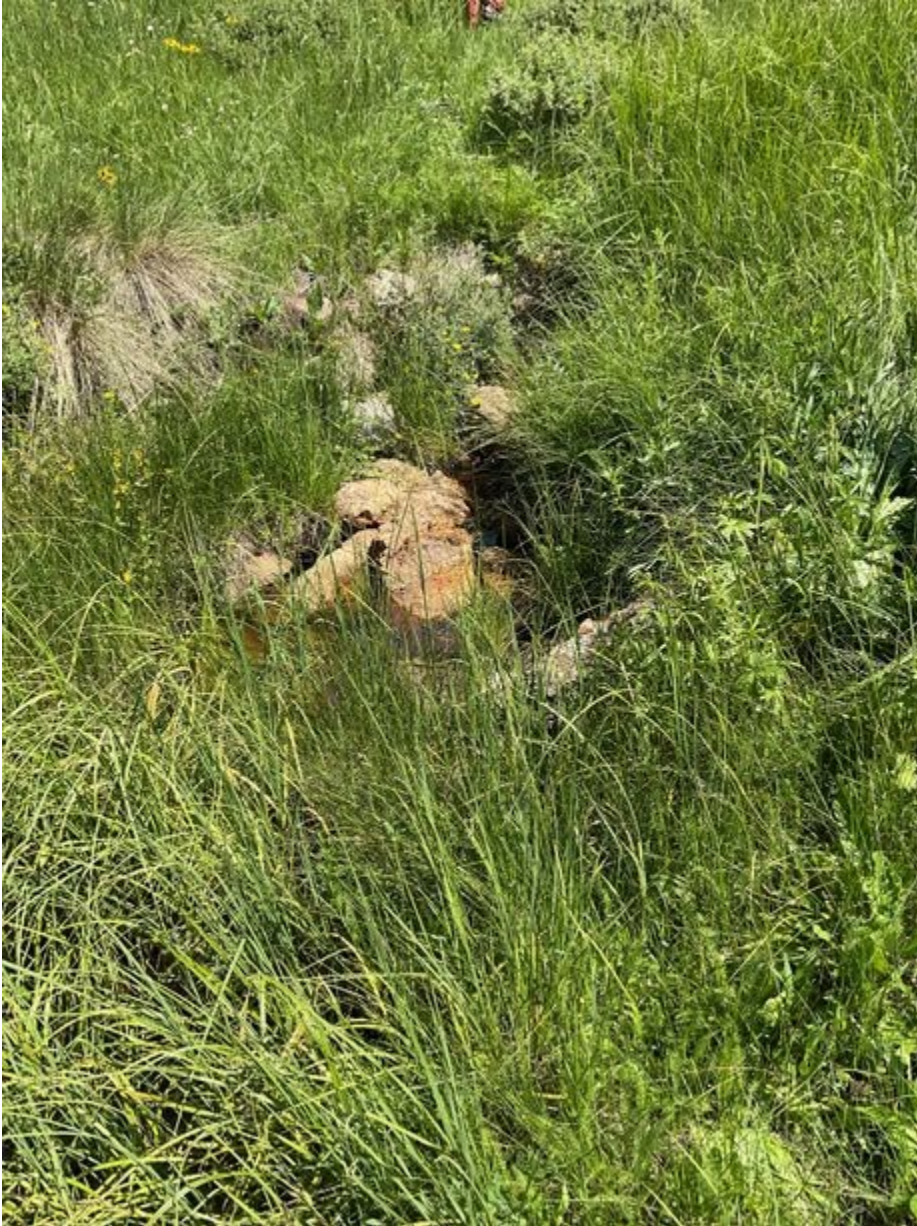
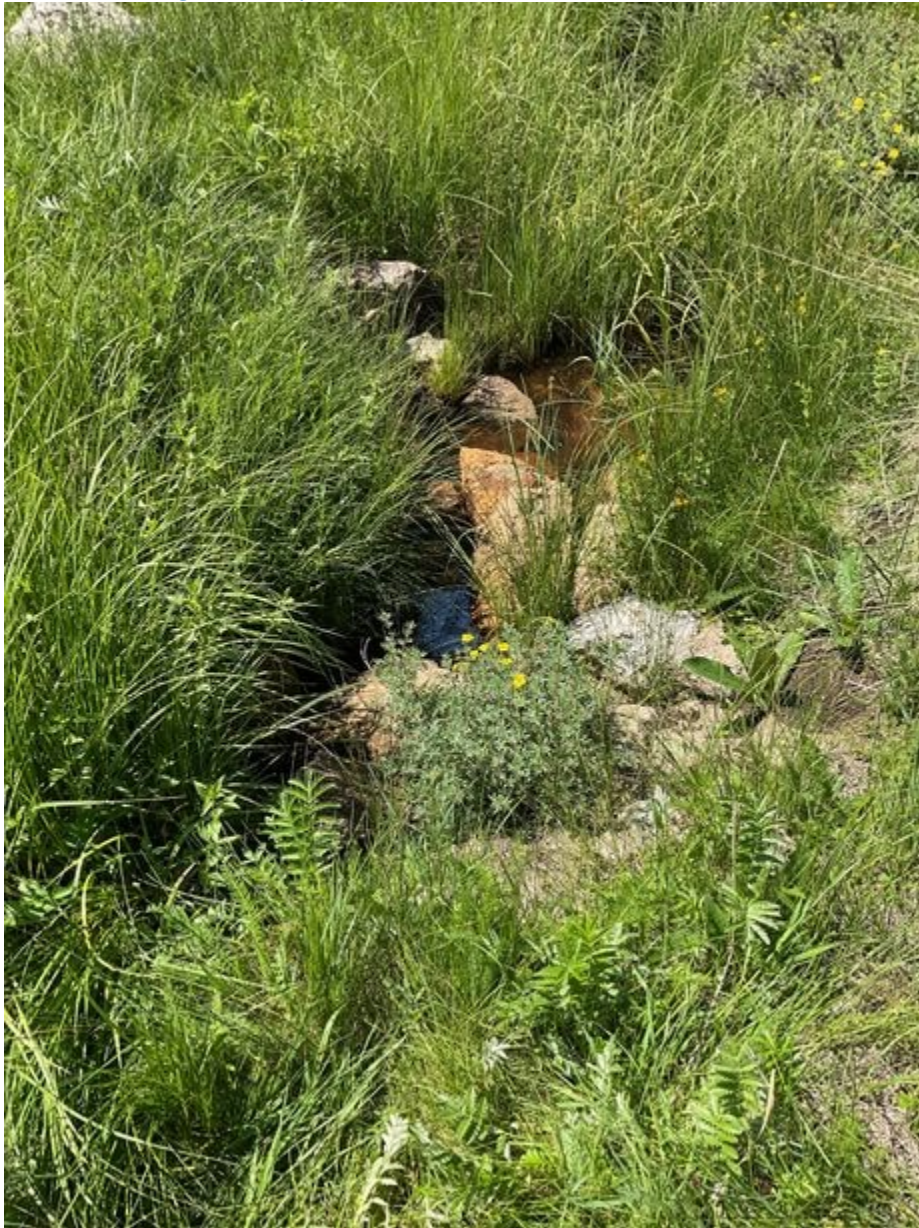
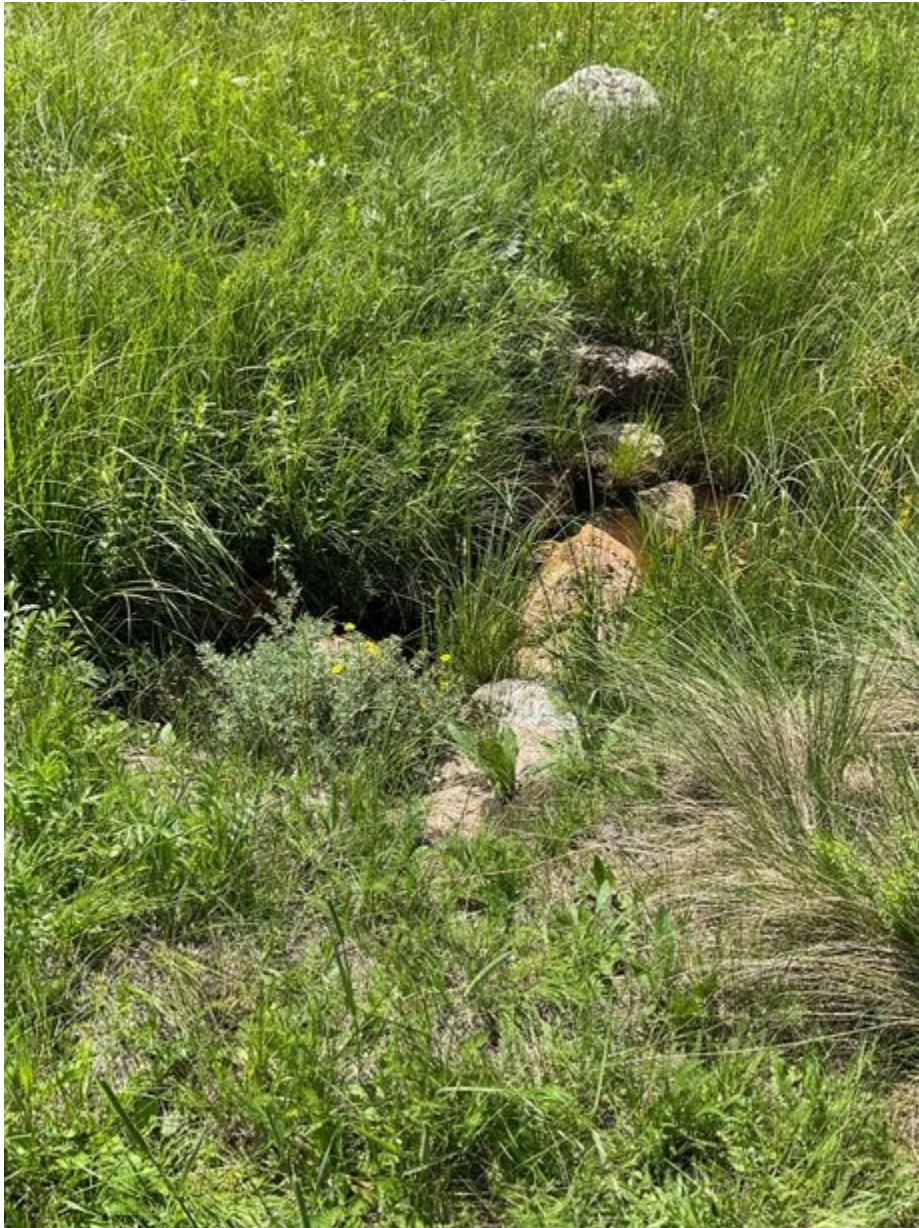
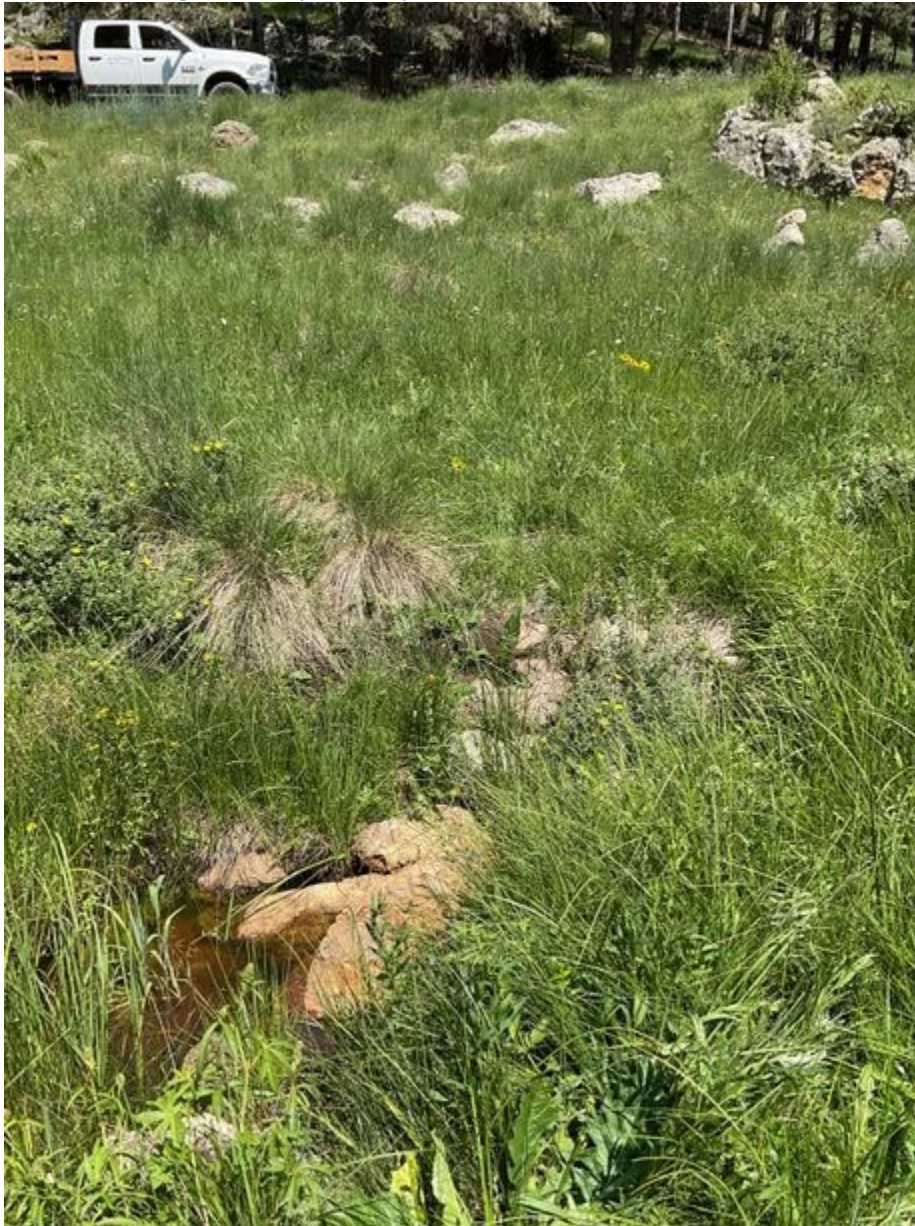
-106.5957161 35.9267053

Some rocks dislodged or broken
