CN R924060

**Zuni Bowl and One Rock Check Dam Research –
Phase 1**

Final Report

Rio Grande Return for the New Mexico Department of Transportation Research Bureau

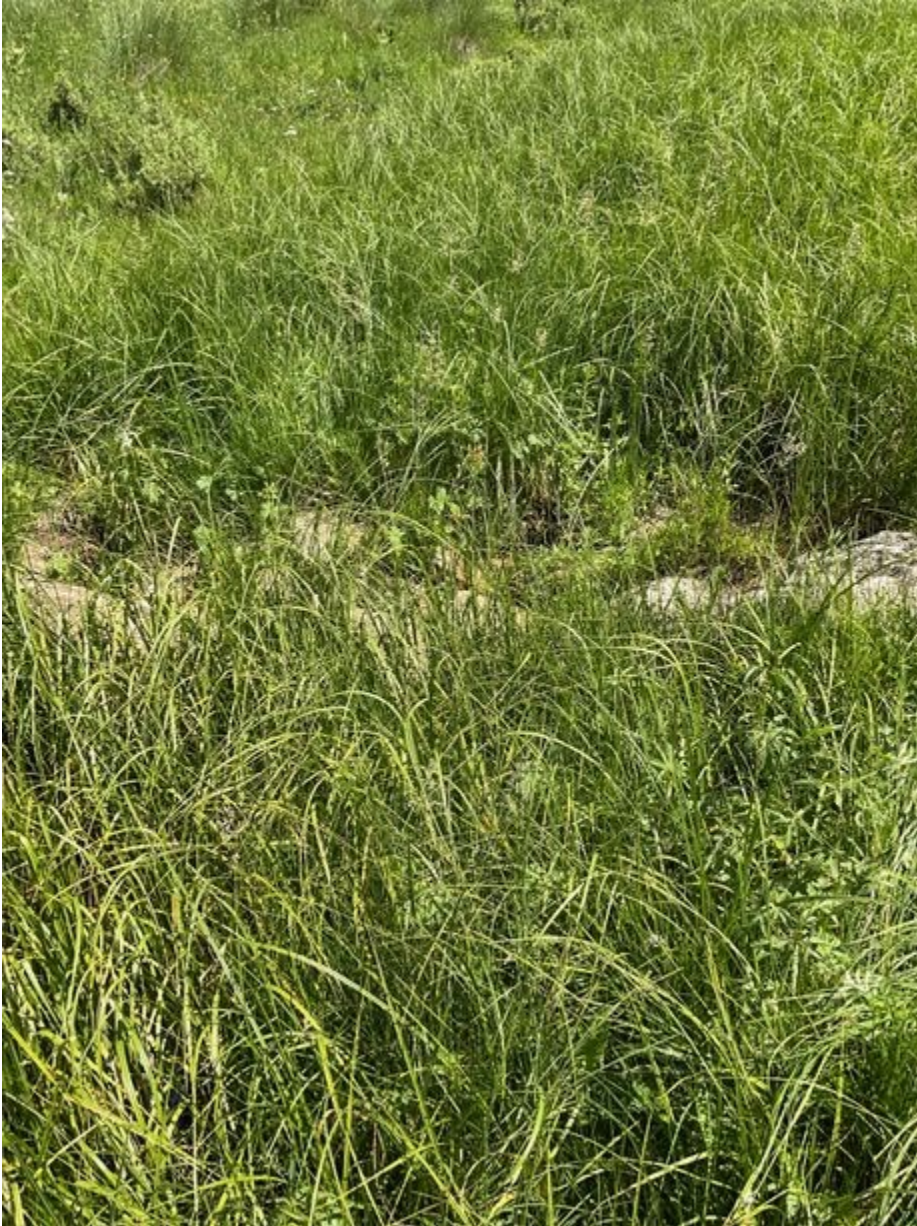
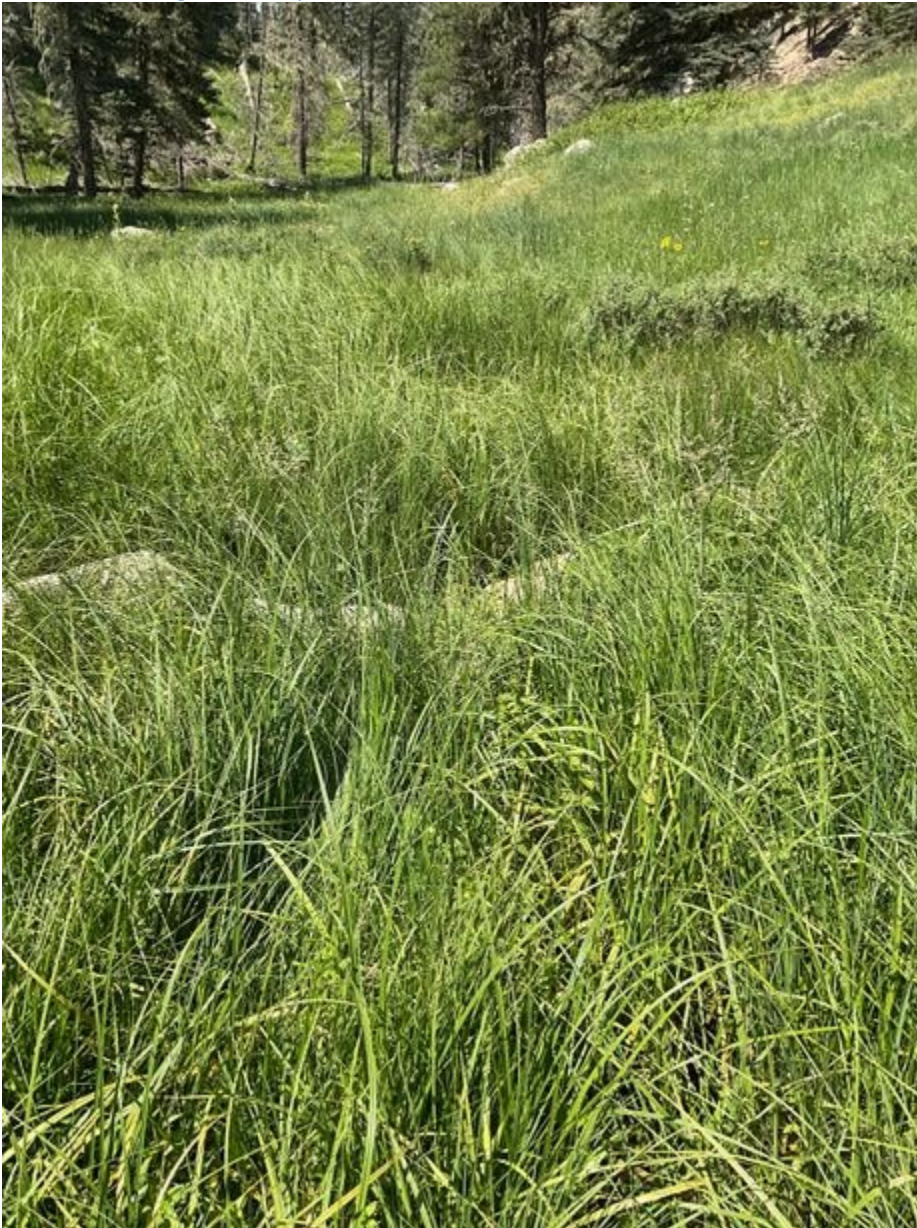
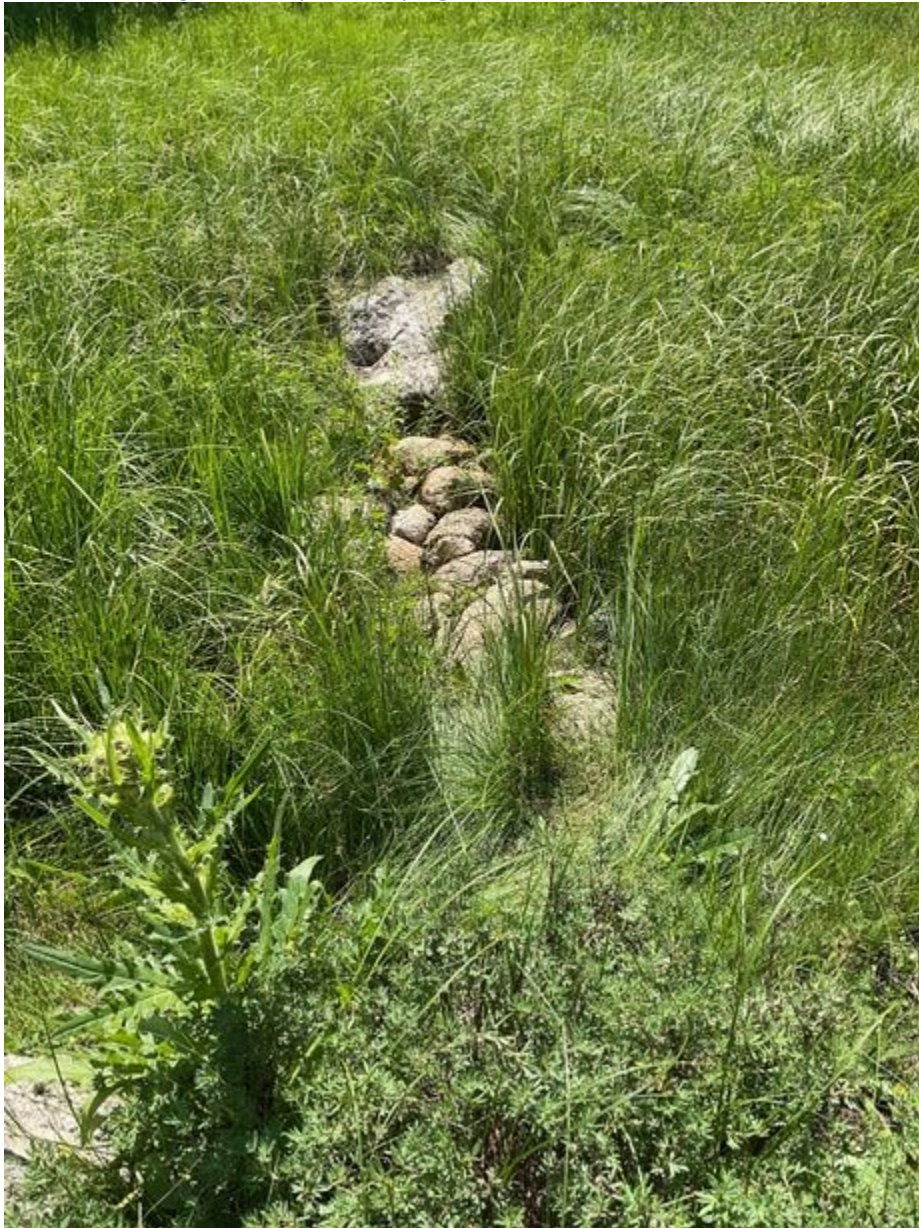
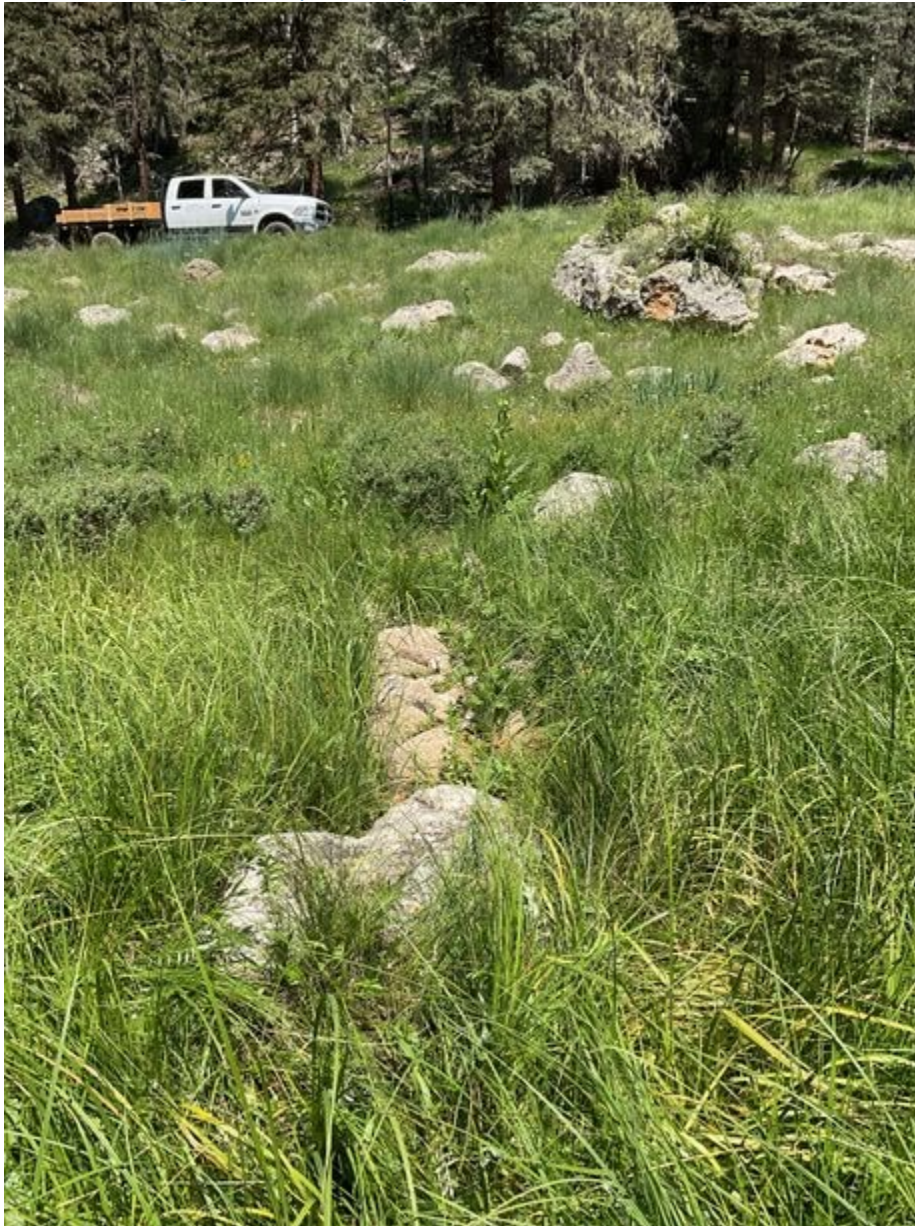
-106.5956386 35.92677082

All rocks intact

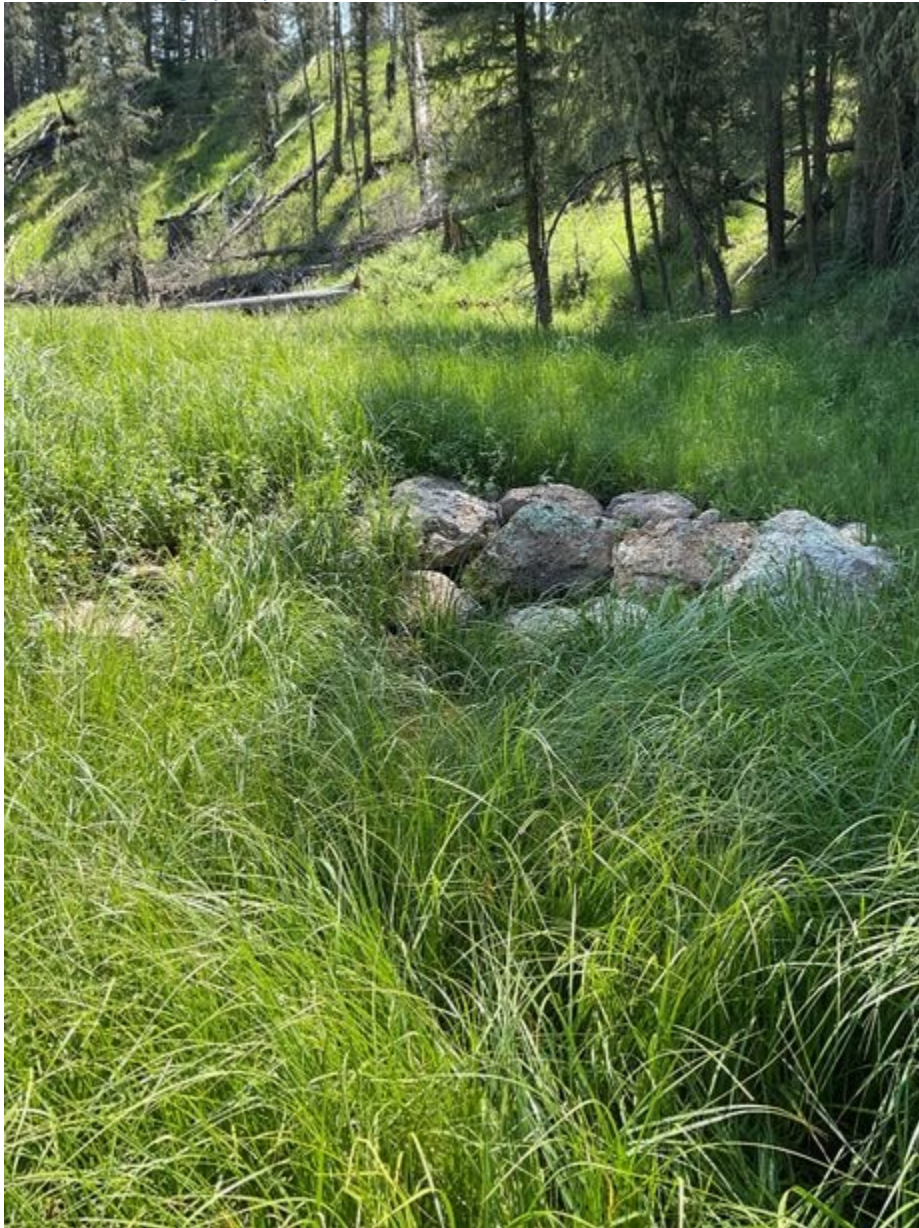
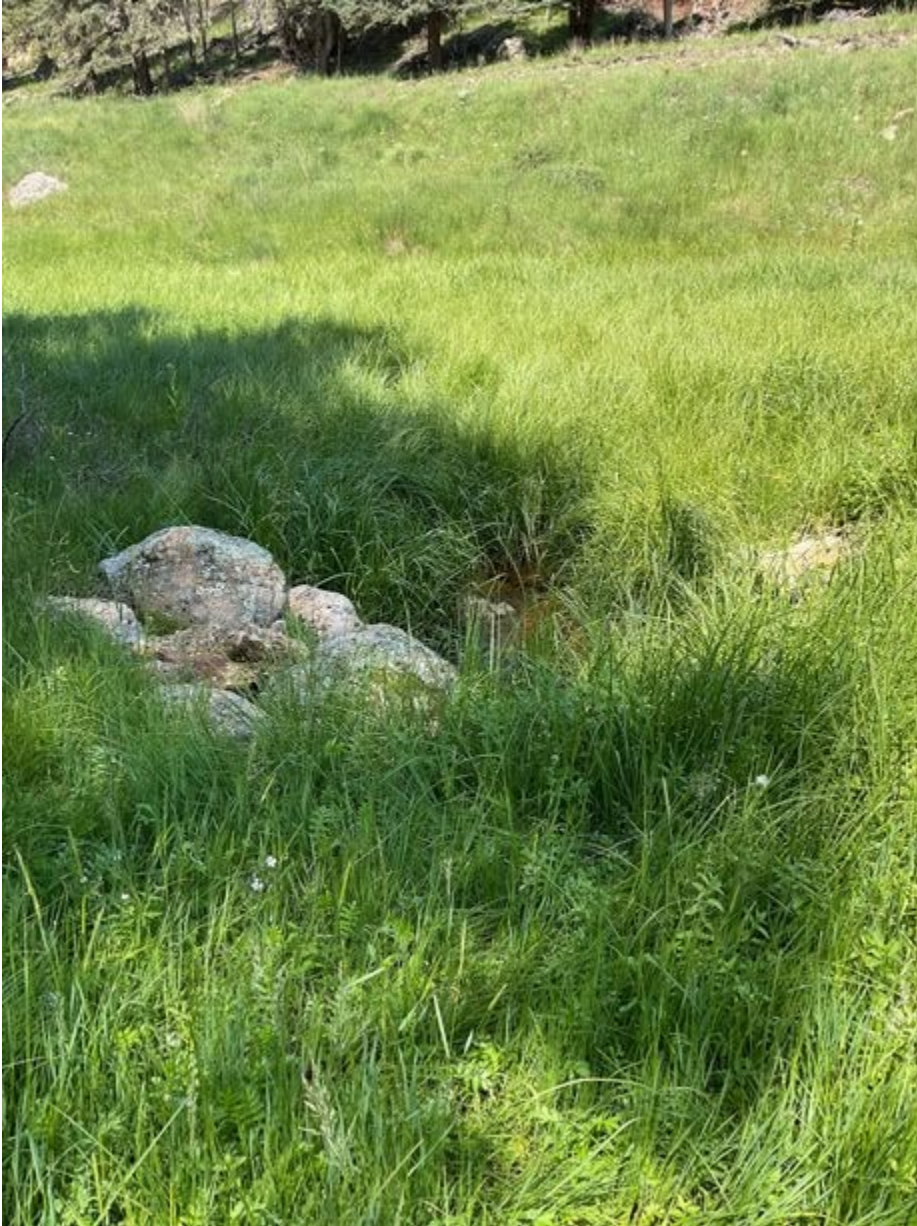
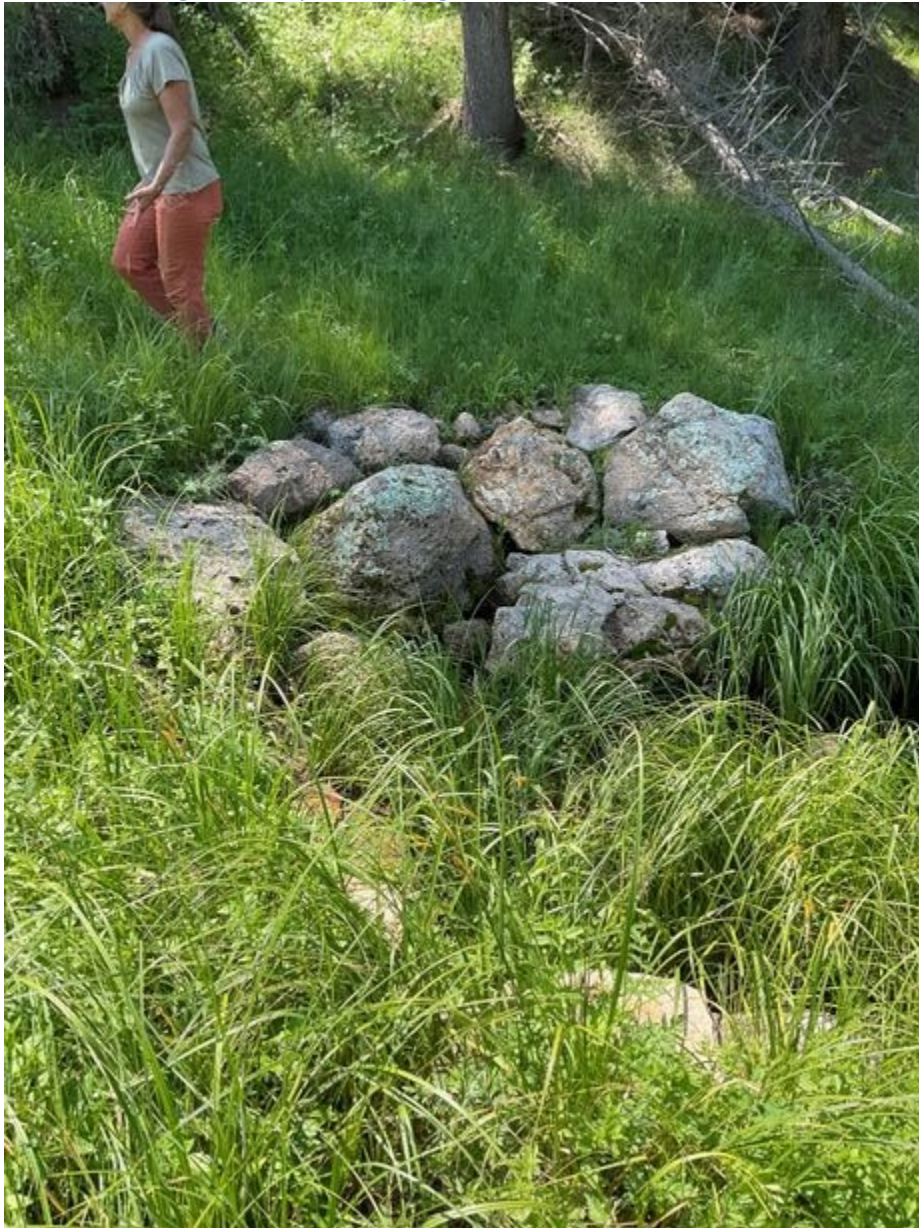
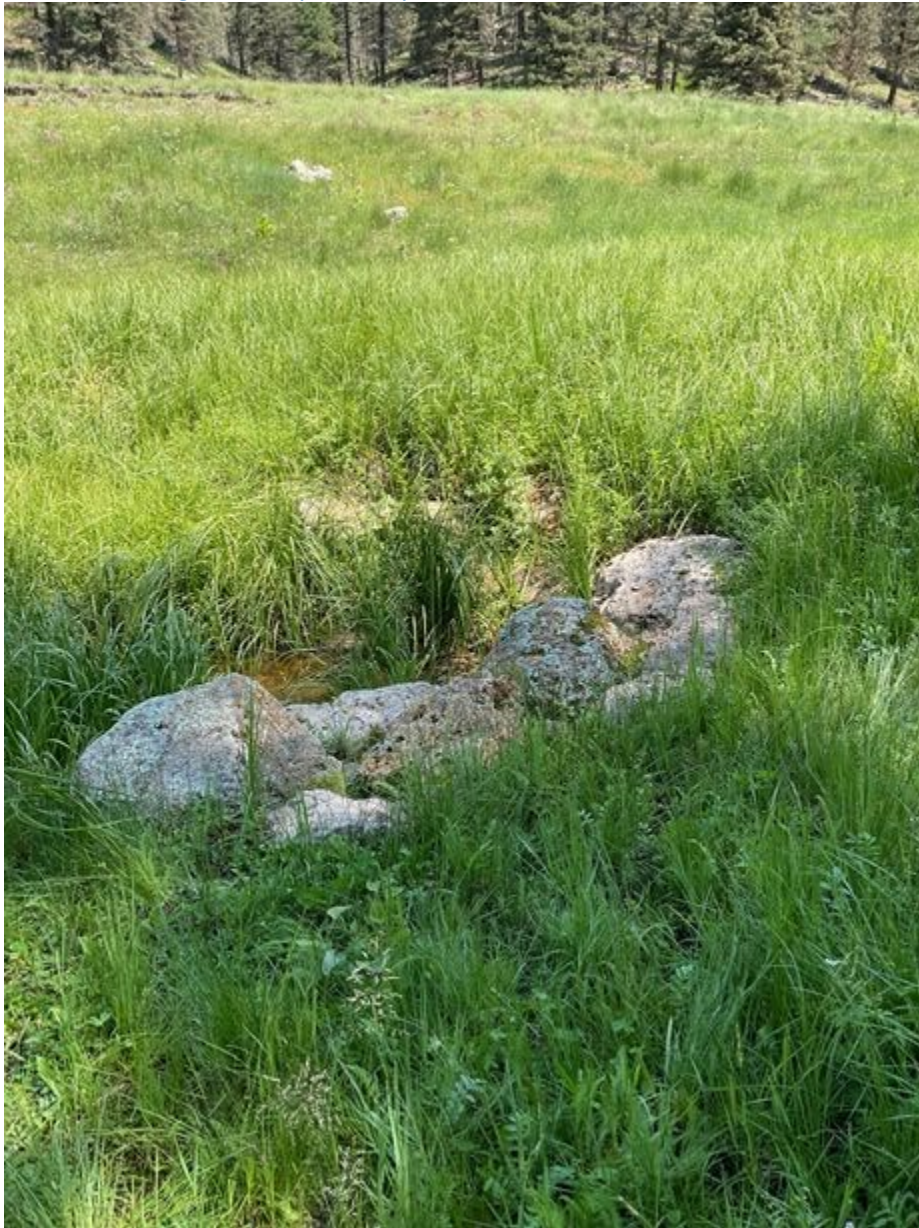
-106.5953365 35.92701612

All rocks intact

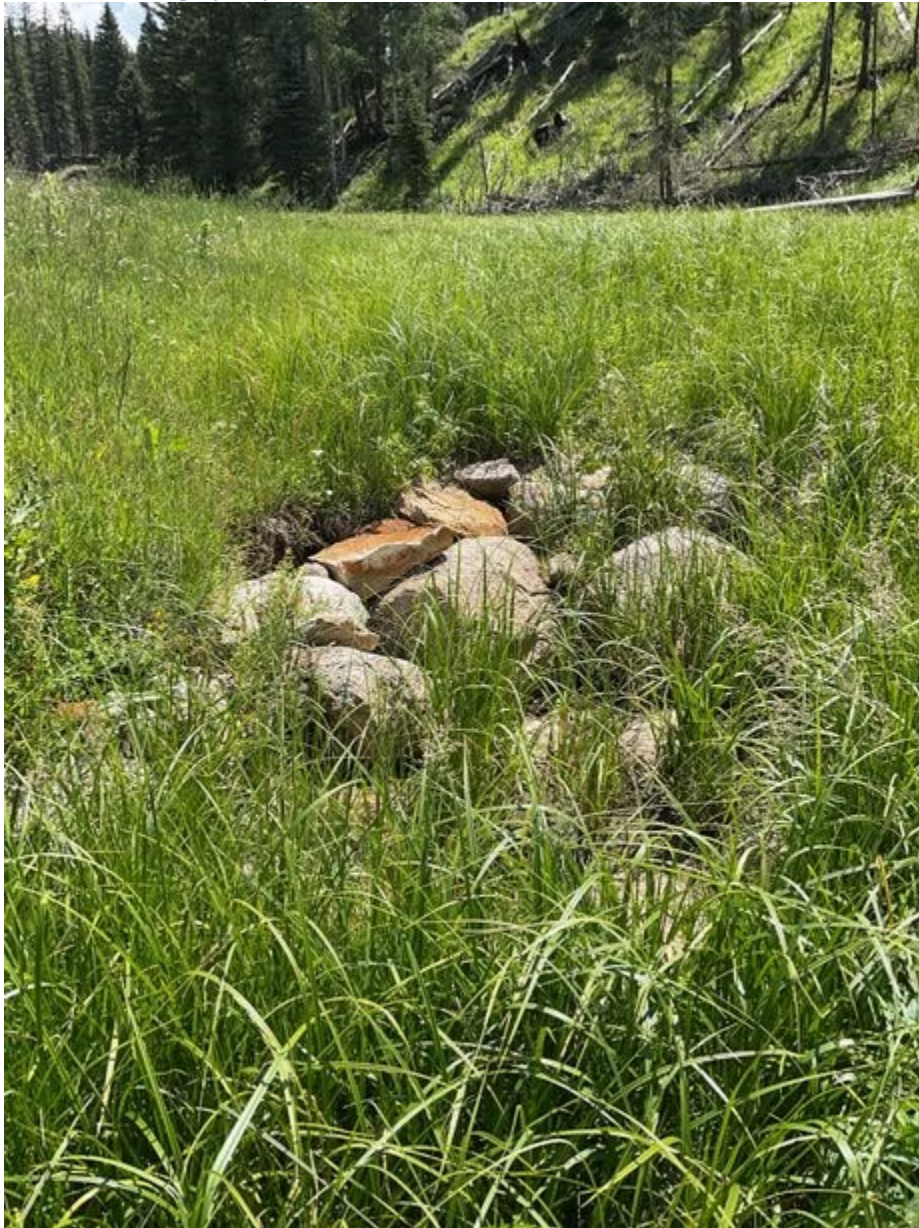
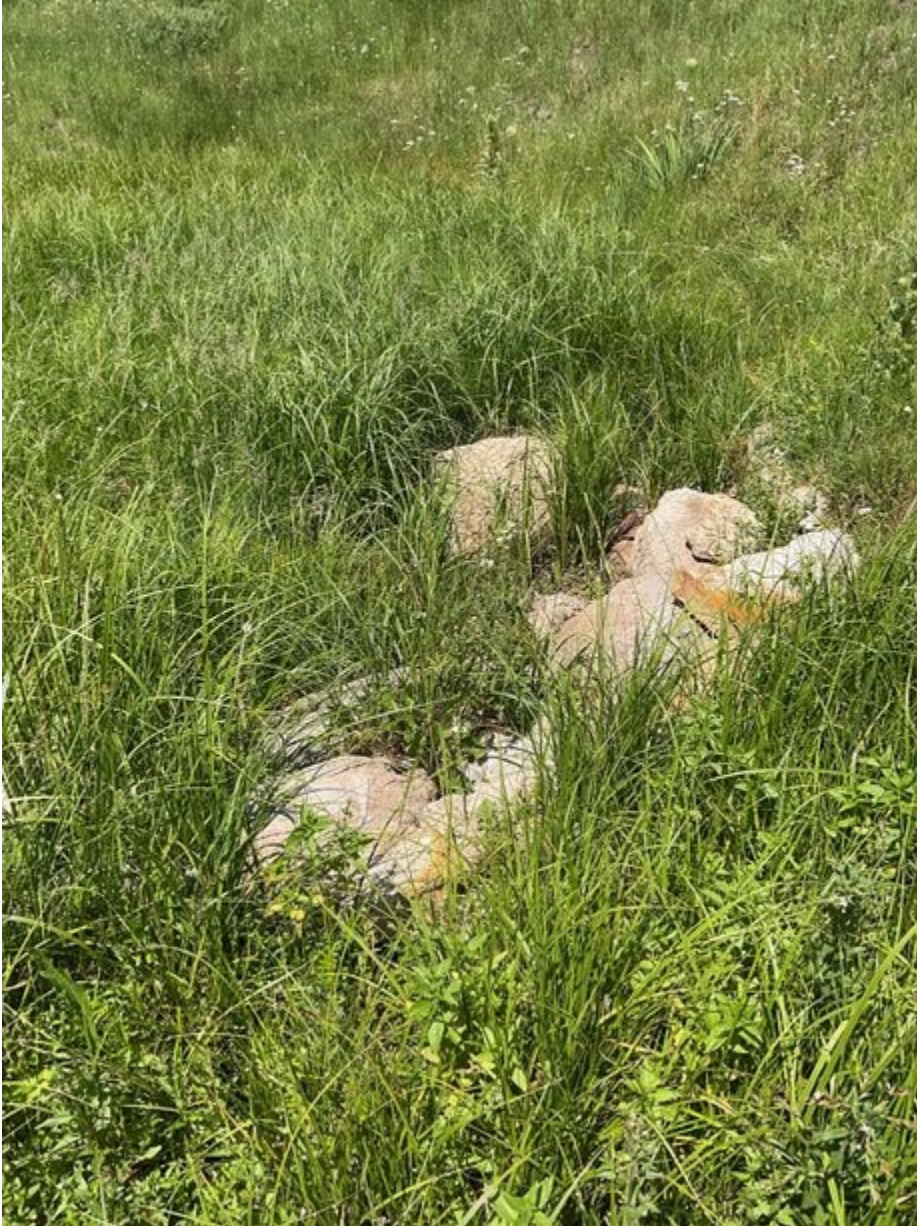
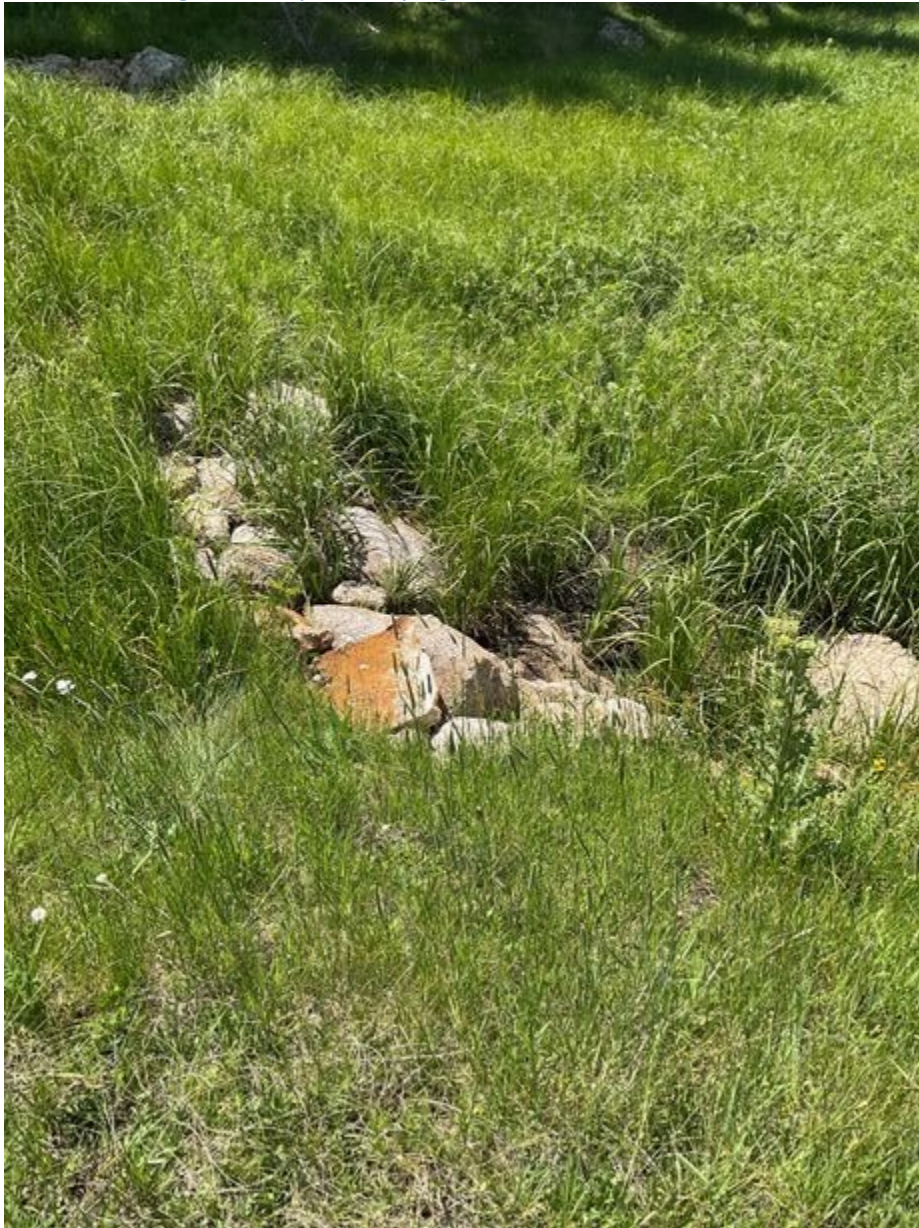
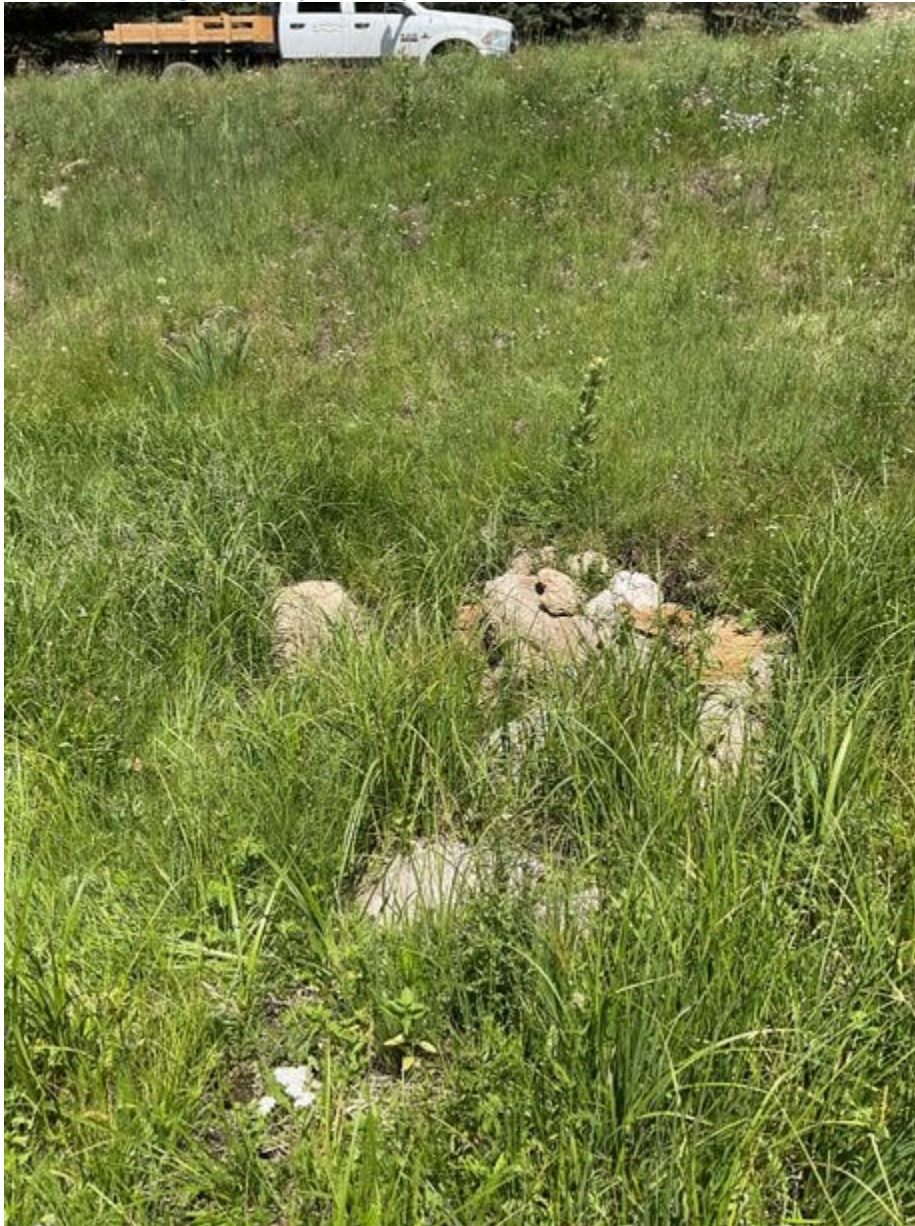
-106.595385 35.92712025

Some rocks dislodged or broken

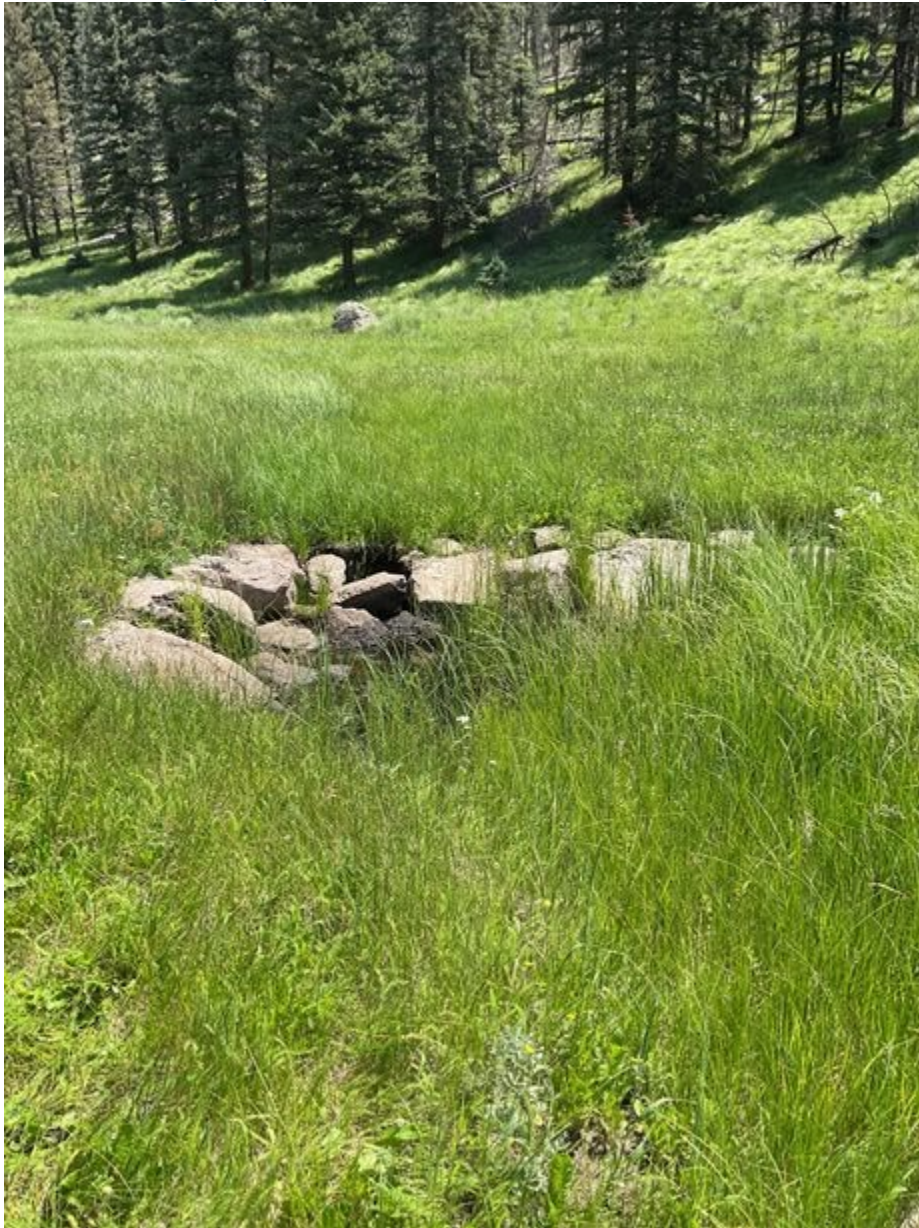
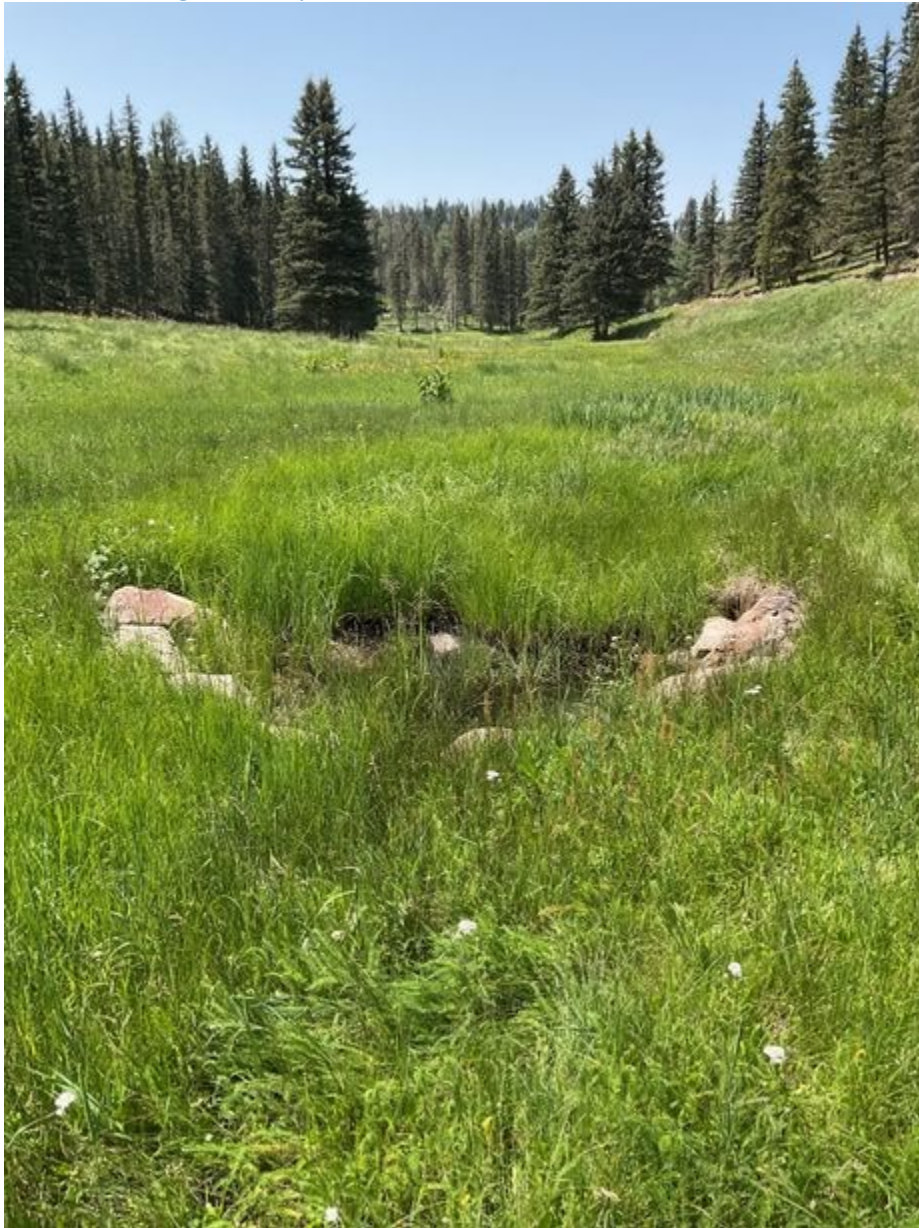
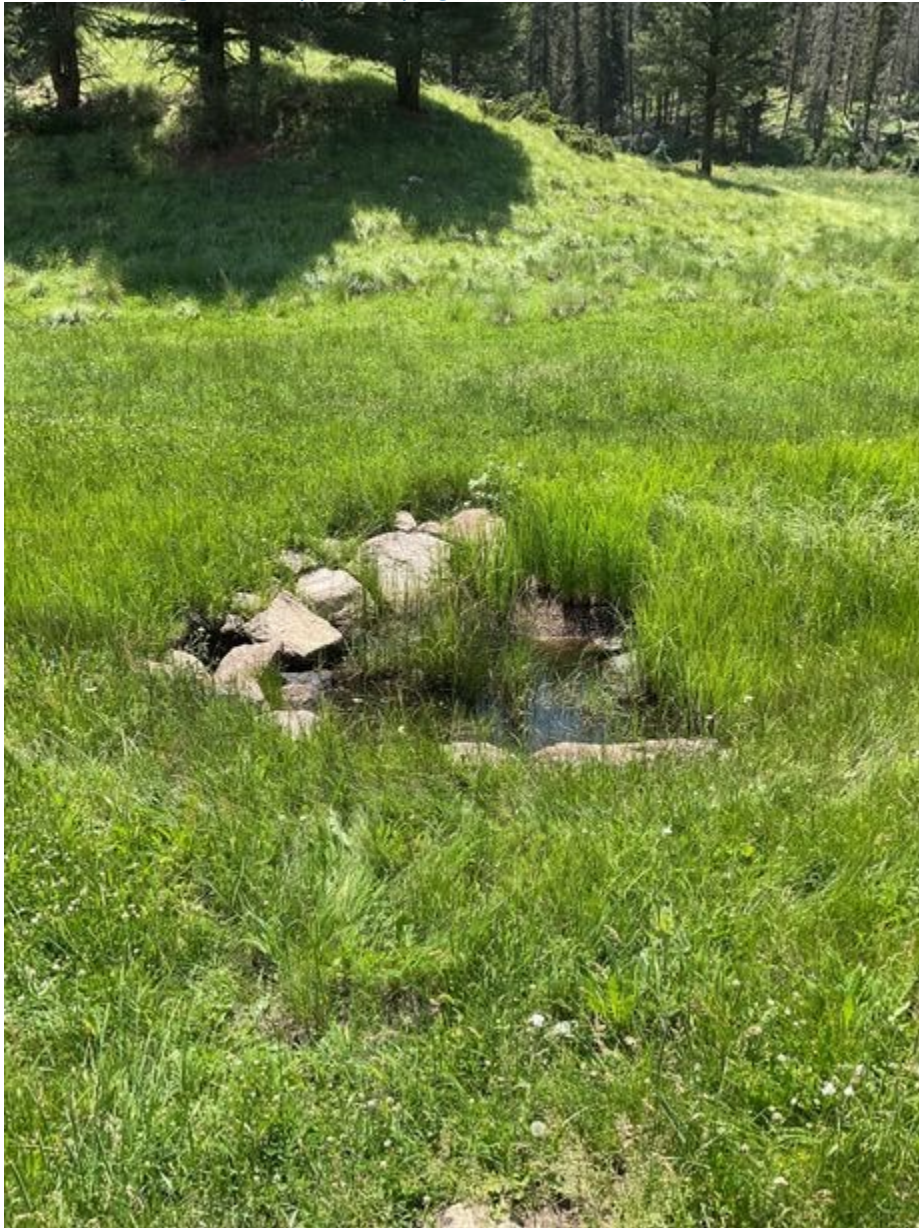
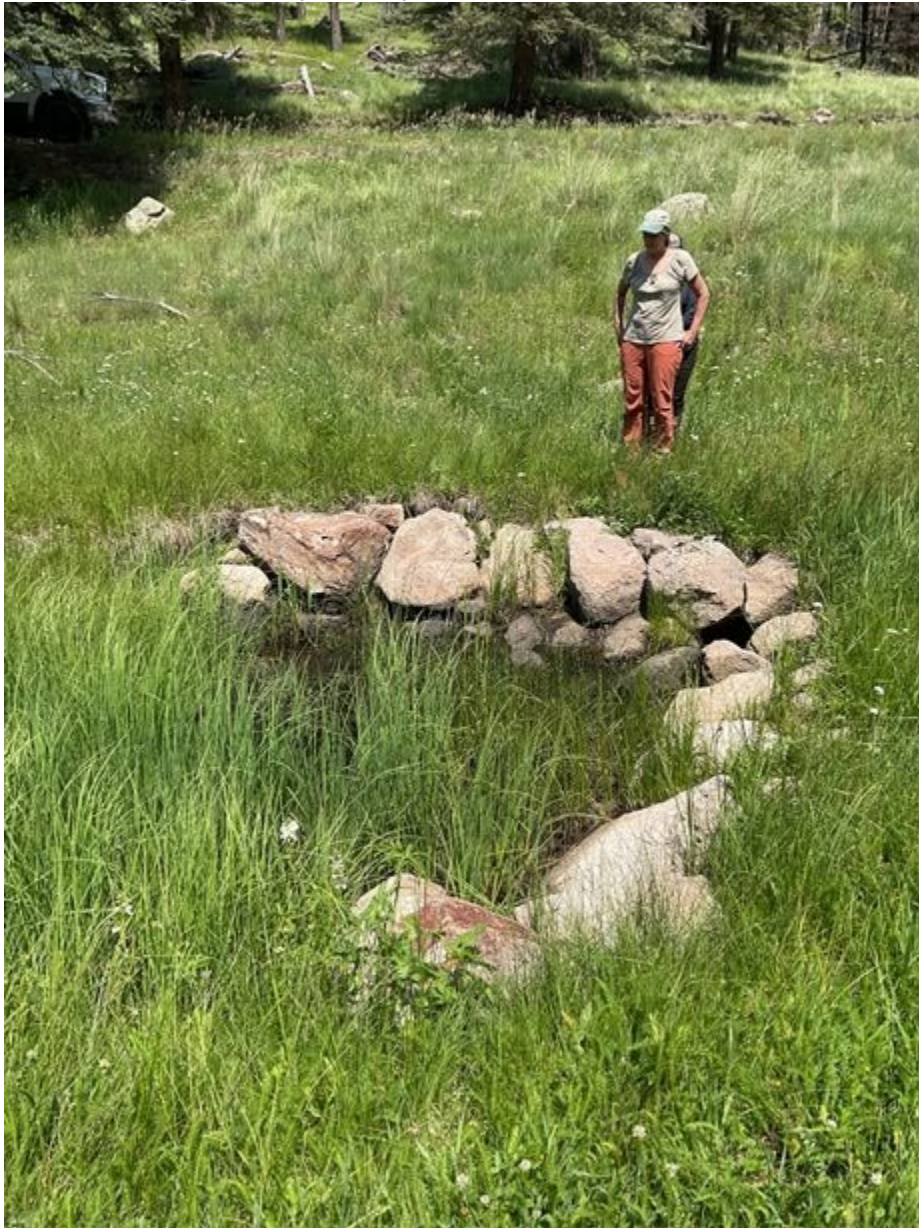
-106.5918327 35.93062668

All rocks intact

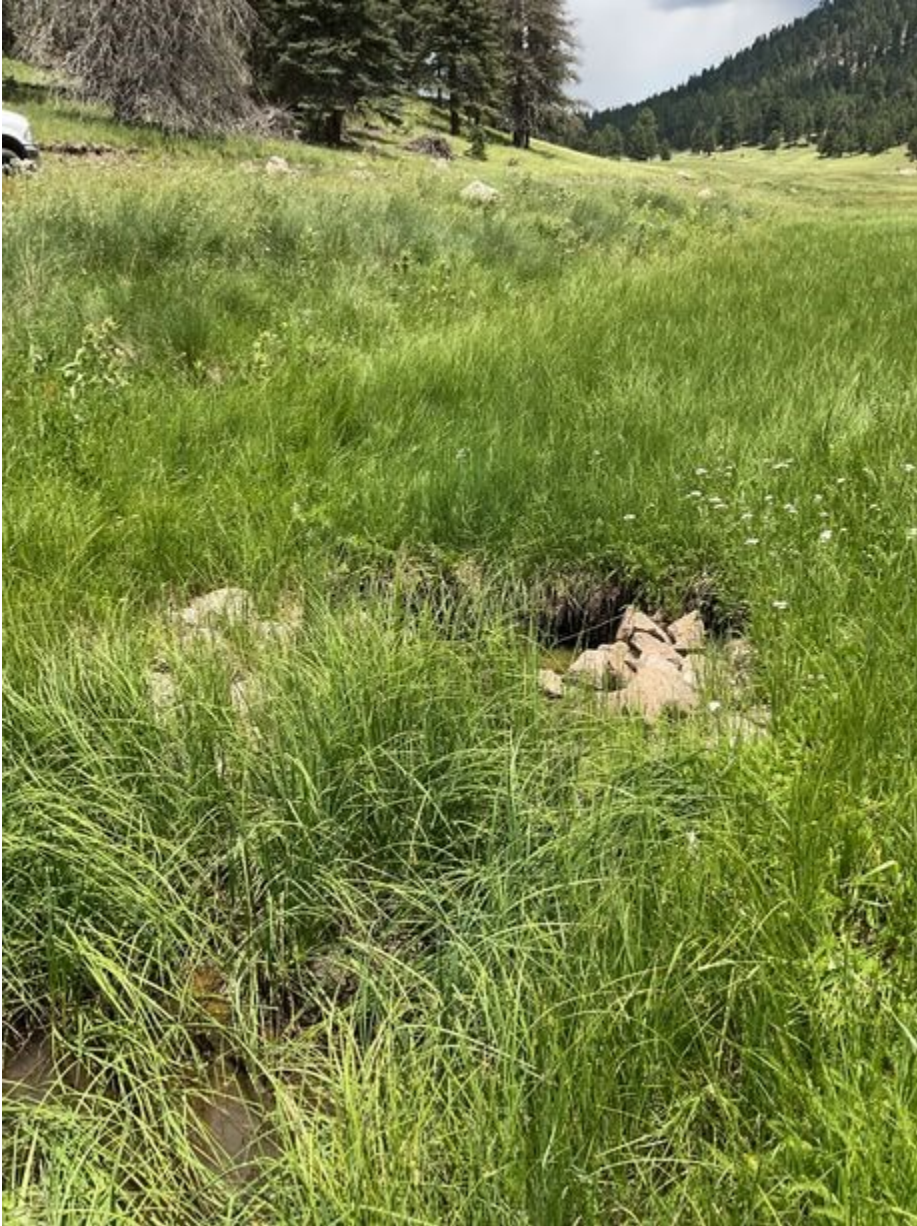
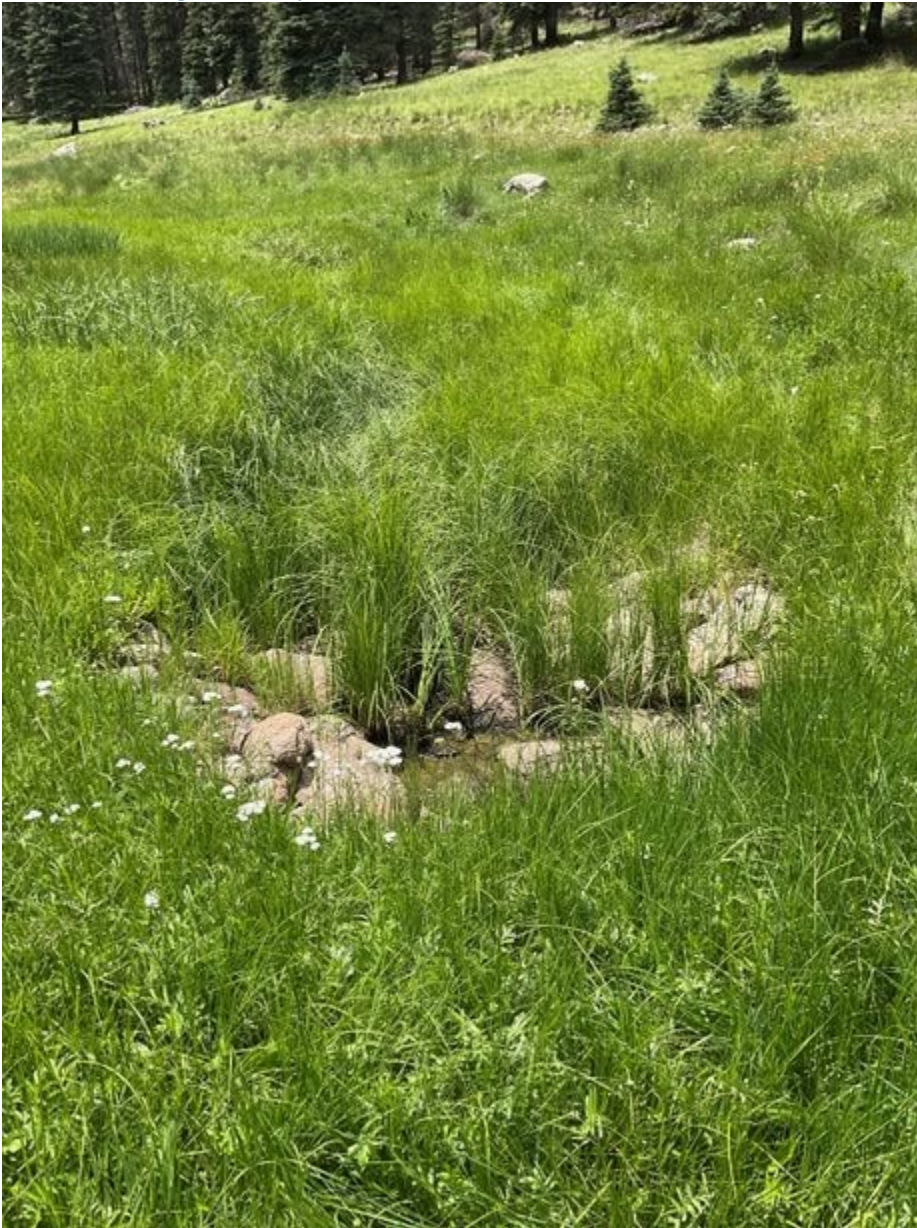
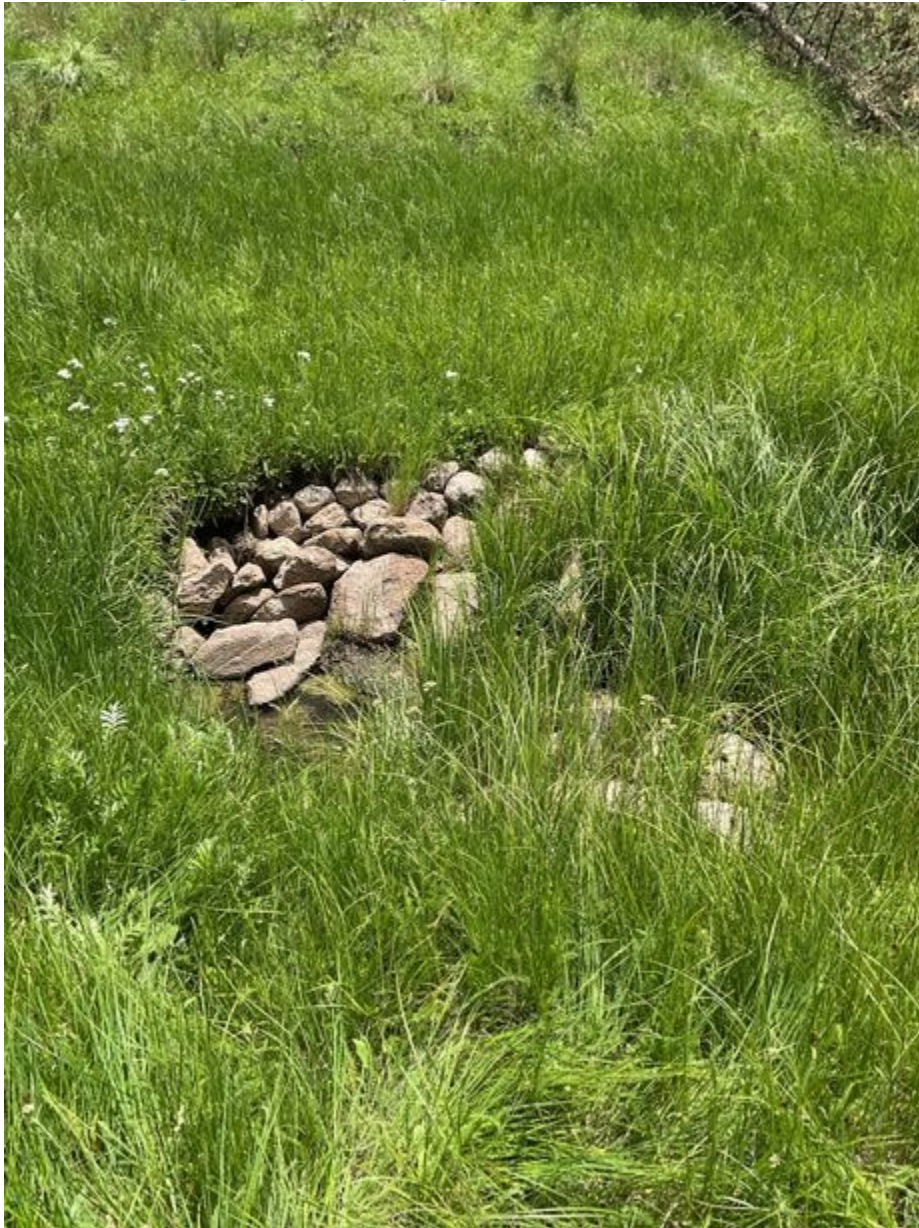
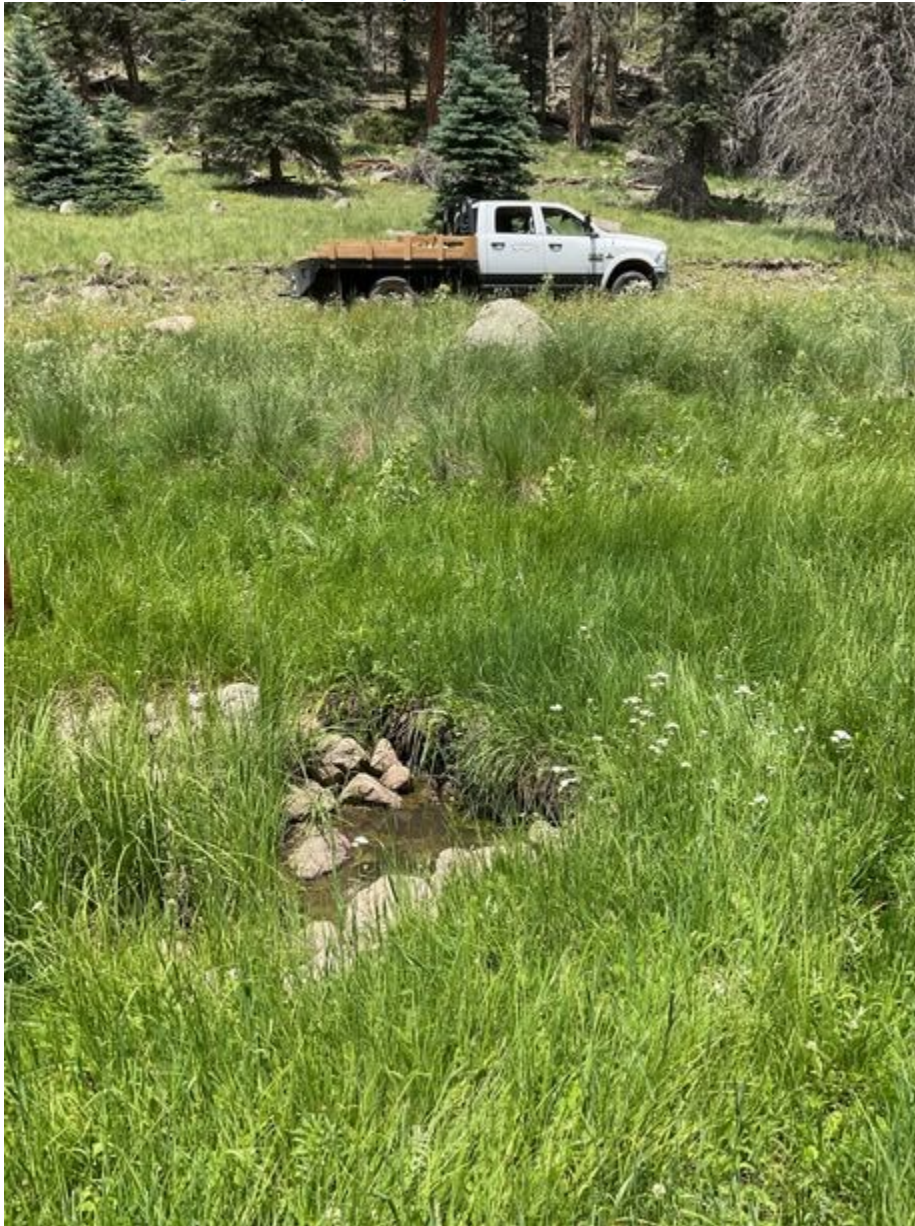
-106.5919297 35.93428847

Some rocks dislodged or broken
