CN R924060

**Zuni Bowl and One Rock Check Dam Research –
Phase 1**

Final Report

Rio Grande Return for the New Mexico Department of Transportation Research Bureau

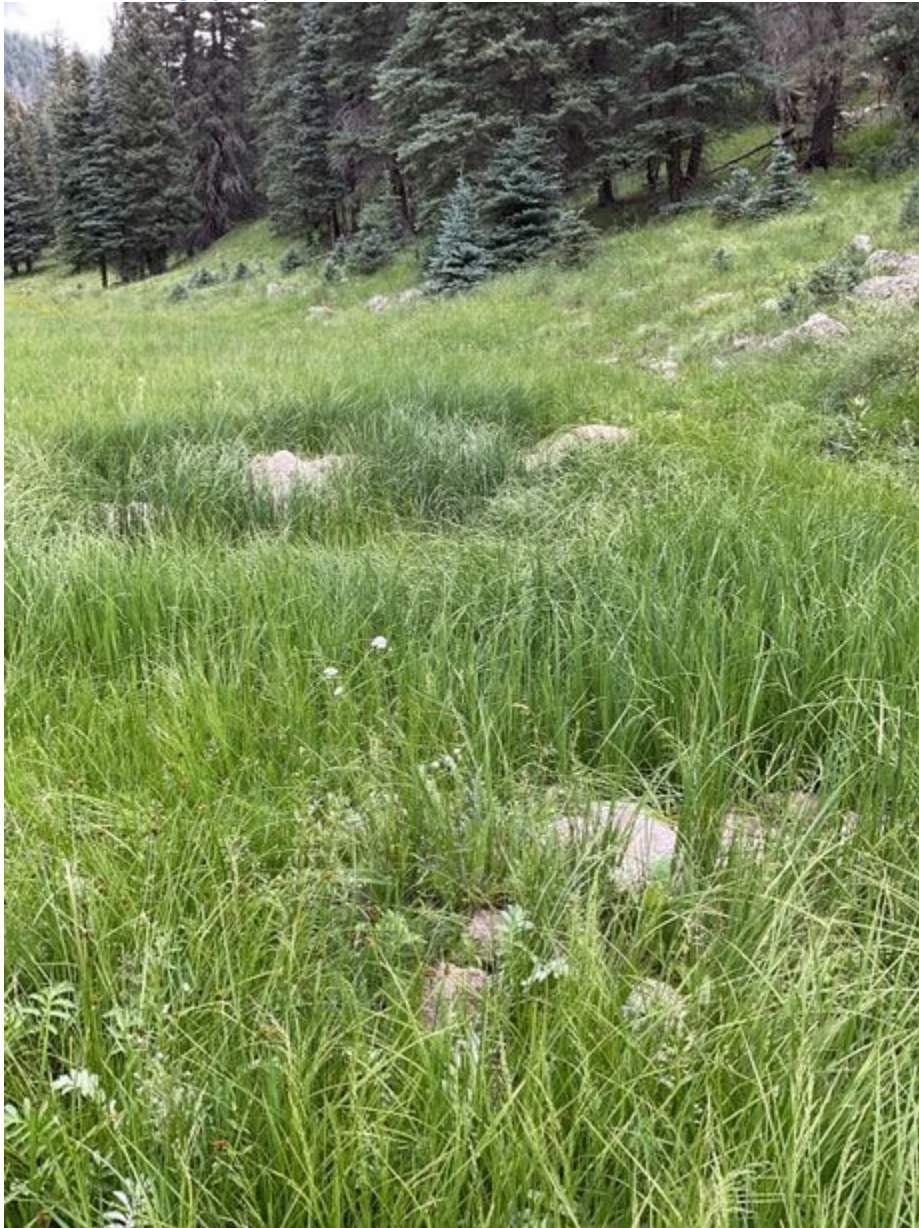
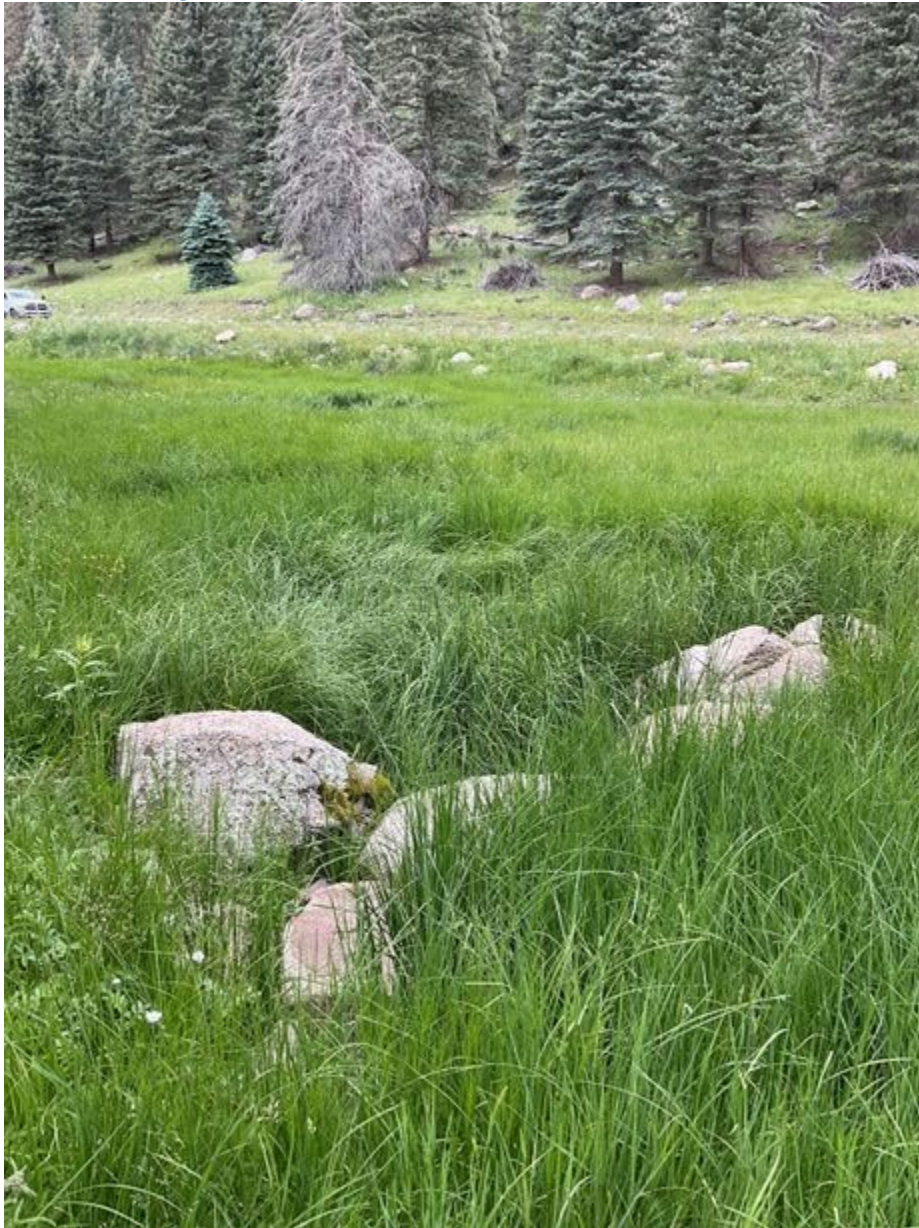
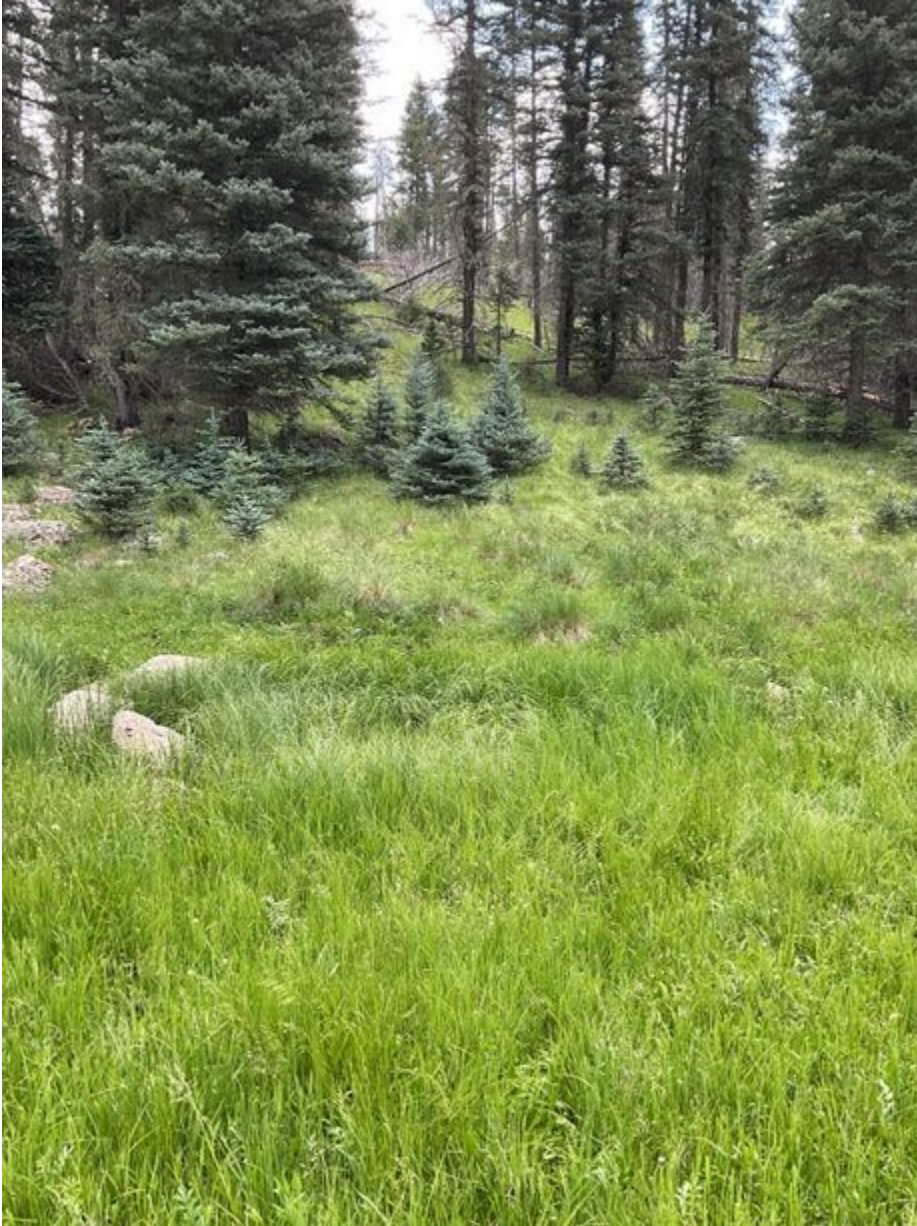
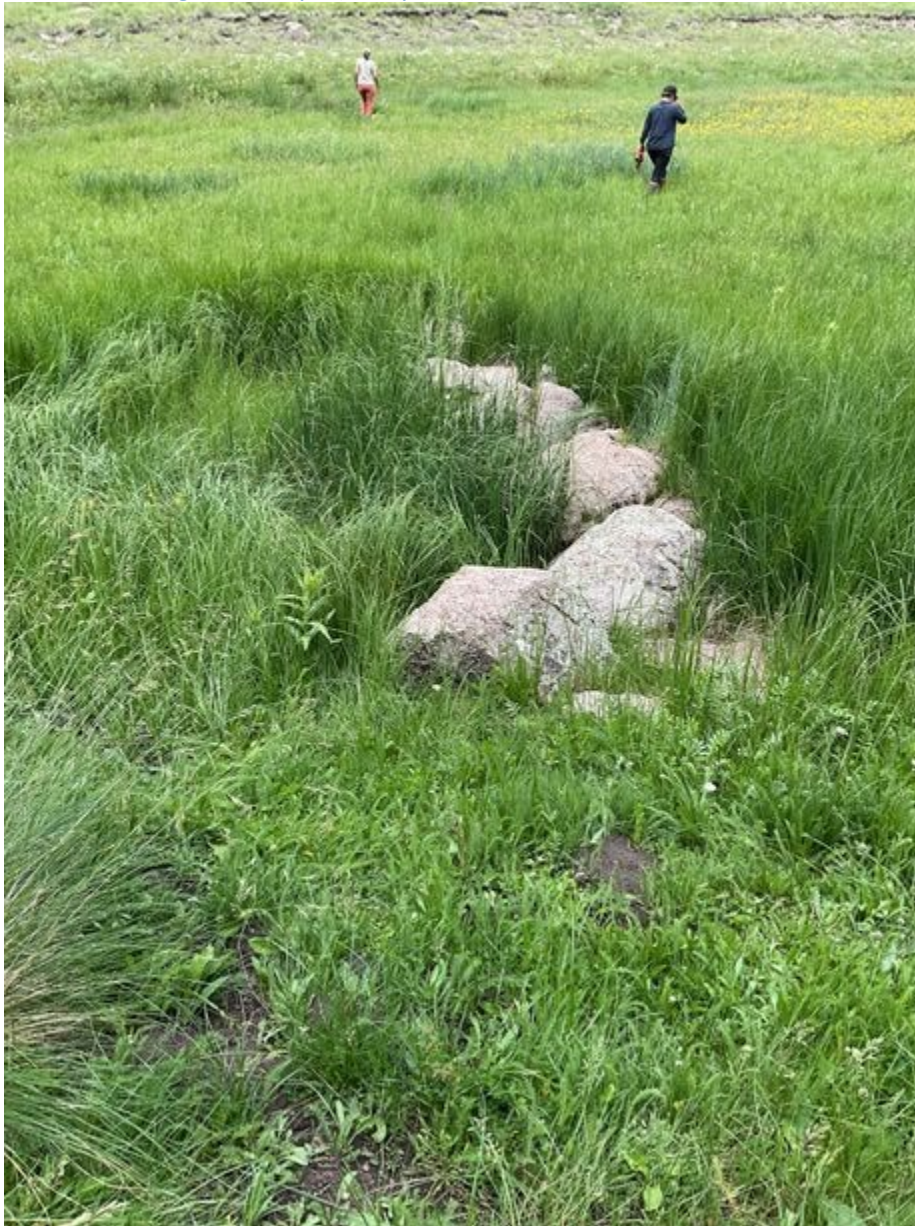
-106.5914269 35.93480662

All rocks intact

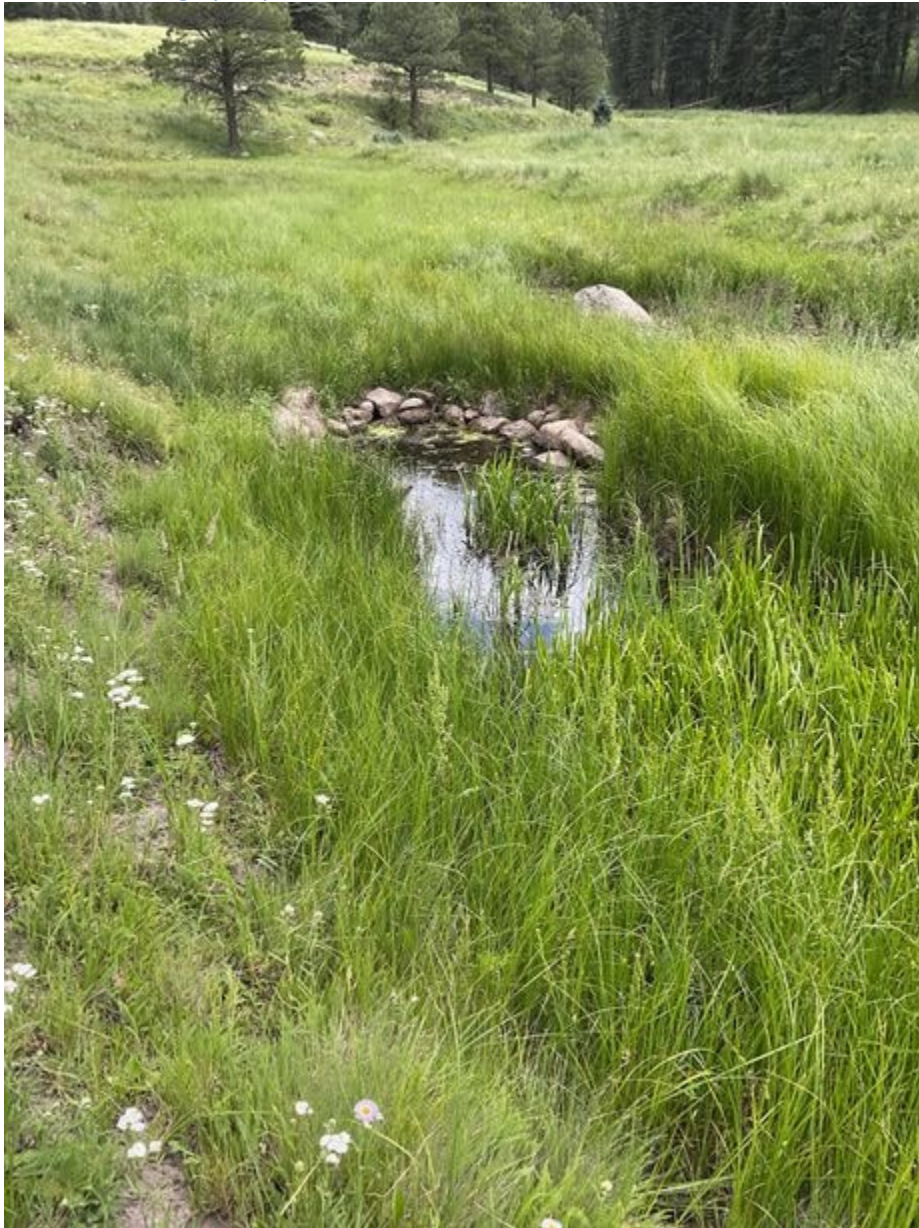
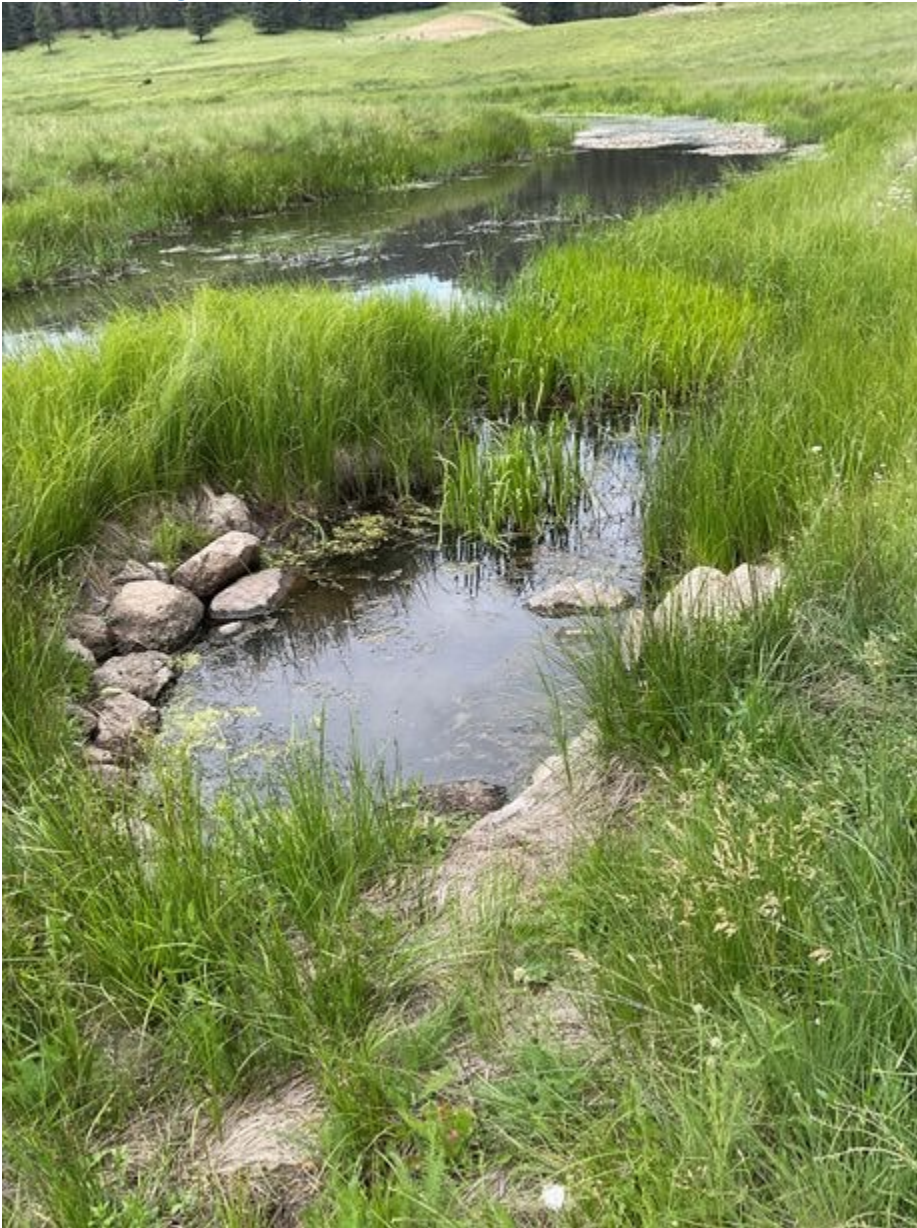
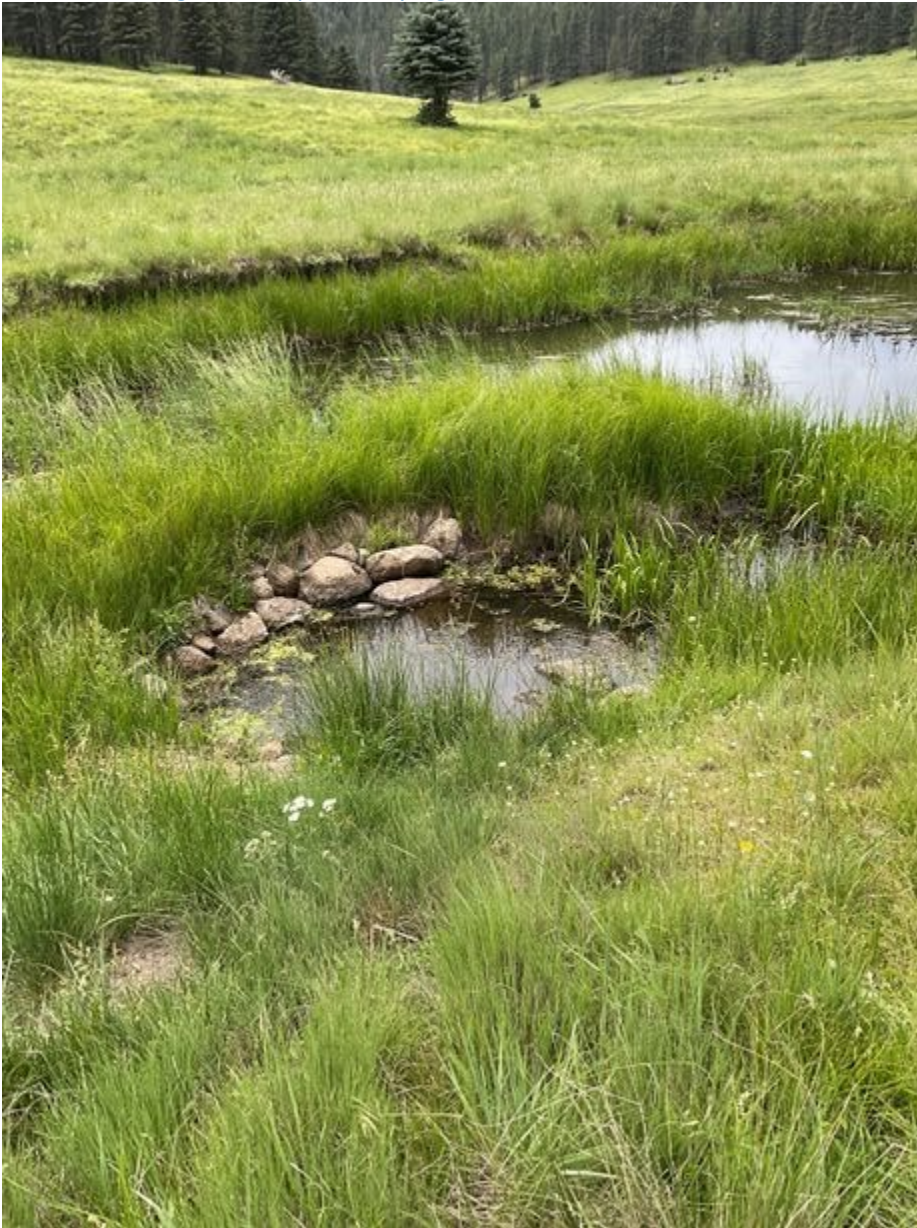
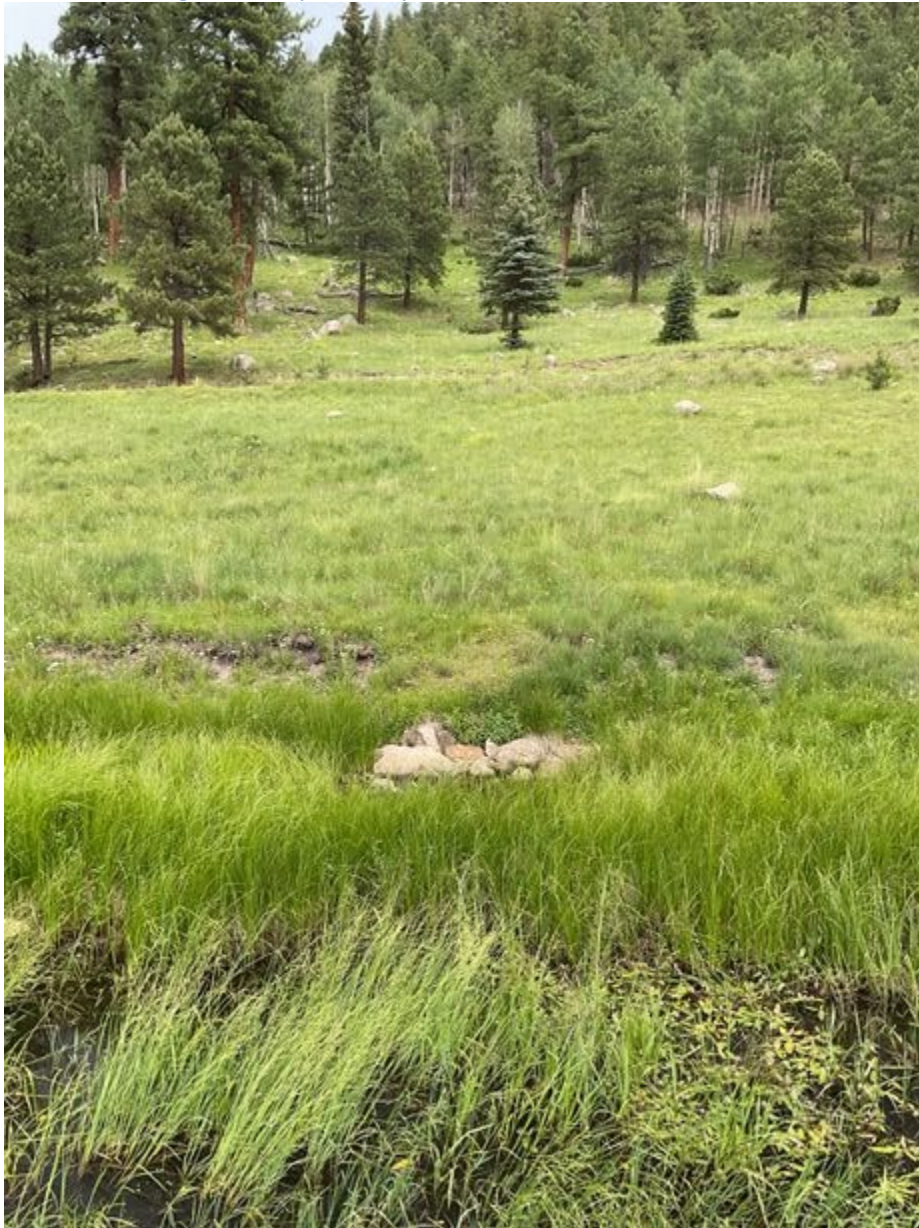
-106.588288 35.93802508

All rocks intact

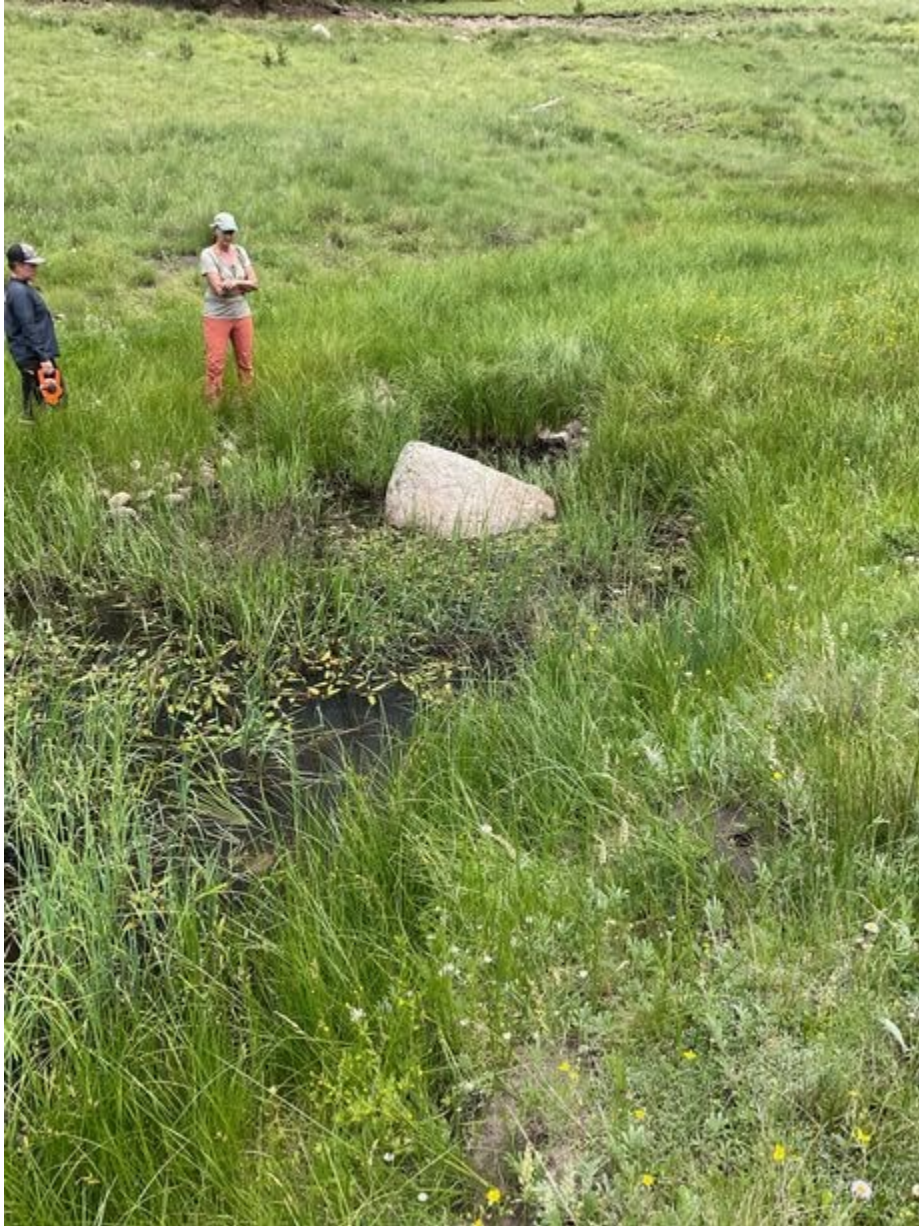
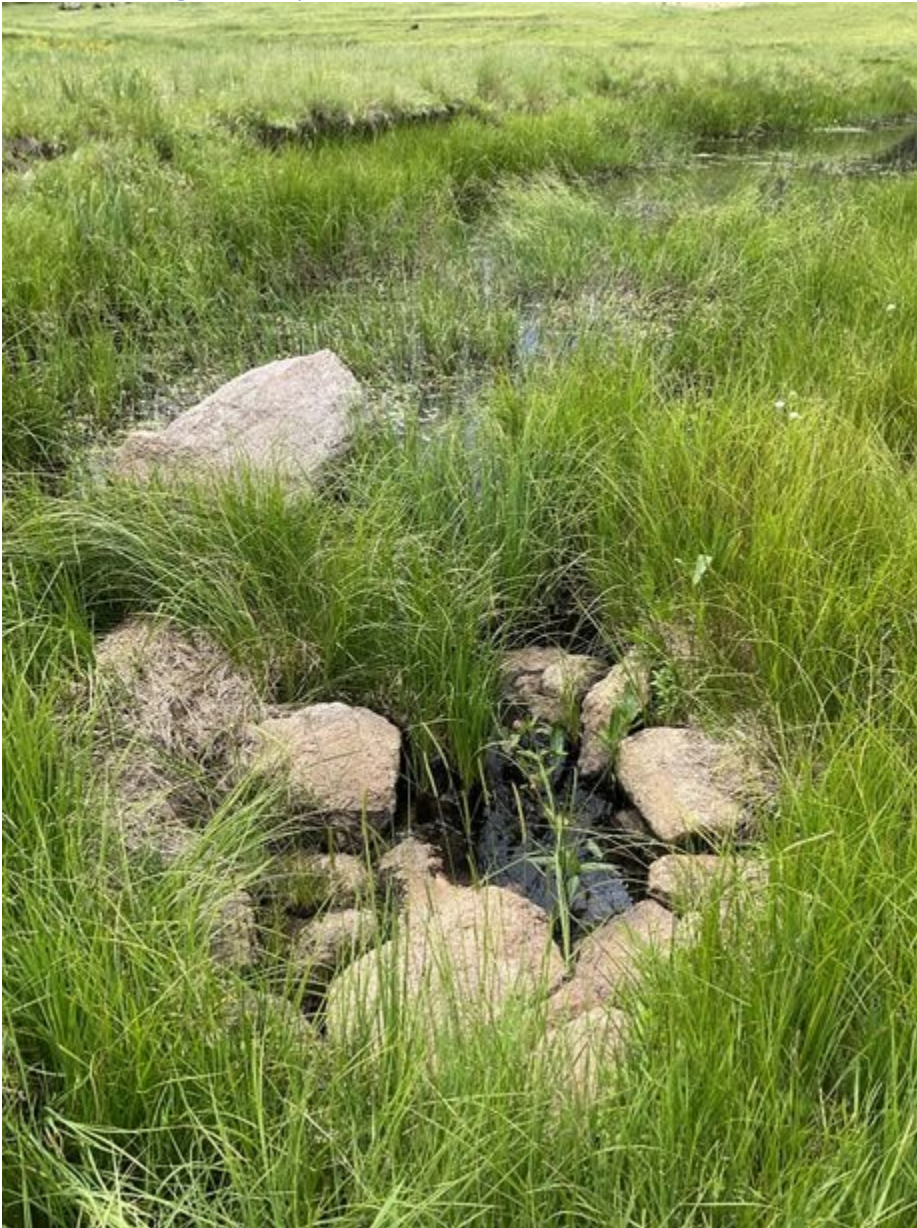
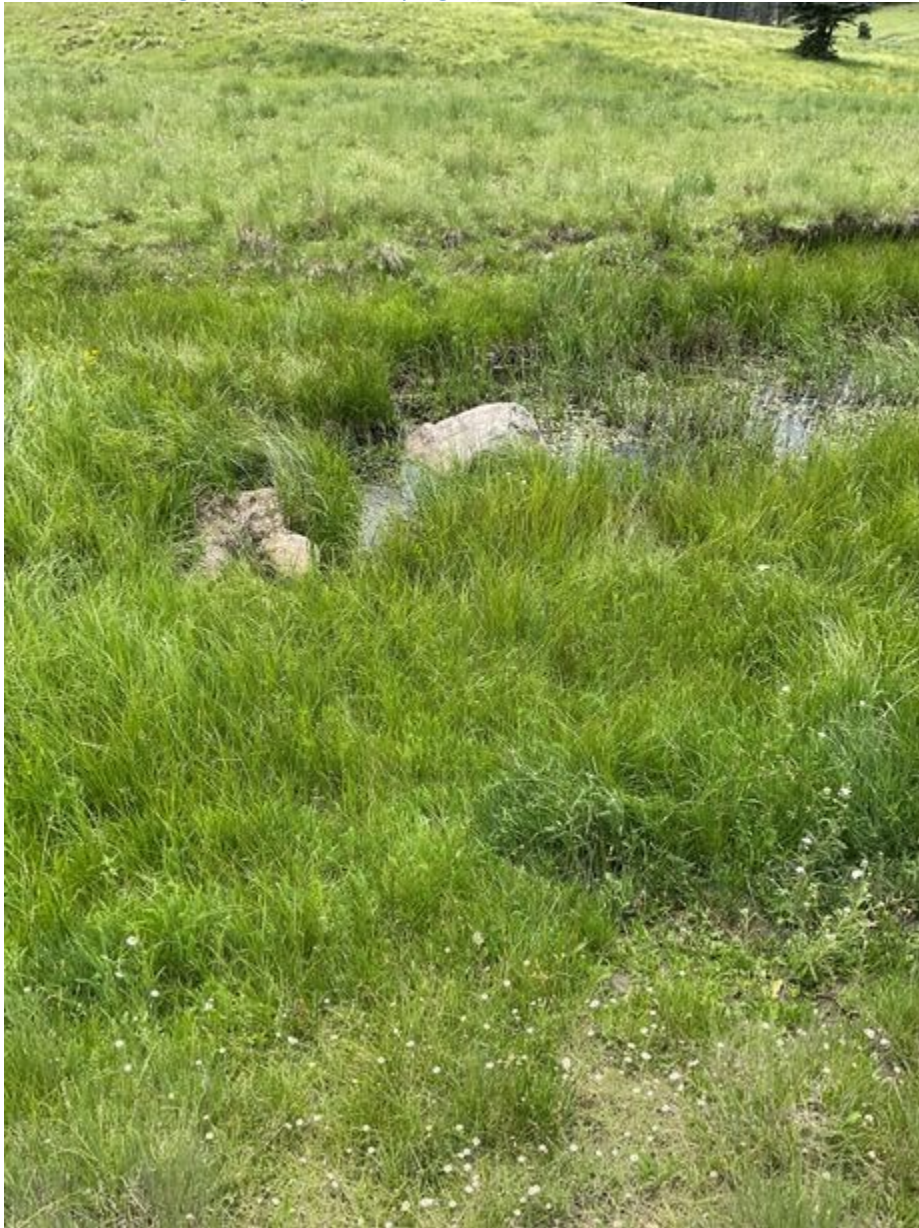
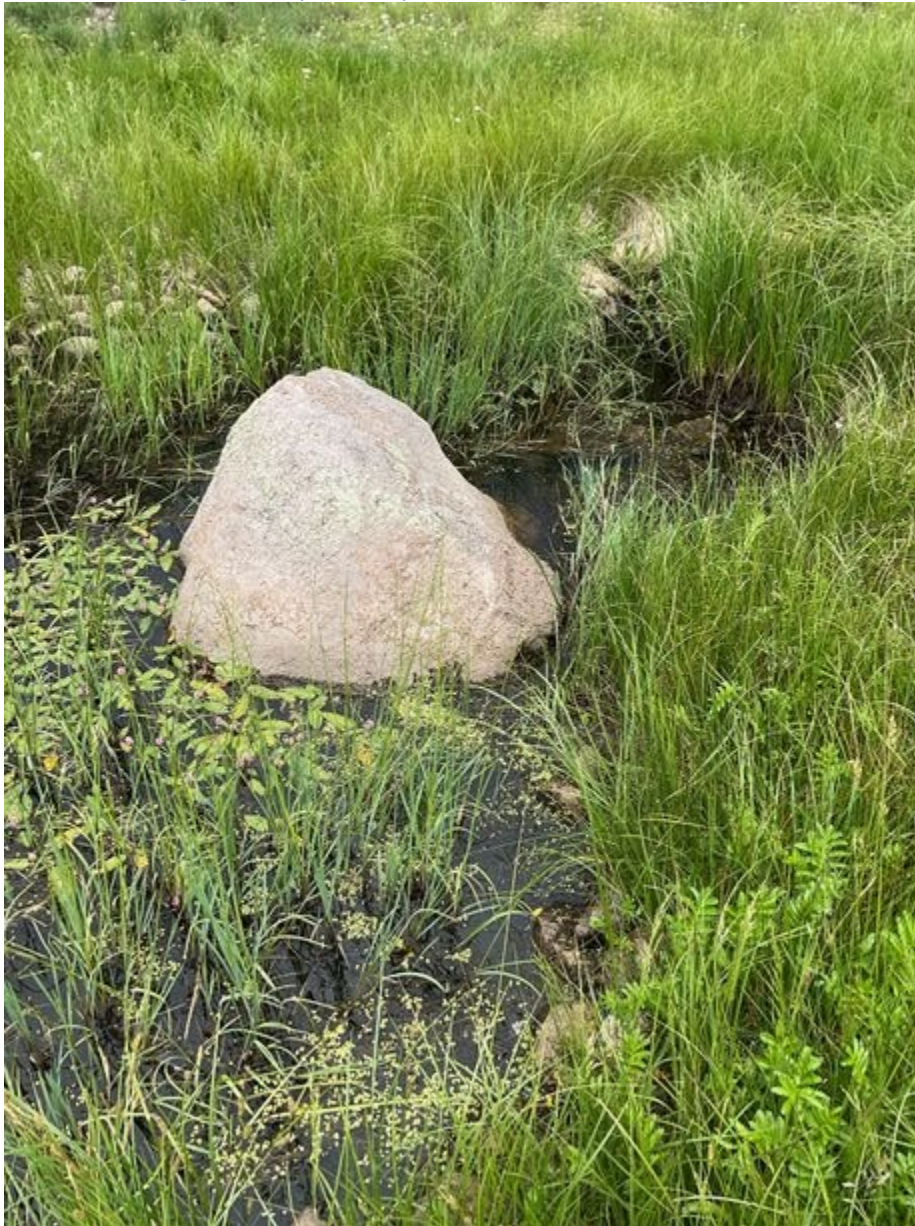
-106.5883033 35.93793888

All rocks intact

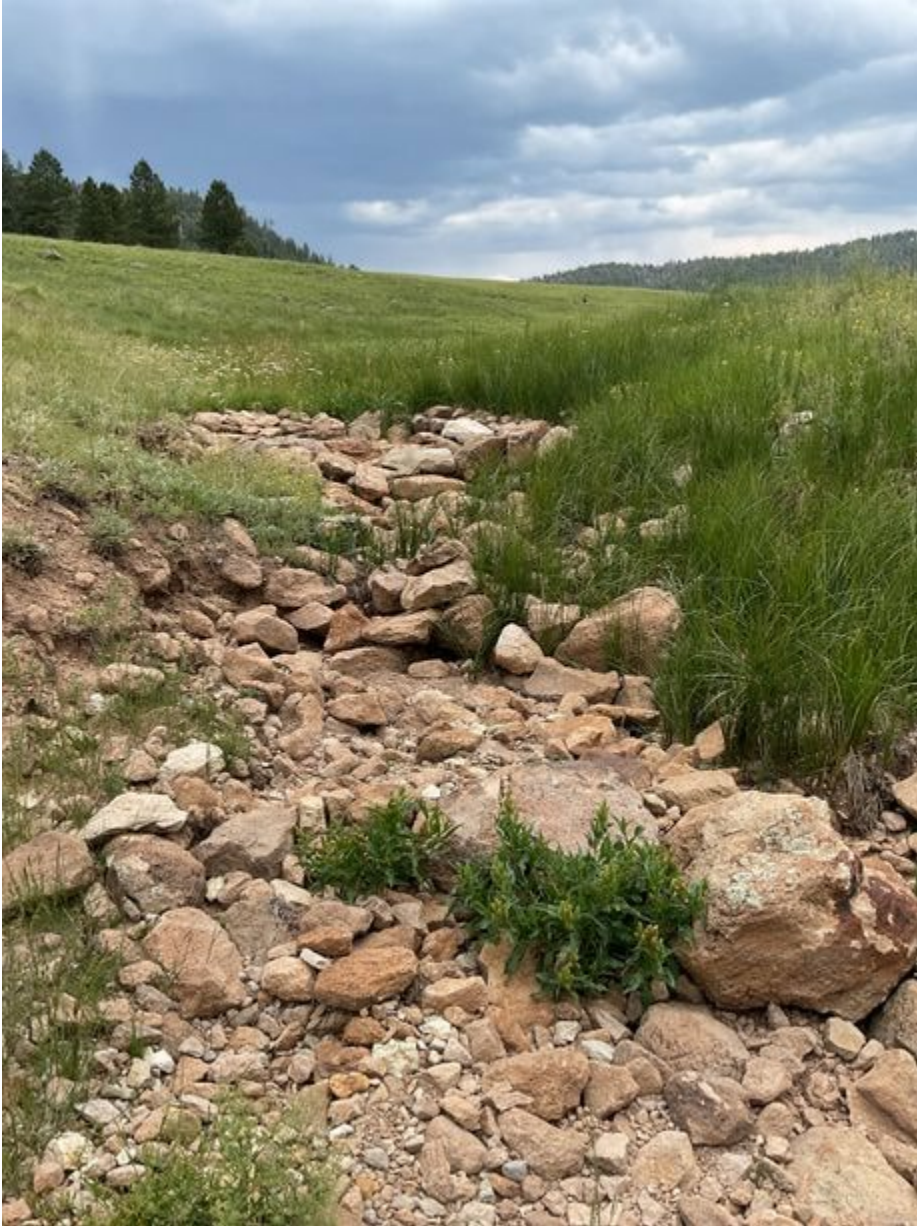
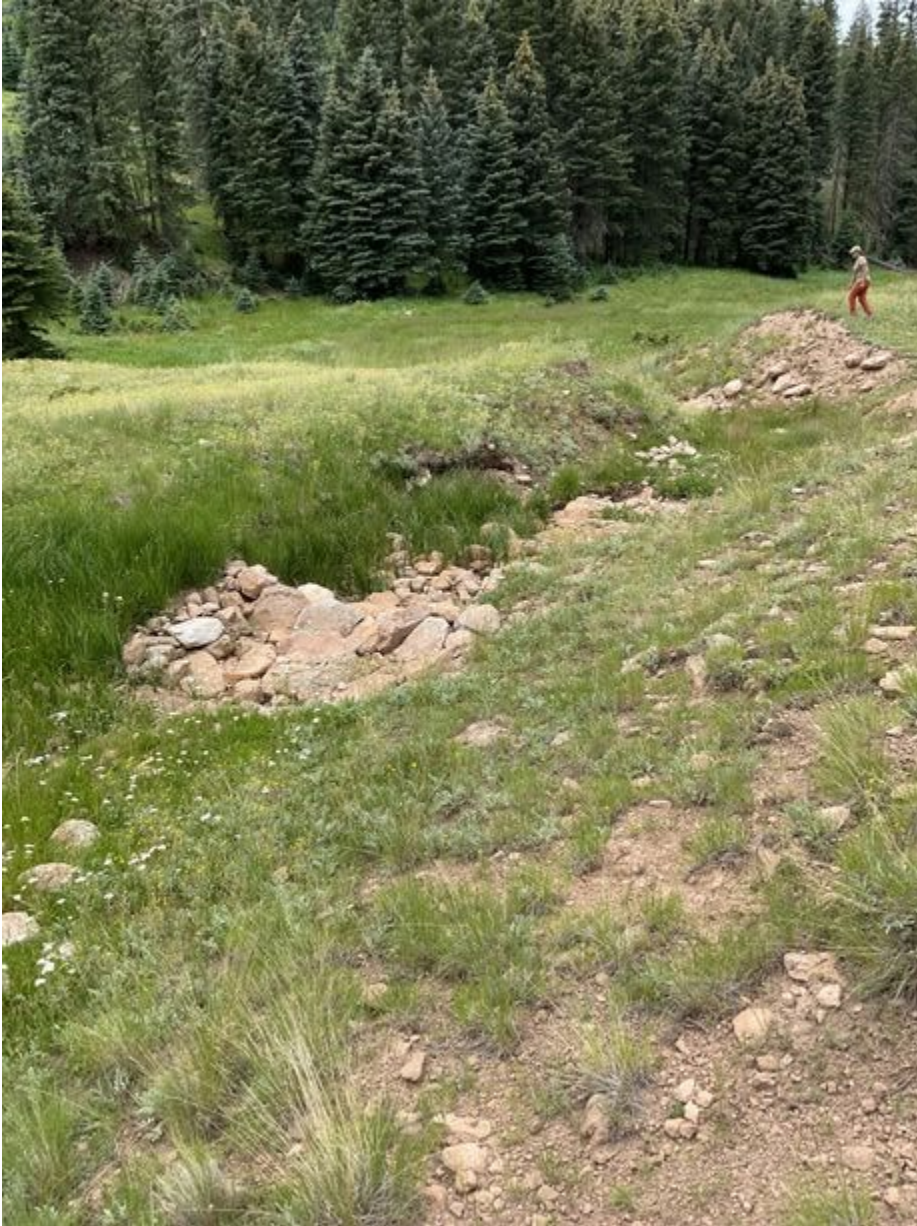
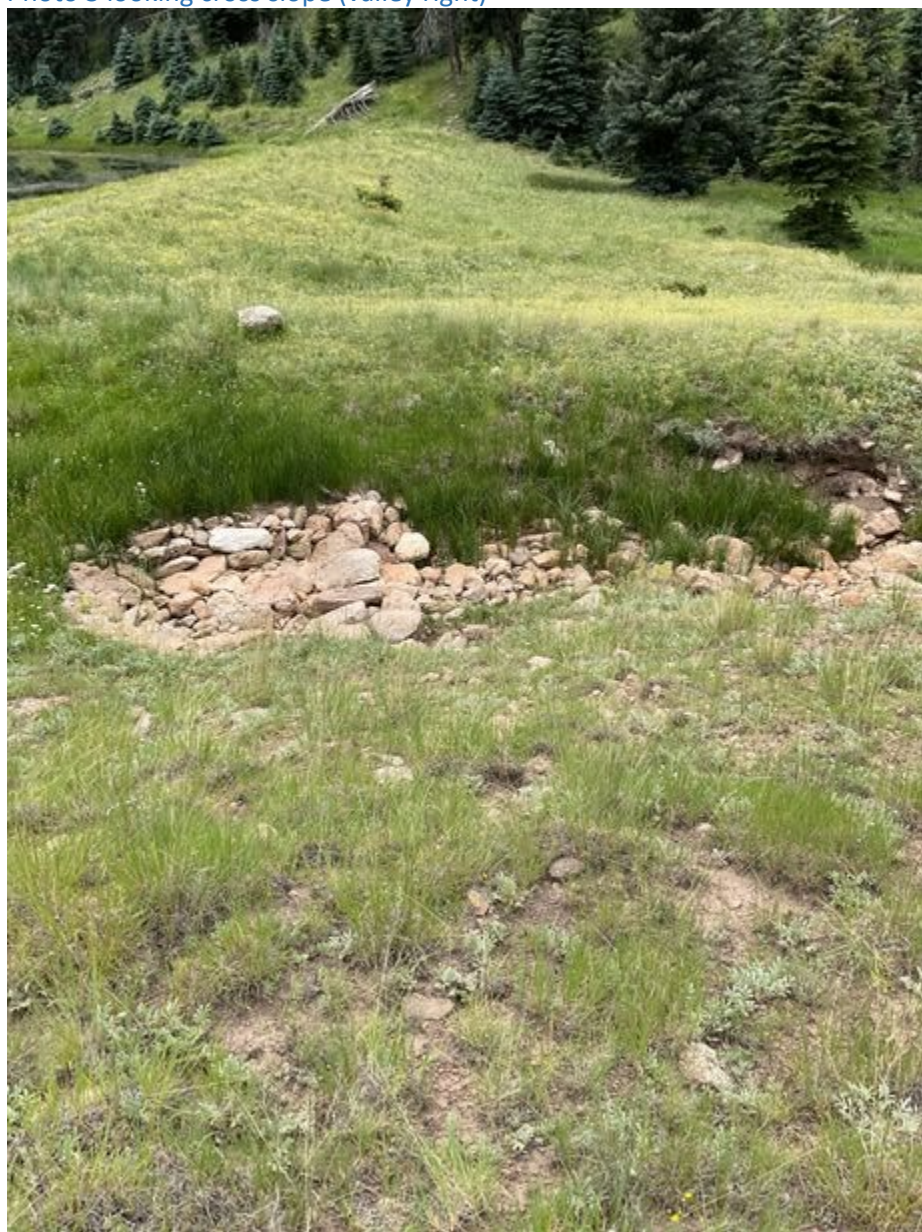
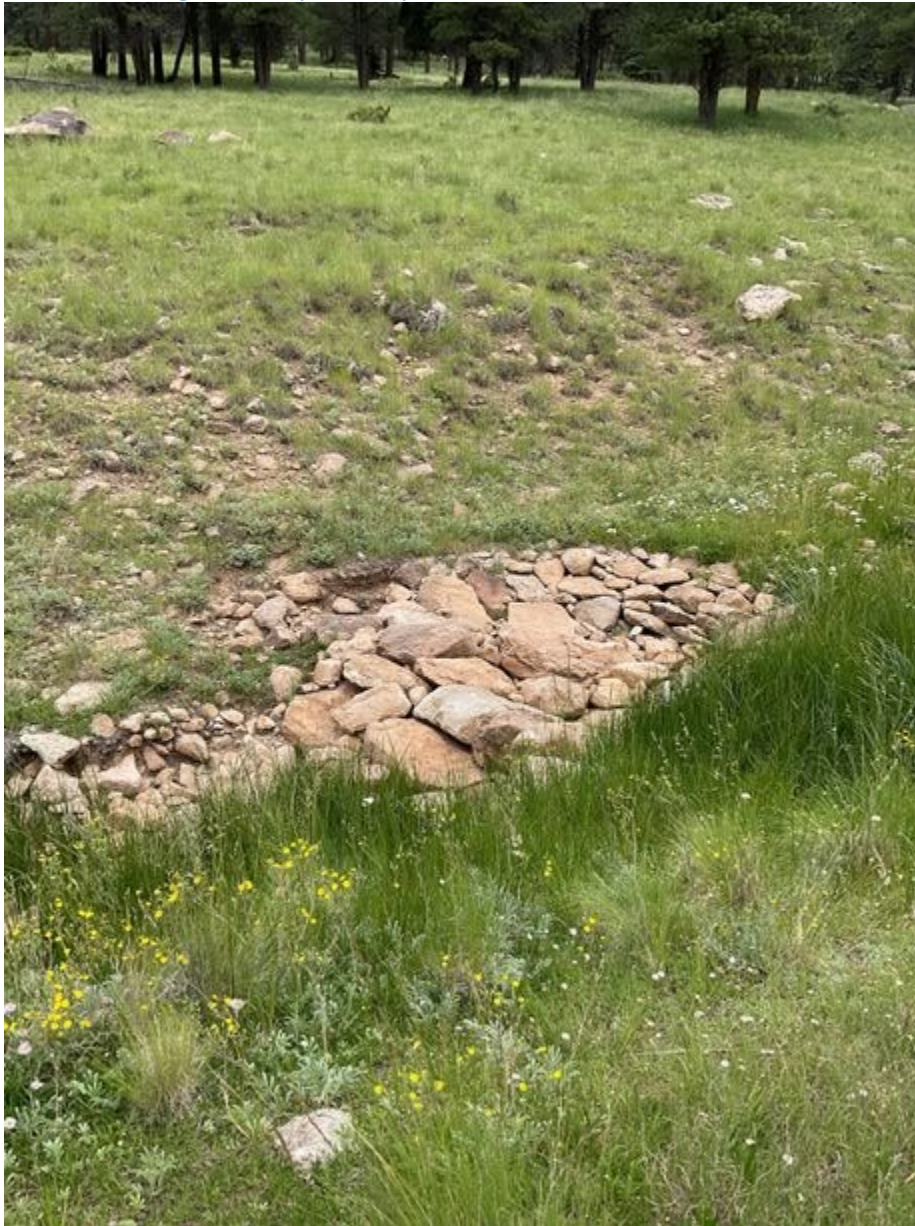
-106.5808215 35.9372305

All rocks intact

Difference between ZB and ORD Condition
Middle half of ORD dislodged

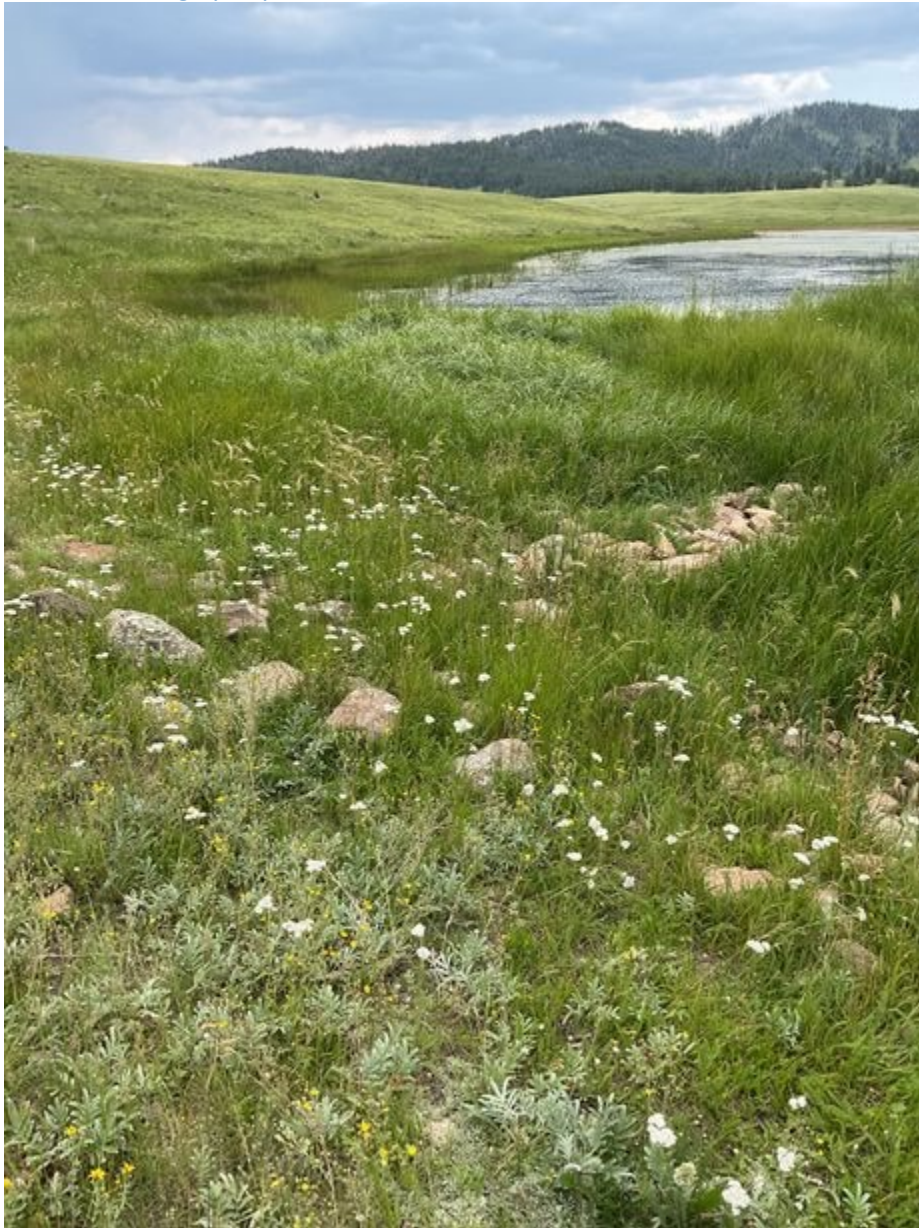
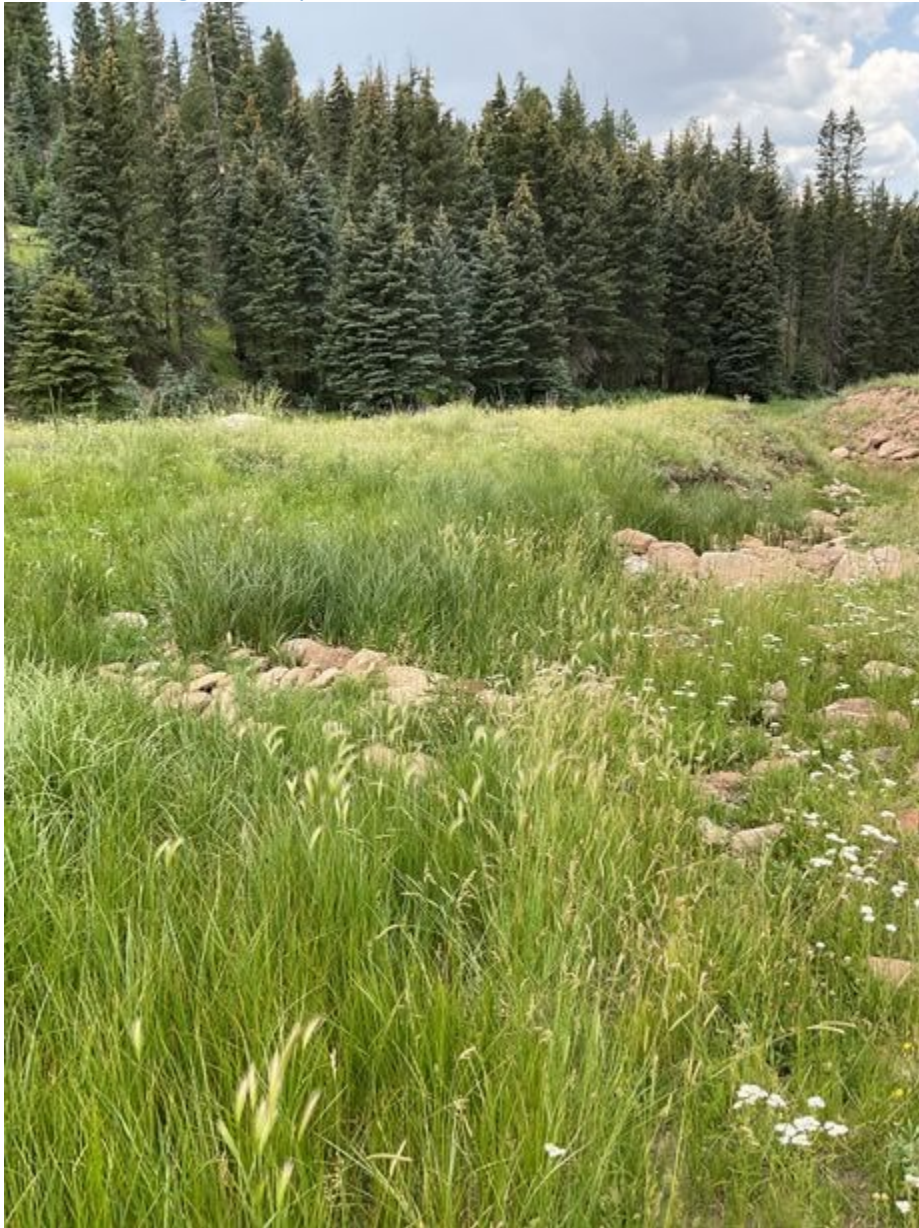
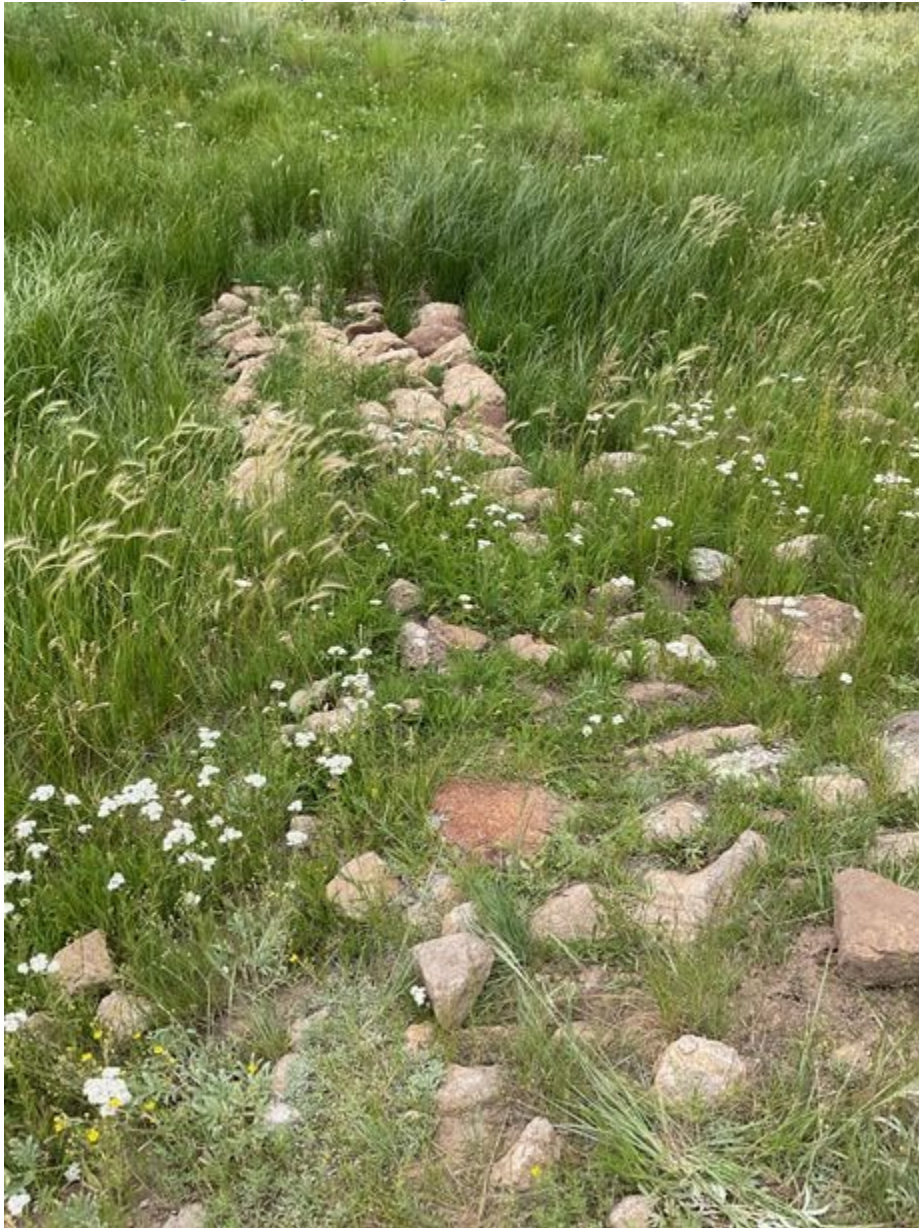
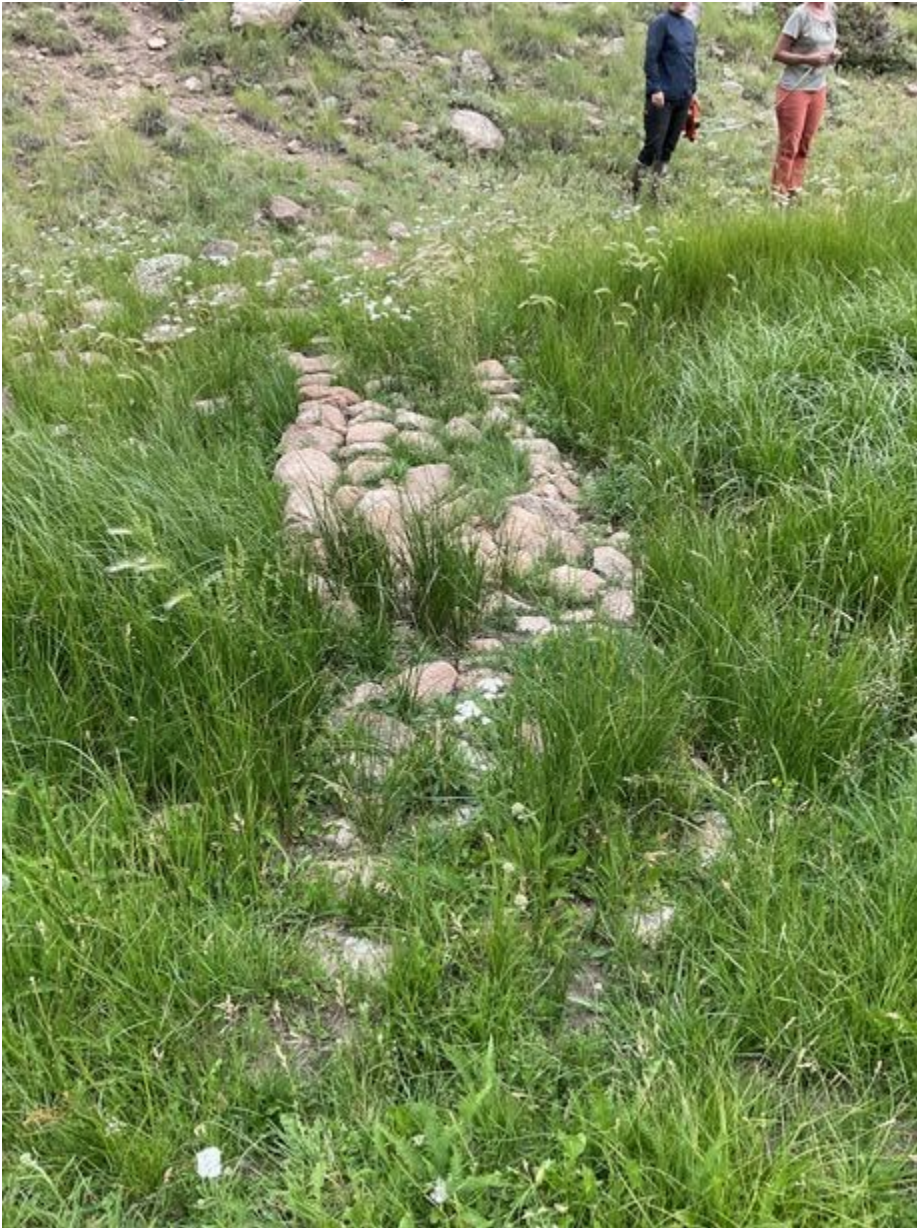
-106.5807458 35.93718655

All rocks intact
