CN R924060

**Zuni Bowl and One Rock Check Dam Research –
Phase 1**

Final Report

Rio Grande Return for the New Mexico Department of Transportation Research Bureau

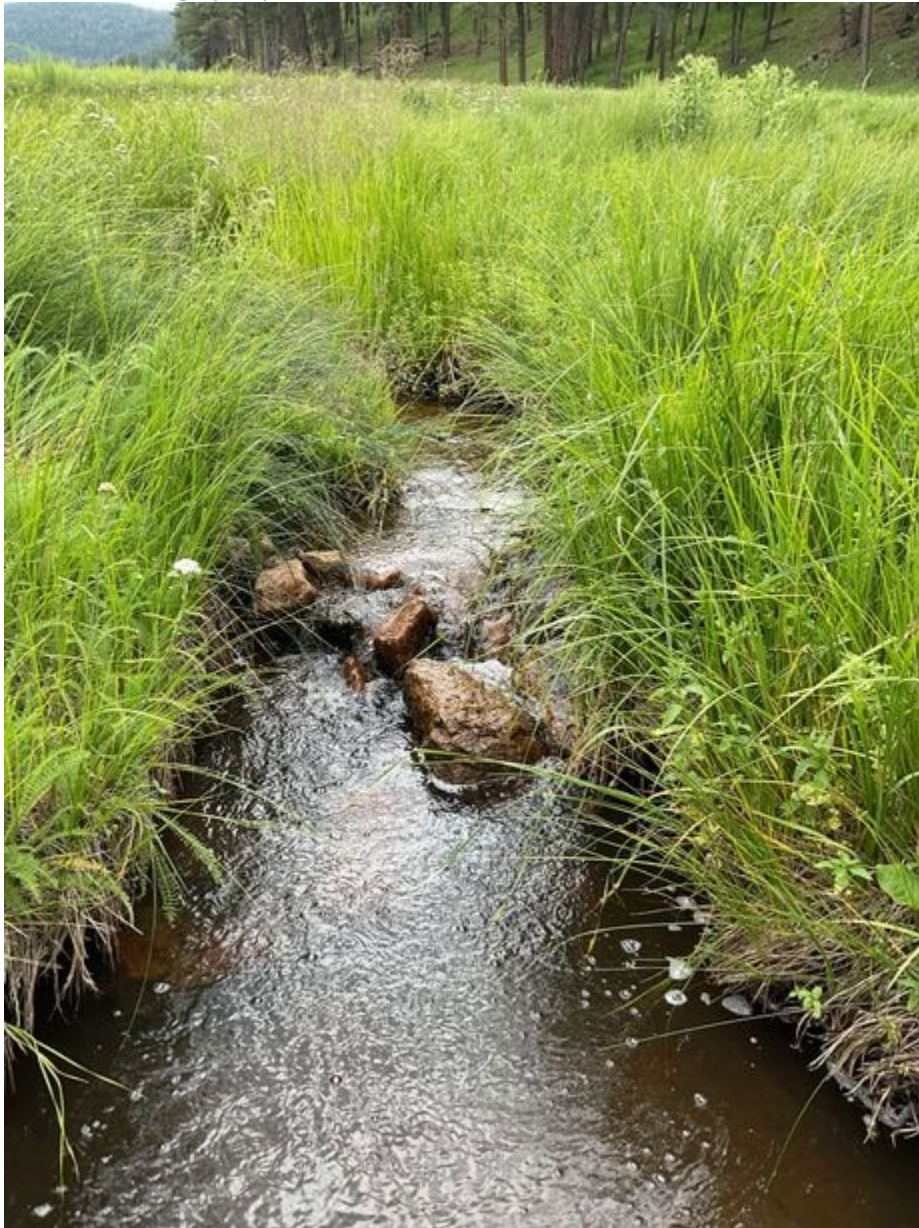
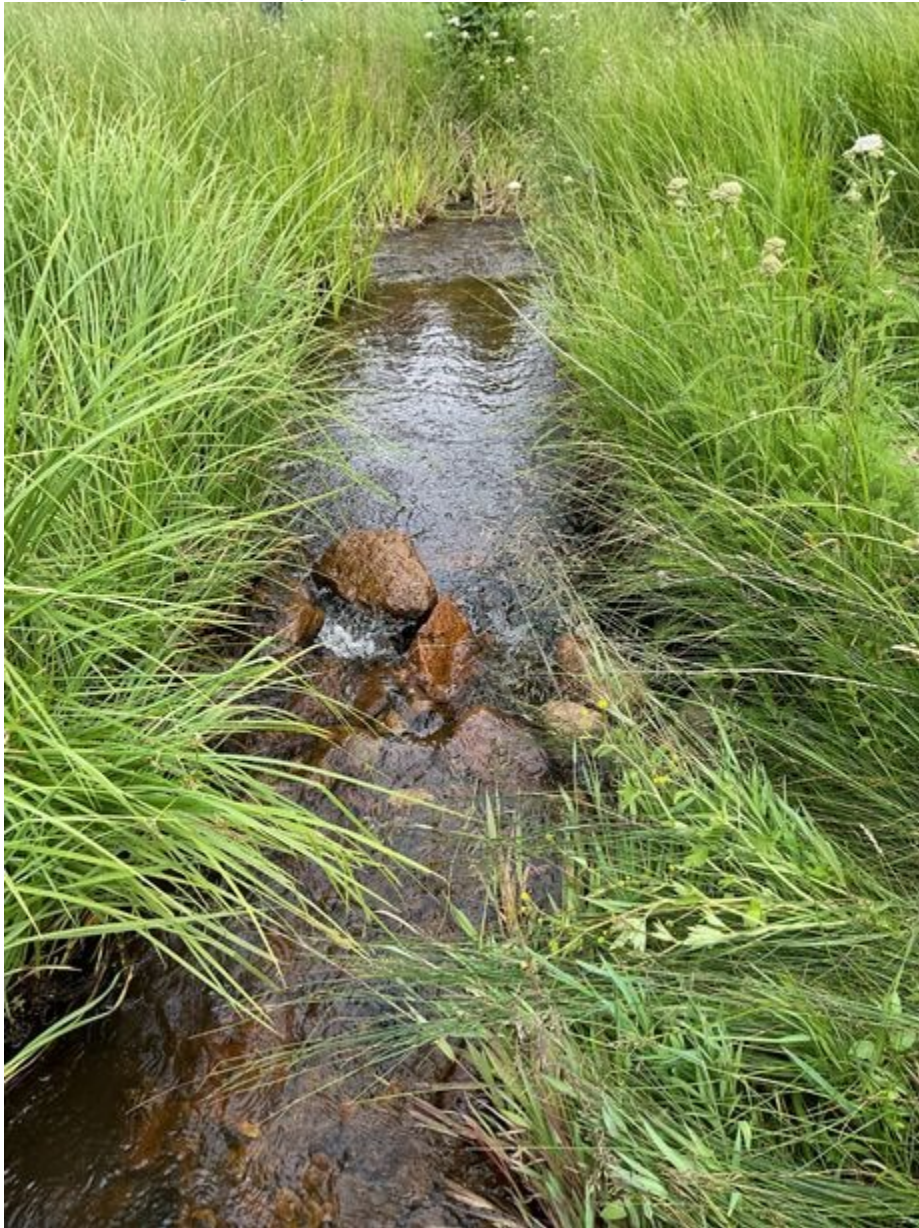
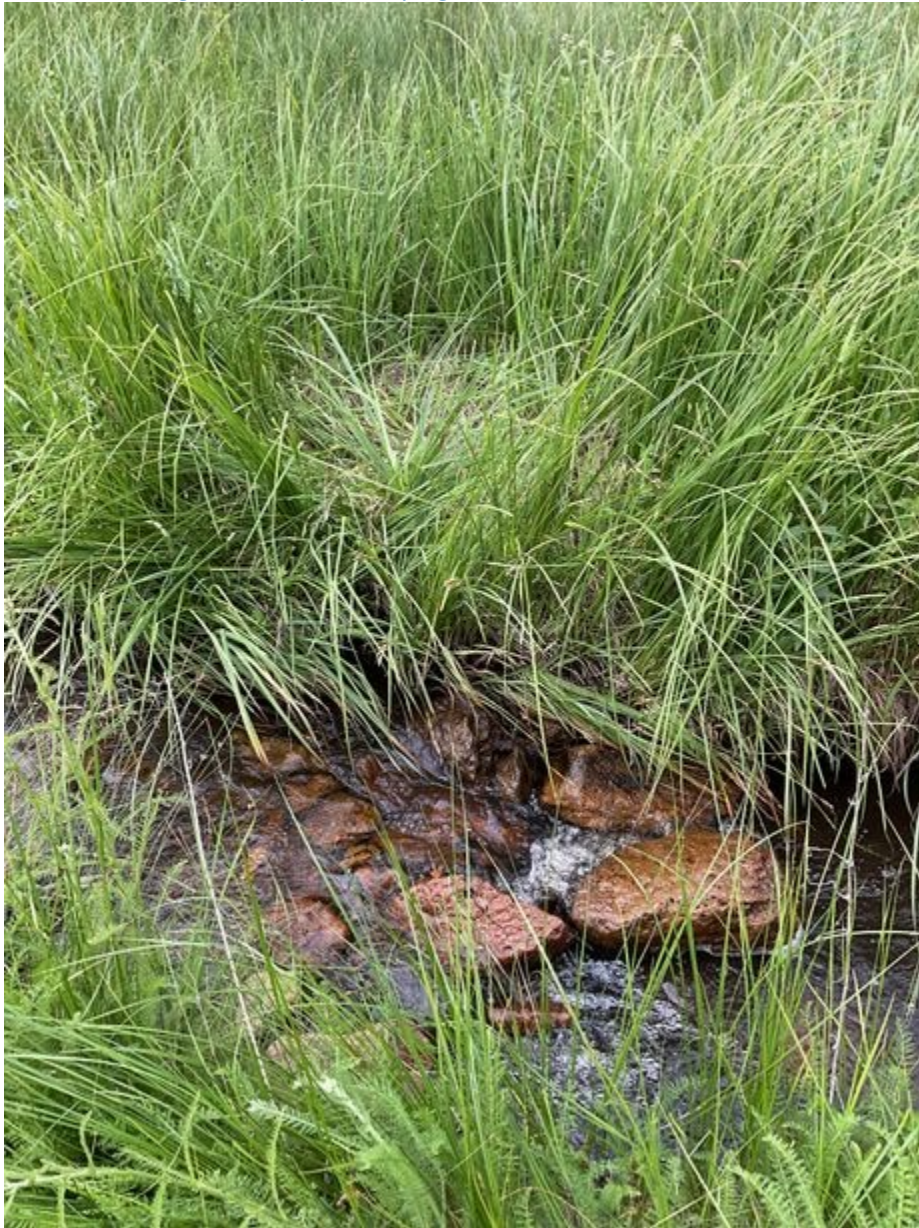
-106.6111231 35.85977217

Some rocks dislodged or broken

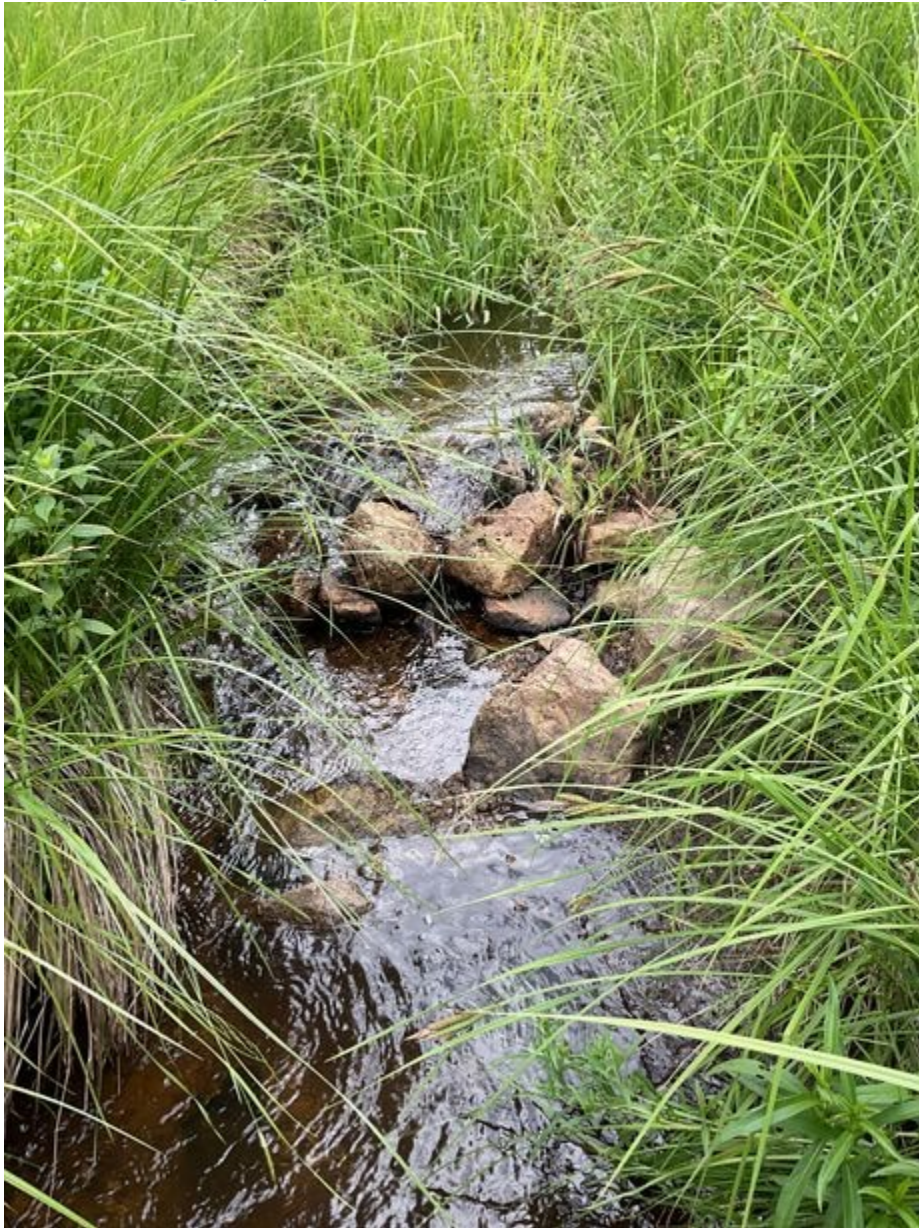
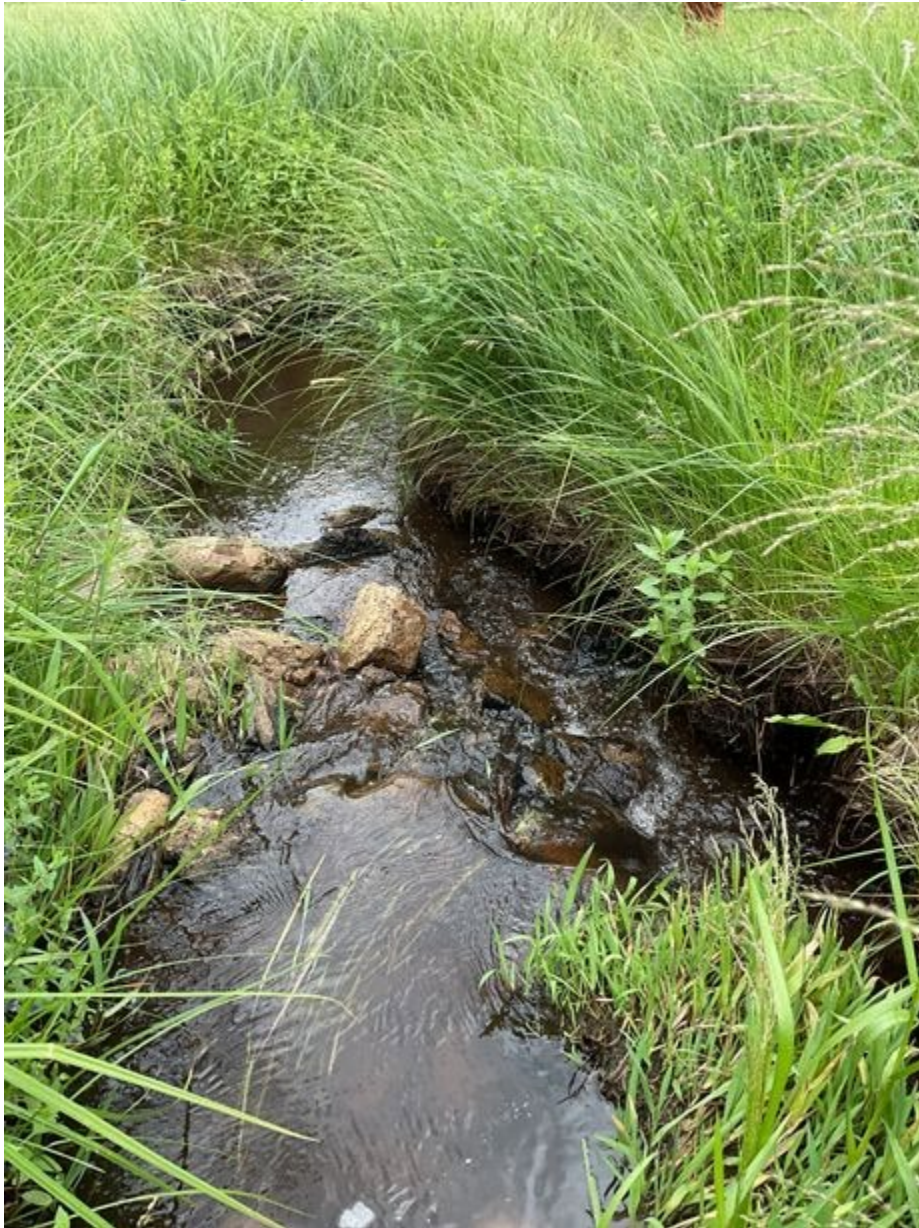
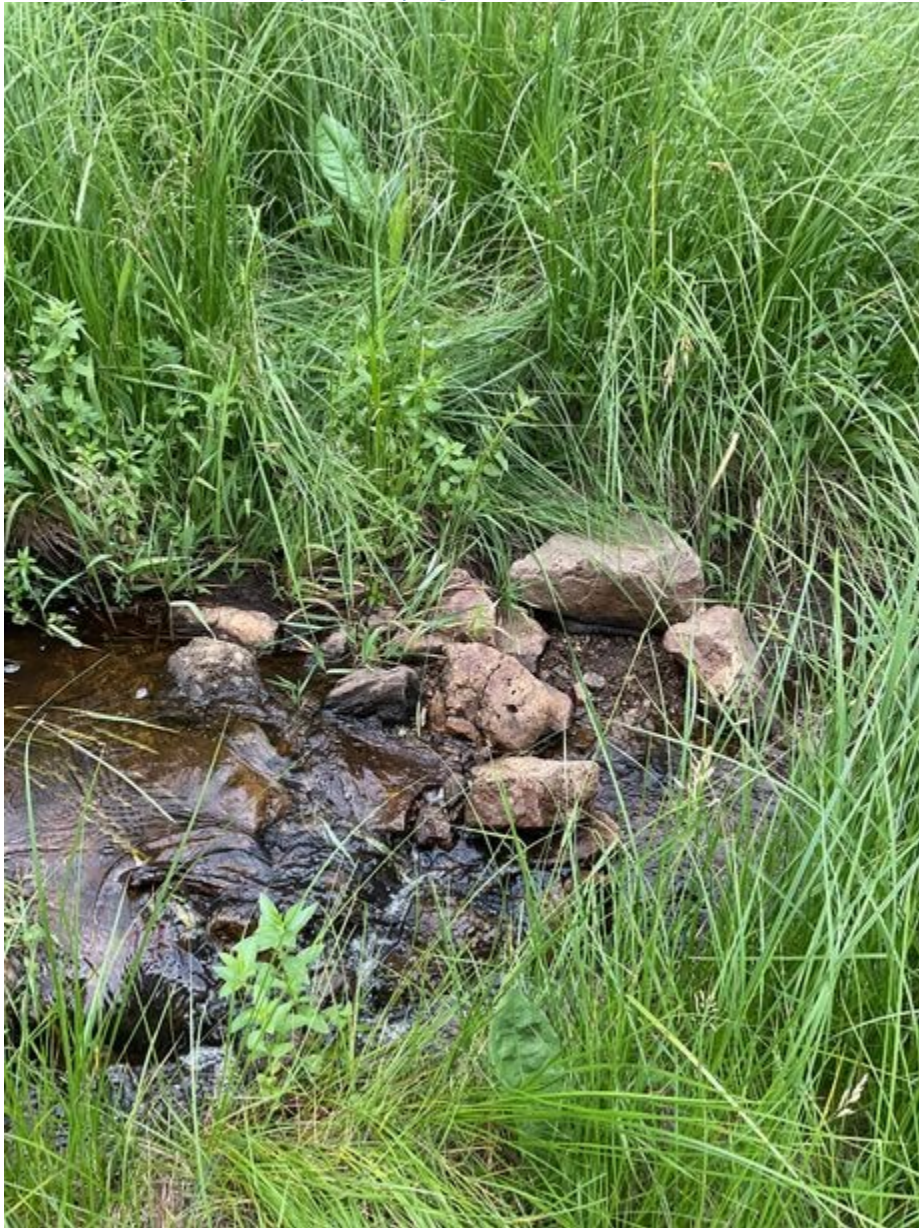
-106.6112377 35.85987838

Some rocks dislodged or broken

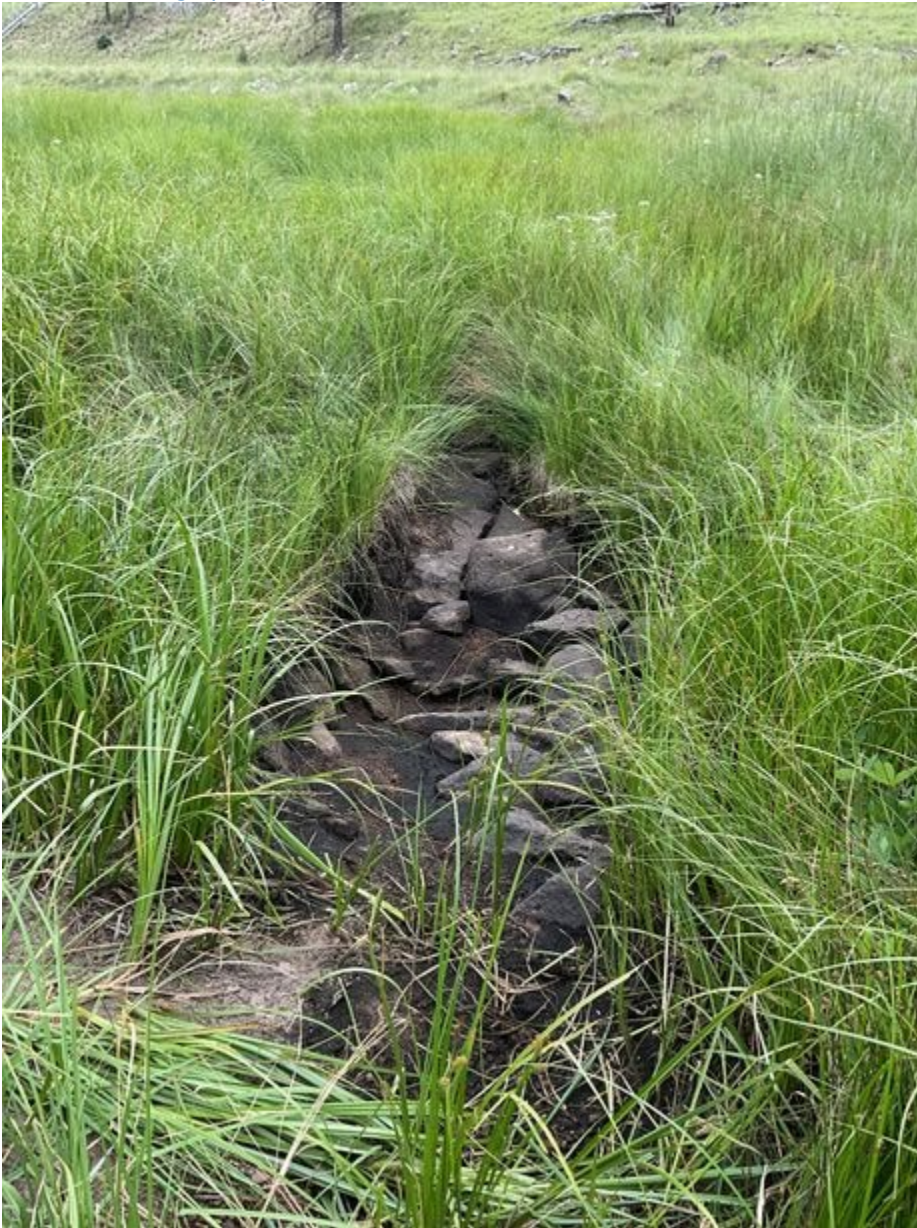
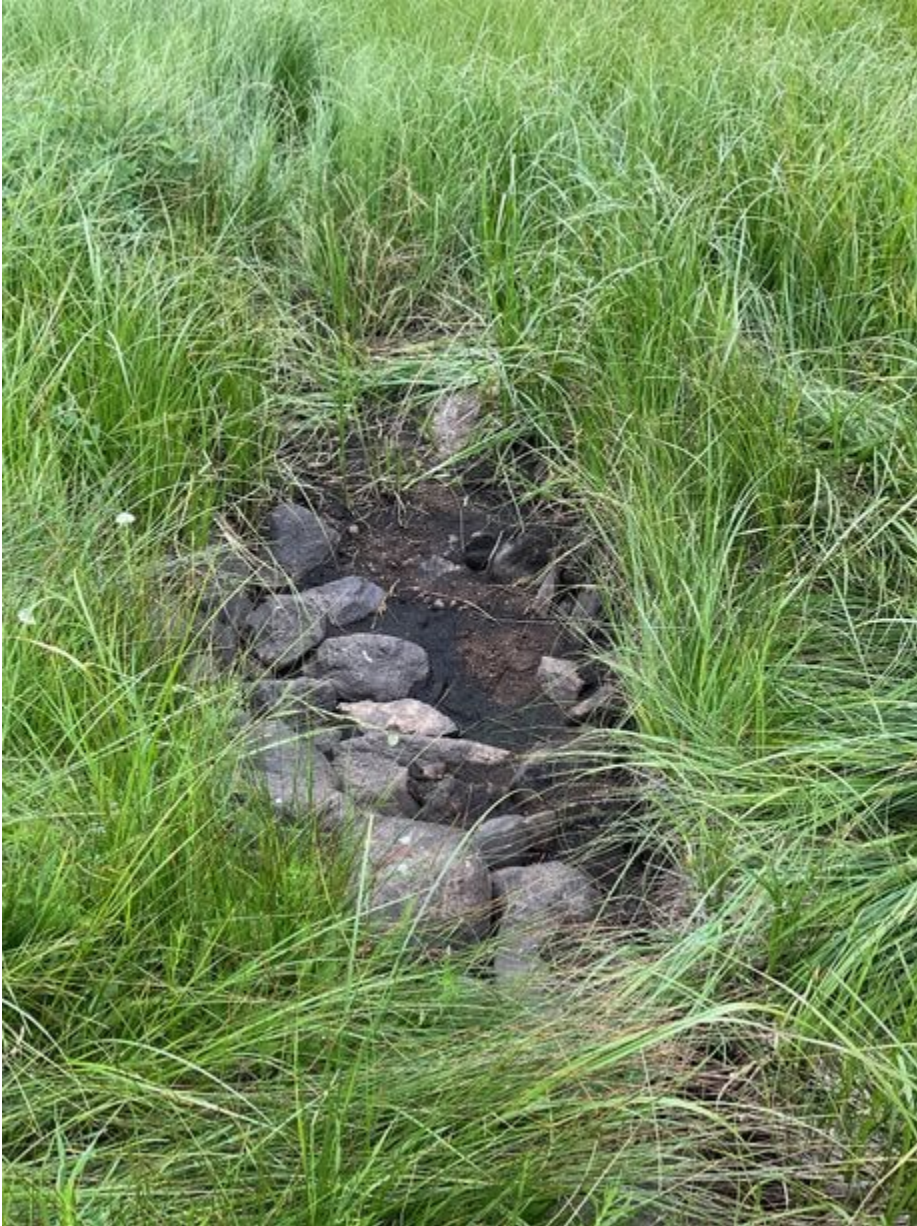
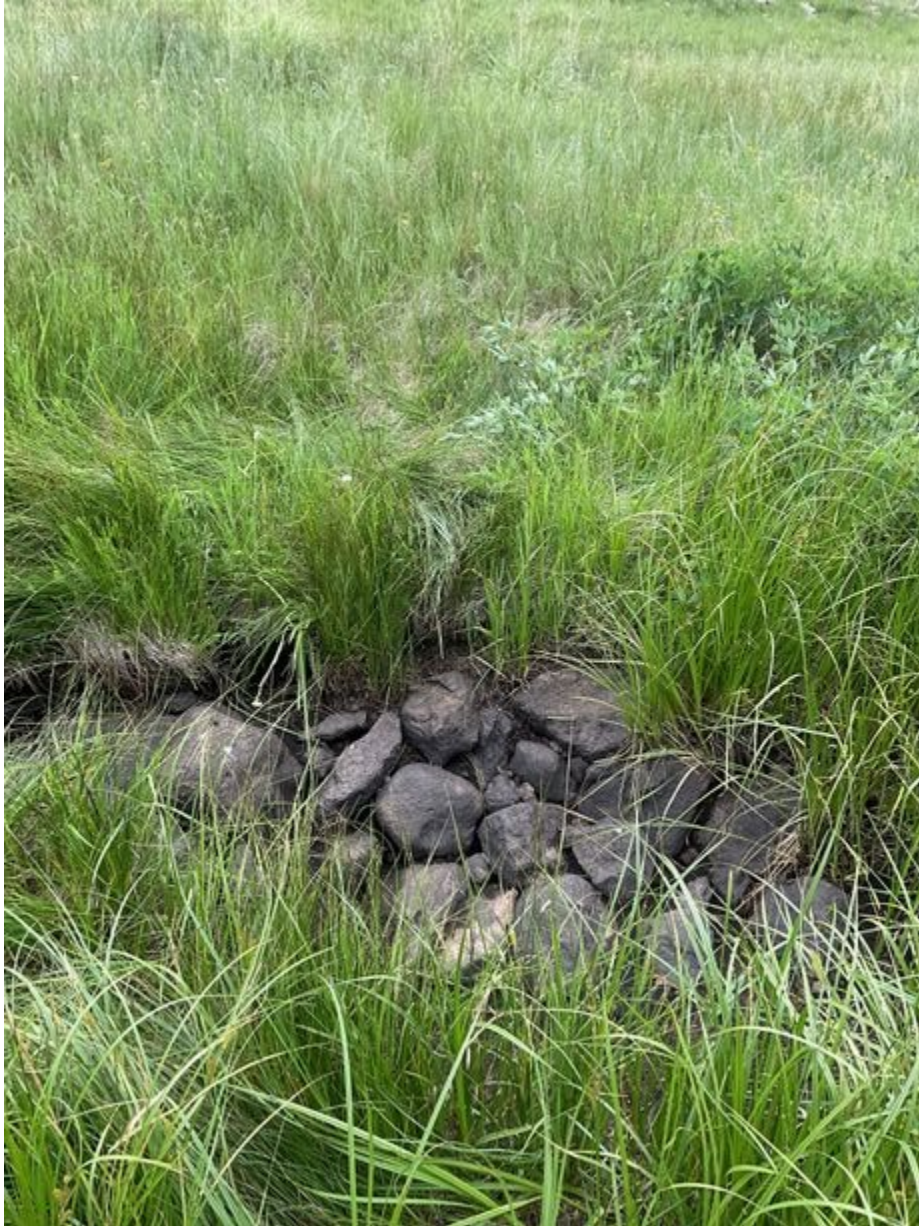
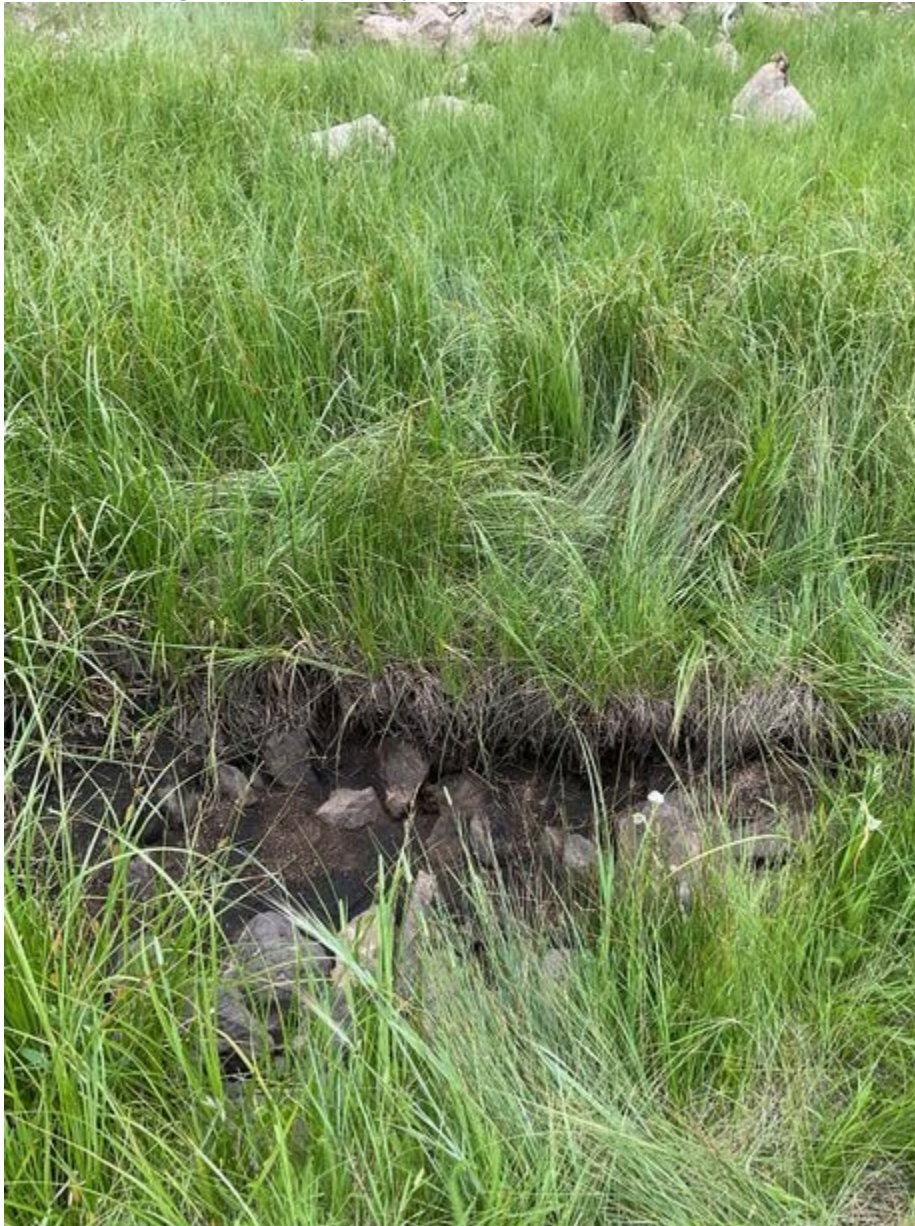
-106.5157222 35.93745675

Some rocks dislodged or broken

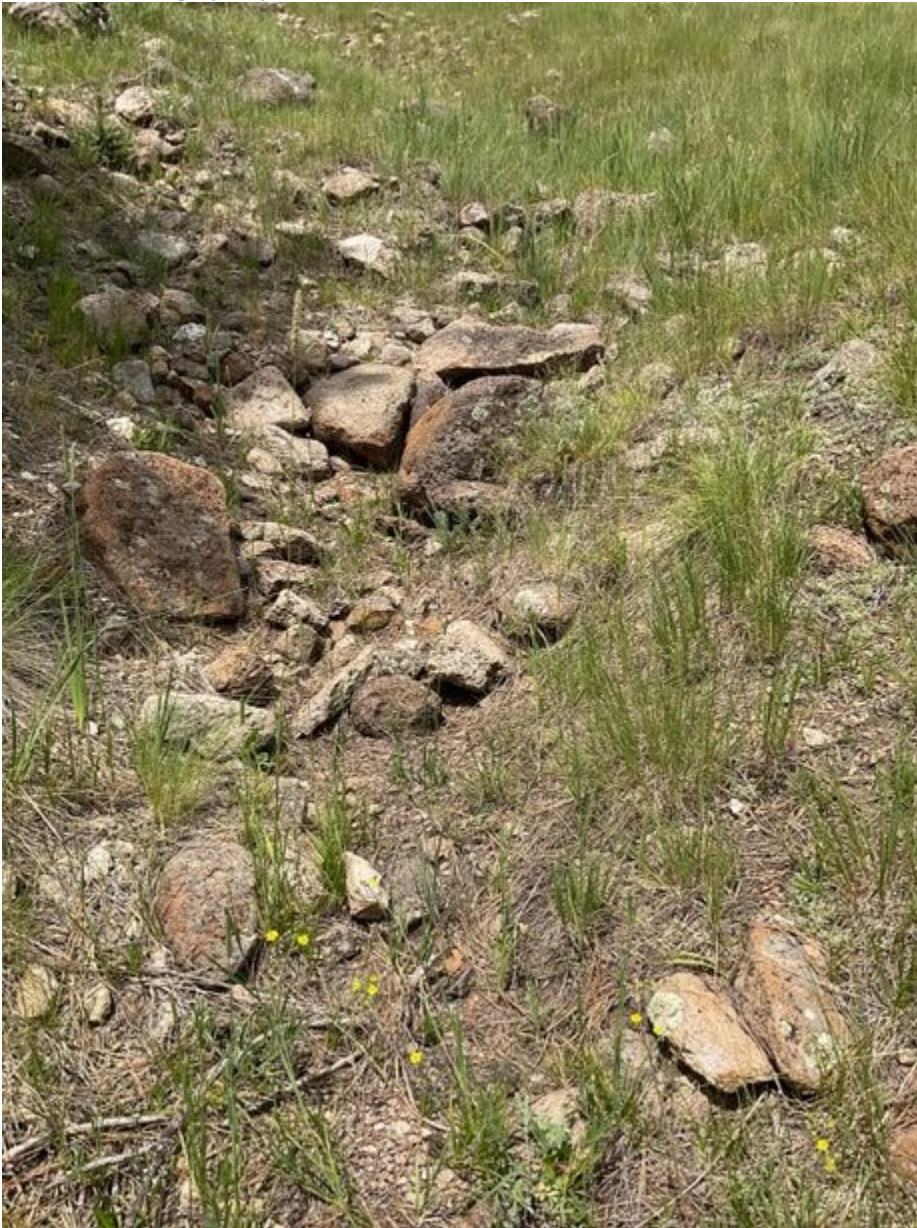
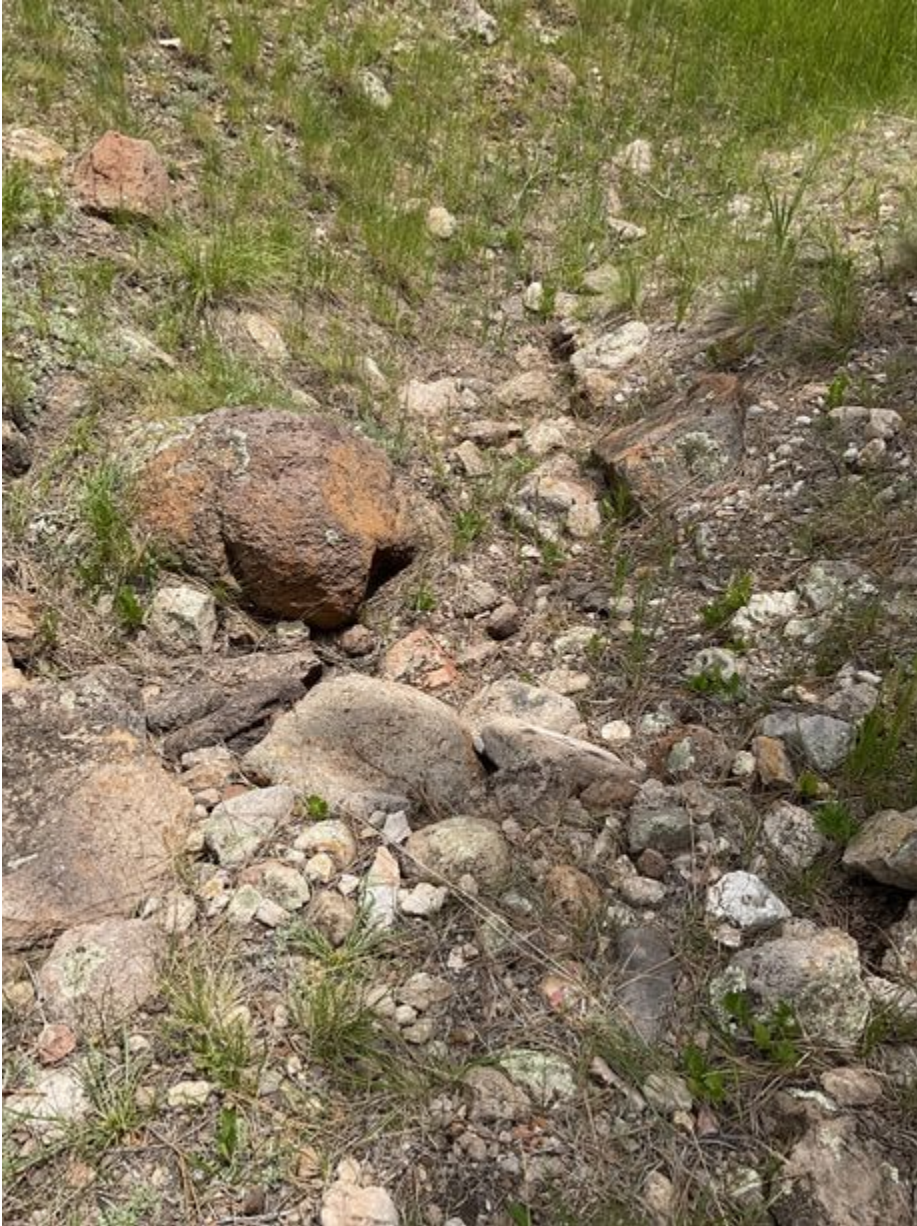
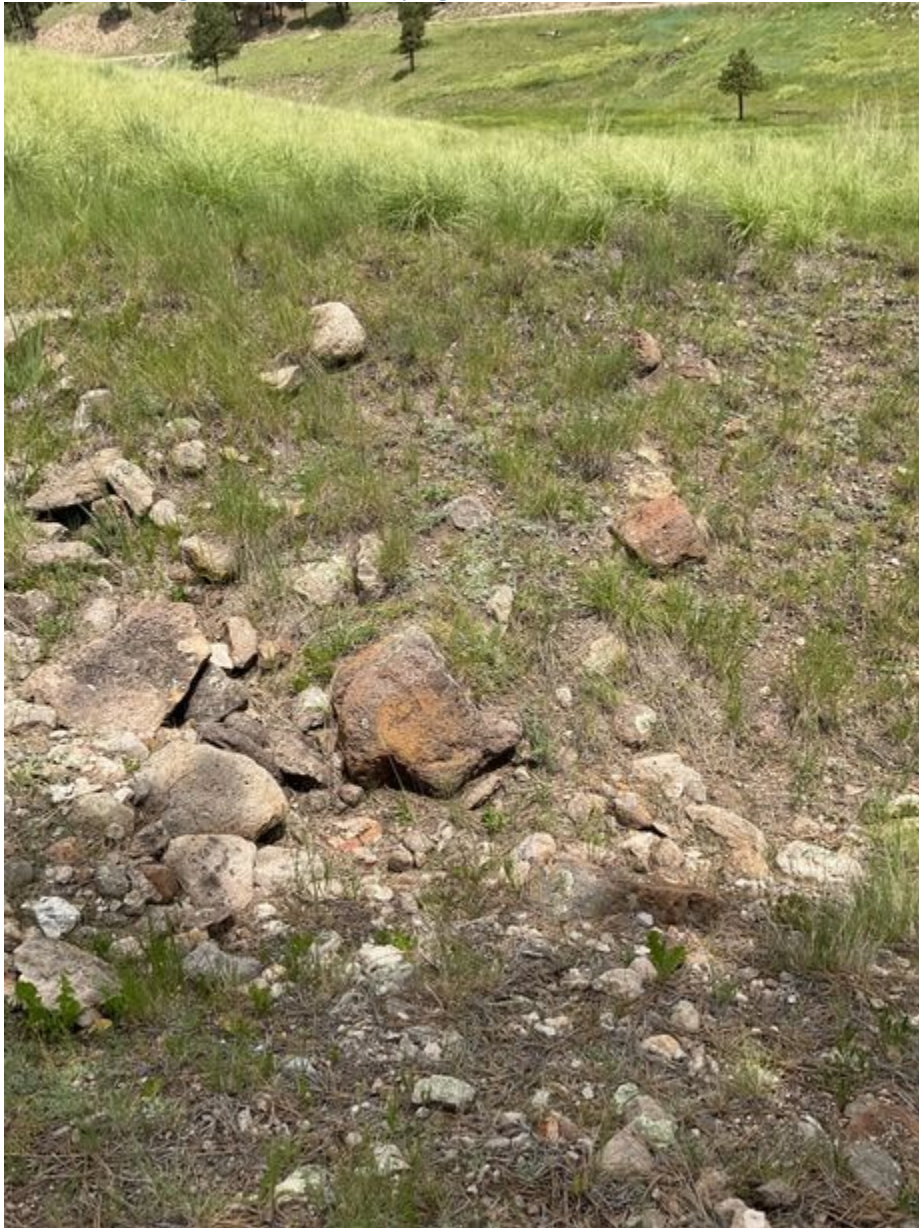
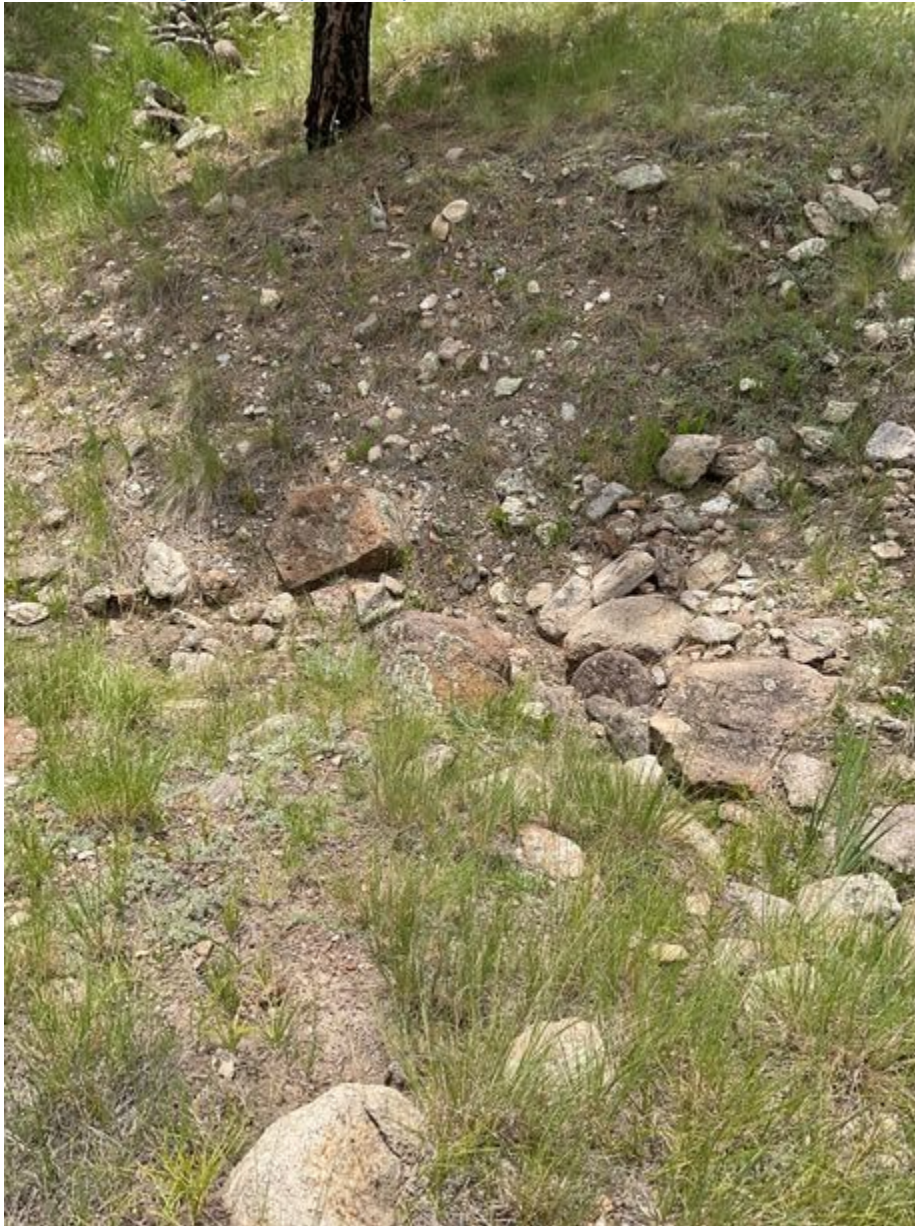
-106.5162171 35.93705398

Some rocks dislodged or broken

Difference between ZB and ORD Condition
ORD is mostly dislodged ZB is missing a few rocks

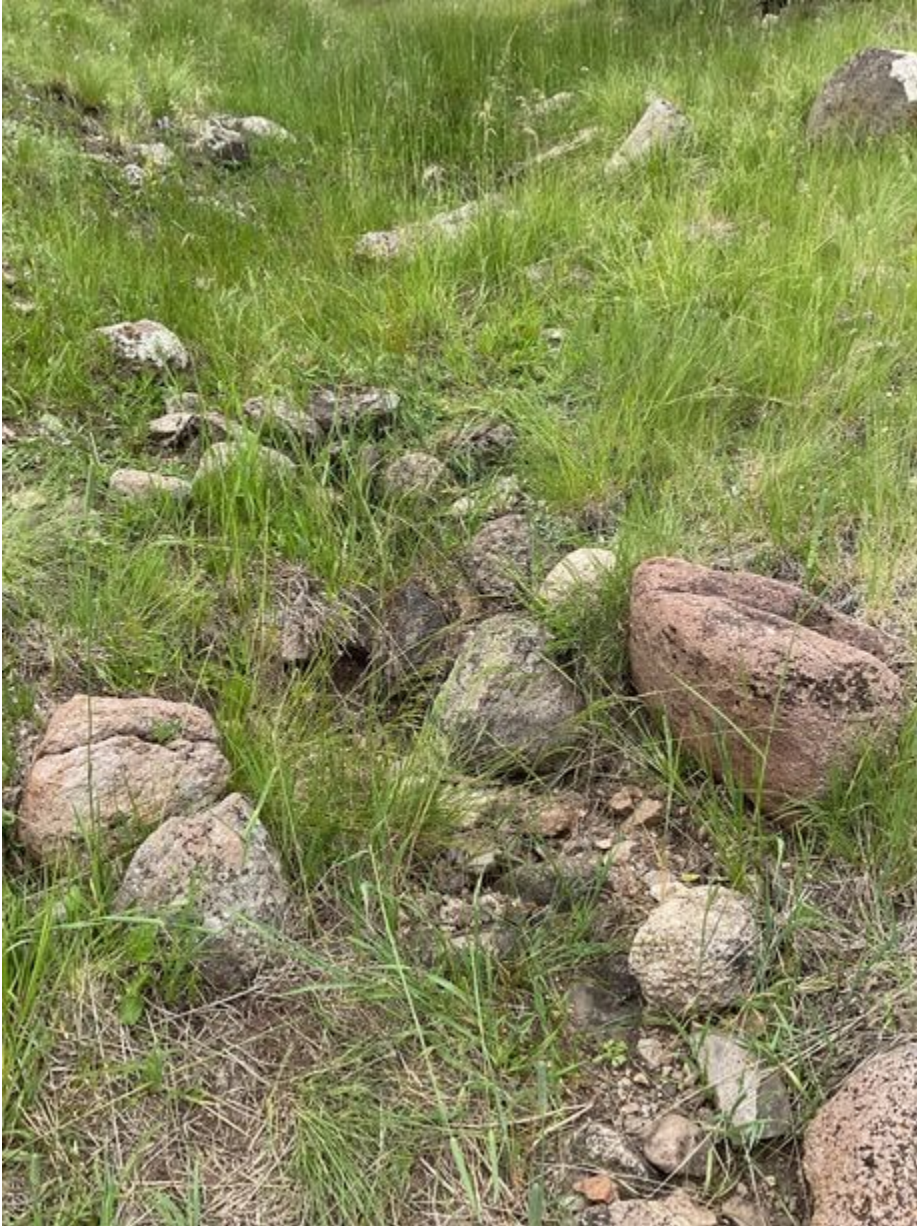
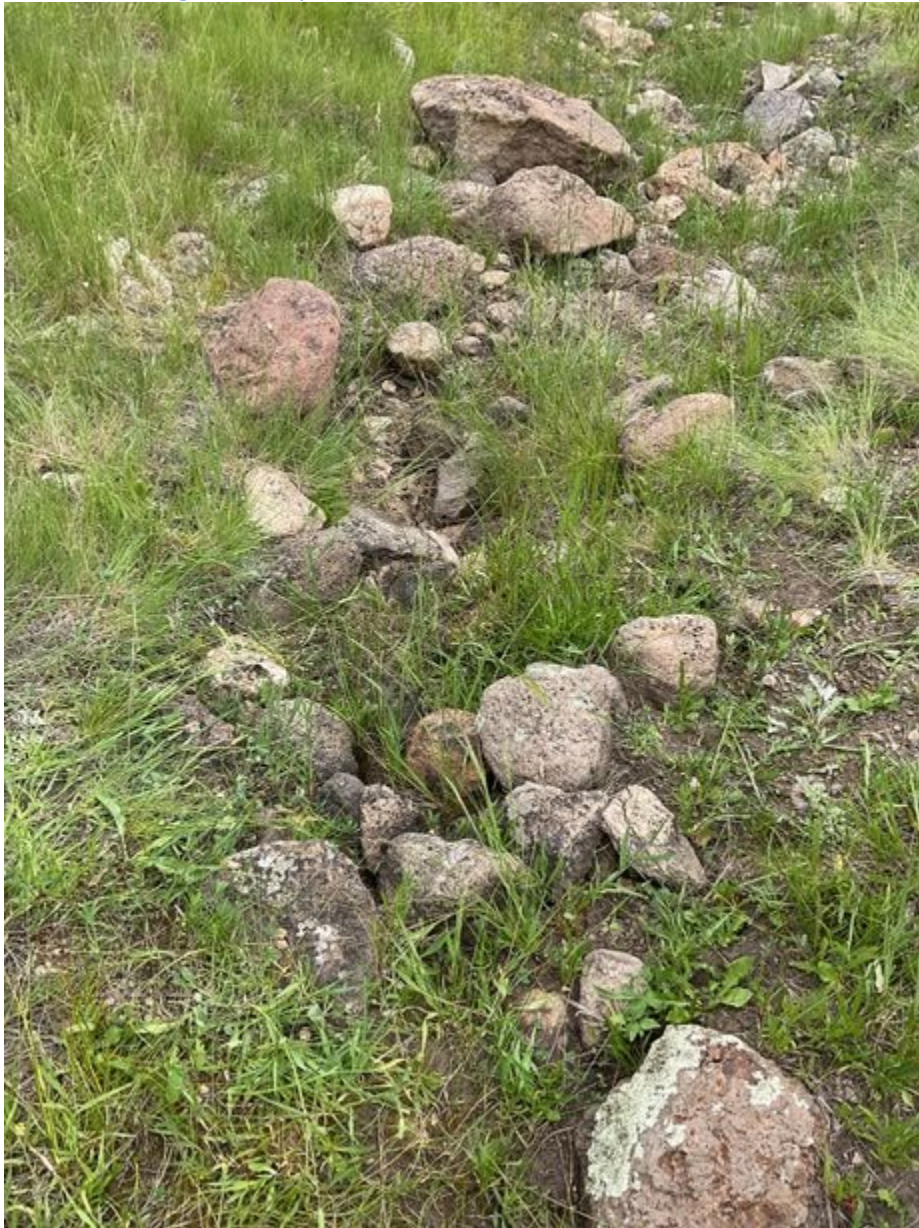
-106.5159811 35.93712195

Some rocks dislodged or broken

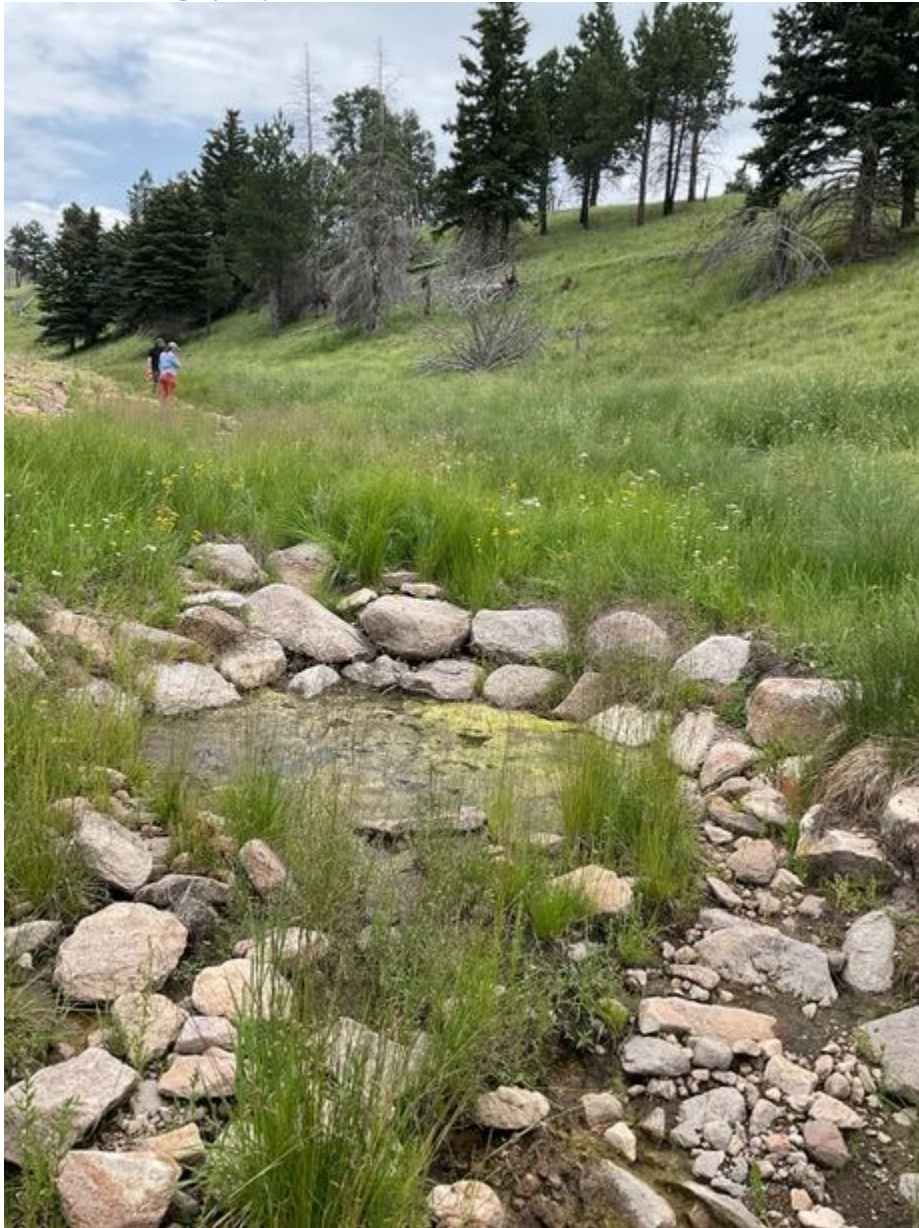
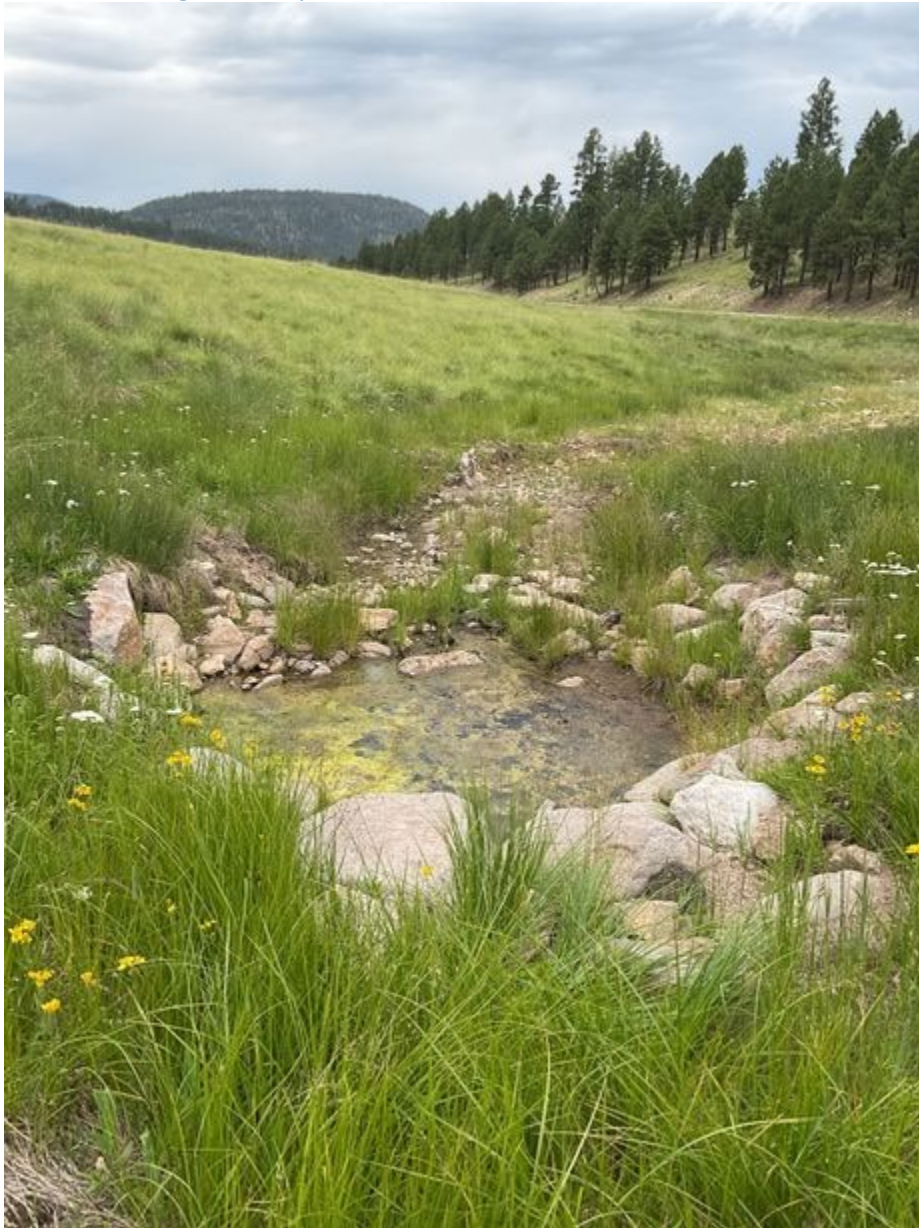
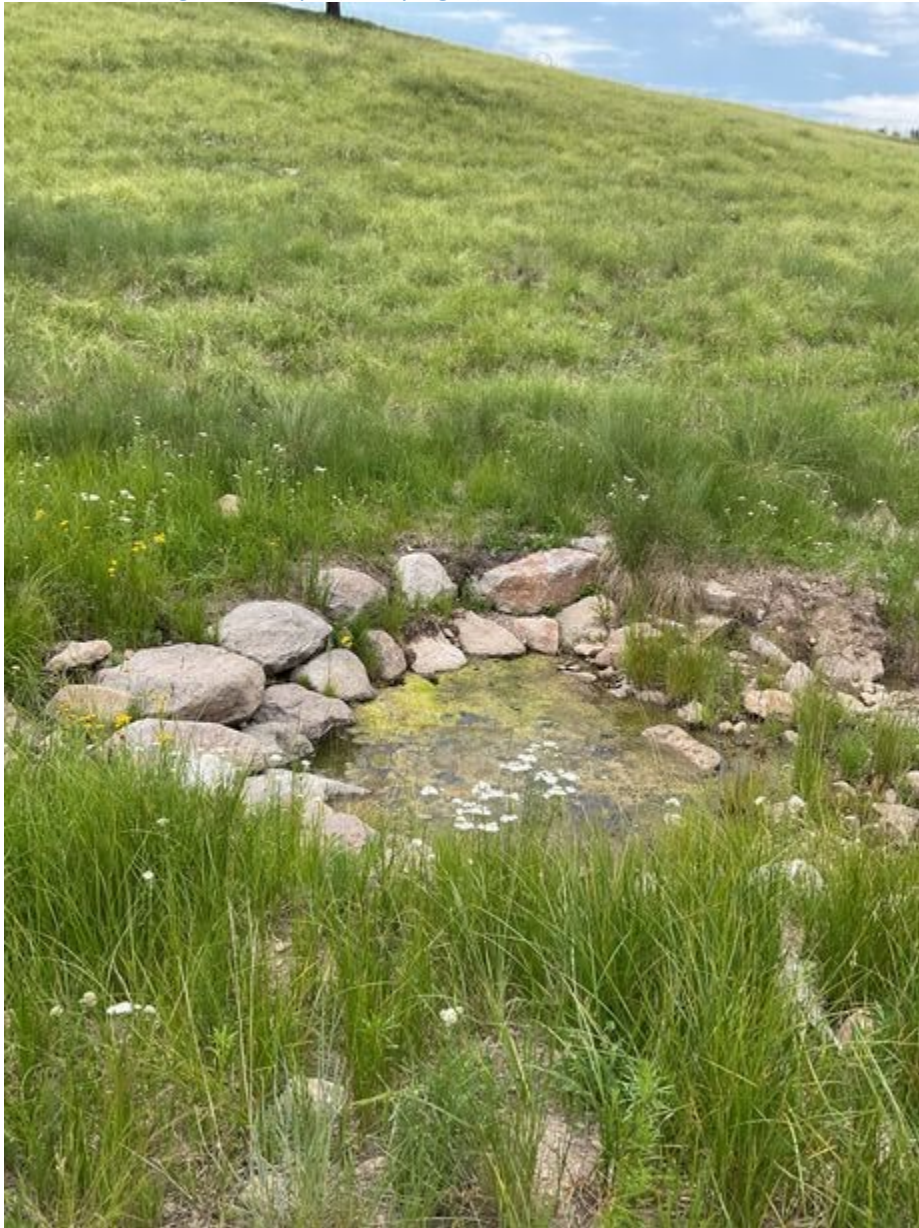
-106.5071629 35.93253932

Some rocks dislodged or broken
