CN R924060

**Zuni Bowl and One Rock Check Dam Research –
Phase 1**

Final Report

Rio Grande Return for the New Mexico Department of Transportation Research Bureau

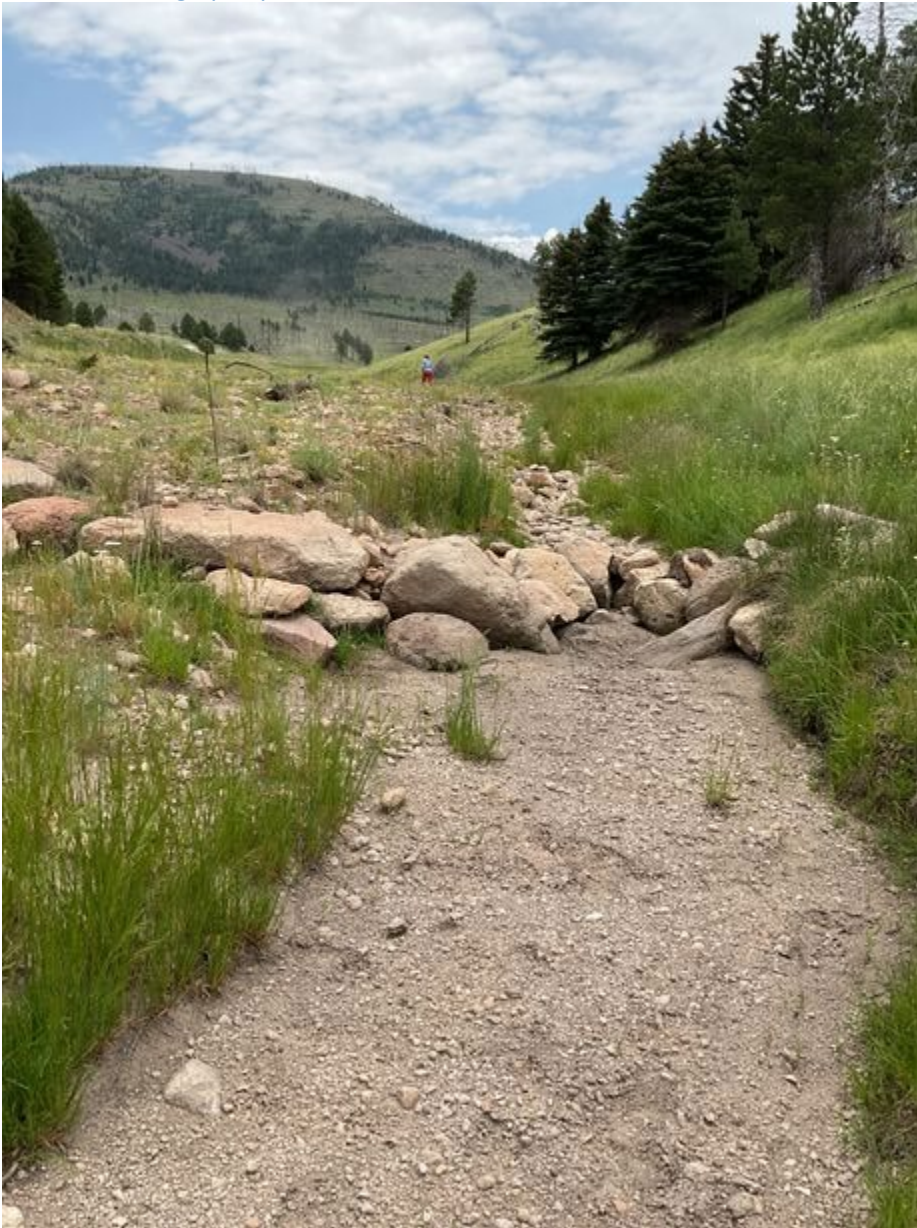
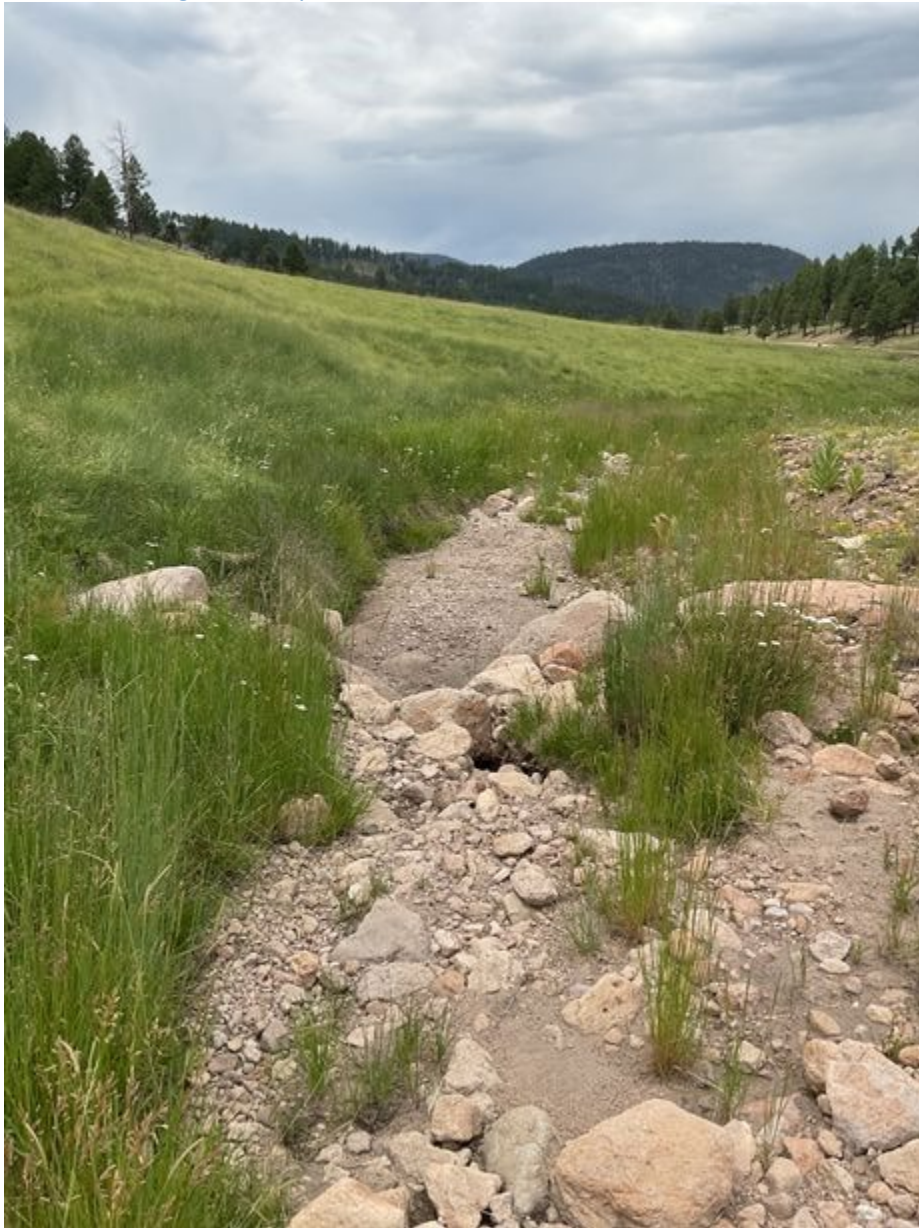
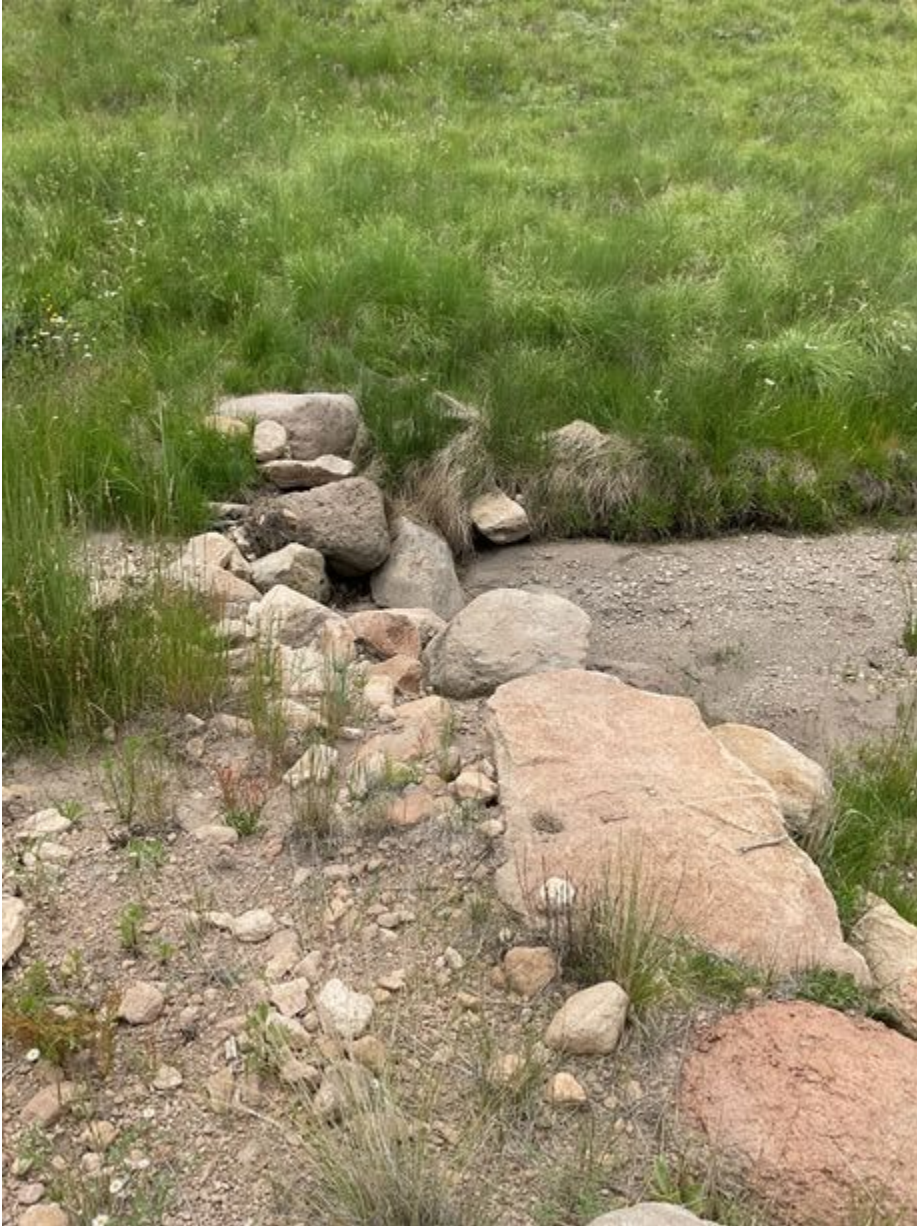
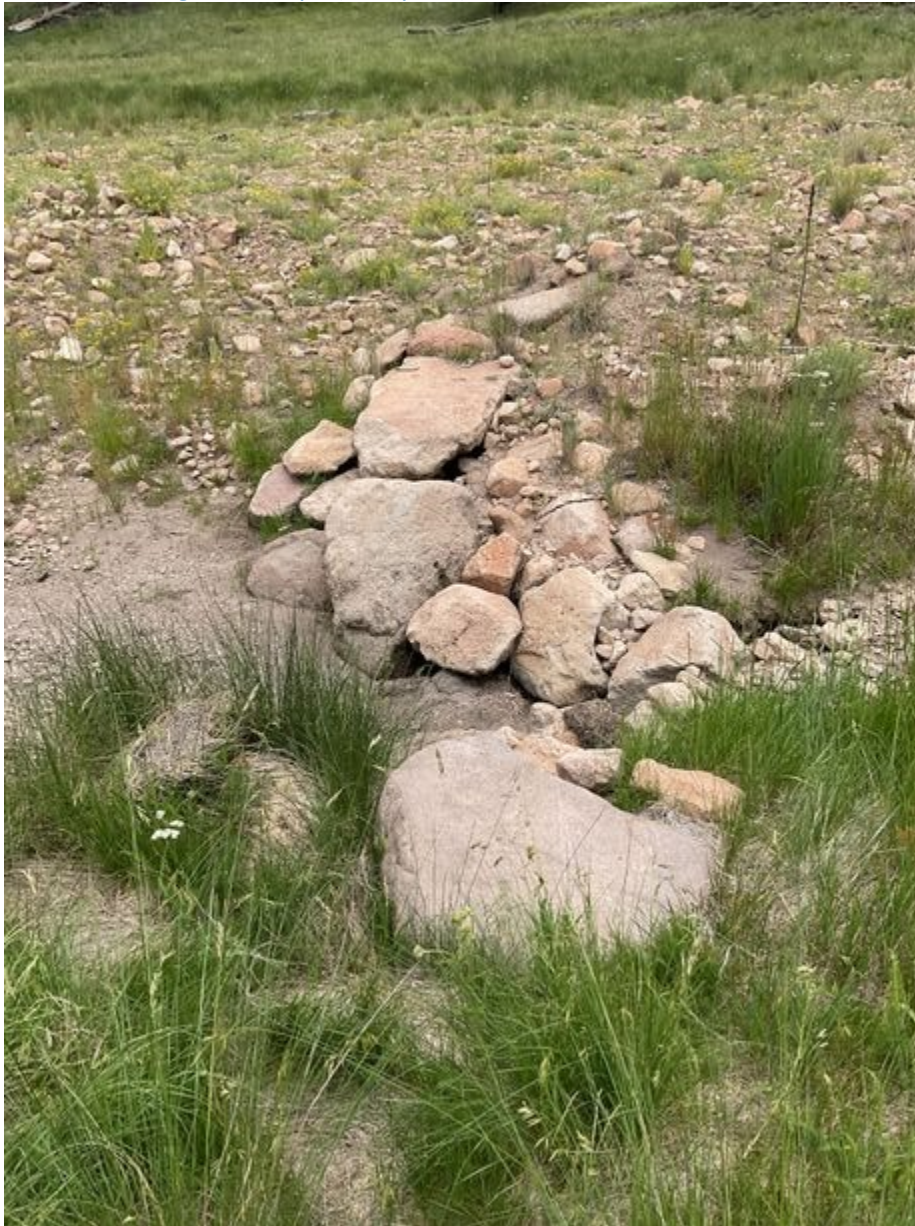
-106.5069708 35.93246877

All rocks intact

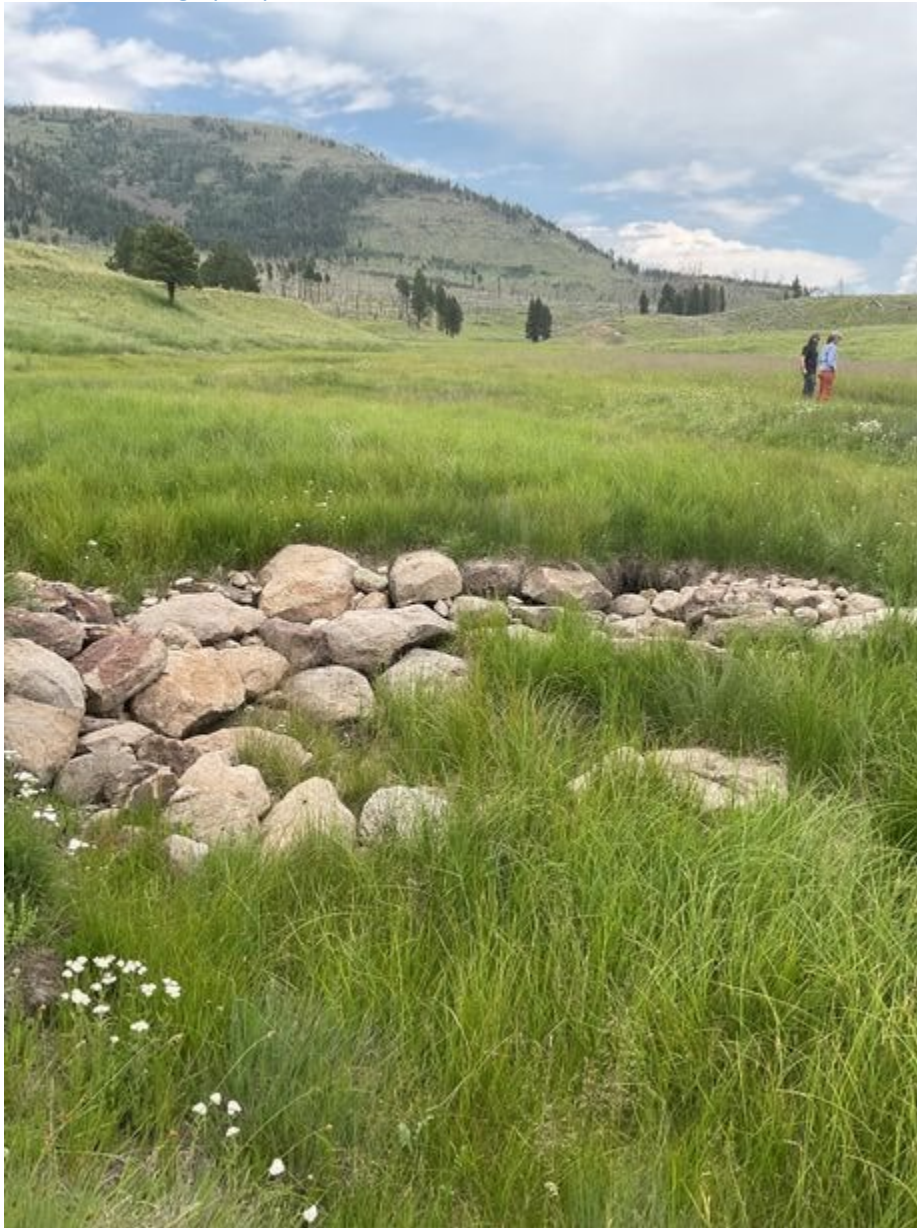
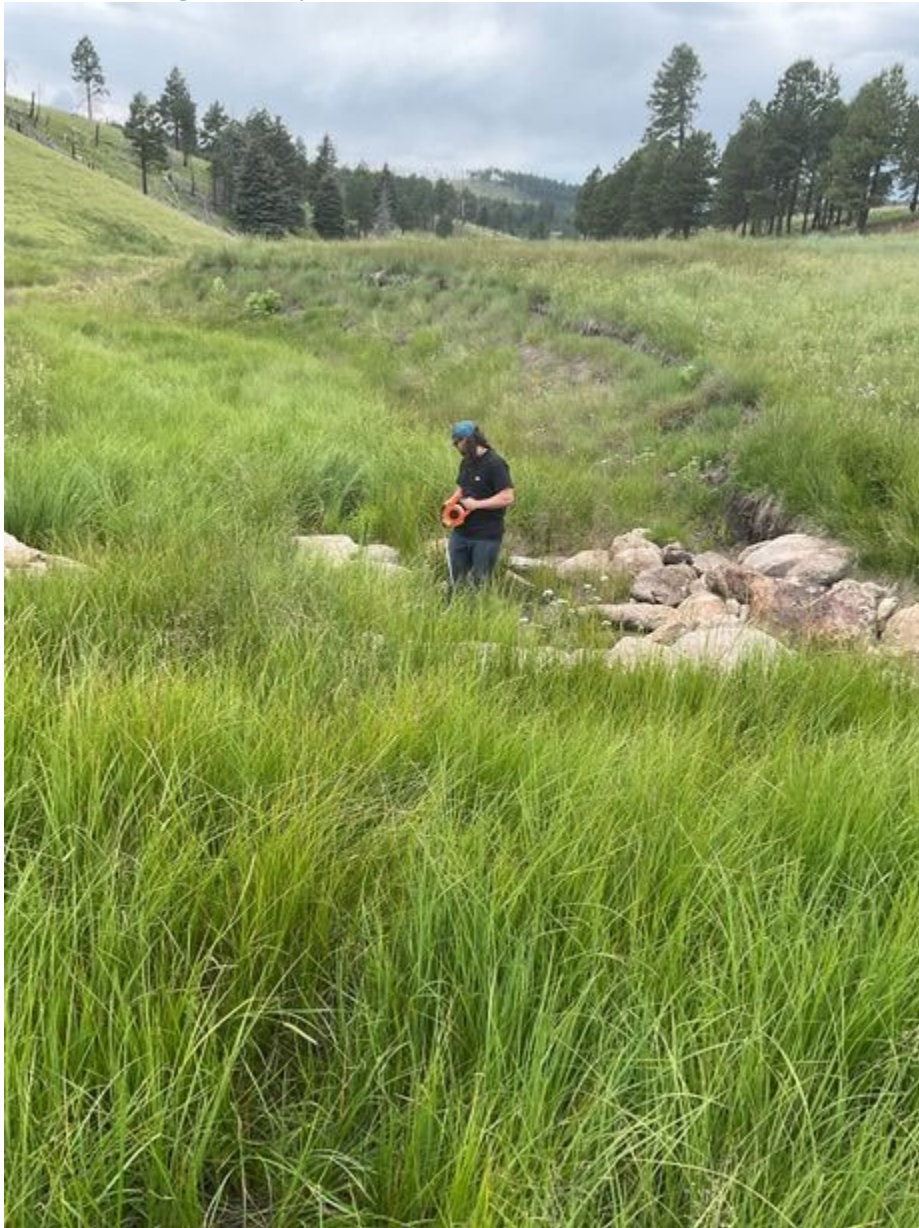
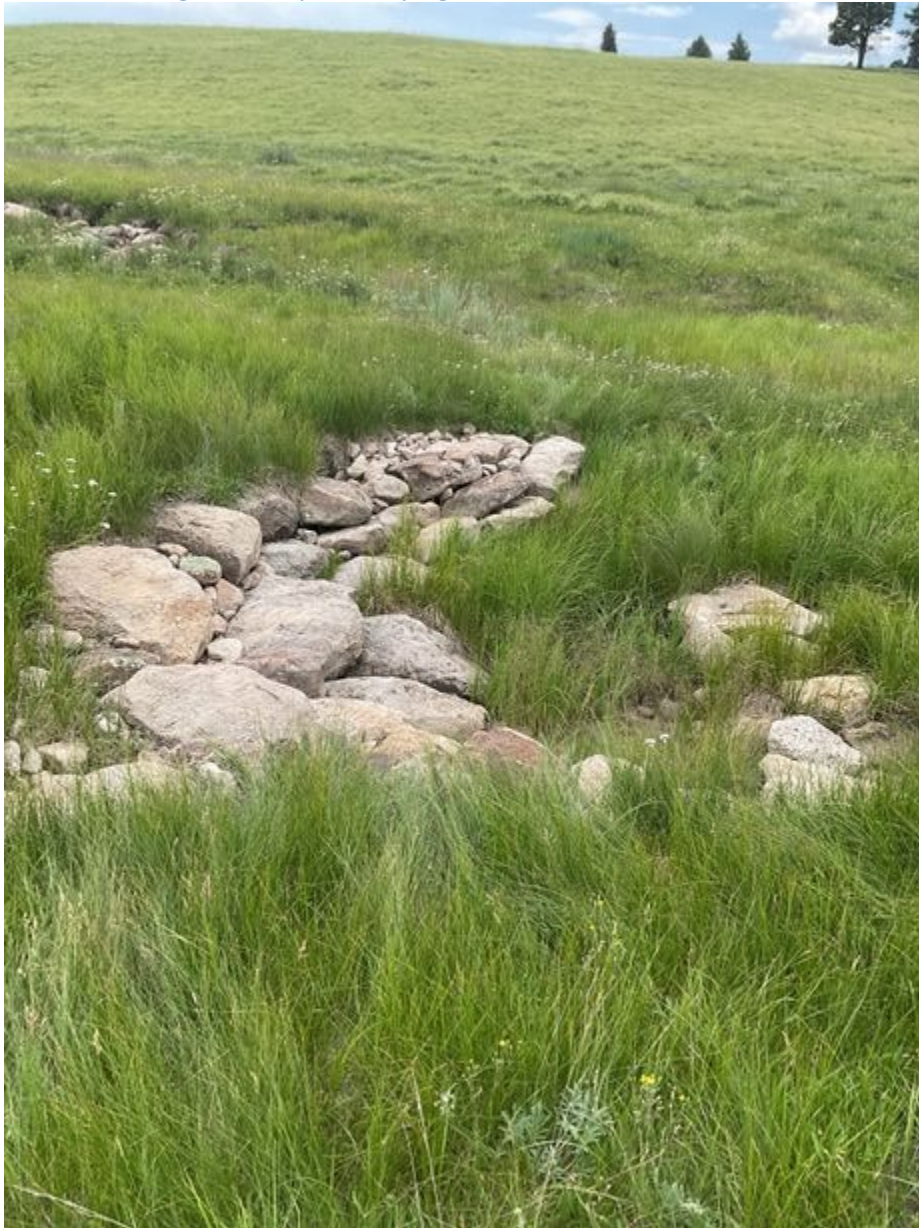
-106.504073 35.93225377

Some rocks dislodged or broken

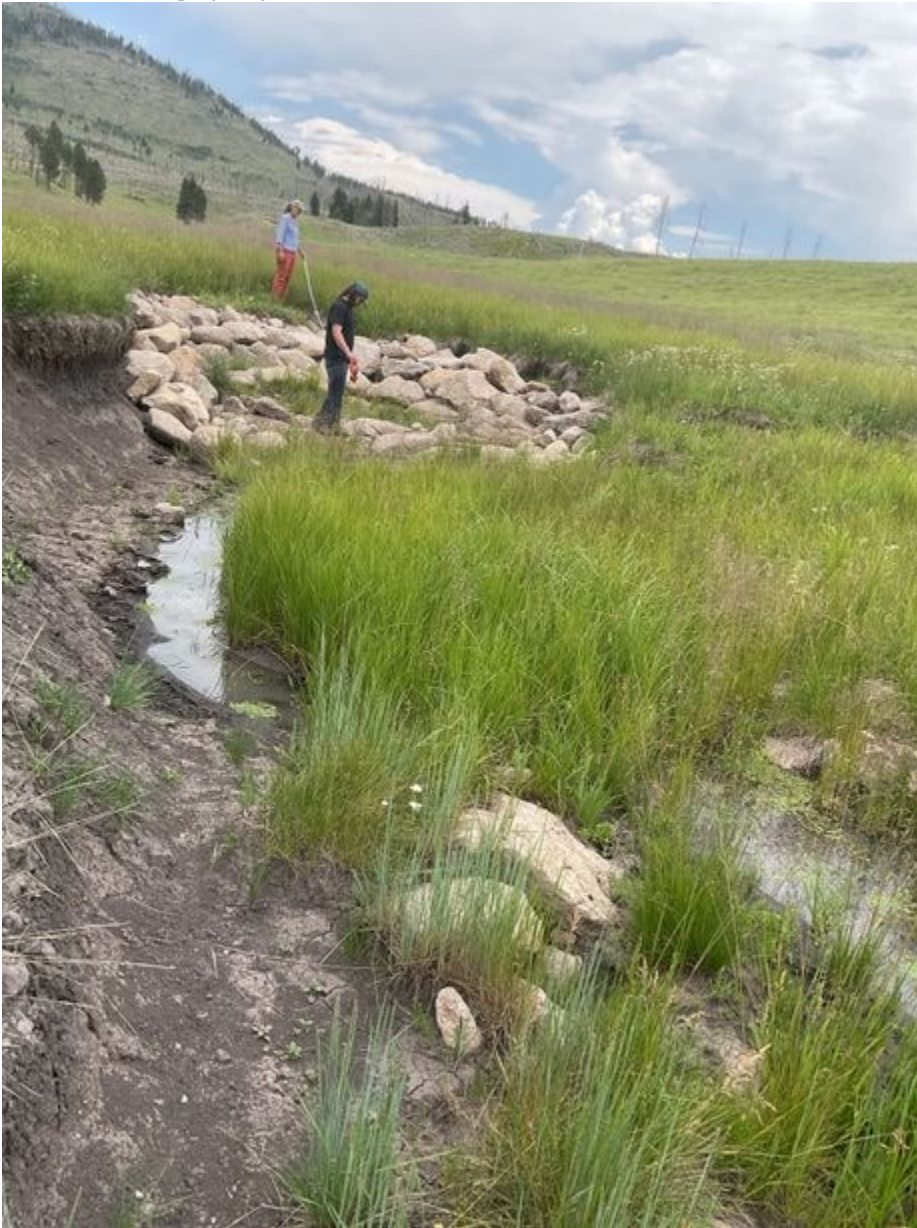
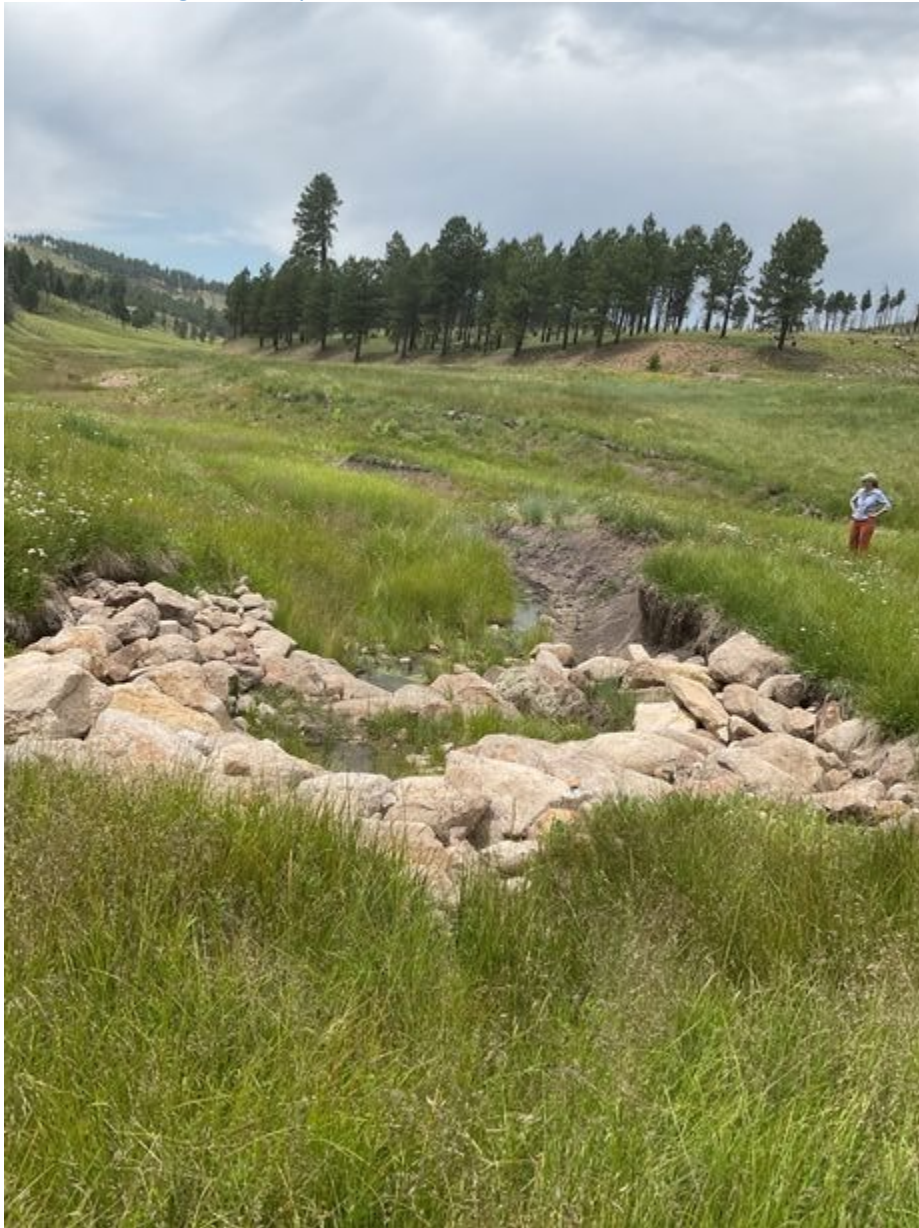
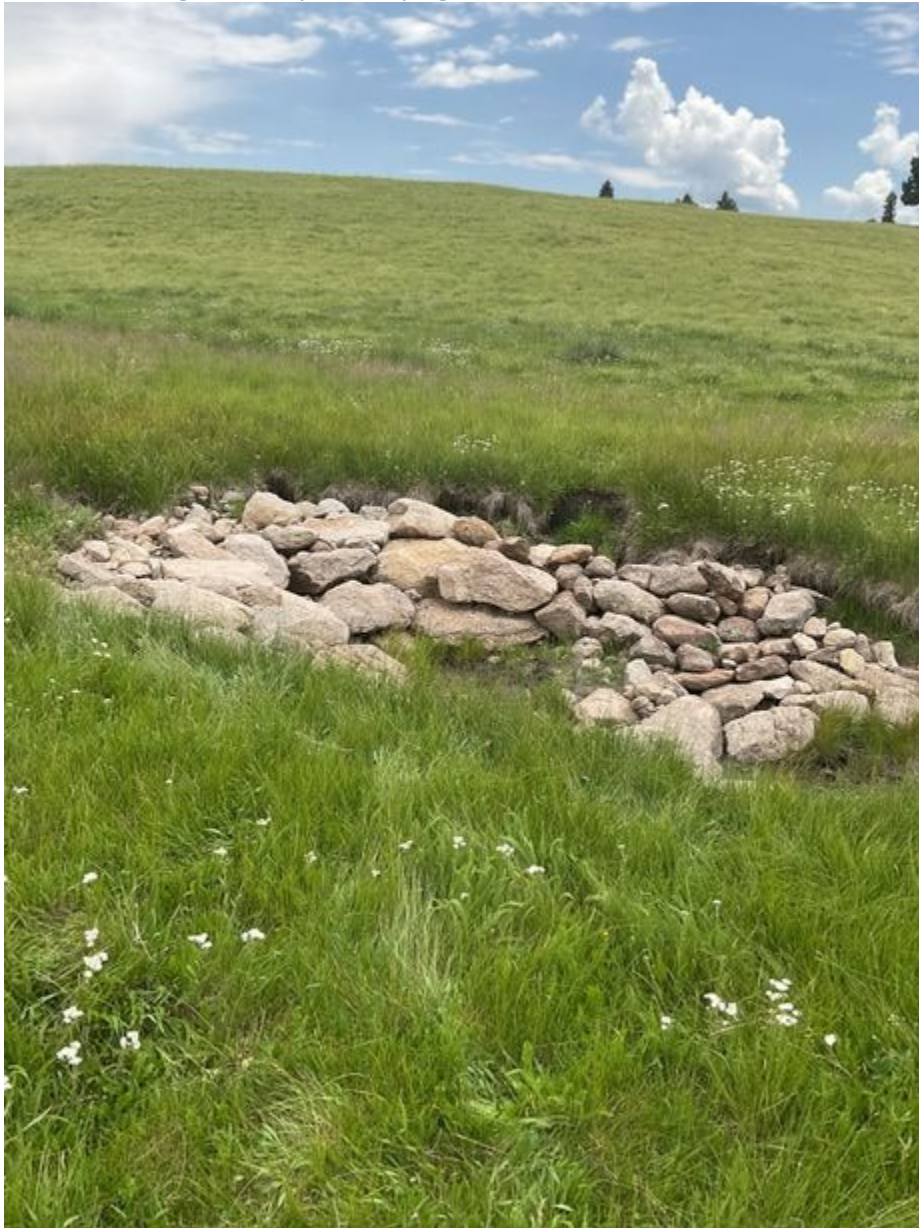
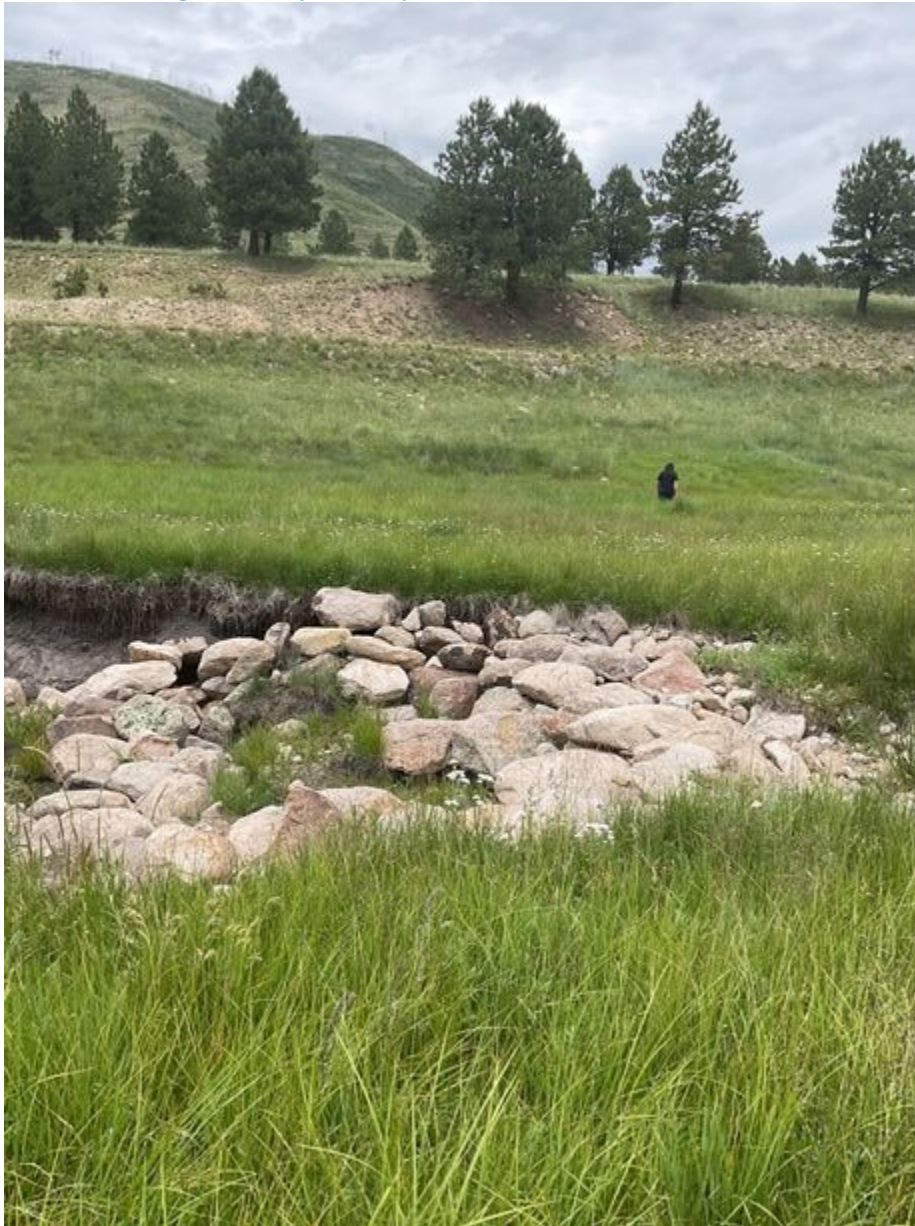
-106.5040297 35.93222283

Some rocks dislodged or broken

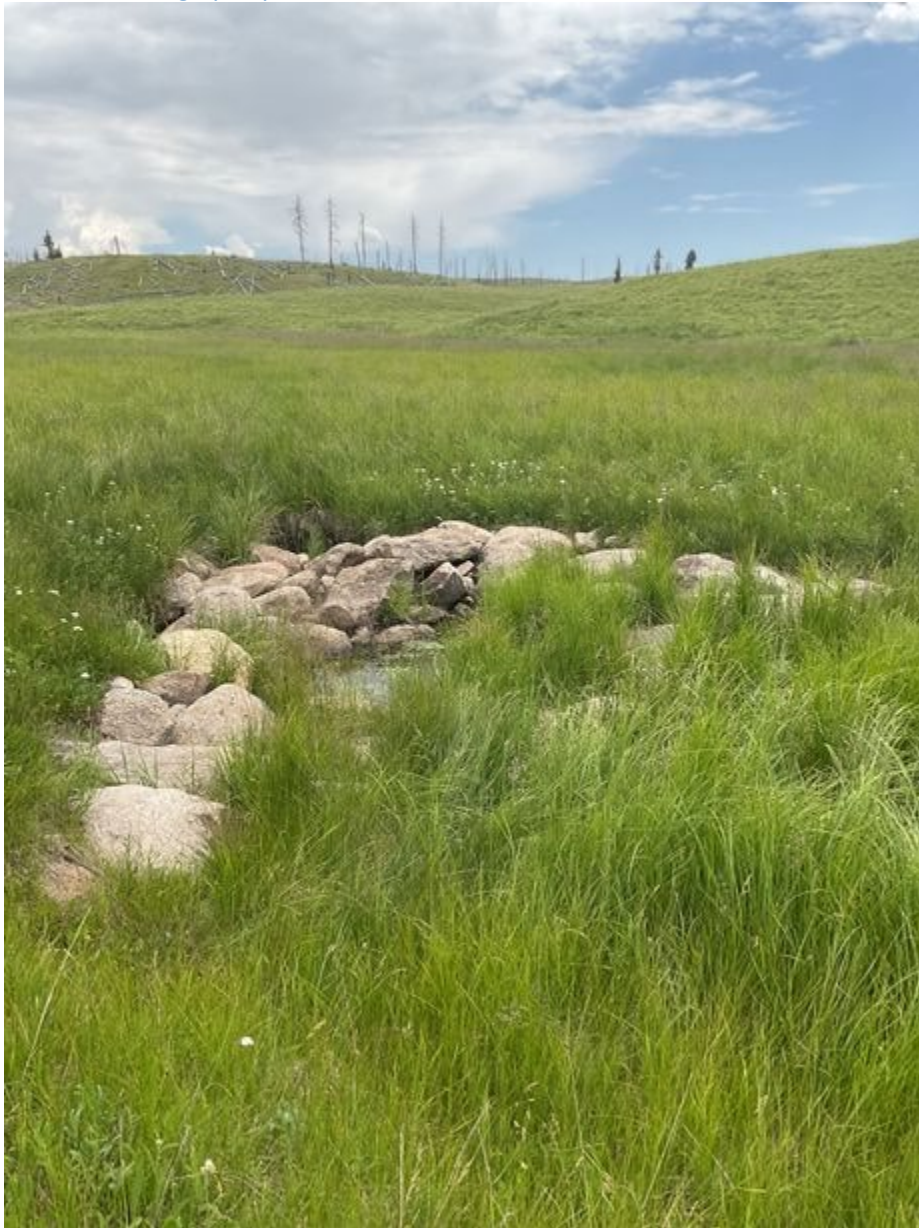
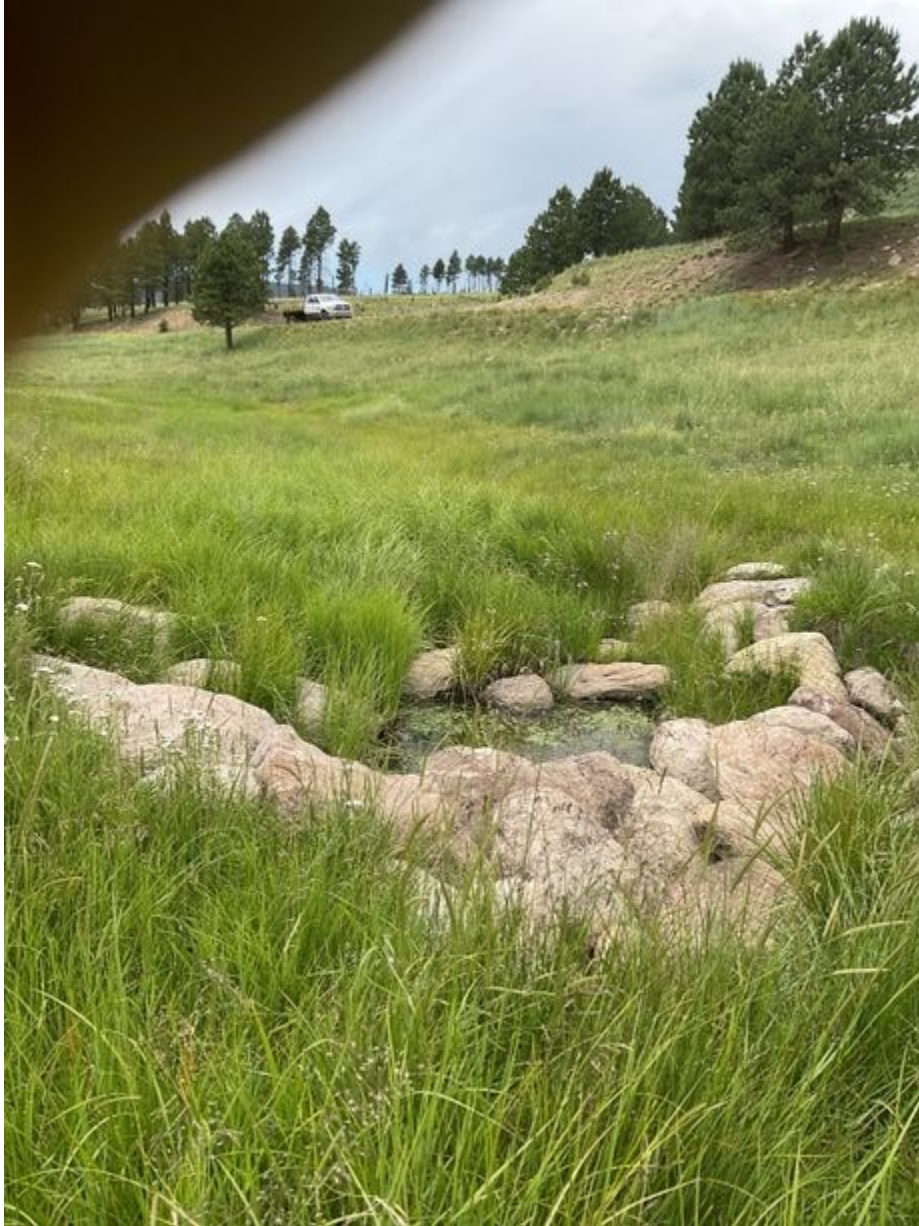
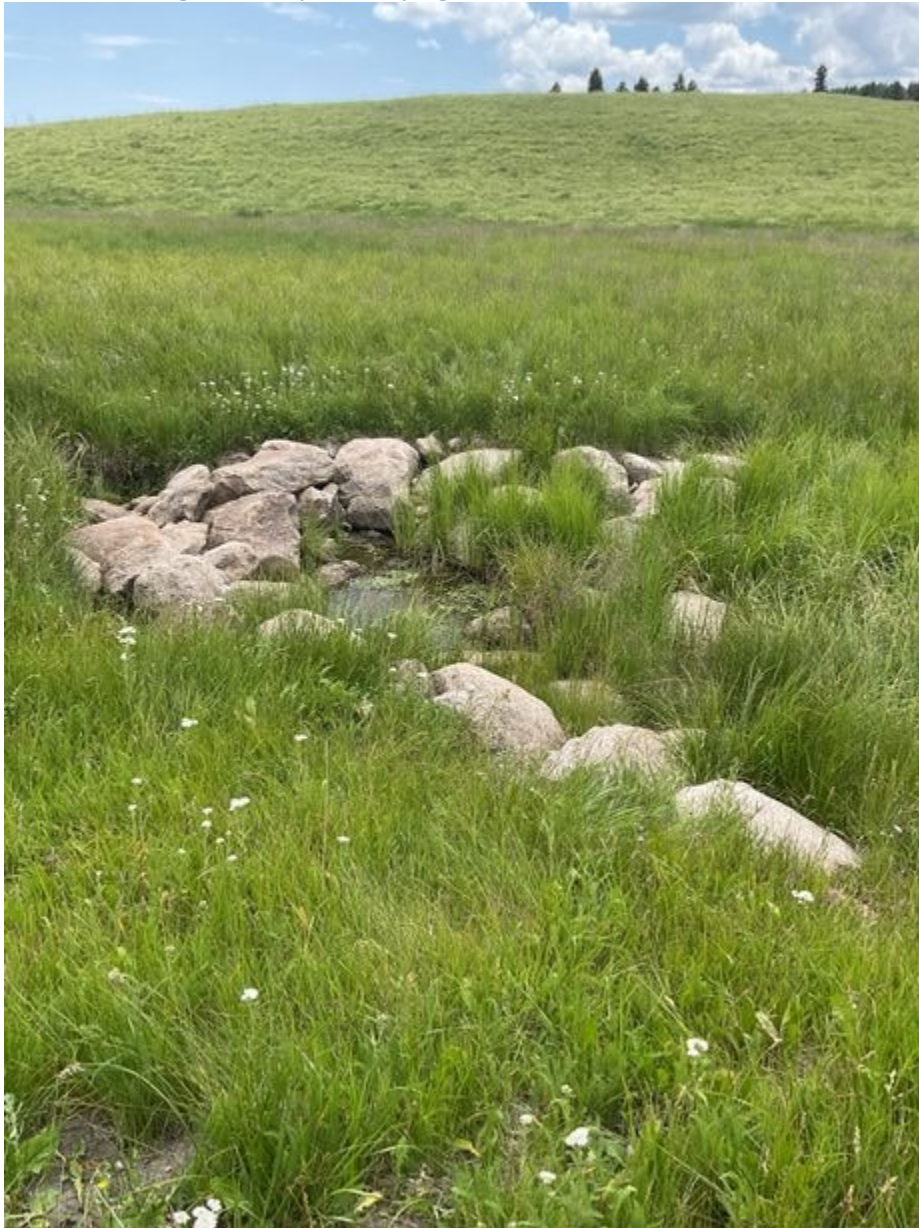
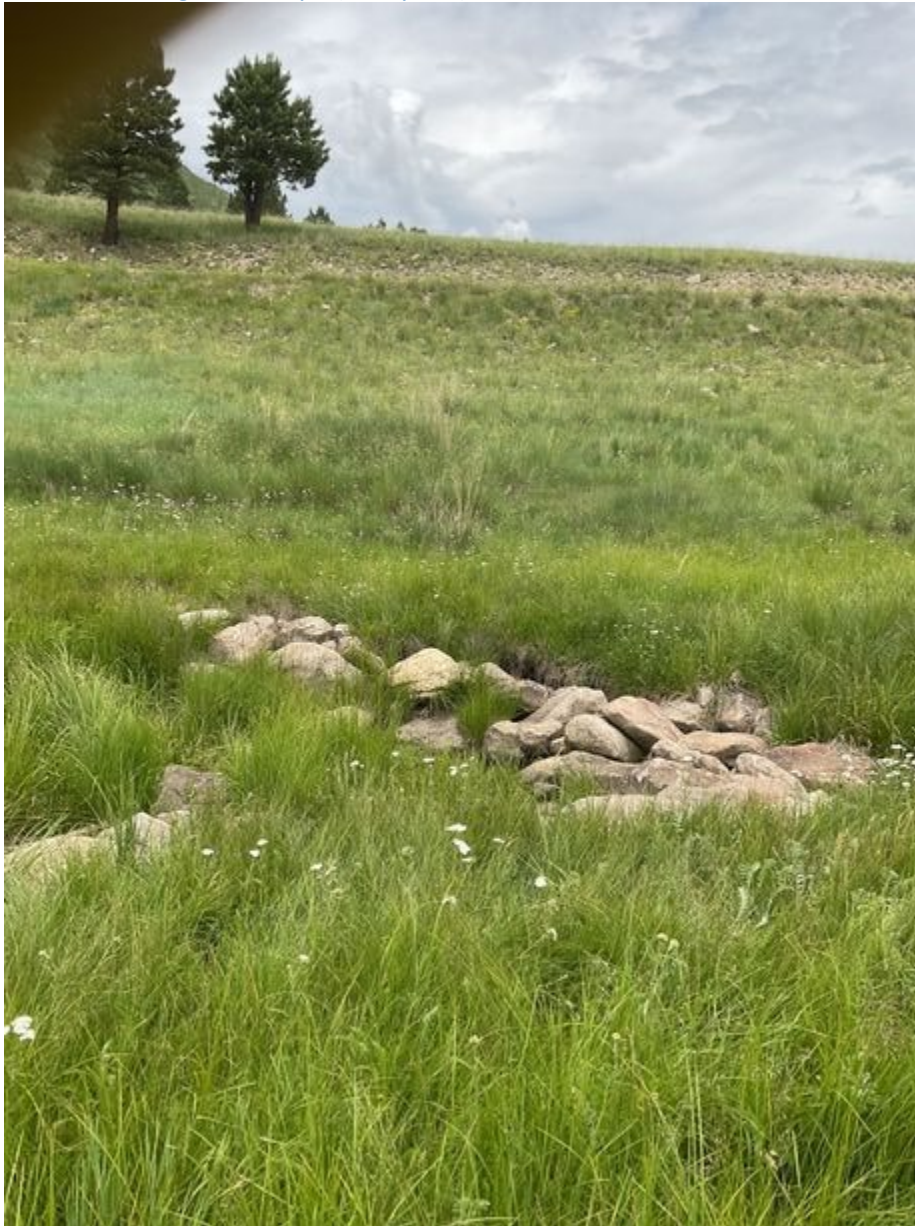
-106.5034389 35.93217562

Some rocks dislodged or broken

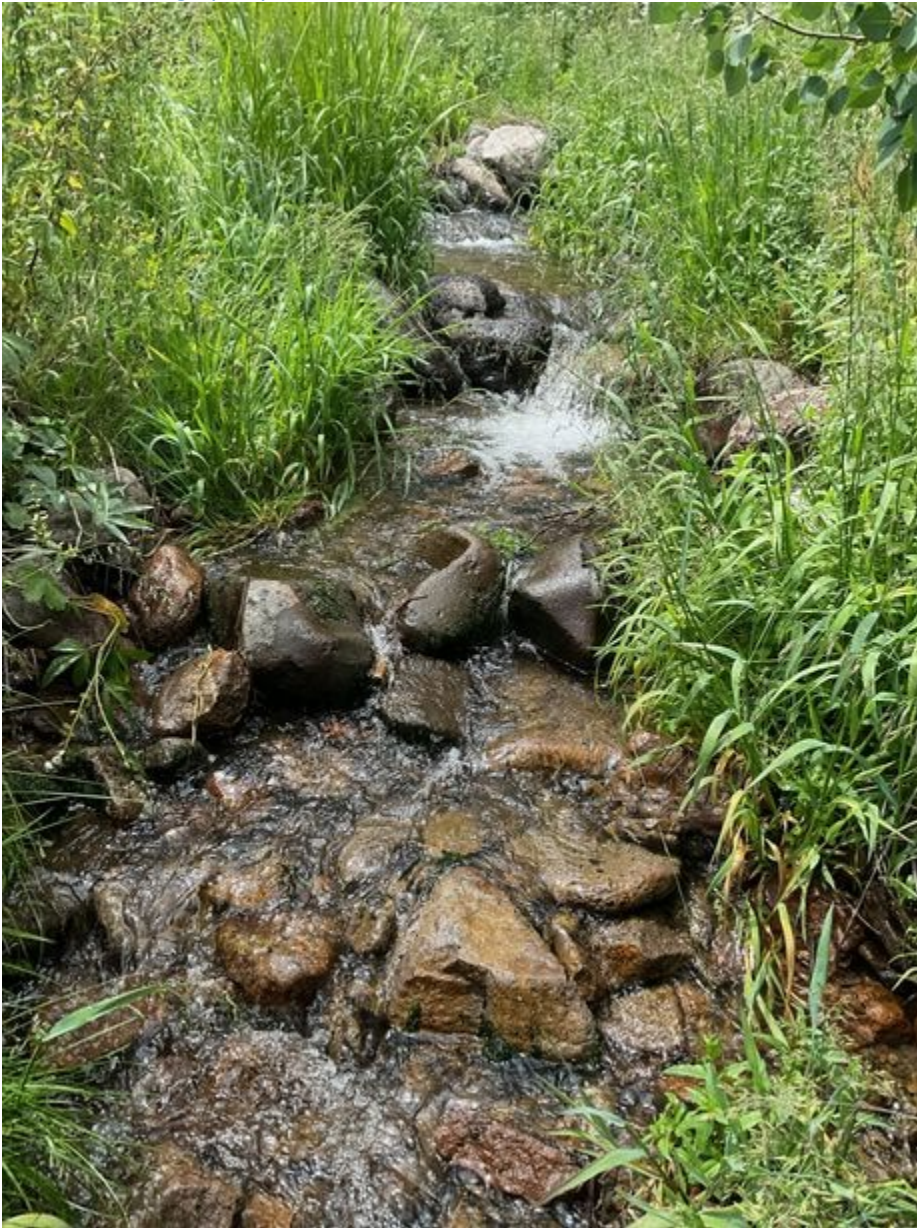
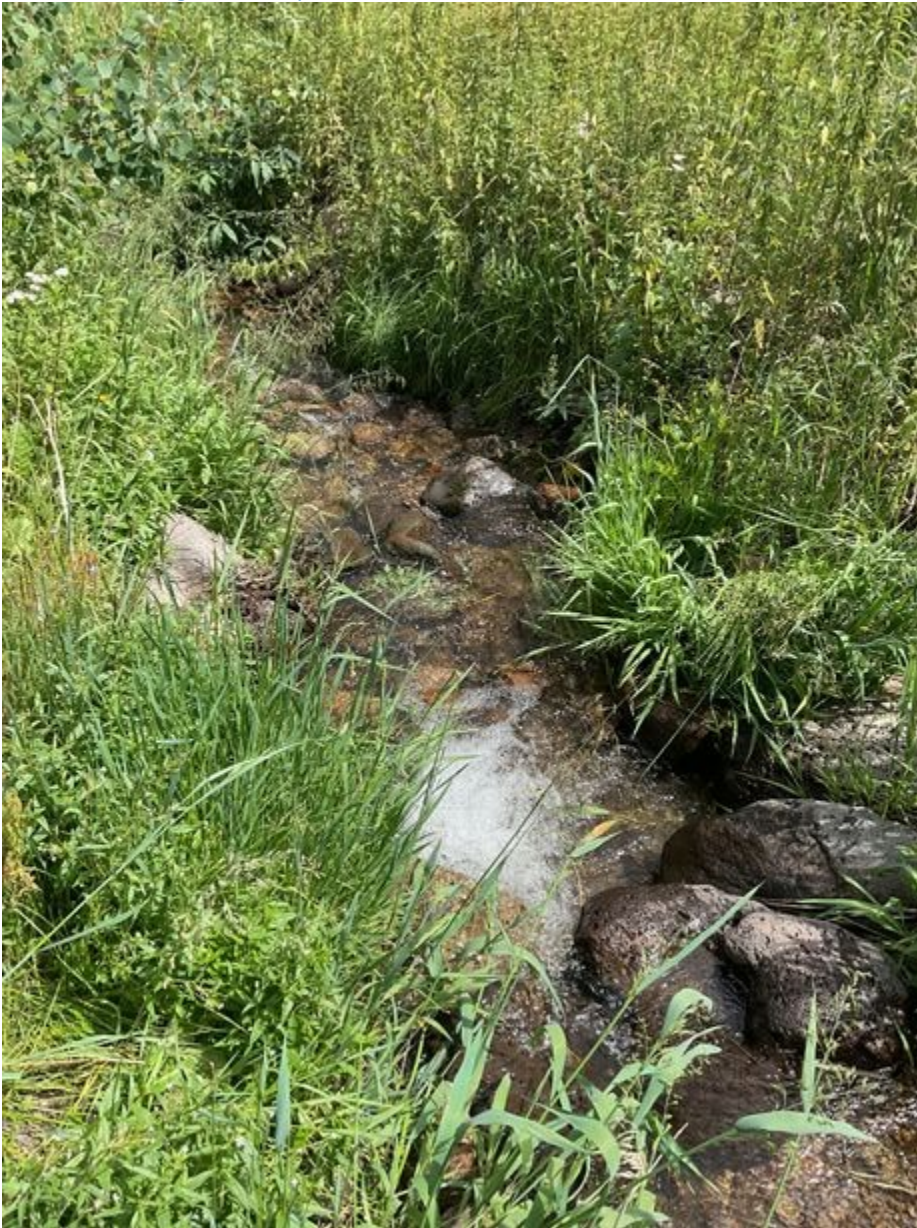
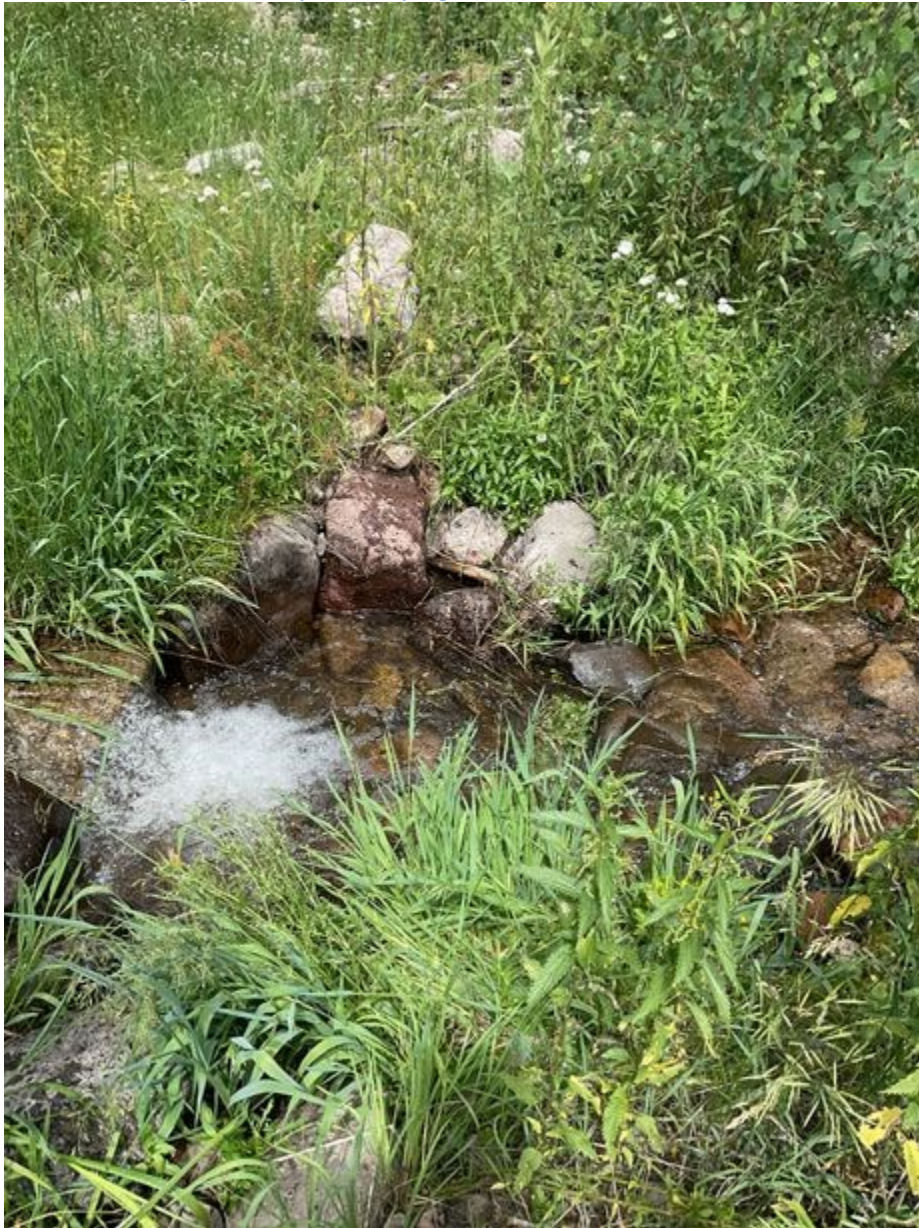
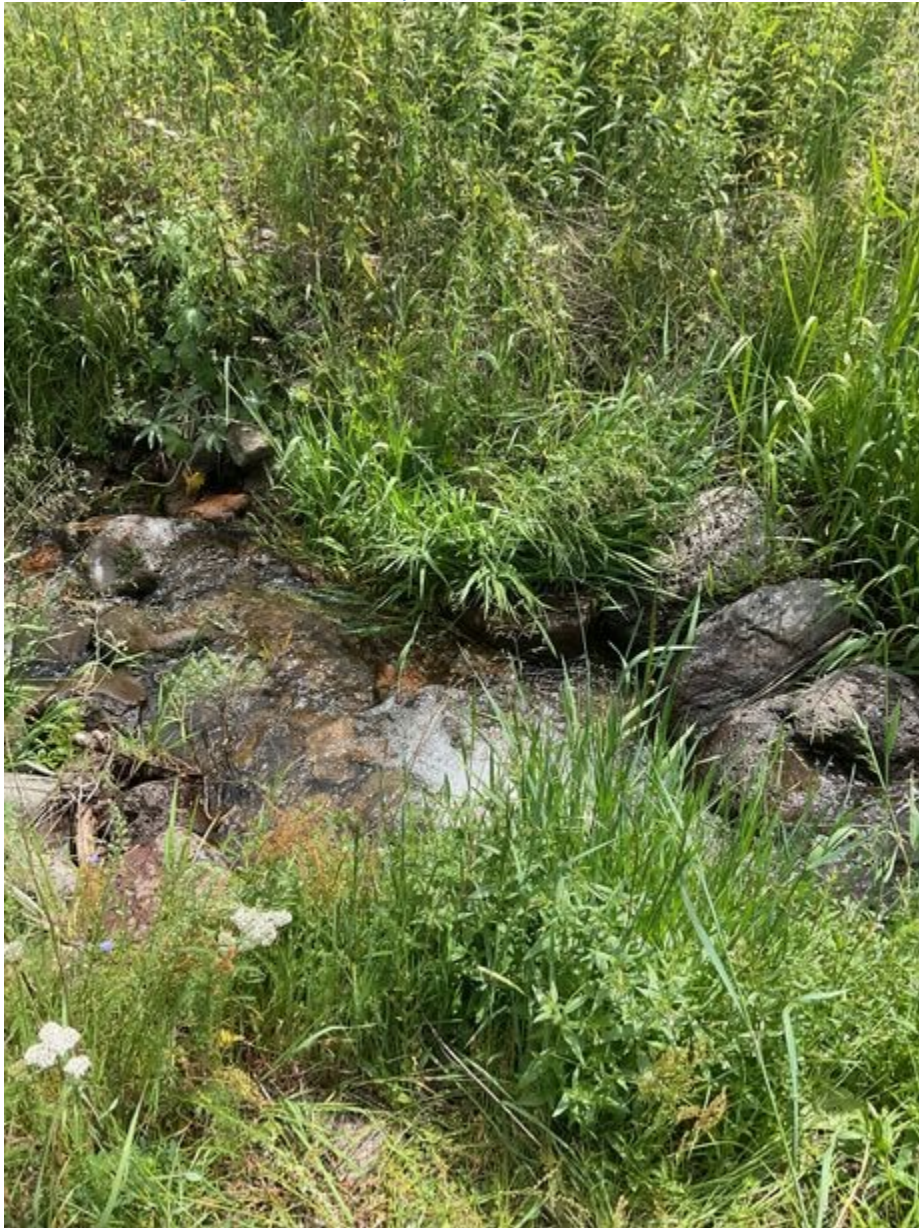
-106.5187872 35.8651939

All rocks intact

Difference between ZB and ORD Condition
ORD center rocks dislodged
