CN R924060

**Zuni Bowl and One Rock Check Dam Research –
Phase 1**

Final Report

Rio Grande Return for the New Mexico Department of Transportation Research Bureau

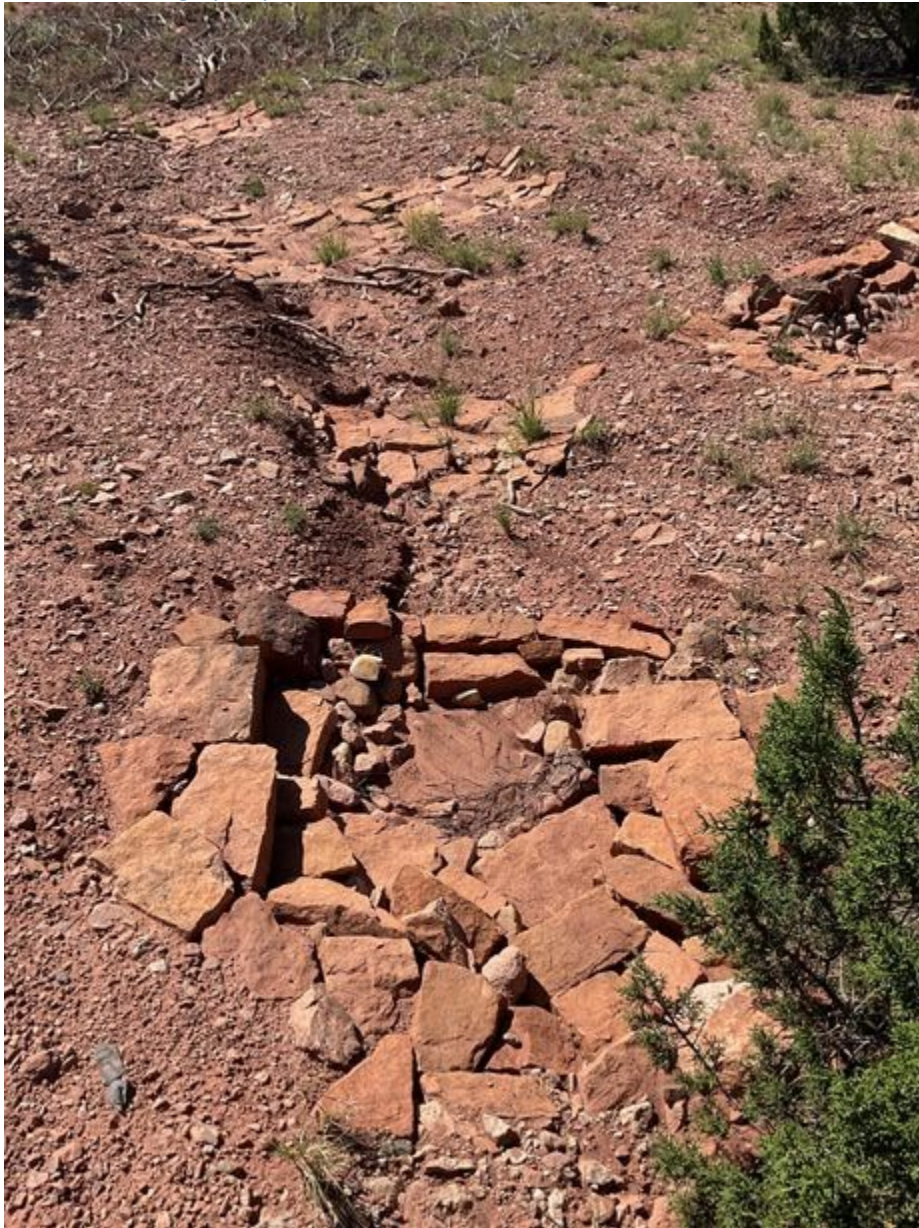
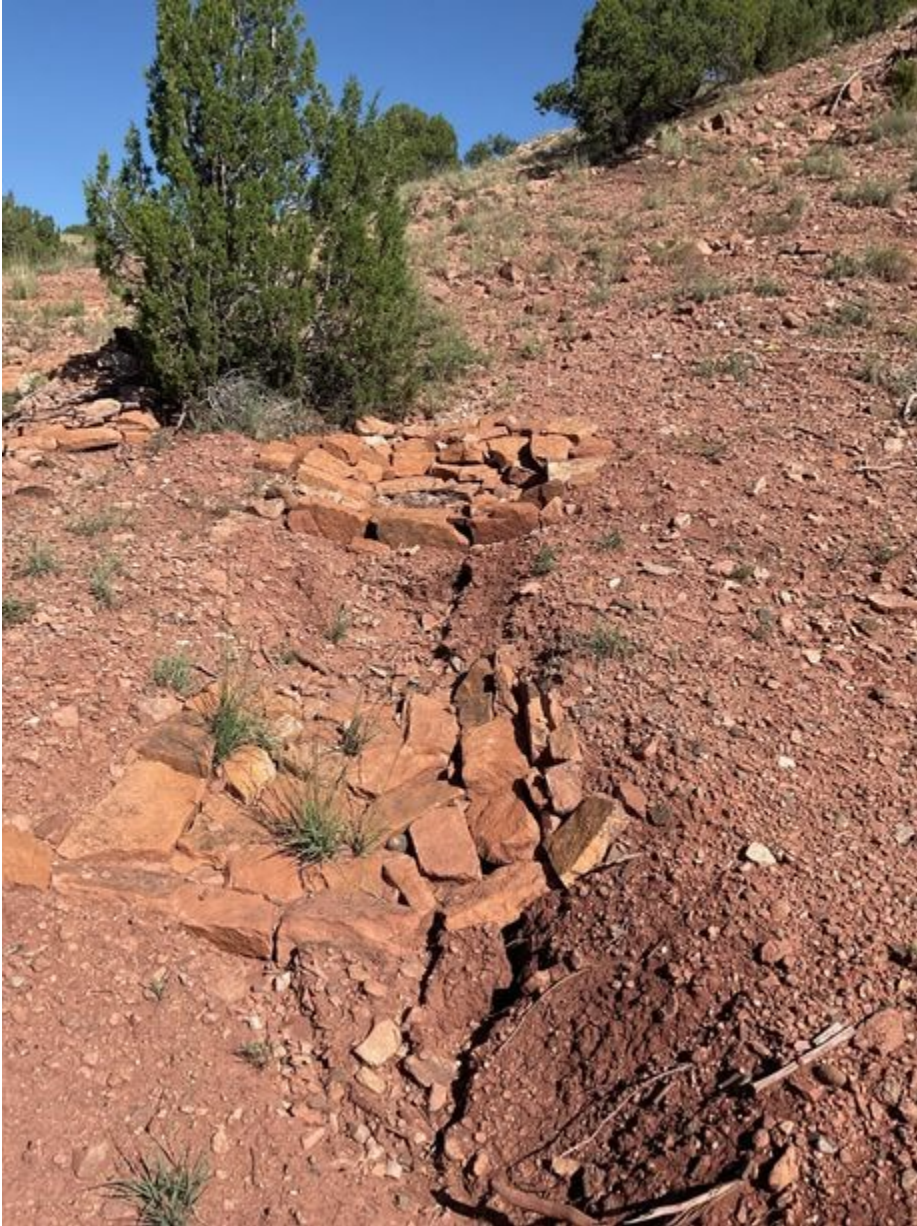
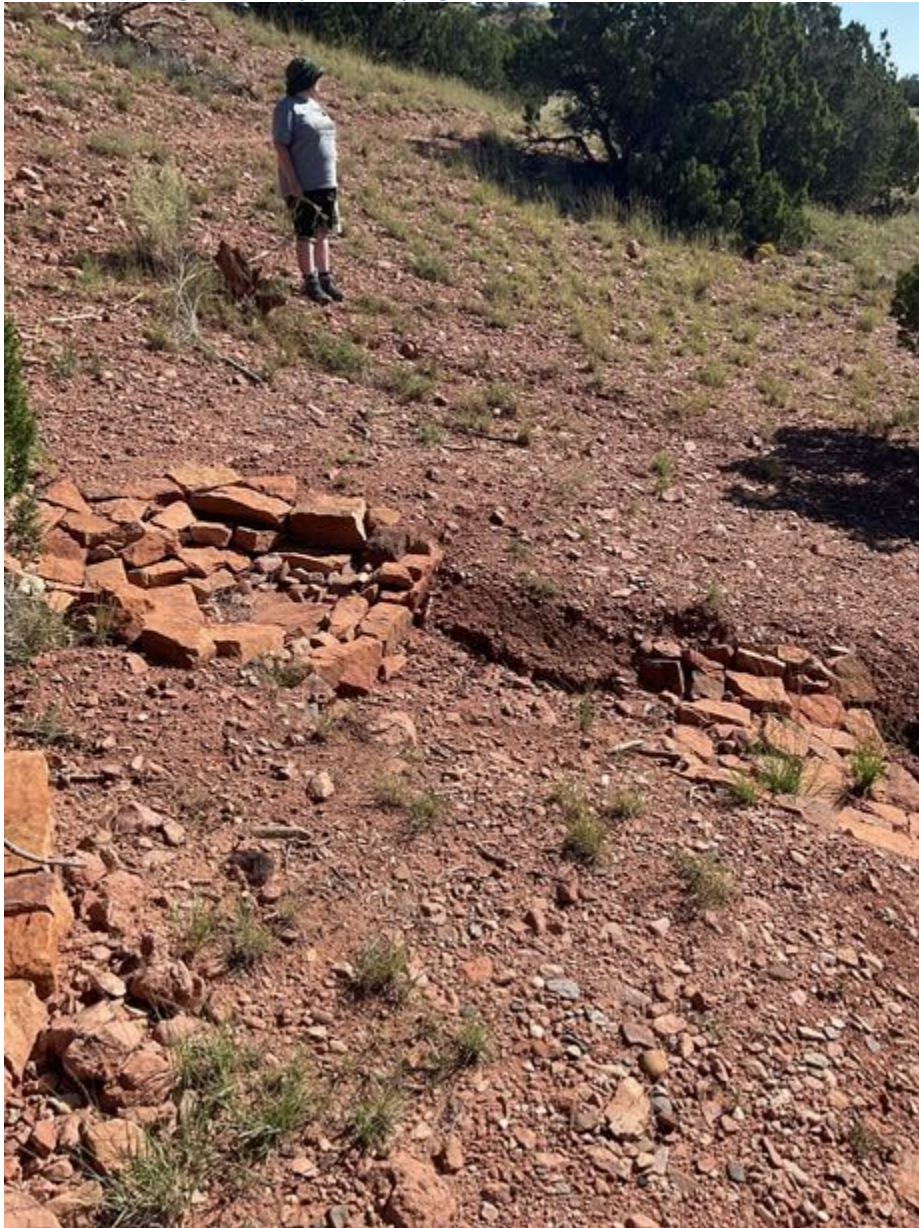
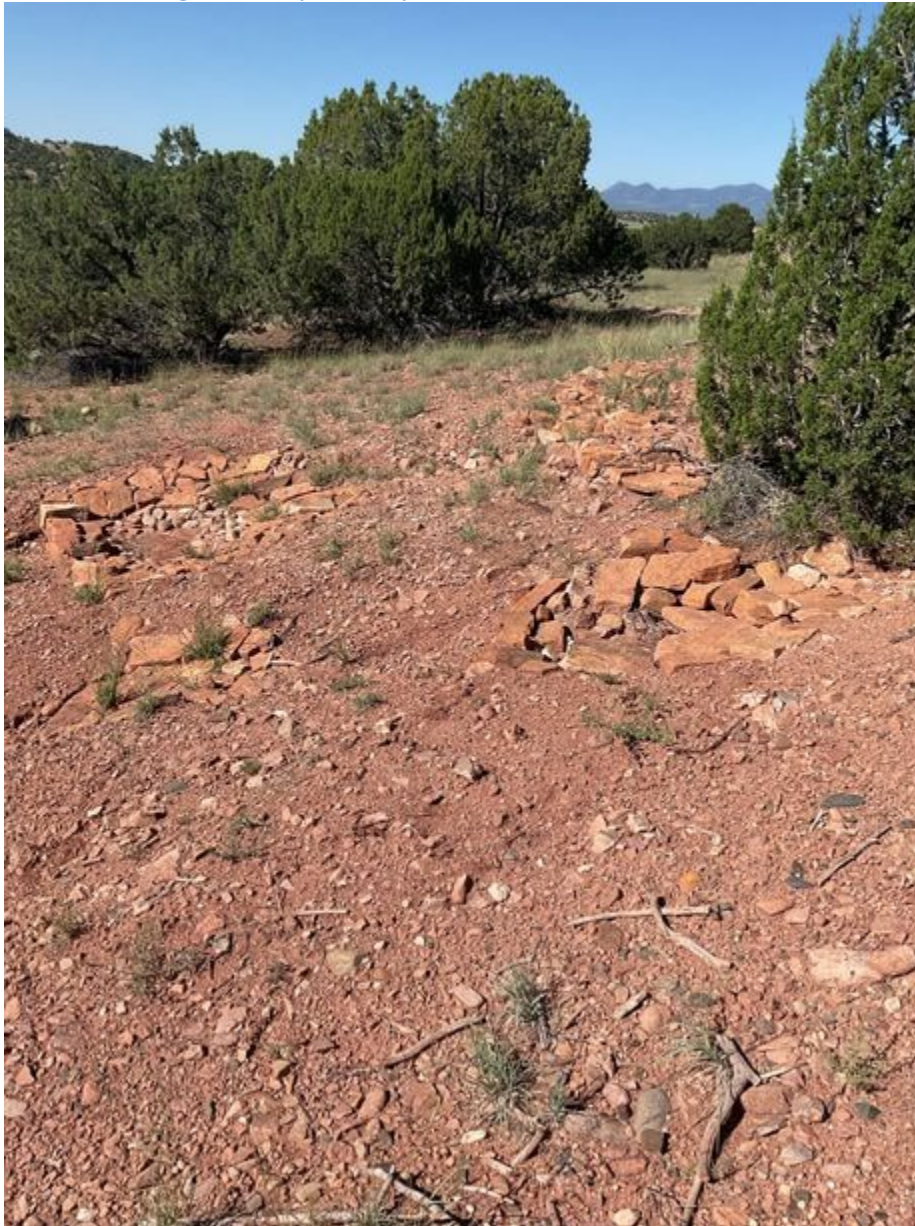
-105.9423819 35.44427455

All rocks intact

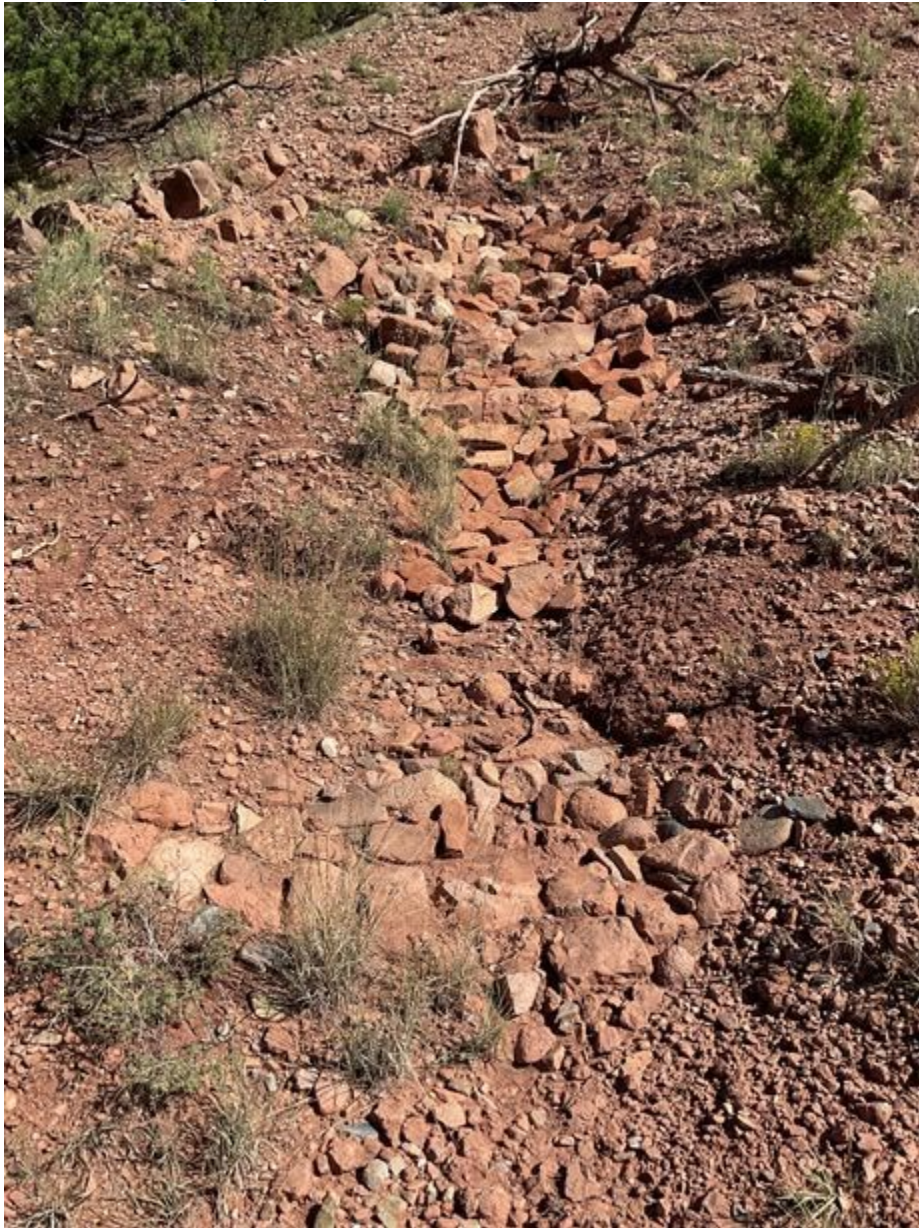
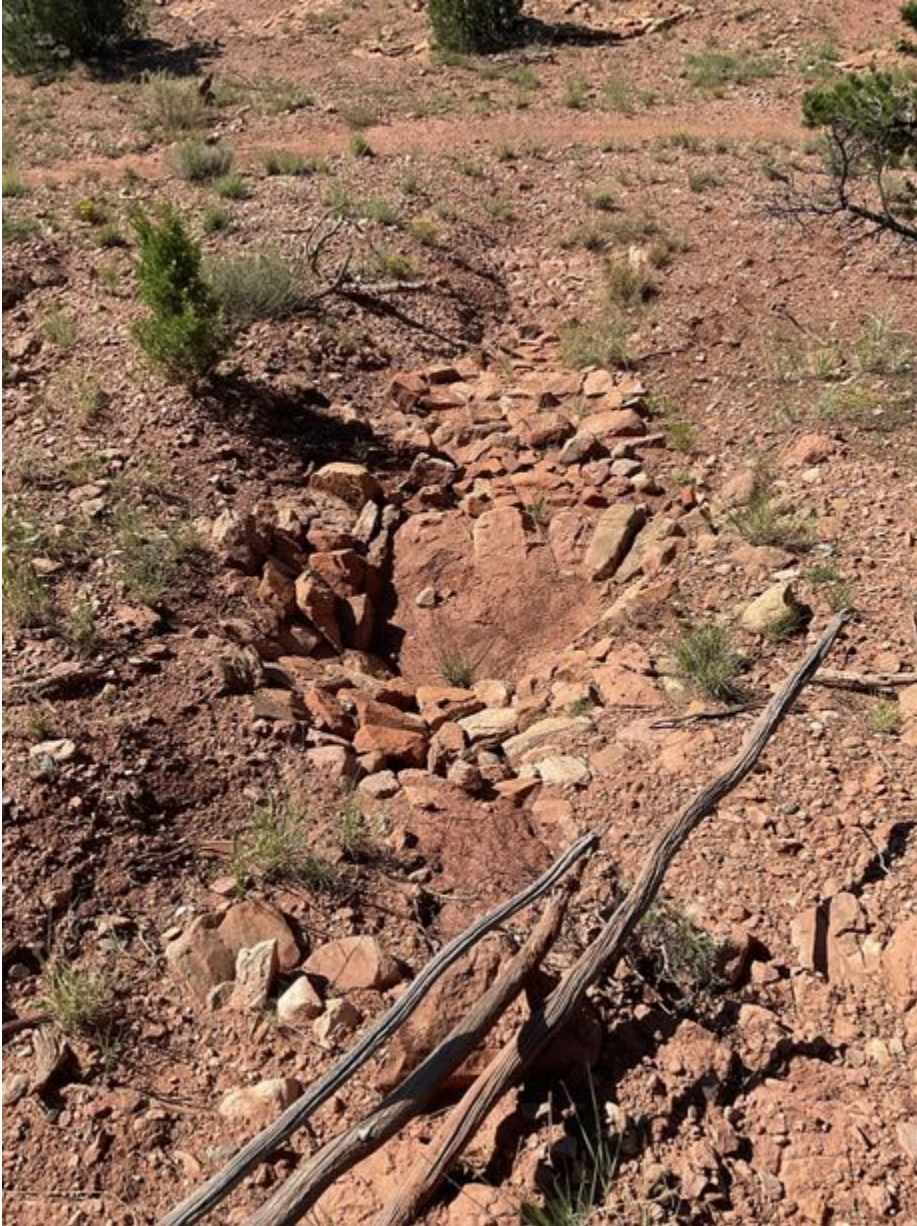
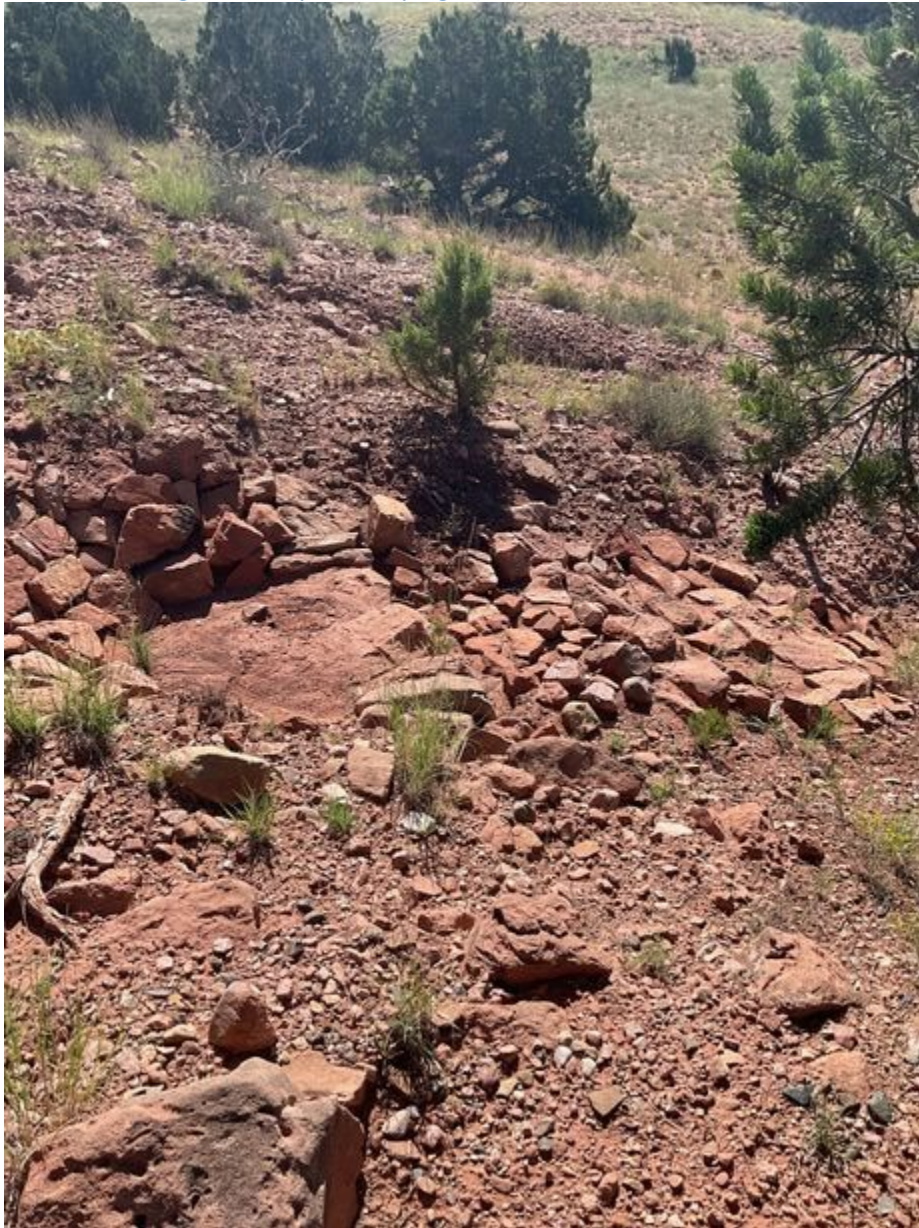
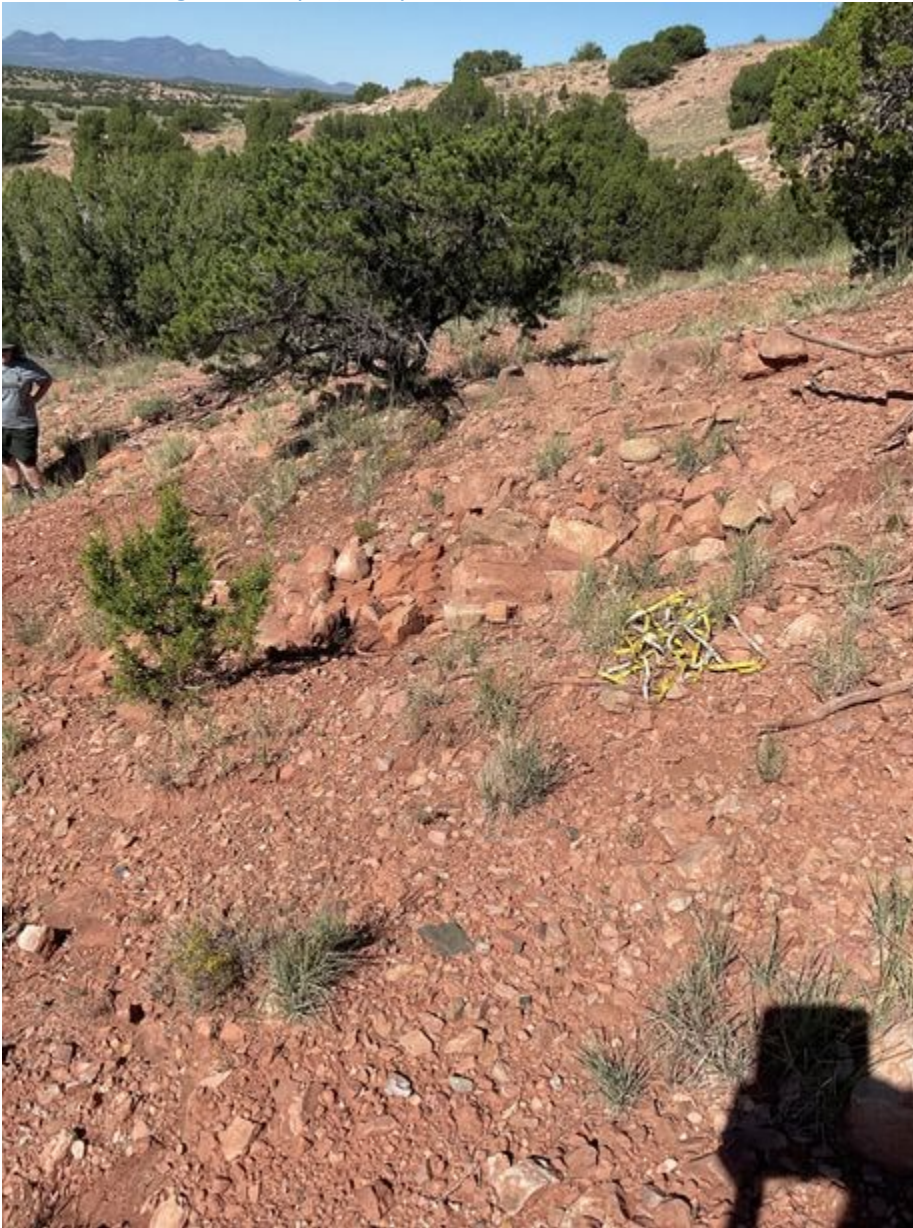
-105.9424171 35.44438518

Some rocks dislodged or broken

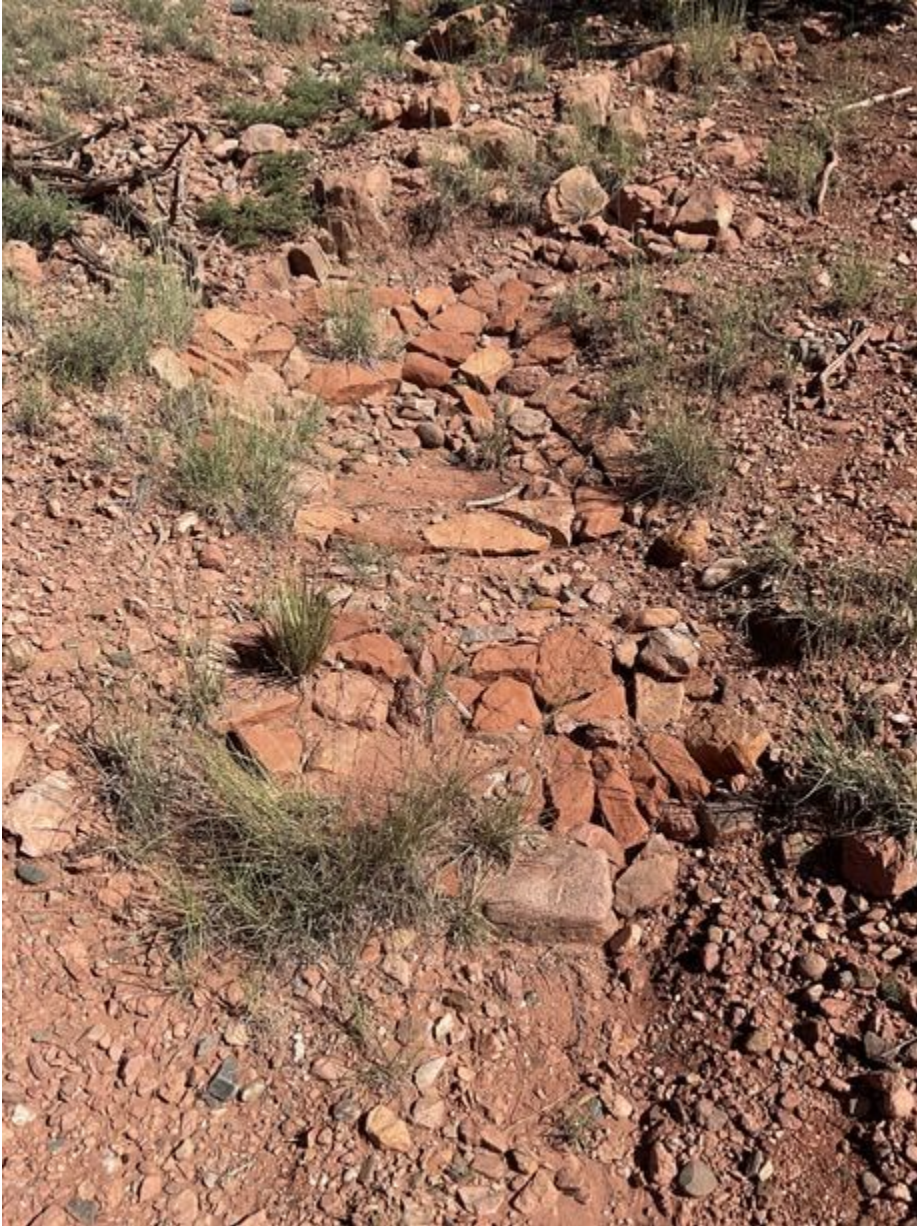
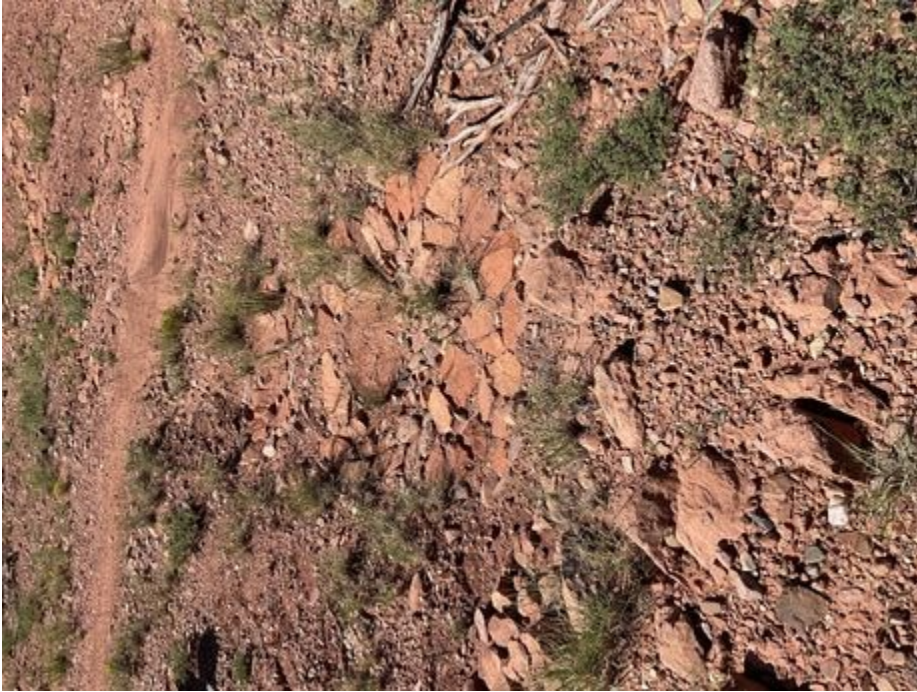
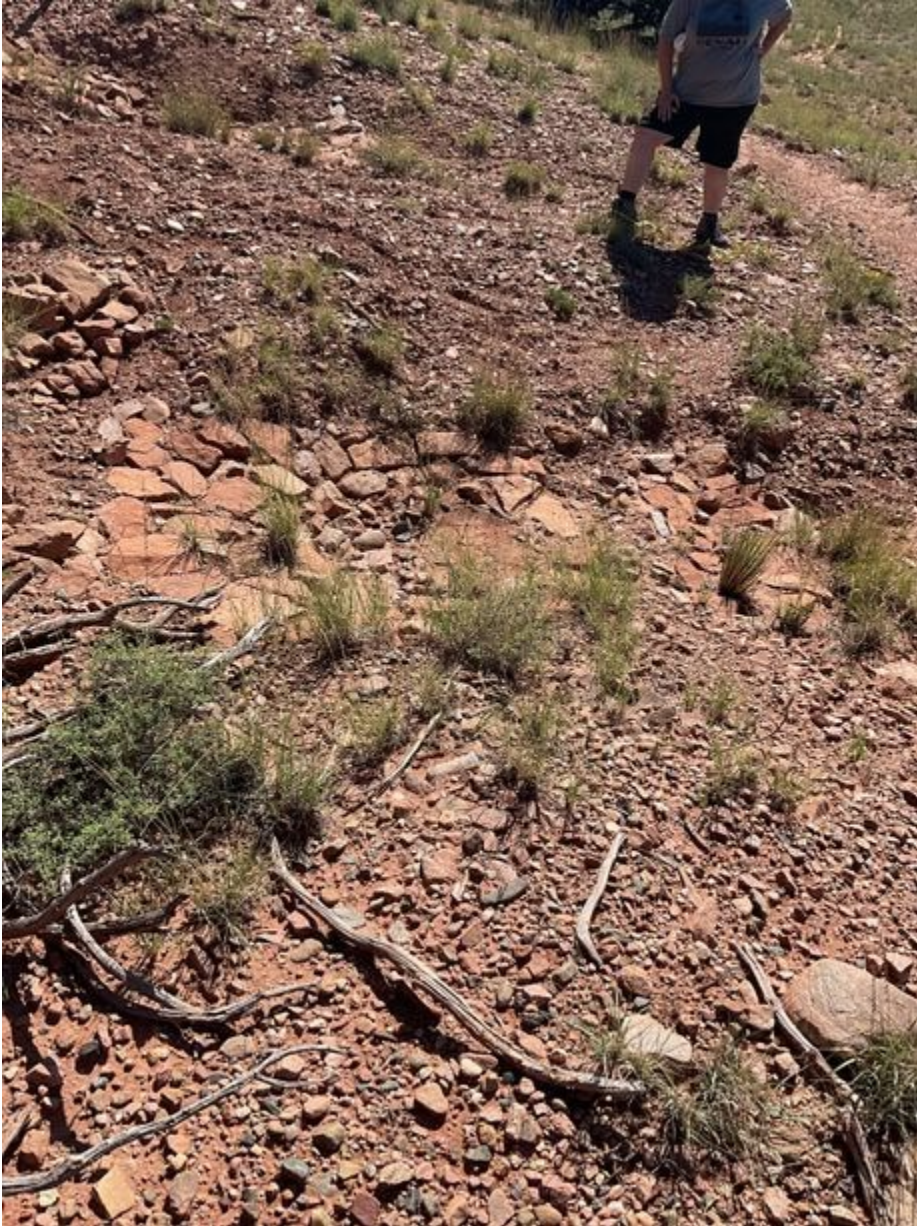
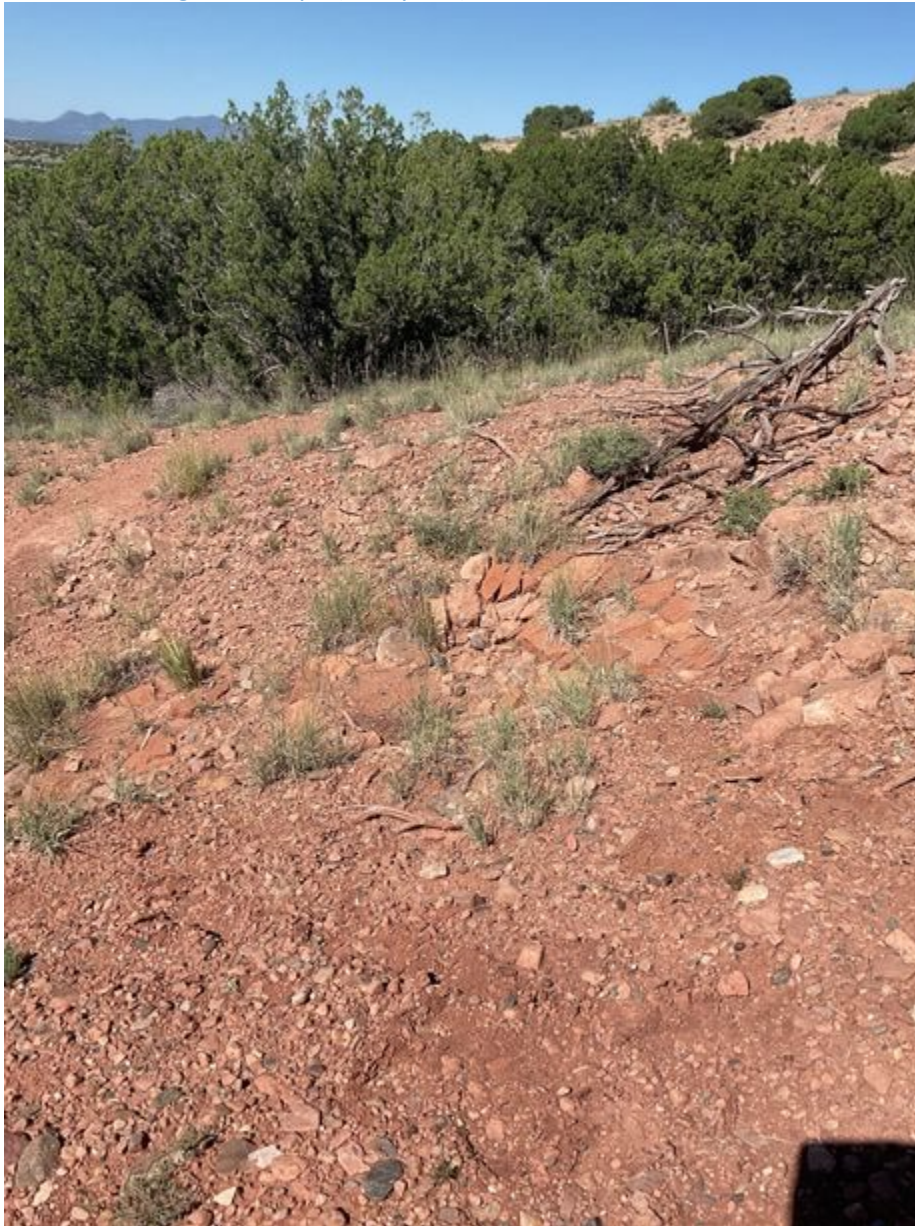
-105.942457 35.44432338

All rocks intact

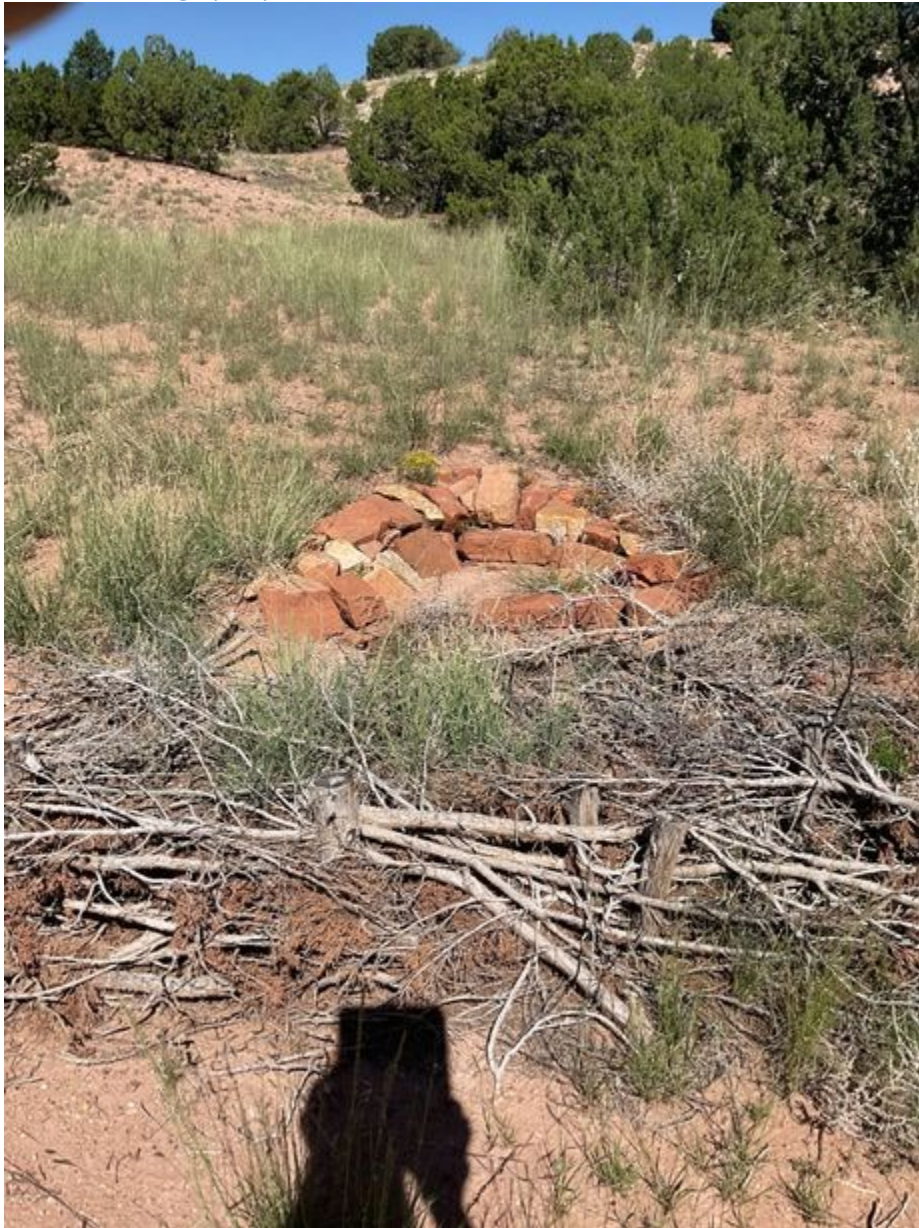
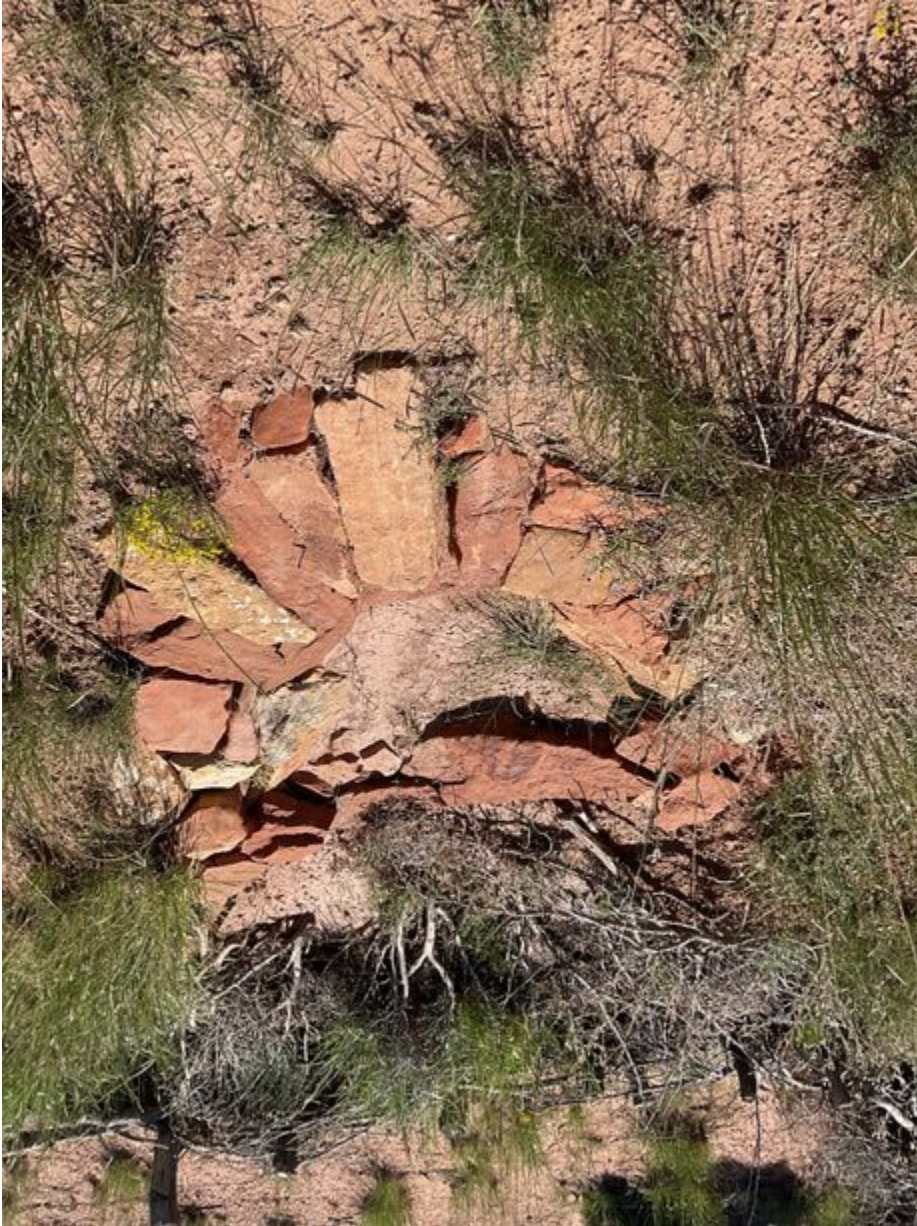
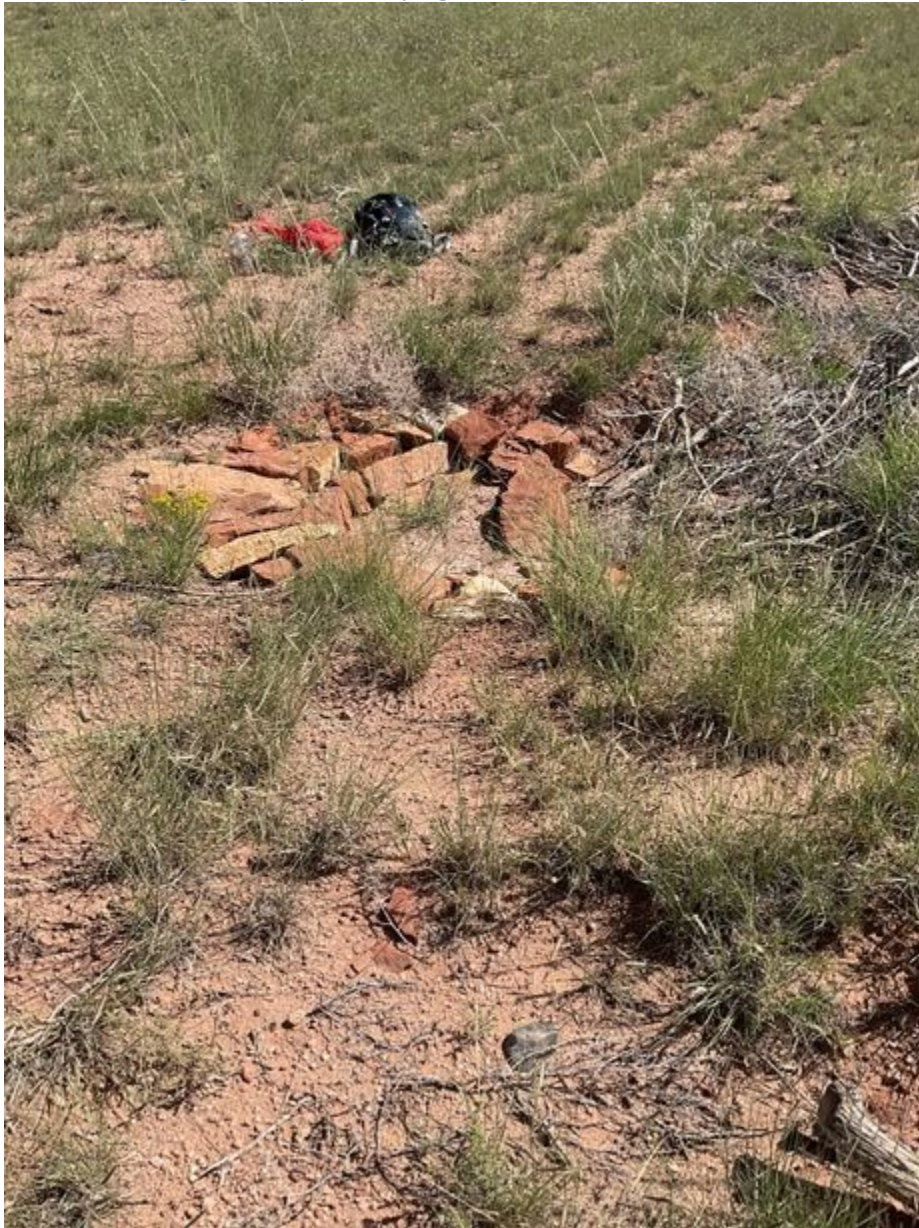
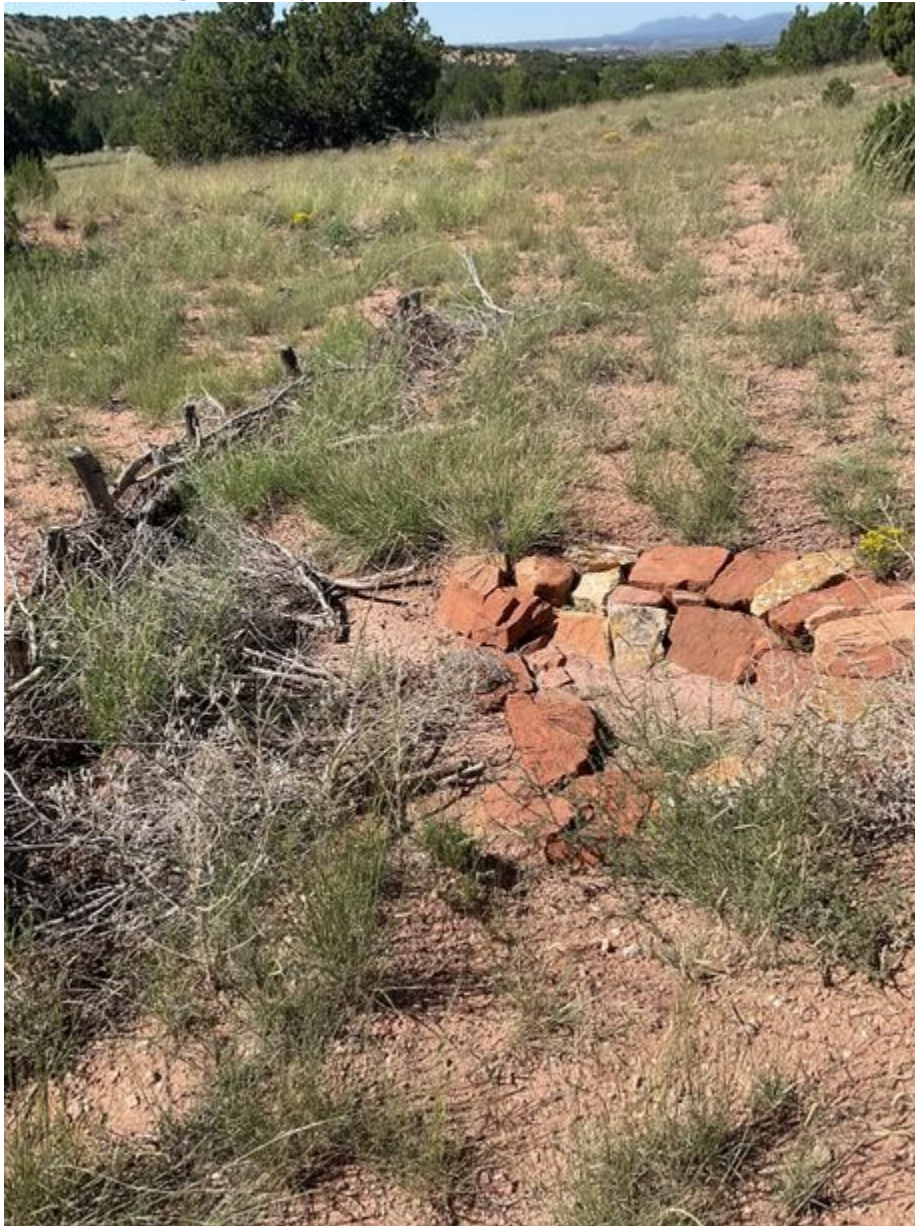
-105.9429858 35.44385002

All rocks intact

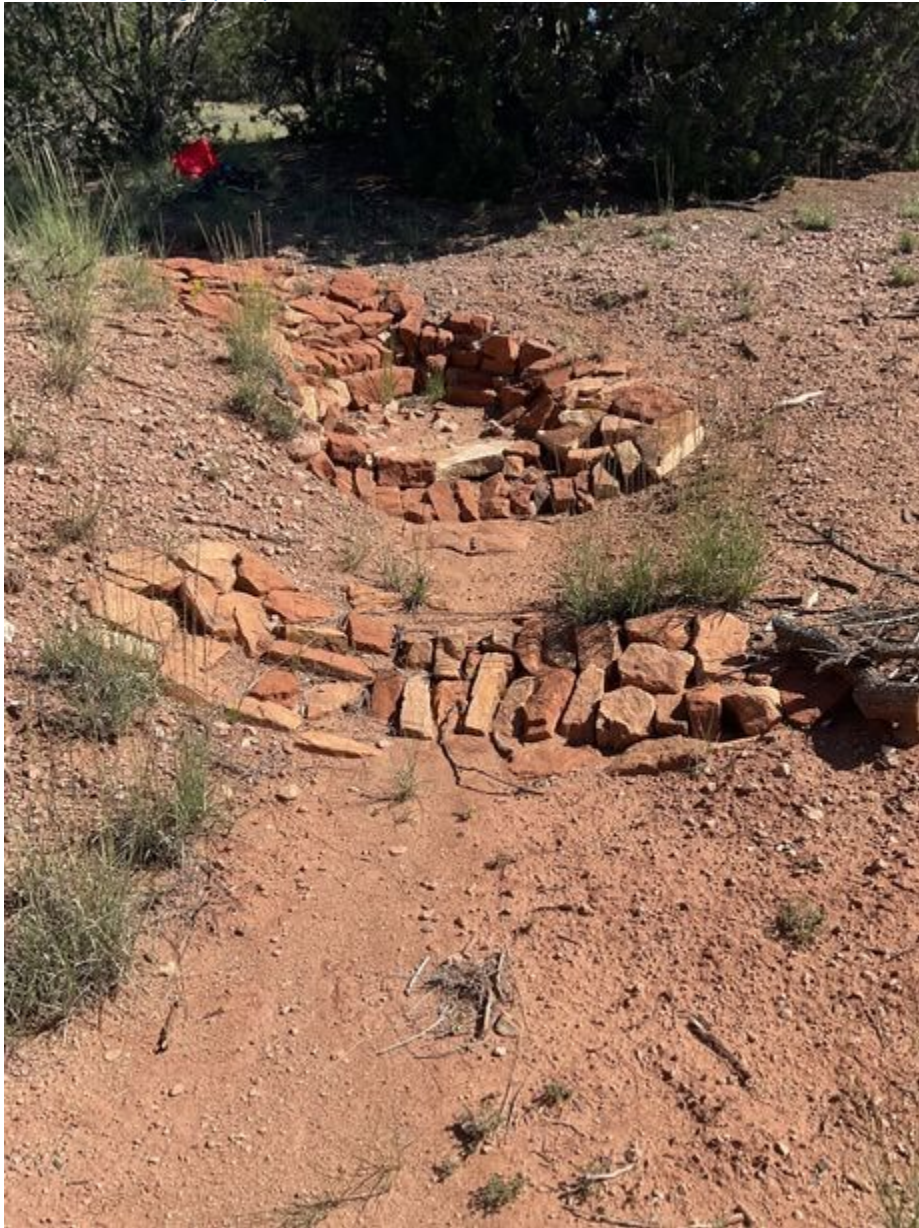
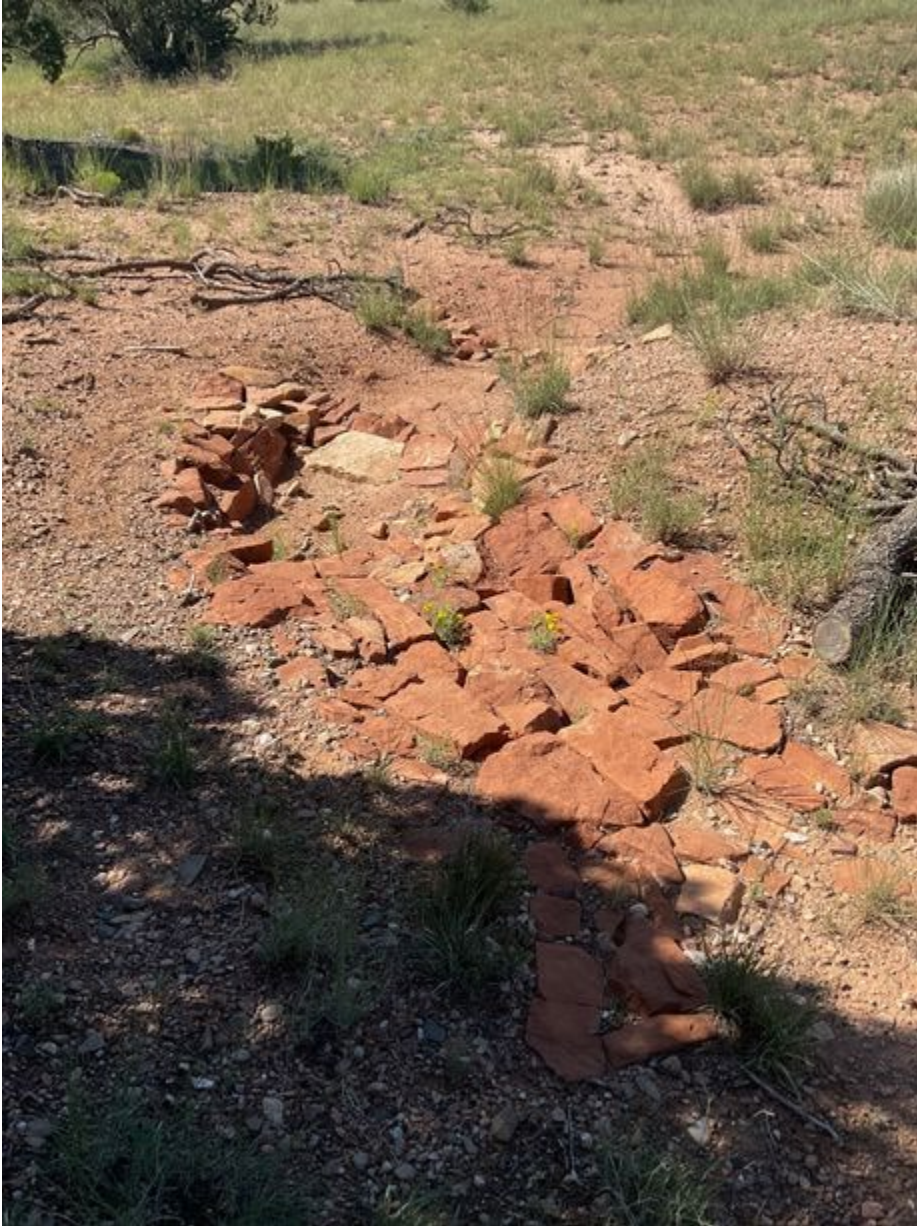
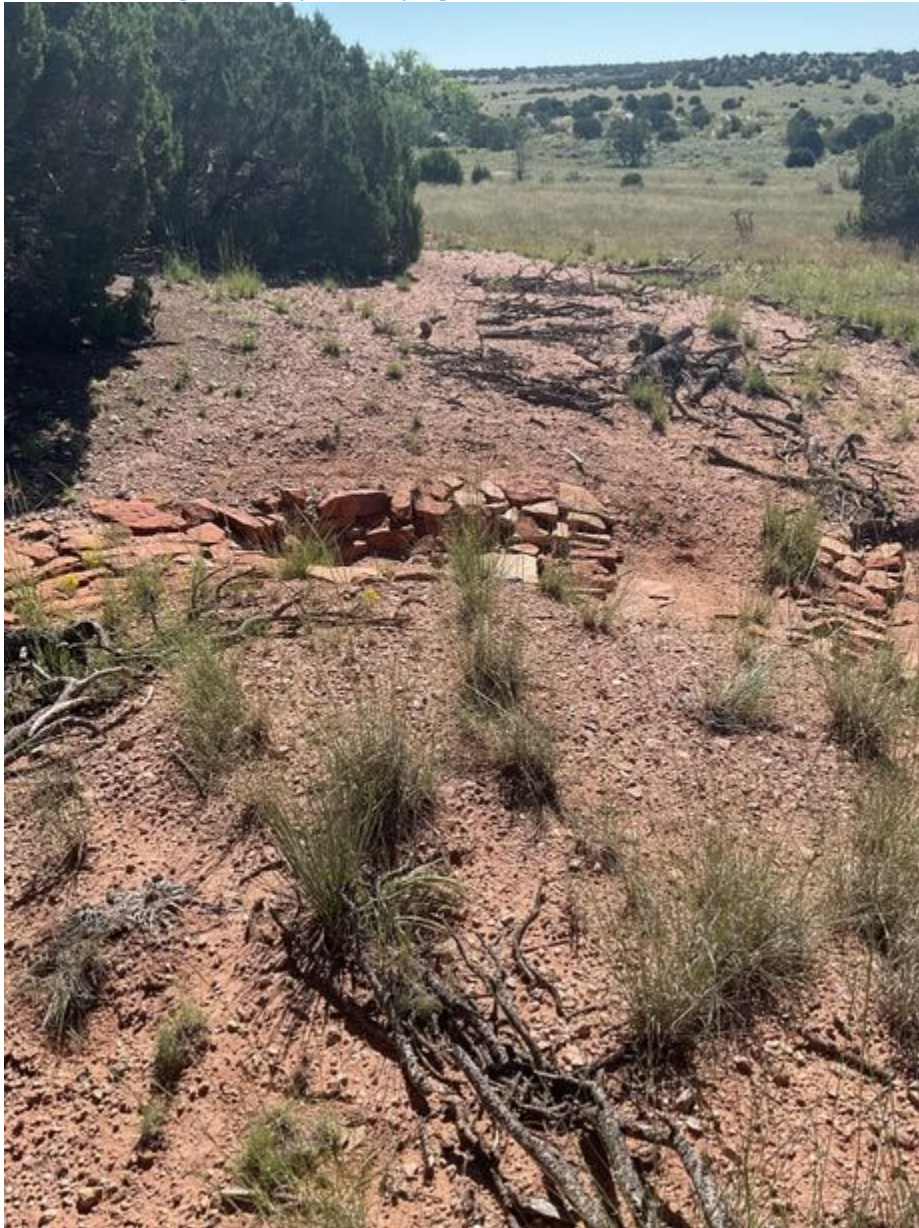
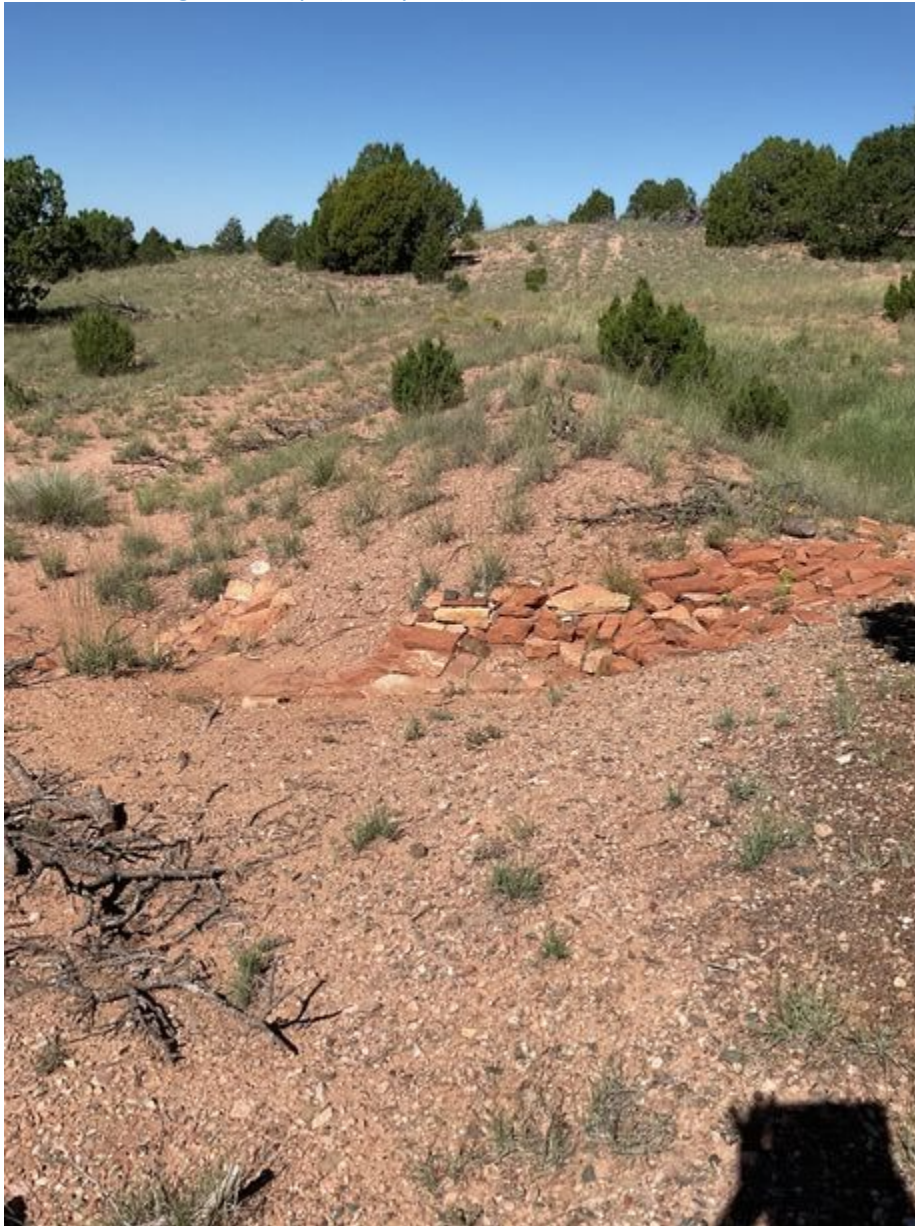
-105.9428874 35.44374573

All rocks intact
