CN R924060

**Zuni Bowl and One Rock Check Dam Research –
Phase 1**

Final Report

Rio Grande Return for the New Mexico Department of Transportation Research Bureau

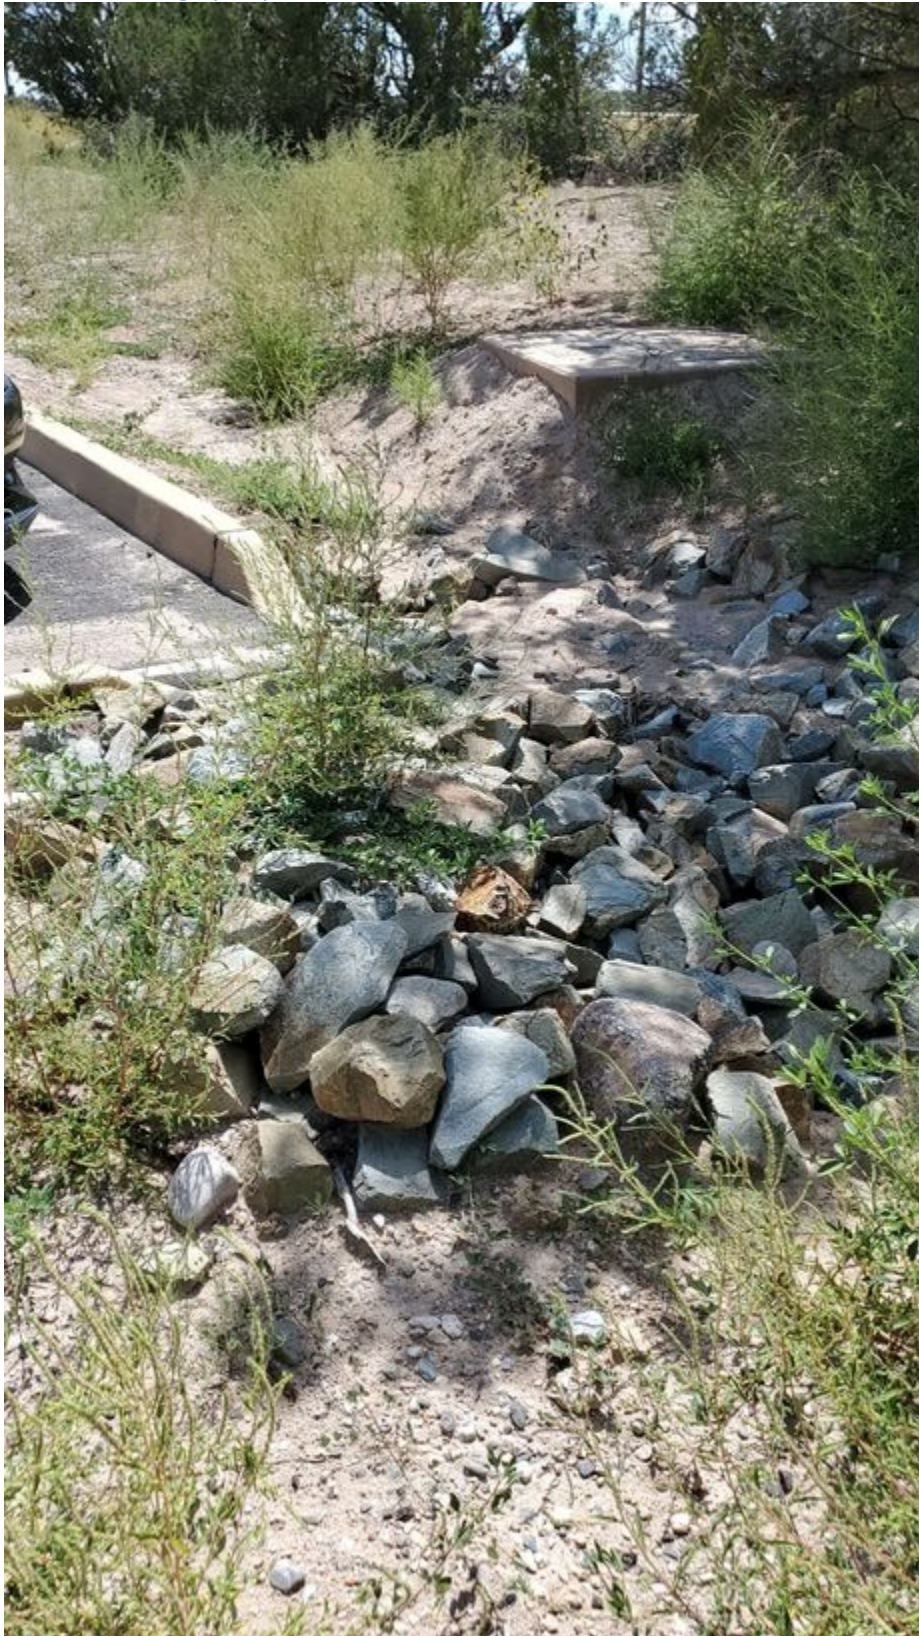
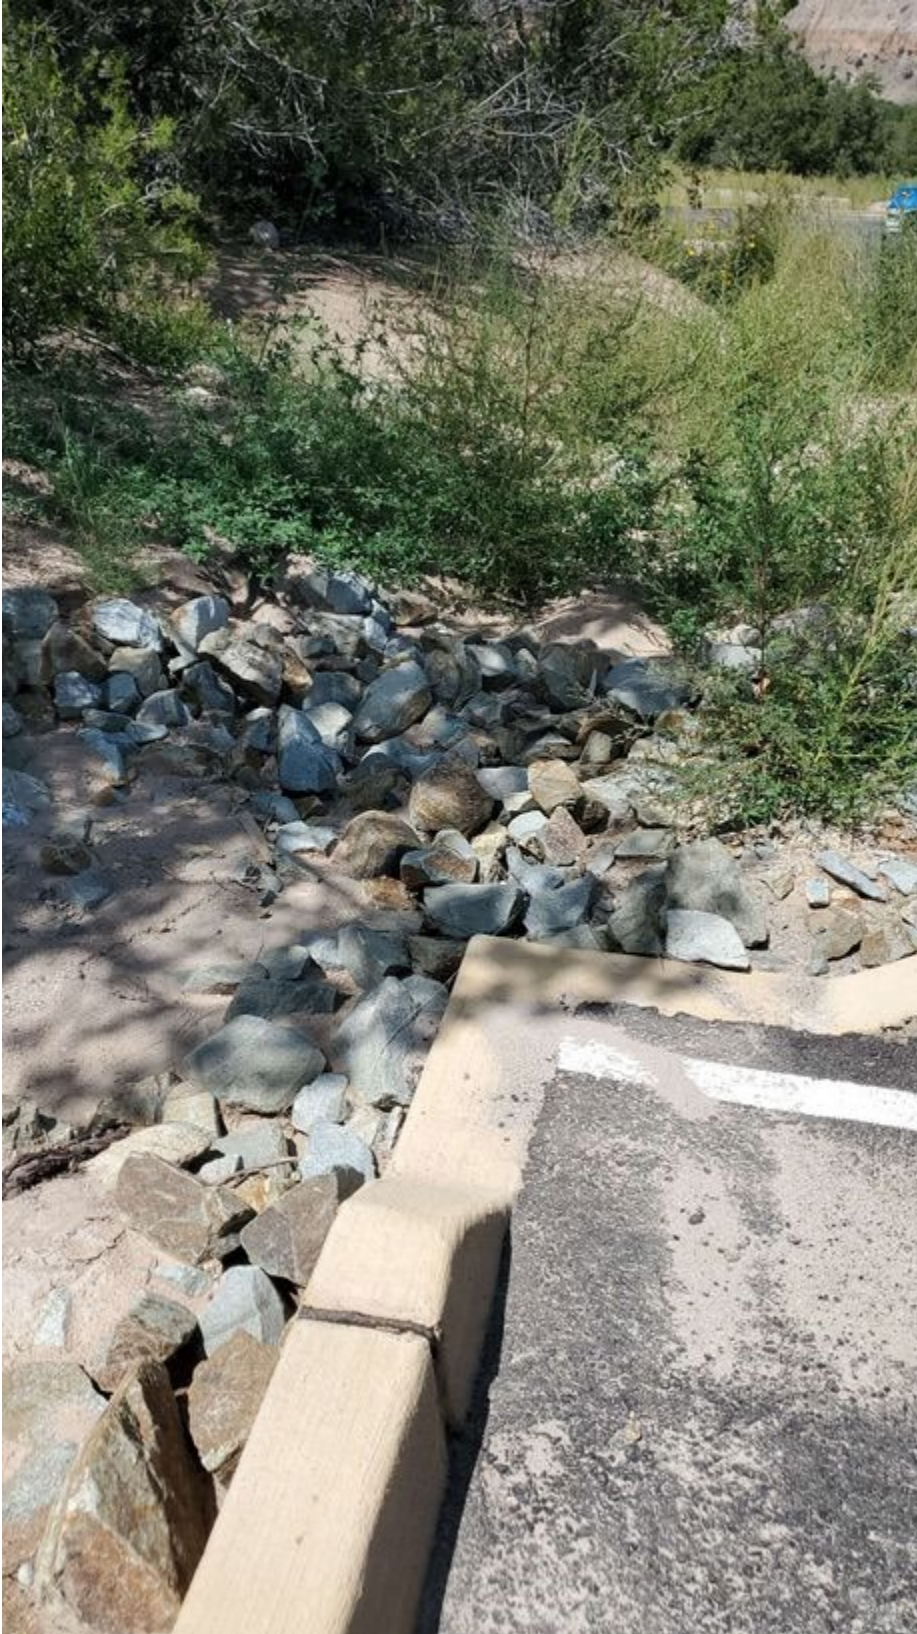
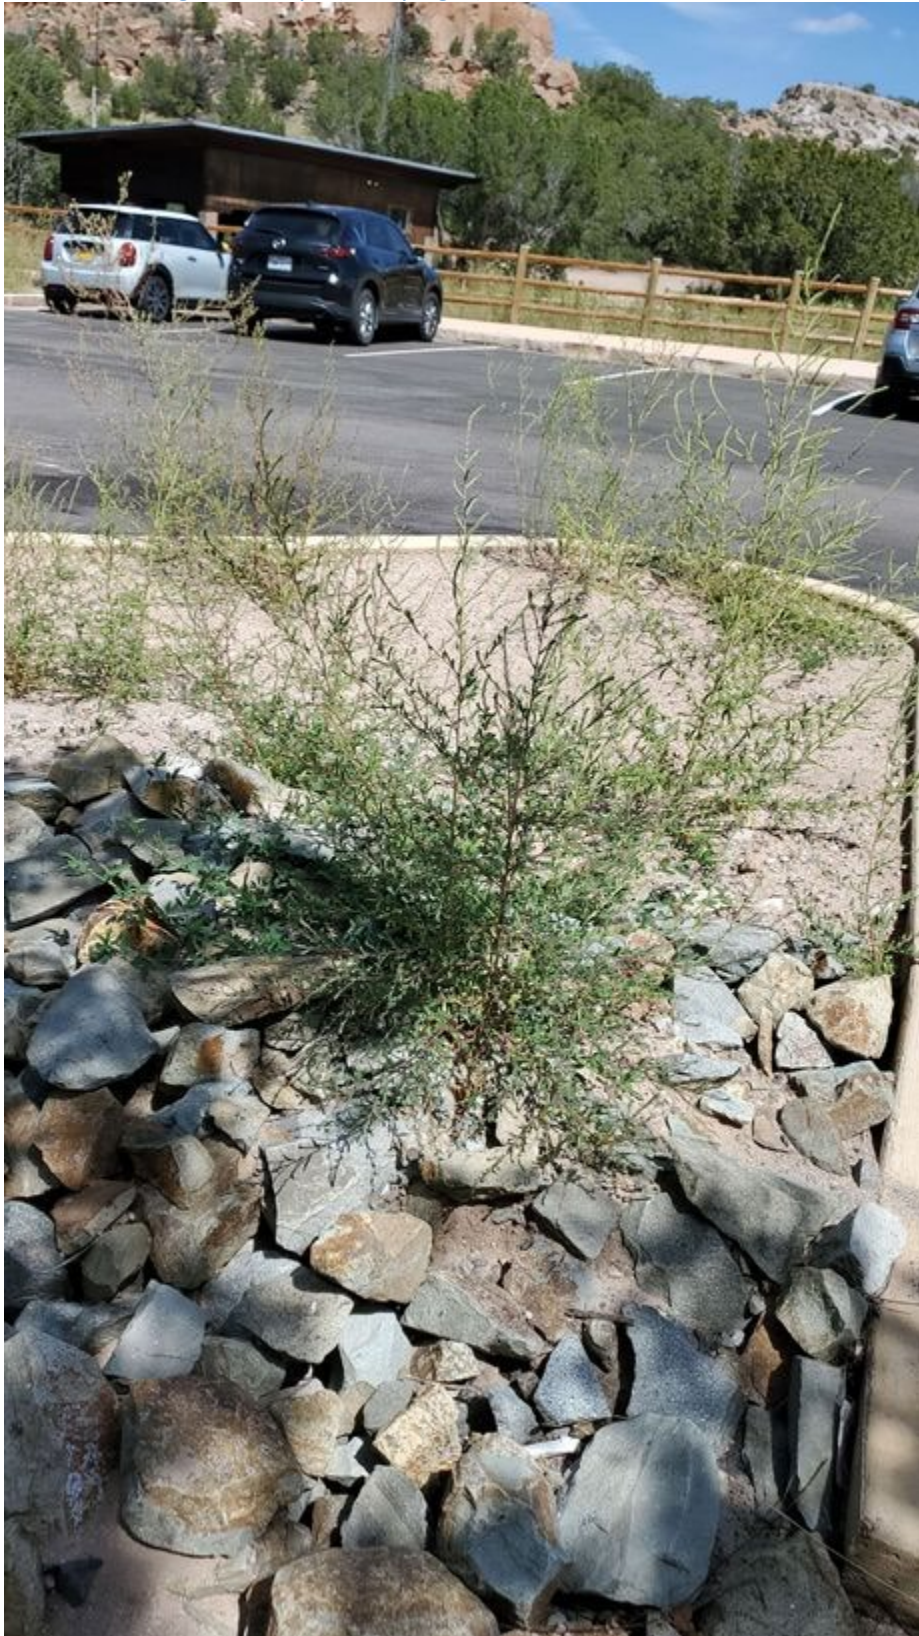
-106.2243189 35.85993323

Some rocks dislodged or broken

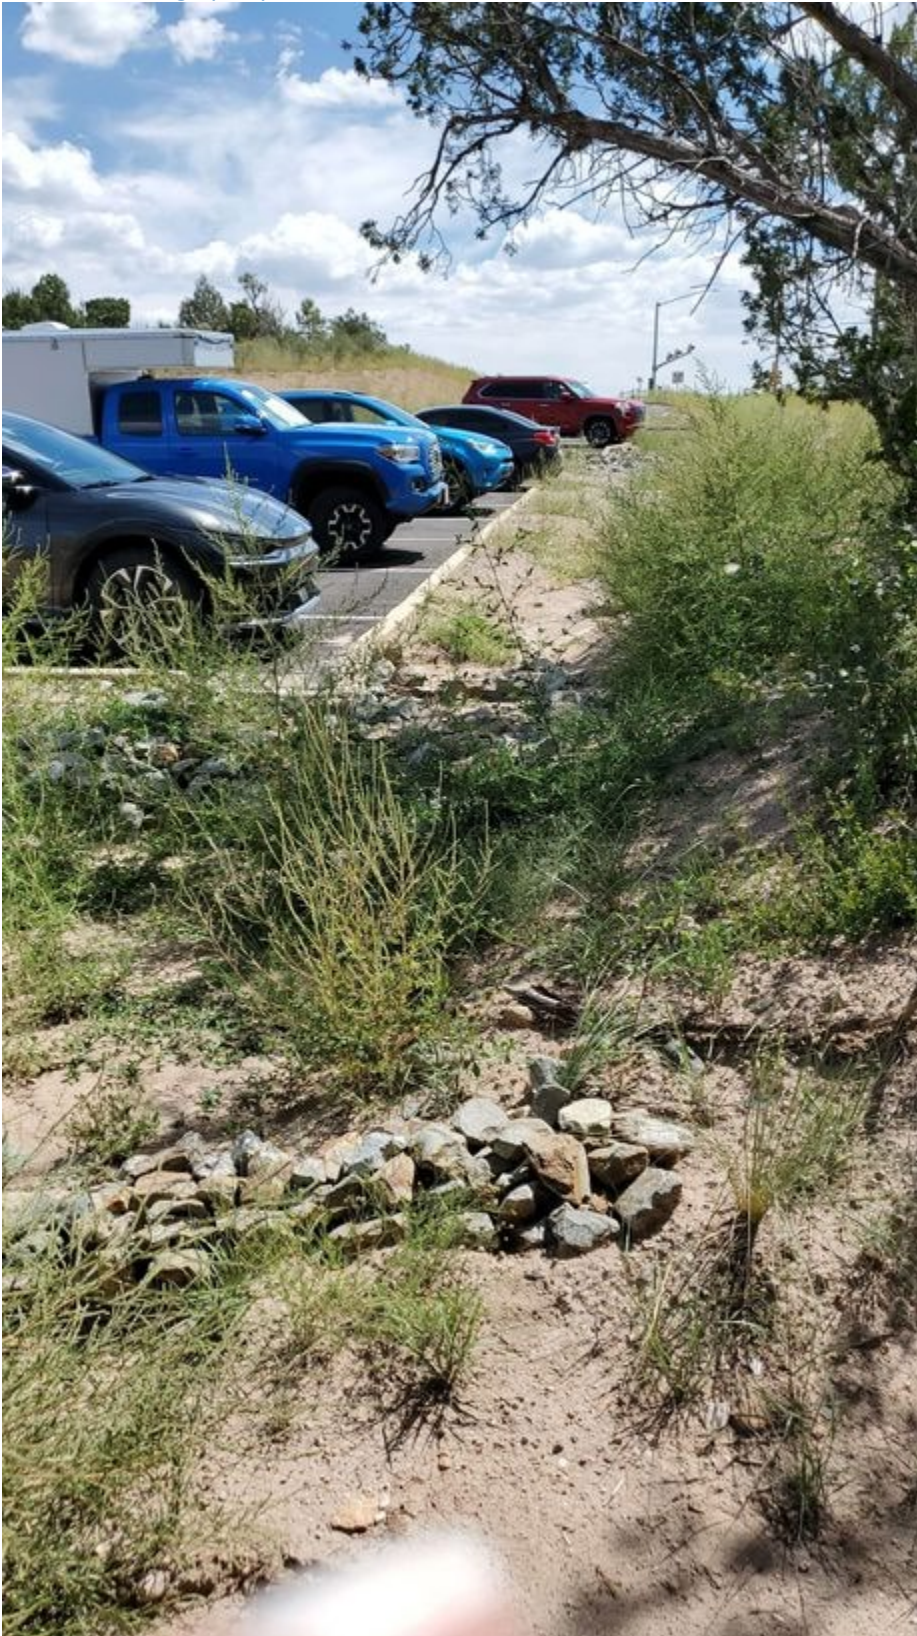
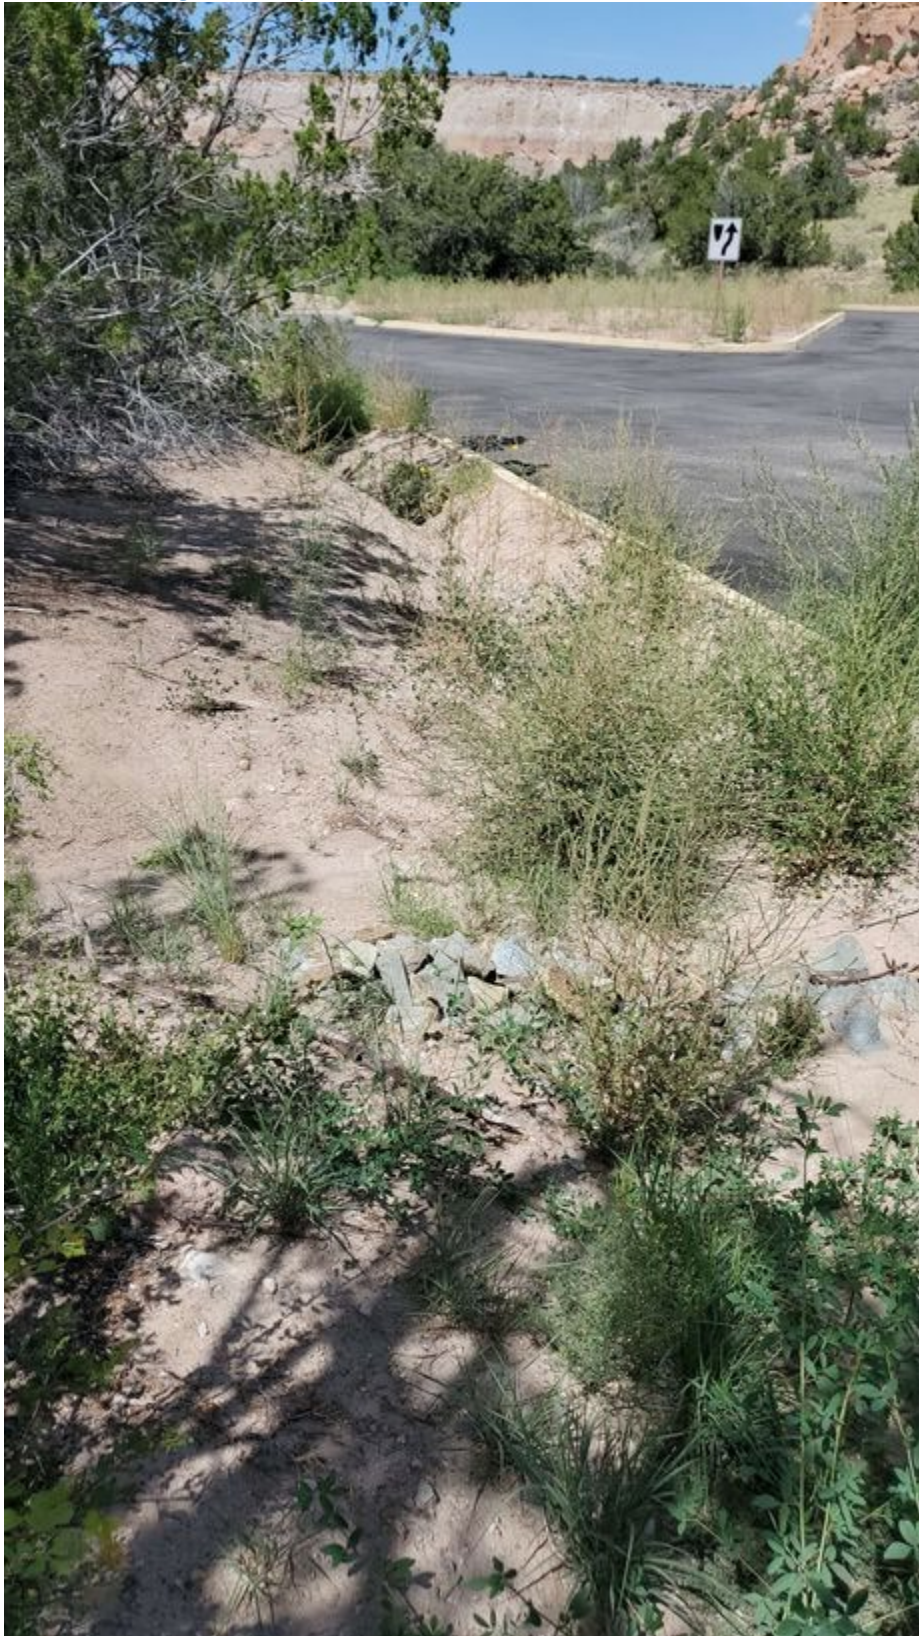
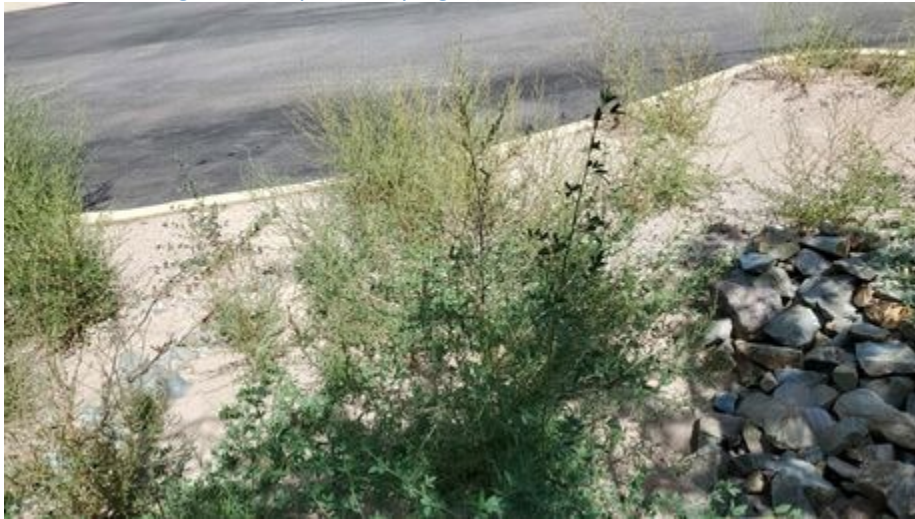
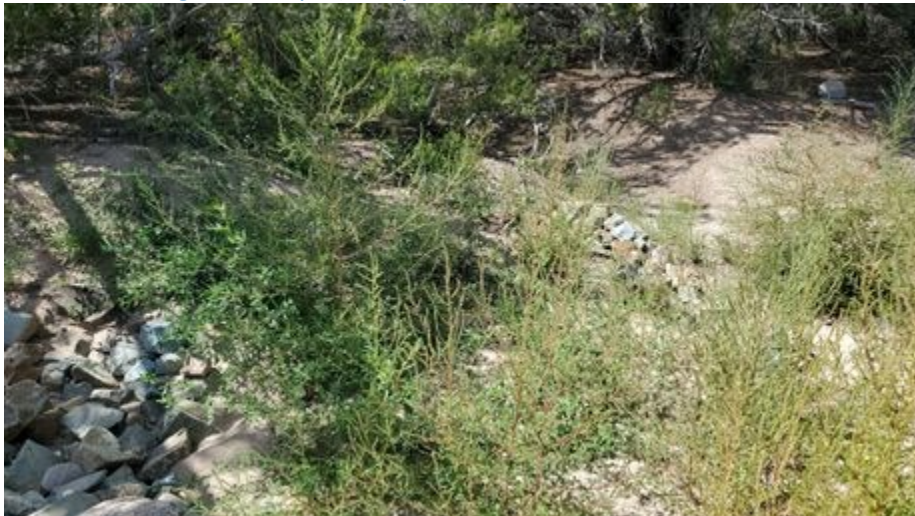
-106.2243784 35.85996151

Some rocks dislodged or broken

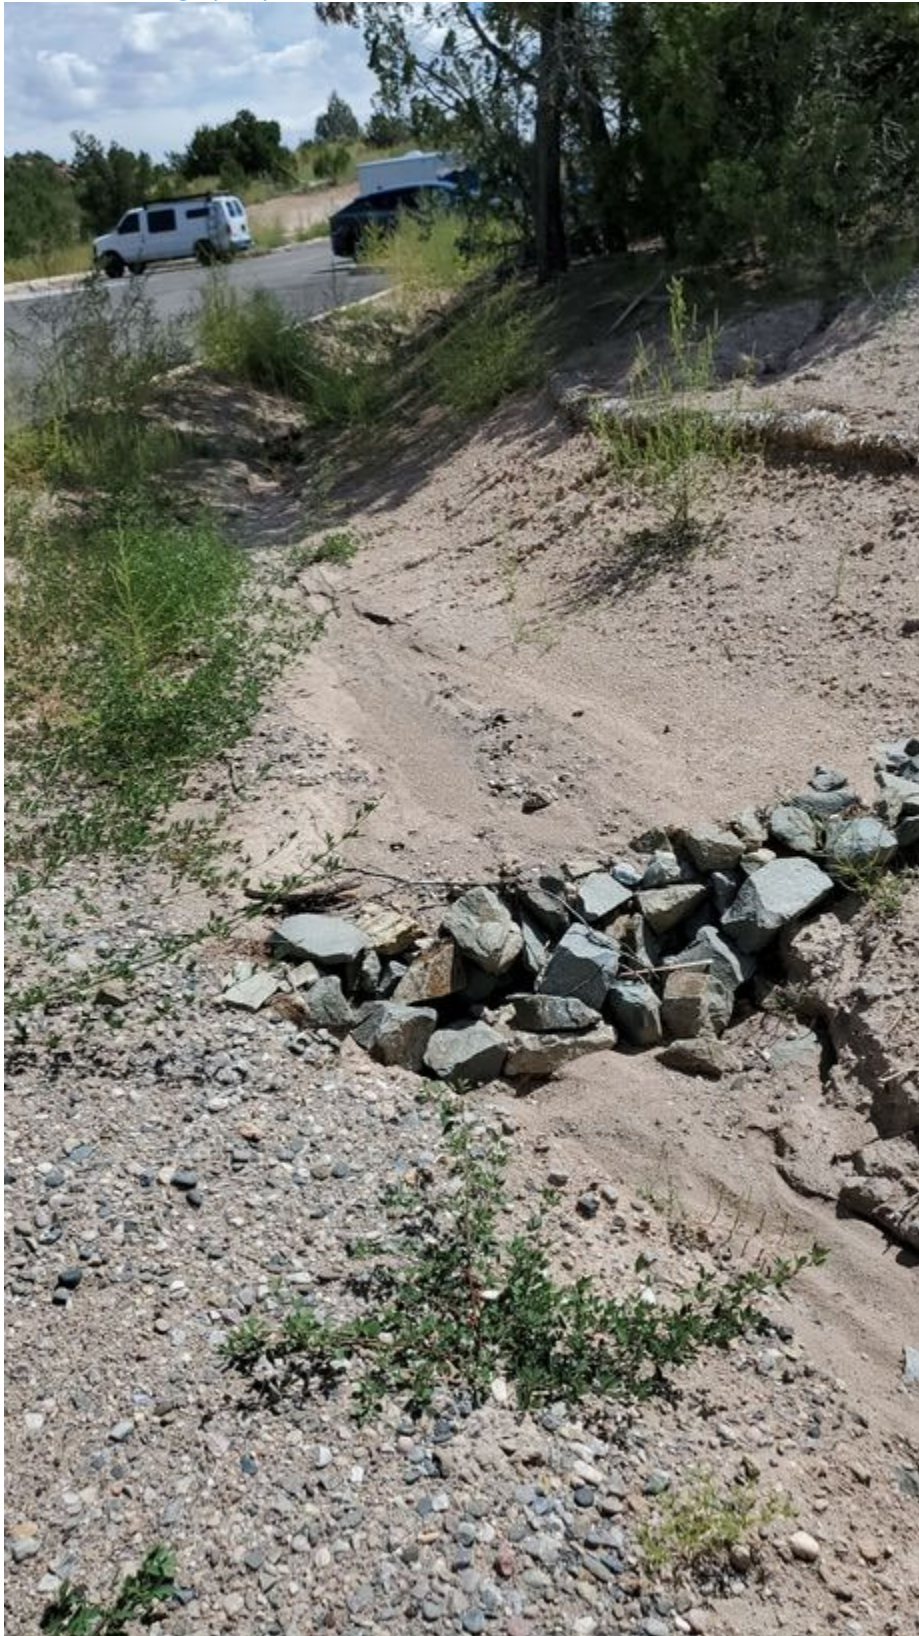
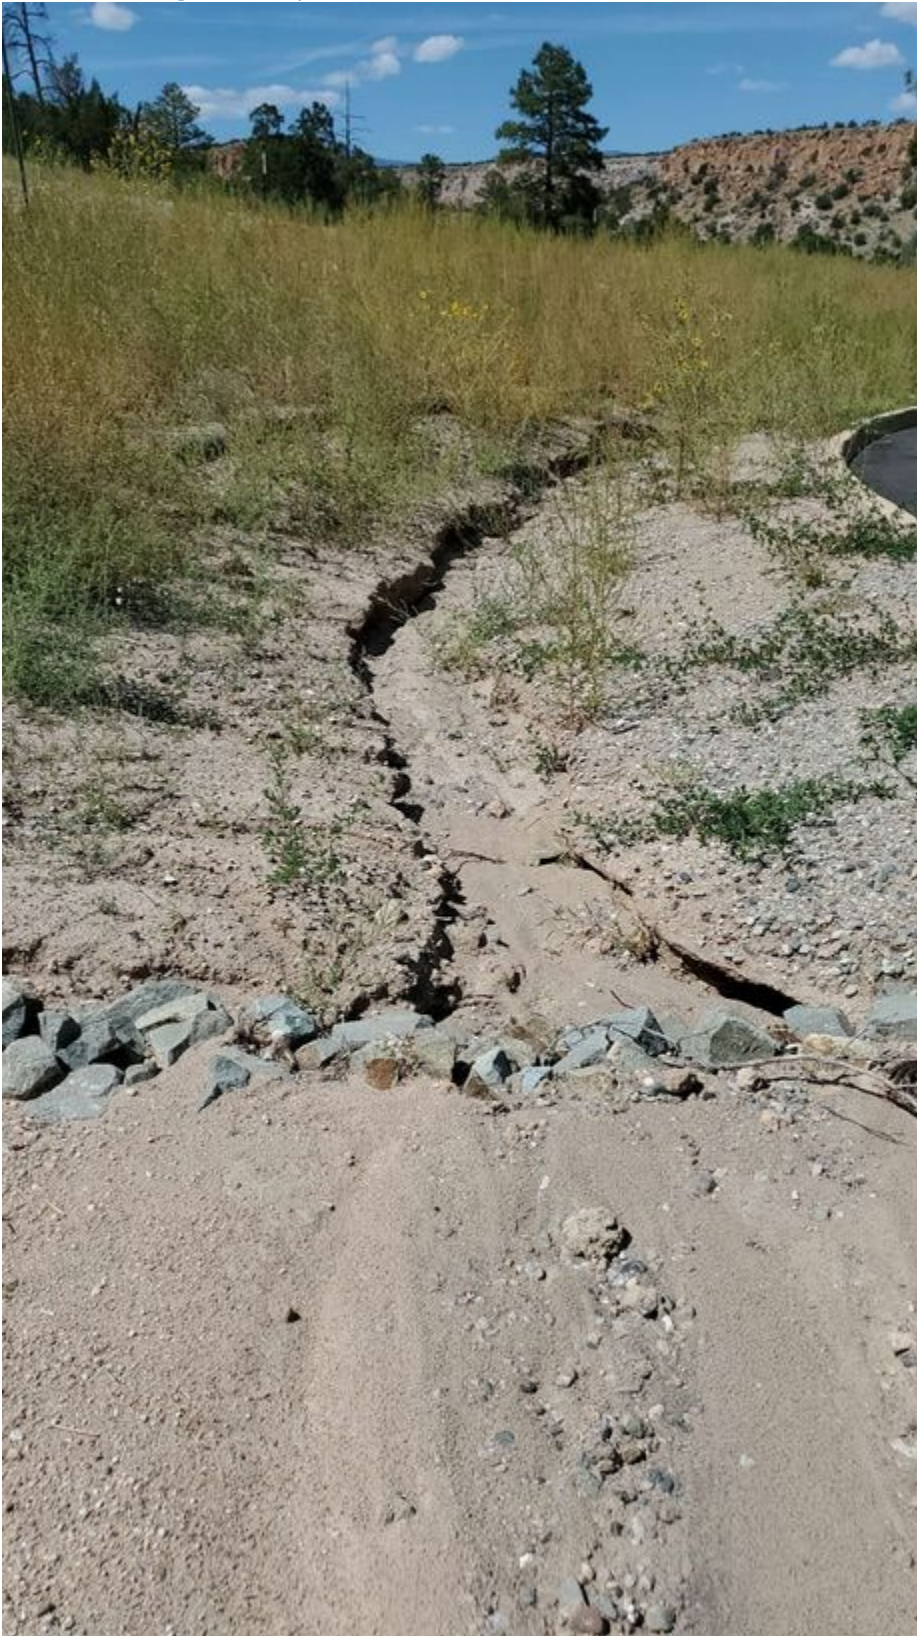
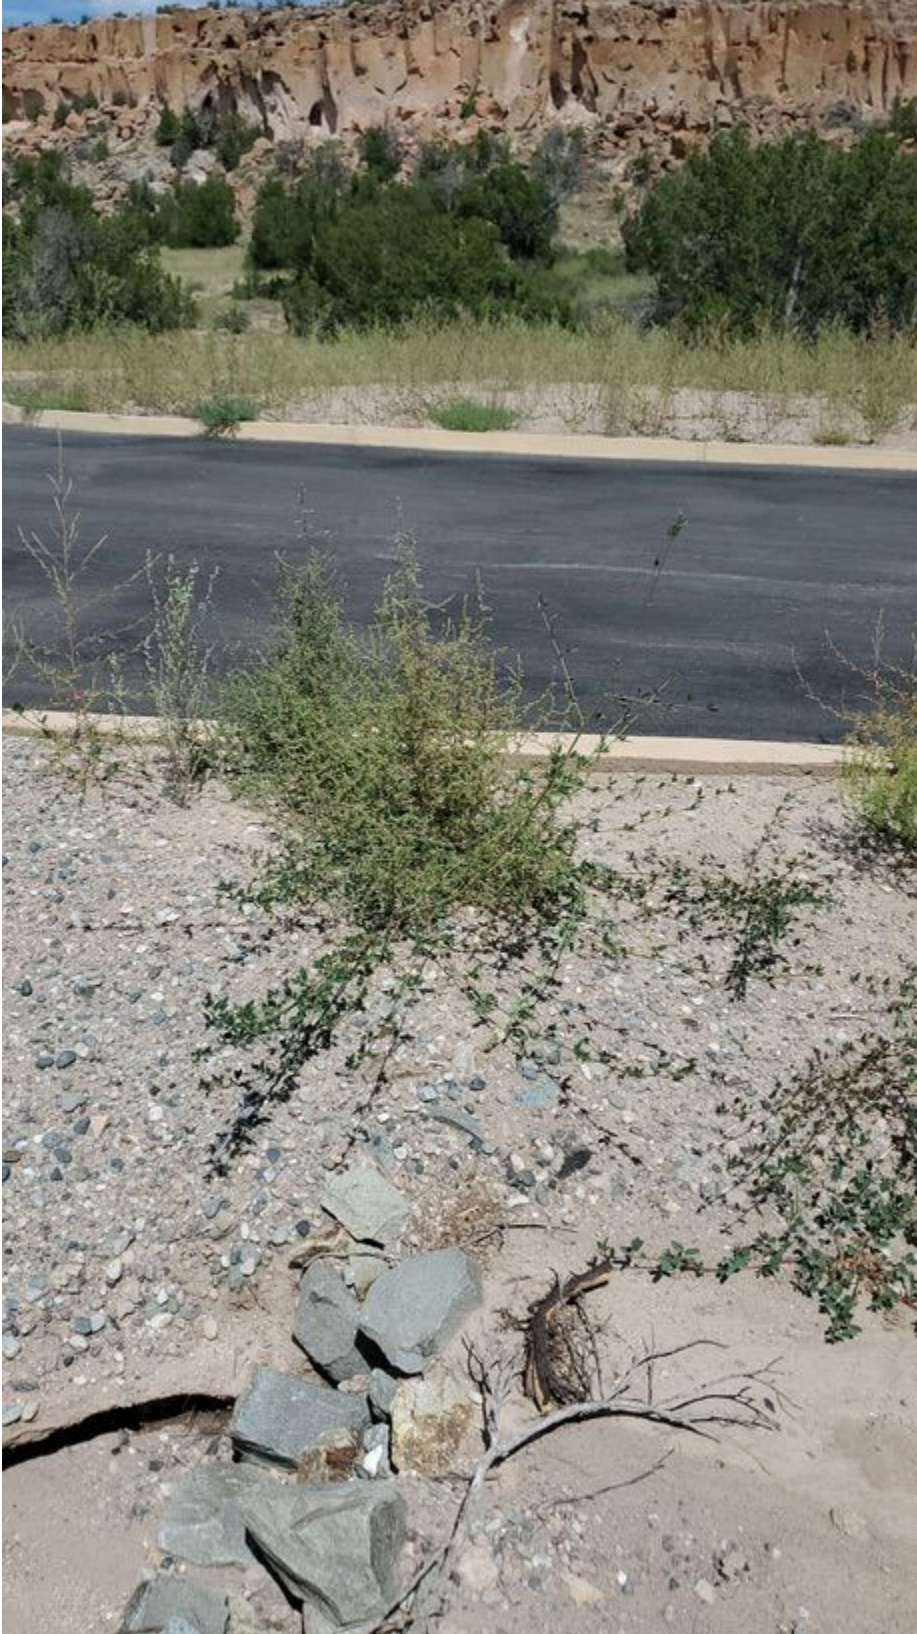
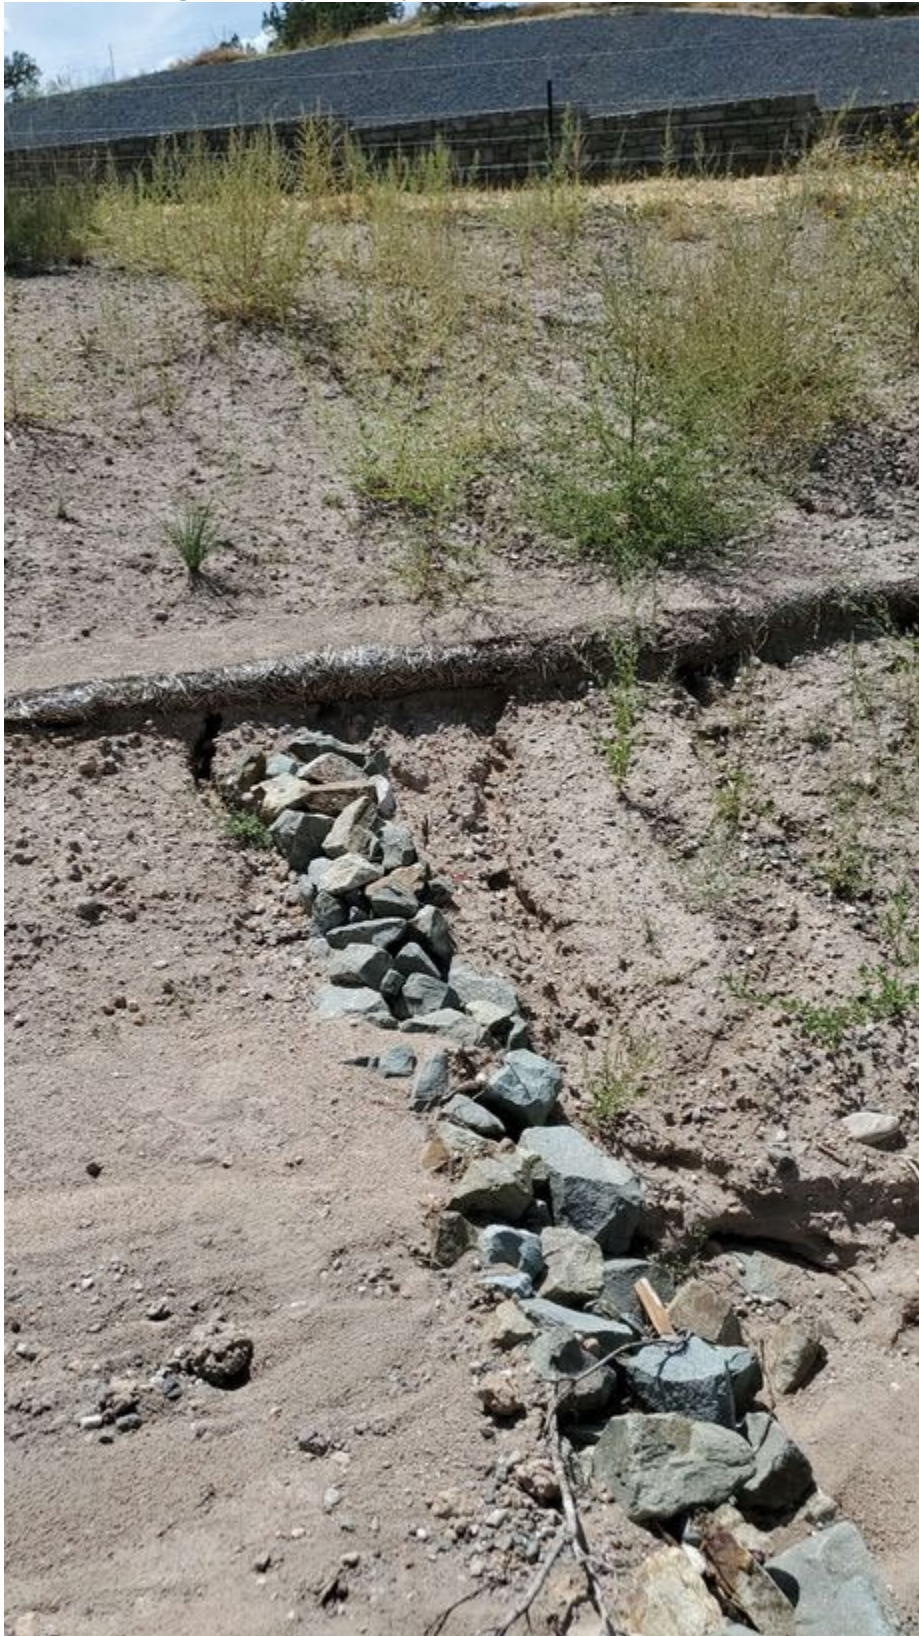
-106.2244515 35.86014432

All rocks intact

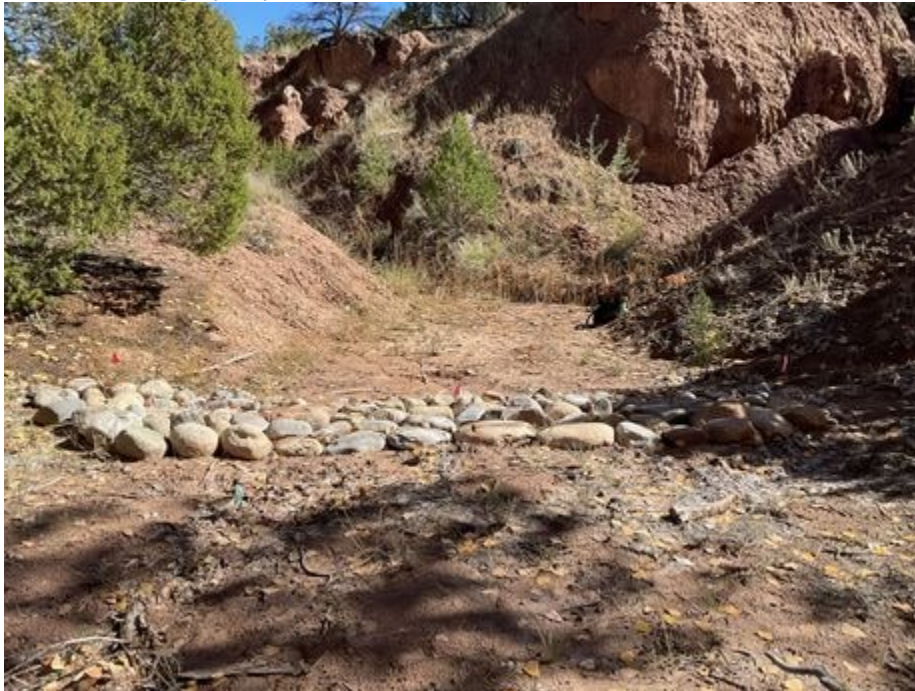
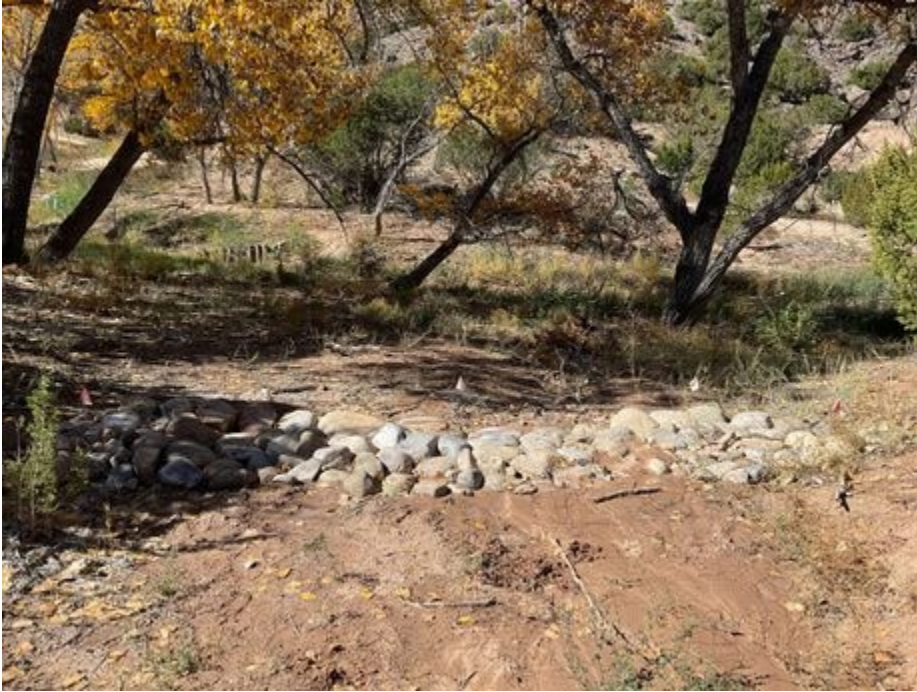
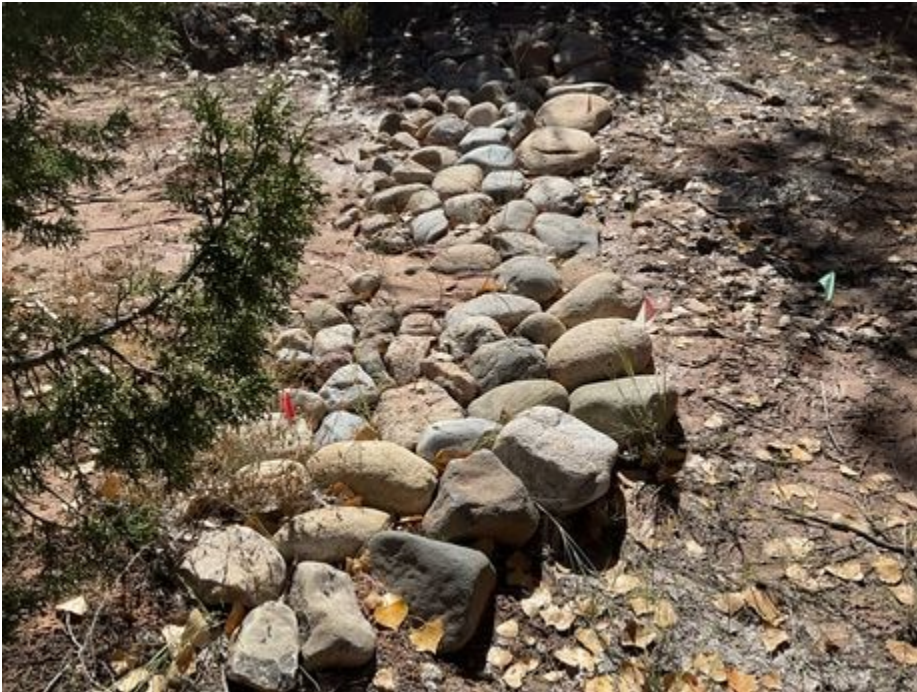
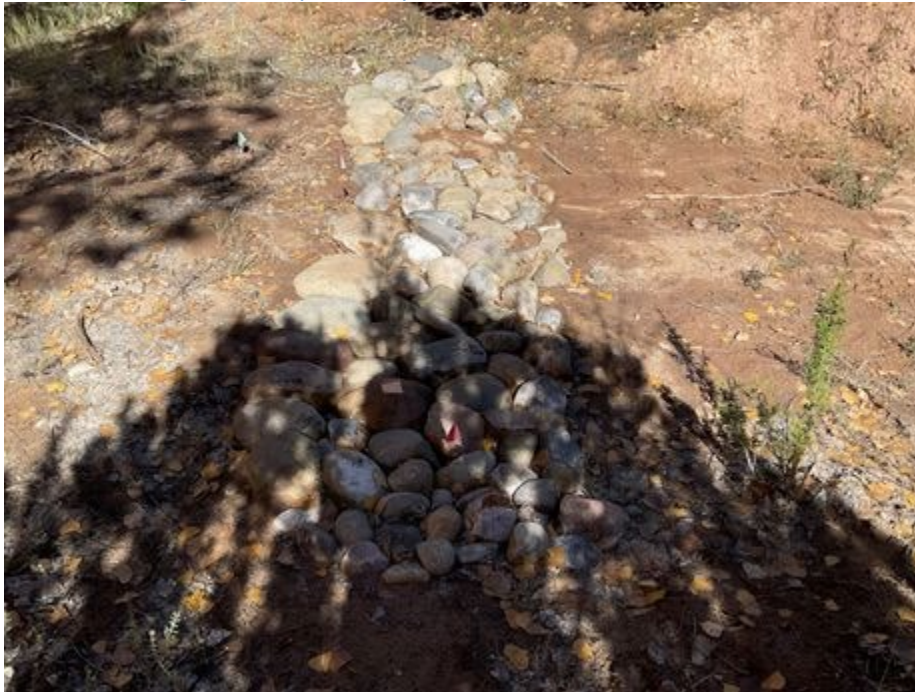
-105.9078511 36.18872842

All rocks intact

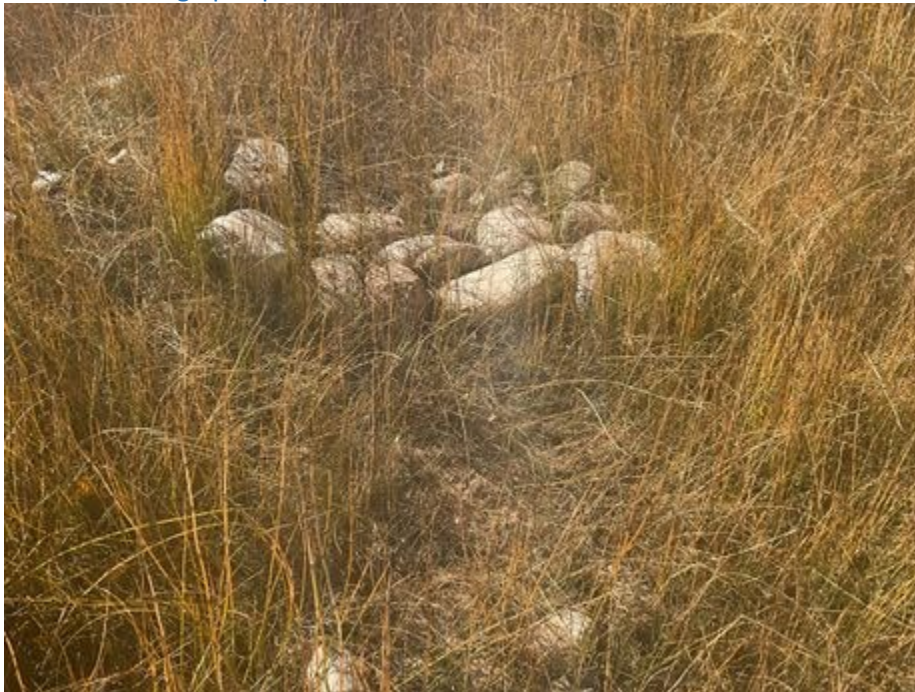
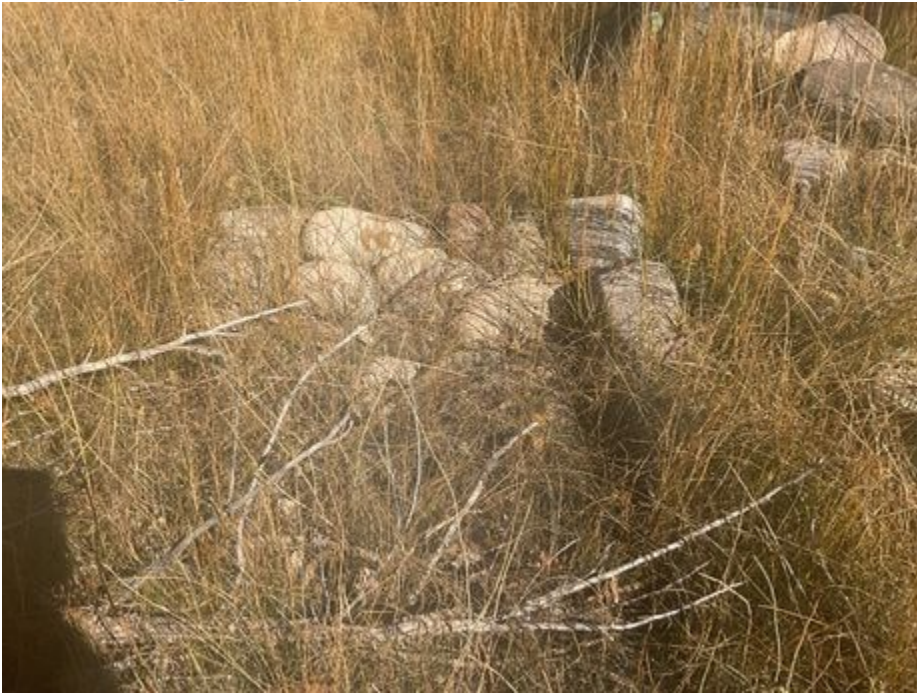
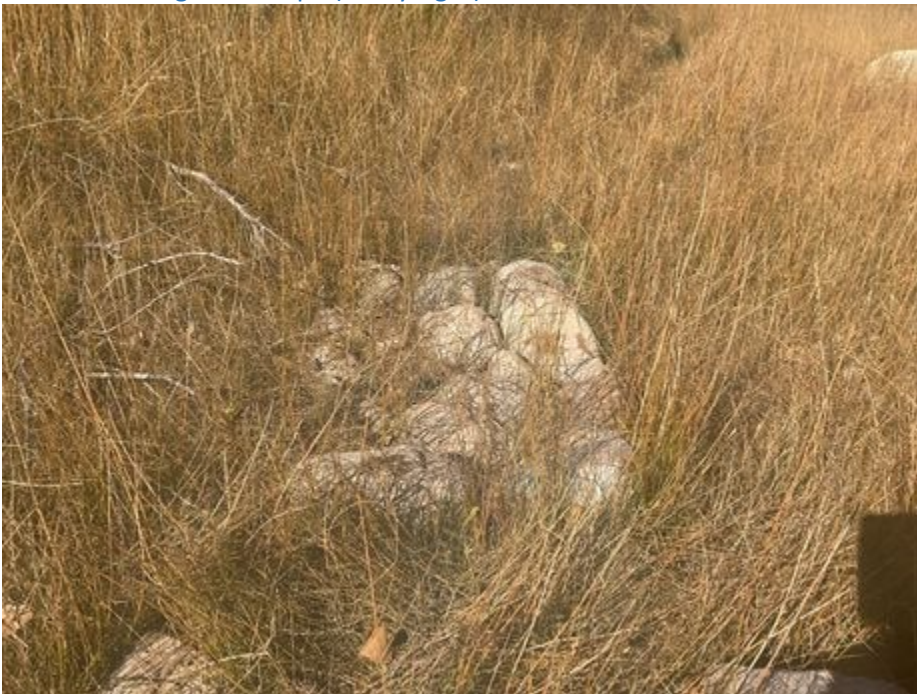
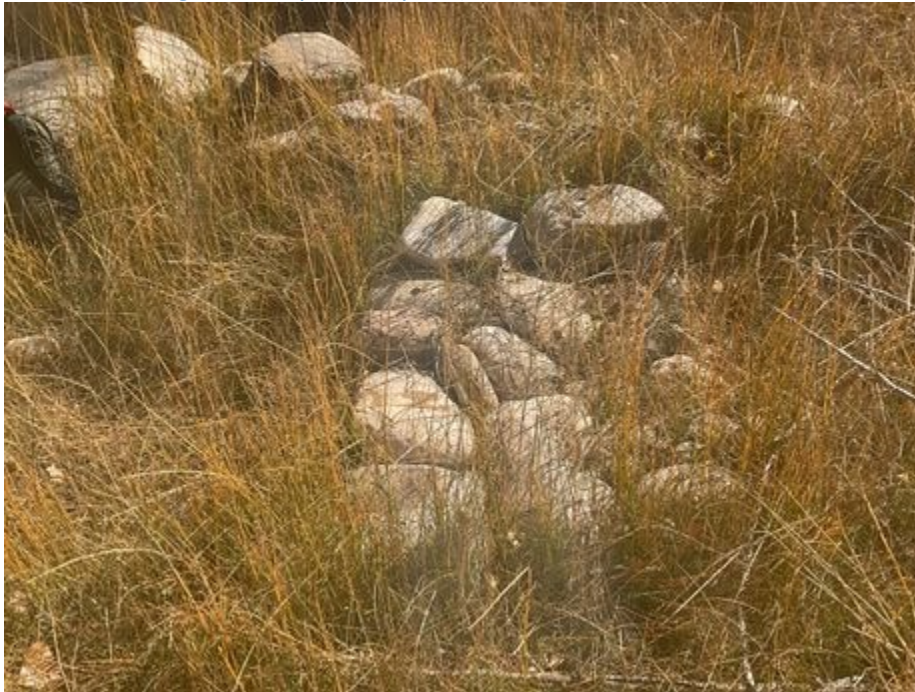
-105.9088917 36.18696822

All rocks intact

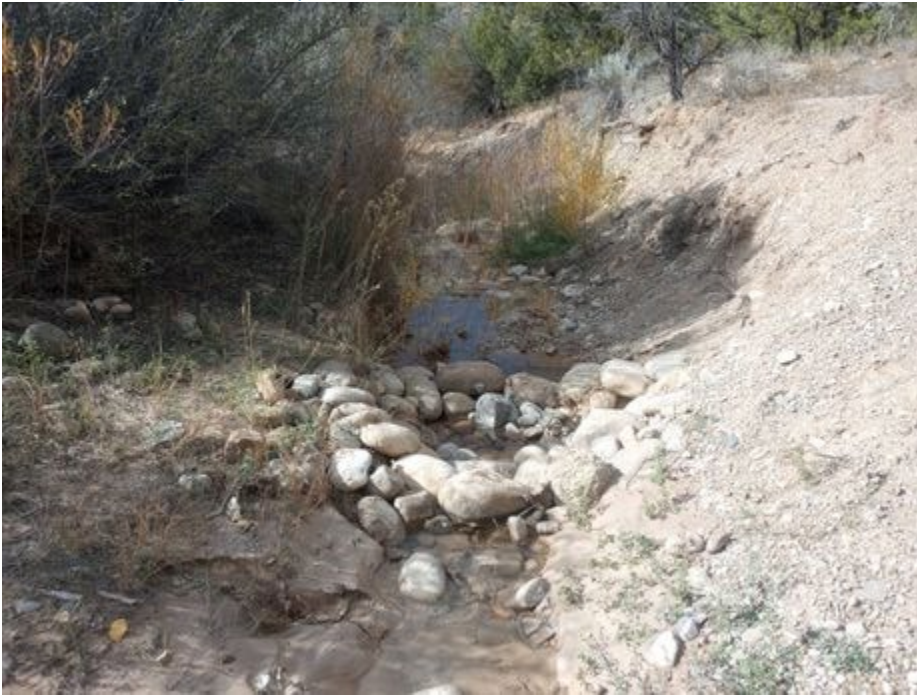
Photo 2 looking downslope

All rocks intact

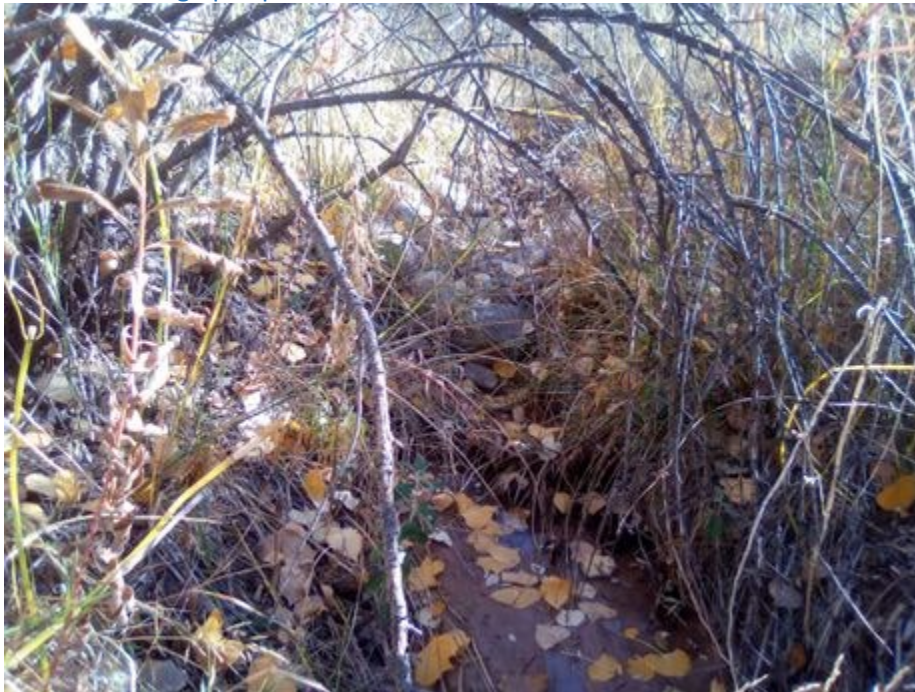
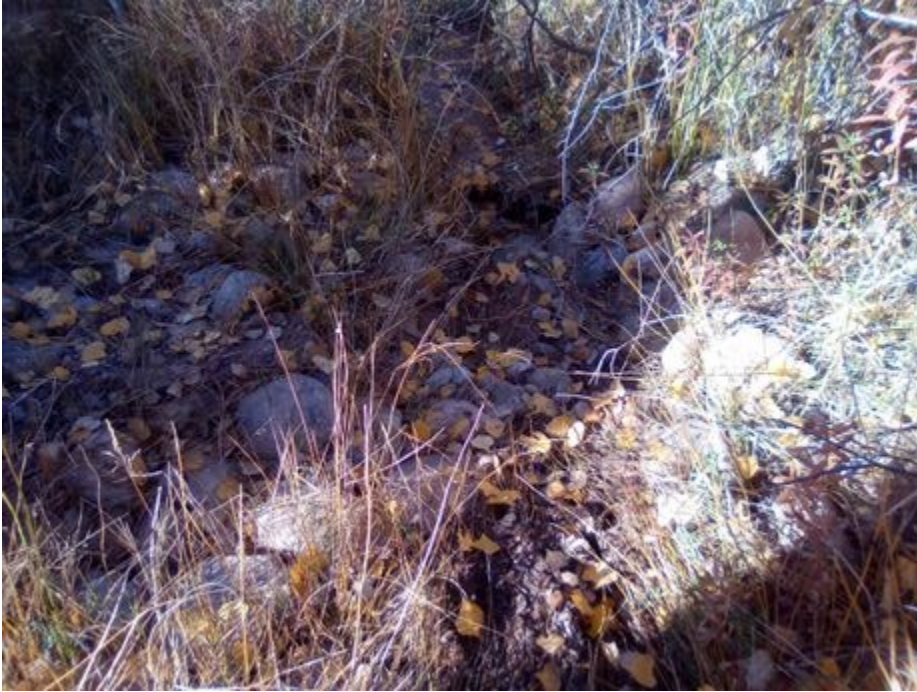
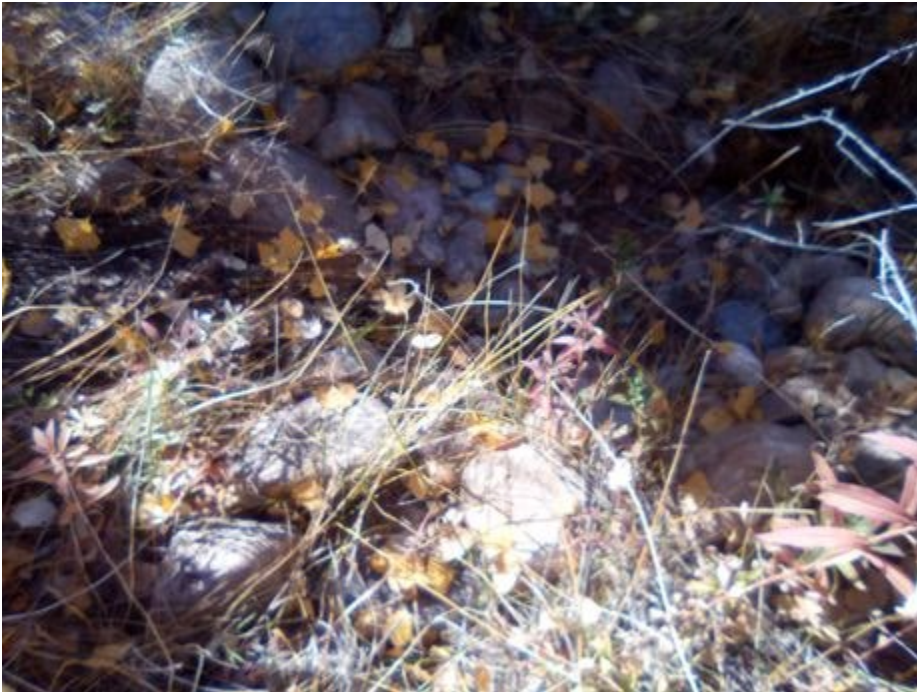
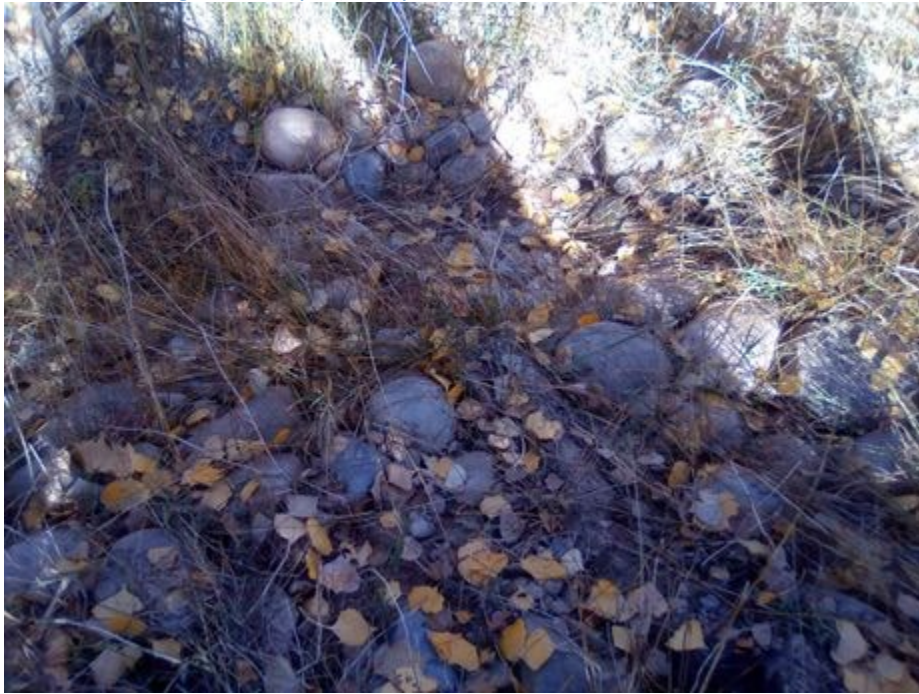
All rocks intact
