CN R924060

**Zuni Bowl and One Rock Check Dam Research –
Phase 1**

Final Report

Rio Grande Return for the New Mexico Department of Transportation Research Bureau

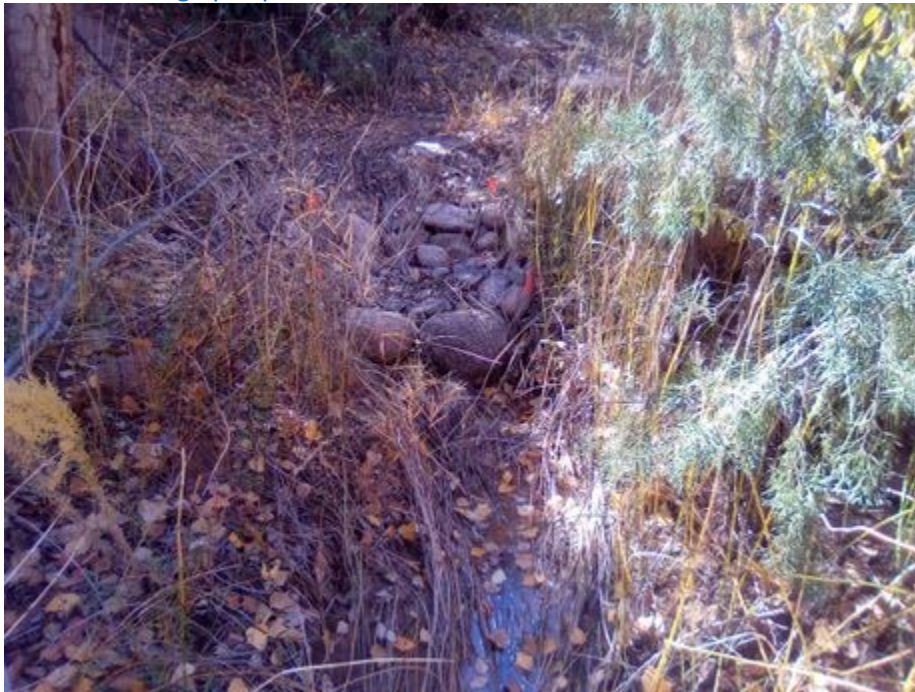
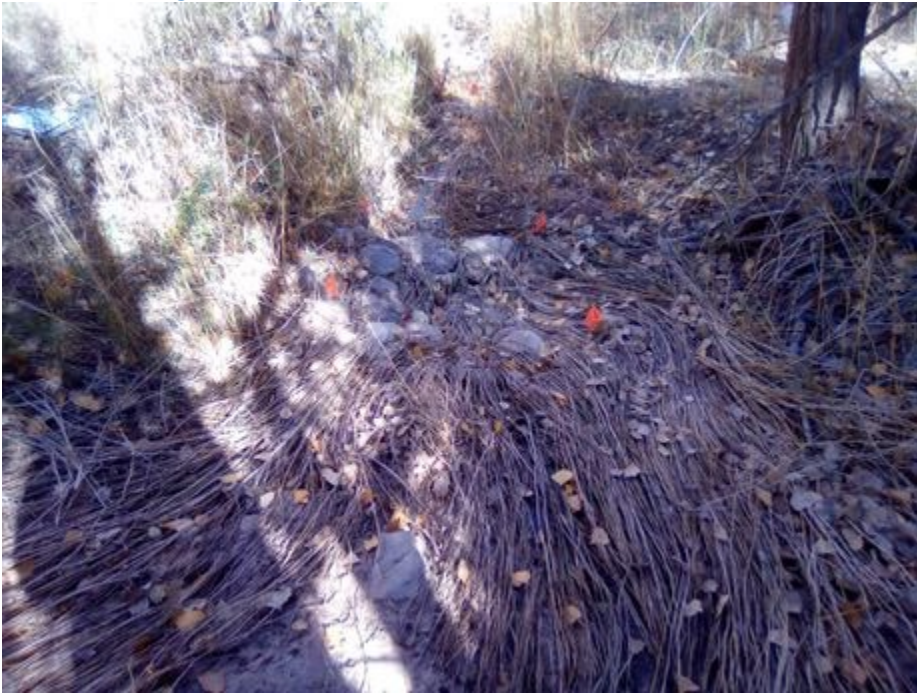
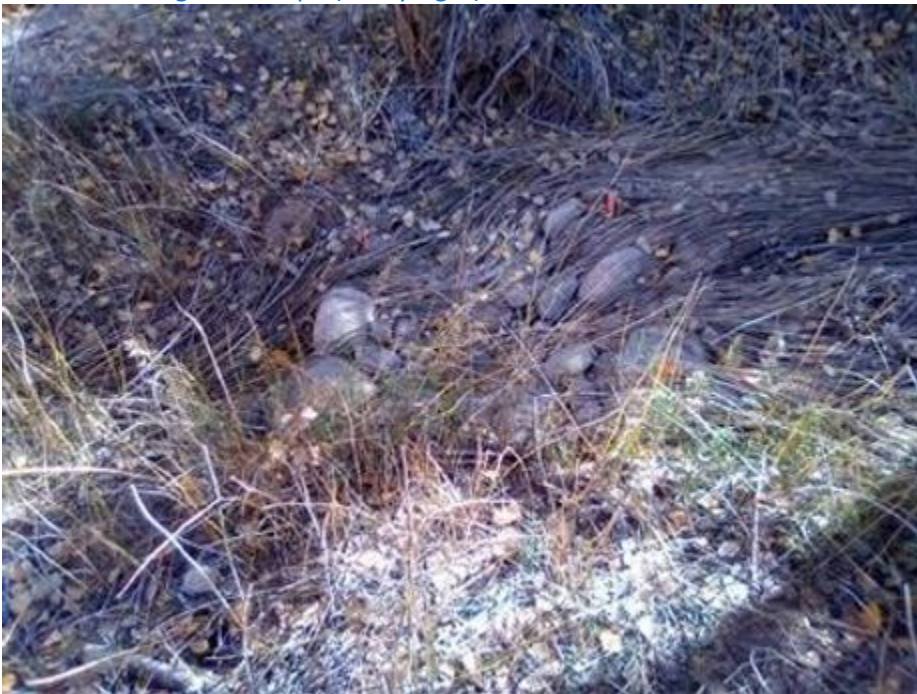
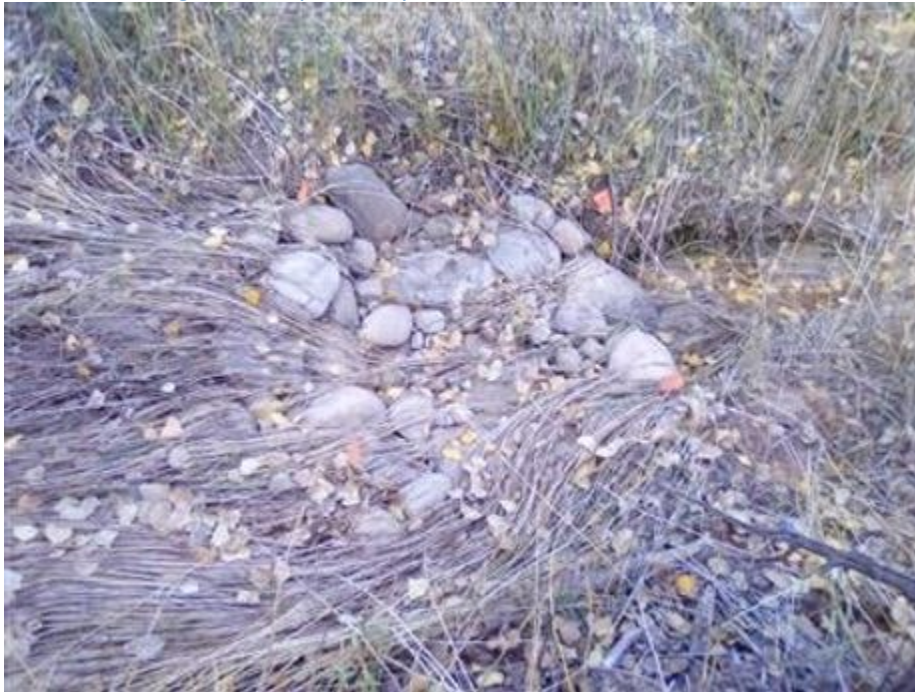
All rocks intact

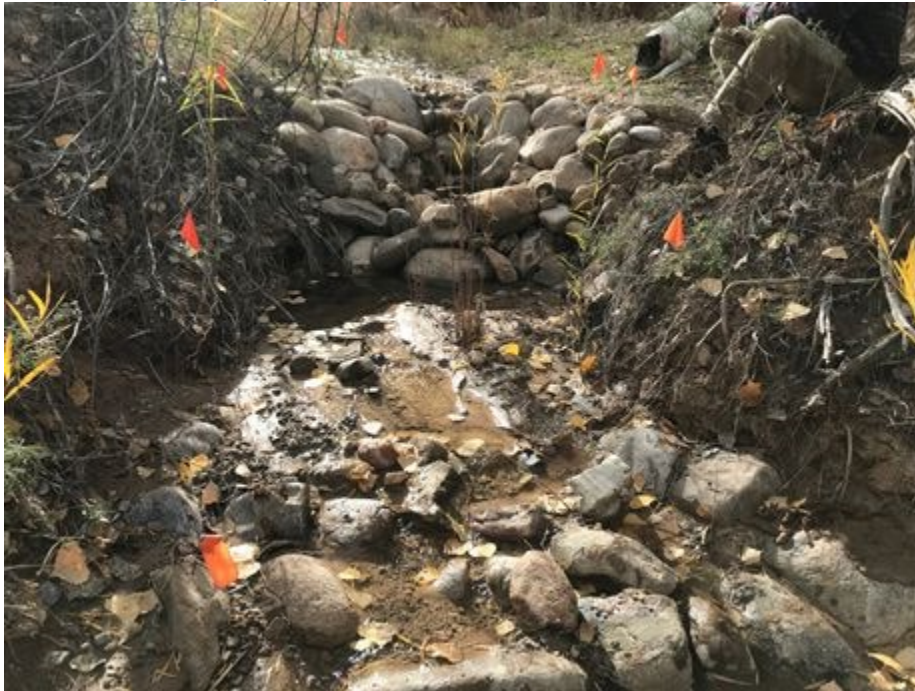
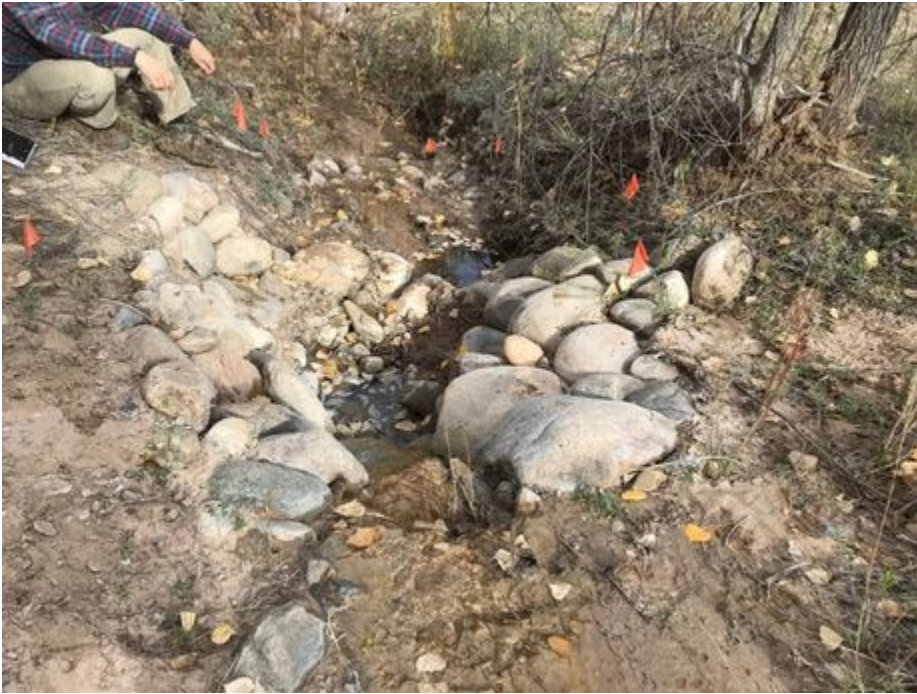
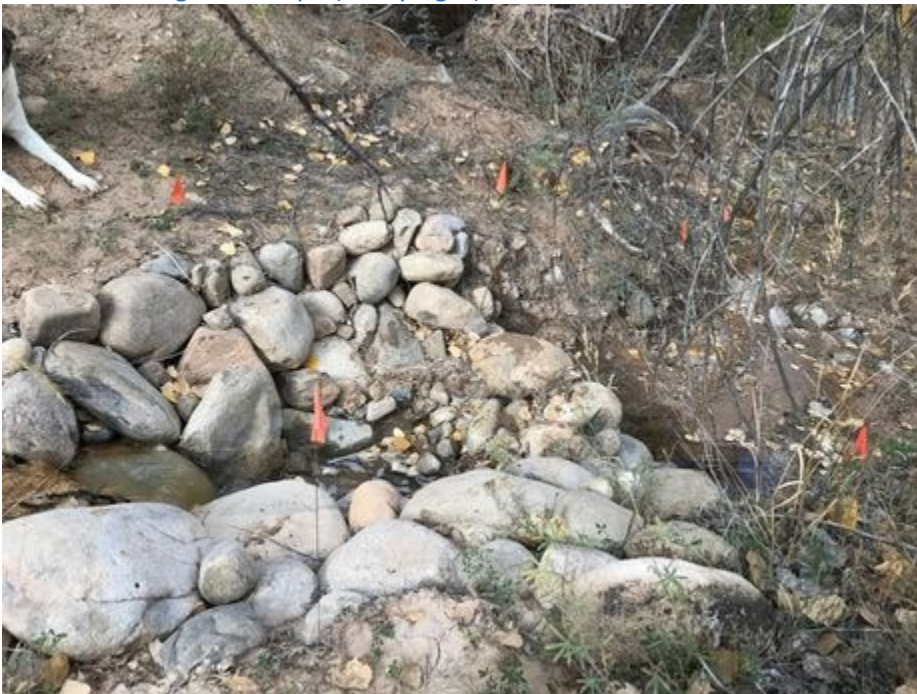
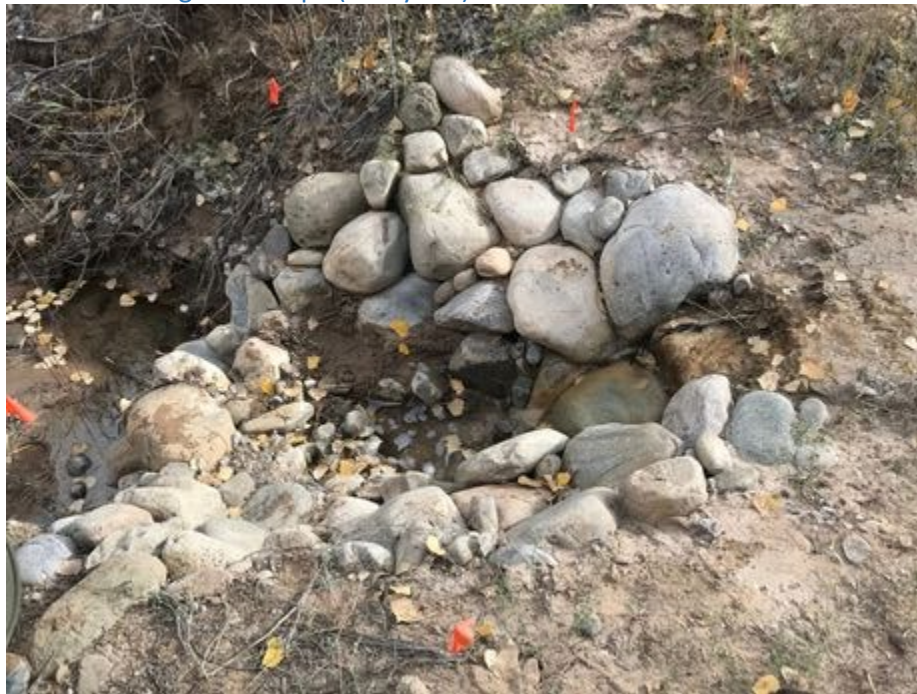
All rocks intact
