# Rock Cut Blasting Aesthetics Best Management Practices Phase II

1. Report No. CDOT-2021-02	2. Government Accession No.	3. Recipient's Catalog No.	
4. Title and Subtitle <b>ROCK CUT BLASTING AESTHETICS BEST MANAGEMENT PRACTICES PHASE II</b>		5. Report Date June 2021	6. Performing Organization Code

7. Author(s) Thomas Allen, Richard Andrew, Sylvia White		8. Performing Organization Report No.	
9. Performing Organization Name and Address Yeh and Associates, Inc. 2000 Clay Street Suite 200 Denver, CO 80211		10. Work Unit No. (TRAIS)	11. Contract or Grant No. 219.10

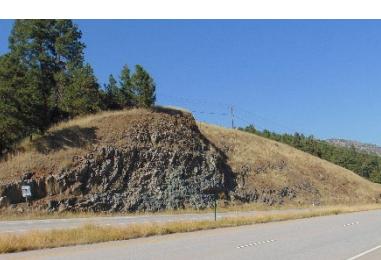
US Highway 285, westbound, northwest side, MP 243.2, 7.4 miles northeast of Conifer  REGION 1 <a href="#">us2852432</a>

Biotite gneiss with schist, foliated, some pegmatite	Height: 60 ft Length: 800 ft Weathered rock at 41 degree southeast facing slope; Intact rock at 70 to 80 degree southeast facing slope	Westbound 19 seconds; Eastbound 50 seconds; static view from intersection of Surrey Drive with US 285 south of cut	The cuts in this area were excavated using ripping techniques with a dozer and an excavator. Cushion blasting was required in the more resistive zones in the bedrock. A pattern of rock bolts was installed in the steeper portion of the rock slope.	The steepened portion of the rock cut was constructed to provide variability to the slope configuration and to protect a natural rock outcrop that was important to the local community.

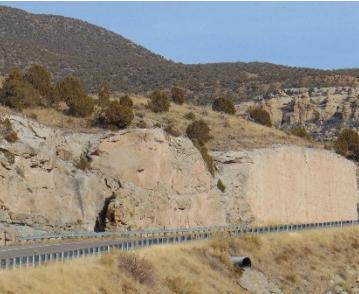
Location	Example (ctrl click link or photo for more)	Geology	Slope Dimensions	Visibility	Construction Methods	Comments
<b>State Highway 65</b>						
State Highway 65, northbound, north side, MP 55.1, 13 miles NE of Palisade  REGION 3 <a href="#">sh65551</a>

Sedimentary rock; massive sandstone with minor mudstone;	Height: 20 to 25 ft Length: 195 ft 85 to 90 degree south facing slope	Northbound 10 seconds; Southbound 31 seconds; pullout on south side and driveways at east end may have static view of cut	Two different blast techniques were used excavate the rock. The intent of using two different drilling and blasting techniques was to evaluate the appearance and performance of the methods. The right half or upstream portion of the cut was drilled and shot using a traditional presplit and production blast pattern.	The site photos illustrate the different results from two blasting methods.

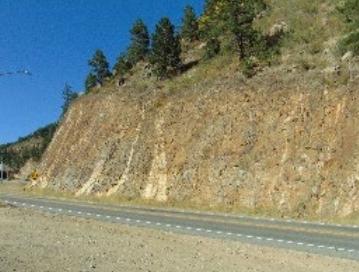
<b>State Highway 119</b>						
State Highway 119, northbound, east side, MP 5.8 to 6.2, 0.5 miles southeast of Black Hawk  REGION 1 <a href="#">sh11958</a>

Metamorphic rock; gneiss with biotite and pegmatite, strongly foliated	Height: 50 to 60 ft Length: 690 ft 71 to 74 degree SW facing slope	Northbound 17 seconds; Southbound 32 seconds; static view from trail/path and fishing access SW of cut	The majority of the rock cut was blasted using a presplit and production drill pattern due to the poor quality of the rock and prevalent adverse rock structure. The ditch width varied along the rock cut to accommodate the hydraulic requirements and to break-up the appearance of the newly excavated rock face. Brown colored draped wire mesh was applied to the final face. Rock bolts used to stabilize large blocks.	The varied foliation of the bedrock helps obscure the half-casts and rock bolts. The dark color of the draped wire mesh makes it less visible. The green-colored mesh anchors are more visible than the mesh. Note that the mesh anchors are designed to extend above the ground surface at the brow. This feature helps catch rockfall from above the cut.

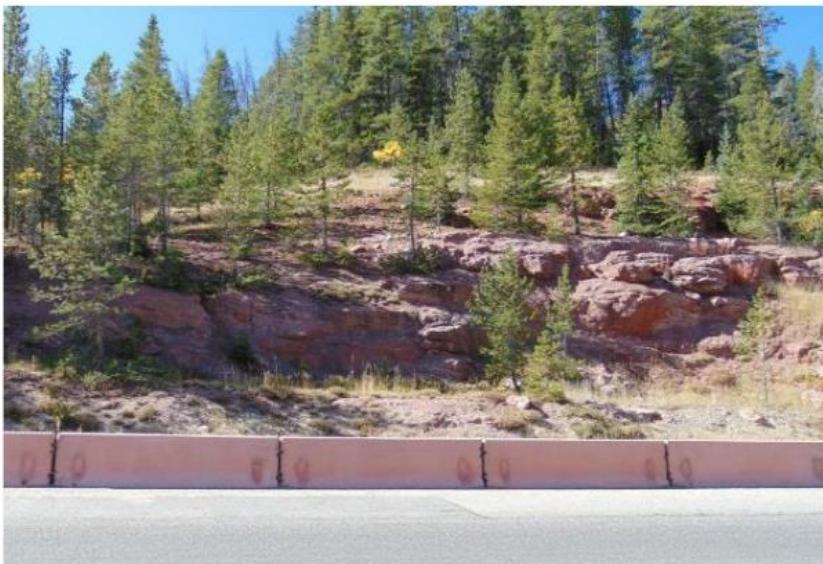
Bedding plane cuts with planting pockets

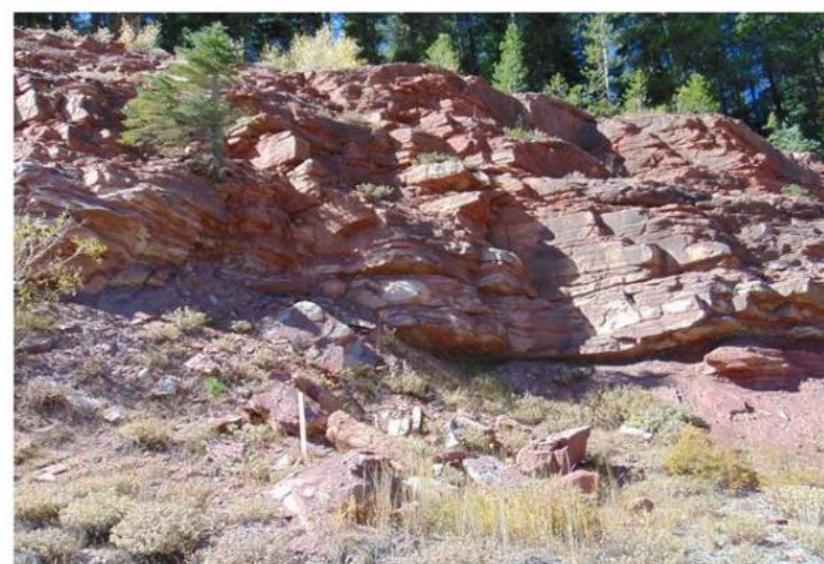
Sandstone undercut by weaker shale; boulders at base of cut

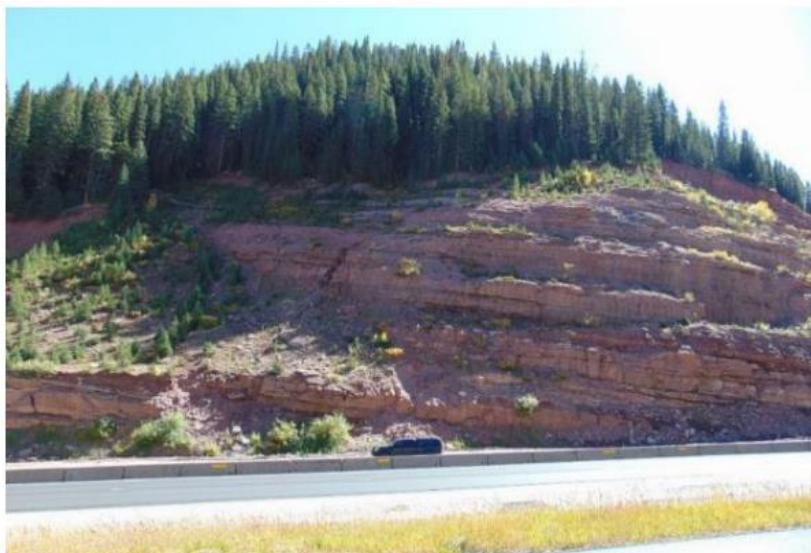
Terraced, bench slopes with revegetation

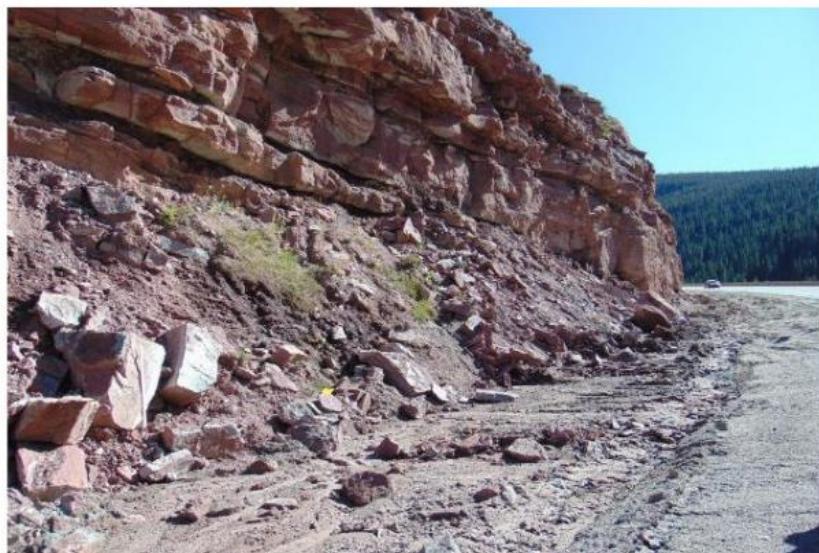
Boulders at base of slope and in ditch

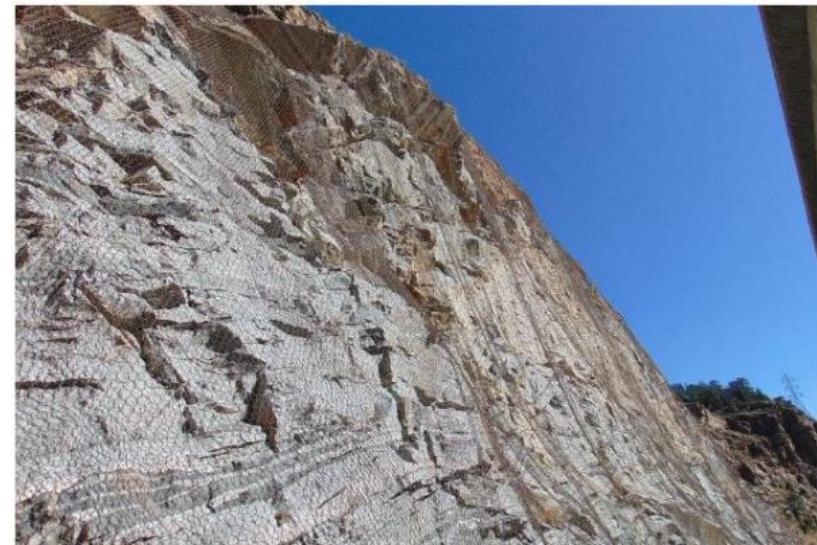
View to northeast, mesh, bolts

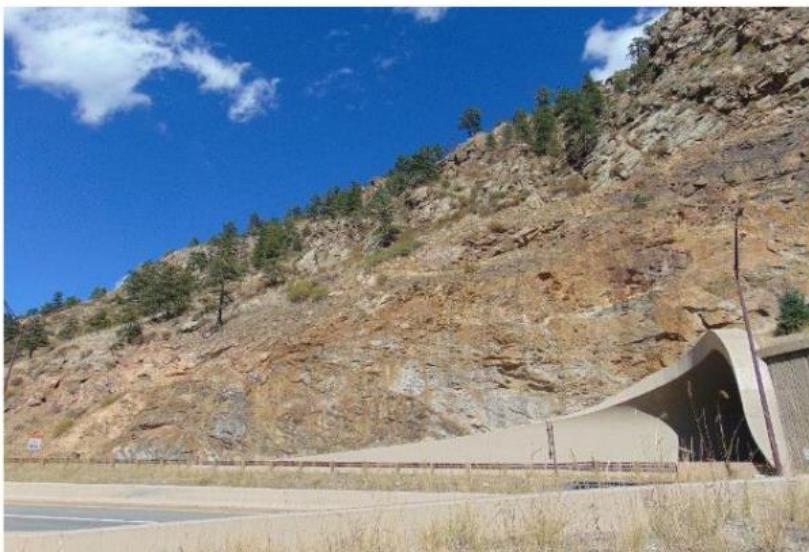
### View to north, joints, foliation layers

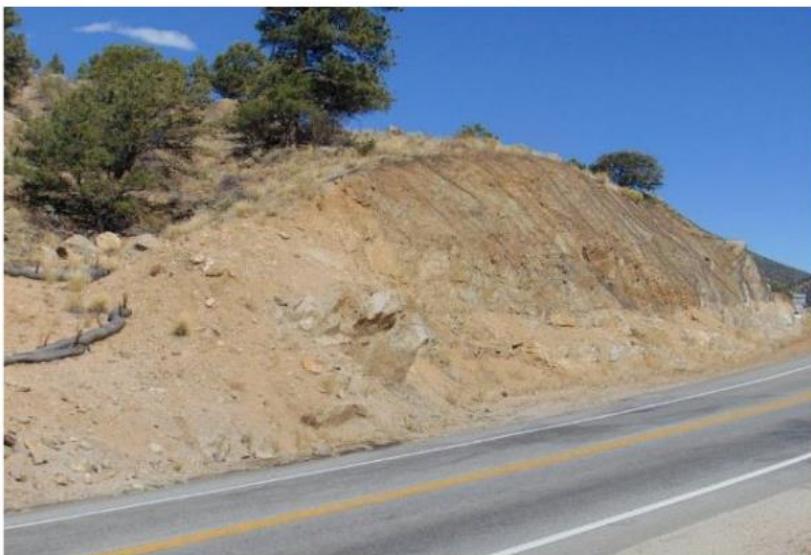
View to northeast, rock mesh

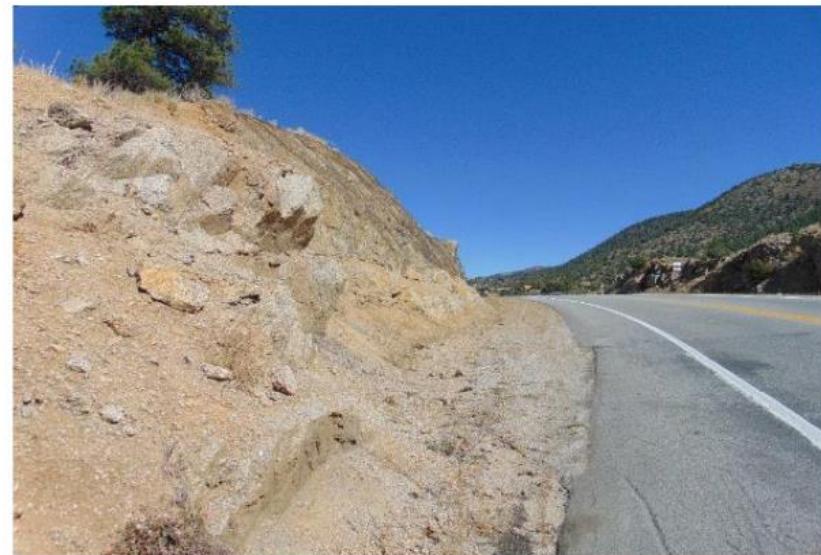
View to north-northeast, rock mesh and catchment ditch

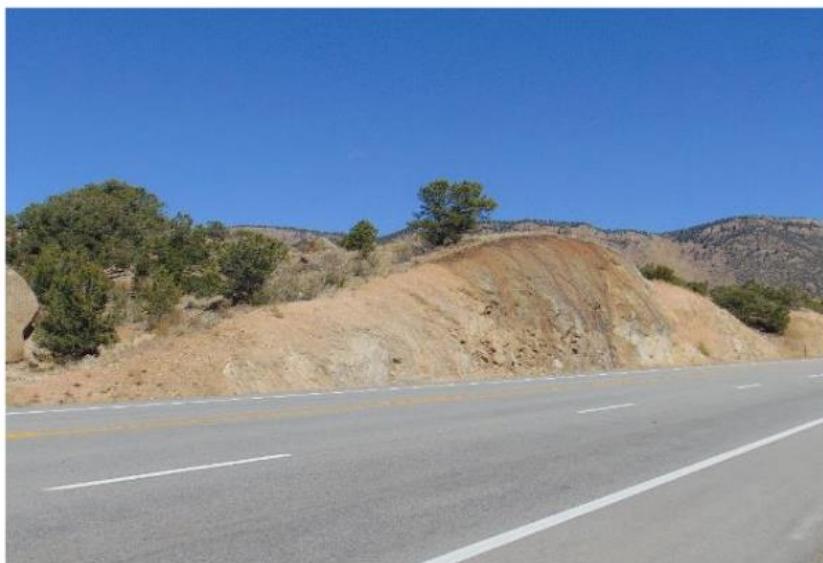
View to northeast, draped mesh

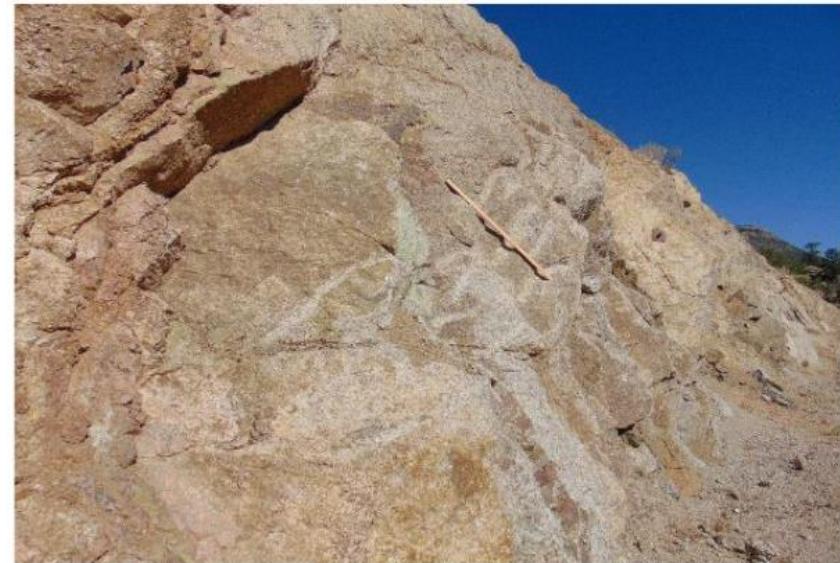
View to northeast with machine marks, bolt

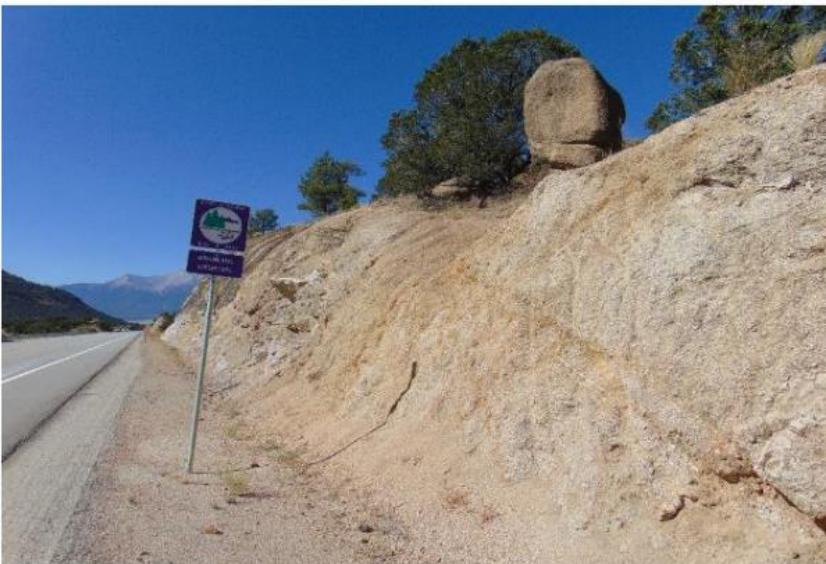
Machine marks in cut below perched boulder

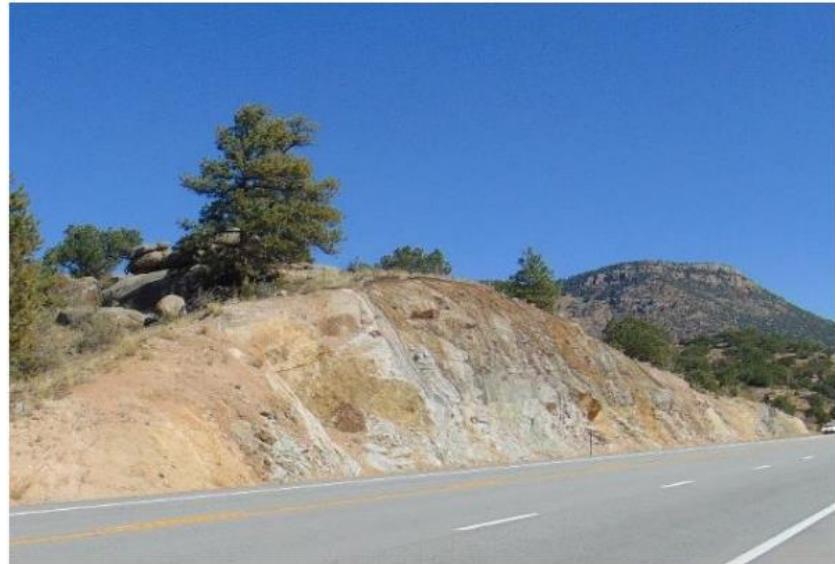
View to northeast, draped mesh at west end

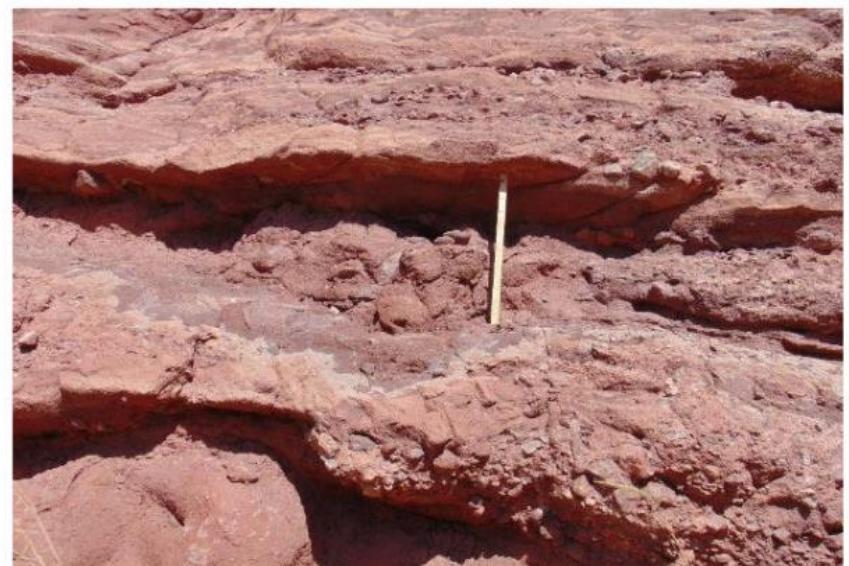
View to north, conglomerate layers with boulder size clasts

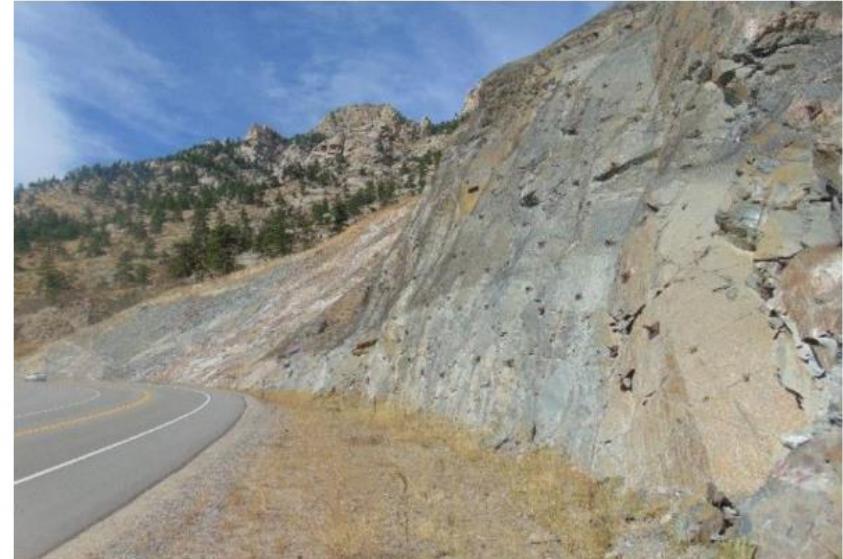
View to northwest, bolts, draped mesh, rocks caught behind mesh

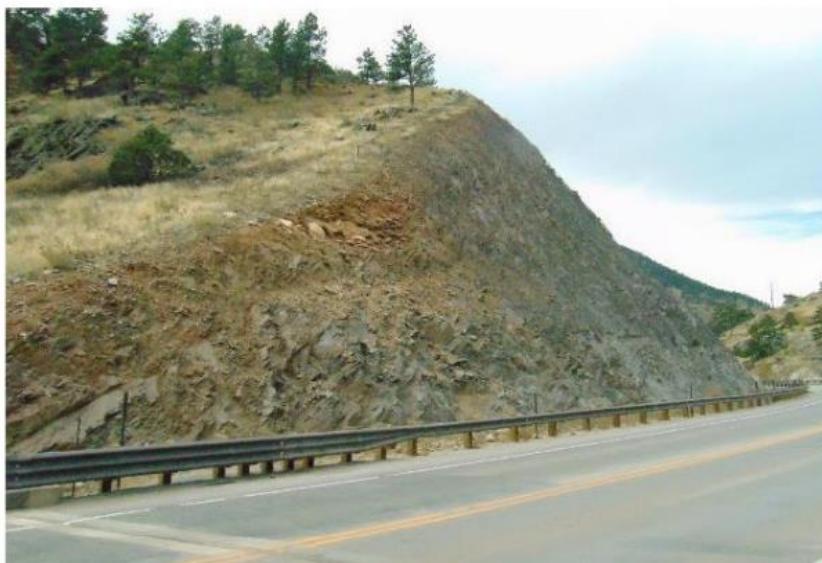
View to southwest, anchors at top of cut, draped mesh

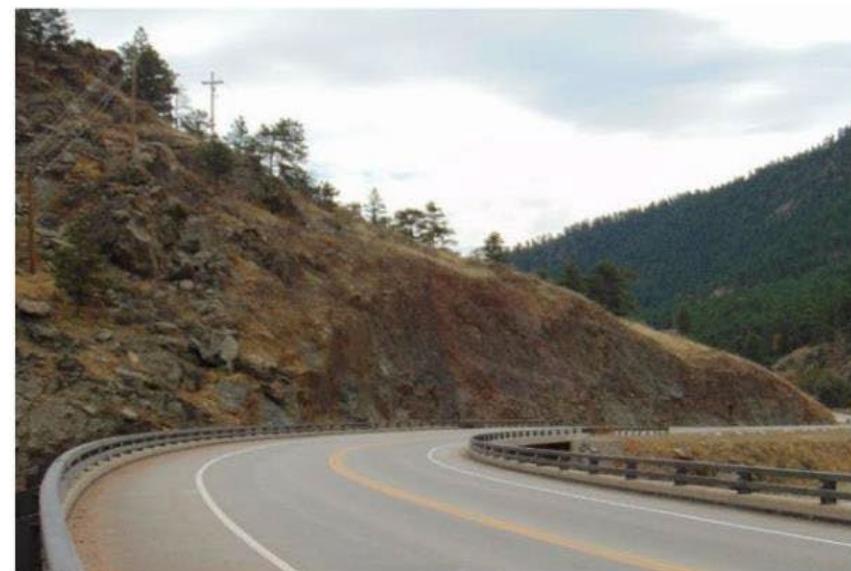
View to north-northwest, anchors at top of cut, draped mesh

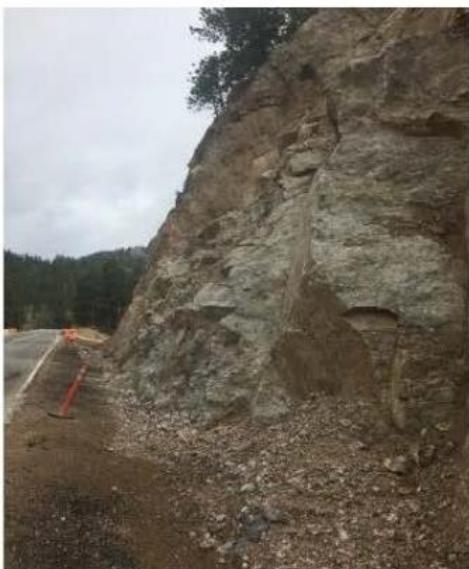
Cobbles at base of cut, view to northwest

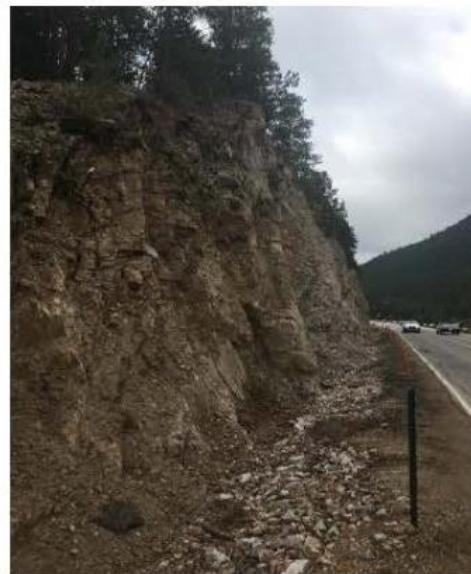
Cobbles in ditch, view to southeast

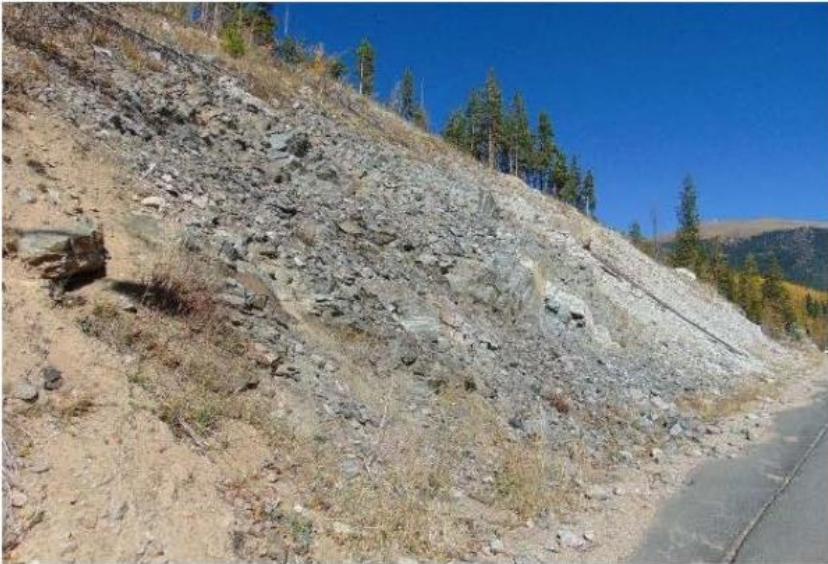
Angular rock debris (scree) on slope and at shoulder, looking east

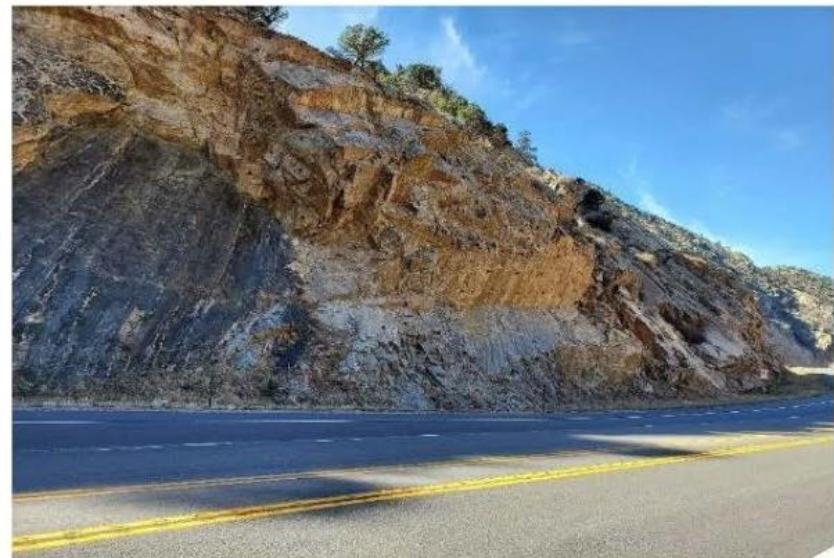
Westbound View, looking south-southeast at rock bolts, tilted rock

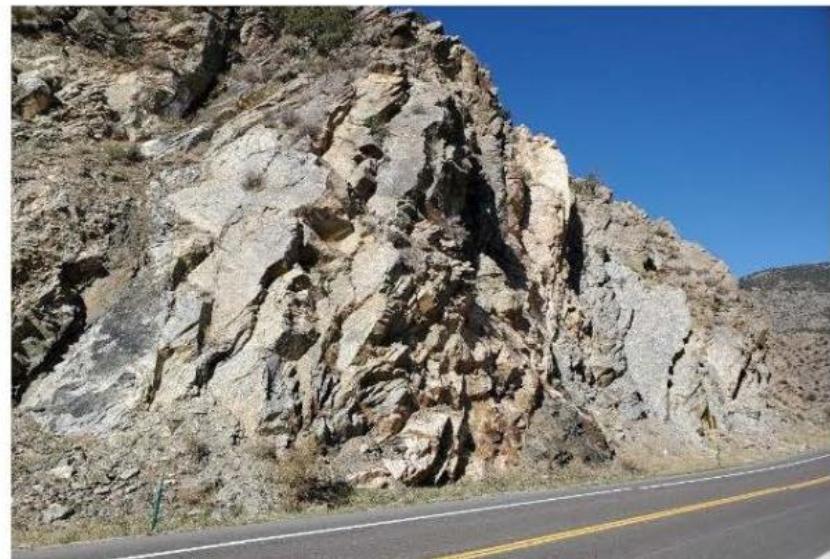
Westbound view, looking west, rocks piling at bottom of cut

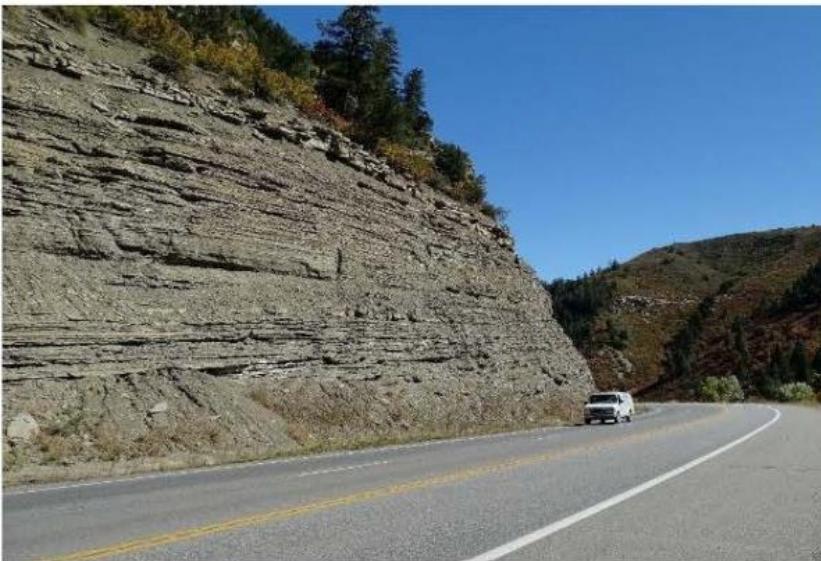
Rock and sediment debris at base of slope

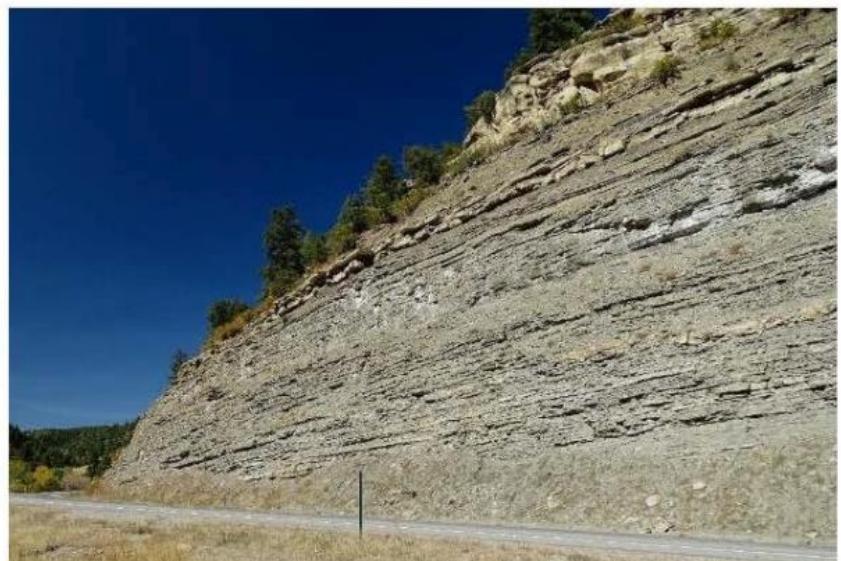
Debris fans at base; sandstone undercut by shale

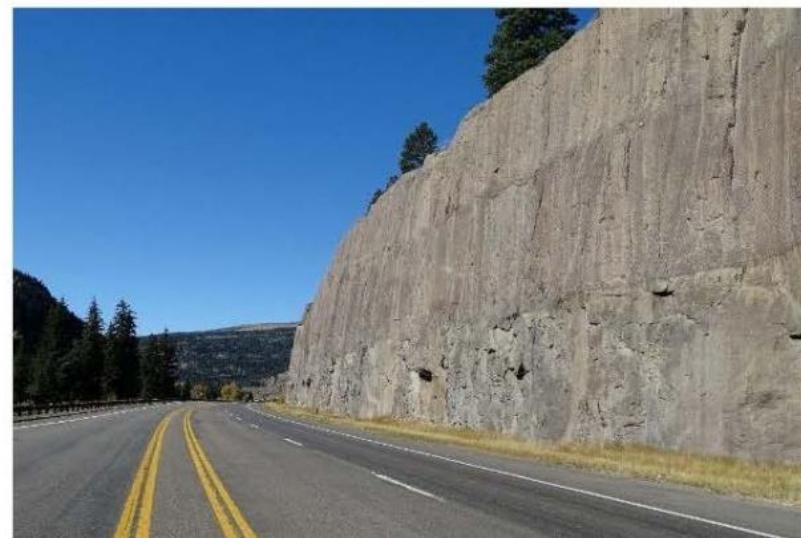
Cut face with mesh

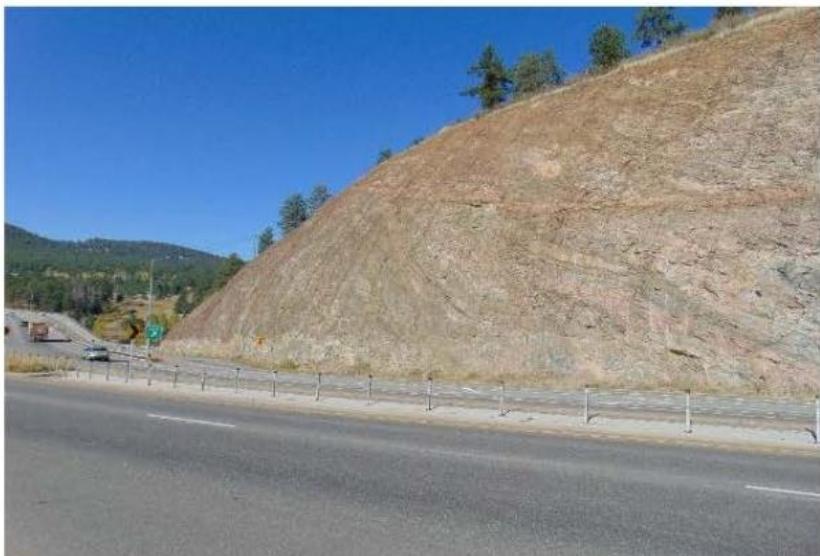
Mesh on west end of cut

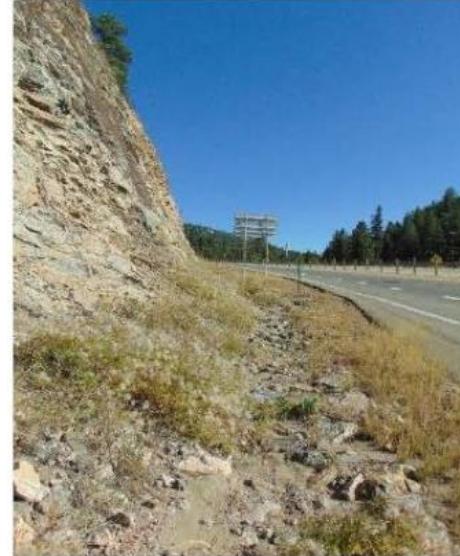
Rocks at base of cut slope

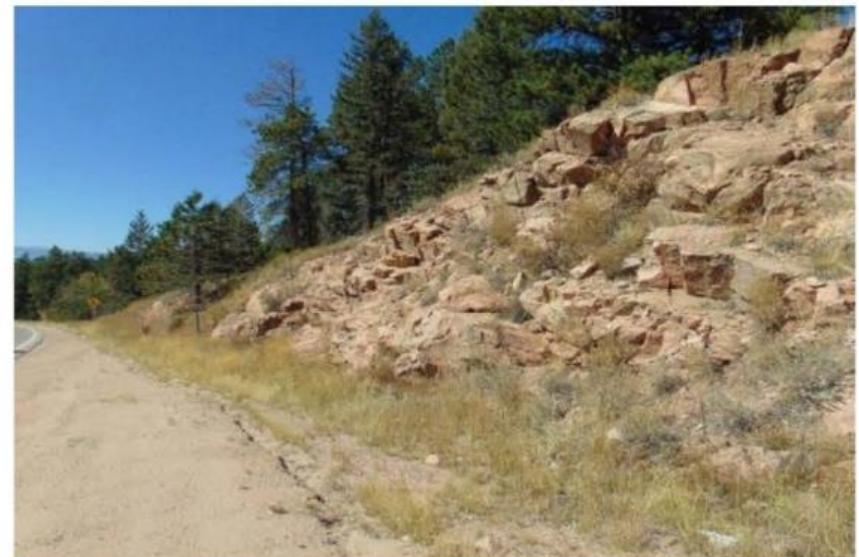
Foliation plane tilted toward roadway

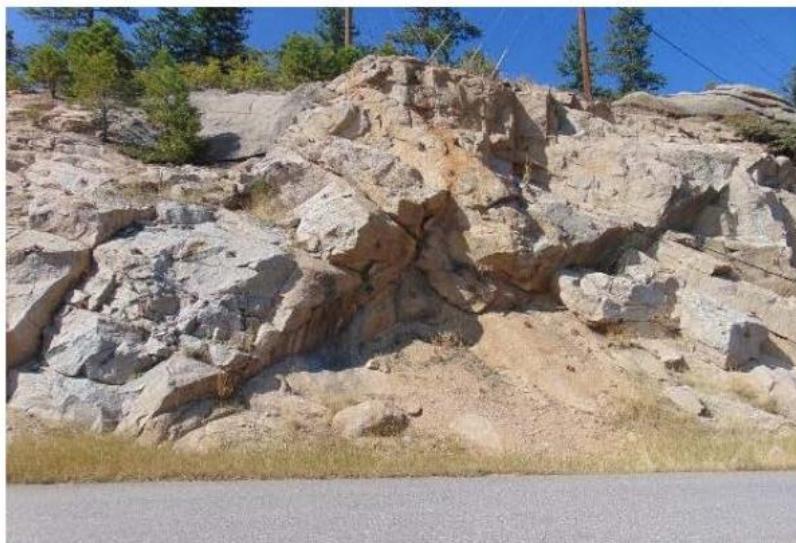
Rockfall mitigation, shotcrete, bolts

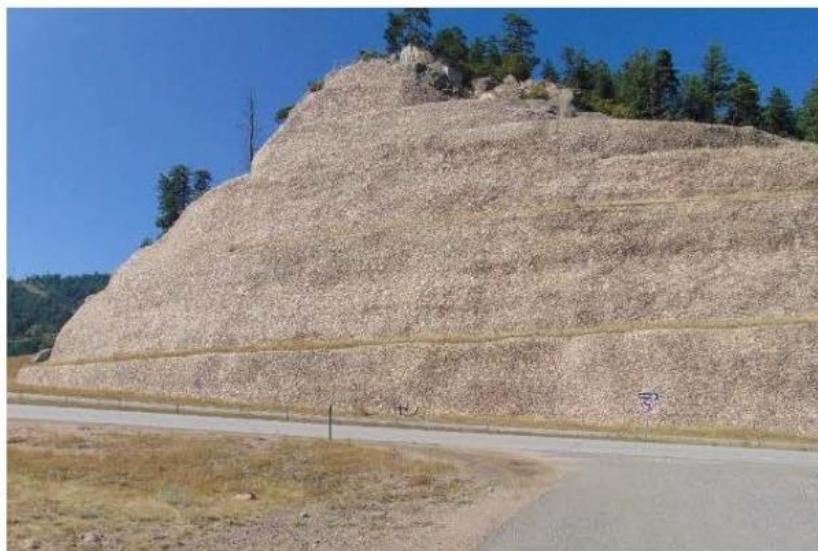
Cut area with terraces and rock facing

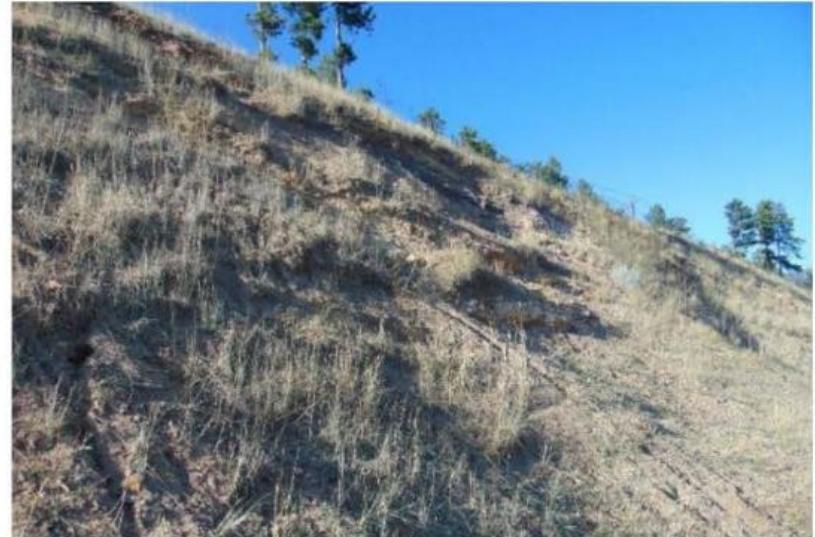
Rilling and gullying on upper soil covered slope

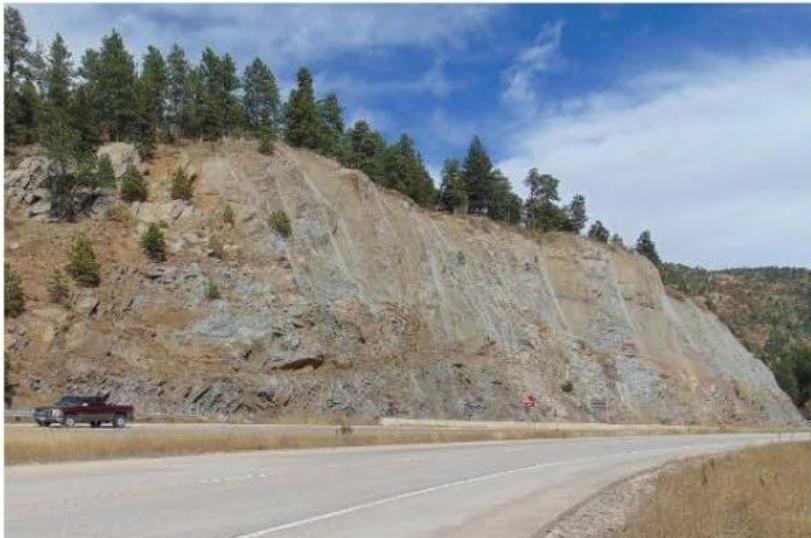
PHOTO LOG	Date	Description			Photo No.	Discussion				
	10/17/2019	Westbound view			1298					
	10/17/2019	Eastbound view			1294					
	10/17/2019	Draped mesh			1241	Silver draped mesh covering face of cut				
	10/17/2019	Blocky fracturing			1259 and 1250	1 to 2 ft fractured blocks

Draped mesh

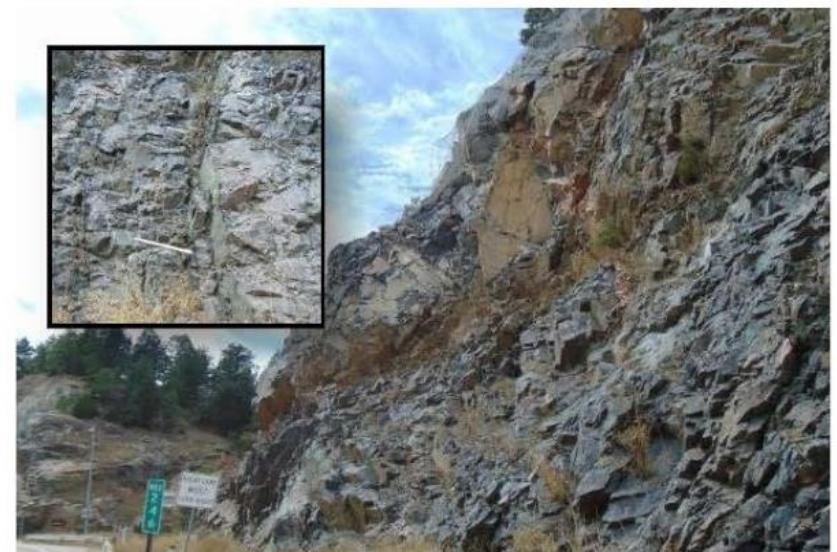
Blocky fracturing

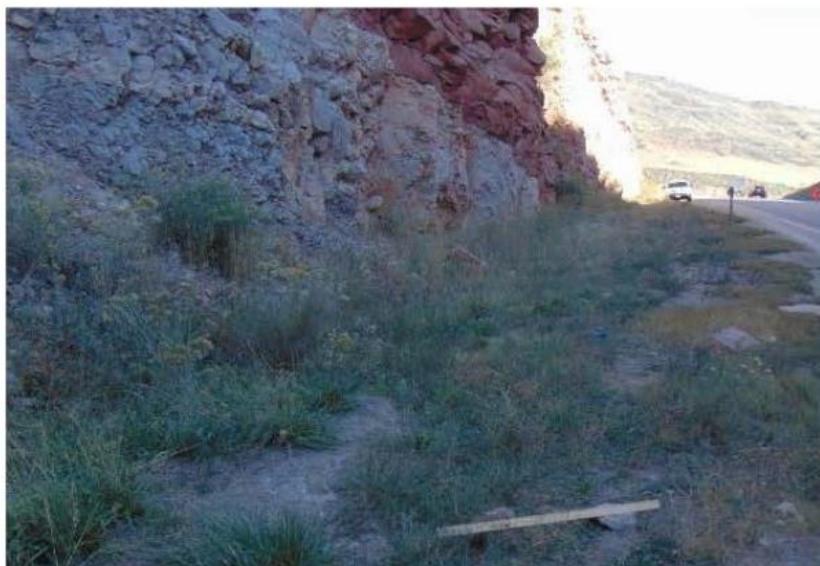
Change in rock type; rocks in ditch with red boulder near face of cut

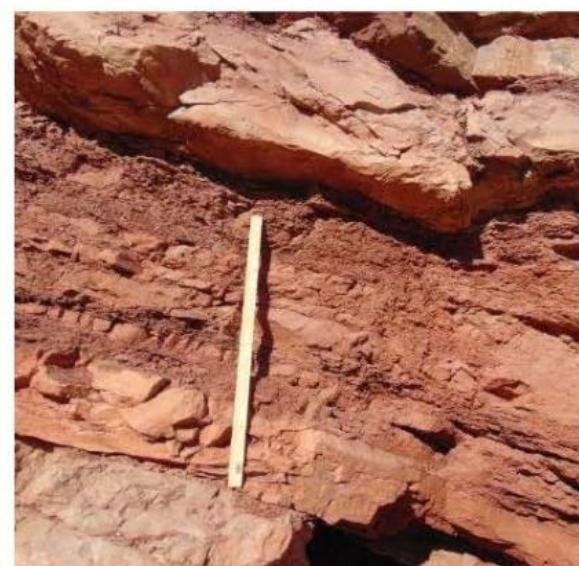
Sandstone undermined by softer shale

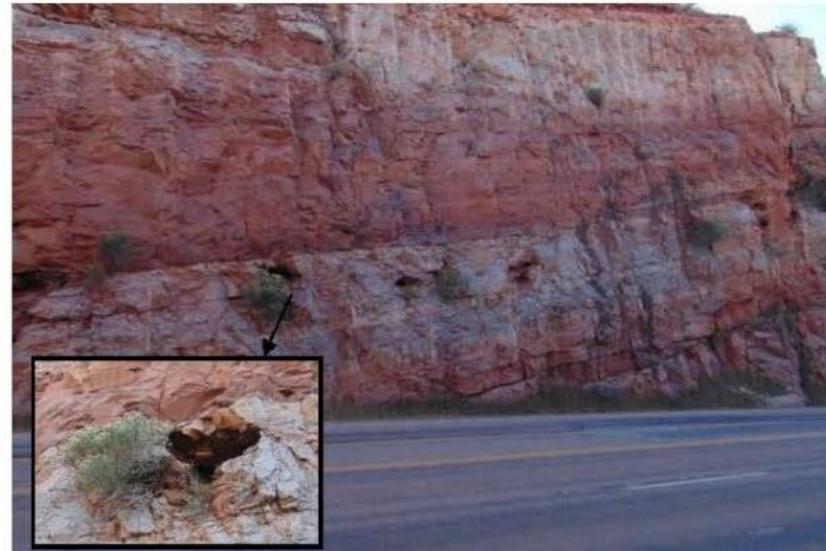
Dissolution cavities and boulders in ditch

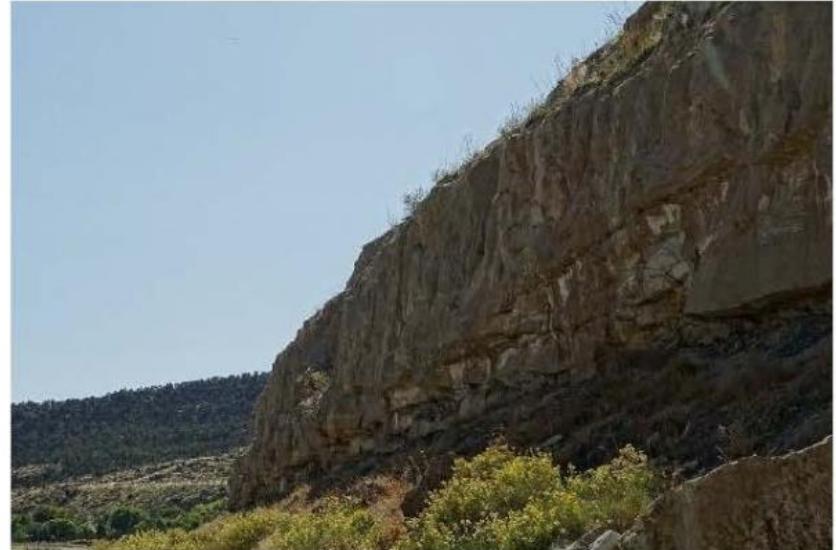
Buried shale layer

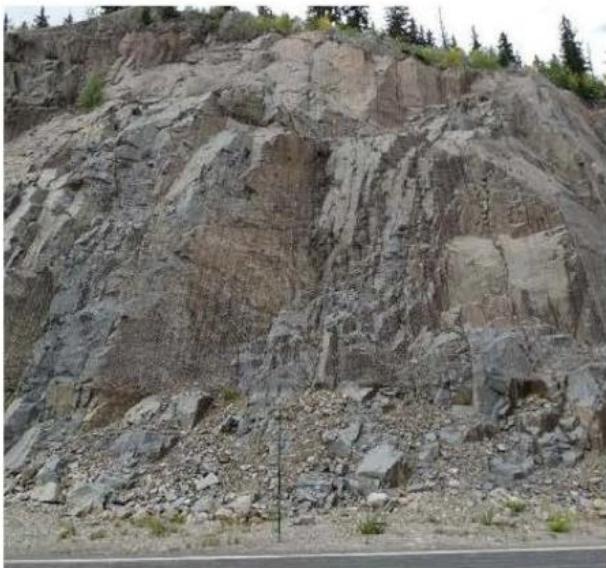
9/16/2019	Northbound viewshed			DSC00026									
	9/16/2019	View to southwest			DSC00029									
	9/16/2019	Foliation and joints			DSC00031		Foliation and joints, fractures							
	9/16/2019	Draped mesh and bolts			DSC00030		Draped mesh and bolts looking north

Foliation and joints

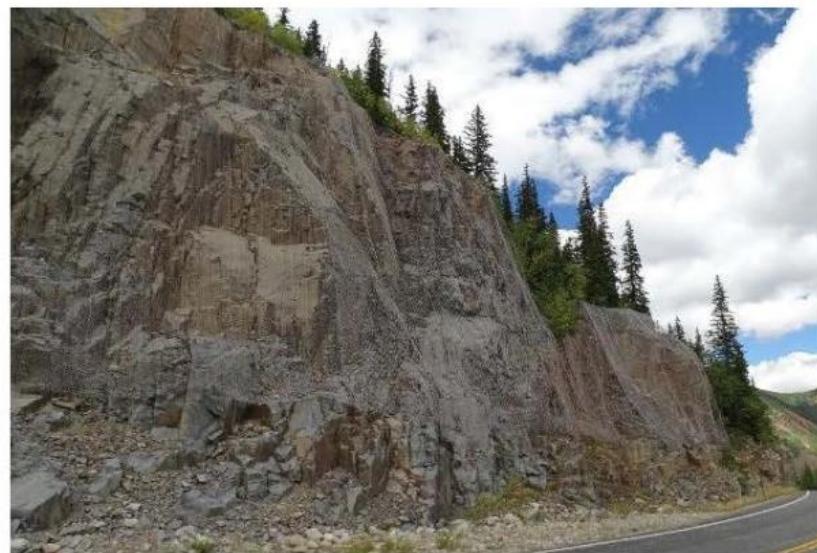
Draped mesh and bolts

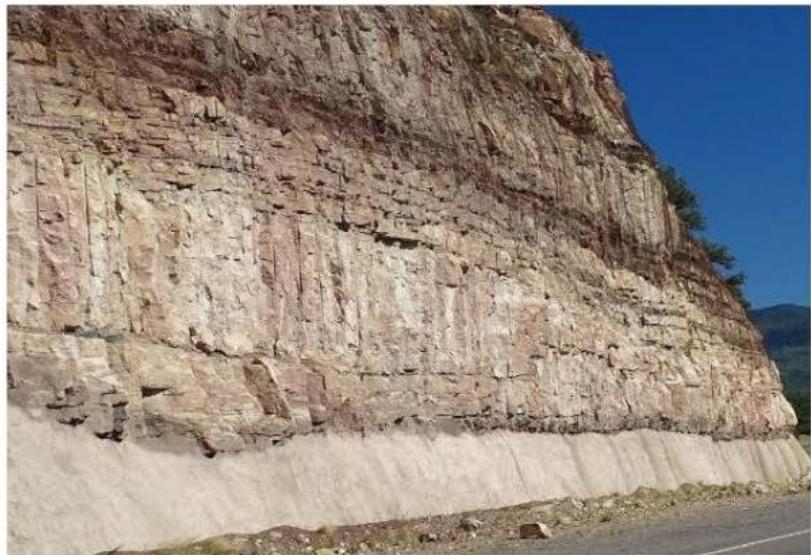
Rocks in ditch

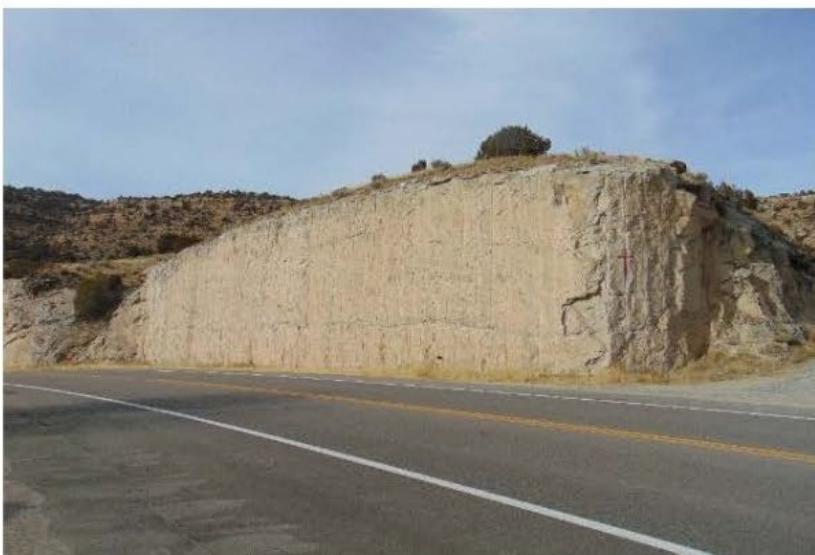
NW view of two different blast techniques (far left of photo and center)

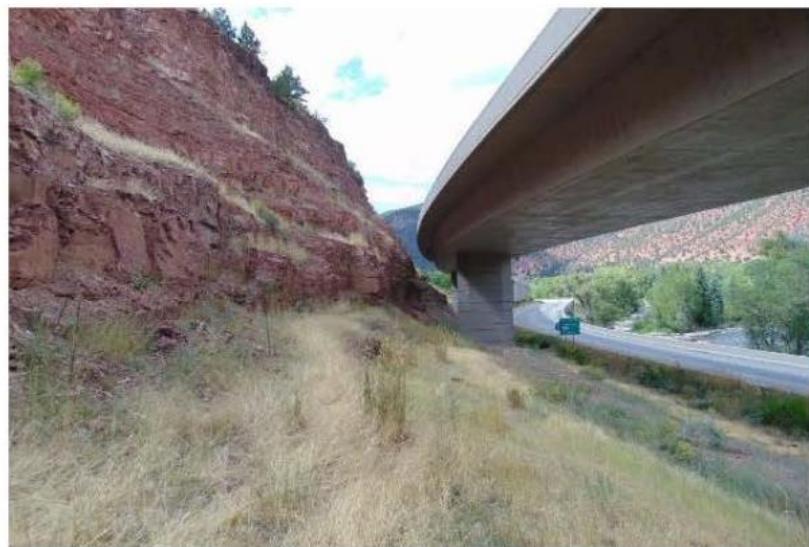
Vegetated terraces

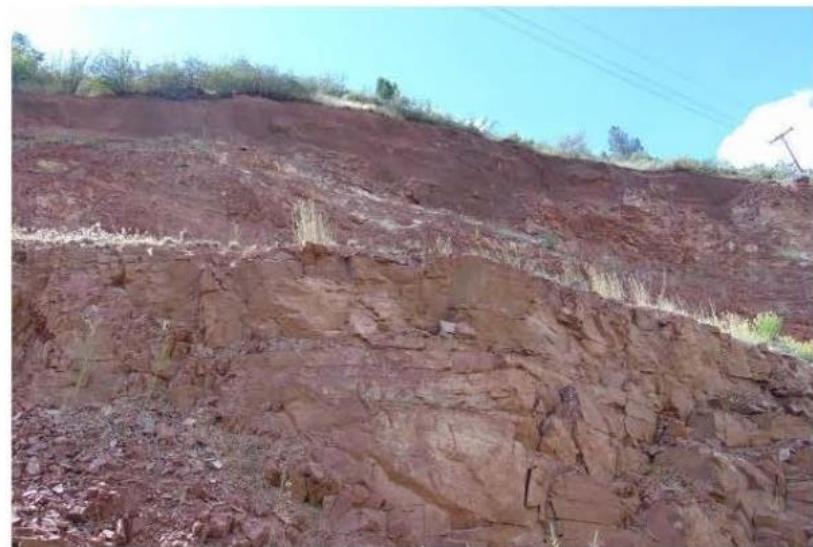
Shotcrete at top of cut

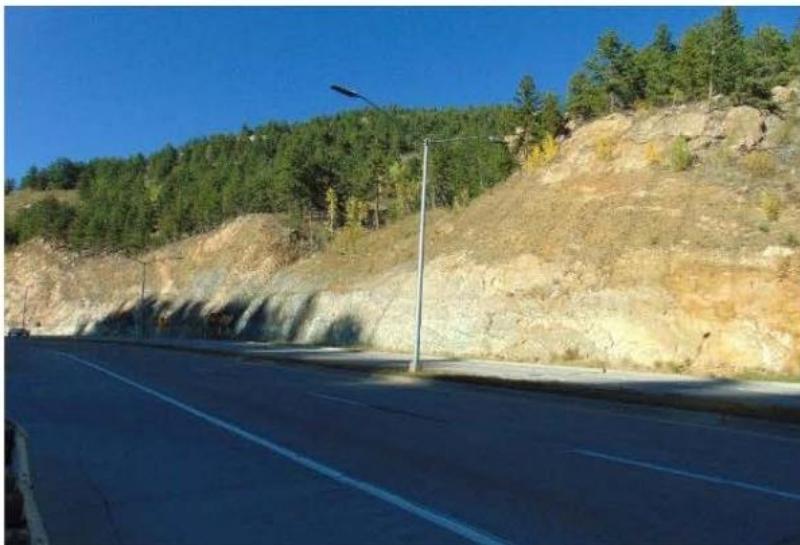
Northbound view

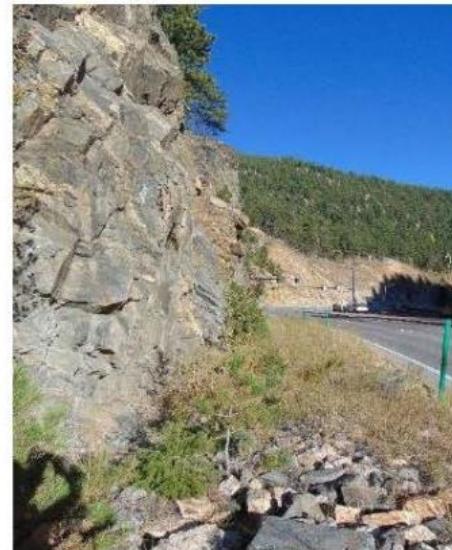
Rocks mantling ditch

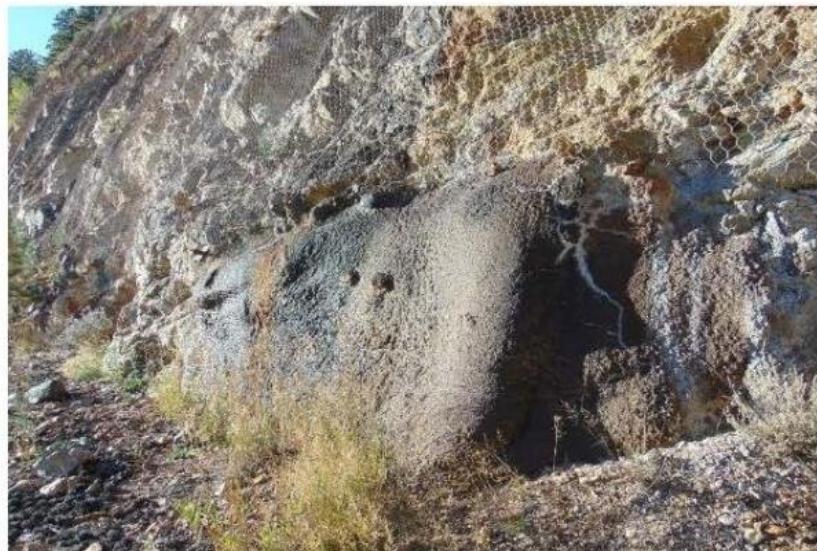
Drains in cut

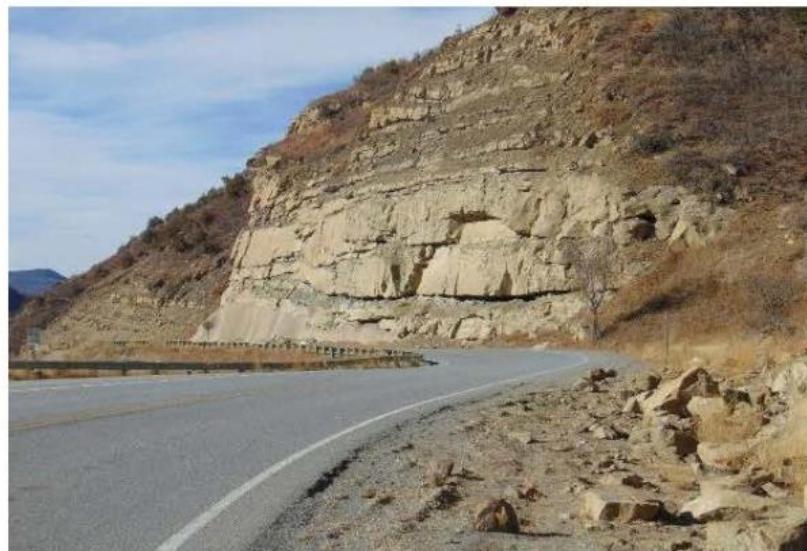
View to west, undercut sandstone, shotcrete lower slope

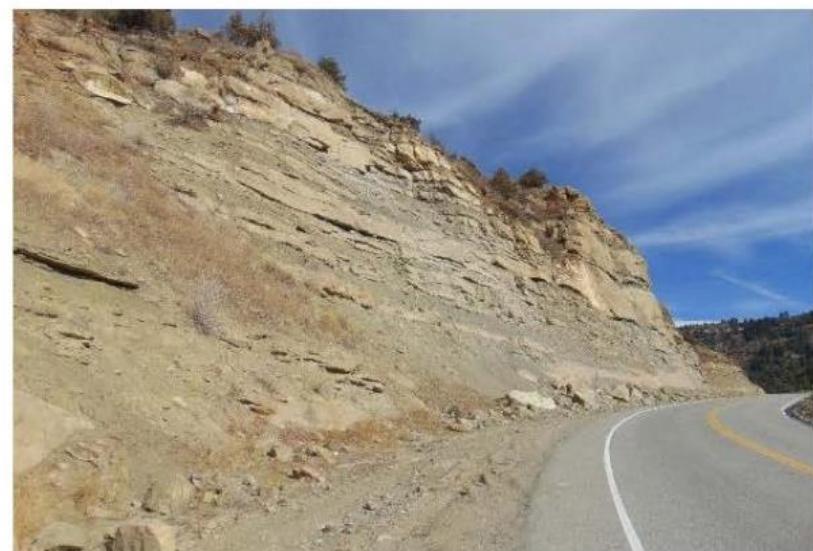
View to ENE, shotcrete lower slope, boulders up to 5 ft diam. In ditch
