# Effect of Y-cracking on CRCP Performance

## **ANNUAL REPORT FOR FY 2011**

ODOT SPR ITEM NUMBER 2230

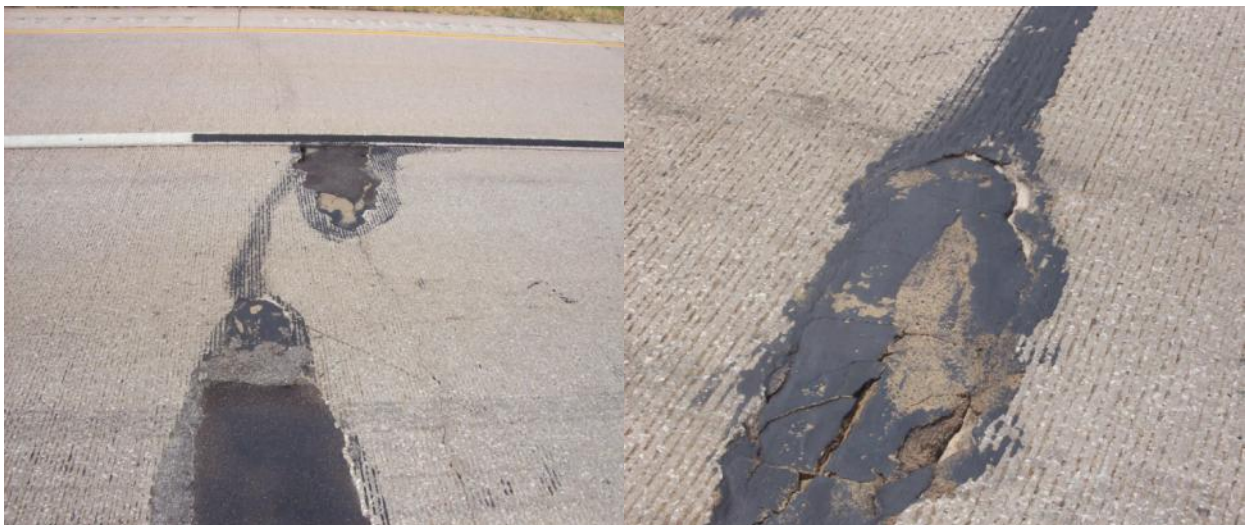
Figure 3.26 shows the terminal joint at the beginning (left) and the end (right) of the west bound inspection. The joints appeared to be in poor shape with several patches. The west bound lane had many patches of both asphalt and Portland cement. Some of the patches filled with asphalt left an outline that seemed to look like a Y-crack, see figure 3.27, while many of the patches seemed to be caused by closely spaced transverse cracks with longitudinal connecting cracks, see

**Figure 3.27** – Y-shaped patches

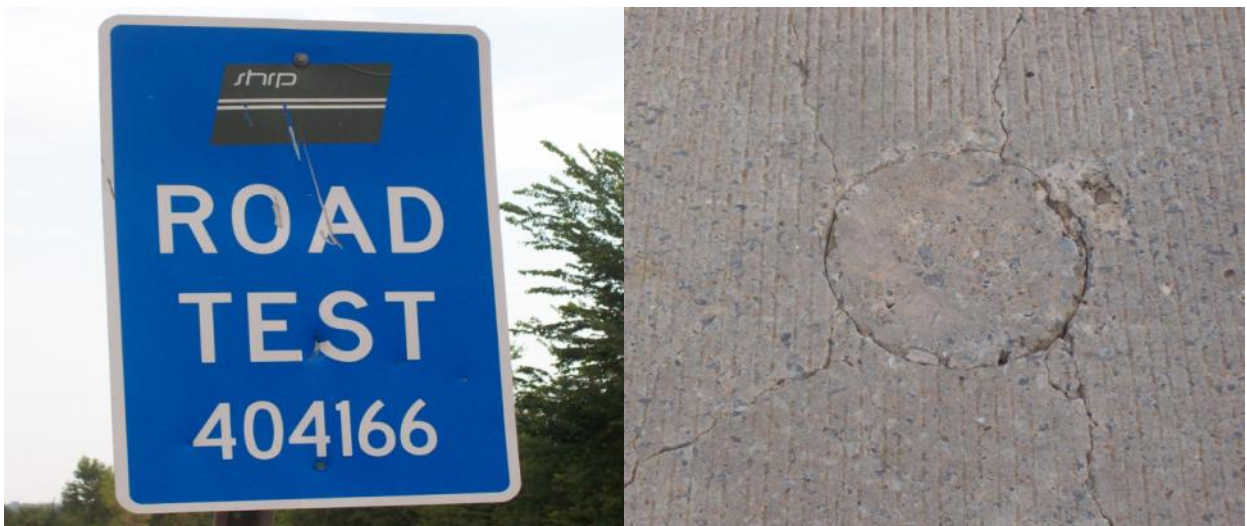
The north bound lane also contained several places where past testing had been done, see figure 3.57. These testing sites consisted of several cores. Some of the cores had been taken from along the outside edge of the pavement and even in the shoulder. A few cores were also taken out of the roadway, and showed signs of sensors of some type being implemented, see figure 3.58.

**Figure 3.57** – (right) road test sign found beside roadway, (left) one of several large cores taken

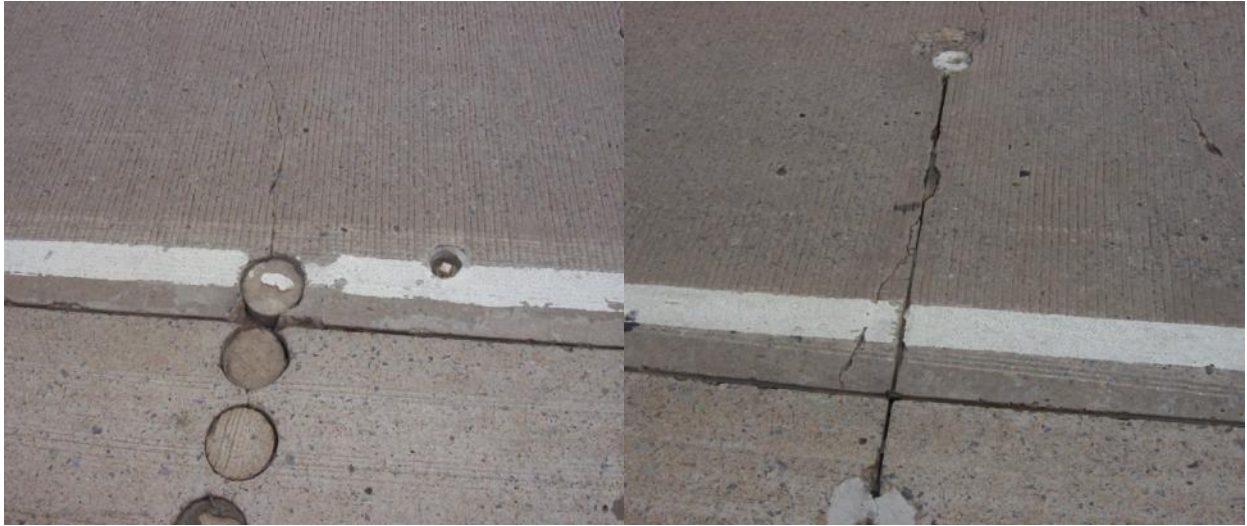
**Figure 3.58** – (left) cores taken from shoulder, (right) core with censor wire extending to shoulder
