Repair of Bridge Deck Fascias
OR22-002

Final Report

Michigan Department of Transportation

1. Report No. SPR-1730	2. Government Accession No. N/A	3. Recipient's Catalog No.	
4. Title and Subtitle Repair of Bridge Deck Fascias	5. Report Date 09/30/2023

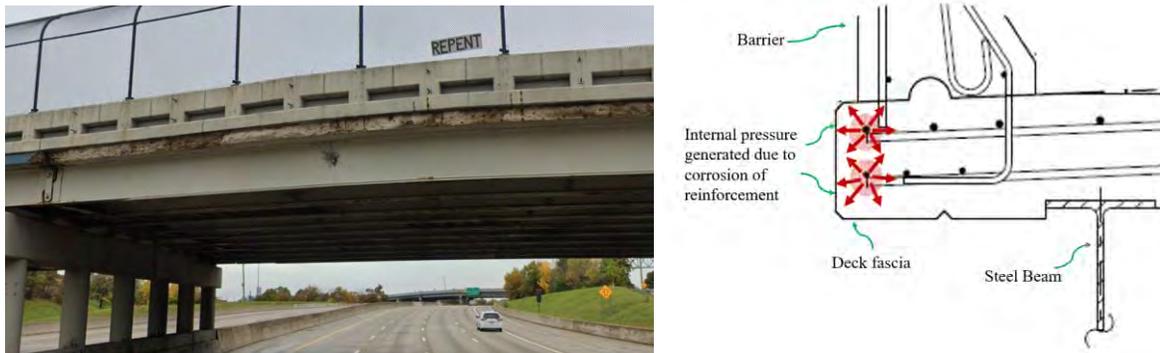
The relatively high supply of moisture in bridge deck fascias often causes them to deteriorate more quickly than other portions of the bridge. This causes the fascia concrete to become debonded from the reinforcement and fall, posing a safety hazard to traffic or pedestrians beneath the bridge. An example of a deteriorated bridge deck fascia is shown in Fig. 1.1 which shows signs of corrosion in deck reinforcement. The current Michigan Department of Transportation (MDOT) maintenance strategy is to avoid patching these areas, since overhead patches can later spall off, posing the same safety risk as the original fascia failure. Rather, delaminated concrete is removed to minimize the potential of falling debris. However, this practice leaves the fascia reinforcement exposed, resulting in corrosion and further degradation.

Fig. 1.1 Example of deck fascia deterioration on McGraw Avenue Bridge over I-96 eastbound (detected by PI) and illustration of built-in pressures due to reinforcement corrosion

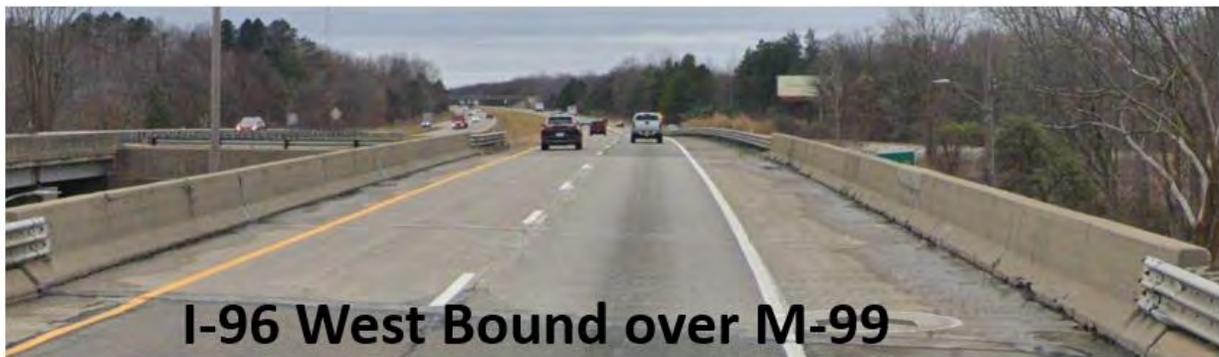
Fig. 3.3 Illustration of the higher moisture near the barrier and deck fascia (image obtained from Google Maps)

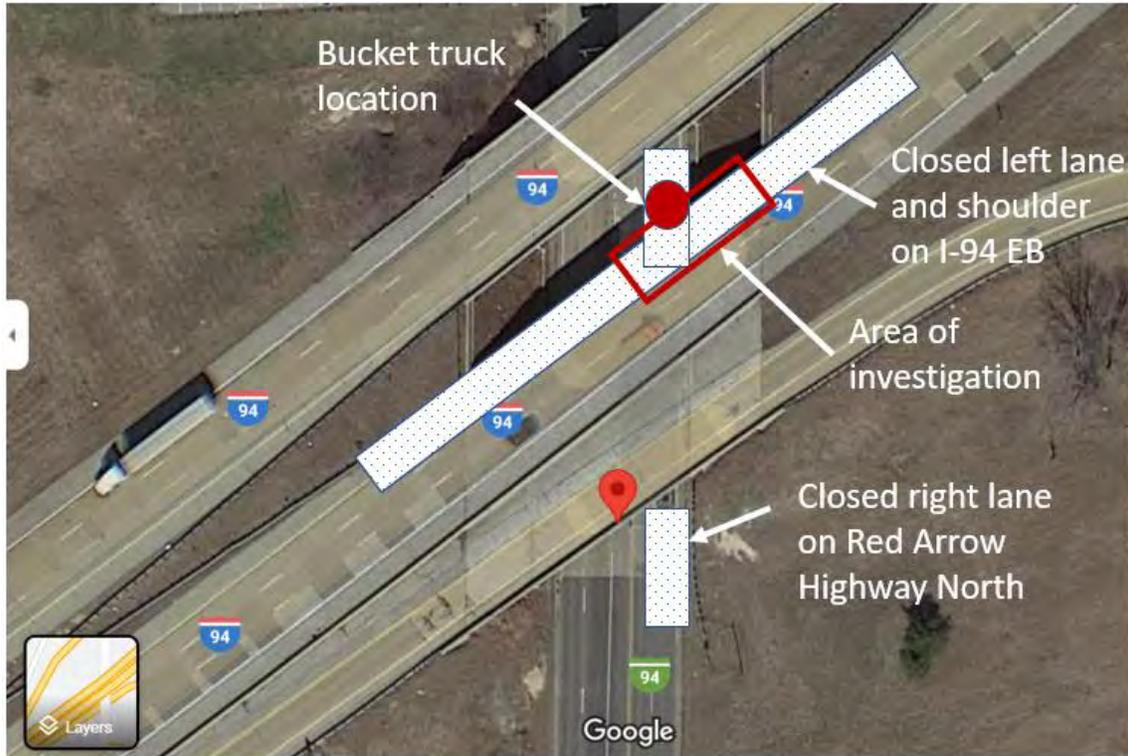
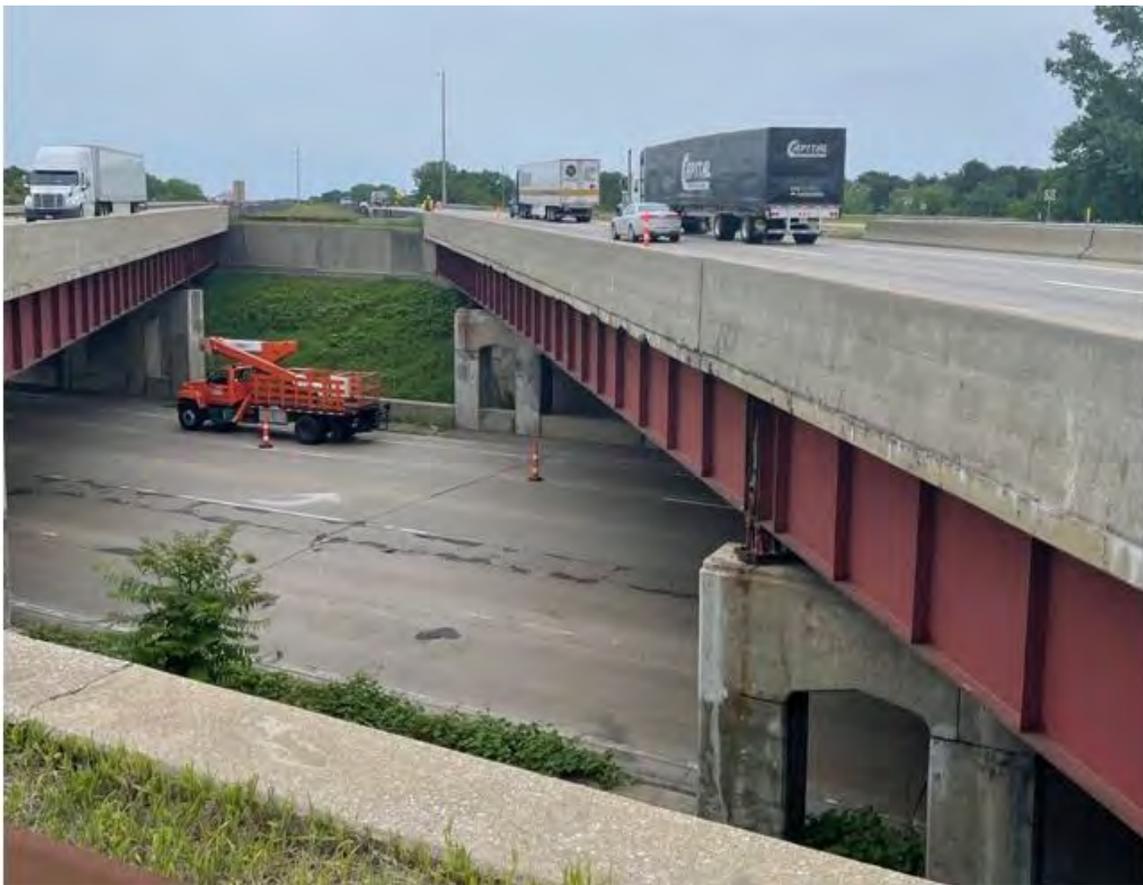
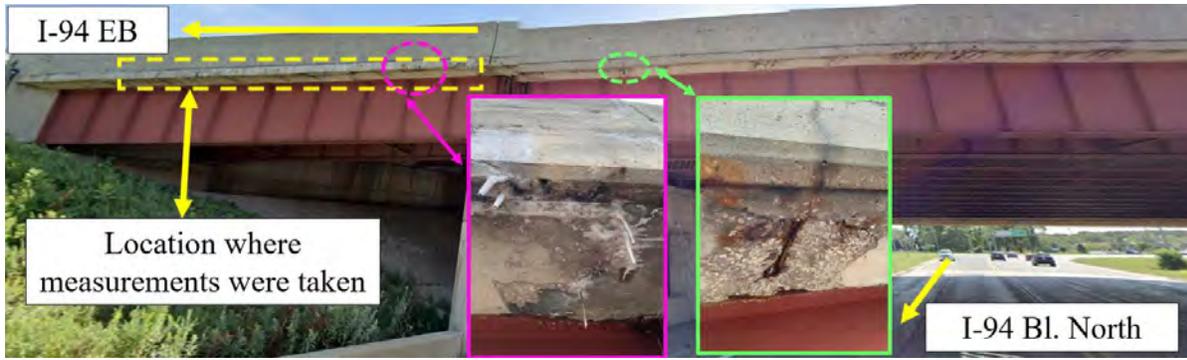
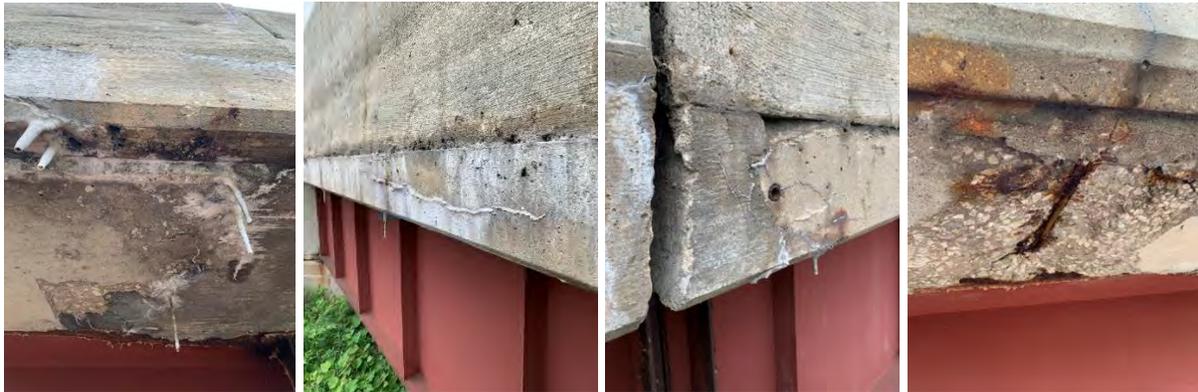
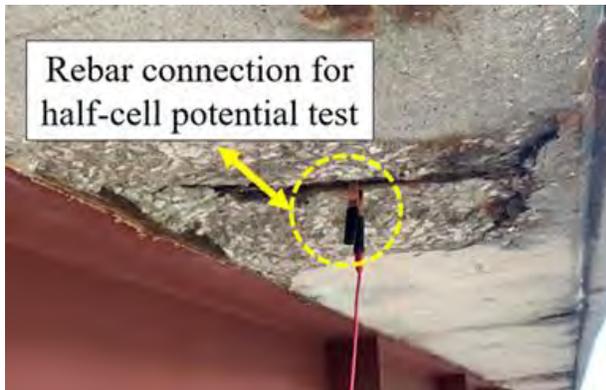
6) Southwest Region: I-94 EB over Red Arrow Highway North. The bridge featured a deteriorated deck fascia. Fig. 3.9a shows the location of the bridge, the area where the investigation was conducted, the location of the bucket truck, which was used to take measurements along the deck fascia, and the lanes that were closed to conduct the investigation. Fig. 3.9b shows the deteriorated deck fascia. Fig. 3.9c shows the location where the measurements were taken along the deck fascia, as well as two close-up photographs illustrating deterioration and corrosion of reinforcement. Fig. 3.9d shows additional close-up photographs illustrating deterioration, the presence of efflorescence, and reinforcement corrosion. Fig. 3.9e shows the location where the electrode was connected to the reinforcement to conduct half-cell potential measurements. Finally, Fig. 3.9f shows the location of the grid that was used to take measurements on the deck surface.

Fig. 3.9 Bridge on I-94 EB over Red Arrow Highway North: a) location of bridge, b) view of deck fascia, c) location where measurements were taken along the fascia, d) photographs of various deck fascia regions, e) connection of electrode to exposed reinforcement at the bottom of deck fascia, f) grid where measurements were taken on the deck surface

For the Bridge on I-94 EB over Red Arrow Highway, the clear cover measurements did not show a clear trend and varied from 2.6-4.4 in. The measurements taken along the deck fascia were lower

than those measured on the deck surface. Generally, clear cover measurements were larger than 3.0 in. The maximum measured clear cover was 4.33 in.

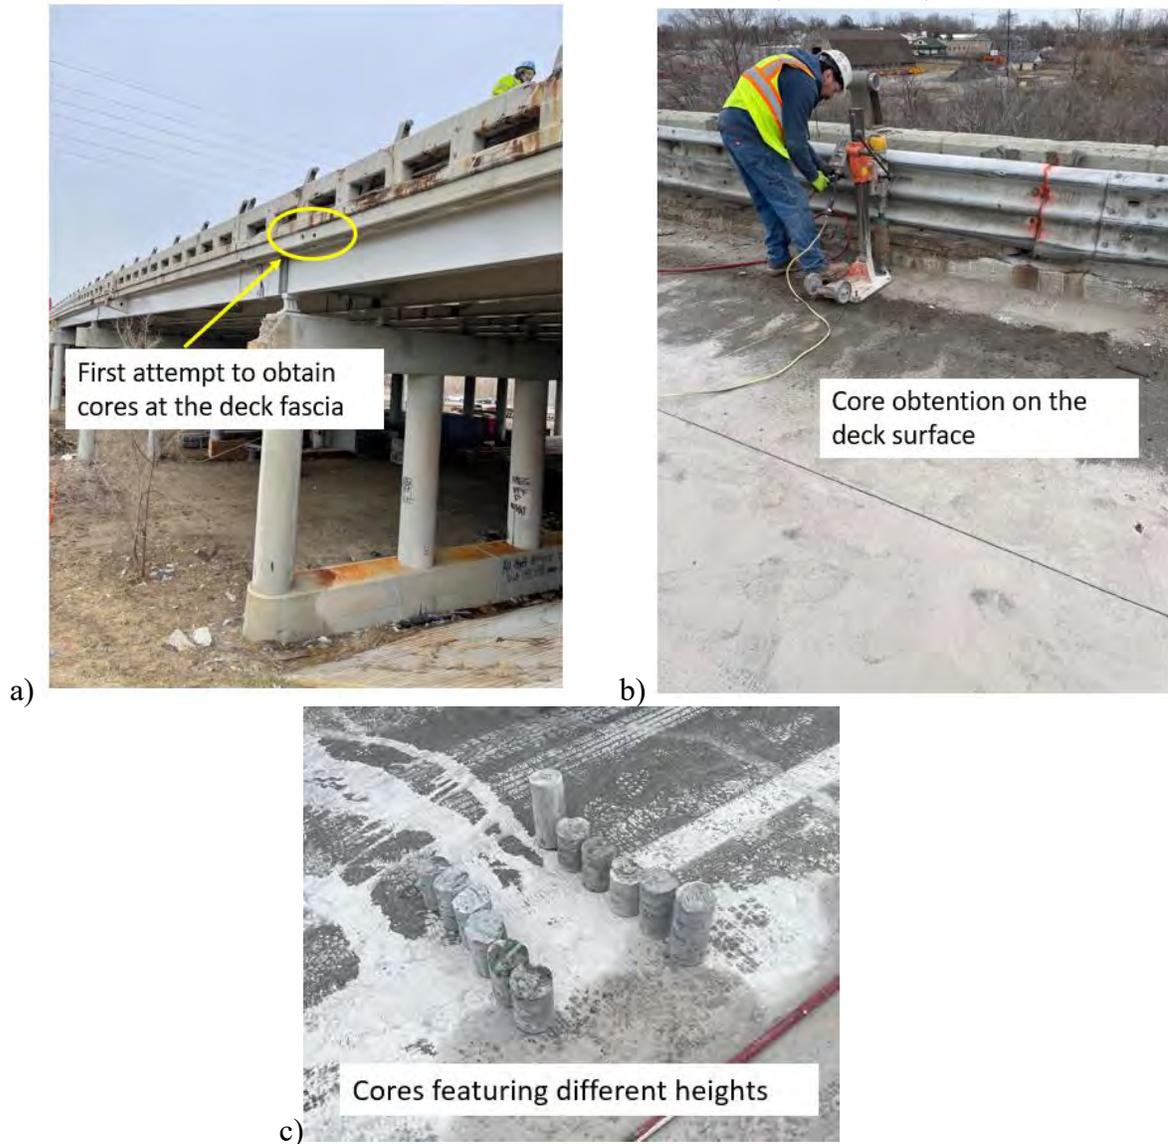
Fig. 3.15 a) First attempt to obtain cores at the deck fascia, b) core obtention on the deck surface, c) cores featuring different heights

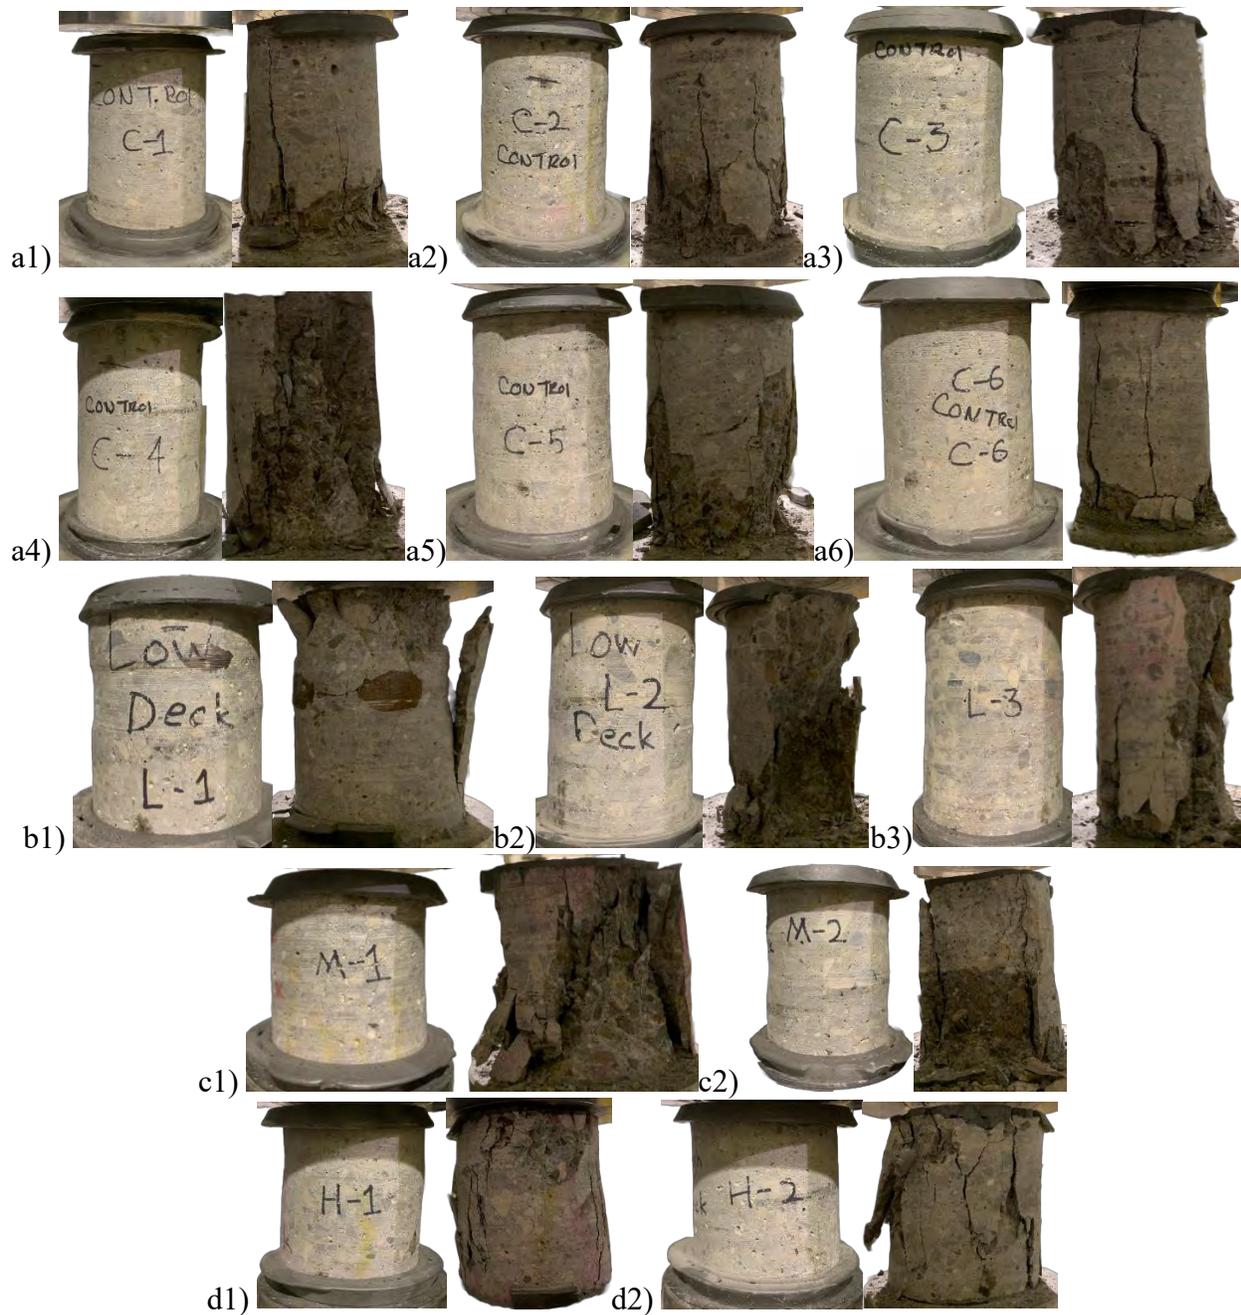
The compressive strength testing of cores was conducted in accordance with ASTM C39 (ASTM 2021). The ends of the specimens were sulfur capped. The conditions of the cores before and after testing are shown in Fig. 3.17. Compressive strength test results are shown in Table 3.4 as well as in Fig. 3.18. Measured compressive strengths were adjusted to account for core size based on ASTM C42 (ASTM 2020). The average compressive strengths for control, low, medium and high deterioration levels are 6.0, 6.9, 7.7 and 8.0 ksi with COVs 9.0%, 23.8%, 29.0% and 1.6%, respectively. The average compressive strength for all cores is 6.8 ksi with 19.4% COV. According to the MiBridge Database, the deck concrete compressive strength for I-69 over Fenton Road bridge is specified as 3 ksi. Therefore, the measured core compressive strength was well above the

specified value. The results suggest that there is no correlation between the measured compressive strength and the observed level of deterioration at the deck fascia. This is explained by the fact that the cores were obtained near the toe of the barrier rather than along the edge of the deck fascia due to difficulties encountered with horizontal core obtention. These results suggest that the deterioration of the deck is limited to the deck fascia and does not extend to the deck region in the vicinity of the toe of the barrier – at least from a concrete compressive strength perspective.

In some specimens, such as M-2, it appears that there are two layers of concrete because the colors at the top and bottom regions of the specimen appear to be different. Based on the information provided in the MiBridge database it appears that an overlay was installed in the bridge deck in 2003 thus explaining the presence of two layers. Since the two layers are connected in series the compressive strength test represents the strength of the weaker material.

Fig. 3.17 Core specimens before and after testing: a) Control; b) Low; c) Medium; and d) High

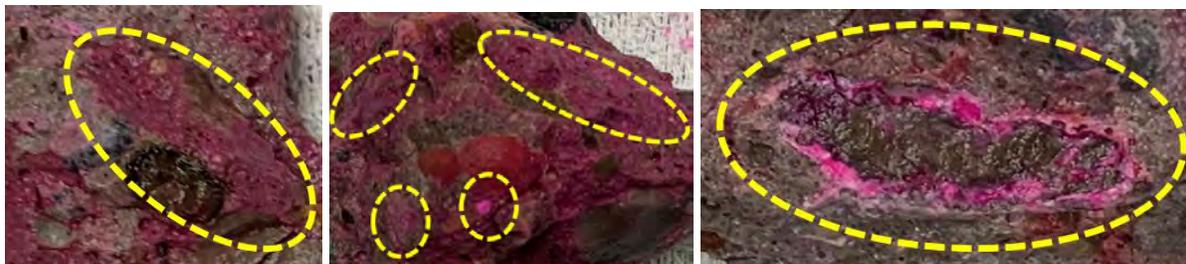
Fig. 3.35 ASR test results for the cores obtained from the bridge located in North Region on County Road over I-75

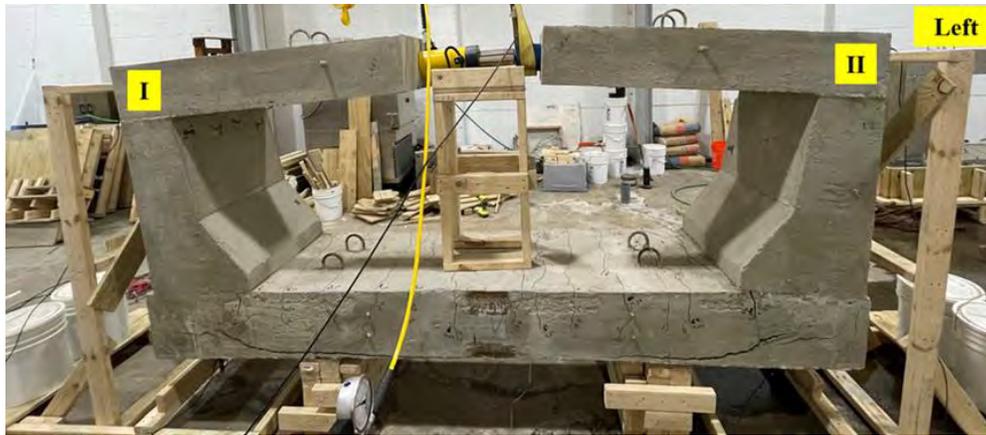
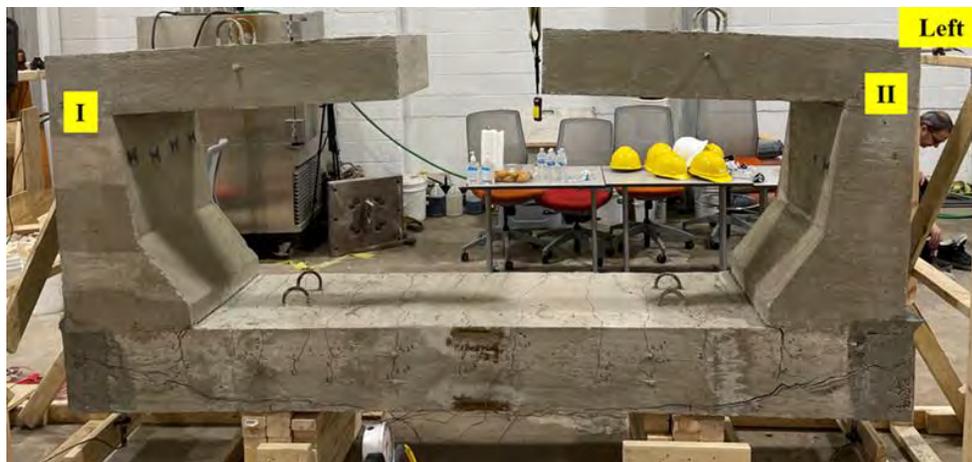
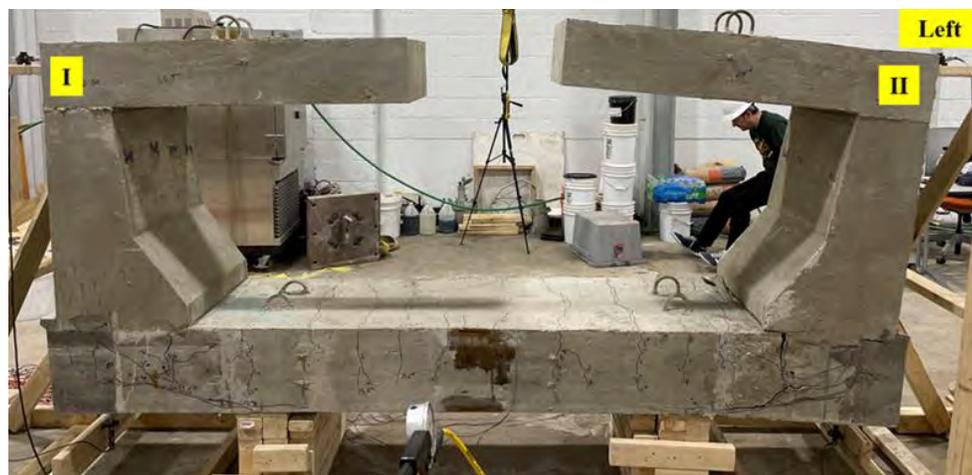
Fig. 6.29 Photographs and video links for all three tested specimens – photographs are taken after failure: a) Control, b) SCC, c) FRSCC

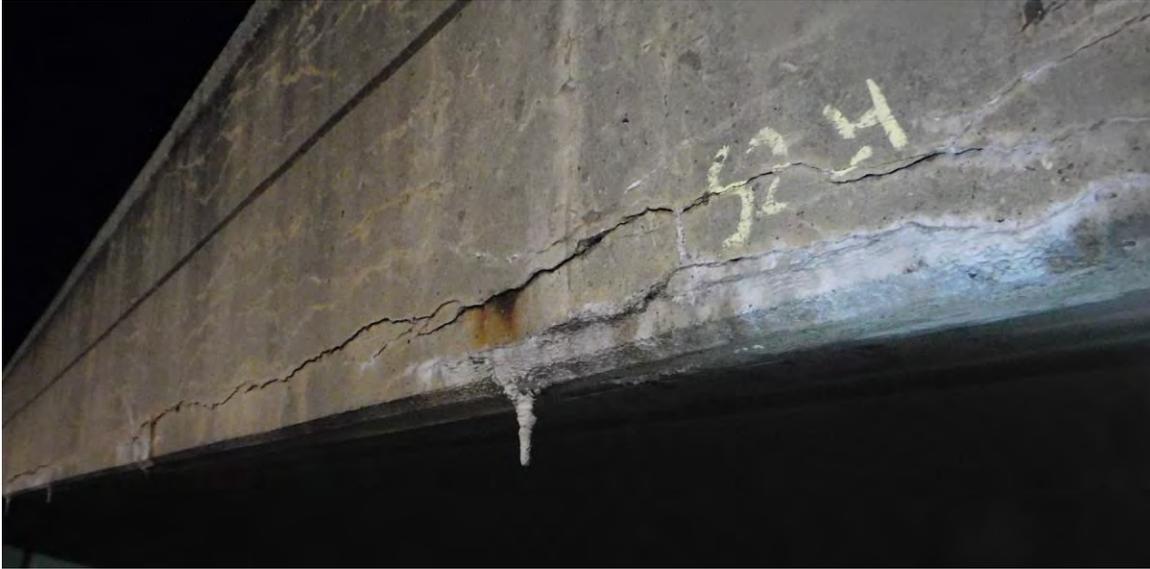
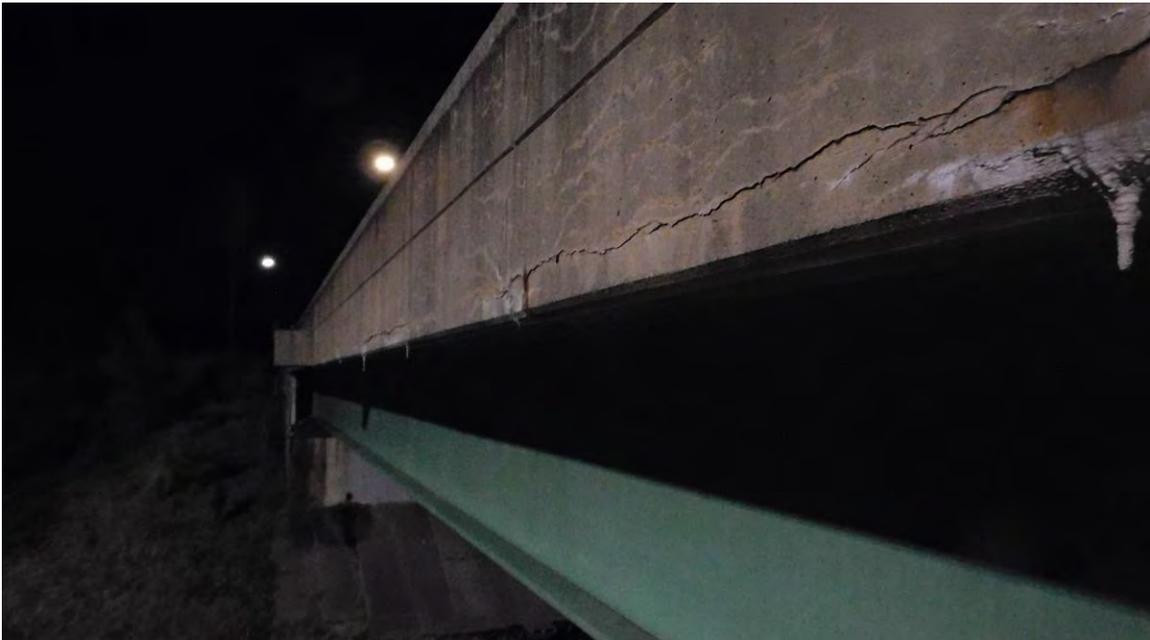
Question 2: In bridges where these details have been implemented, have you observed any deterioration in the bridge deck fascia? **Yes, I have been informed that we still do have this problem on some of our bridges (see attached picture). This being a cold joint between the parapet and deck, water does make its way through. If the key was reversed and went up, this possibly could help slow down the migration of water seepage. Also, not sure how good a job contractors are doing at putting the bonding agent along this joint before they pour which could be another contributing factor.**

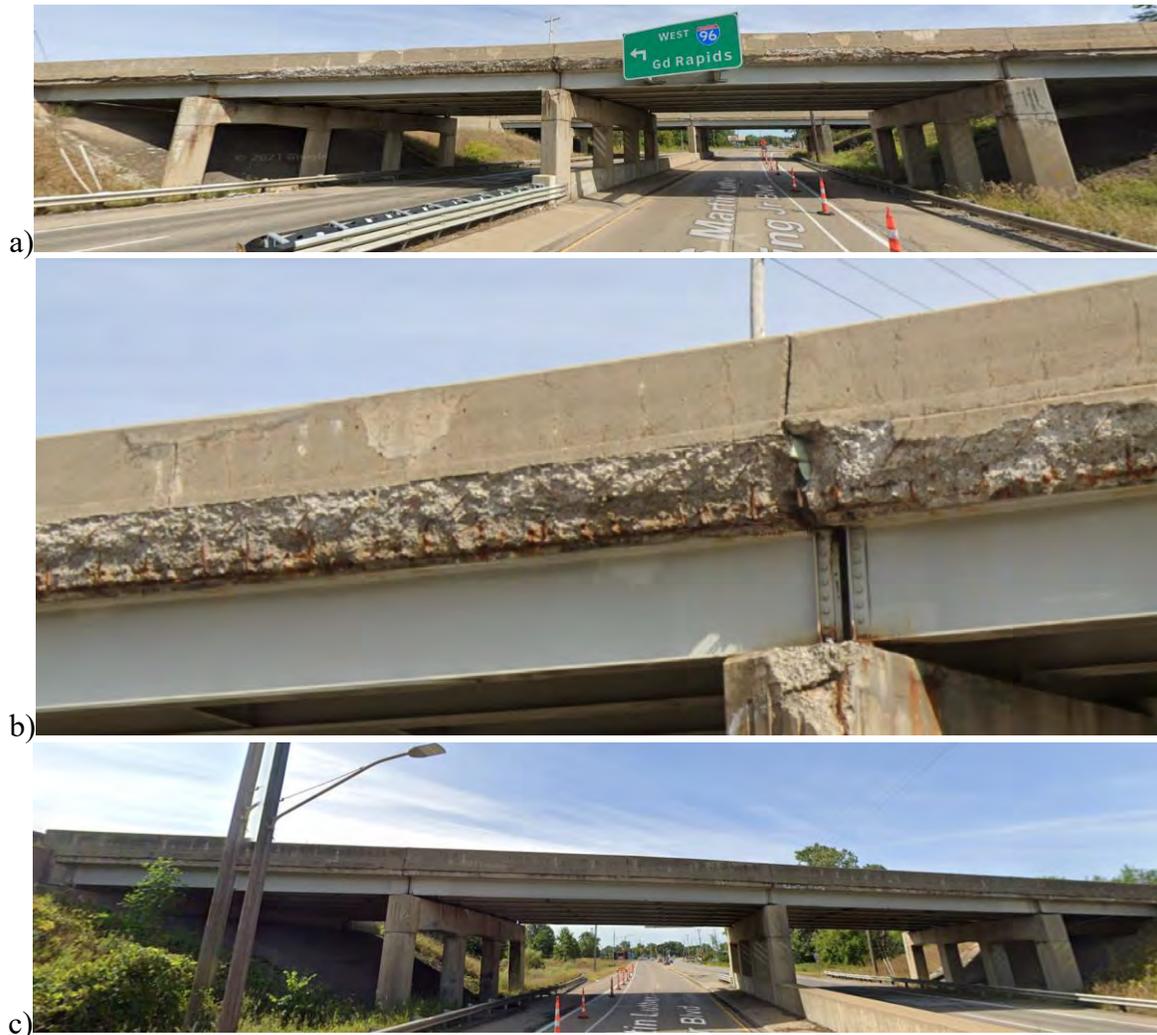
Fig. D.1 I-96 EB over M-99: a-b) lower side; c) upper side

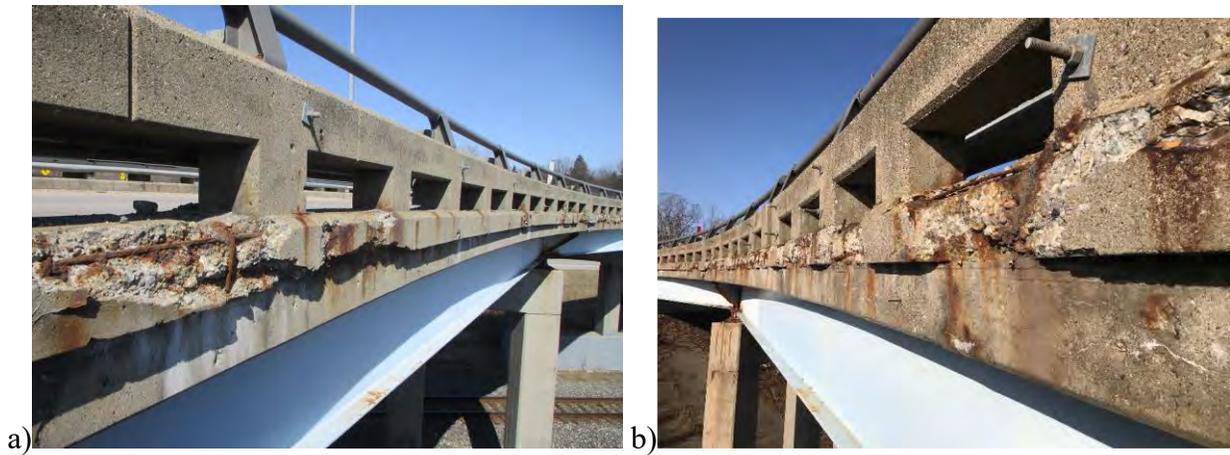
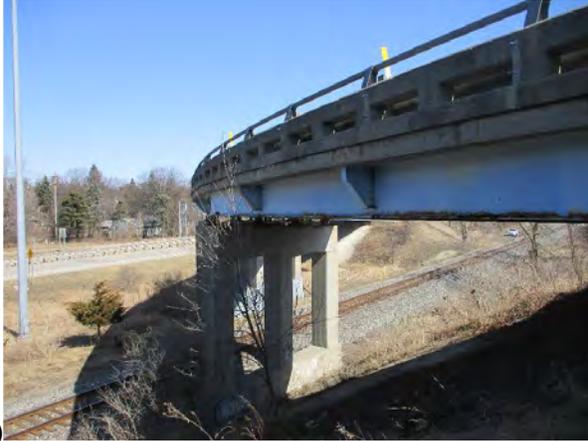
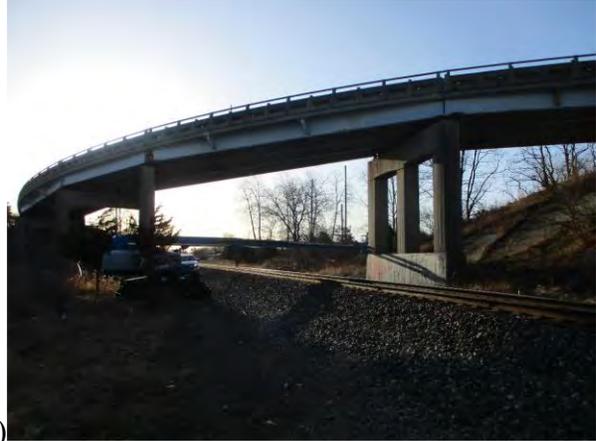
c) d)
Fig. D.2 I-496 WB Ramp over CSX Railroad: a-b) lower side; c-d) upper side (obtained from MDOT inspection report conducted on 3/19/2021)

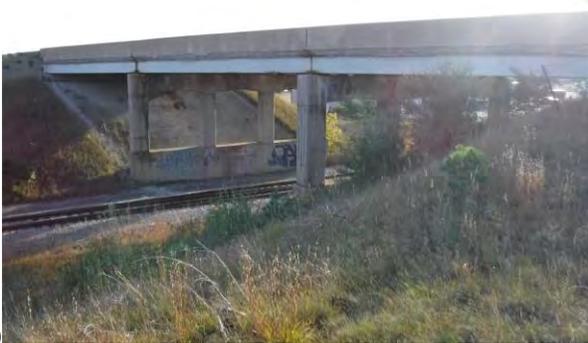
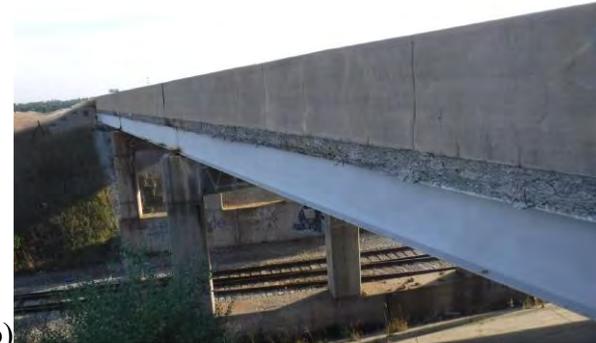
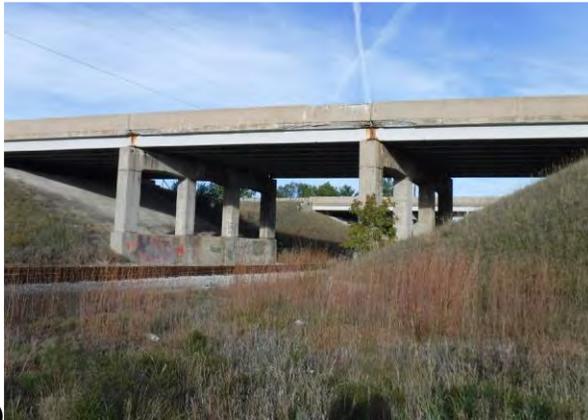
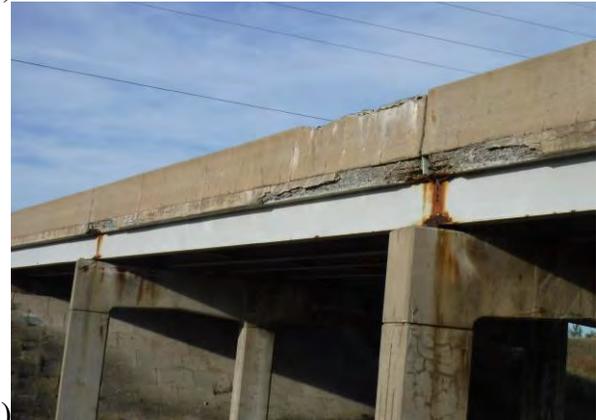
a) b) c) d)
Fig. D.3 I-75 NB over Lake State Railroad: a-b) lower side; c-d) upper side (obtained from MDOT inspection report conducted on 09/27/2021)

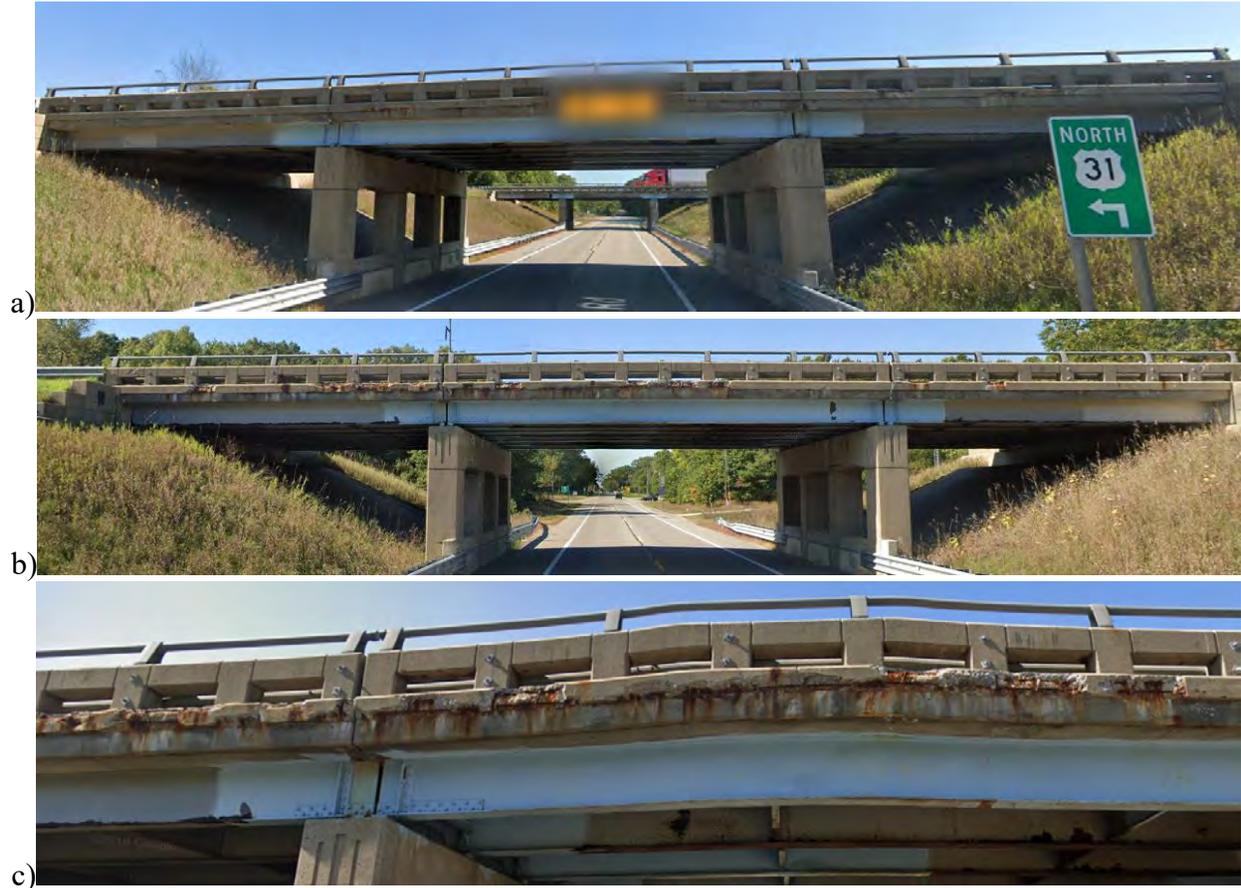
Fig. D.4 US-31 SB US-31 Business Route: a) lower side; b-c) upper side

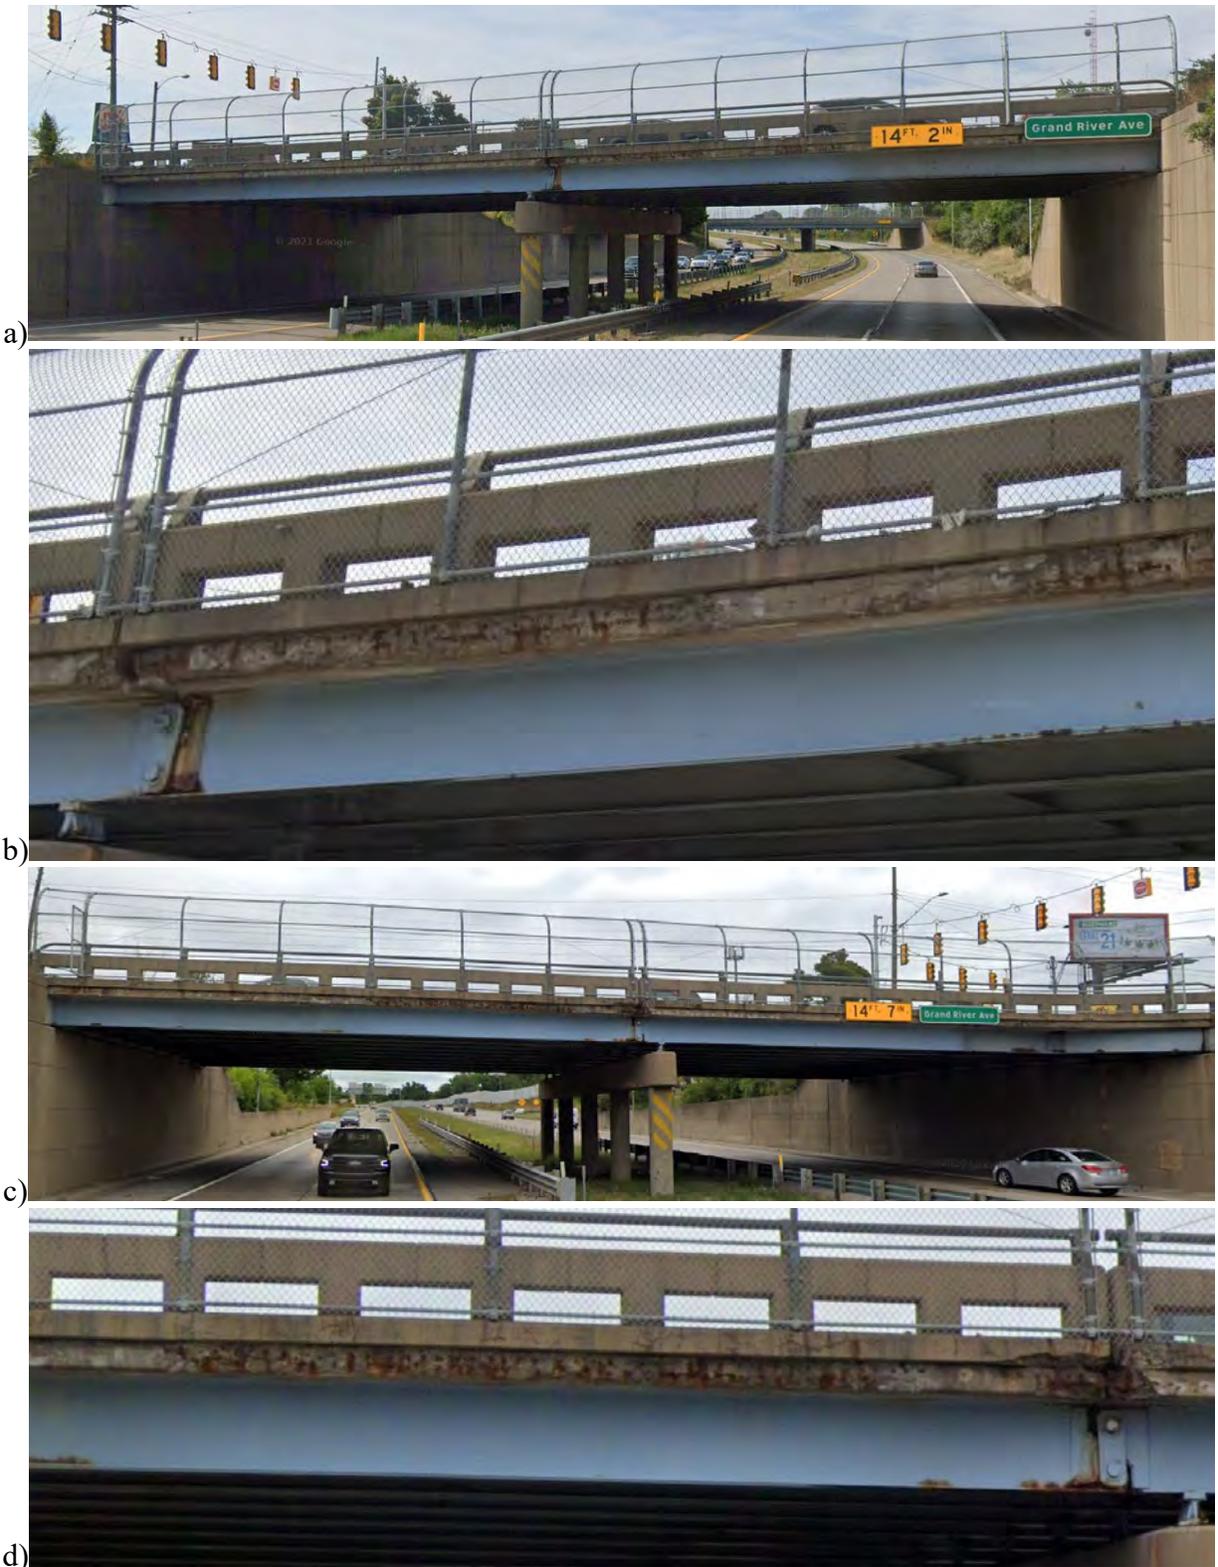
Fig. D.5 M-43 WB (Grand River) over US-127: a-b) lower side; c-d) upper side

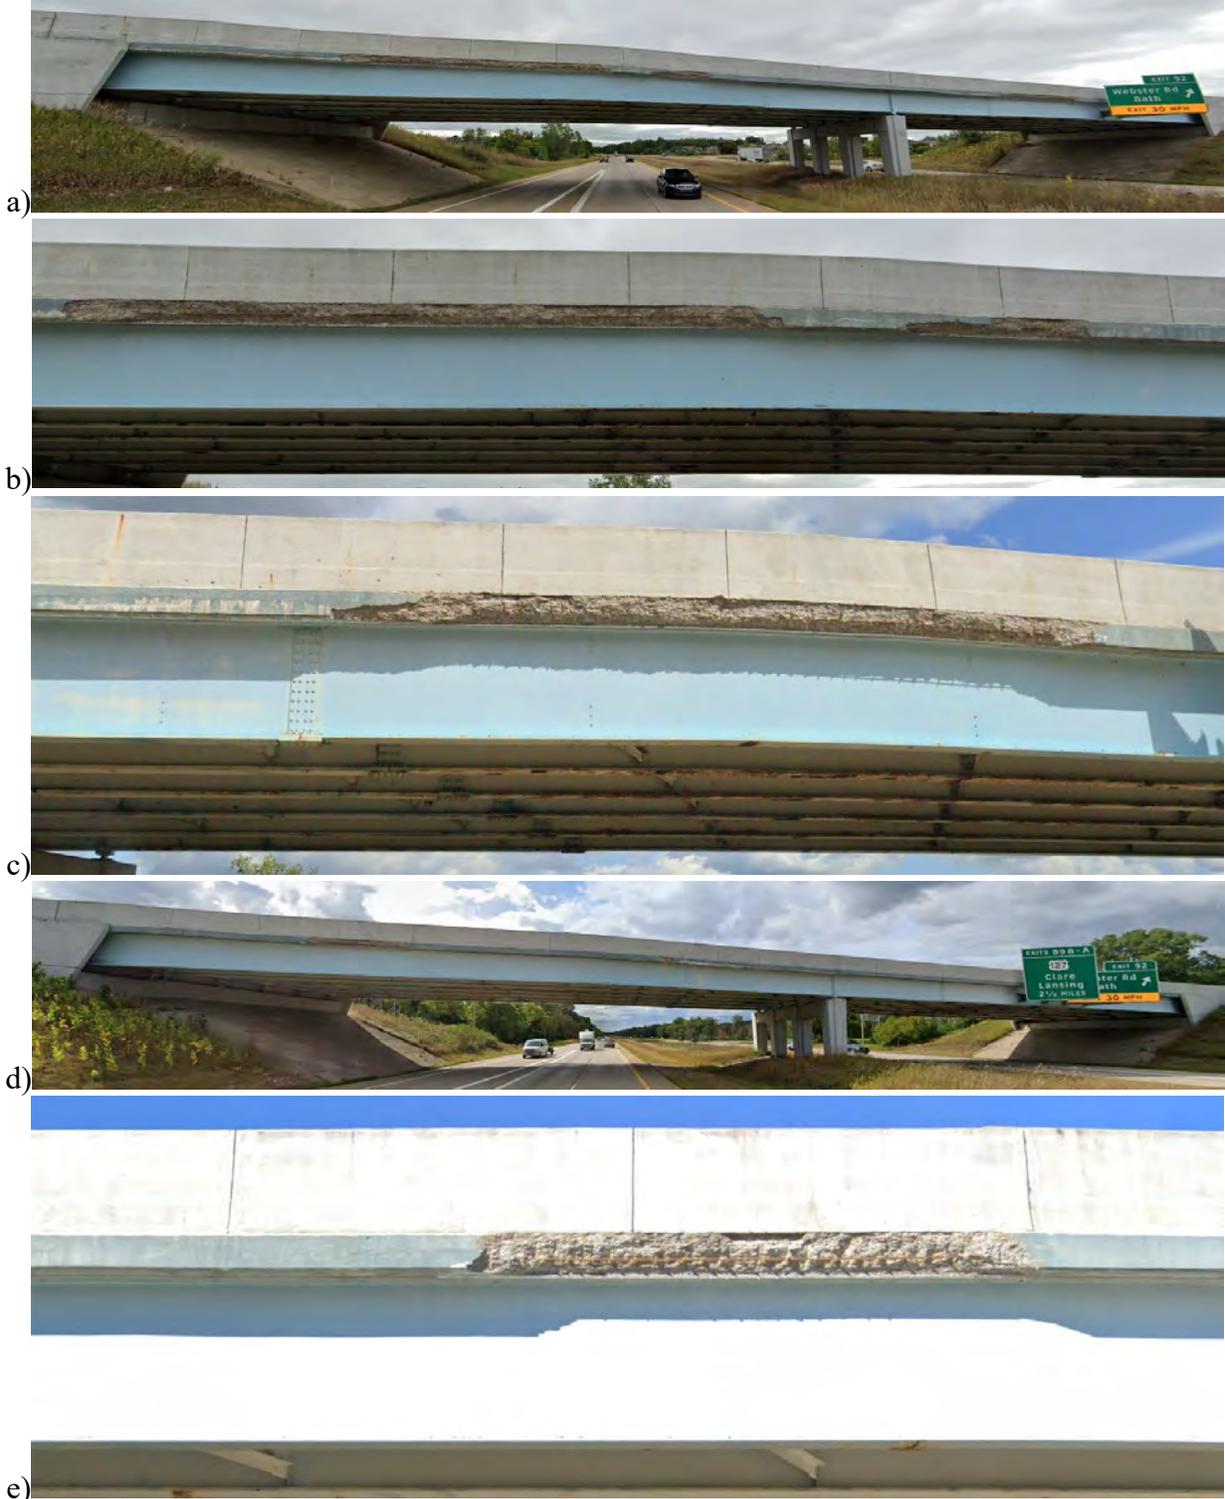
Fig. D.6 Webster Rd. over I-69: a-c) lower side; d-e) upper side

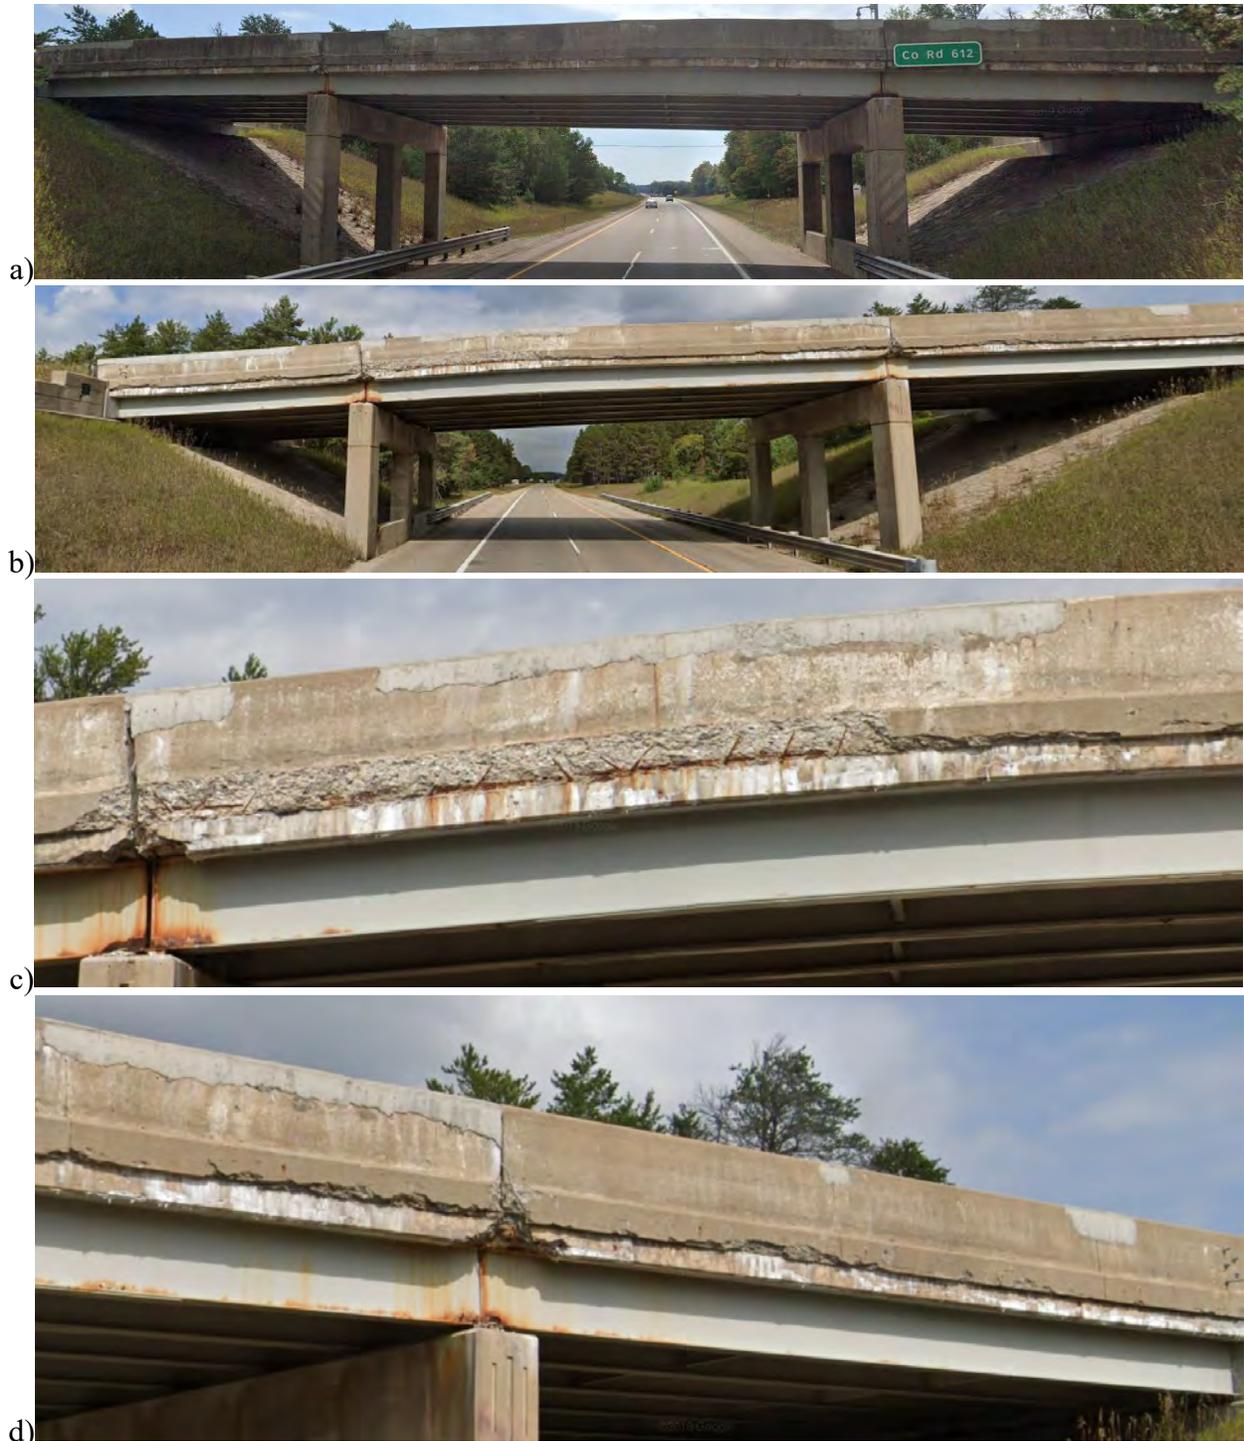
Fig. D.7 County Rd. 612 over I-75 SB: a) lower side; b-d) upper side
