Repair of Bridge Deck Fascias
OR22-002

Final Report

Michigan Department of Transportation

1. Report No. SPR-1730	2. Government Accession No. N/A	3. Recipient's Catalog No.	
4. Title and Subtitle Repair of Bridge Deck Fascias	5. Report Date 09/30/2023

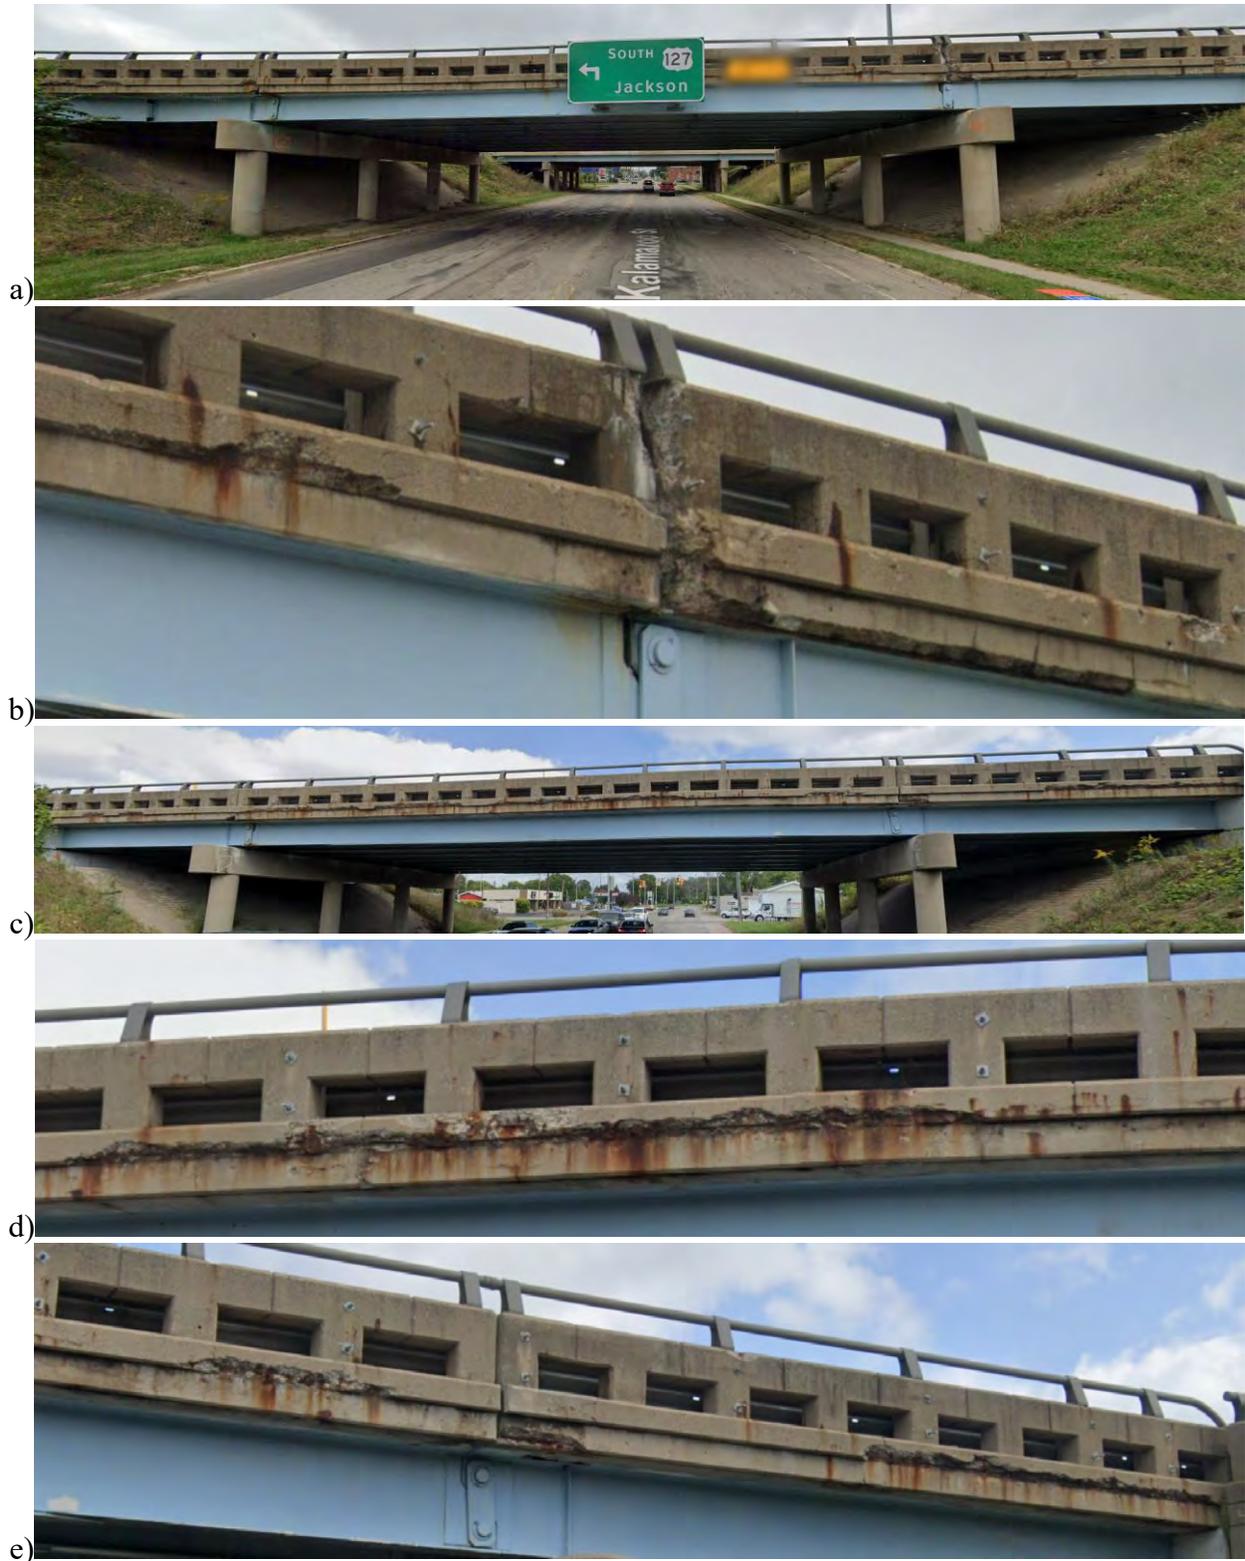
Fig. D.8 US-127 NB over Kalamazoo St.: a-b) lower side; c-e) upper side

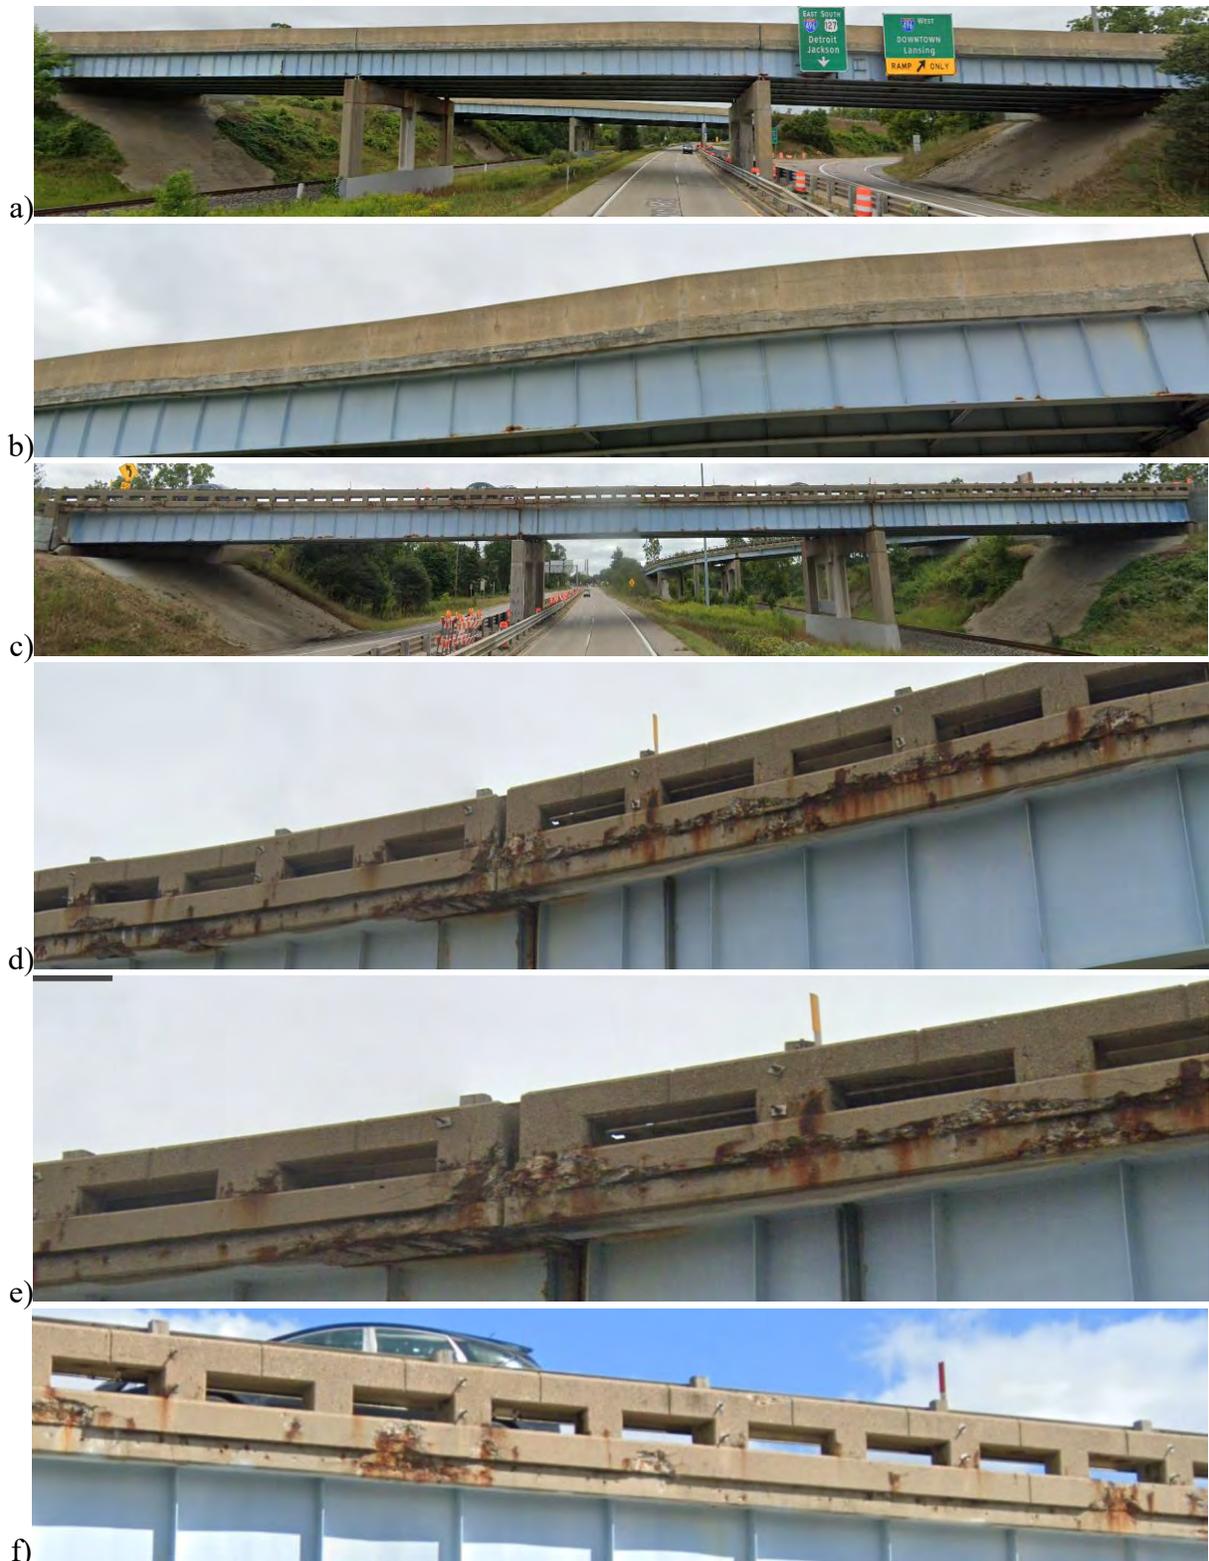
Fig. D.9 I-496 WB over CSX Railroad & Trowbridge Ramp: a-b) lower side; c-f) upper side

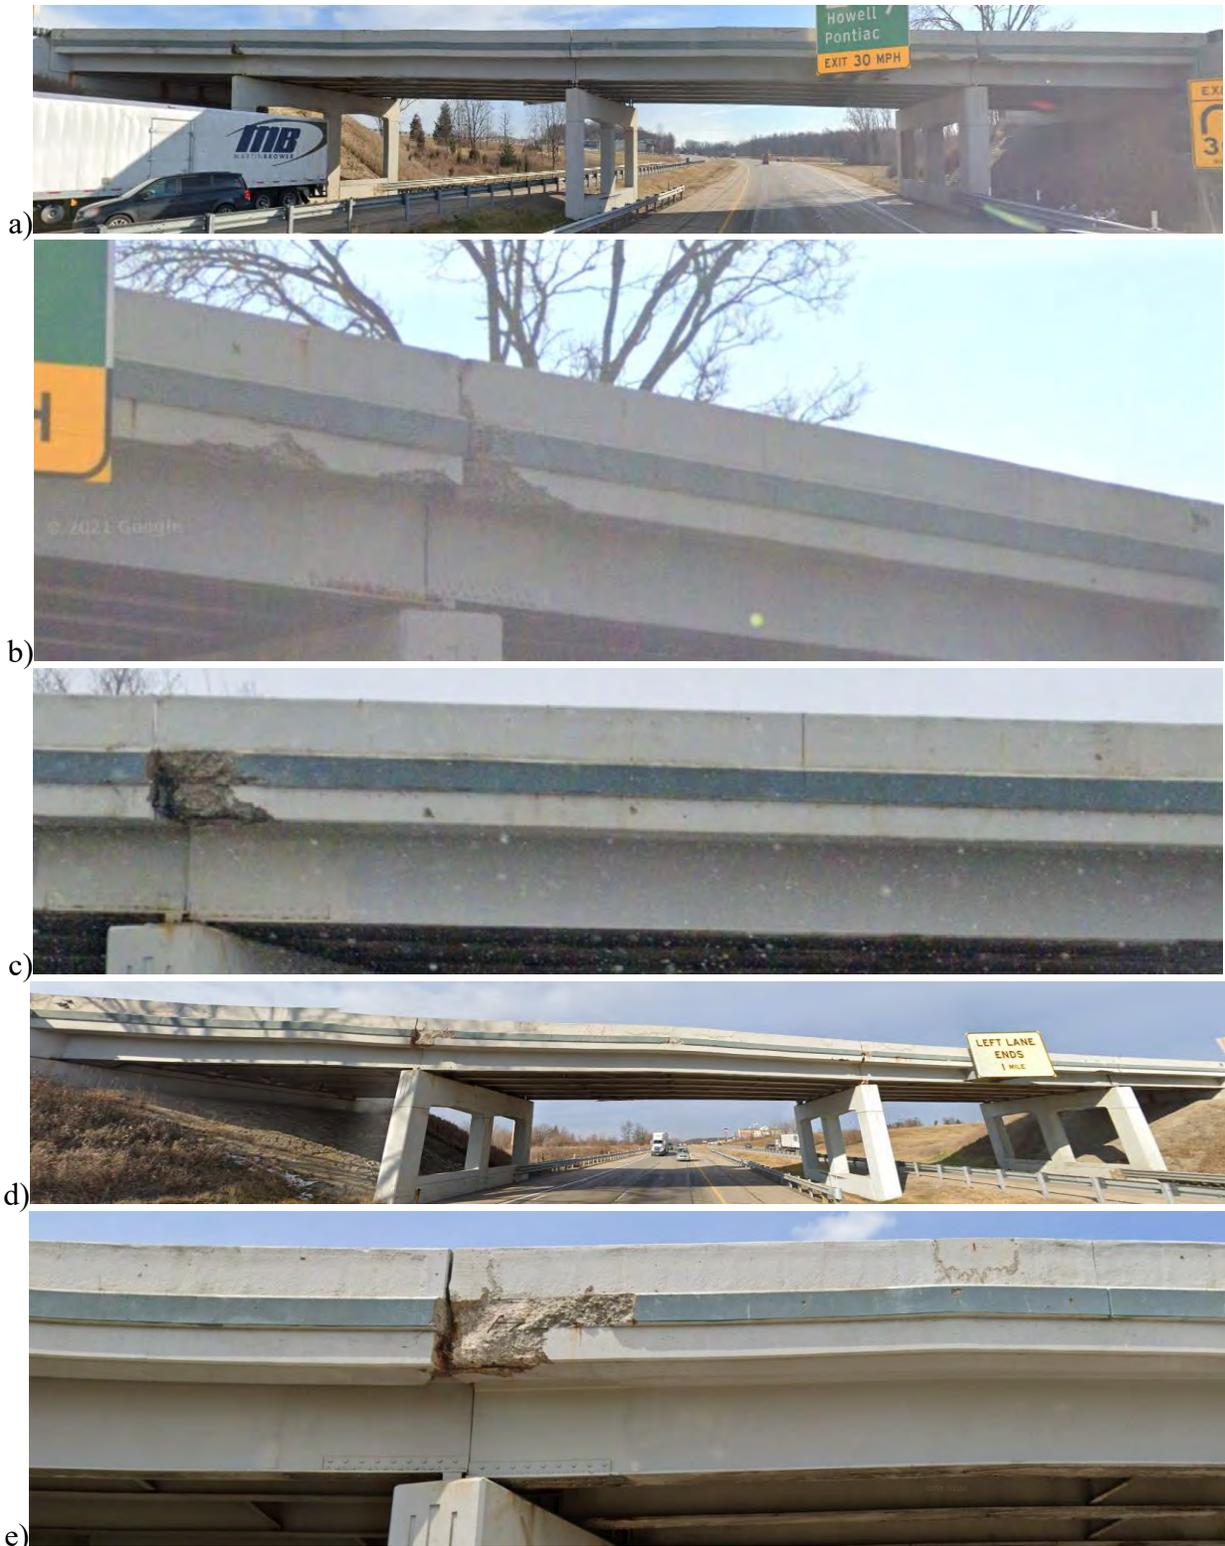
Fig. D.11 M-59 / I-96 Bl. over I-96: a-c) lower side; d-e) upper side

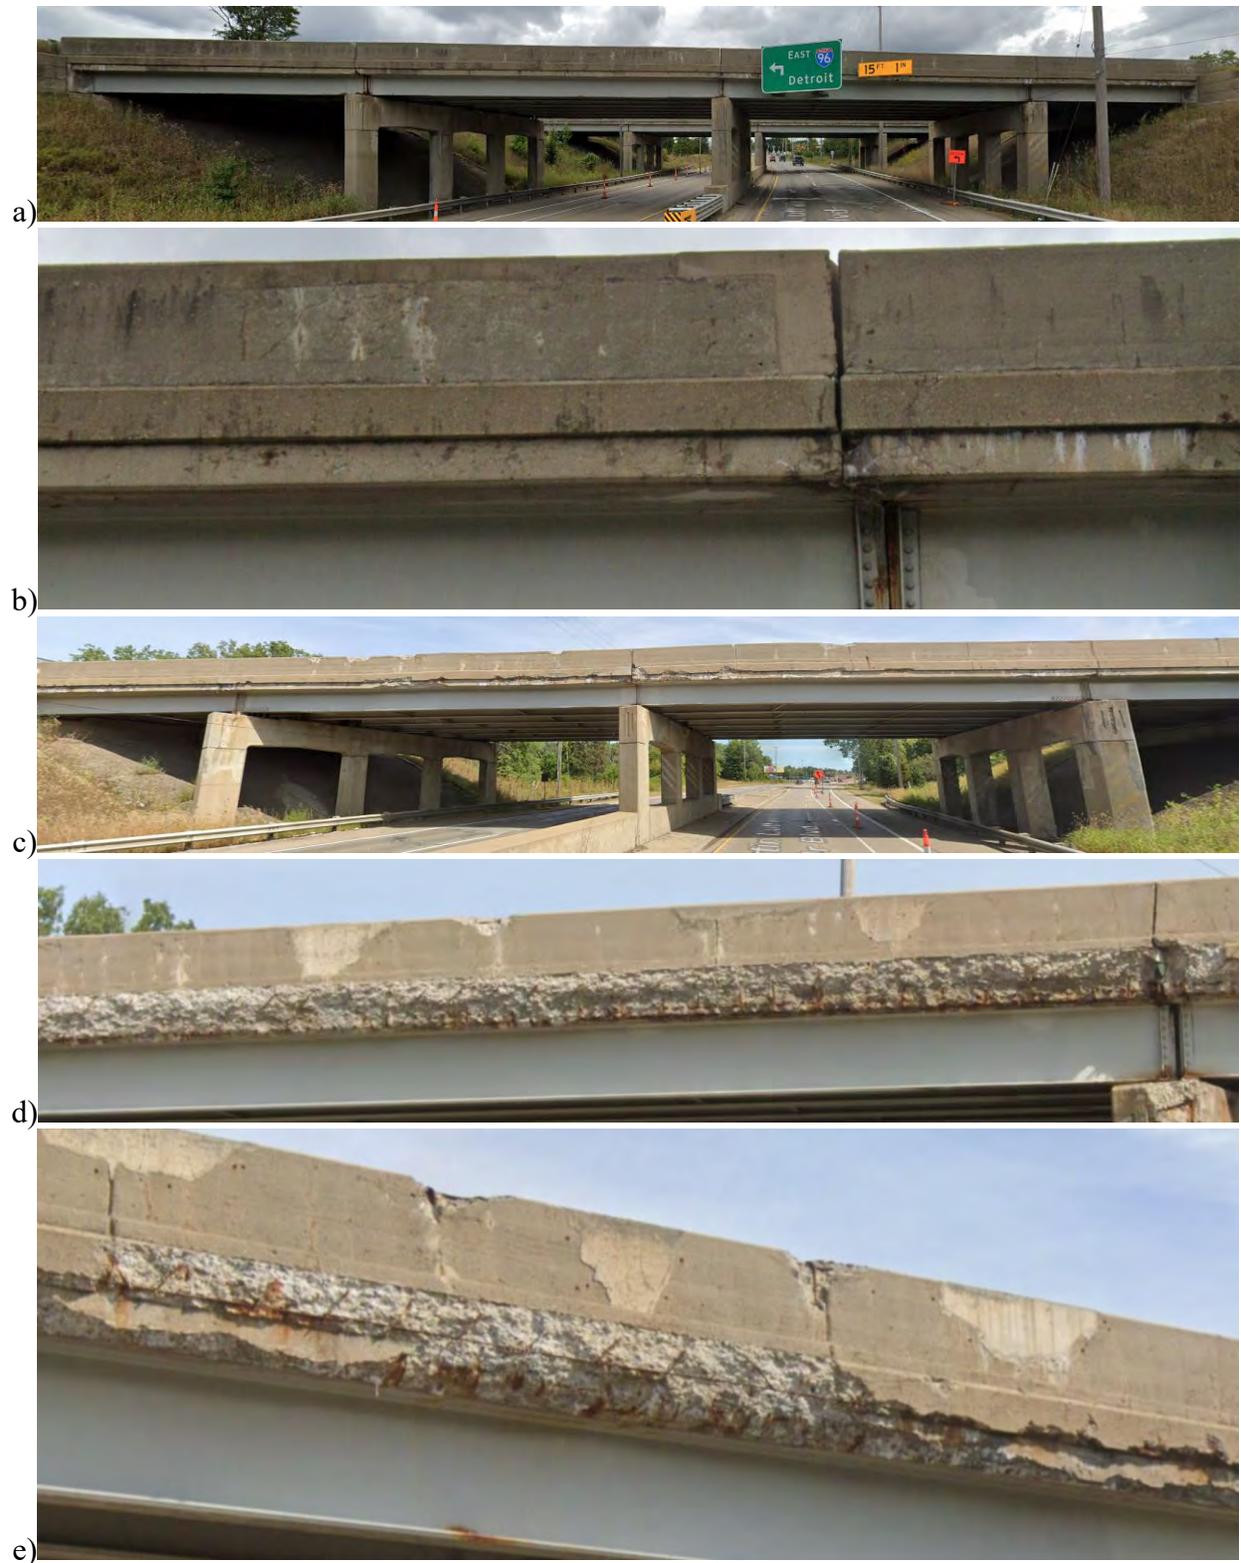
Fig. D.12 I-96 WB over M-99: a-b) lower side; c-e) upper side

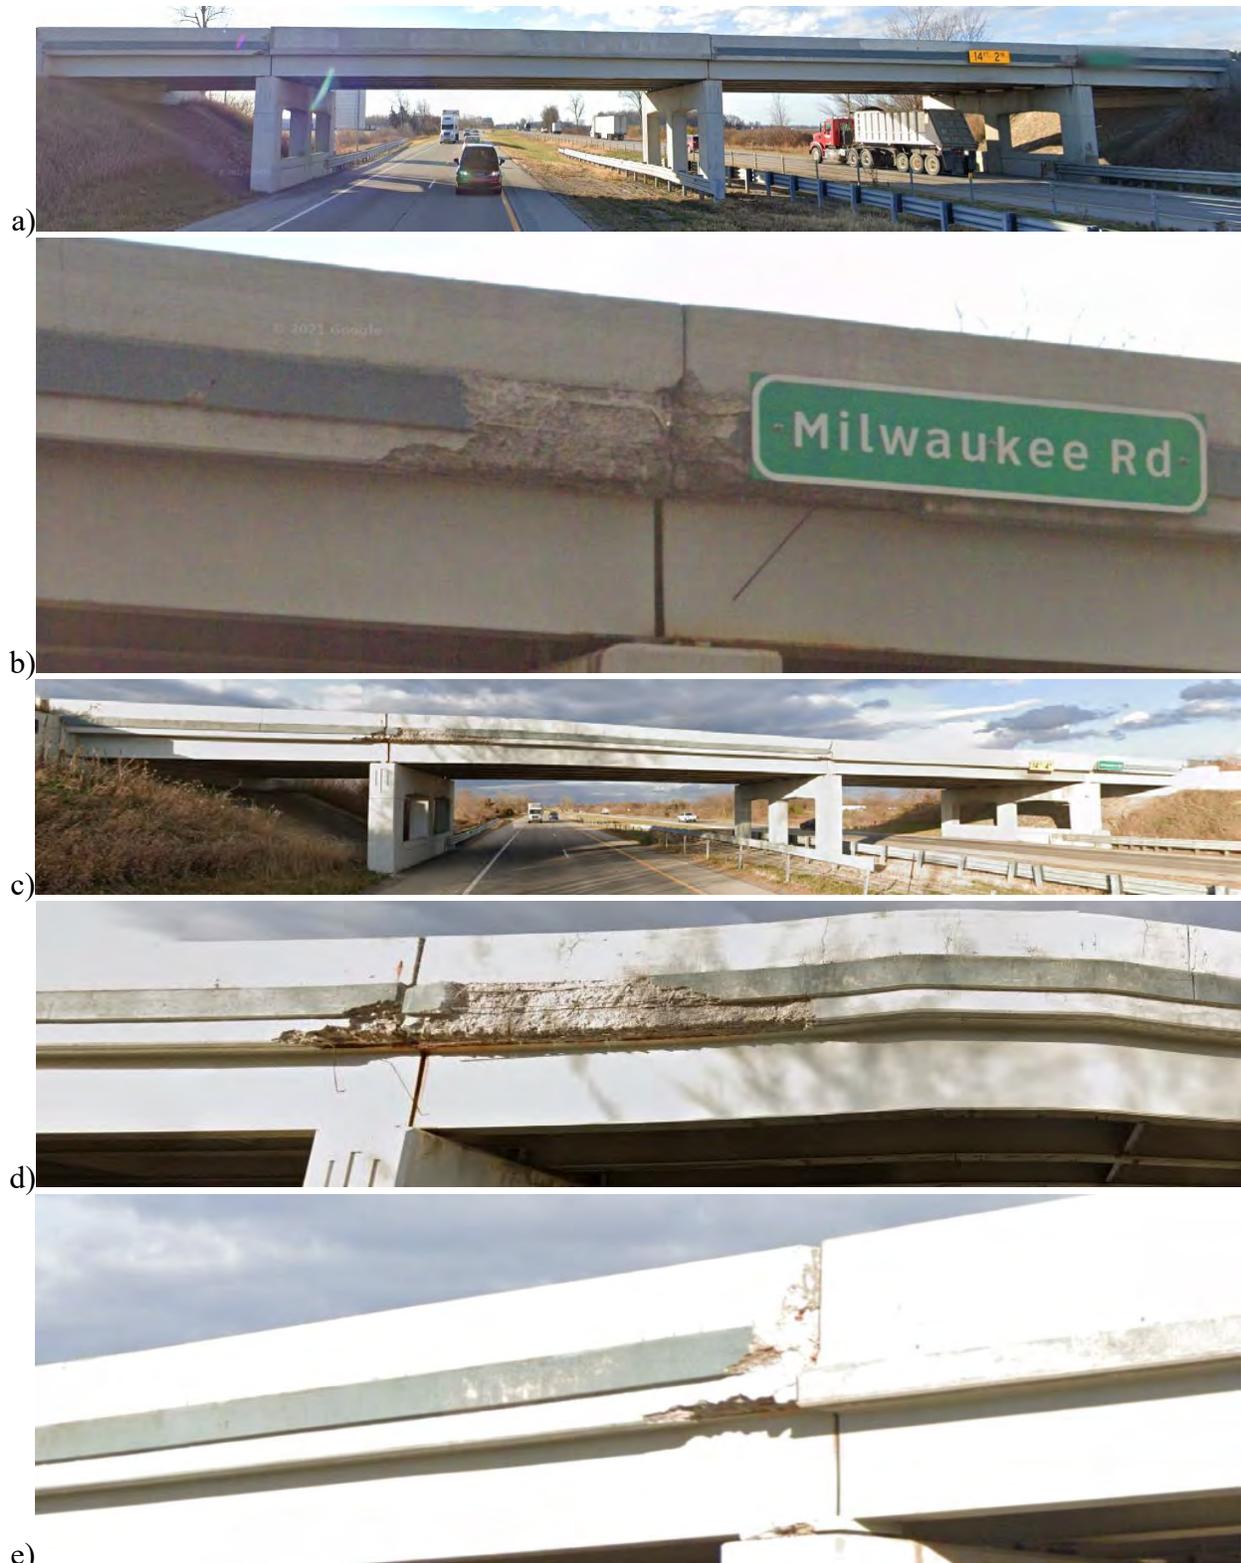
Fig. D.13 Milwaukee Rd. over US-23: a-b) lower side; c-e) upper side

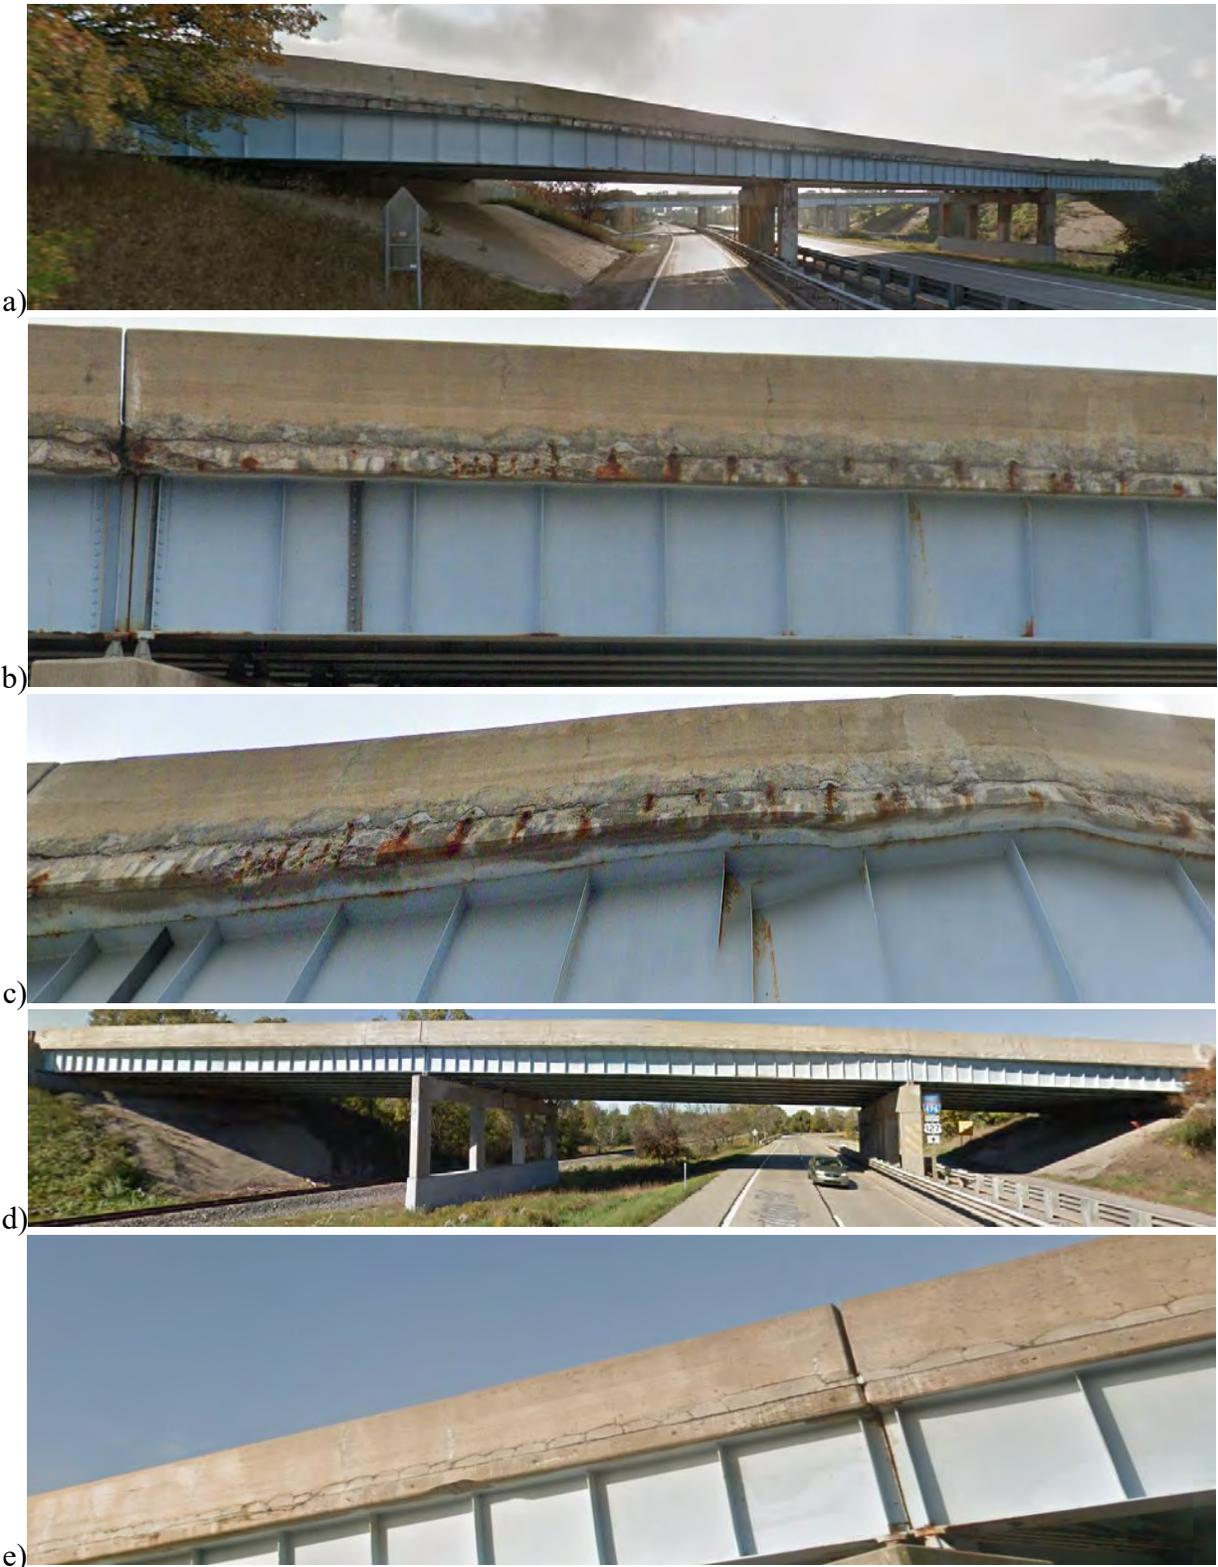
Fig. D.14 I-496 EB over CSX Railroad & Trowbridge Ramp: a-c) lower side; d-e) upper side

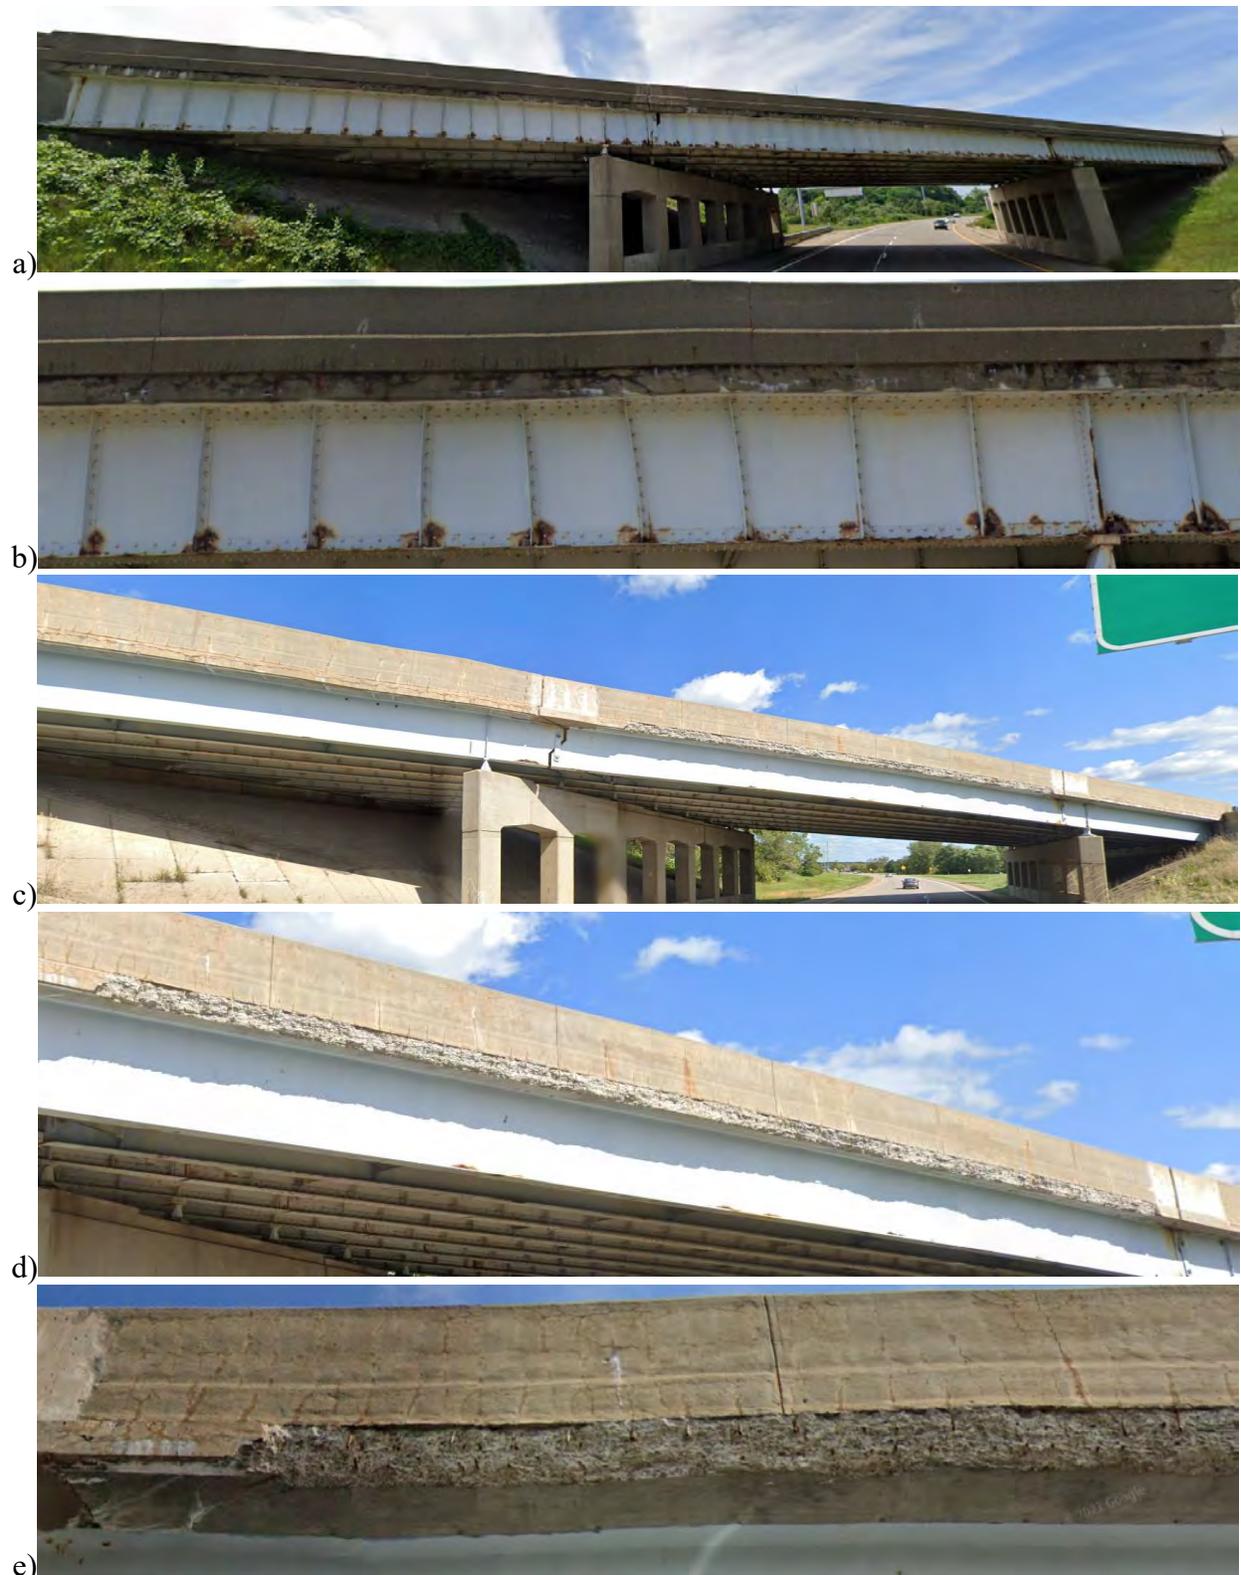
Fig. D.15 I-296 WB connector over I-96 EB: a-b) lower side; c-e) upper side

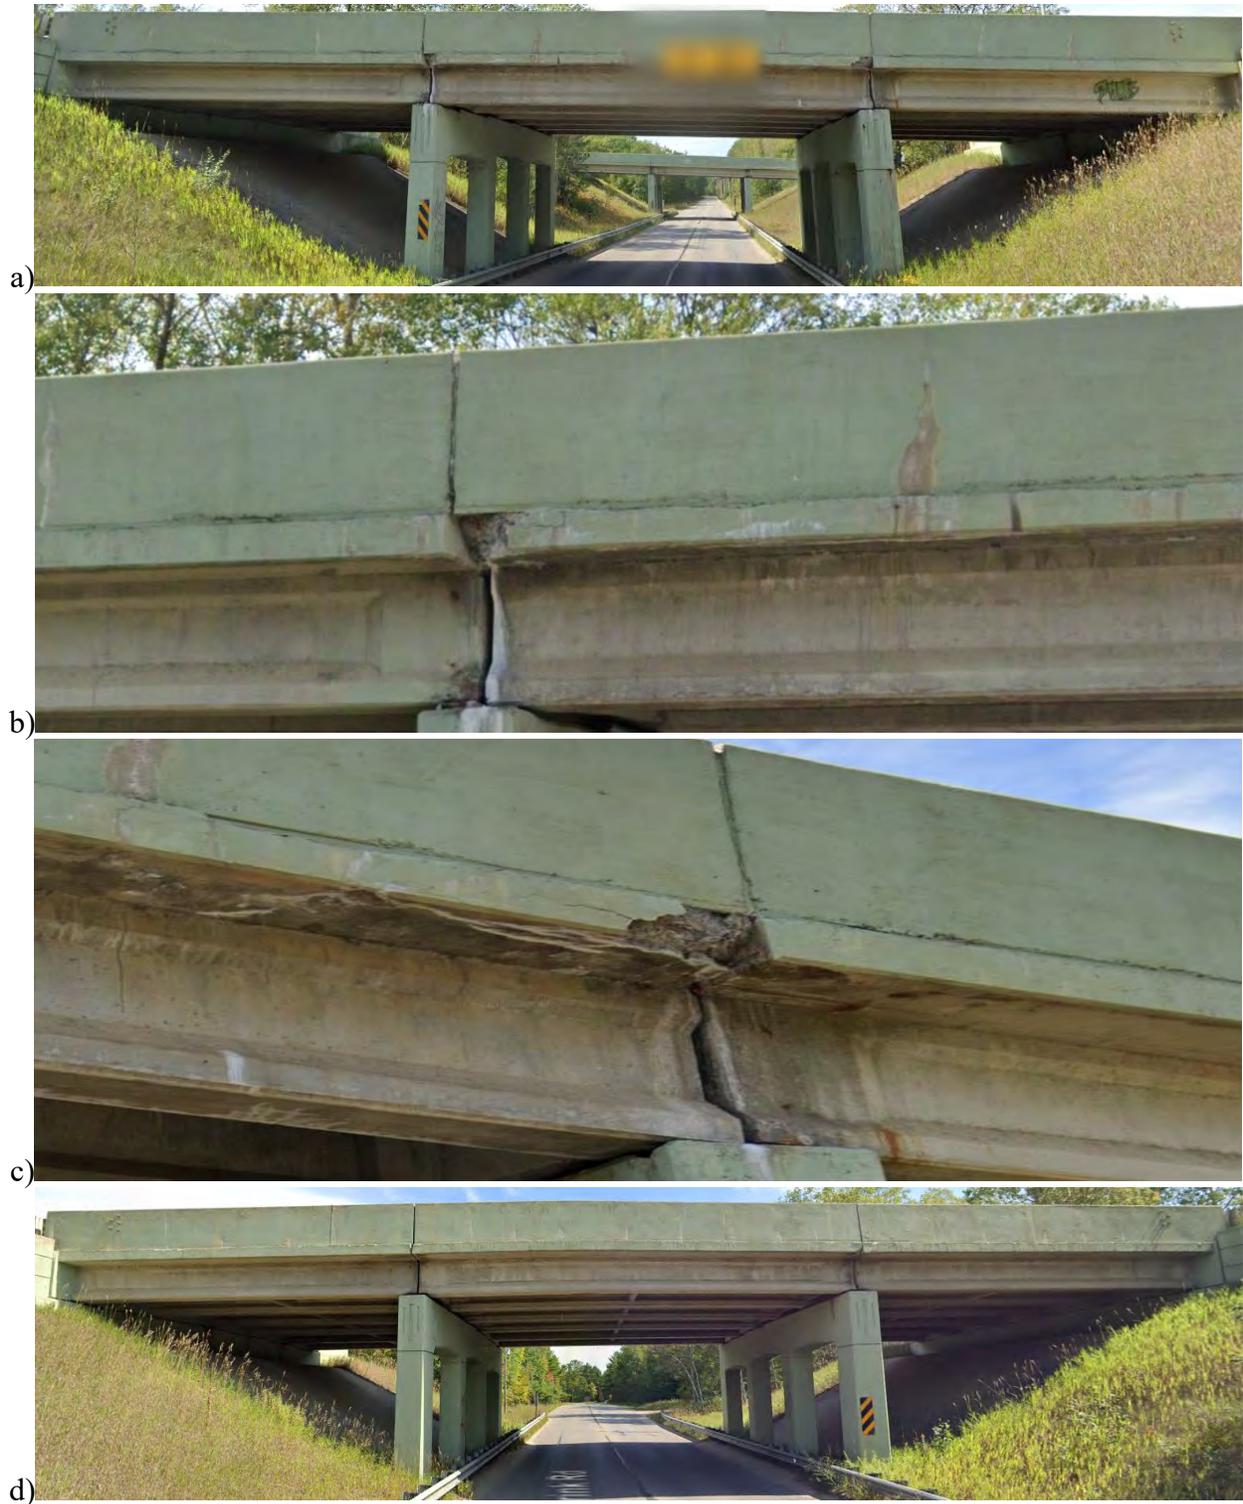
Fig. D.16 I-75 NB over Charles Brink: a-c) lower side; d) upper side

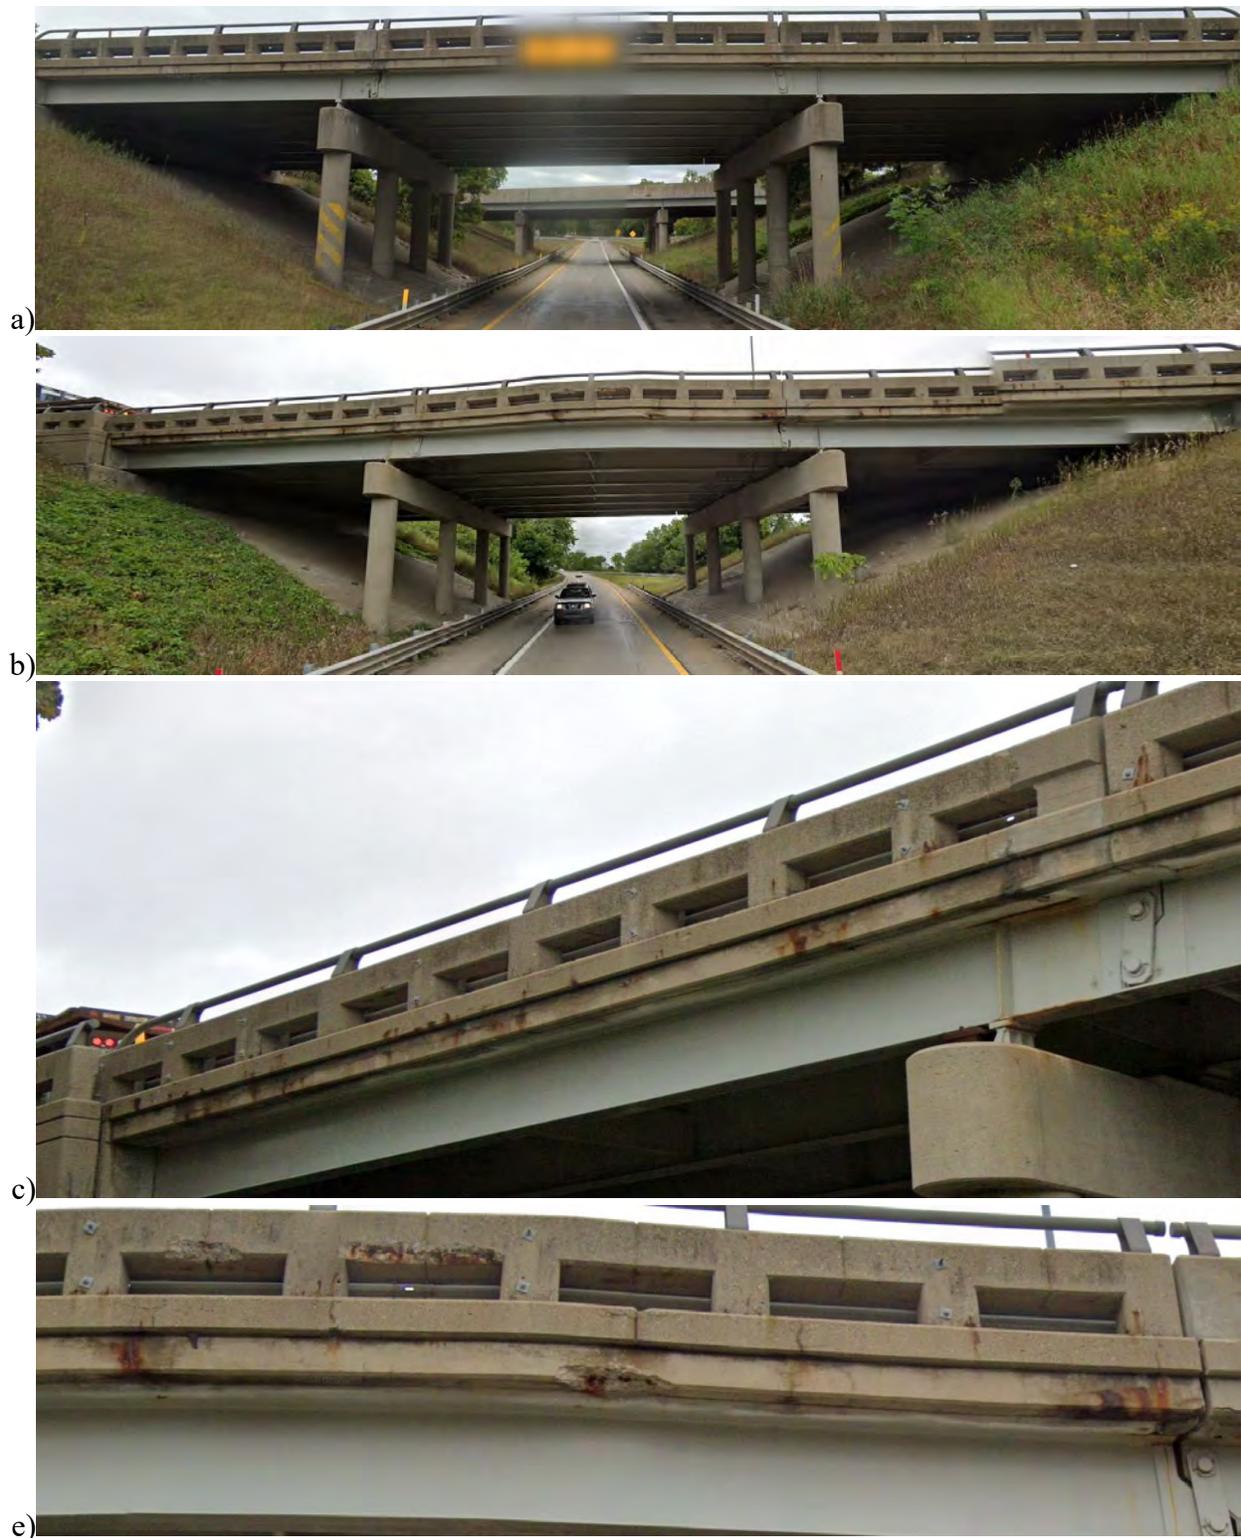
Fig. D.17 I-496 WB over US-127 SB Ramp: a) lower side; b-e) upper side

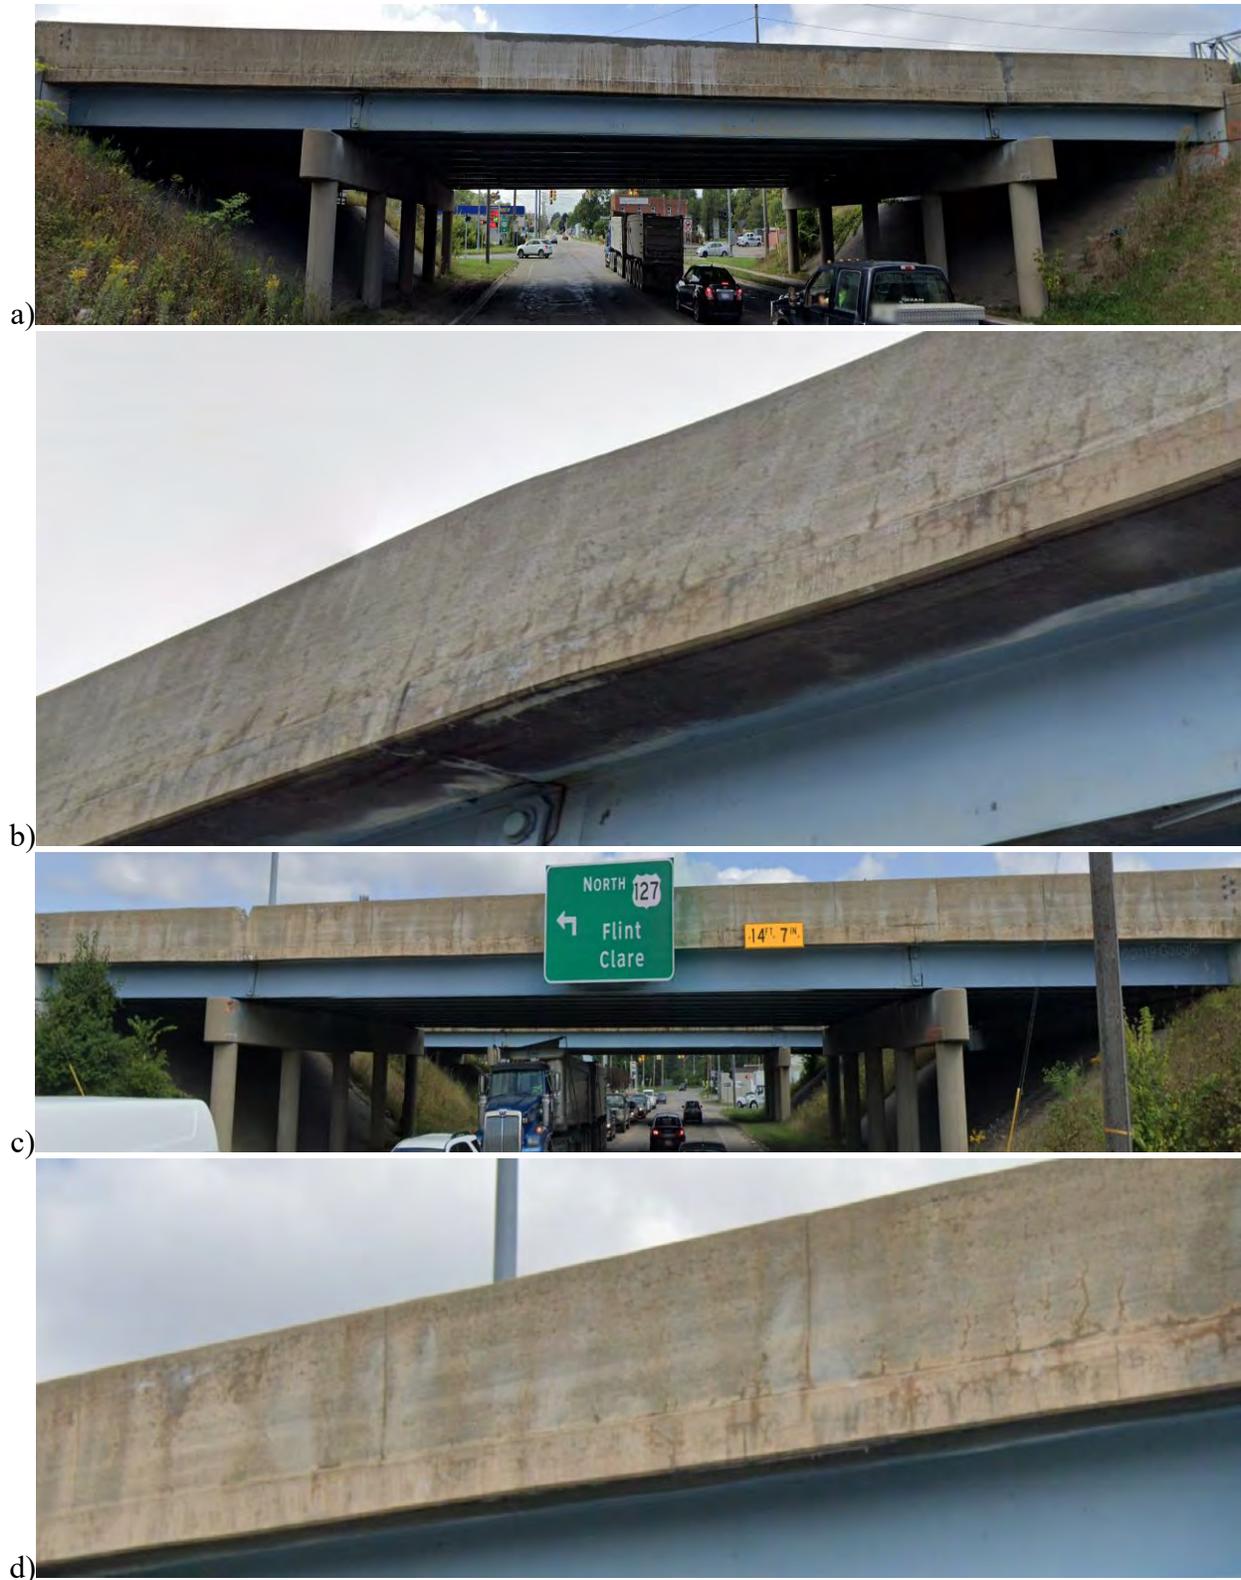
Fig. D.18 US-127 SB over Kalamazoo St.: a-b) lower side; c-d) upper side

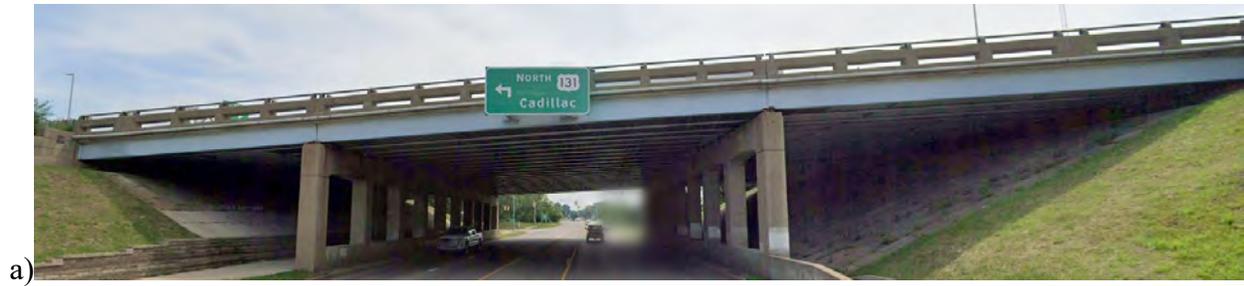
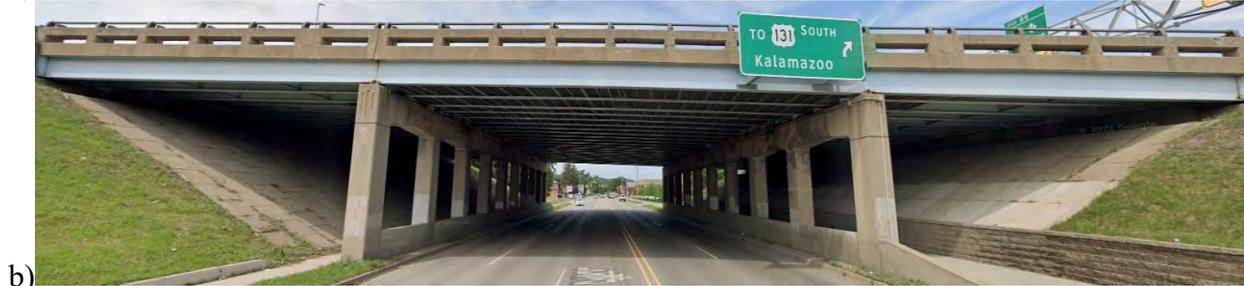
Fig. D.19 I-296WB / US-131 over Ann St.: a) lower side; b) upper side

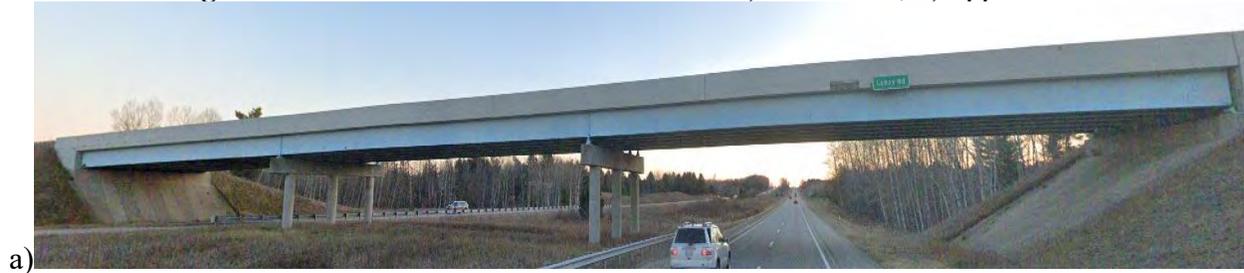
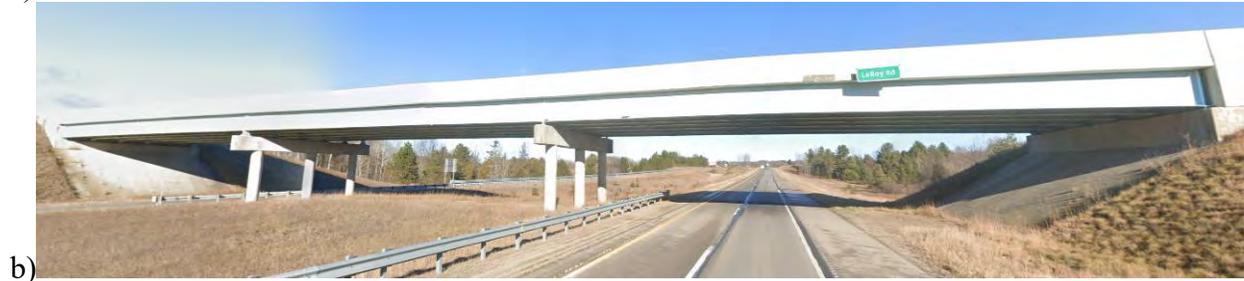
Fig. D.20 Leroy Rd. over US-131: a) lower side; b) upper side

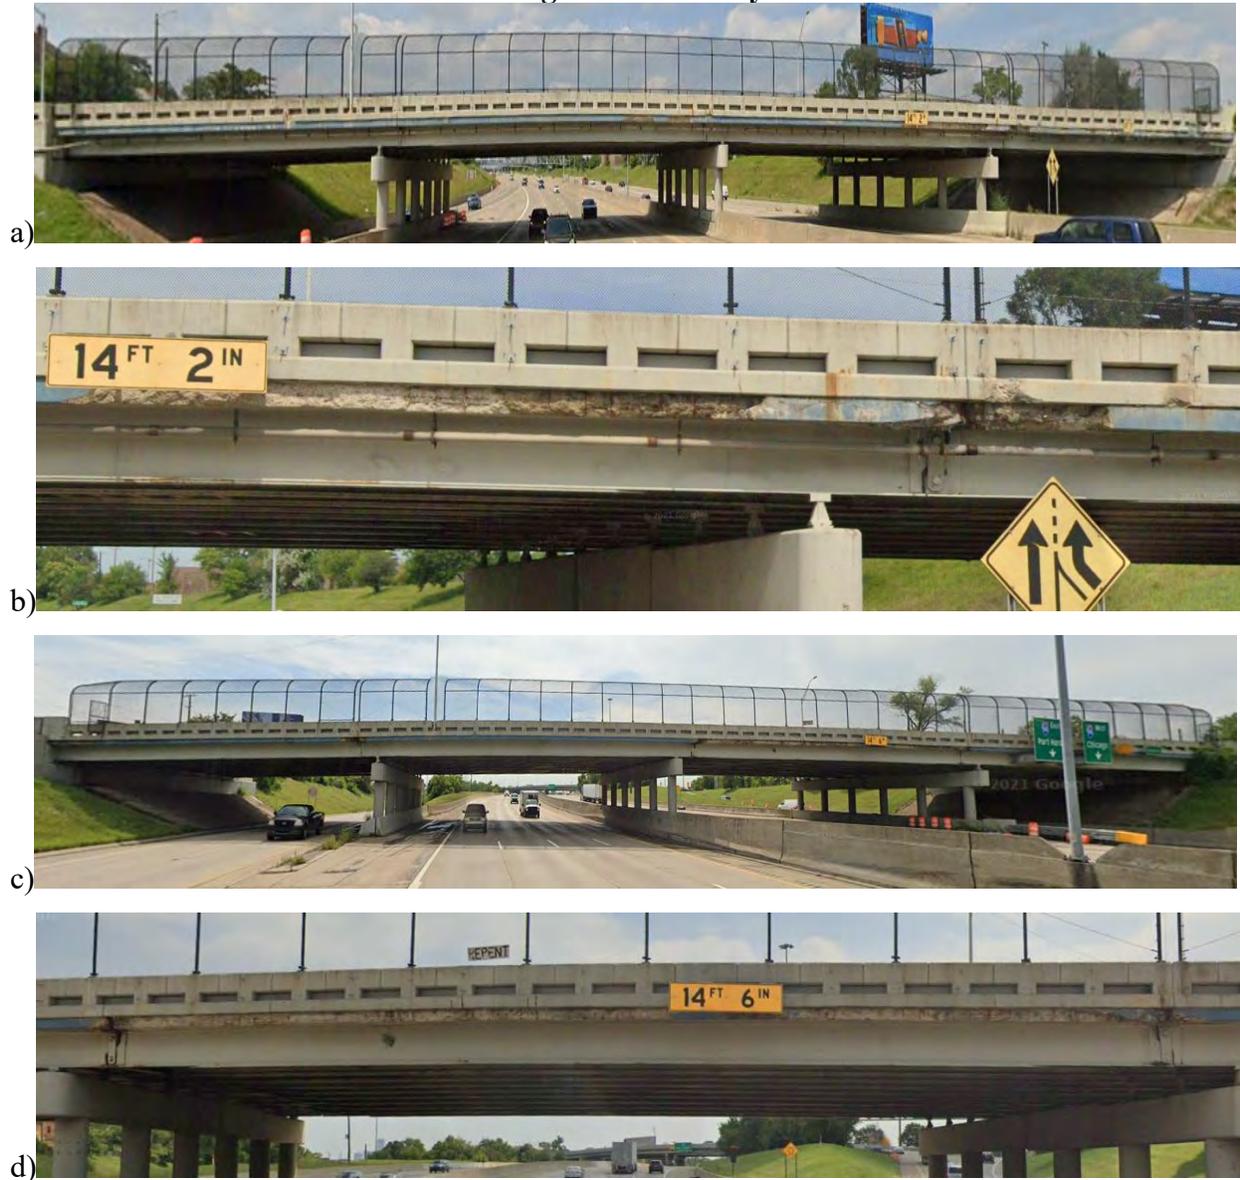
Fig. D.21 McGraw Ave. over I-96 in Detroit: a-b) lower side; c-d) upper side
