Repair of Bridge Deck Fascias
OR22-002

Final Report

Michigan Department of Transportation

1. Report No. SPR-1730	2. Government Accession No. N/A	3. Recipient's Catalog No.	
4. Title and Subtitle Repair of Bridge Deck Fascias	5. Report Date 09/30/2023

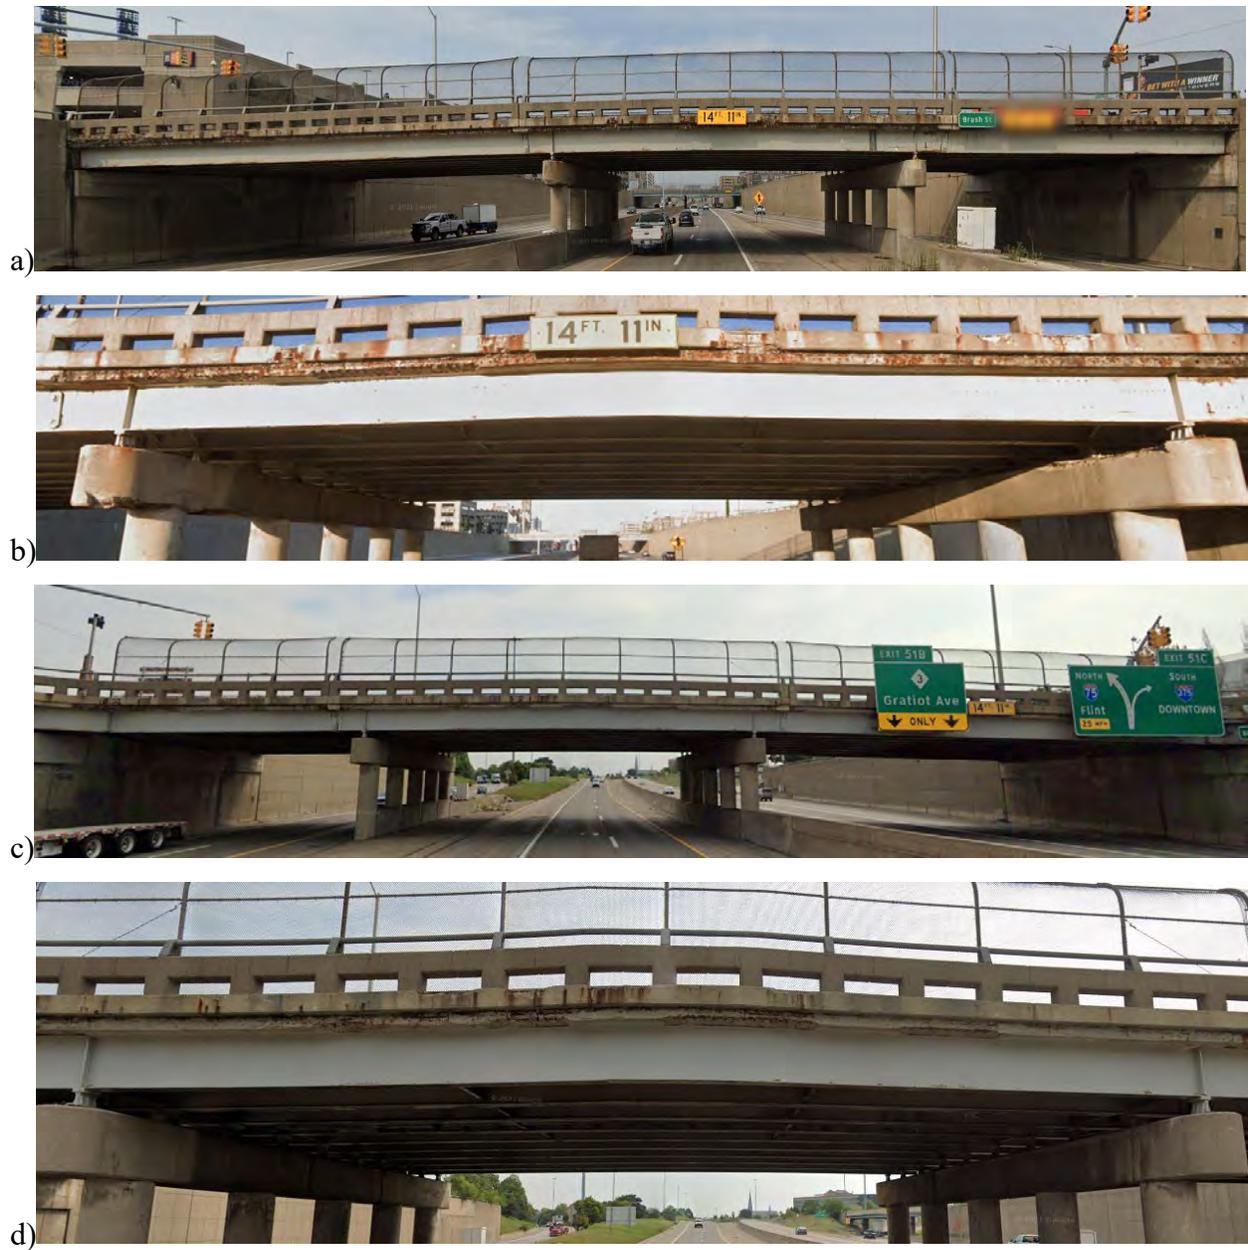
Fig. D.22 Brush St. over I-75: a-b) lower side; c-d) upper side

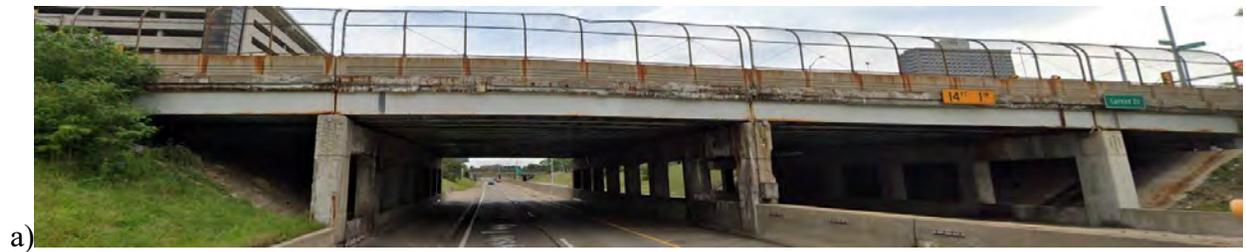
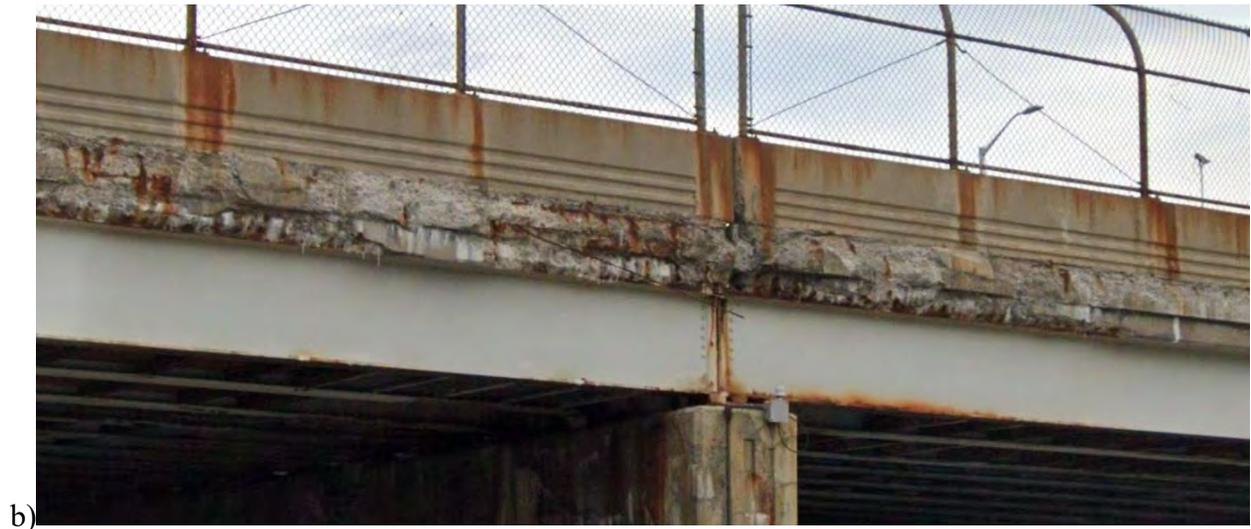
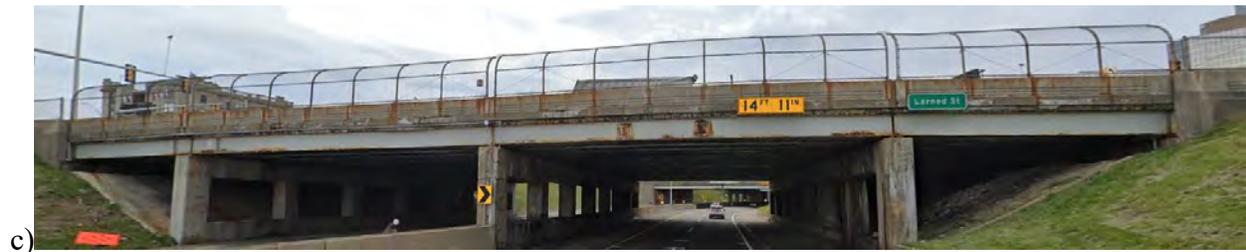
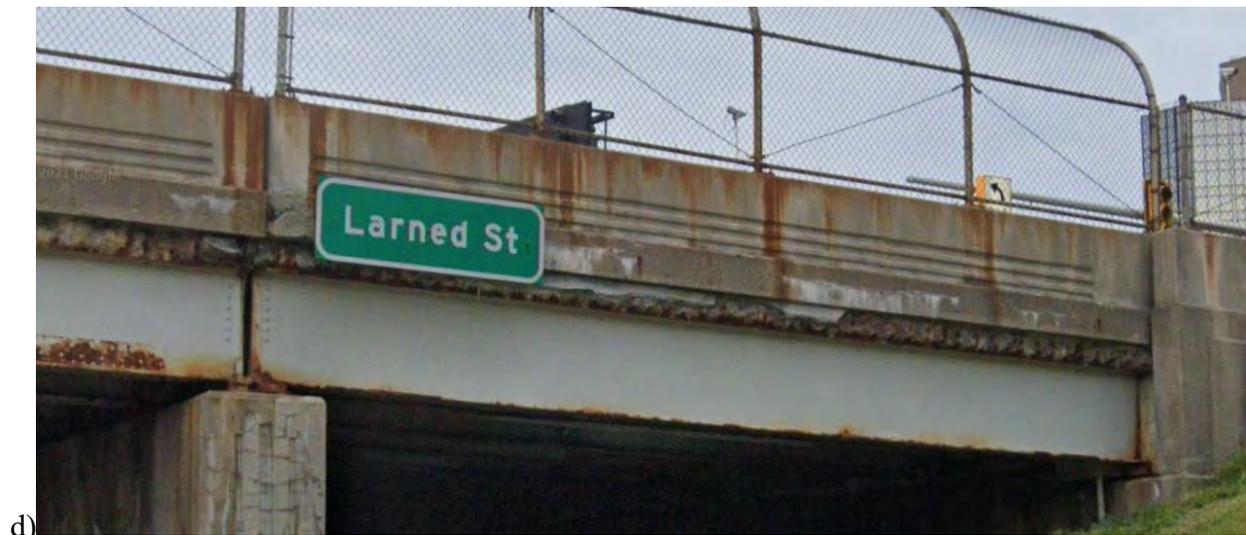
Fig. D.23 Larned St. over I-375: a-b) lower side; c-d) upper side

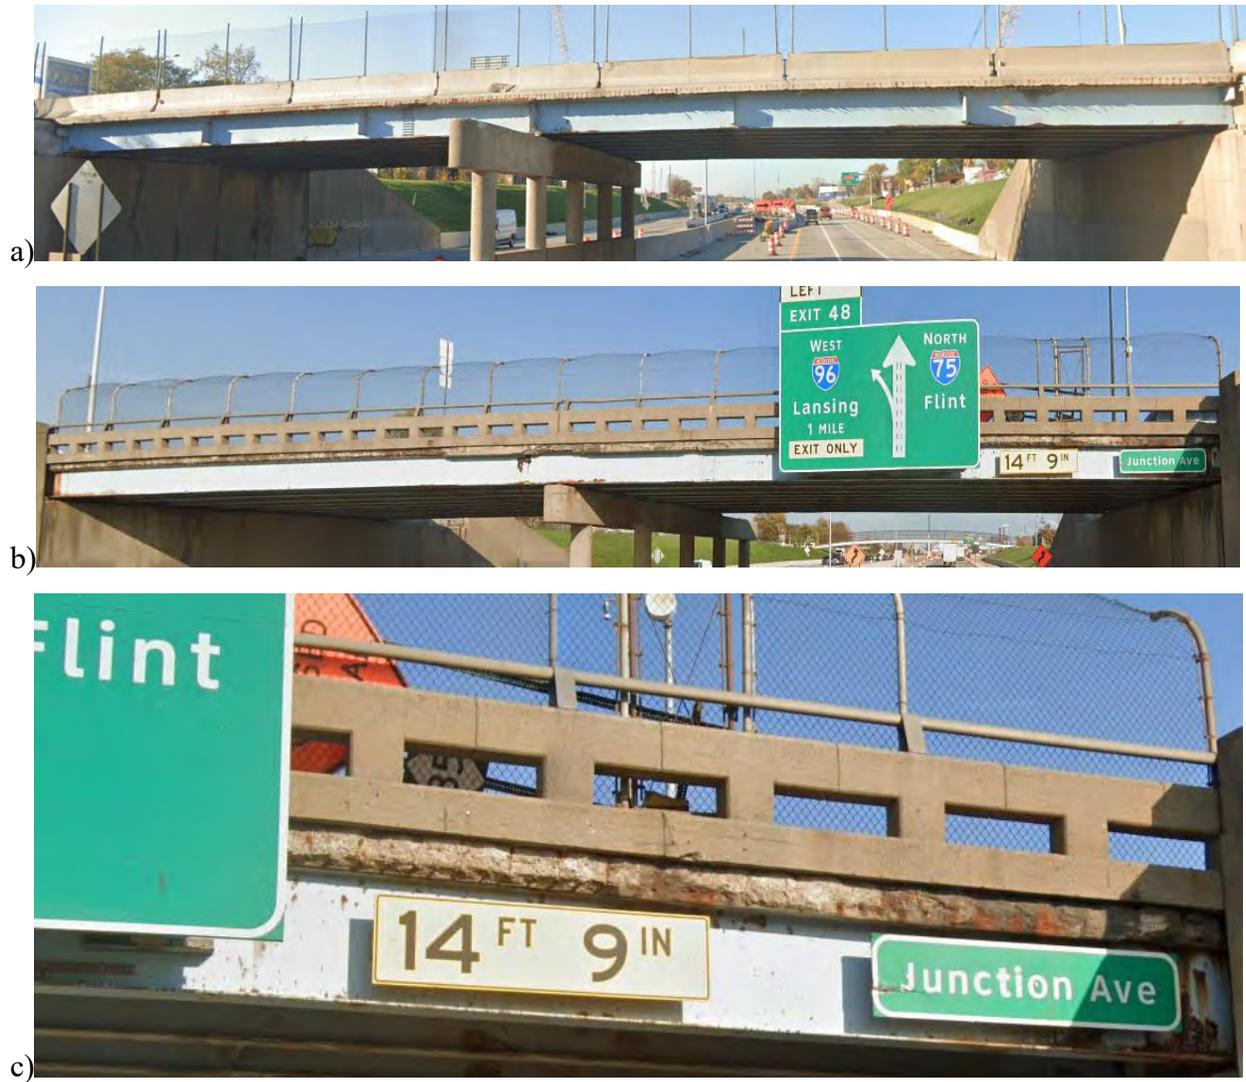
Fig. D.24 Junction Ave. over I-75: a) lower side; b-c) upper side

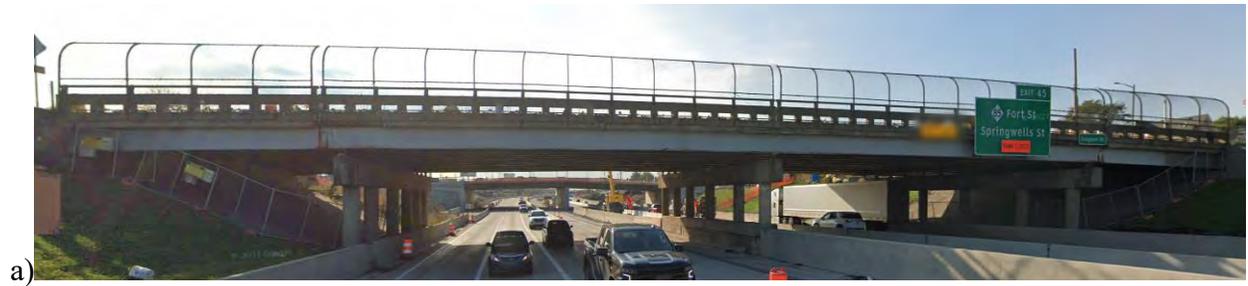
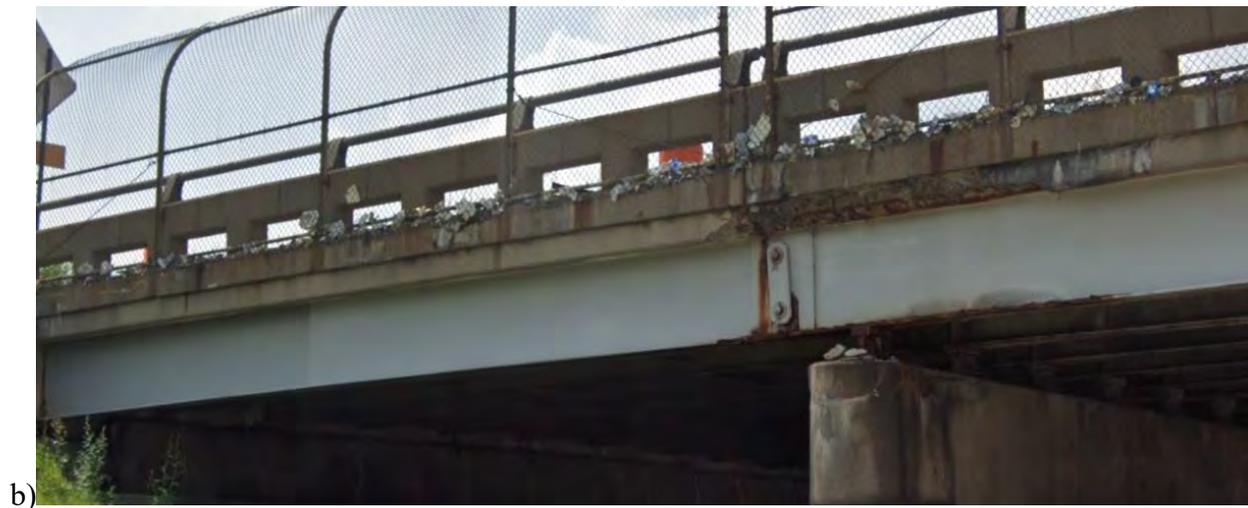
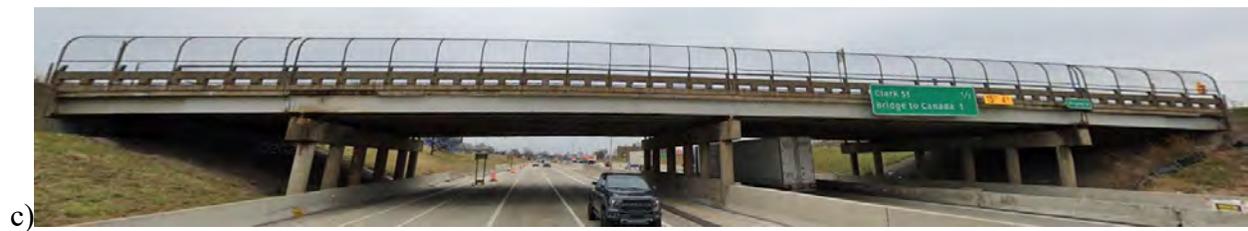
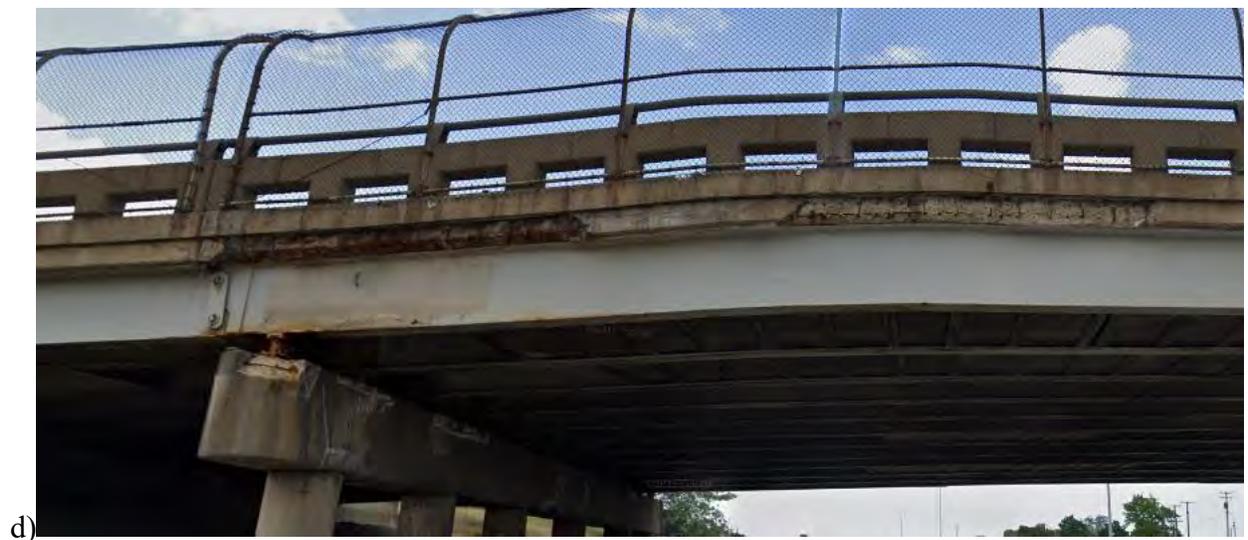
Fig. D.25 Dragon St. over I-75: a-b) lower side; c-d) upper side

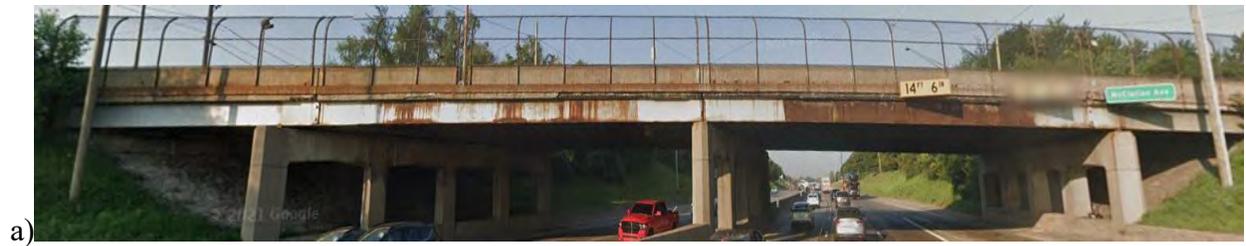
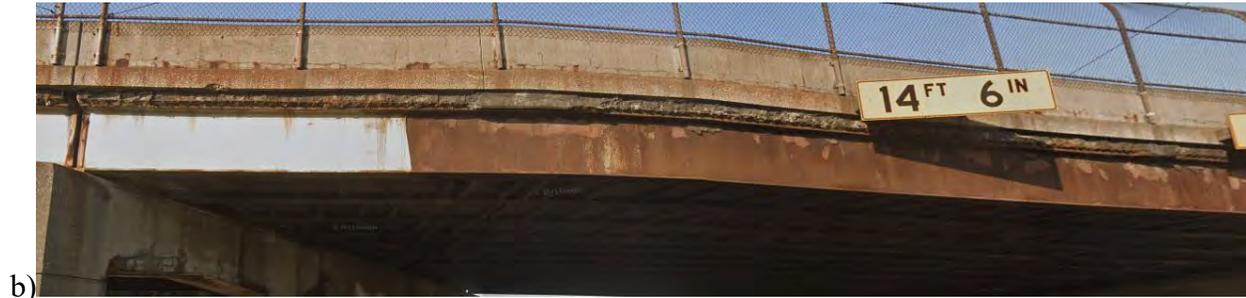
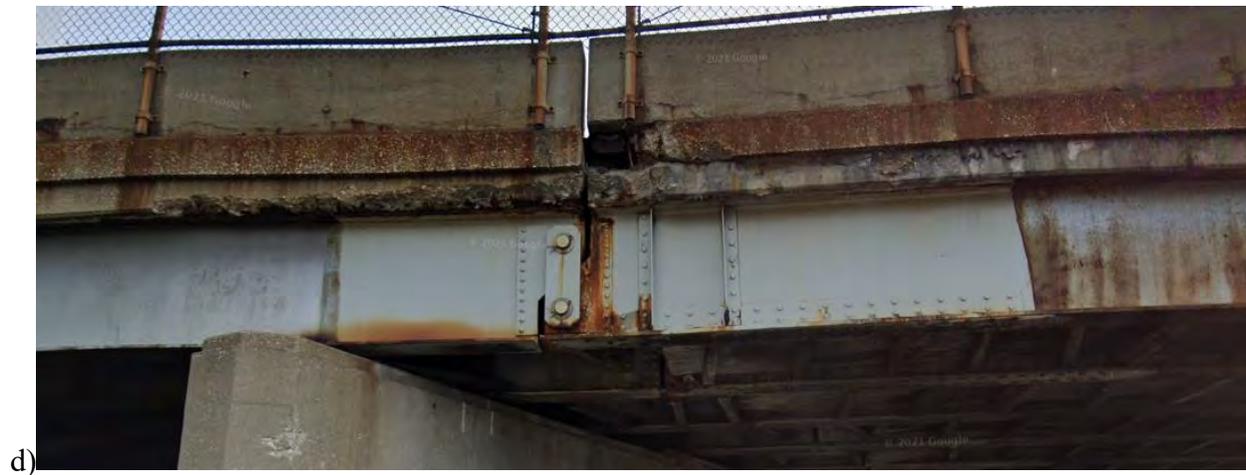
Fig. D.26 McClellan Ave. over I-94: a-b) lower side; c-d) upper side

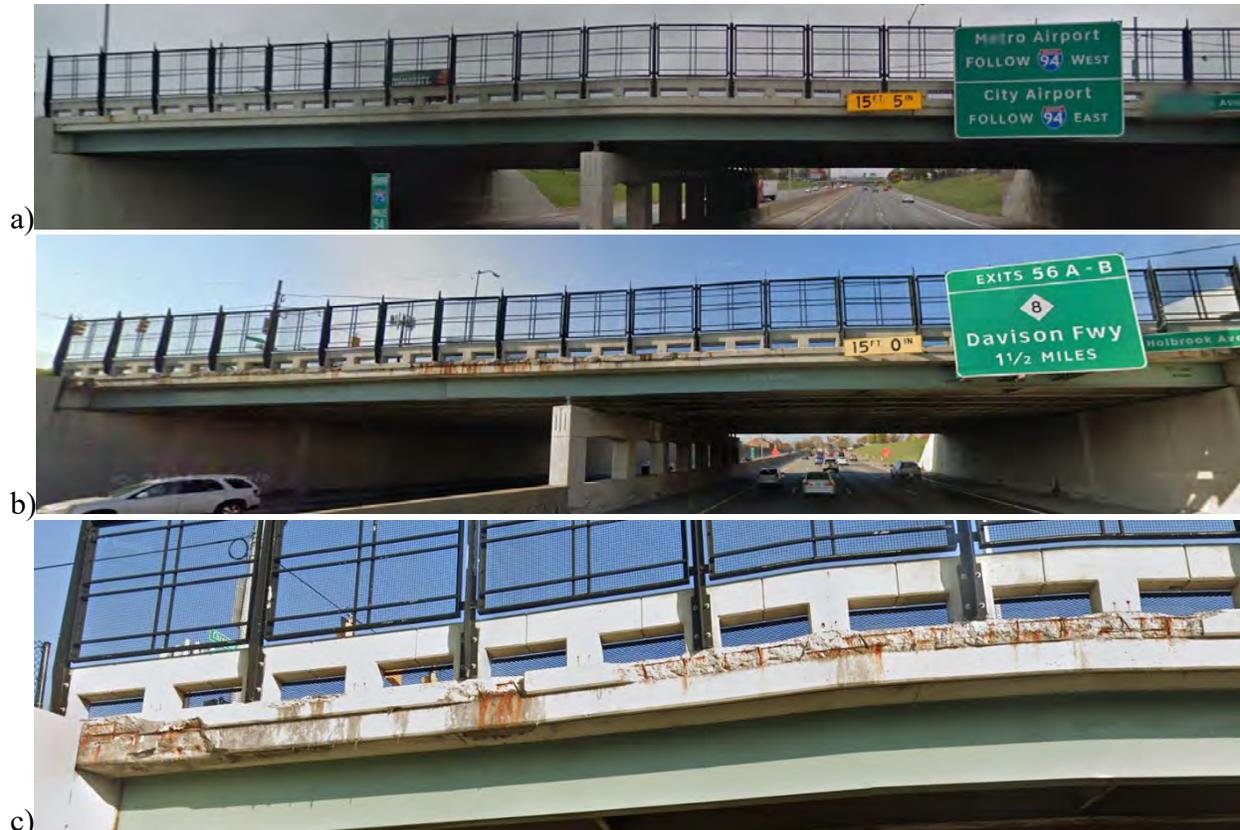
Fig. D.27 Holbrook Ave. over I-75: a) lower side; b-c) upper side

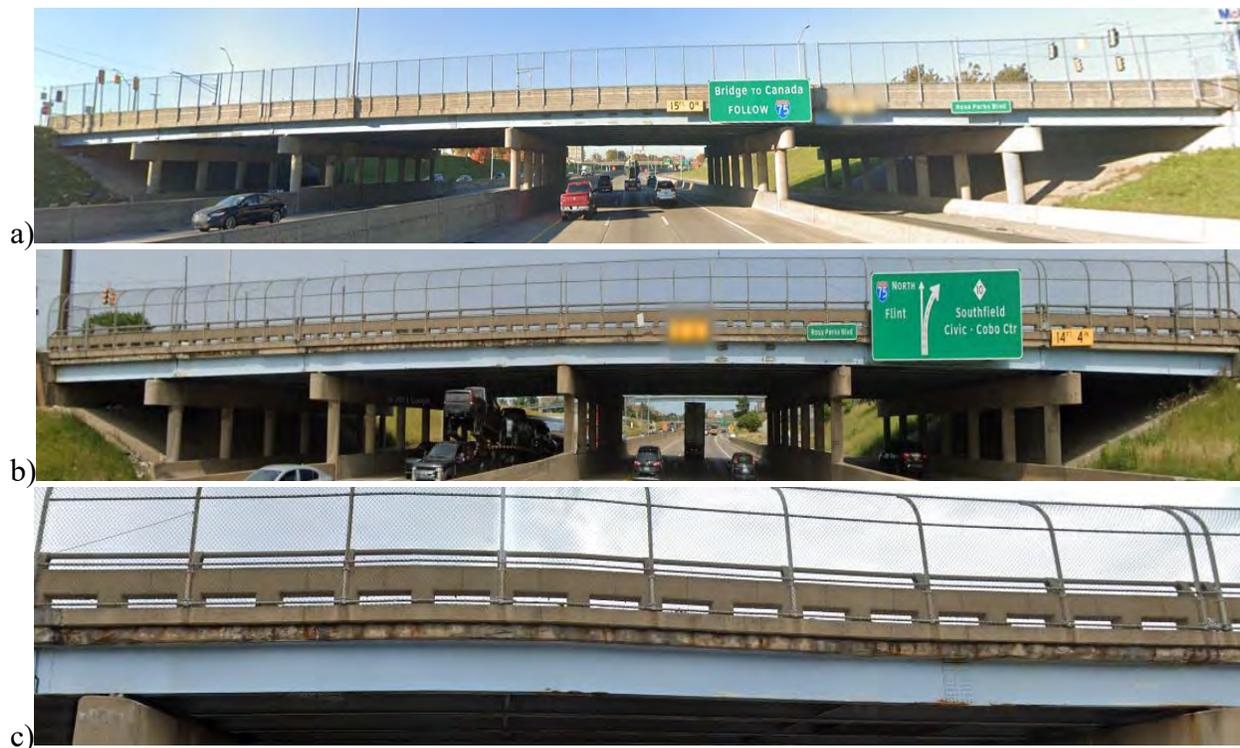
Fig. D.28 Rosa Parks Blvd. over I-75: a) lower side; b-c) upper side
