Report No. CDOT-DTD-R-91-4

# **RUT-RESISTANT COMPOSITE PAVEMENT DESIGN**

Donna S. Harmelink  
Colorado Department of Transportation  
4201 East Arkansas Avenue  
Denver, Colorado 80222

Final Report  
July 1991

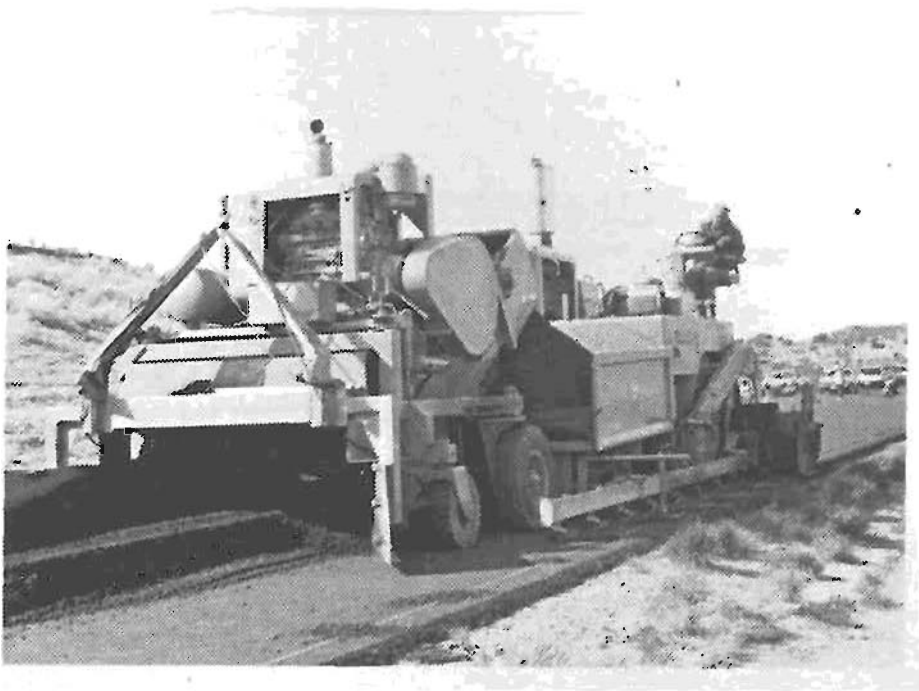
PHOTO 1

A paving operation  
using windrow  
placement.

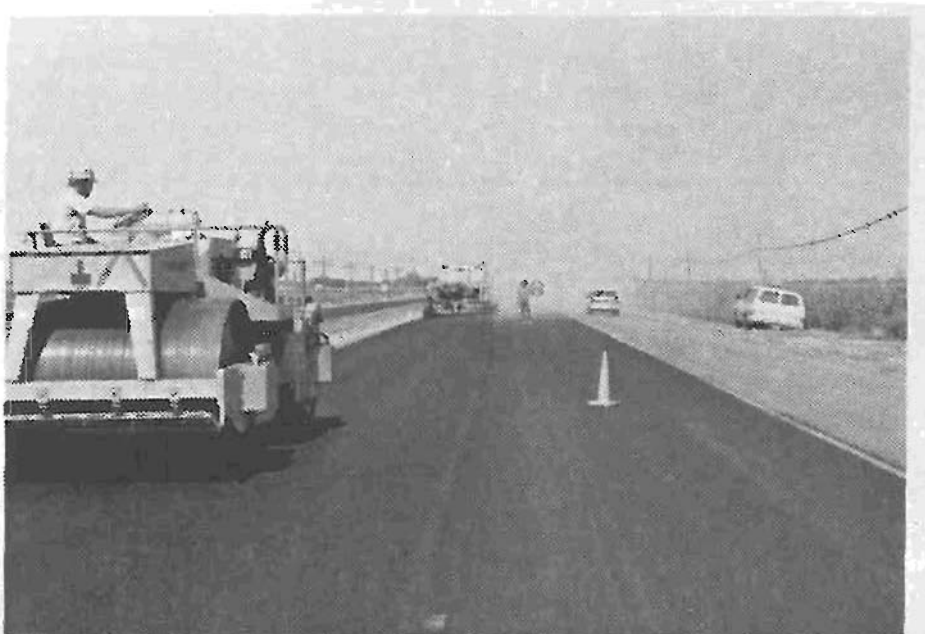
PHOTO 2

Steel-wheeled  
roller used for  
break down.

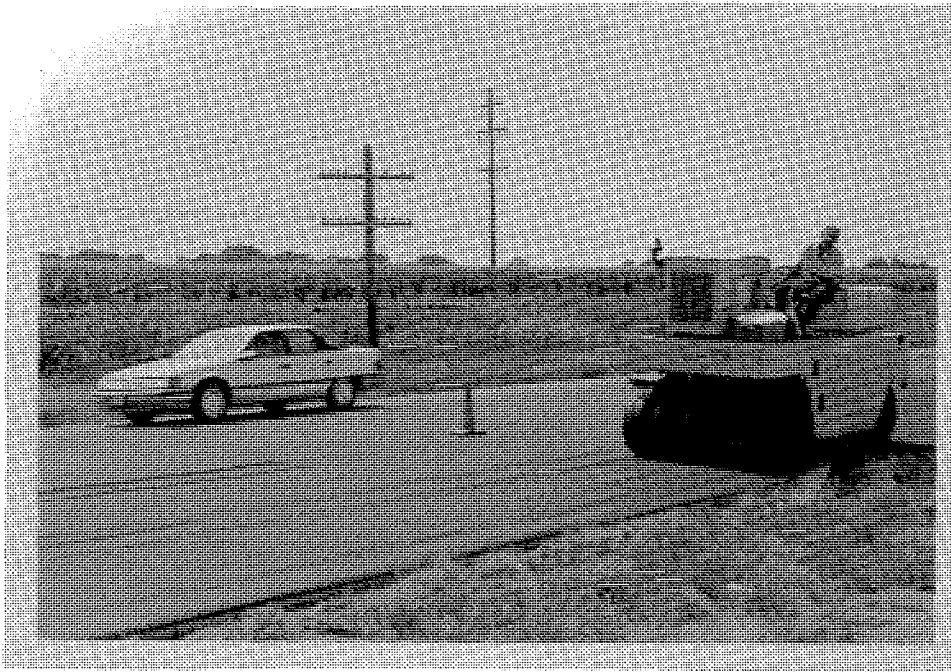
PHOTO 3

Pneumatic roller  
was used prior to  
finish roller.

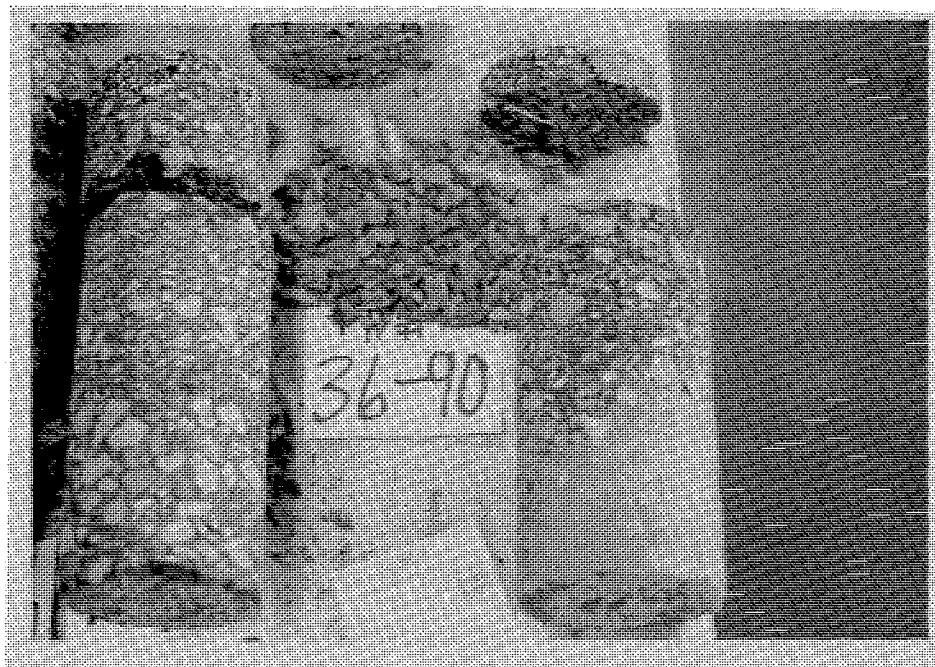
PHOTO 5

At most of the evaluation sites the cores showed signs of stripping progressing from year to year in the layer immediately below the PMSC, some sites more severe than others. A comparison of a core taken in 1990 at the Debeque location to a core taken in 1991 at the same location is shown in Photo 4. The core in Photo 5 was taken from C470 in 1990.

This photo shows an extreme case of stripping below the PMSC. Both cores were taken out of C470 in 1990.
